### **Tree Preservation and Removal Proposal**

**Proposed Development at  
Fanling Sheung Shui Town Lot No. 245,  
On Kui Street, Fanling, New Territories**

**TREE PRESERVATION AND REMOVAL PROPOSAL  
(PINK AREA)  
RE-SUBMISSION**

**Oriental Landscapes Limited**  
**東方綠化有限公司**

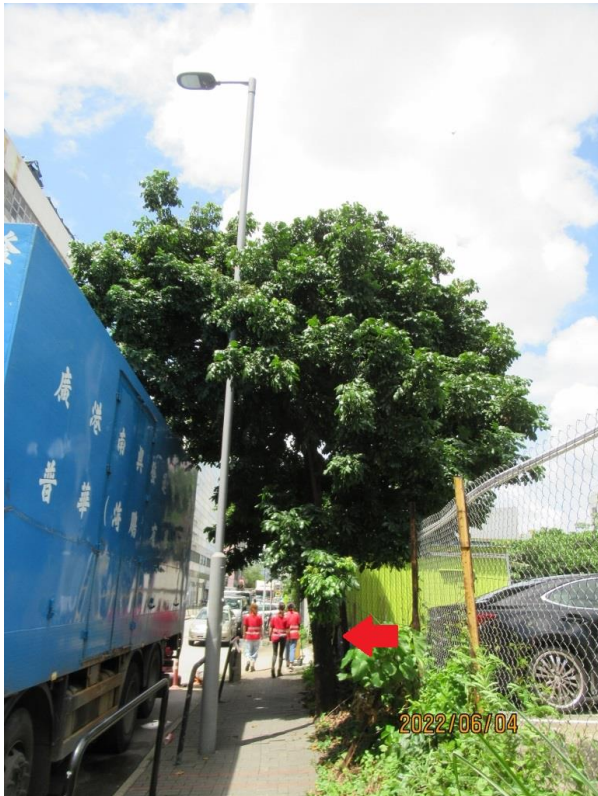
T1 Overall View - **FELL**  
(under separation submission)

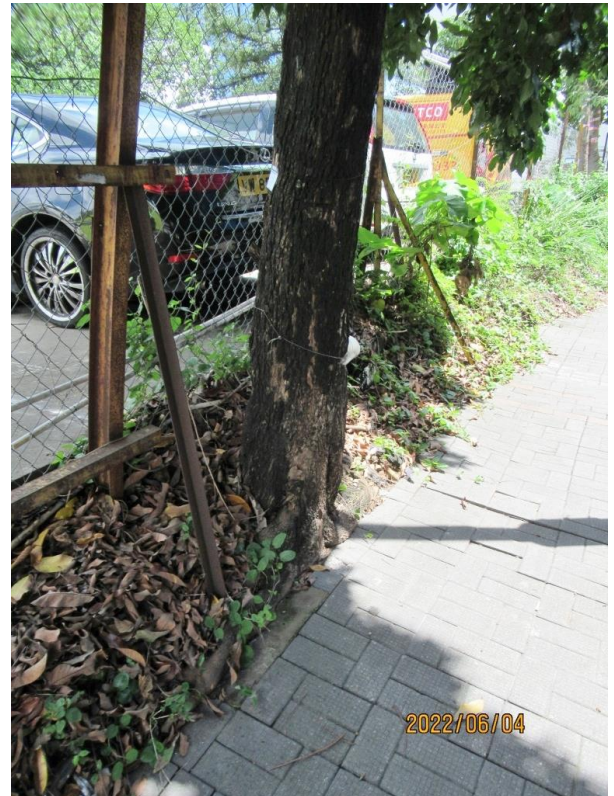
T1 Lower Trunk & Ground Condition - **FELL**  
(under separation submission)

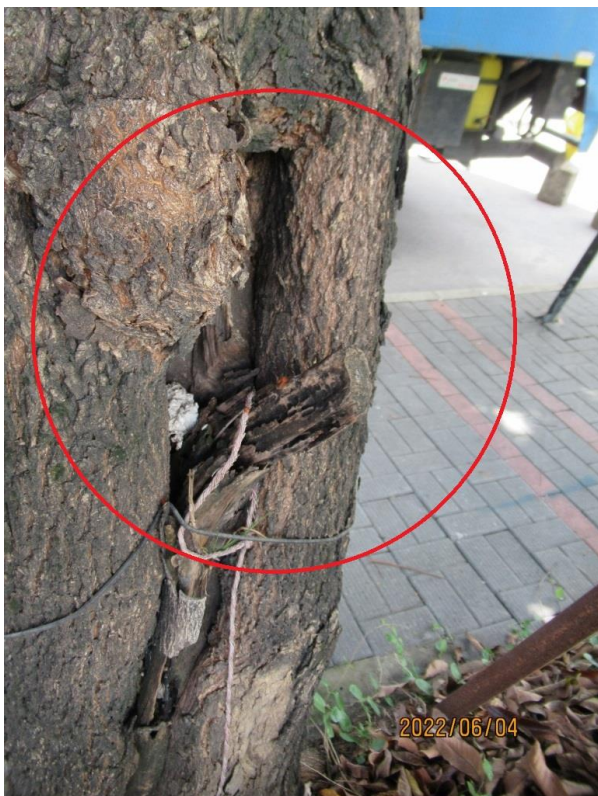
T1 Cavity on Trunk - **FELL**  
(under separation submission)

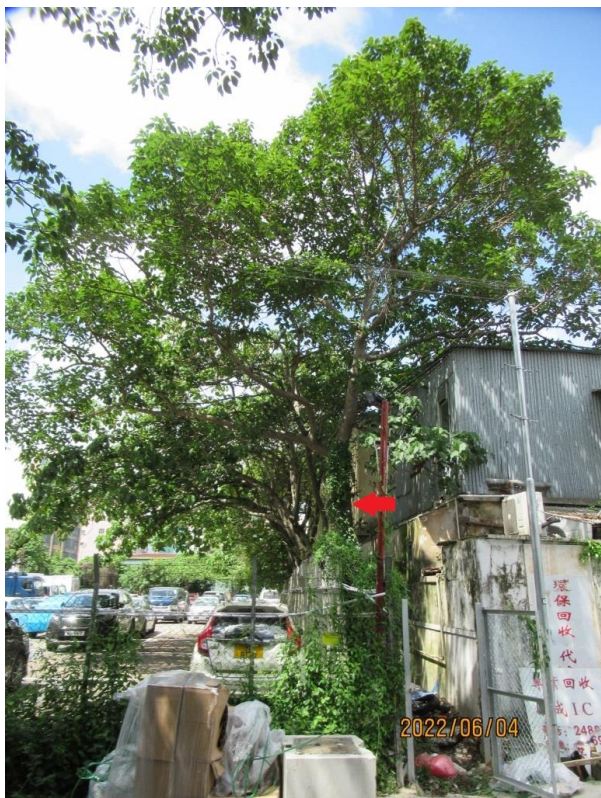
| Tree No. | Scientific Name | Chinese Name | Original Location<br>(Lot/GA/<br>YA/GHBA,<br>etc.) | Tree Size | | | Form | Health Condition<br><br>(Good/ Fair/<br>Poor) | Structural Condition | Anticipated survival rate after transplanting | | Conservati<br>on status | Proposed Treatment | | Additional Remarks |
|---|---|---|---|---|---|---|---|---|---|---|---|---|---|---|---|
| T4 | <i>Ficus variegata</i> | 青果榕 | Lot | 13 | 430 | 9 | | Poor | Fair | Low | b, c, f | N | Fell | A,E | Forked, vined, buttress roots, root restricted by pavement & foundation, shared root zone with other tree |

T4 Overall view - **FELL**

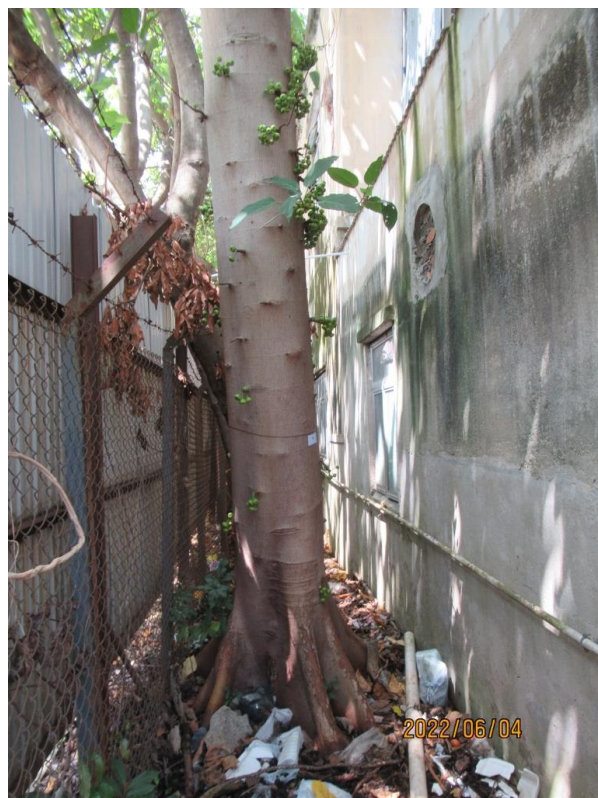
T4 Lower Trunk & Ground Condition - **FELL**

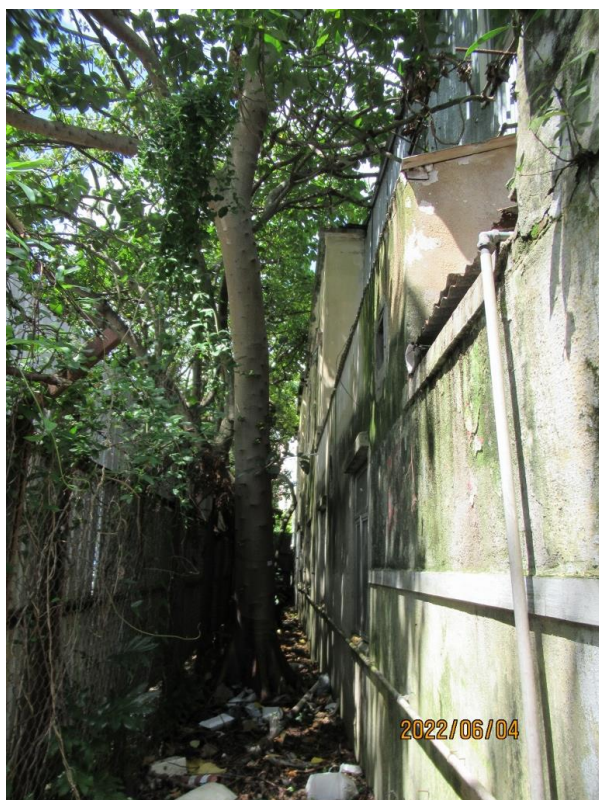
T4 Trunk Condition - **FELL**

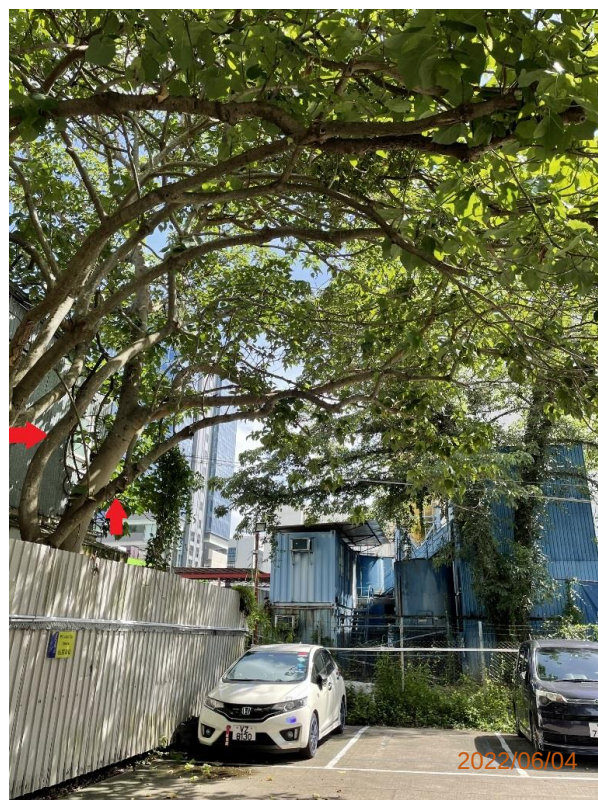
| Tree No. | Scientific Name | Chinese Name | Original Location<br>(Lot/GA/<br>YA/GHBA,<br>etc.) | Tree Size | | | Form | Health Condition<br><br>(Good/ Fair/<br>Poor) | Structural Condition | Anticipated survival rate after transplanting | | Conservati<br>on status | Proposed Treatment | | Additional Remarks |
|---|---|---|---|---|---|---|---|---|---|---|---|---|---|---|---|
| T5 | <i>Macaranga tanarius var. tomentosa</i> | 血桐 | Lot | 8 | 240 | 6 | | Poor | Fair | Low | a, b, c, f | N | Fell | A,E | Leaning, codominant main branches, root restricted by pavement & foundation, shared root zone with other tree |

T5 Overall view - **FELL**

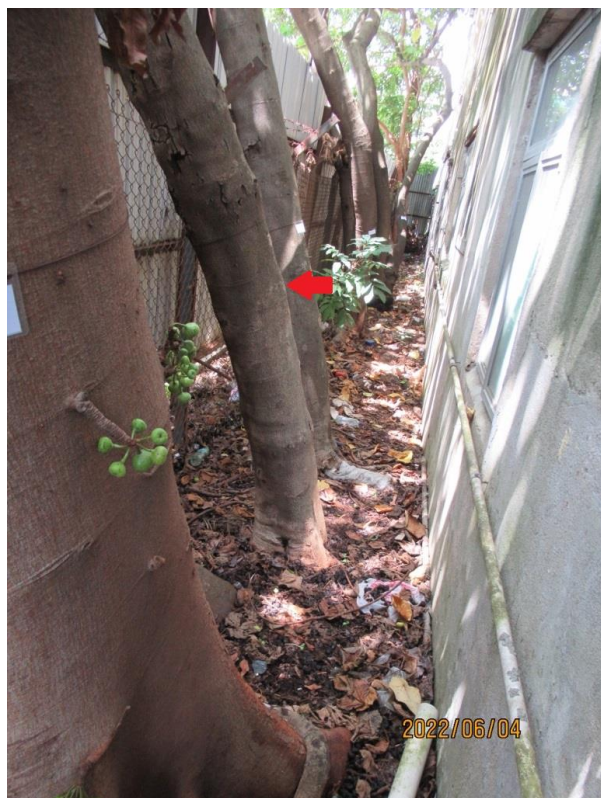
T5 Lower Trunk Ground Condition - **FELL**

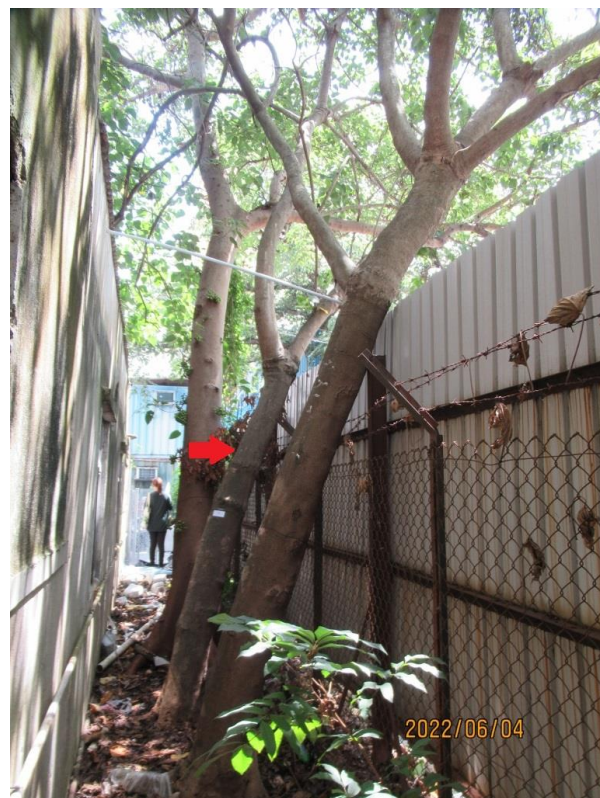
T5 Trunk Condition - **FELL**

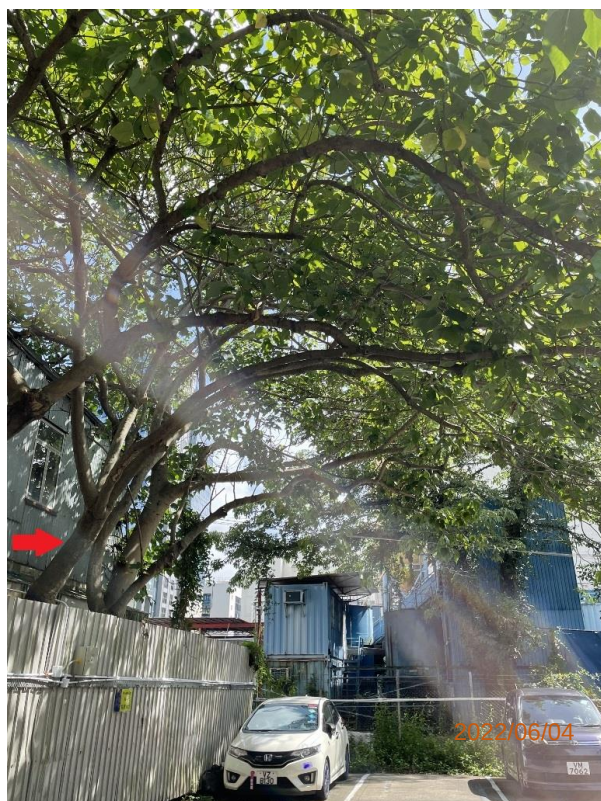
| Tree No. | Scientific Name | Chinese Name | Original Location<br>(Lot/GA/<br>YA/GHBA,<br>etc.) | Tree Size | | | Form | Health Condition<br><br>(Good/ Fair/<br>Poor) | Structural Condition | Anticipated survival rate after transplanting | | Conservati<br>on status | Proposed Treatment | | Additional Remarks |
|---|---|---|---|---|---|---|---|---|---|---|---|---|---|---|---|
| T6 | <i>Macaranga tanarius var. tomentosa</i> | 血桐 | Lot | 8 | 270 | 6 | | Poor | Fair | Low | a, b, c, f | N | Fell | A,E | Leaning, codominant main branches, root restricted by pavement & foundation, shared root zone with other tree |

T6 Overall view - **FELL**

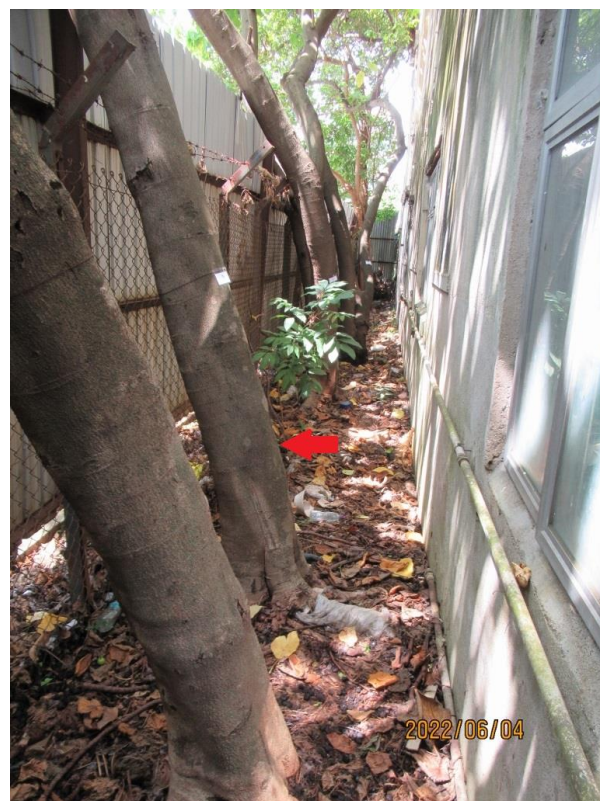
T6 Lower Trunk & Ground Condition - **FELL**

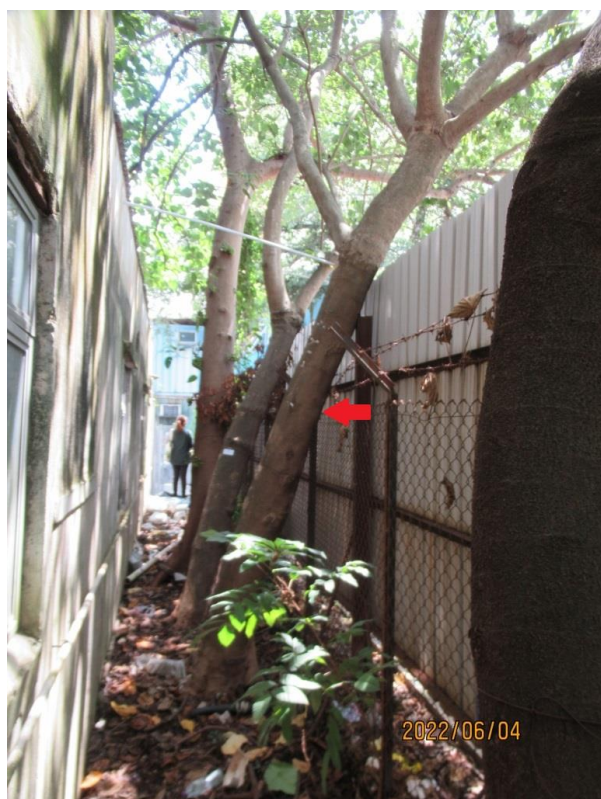
T6 Trunk Condition - **FELL**

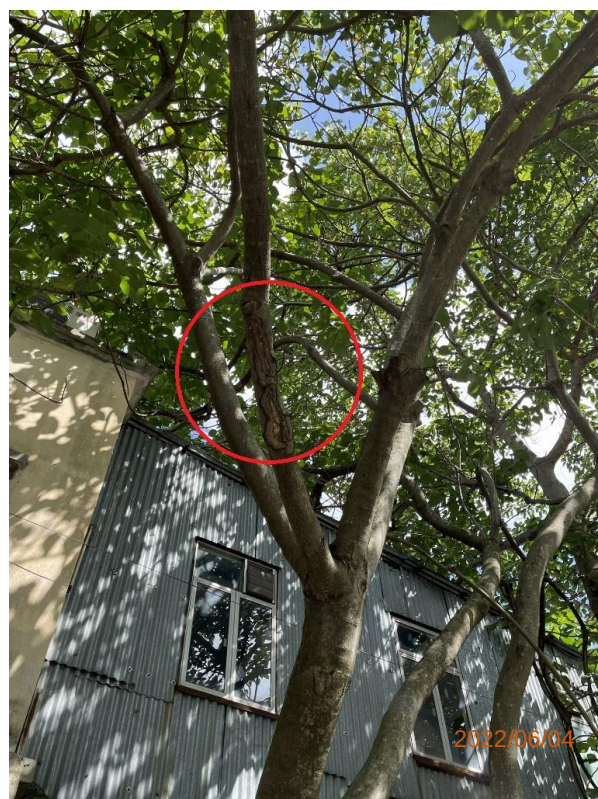
T6 Wound on Branch - **FELL**

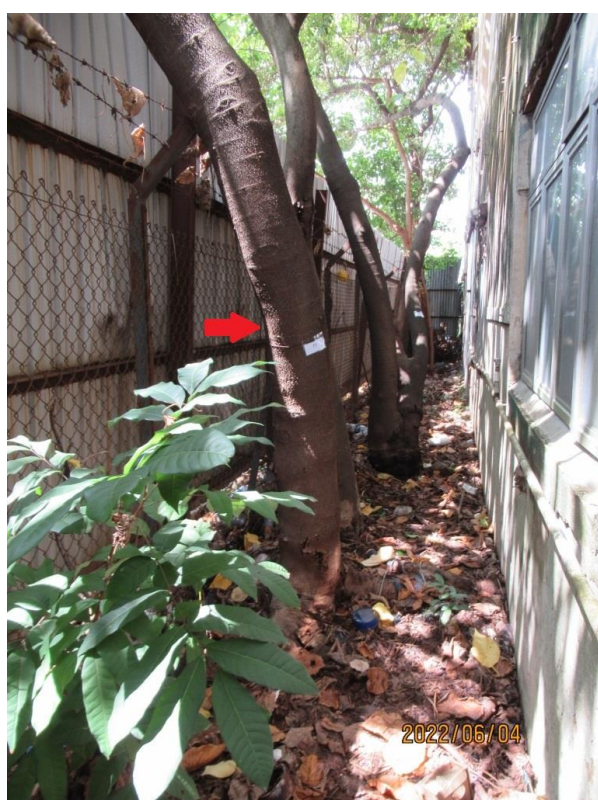
T7 Lower Trunk & Ground Condition - **FELL**

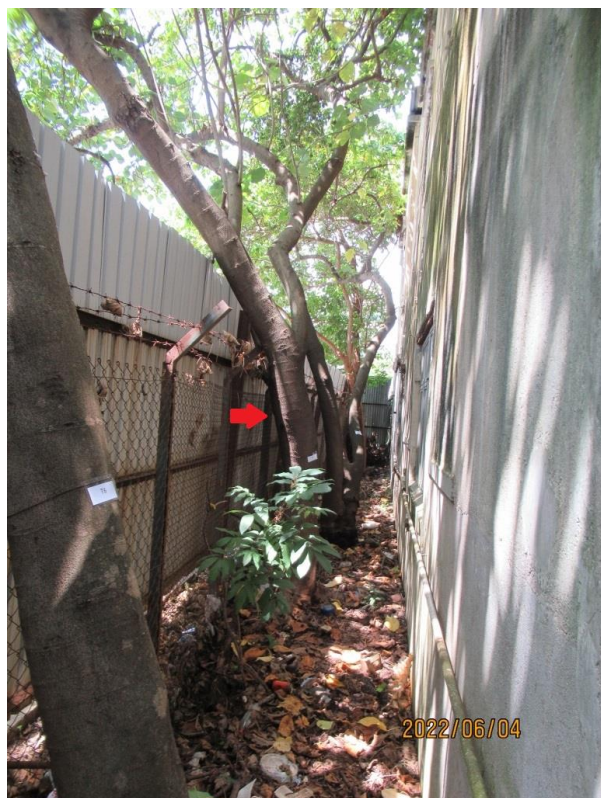
| Tree No. | Scientific Name | Chinese Name | Original Location<br>(Lot/GA/<br>YA/GHBA,<br>etc.) | Tree Size | | | Form | Health Condition<br><br>(Good/ Fair/<br>Poor) | Structural Condition | Anticipated survival rate after transplanting | | Conservati<br>on status | Proposed Treatment | | Additional Remarks |
|---|---|---|---|---|---|---|---|---|---|---|---|---|---|---|---|
| T7 | <i>Macaranga tanarius var. tomentosa</i> | 血桐 | Lot | 8 | 243 | 5 | | Poor | Poor | Low | a, b, c, f | N | Fell | A,E | Leaning, codominant main branches, wound on branch, root restricted by pavement & foundation, shared root zone with other tree |

T7 Trunk Condition - **FELL**

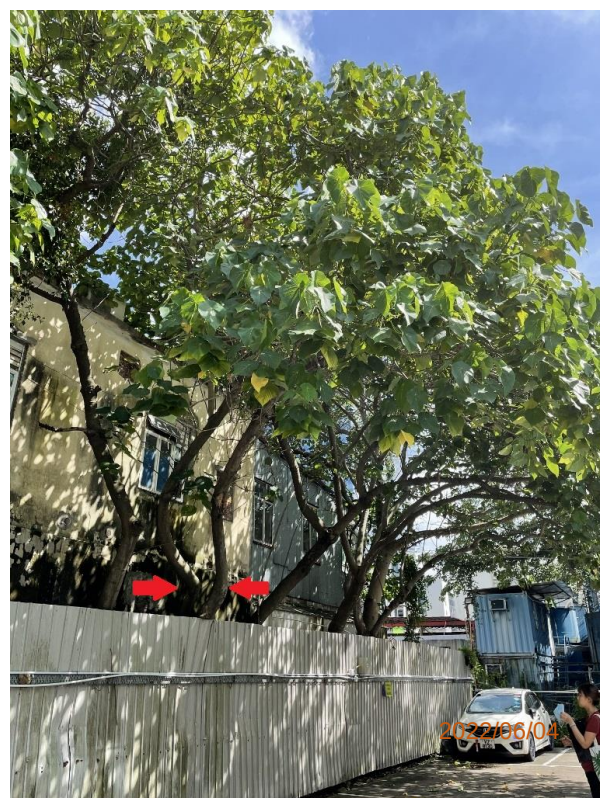
| Tree No. | Scientific Name | Chinese Name | Original Location<br>(Lot/GA/<br>YA/GHBA,<br>etc.) | Tree Size | | | Form | Health Condition<br><br>(Good/ Fair/<br>Poor) | Structural Condition | Anticipated survival rate after transplanting | | Conservati<br>on status | Proposed Treatment | | Additional Remarks |
|---|---|---|---|---|---|---|---|---|---|---|---|---|---|---|---|
| T8 | <i>Macaranga tanarius var. tomentosa</i> | 血桐 | Lot | 9 | 247 | 4 | | Poor | Fair | Low | a, b, c, f | N | Fell | A,E | Leaning, codominant main branches, cavity on main branch, wound on branch, trunk embedded with hoarding, root restricted by pavement & foundation, shared root zone with other tree |

T8 Overall view - **FELL**

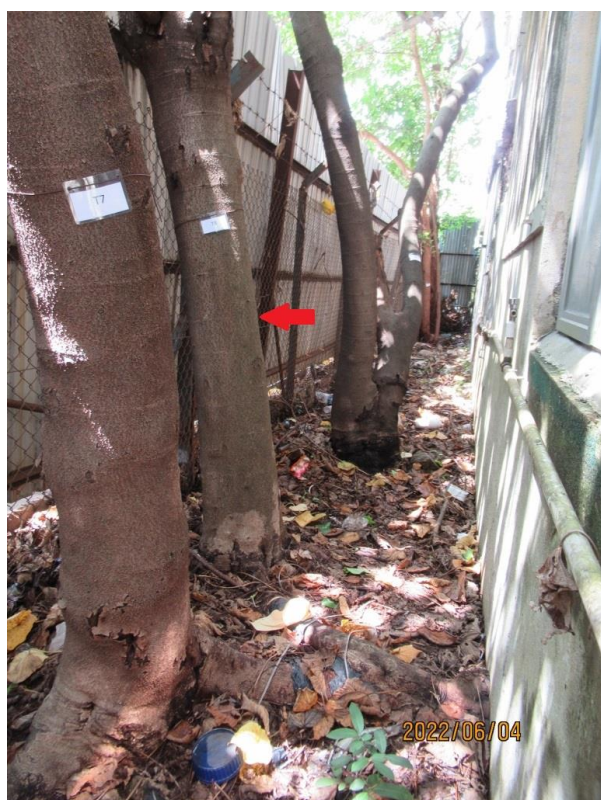
T8 Lower Trunk & Ground Condition - **FELL**

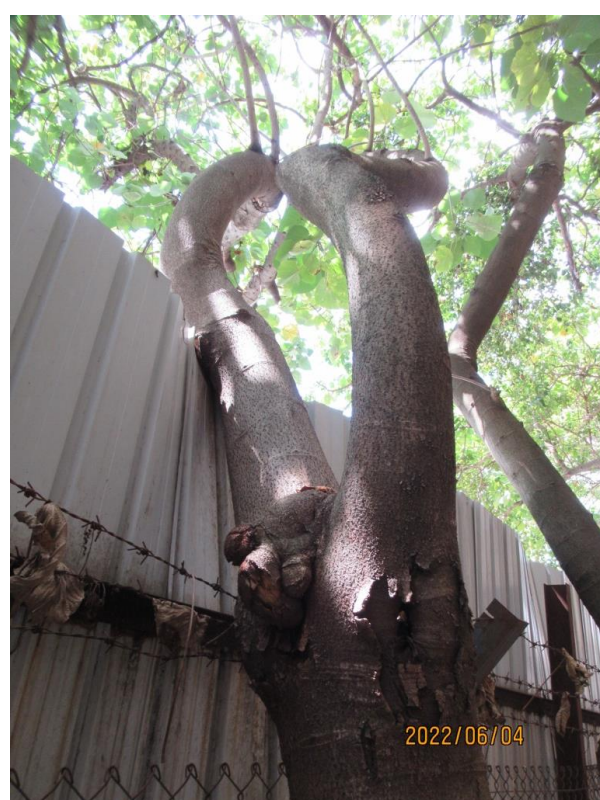
T8 Trunk Condition - **FELL**

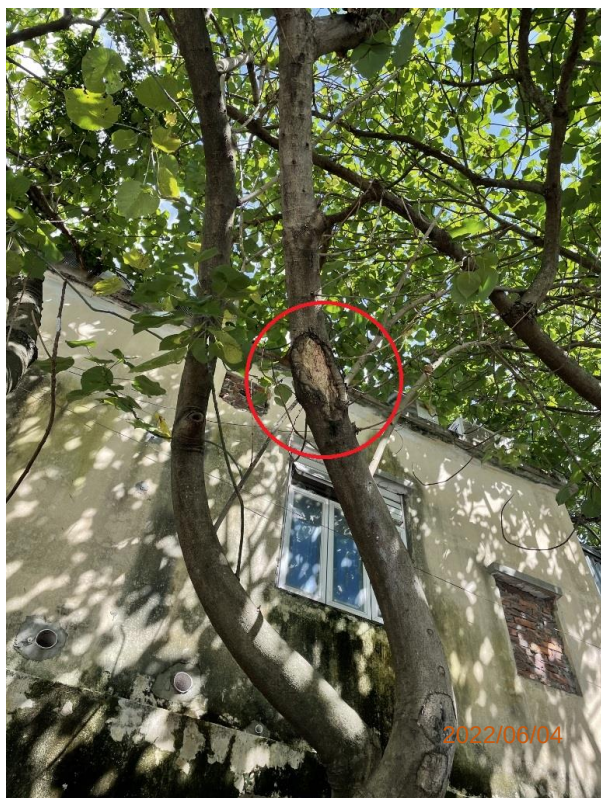
T8 Wound on Branch - **FELL**

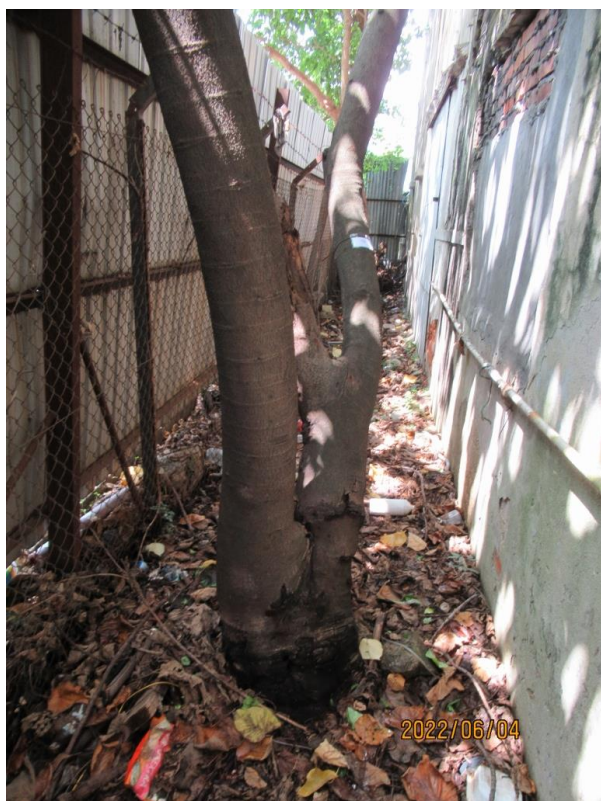
T9 Lower Trunk & Ground Condition - **FELL**

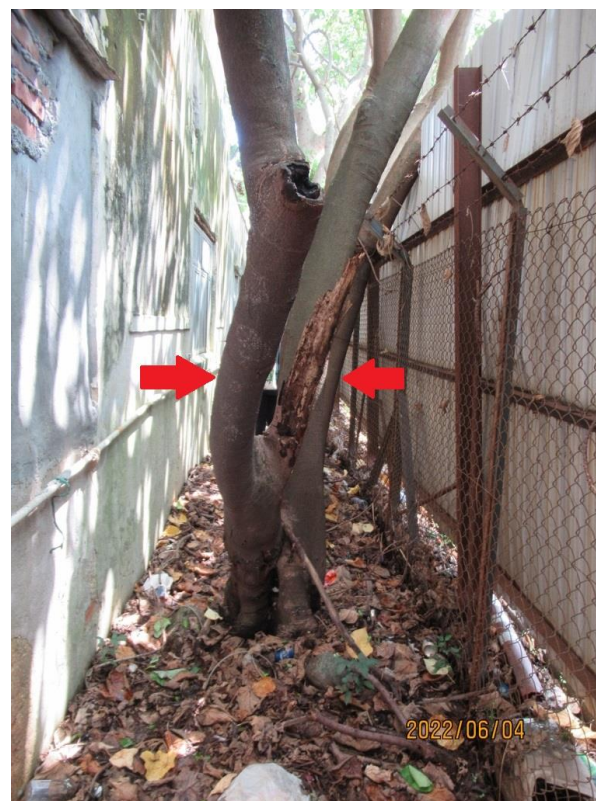
T9 Trunk Condition - **FELL**

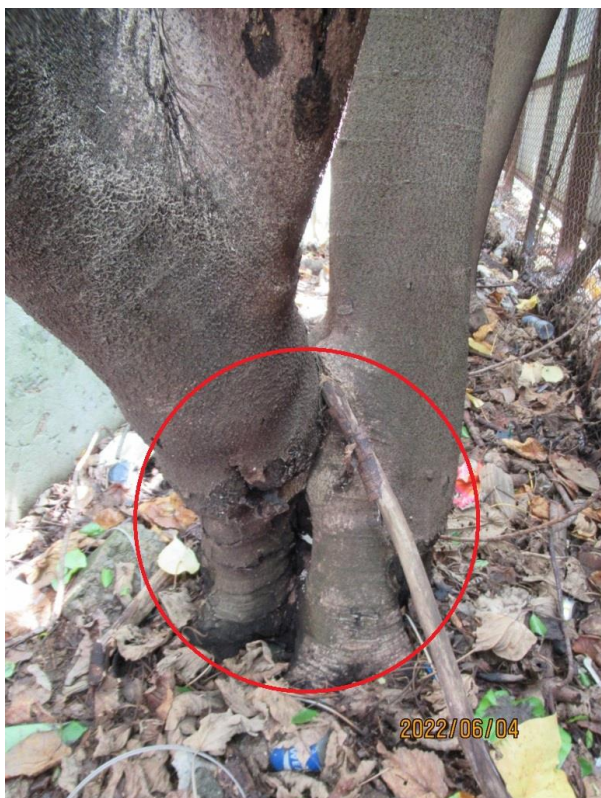
| Tree No. | Scientific Name | Chinese Name | Original Location<br>(Lot/GA/<br>YA/GHBA,<br>etc.) | Tree Size | | | Form | Health Condition<br><br>(Good/ Fair/<br>Poor) | Structural Condition | Anticipated survival rate after transplanting | | Conservati<br>on status | Proposed Treatment | | Additional Remarks |
|---|---|---|---|---|---|---|---|---|---|---|---|---|---|---|---|
| T9 | <i>Macaranga tanarius var. tomentosa</i> | 血桐 | Lot | 9 | 276 | 7 | | Poor | Poor | Low | a, b, c, f | N | Fell | A,E | Leaning, codominant trunks, included bark with decay, cavity on main branch, root restricted by pavement & foundation, shared root zone with other tree |

T9 Codominant Trunks with  
Included Bark Decay - **FELL**

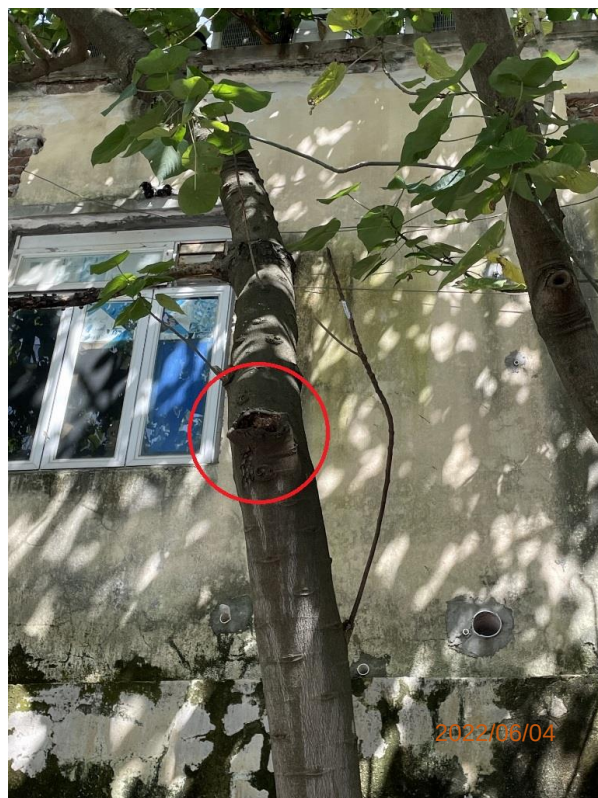
T9 Cavity on Trunk - **FELL**

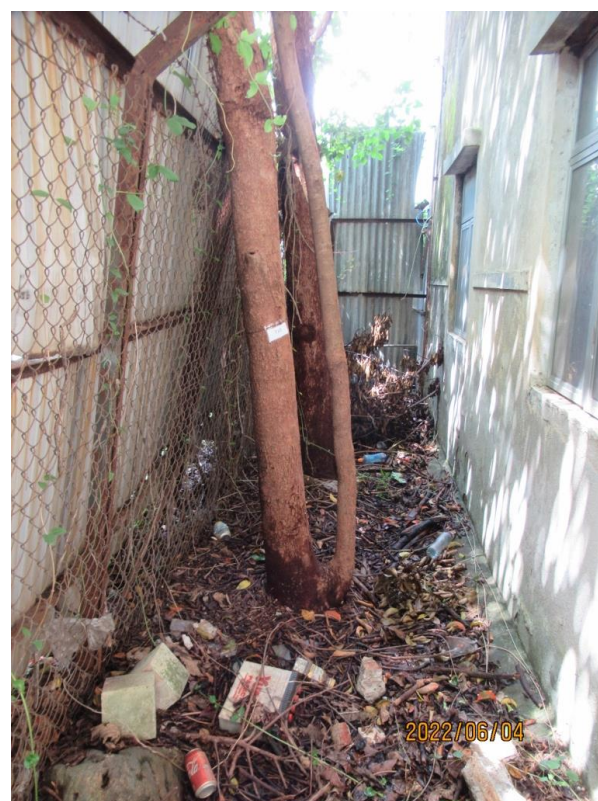
| Tree No. | Scientific Name | Chinese Name | Original Location<br>(Lot/GA/<br>YA/GHBA,<br>etc.) | Tree Size | | | Form | Health Condition<br><br>(Good/ Fair/<br>Poor) | Structural Condition | Anticipated survival rate after transplanting | | Conservati<br>on status | Proposed Treatment | | Additional Remarks |
|---|---|---|---|---|---|---|---|---|---|---|---|---|---|---|---|
| T10 | <i>Bischofia javanica</i> | 秋楓 | Lot | 8 | 179 | 4 | | Poor | Poor | Low | a, b, c, f | N | Fell | A,E | Leaning, root restricted by pavement & foundation, shared root zone with other tree |

T10 Lower Trunk & Ground Condition - **FELL**

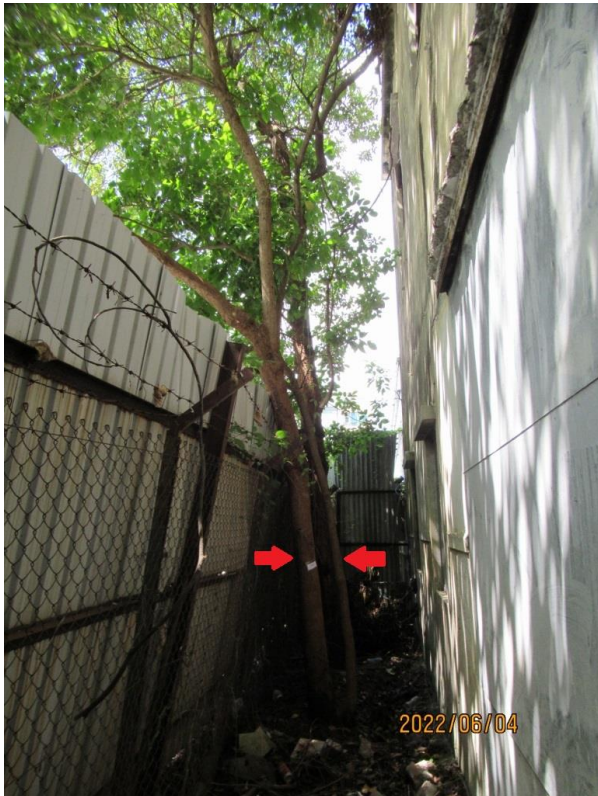
T10 Trunk Condition - **FELL**

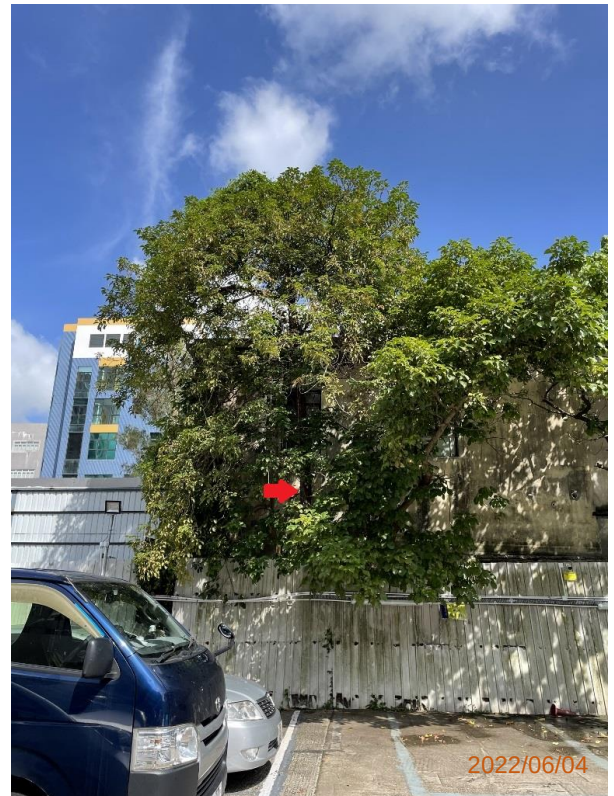
| Tree No. | Scientific Name | Chinese Name | Original Location<br>(Lot/GA/<br>YA/GHBA,<br>etc.) | Tree Size | | | Form | Health Condition<br><br>(Good/ Fair/<br>Poor) | Structural Condition | Anticipated survival rate after transplanting | | Conservati<br>on status | Proposed Treatment | | Additional Remarks |
|---|---|---|---|---|---|---|---|---|---|---|---|---|---|---|---|
| T11 | <i>Bischofia javanica</i> | 秋楓 | Lot | 9 | 268 | 5 | | Poor | Fair | Low | b, c, f | N | Fell | A,E | Leaning, root restricted by pavement & foundation, shared root zone with other tree |

T11 Overall view - **FELL**

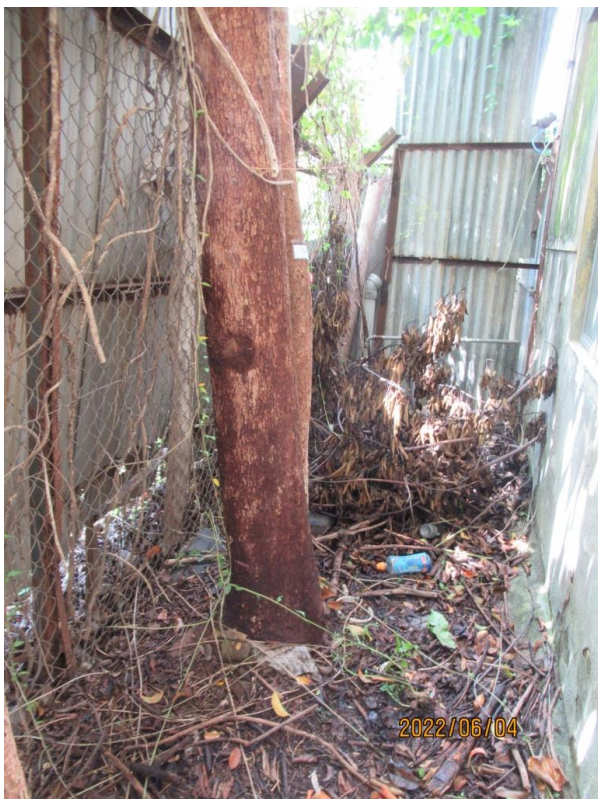
T11 Lower Trunk & Ground Condition - **FELL**

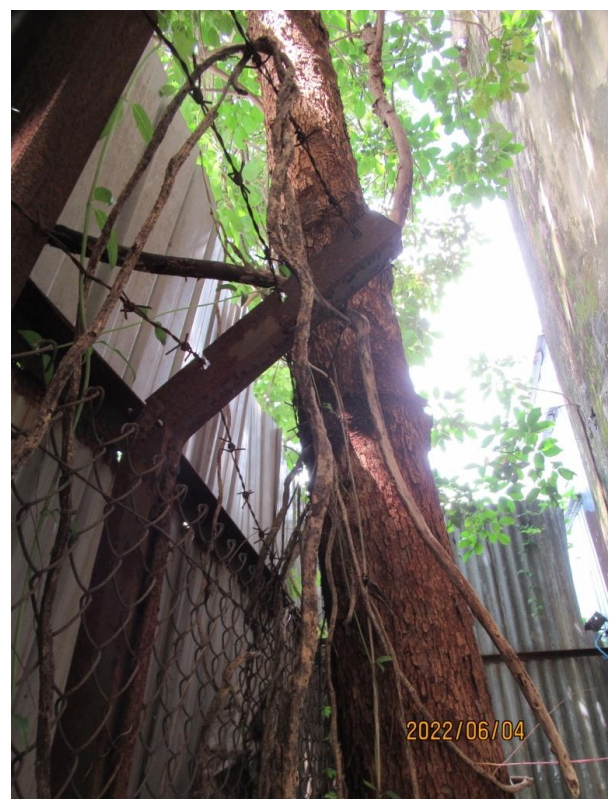
T11 Trunk Condition - **FELL**

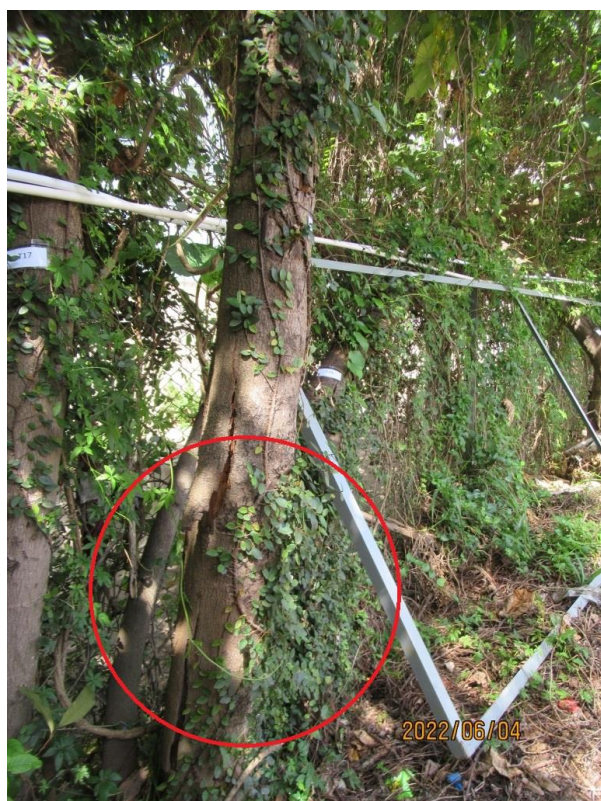
| Tree No. | Scientific Name | Chinese Name | Original Location<br>(Lot/GA/<br>YA/GHBA,<br>etc.) | Tree Size | | | Form | Health Condition<br><br>(Good/ Fair/<br>Poor) | Structural Condition | Anticipated survival rate after transplanting | | Conservati<br>on status | Proposed Treatment | | Additional Remarks |
|---|---|---|---|---|---|---|---|---|---|---|---|---|---|---|---|
| T18 | <i>Macaranga tanarius var. tomentosa</i> | 血桐 | Lot | 5 | 175 | 5 | | Poor | Poor | Low | a, b, c, f | N | Fell | A,E | Leaning, abnormal bark crack, severely dieback, heavily vined, broken branch, root restricted by pavement, shared root zone with other tree |

T18 Abnormal Bark Crack on Trunk - **FELL**

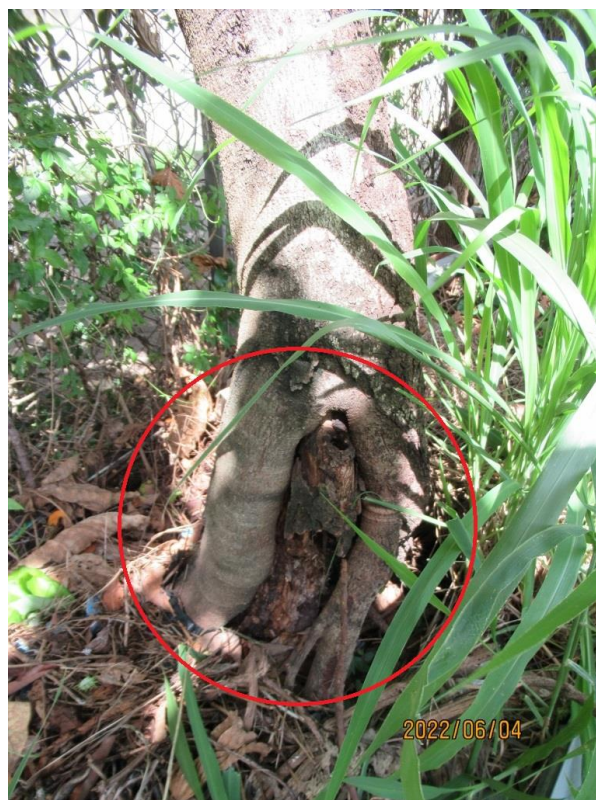
T19 Cavity on Root Crown - **FELL**

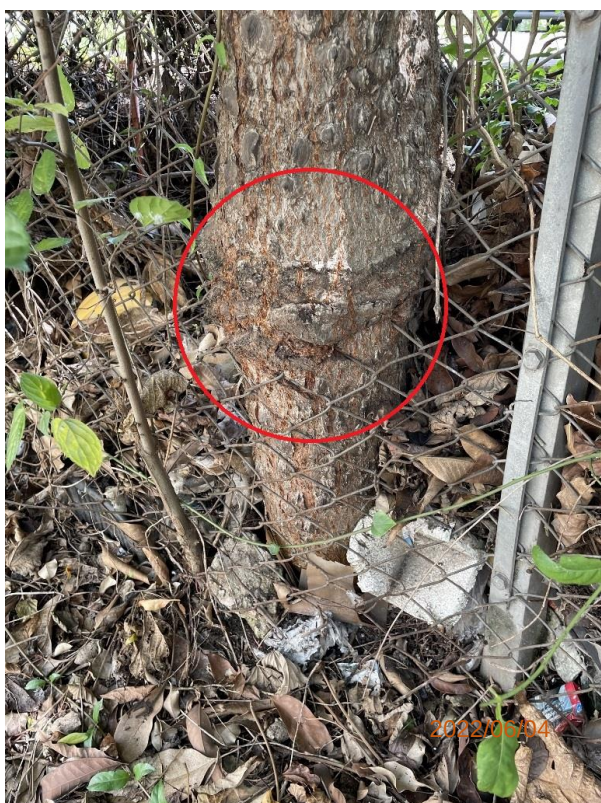
T23 Wire Enveloped in Trunk - **FELL**

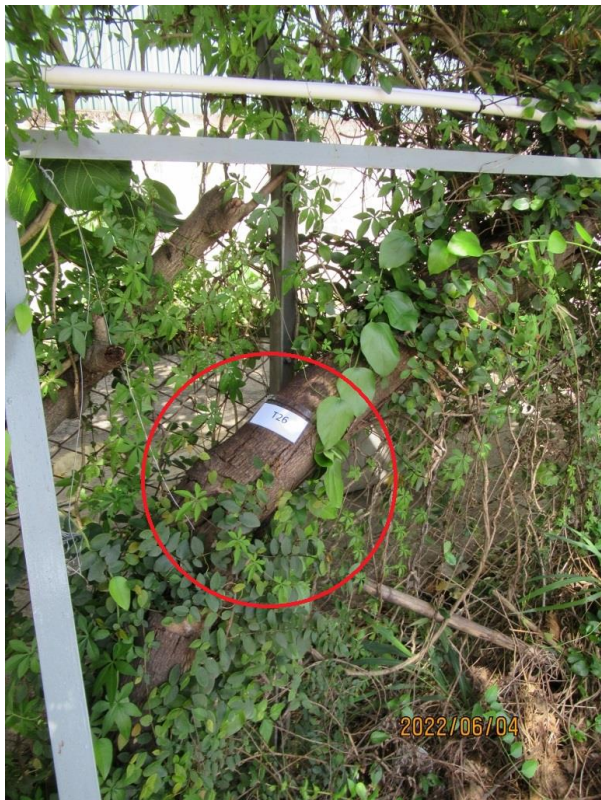
T26 Abnormal Bark Crack on Trunk - FELL

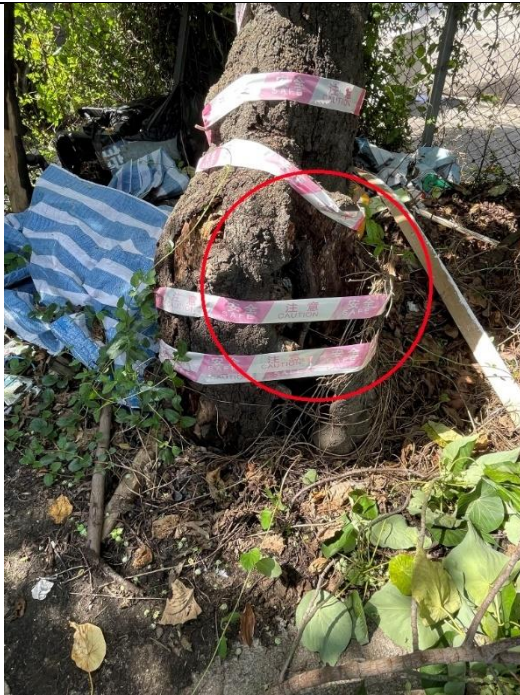
Tree Condition of T15 before Typhoon Chaba (Caloy)

Leaning, heavily vined, cavity with decay at root crown, dead branches, wound on main trunk, root restricted by pavement

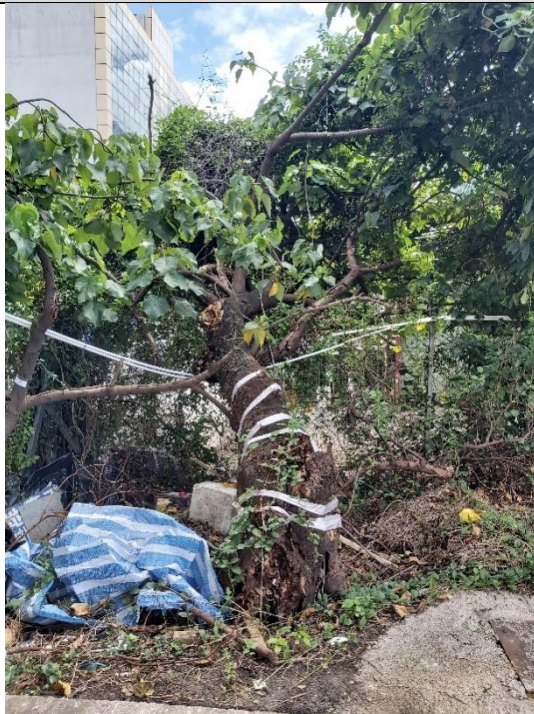
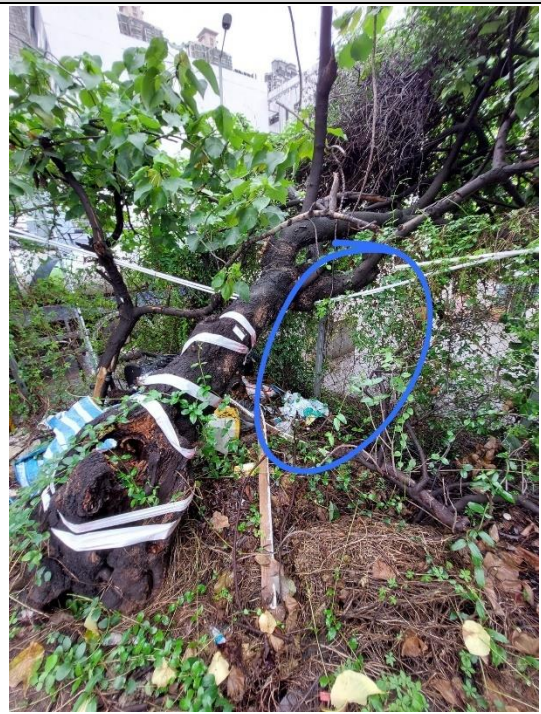
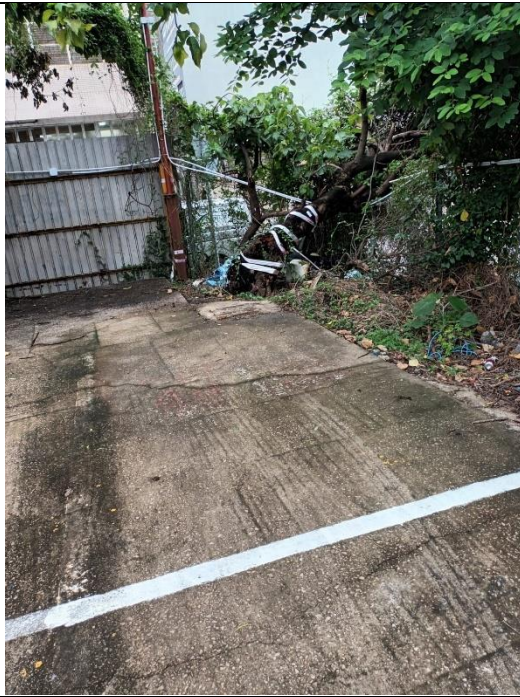
**T15 - After Typhoon Chaba (Caloy) (Date of Inspection: 4 July 2022)**

Cause: Due to Typhoon Chaba (Caloy) on 1<sup>st</sup> and 2<sup>nd</sup> July 2022, inclement weather such as heavy raining and gust wind might cause soil loss or impaired the stability of the tree. The tree was found to collapsed towards the public pedestrian pathway at On Kui Street, emergency removal of the tree is recommended by the Landscape Consultant and Landscape Contractor.

Tree Condition of T15 after Typhoon Chaba (Caloy)

Leaning becomes more serious and nearly collapsed, heavily vined, cavity with decay at root crown, dead branches, wound on main trunk, root restricted by pavement

Hazardous trees T15 and T25 were emergency removed from the site in consideration of potential risk of public safety as these 2 nos. of hazard trees are closed to the public pedestrian pathway at On Kui Street. Below photographic records indicate the sequence of tree removal works.

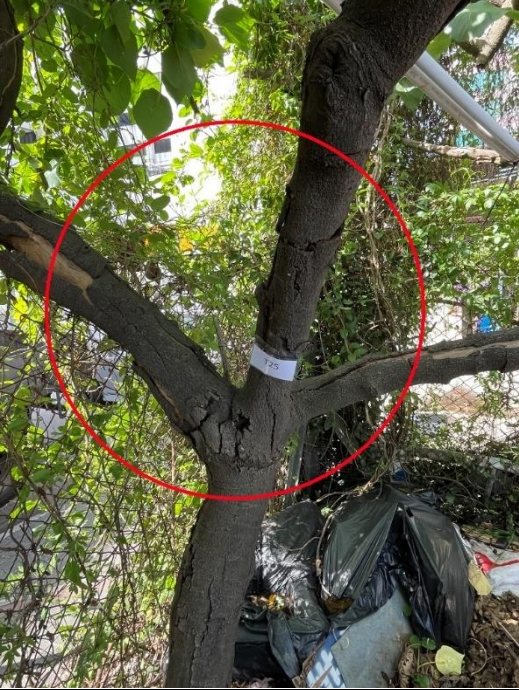
**T25 - Before Typhoon Chaba (Caloy) (Date of Tree Survey: 13 June 2022)**

| | <p>Tree Condition of T25 before Typhoon Chaba (Caloy)</p> <p>It is a dead tree and leaning</p> |

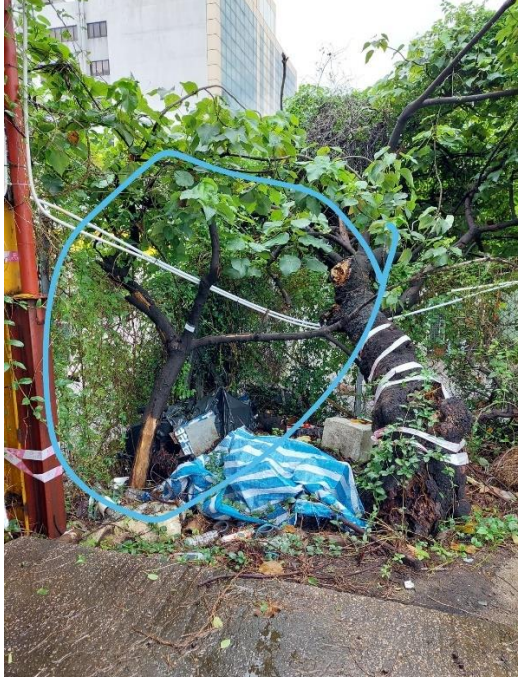
| <p><b>T25 - After Typhoon Chaba (Caloy) (Date of Inspection: 4 July 2022)</b></p> | |

| | <p>Tree Condition of T25 after Typhoon Chaba (Caloy)</p> <p>It is a dead tree and leaning becomes more serious and nearly collapsed</p> |
