37 CUMBERLAND ROAD KOWLOON TONG

Tree Condition Assessment Report  
by Registered Arborist  
(2 Trees – T1 & T2)

JULY 2026

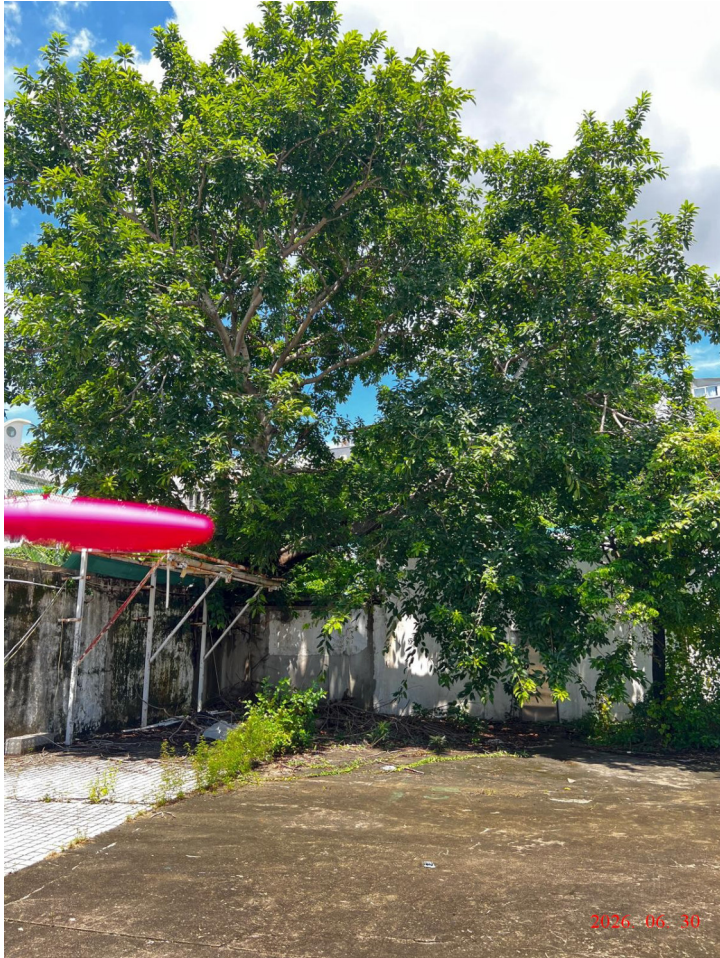
1. Site condition

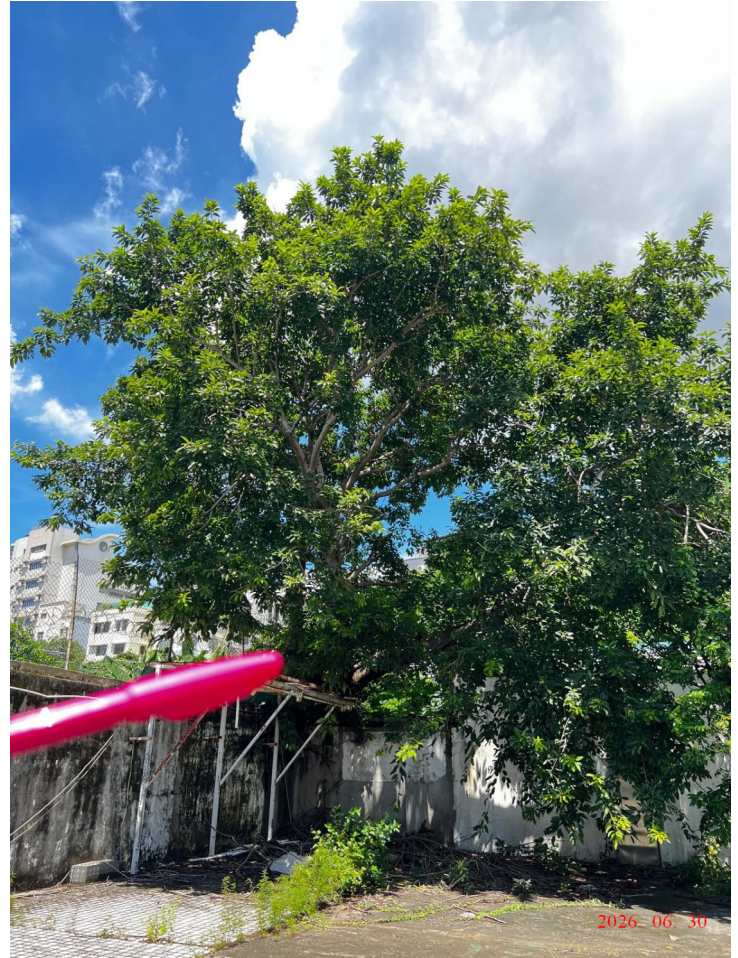
2. Whole view

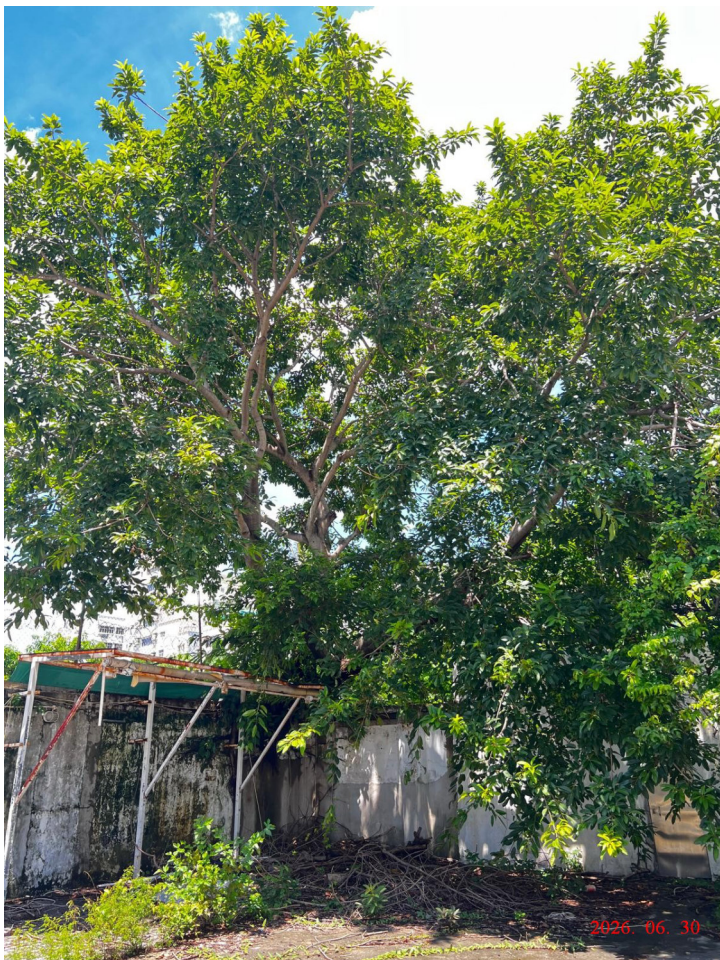
3. Crown condition

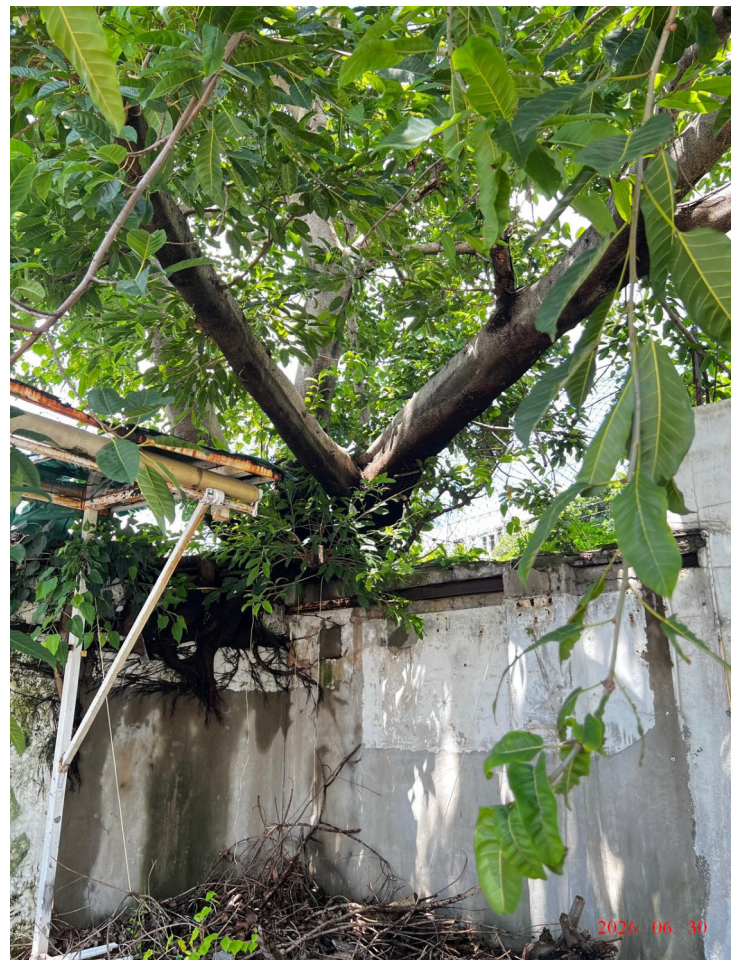
4. Trunk condition\_multi trunk

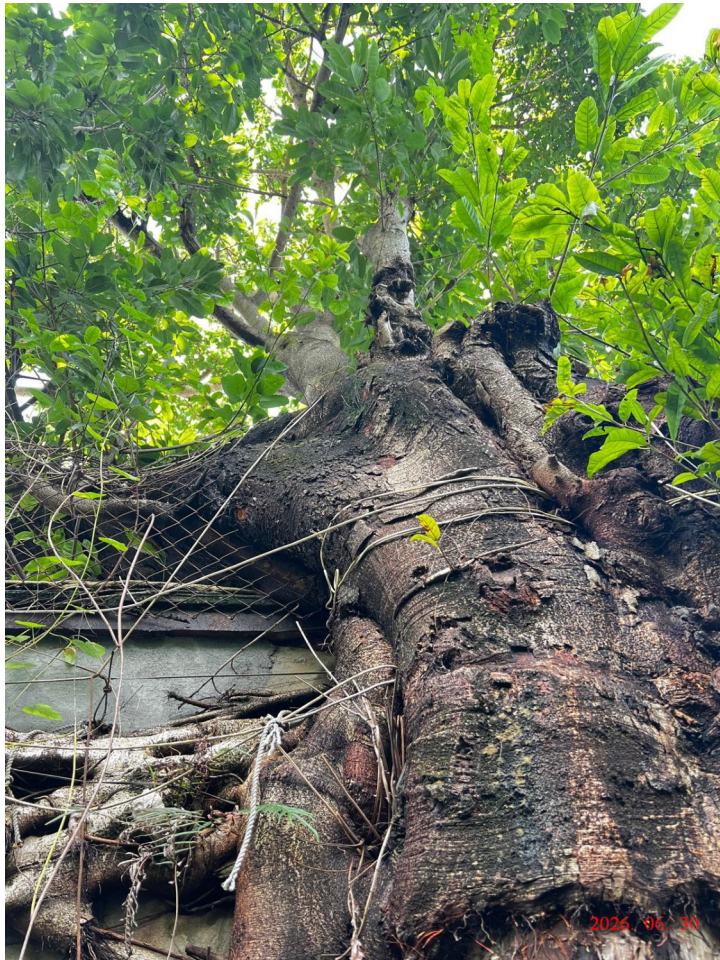
5. Trunk condition\_1

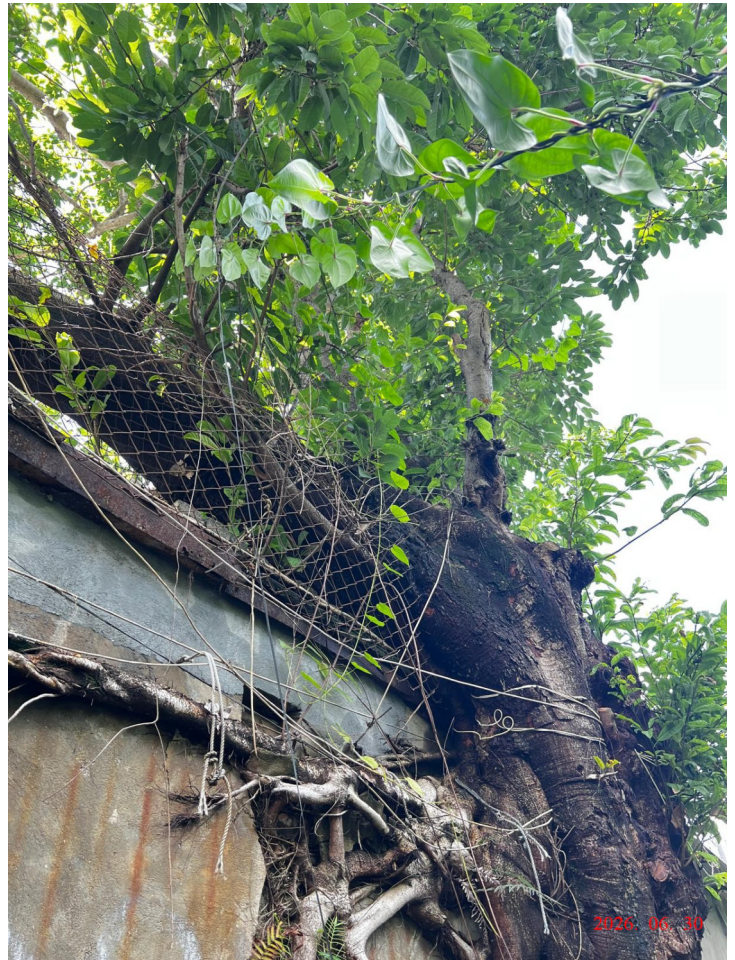
6. Trunk condition\_2

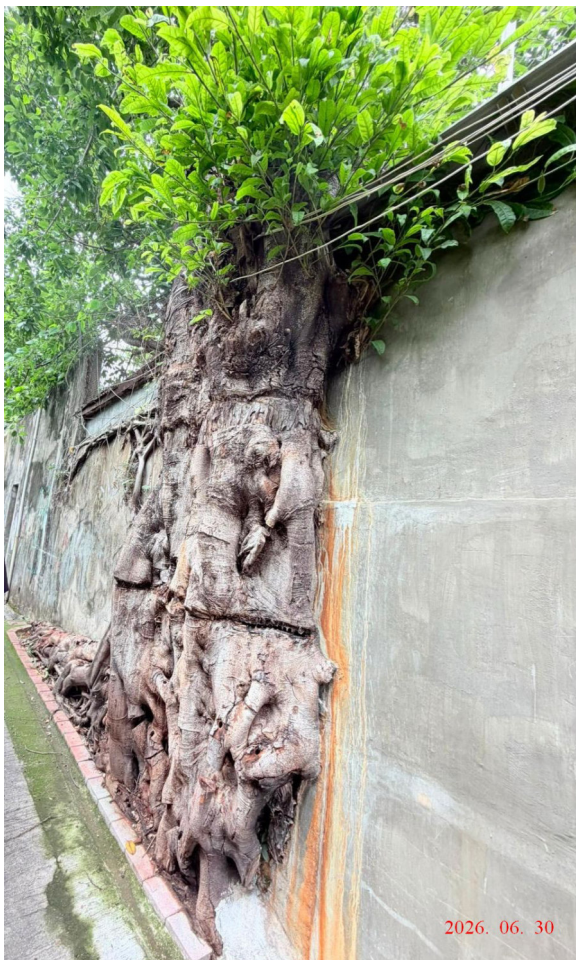
7. Root condition\_1

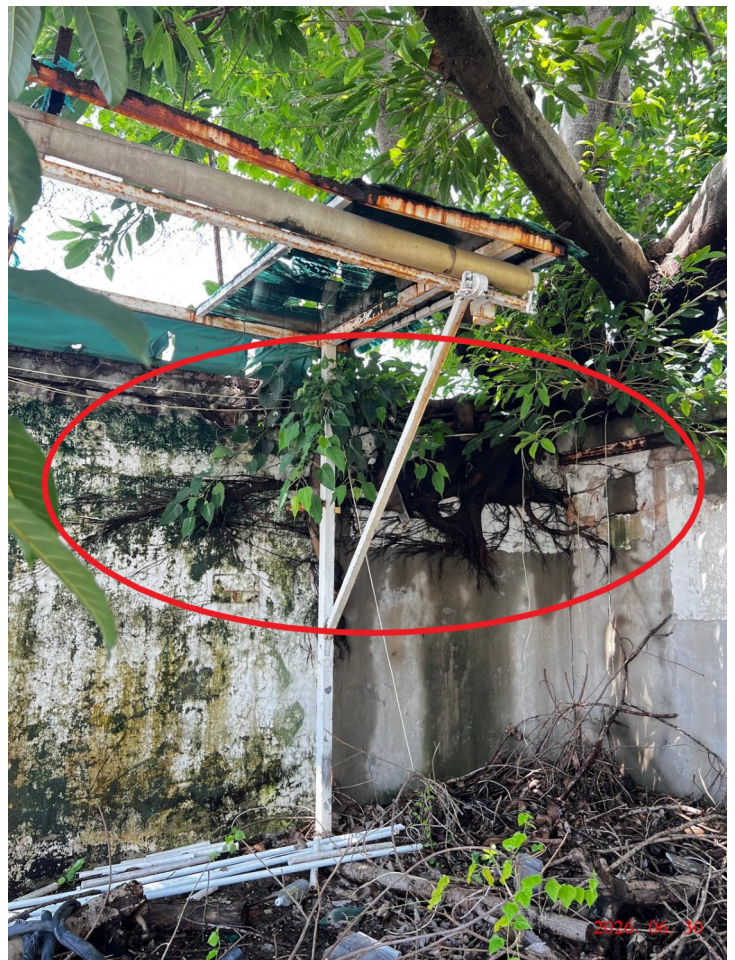
8. Root condition\_2

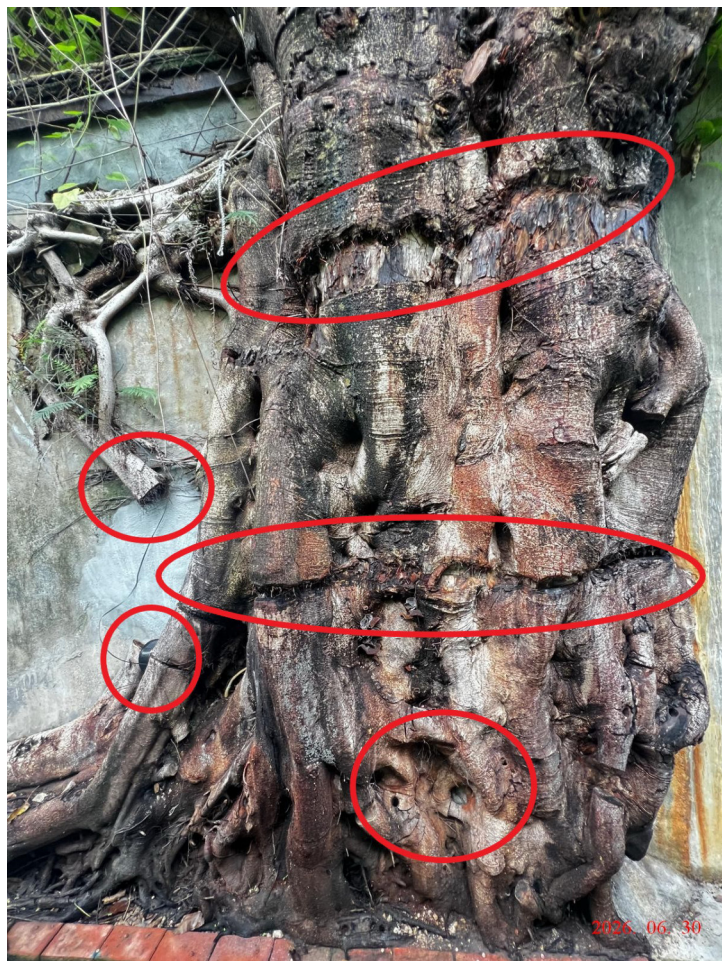
9. Root condition\_mechanical injury\_1

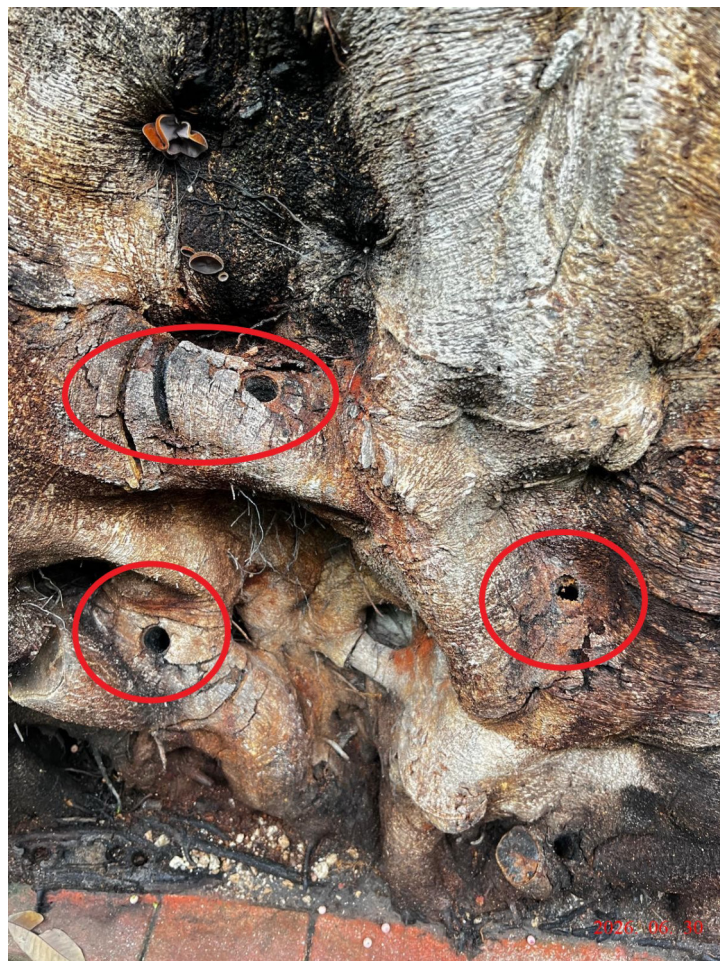
10. Root condition\_mechanical injury\_2

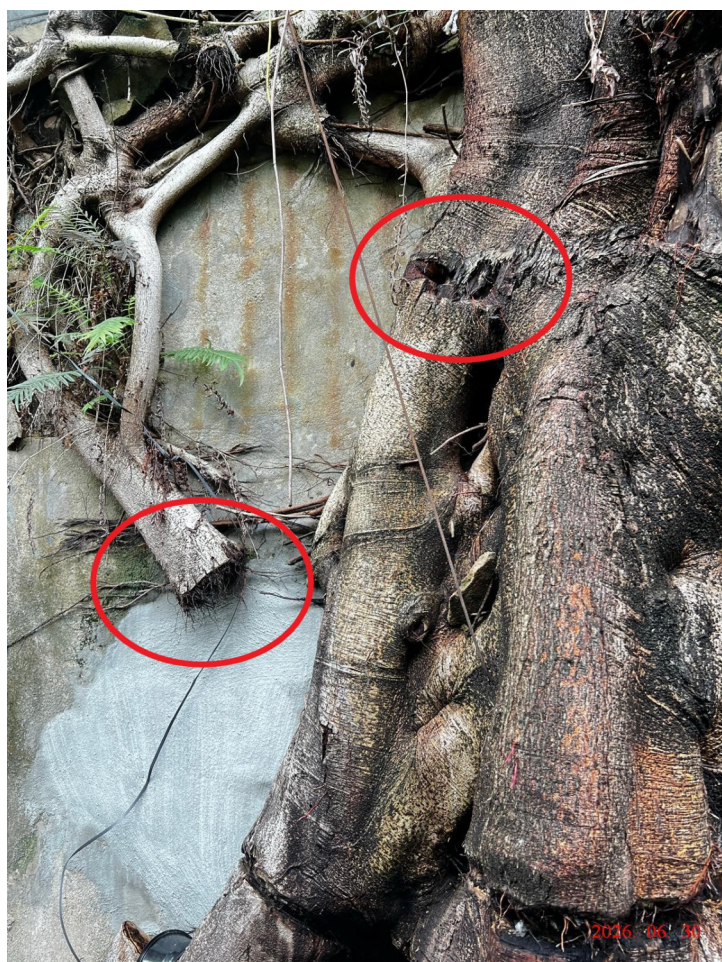
11. Root condition\_mechanical injury\_3

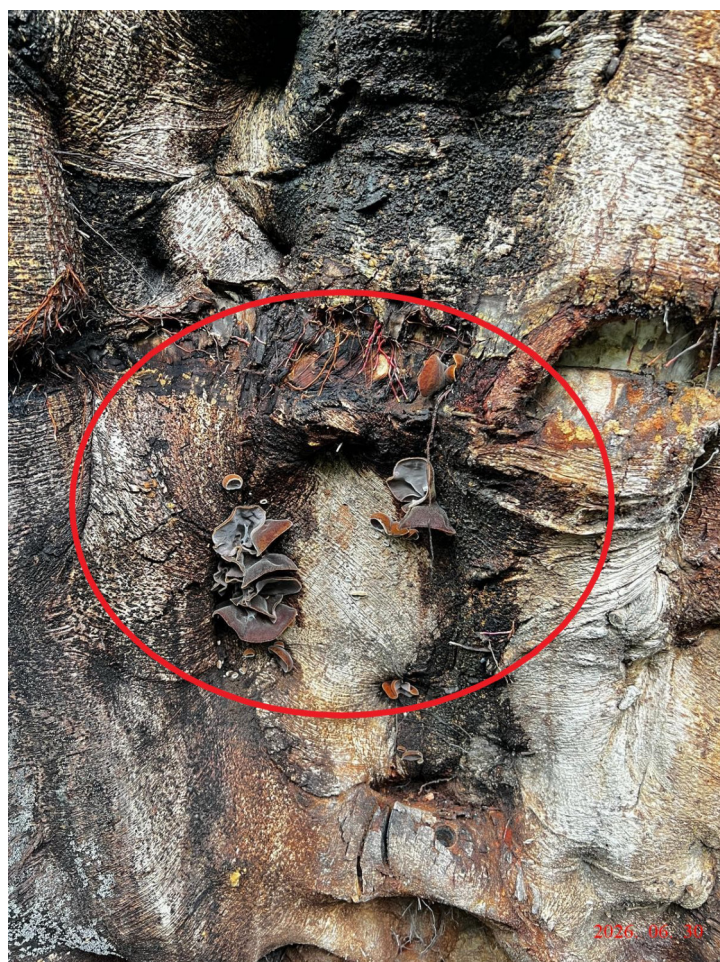
The tree is growing on a wall with its root system primarily confined to the wall. Only a small portion of roots extends to the ground outside the wall; these external roots have previously been severed. Fungal growth (*Auricularia polytricha*) is present on the roots, with associated wood decay and death. The multi-trunk structure features included bark, making it prone to splitting and failure. Overall, the tree's structure is unstable.

12. Root condition\_fungal fruiting bodies

Removal due to poor health, restricted root system, and high structural instability.

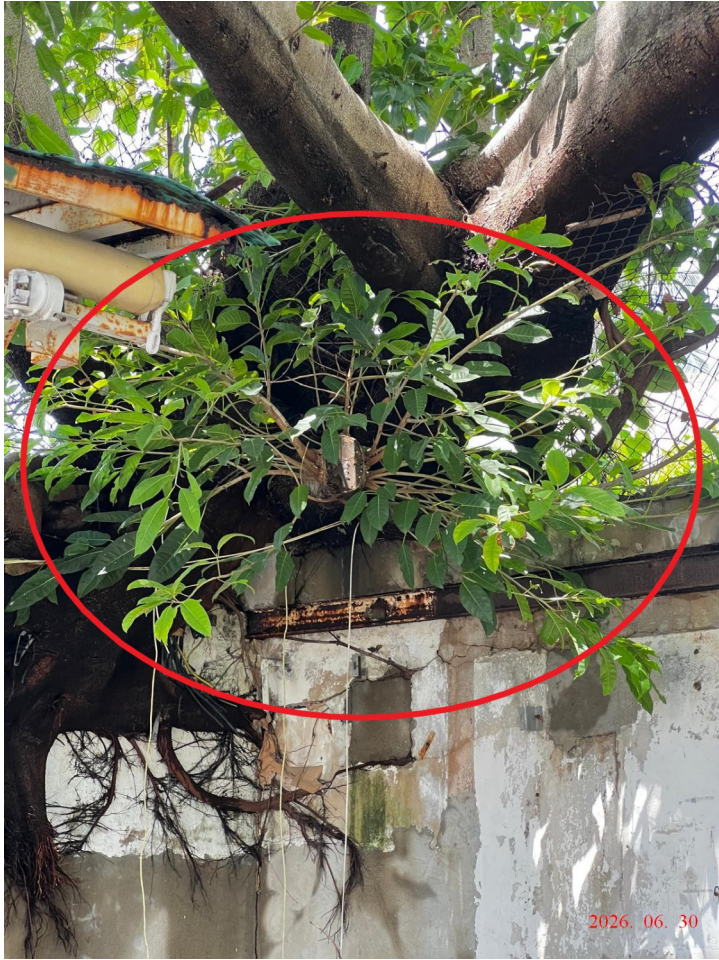
13. Tree grown on wall

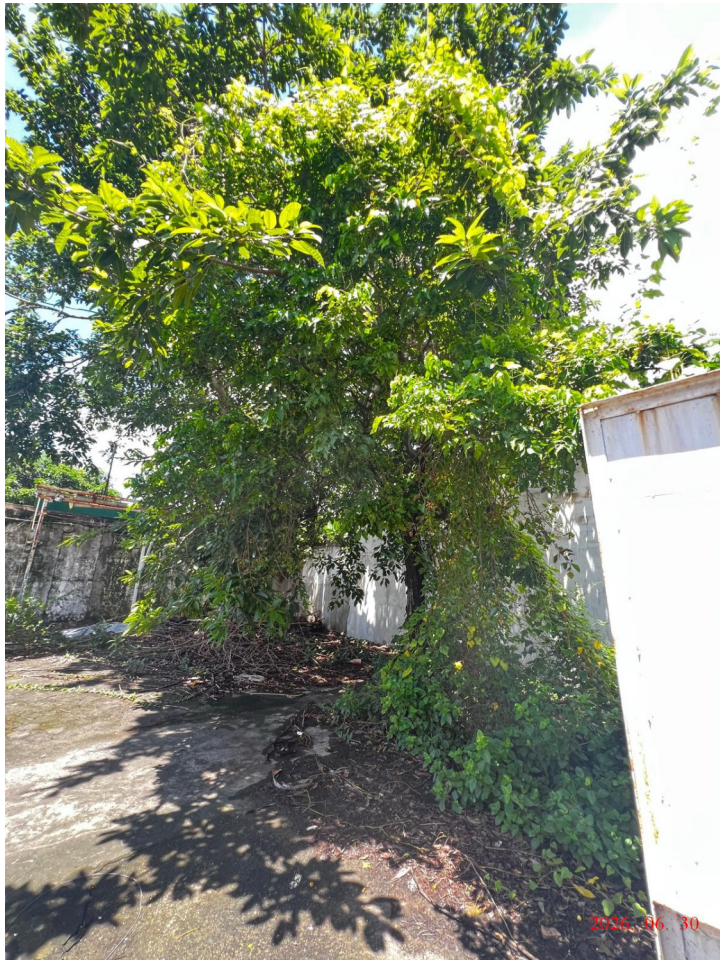
1. Site condition

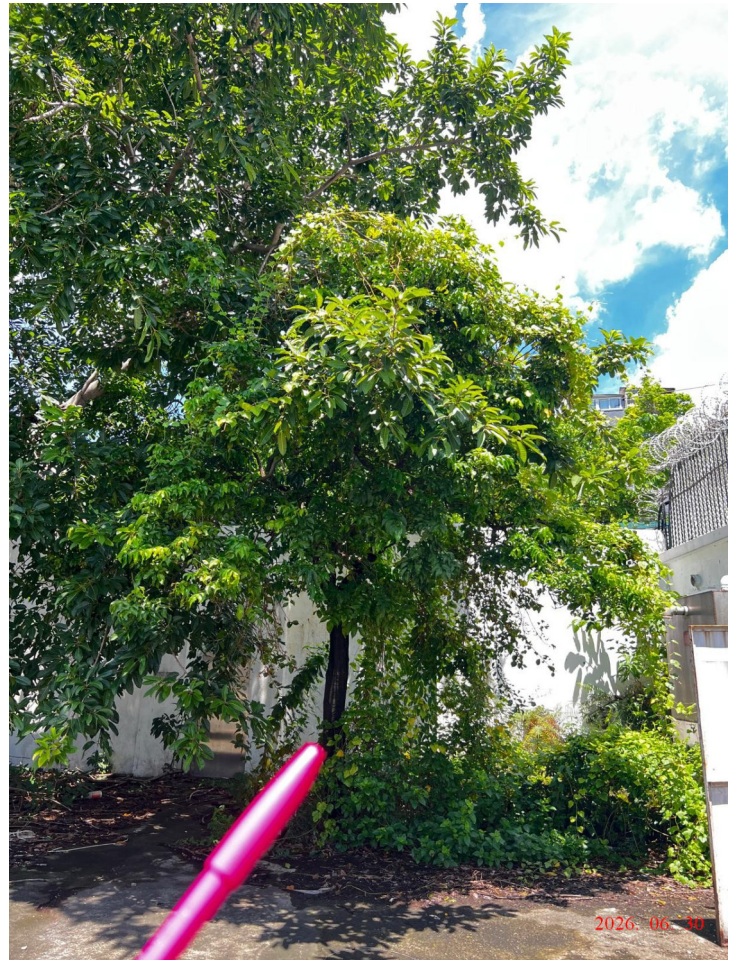
2. Whole view

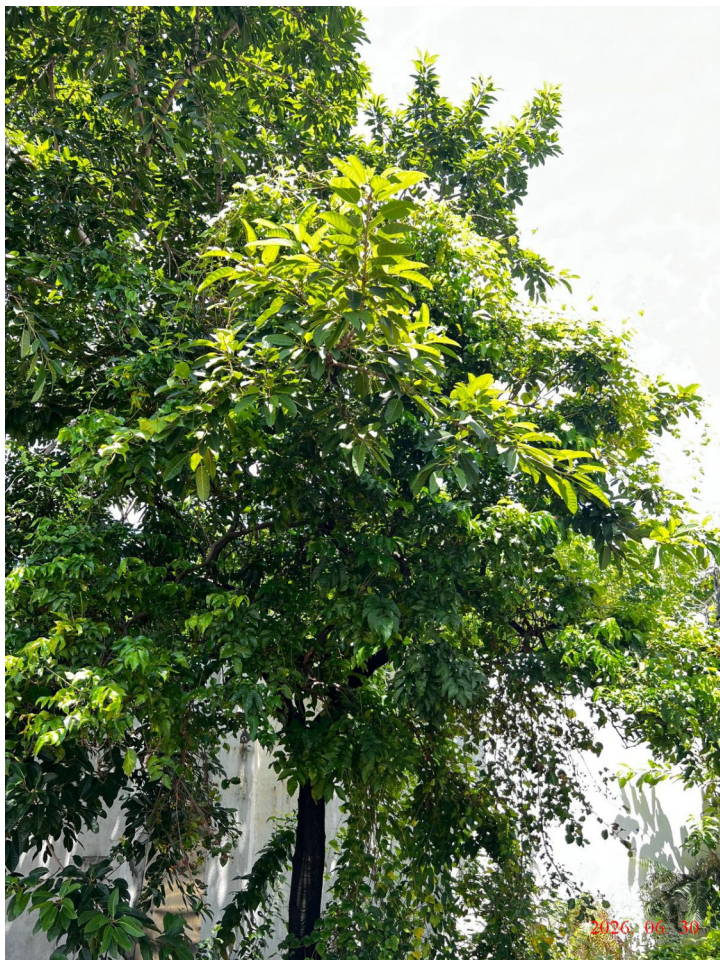
3. Crown condition

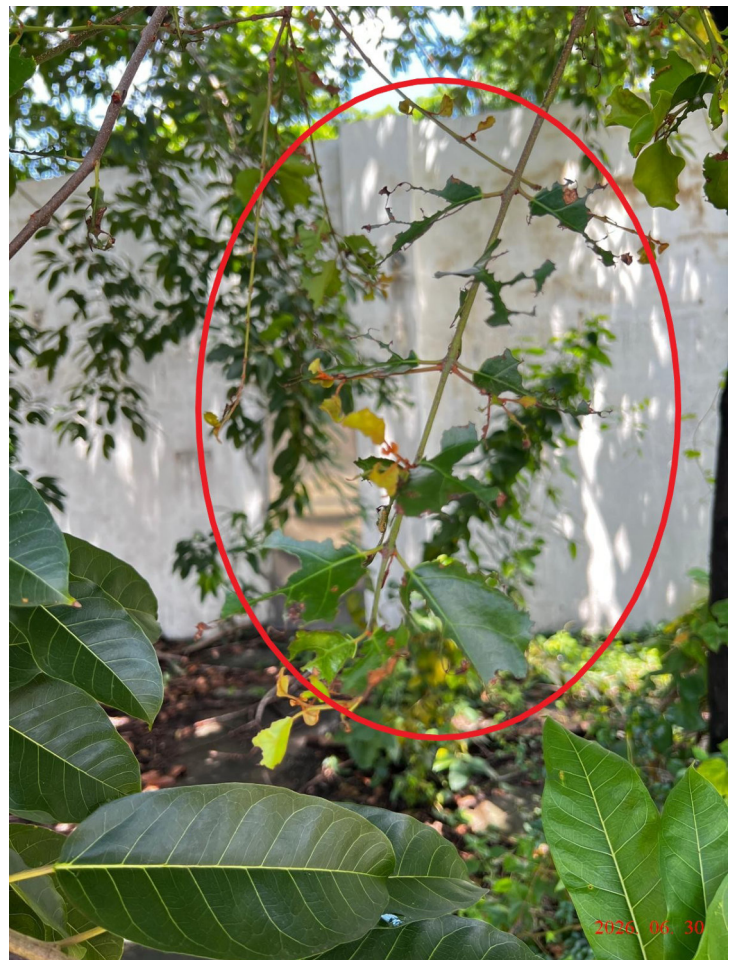
The root system is severely restricted. Foliage shows insect damage, along with the presence of dead branches and fungal infection (*Auricularia polytricha*). Both health and structural integrity are compromised and unstable.

4. Crown condition\_pest and disease\_1

Removal due to poor health decline and structural instability.

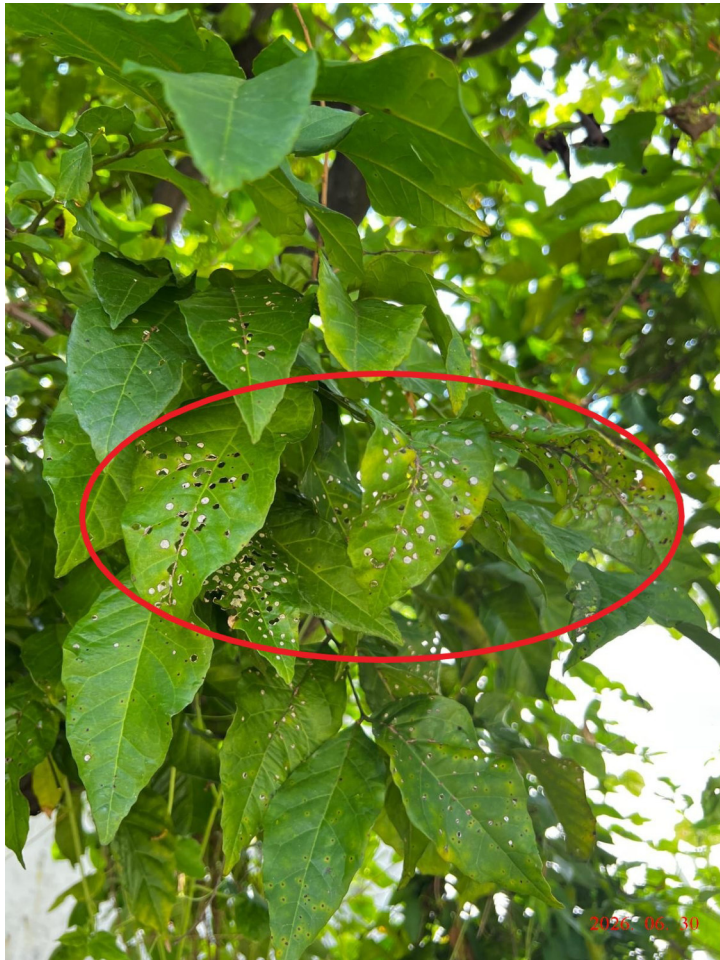
5. Crown condition\_pest and disease\_2

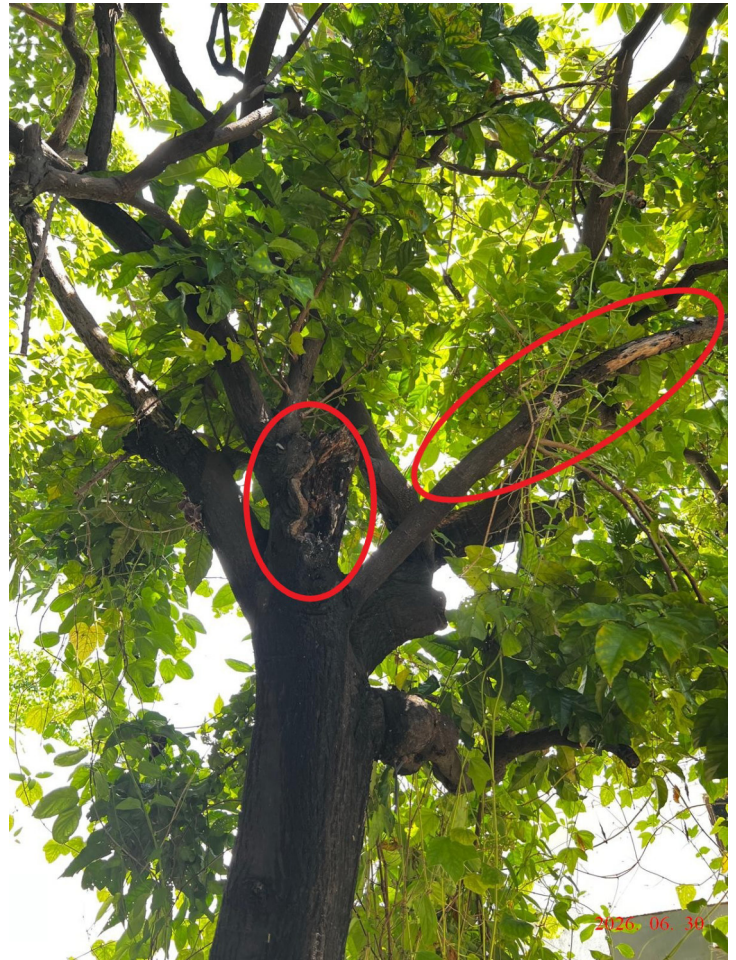
6. Branches condition\_decay & dead branches

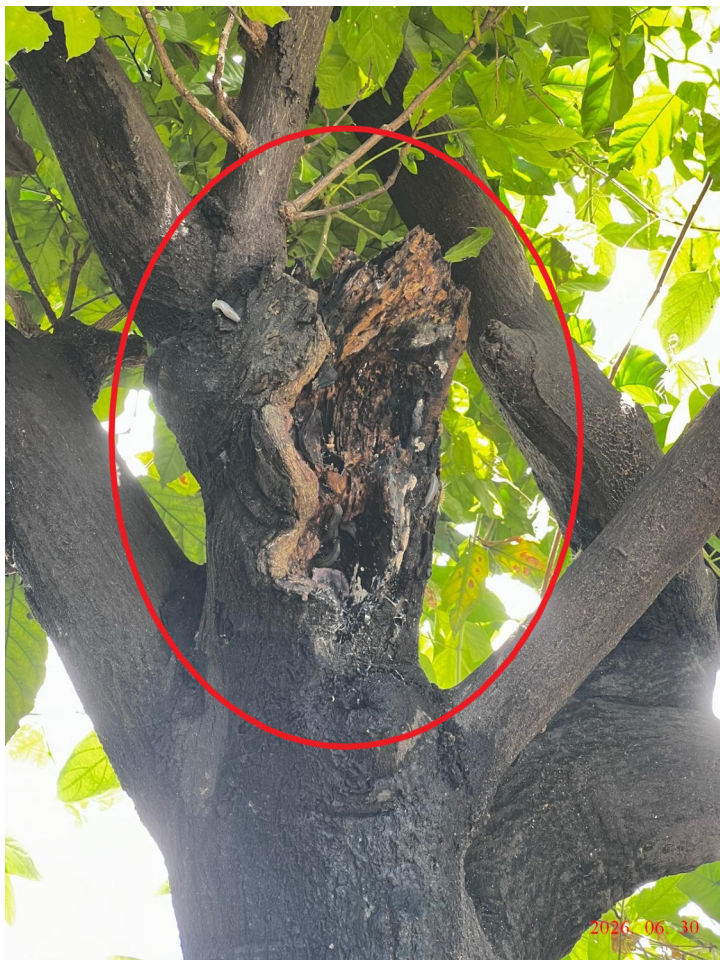
7. Branches condition\_decay\_closeup

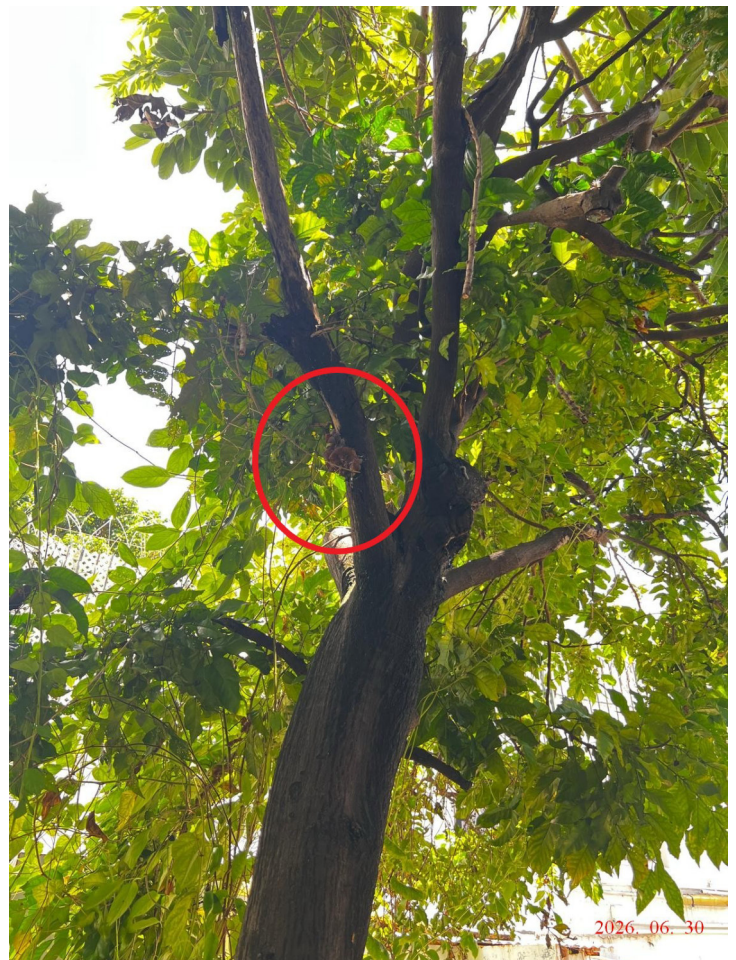
8. Branches condition\_fungal fruiting bodies

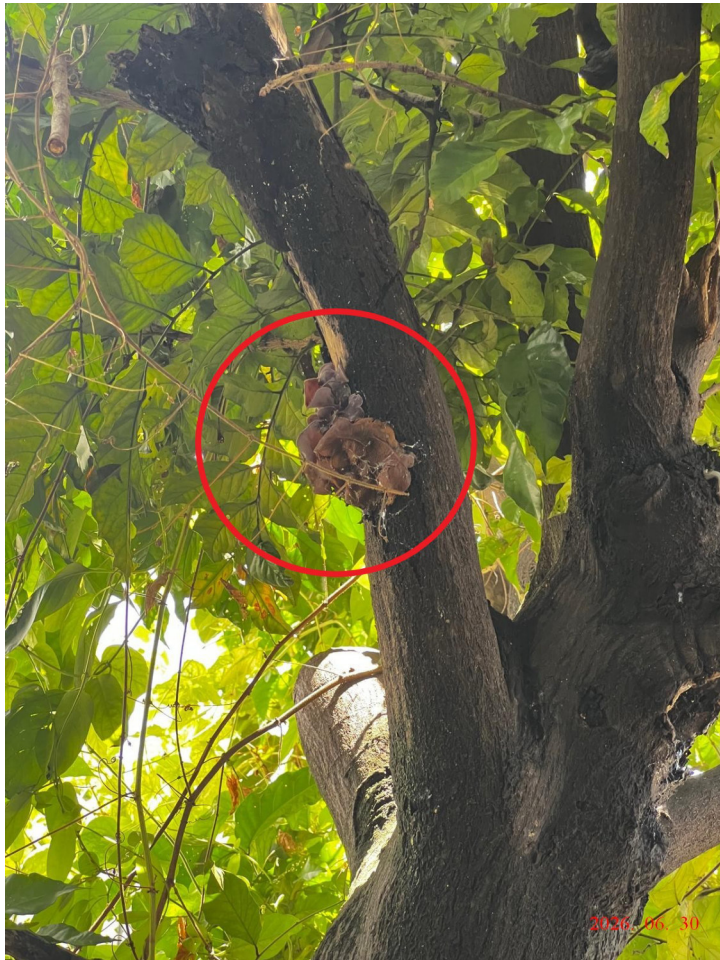
9. Branches condition\_fungal fruiting bodies\_closeup

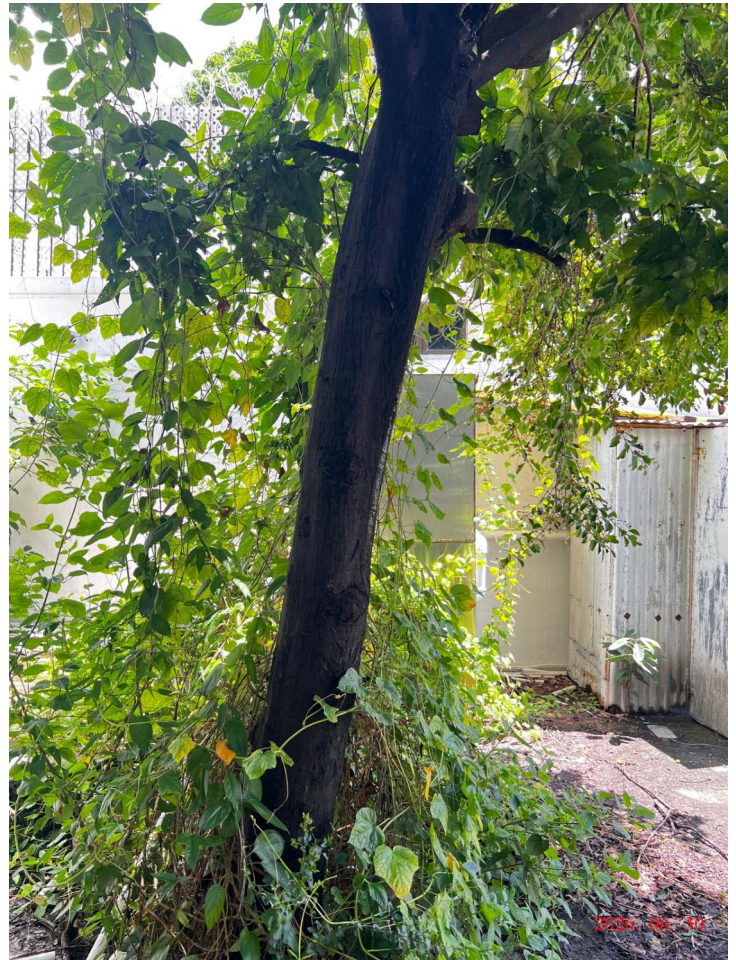
10. Trunk condition

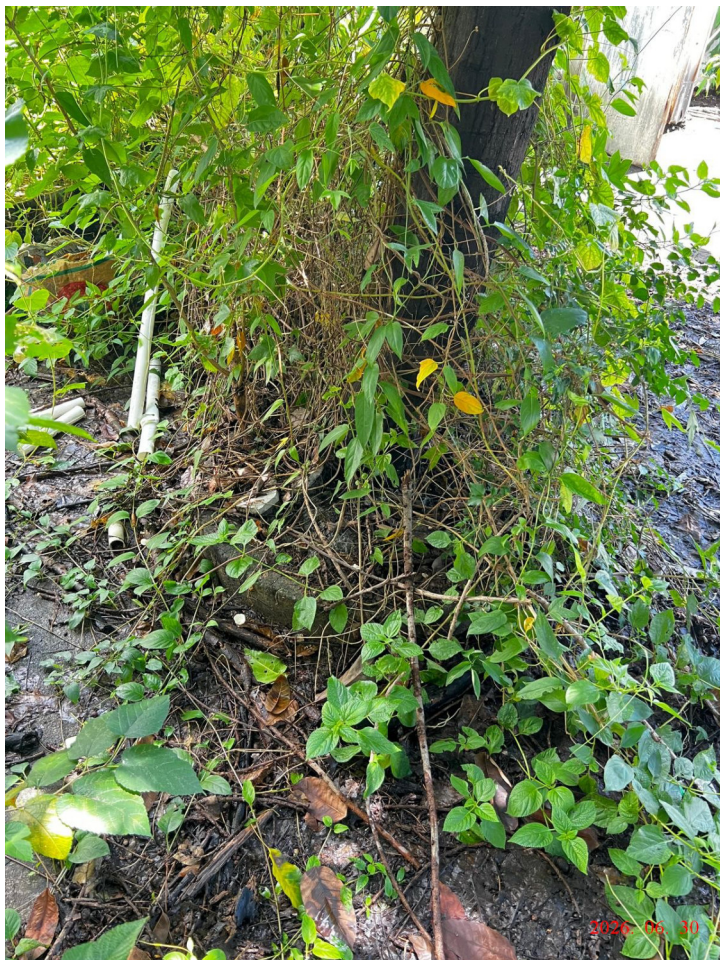
11. Root condition
