**Proposed Temporary Place of Recreation, Sports or Culture (Hobby Farm) with
Ancillary Facilities and Associated Filling of Land for a Period of 5 Years
Various Lots in D.D. 16, Lam Tsuen, Tai Po, New Territories
(Application No.: A/NE-KLH/657)**

Further Information for Planning Application No. A/NE-KLH/657**Response-to-Comments****Comments from the Geotechnical Engineering Office, CEDD**

**Geotechnical Planning Review Report
for
Proposed Temporary Place of Recreation, Sports or
Culture (Hobby Farm) with
Ancillary Facilities and Associated Filling of Land
for a Period of 5 Years
at Lots 86, 90, 91(Part), 92(Part), 103(Part),
147(Part), 148 S.A(Part), 148 S.B(Part),
149(Part), 150 S.A, 151 S.A(Part), 153(Part),
572(Part) and 576(Part) in D.D.16,
Lam Tsuen, Tai Po, New Territories**

Geotechnical Planning Review Report

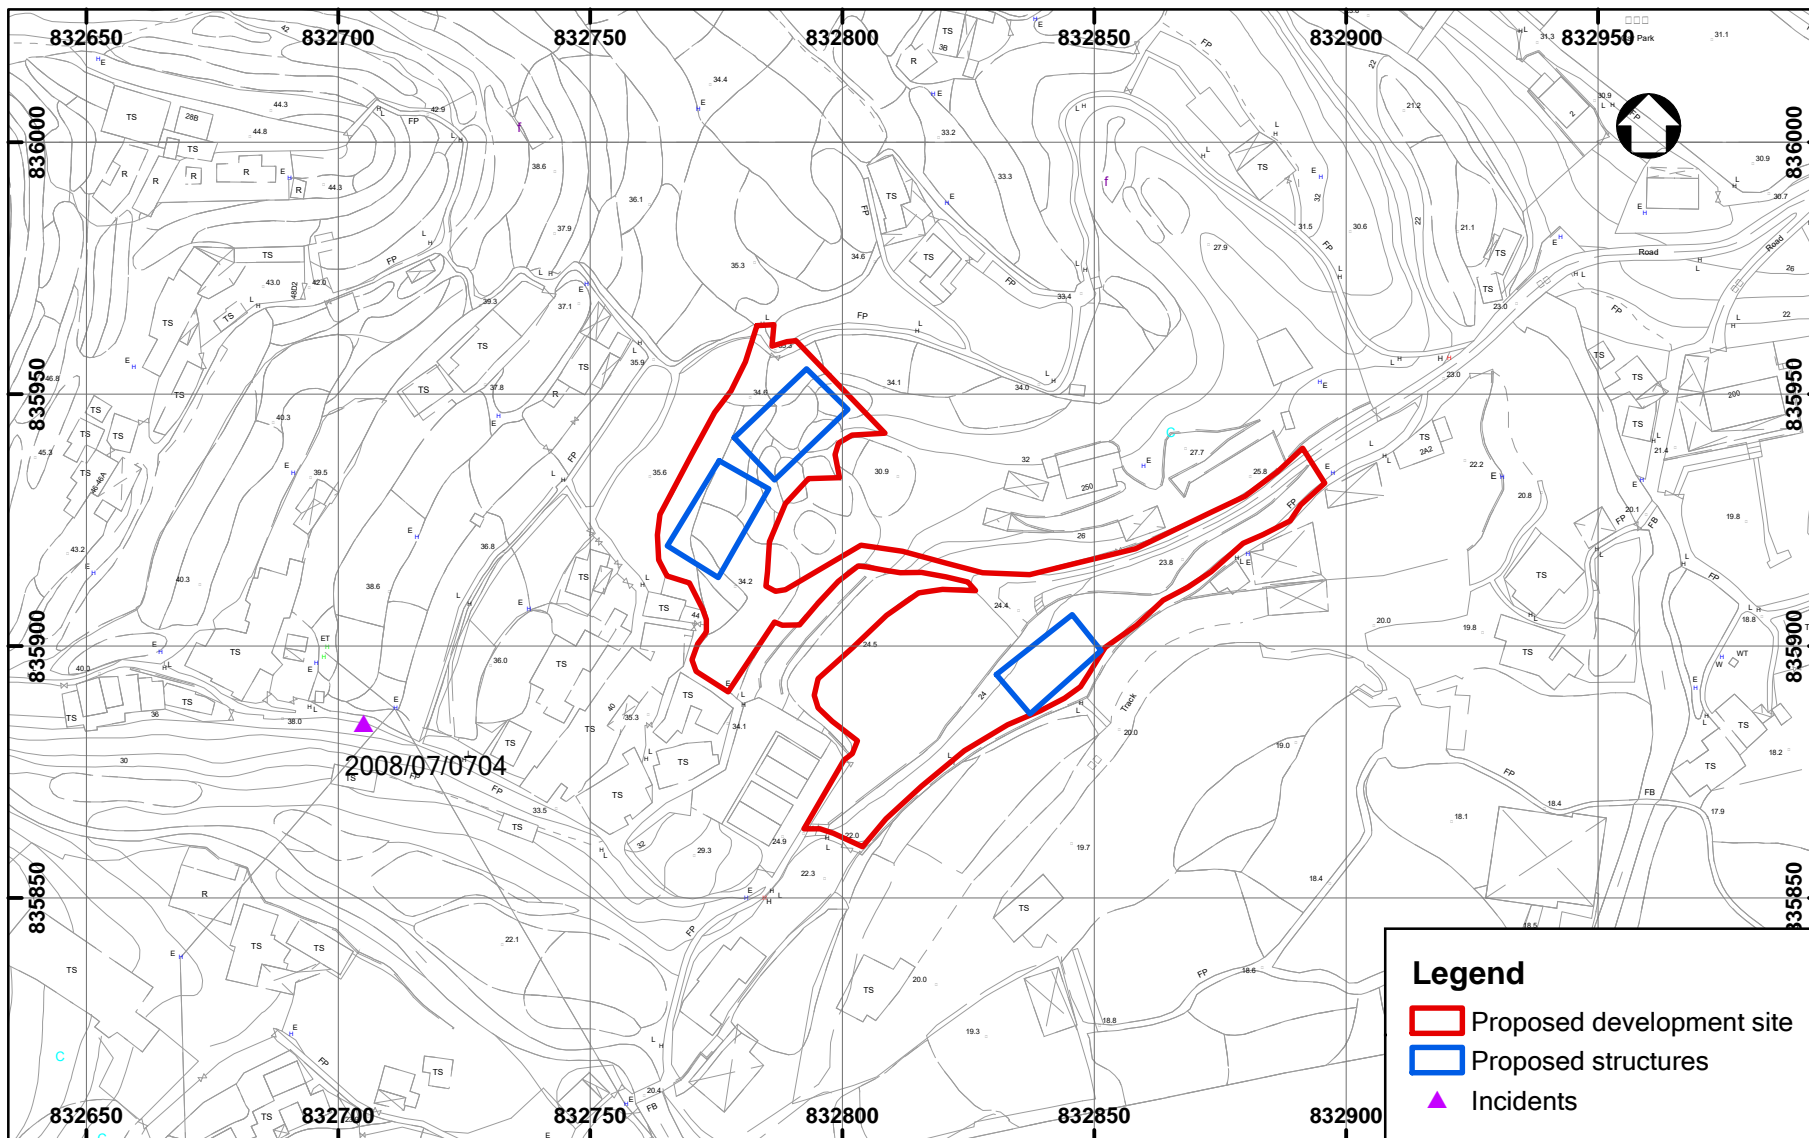
FIGURE NO :
FIGURE 5

No landslide incident record has been recorded within the Site. However, one minor landslide incident has been reported at about 64m to the west of the Site. It involved a minor washout of about 3.0m³ from the upper portion of the registered man-made cut-slope.

GCO/GEO Incident No.	Report Date	Location of Failure	Approx. Failure Volume (m ³)	Possible Cause of Failure
2008/07/0704 (about 64m to the west of the Site)	2008/07/10	7NW-A/C97	3.0	Washout

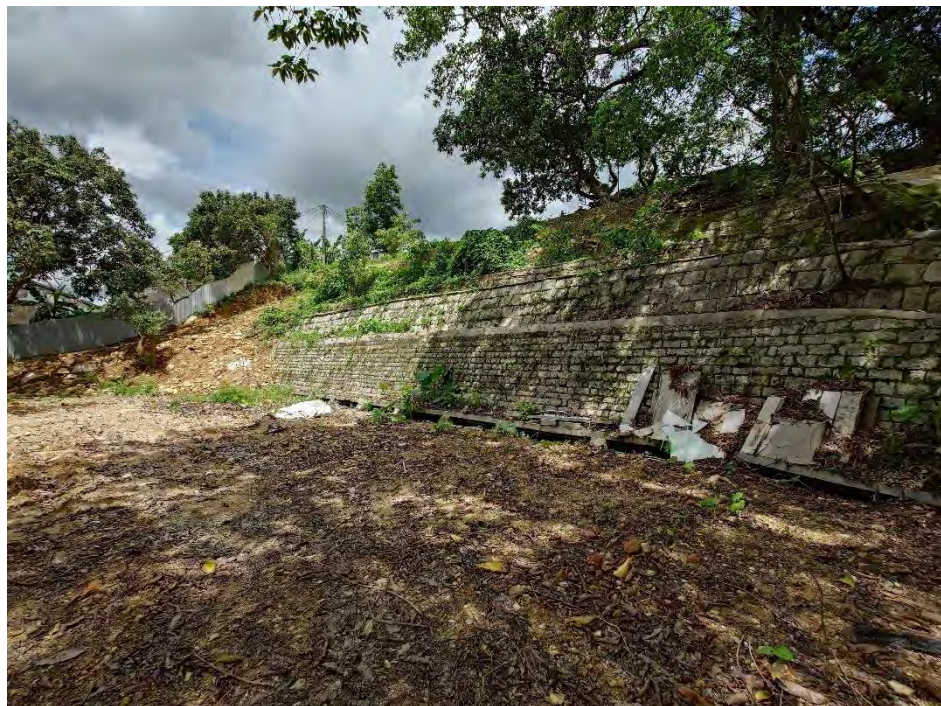
The proposed development has impact only on a small portion of the registered man-made cut slope Feature no. 7NW-A/C93, which is located at the south-western end of the Site adjacent to the Site boundary. According to the SIS record, the feature is about 40m long and 4.6m high with slope gradient ranging at about 61° to the horizontal.

Small portion of Feature No. 7NW-A/C93 along the south-western boundary of the Site may be modified for the proposed development, hence, the feature will be affected or being affected by the proposed development. Further detailed of the slope stability assessment shall be covered in the next stage of the project, i.e. the geotechnical assessment report.

Photo F – General View of the Feature No. 7NW-A/C93

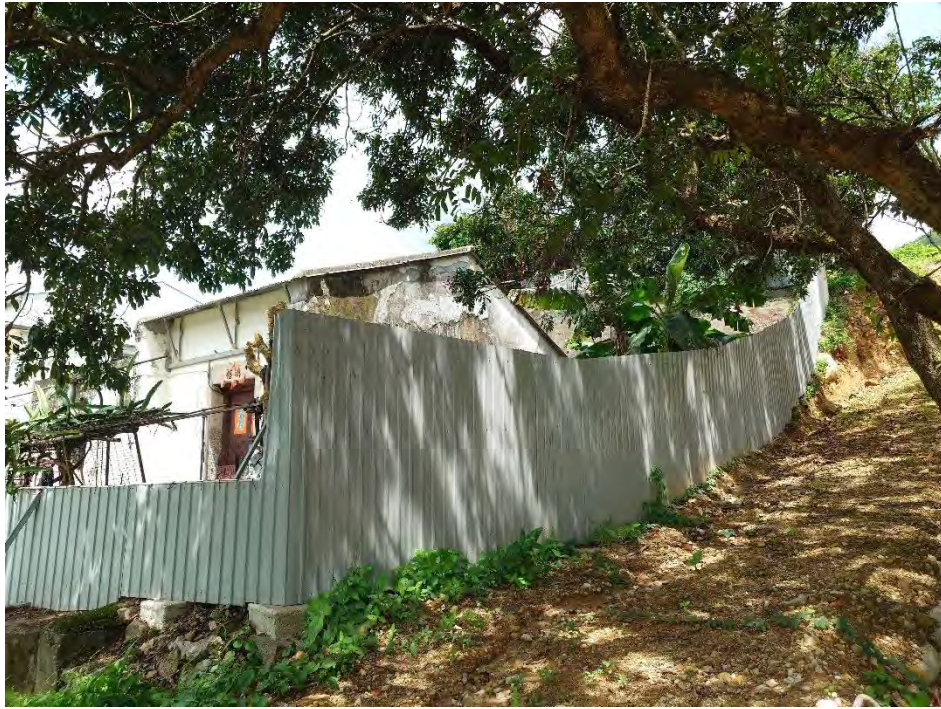
Photo G – General View of the Feature No. 7NW-A/C92

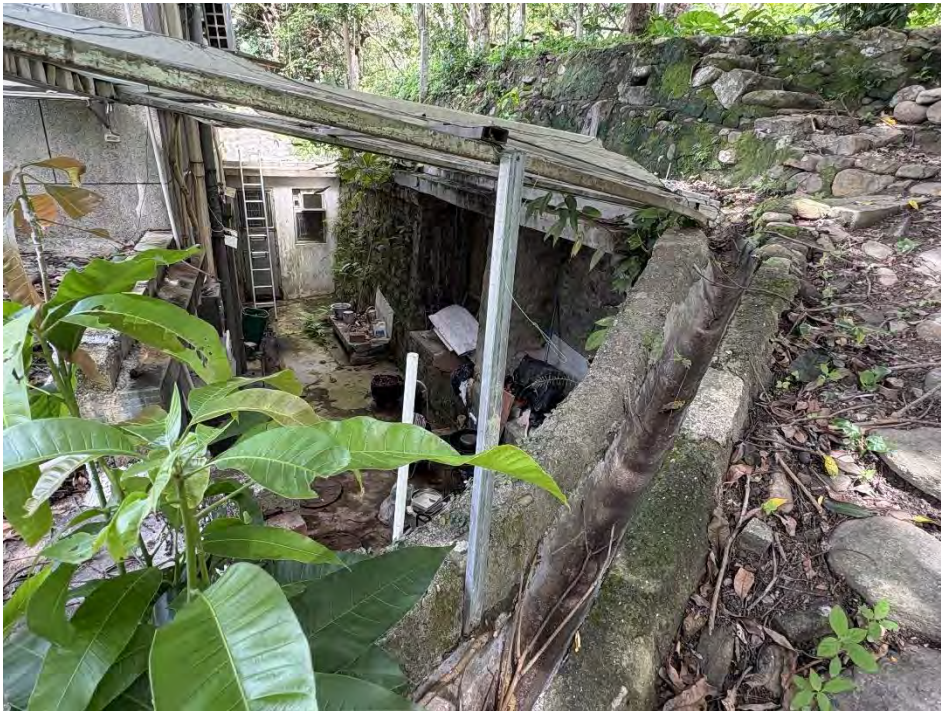
Photo H – General View of the Feature No. 7NW-A/CR95

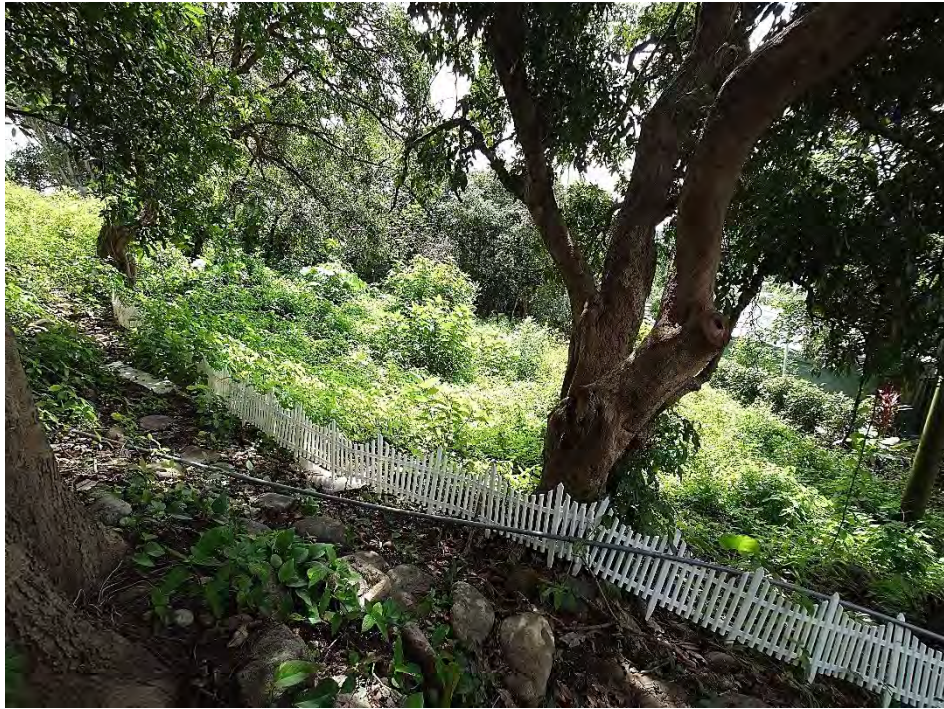
Photo I – General View of the Feature No. 7NW-A/C96

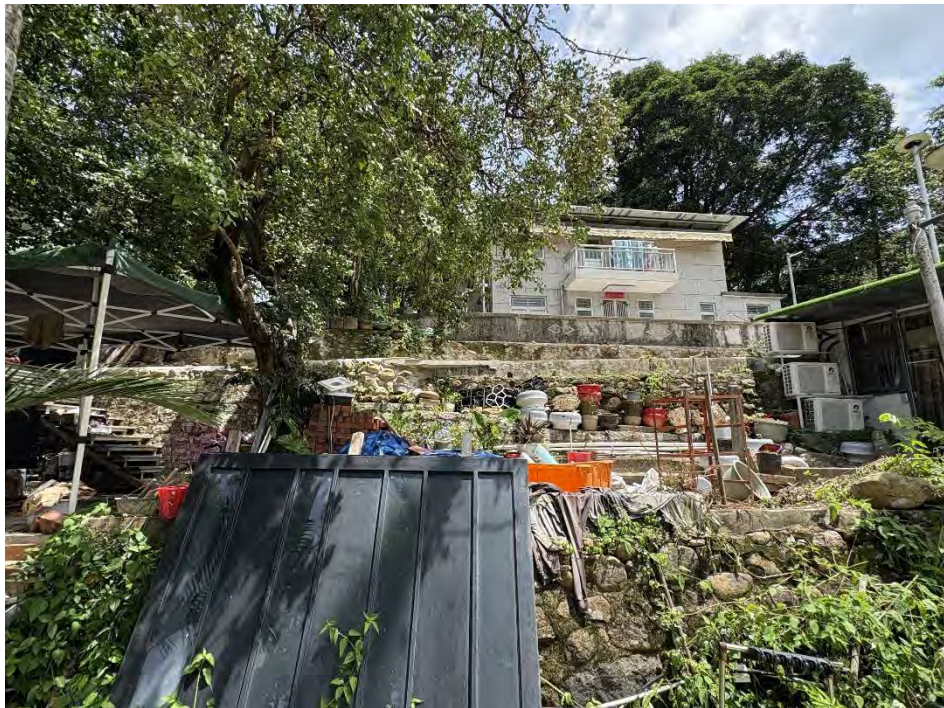
Photo J – General View of the Feature No. 7NW-A/R14

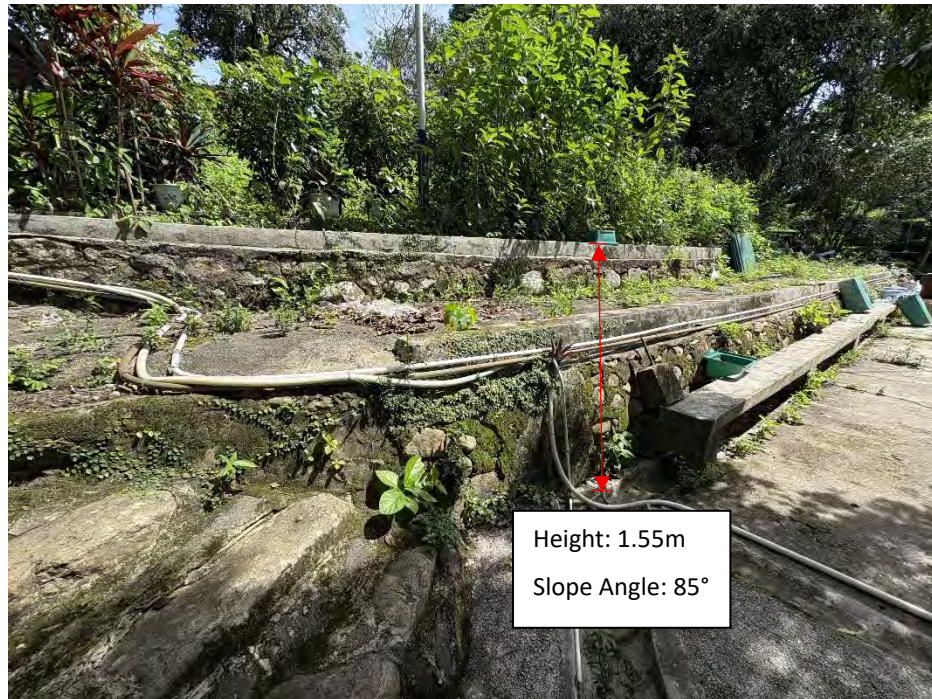
Unregistered Feature No.	Type	Length (m)	Height (m)	Slope Gradient (°)	Remark from Site Observations
A (Photo K)	Rubble wall	27	1.55	85	No sign of distress
B (Photo L)	Rubble wall	21	0.65	90	Cracks and losing mortar
C (Photo M)	Rubble wall	26	1.10	90	No sign of distress
D (Photo N)	Soil cut slope	20	2.80	75	Bared surface
E (Photo O)	Rubble wall	29	2.10	80	Minor collapse of rubble wall

Photo K – General View of the Unregistered Feature A

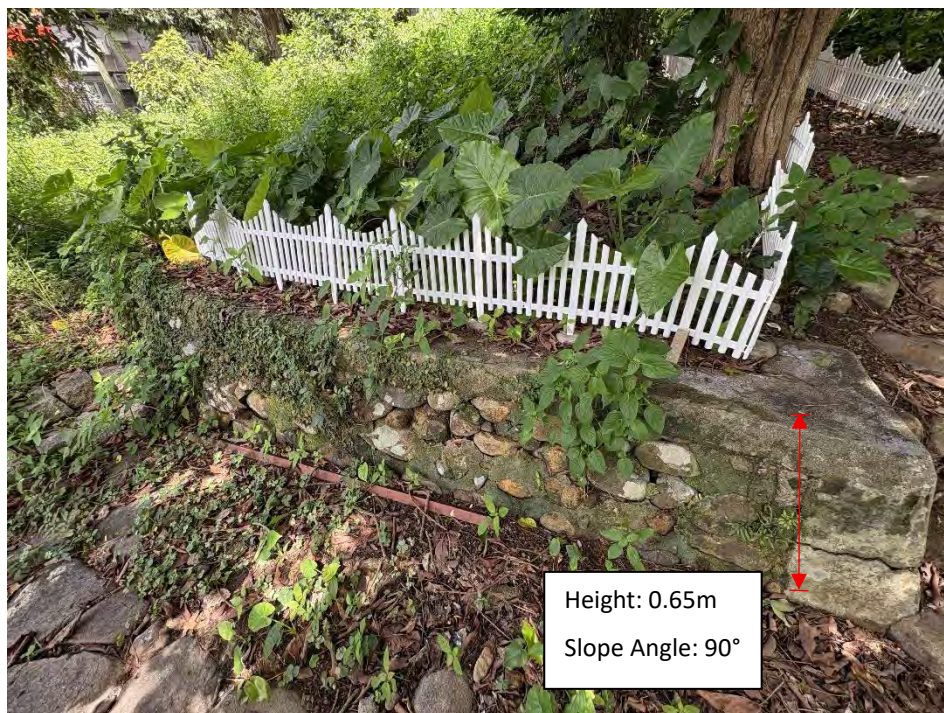
Photo L – General View of the Unregistered Feature B

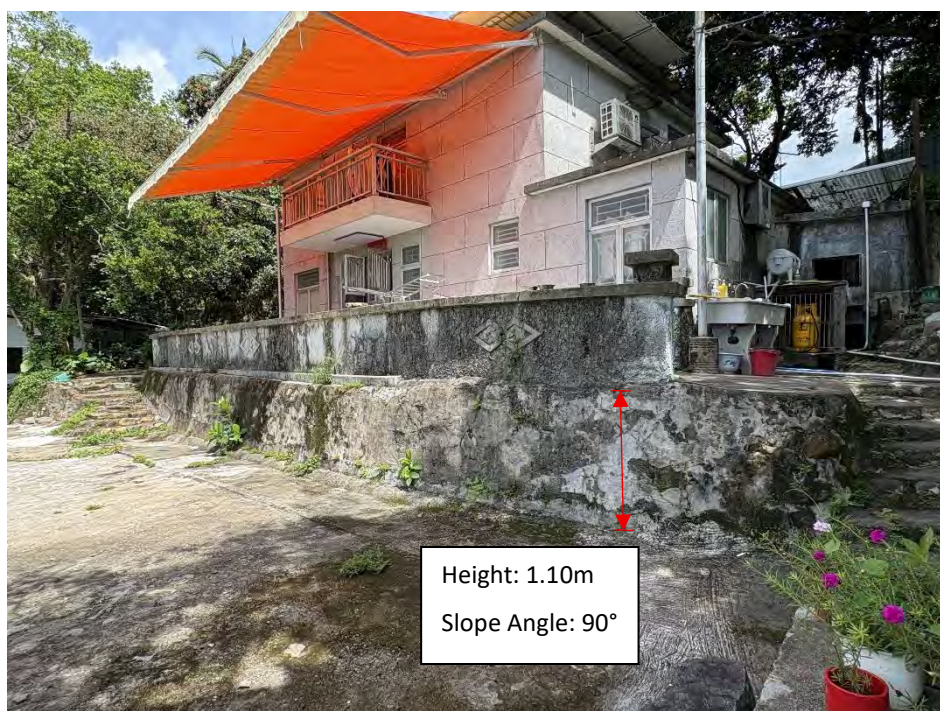
Photo M – General View of the Unregistered Feature C

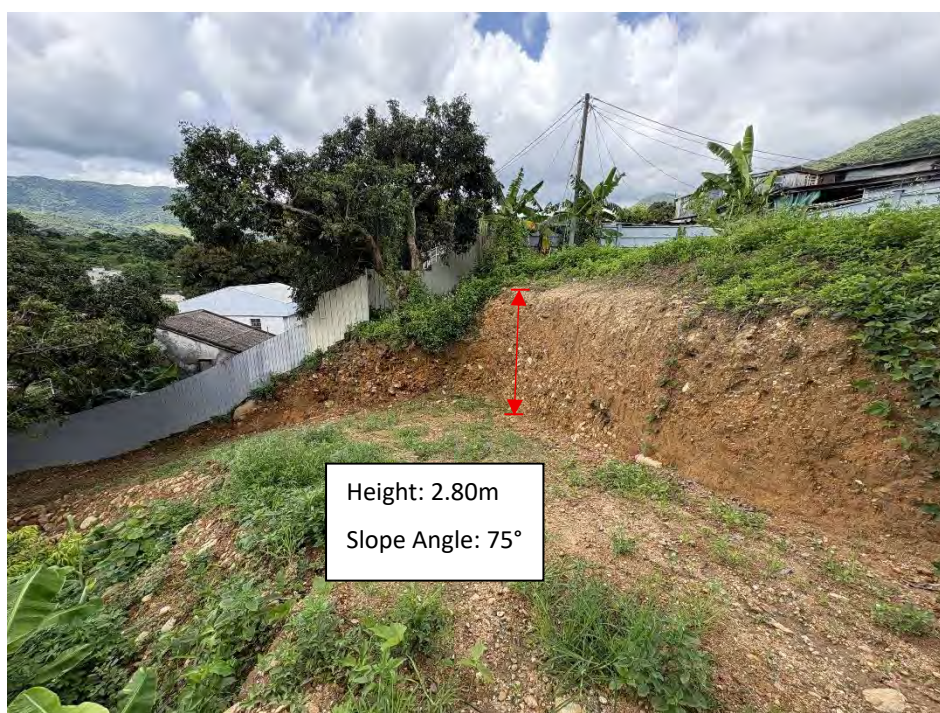
Photo N – General View of the Unregistered Feature D

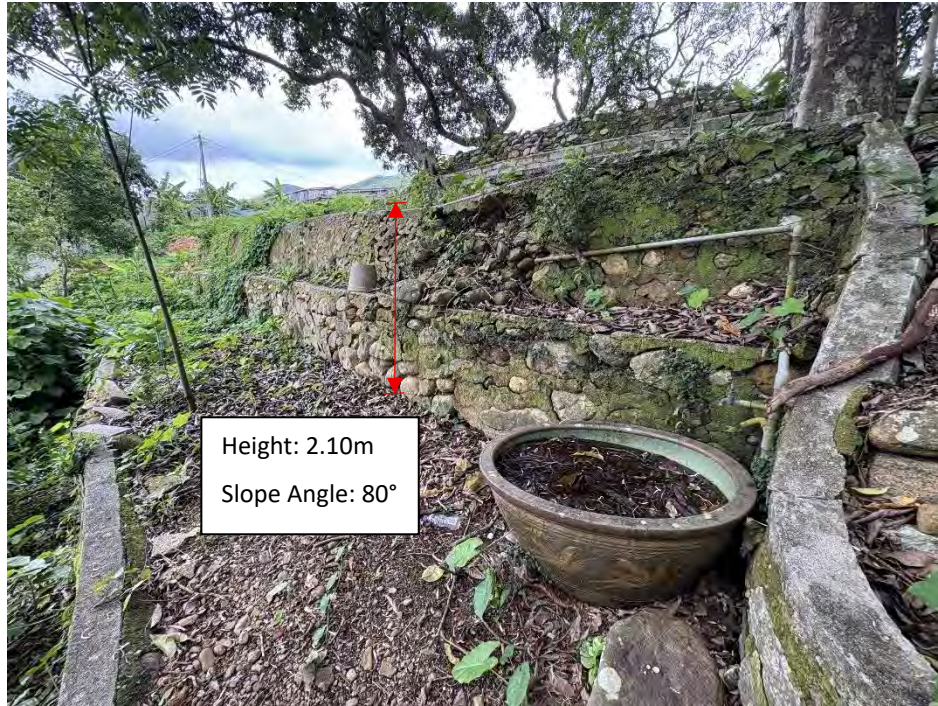
Photo O – General View of the Unregistered Feature E

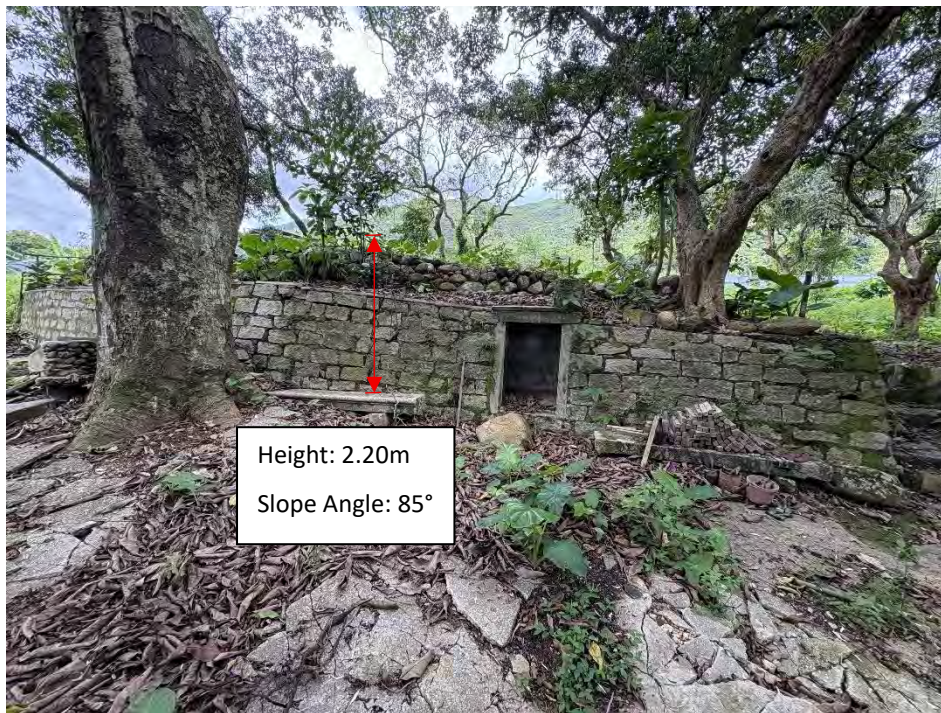
F (Photo P)	Masonry wall	35	2.20	85	No sign of distress
G (Photo Q)	Rubble and masonry wall	76	1.15	90	No sign of distress
H (Photo R)	Rubble wall	31	1.40	85	No sign of distress
I (Photo S)	Masonry wall	47	2.20	80	No sign of distress
J (Photo T)	Rubble wall	22	1.95	90	Cracks and losing mortar

Photo P – General View of the Unregistered Feature F

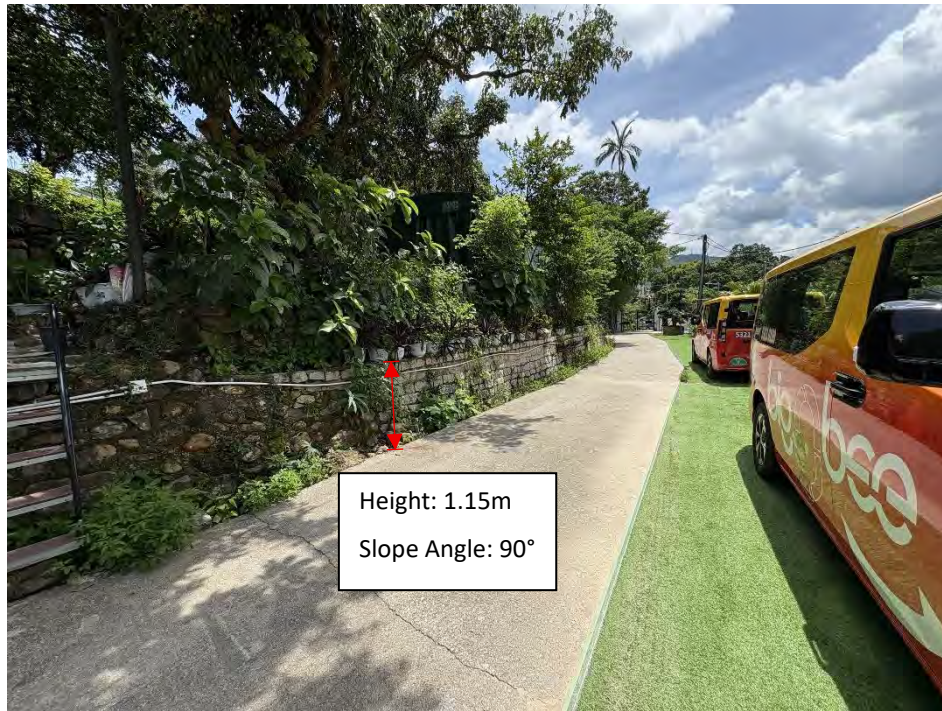
Height: 1.15m
Slope Angle: 90°

Photo Q – General View of the Unregistered Feature G

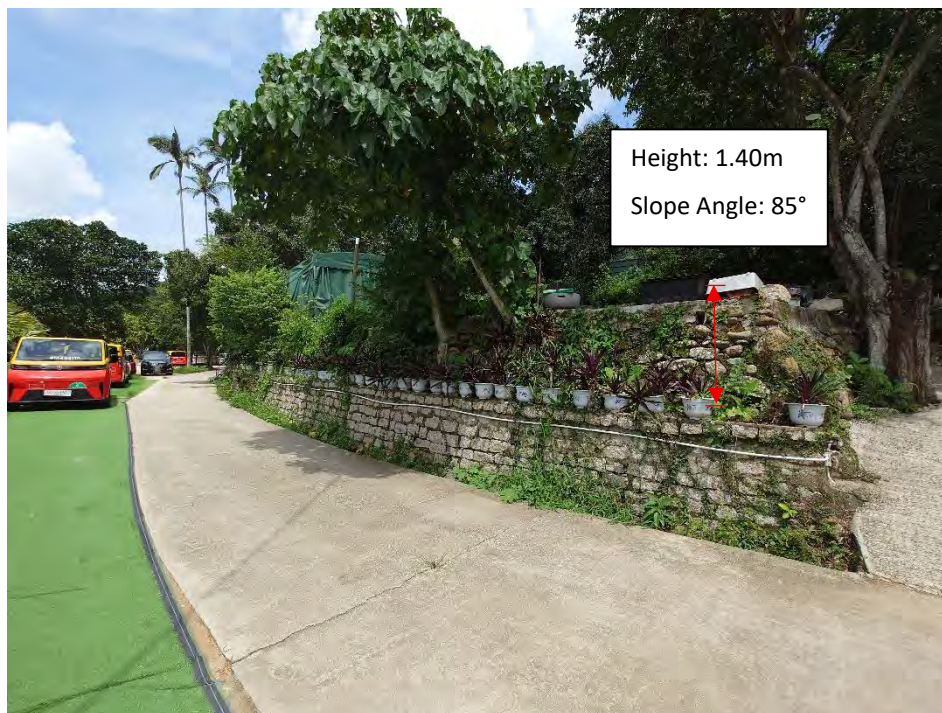
Height: 1.40m
Slope Angle: 85°

Photo R – General View of the Unregistered Feature H

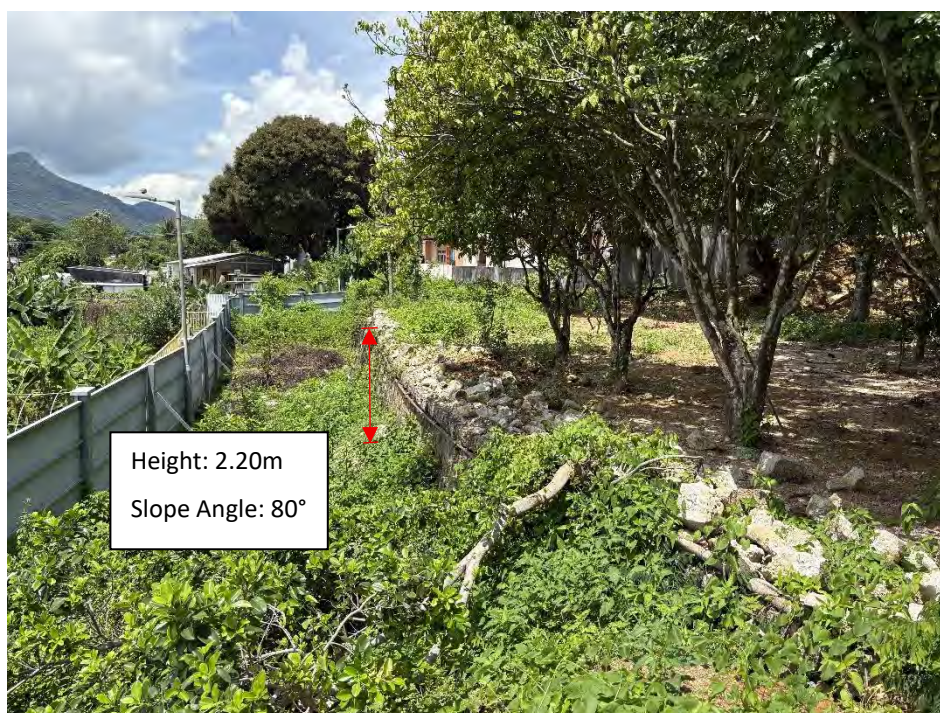
Height: 2.20m
Slope Angle: 80°

Photo S – General View of the Unregistered Feature I

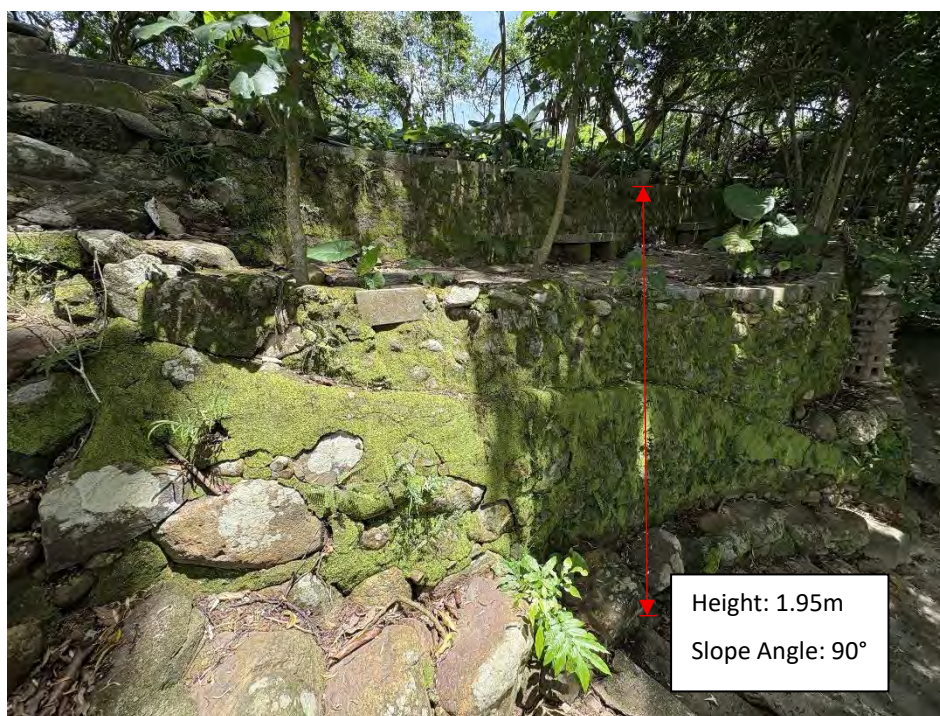
Height: 1.95m
Slope Angle: 90°

Photo T – General View of the Unregistered Feature J
