**Geotechnical Planning Review Report  
for  
Proposed Temporary Place of Recreation, Sports or  
Culture (Hobby Farm) with  
Ancillary Facilities and Associated Filling of Land  
for a Period of 5 Years  
at Lots 86, 90, 91(Part), 92(Part), 103(Part),  
147(Part), 148 S.A(Part), 148 S.B(Part),  
149(Part), 150 S.A, 151 S.A(Part), 153(Part), 572  
S.A(Part) and 572 S.B (Part), 572 RP (Part) and  
576(Part) in D.D.16,  
Lam Tsuen, Tai Po, New Territories**

**January 2026**

***Philip So & Associates Consulting Civil & Geotechnical Engineers Ltd.***

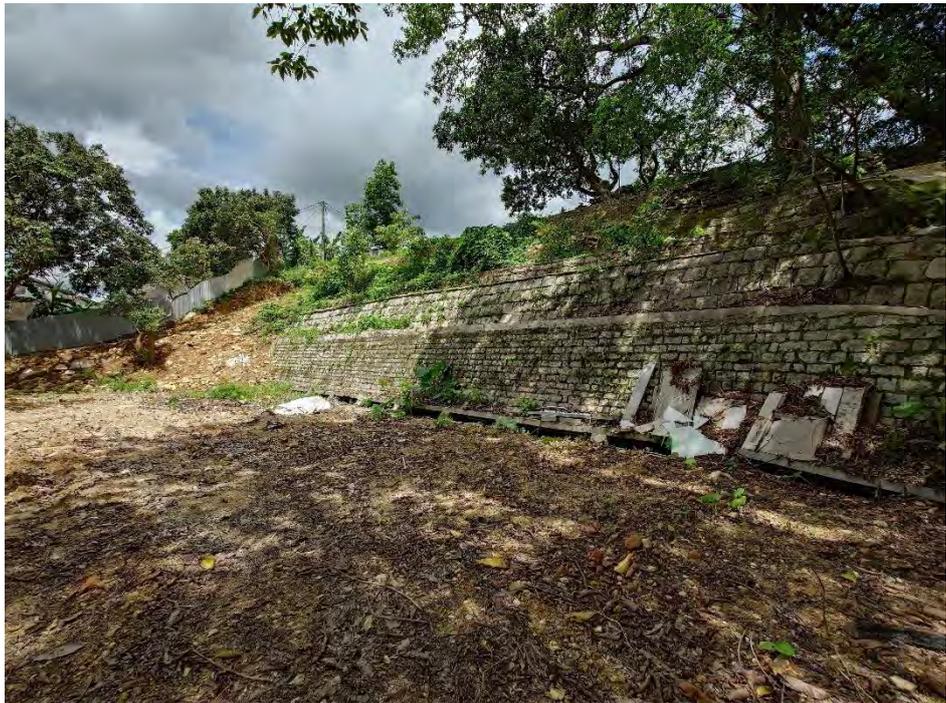
**Photo F – General View of the Feature No. 7NW-A/C93**

The registered man-made cut slope Feature no. 7NW-A/C93 is located at the south-western end of the Site adjacent to the Site boundary. According to the SIS record, the feature is about 40m long and 4.6m high with slope gradient ranging at about 61° to the horizontal and covered with masonry facing.

Nevertheless, further assessment of whether the existing stability of the Feature No. 7NW-A/C93 may affect or being affected by the proposed development shall be carried out. Further detailed of the slope stability assessment will be covered in the next stage of the project, i.e. the geotechnical assessment report.

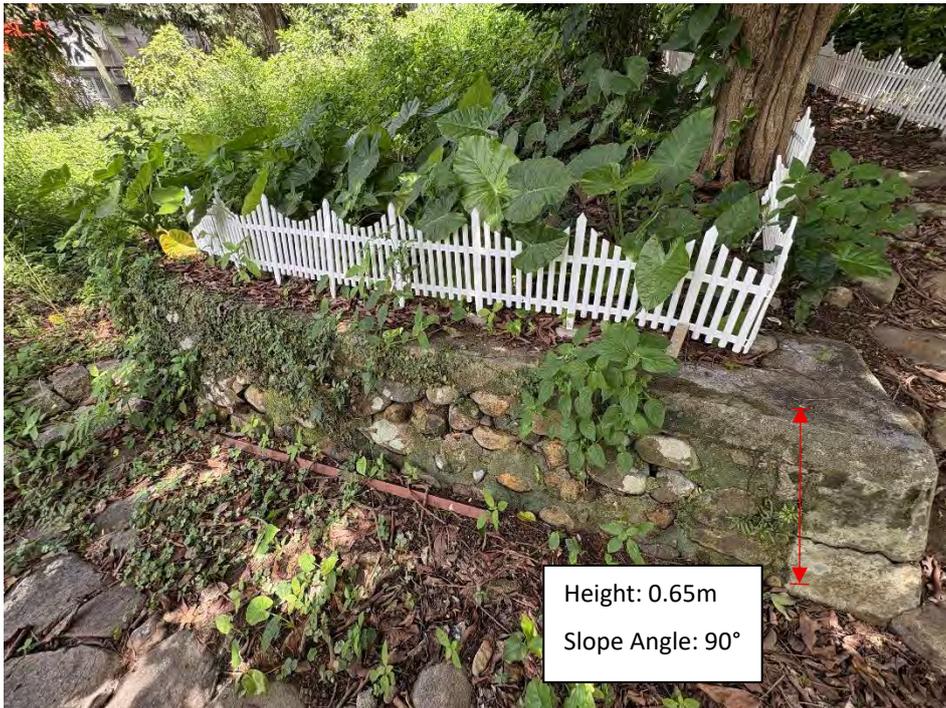
**Photo L – General View of the Unregistered Feature B**

B (Photo L)	Rubble wall	21	0.65	90	Cracks and losing mortar
C (Photo M)	Rubble wall	26	1.10	90	No sign of distress
D (Photo N)	Soil cut slope	20	2.80	75	Bared surface
E (Photo O)	Rubble wall	29	2.10	80	Minor collapse of rubble wall
F (Photo P)	Masonry wall	35	2.20	85	No sign of distress
G (Photo Q)	Rubble and masonry wall	76	1.15	90	No sign of distress
H (Photo R)	Rubble wall	31	1.40	85	No sign of distress
I (Photo S)	Masonry wall	47	2.20	80	No sign of distress
J (Photo T)	Rubble wall	22	1.95	90	Cracks and losing mortar

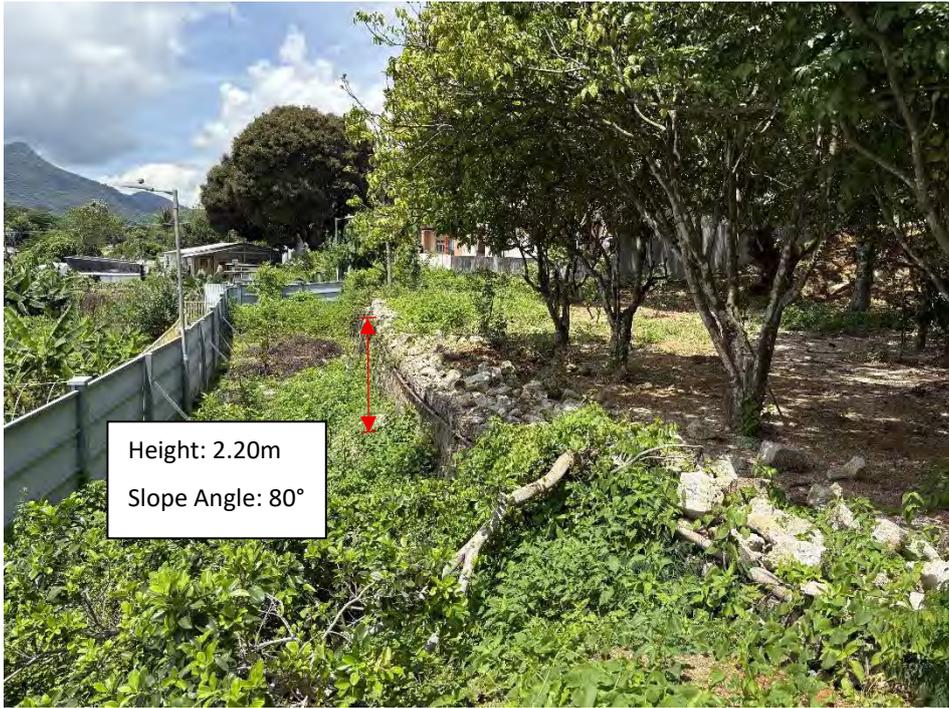
**Photo S – General View of the Unregistered Feature I**

Height: 2.20m  
Slope Angle: 80°

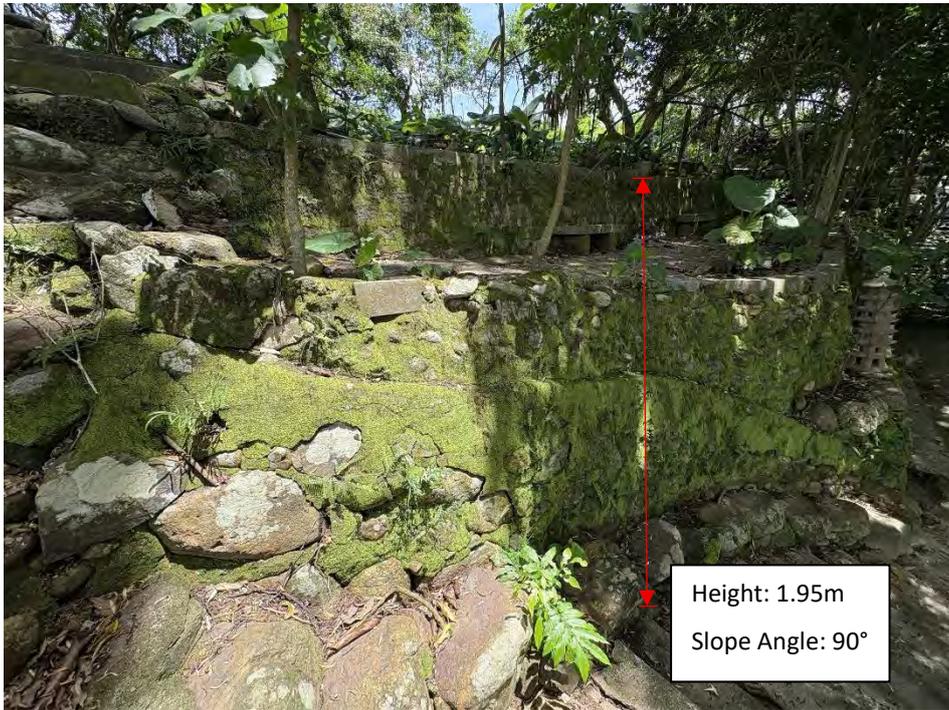
**Photo T – General View of the Unregistered Feature J**

Height: 1.95m  
Slope Angle: 90°
