**Appendix IV**  
**Updated Storm Water Drains Photographic Record**  
**(As of April 2026)**

PROJECT :  
Topographical and Tree Location Survey for Various Lots in D.B.100 and the Adjoining Government Land in Ying Pun, Kwo Tung South

DATE OF SURVEY May 2026	SCALE AT A1 1:400
DRAWING NUMBER KEL/TOPD/26/03	REVISION 0

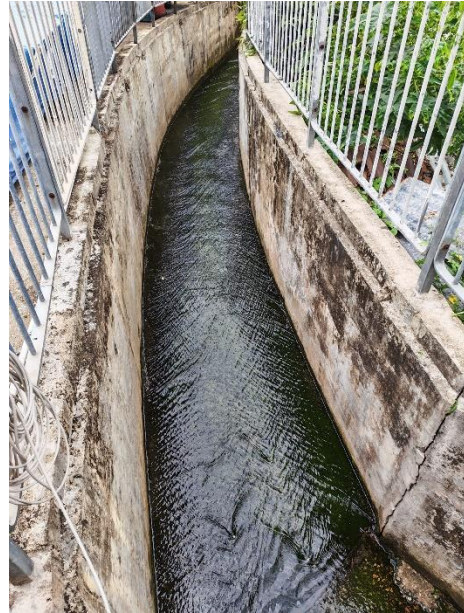
Photo No. 4: Existing Stream Condition

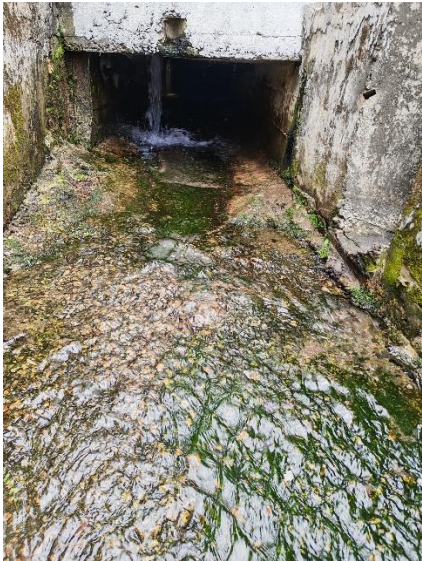
Photo No. 5: Existing 225 U/C Condition

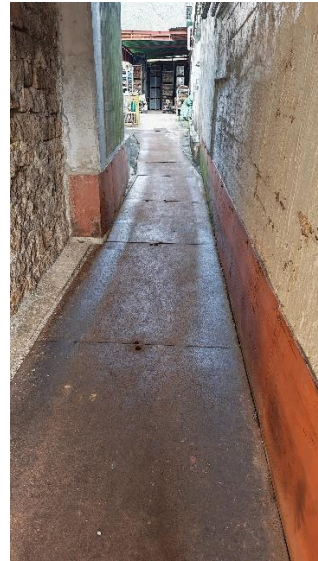
Photo No. 6: Existing 225 U/C Condition

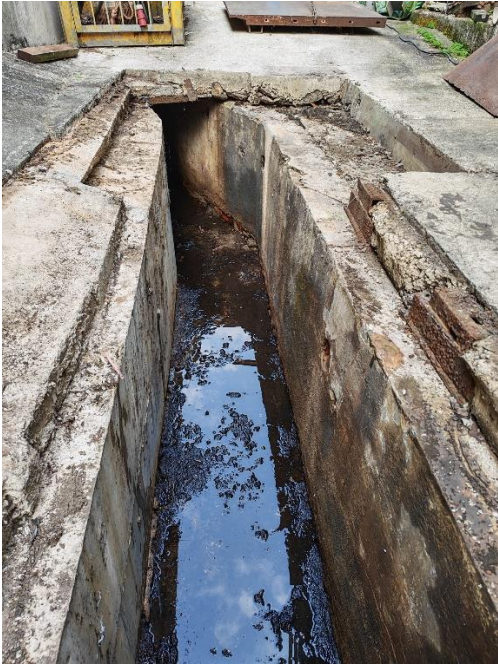
Photo 7: Existing 225 U/C Condition

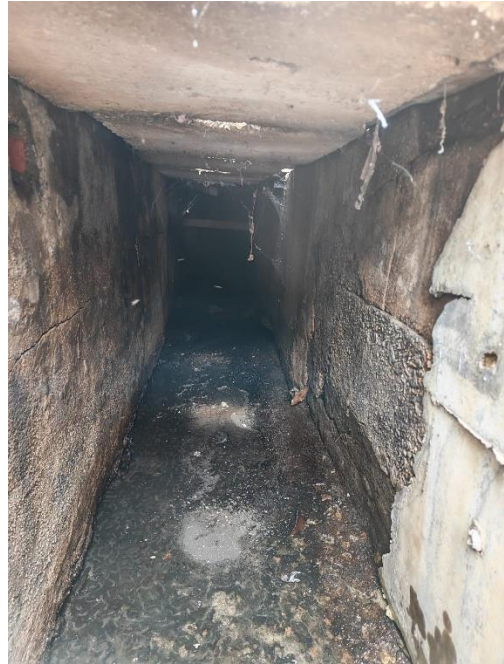
Photo 8: Existing 600 U/C Condition

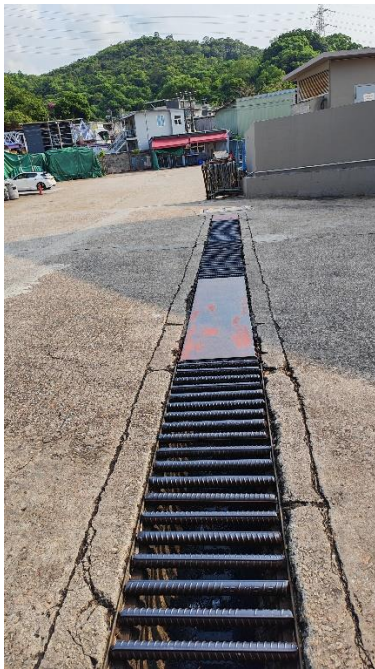
Photo 9: Existing 225 U/C Condition

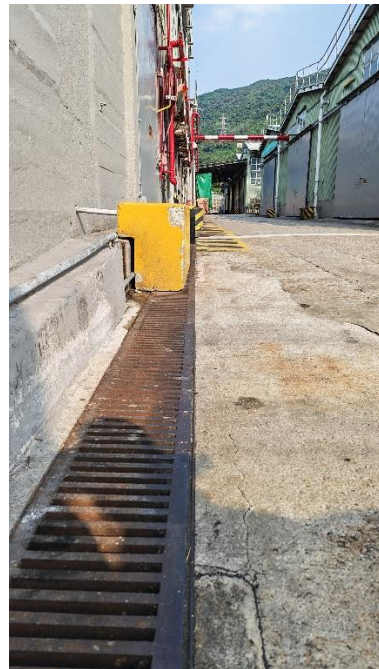
Photo 10: Existing 225 U/C Condition

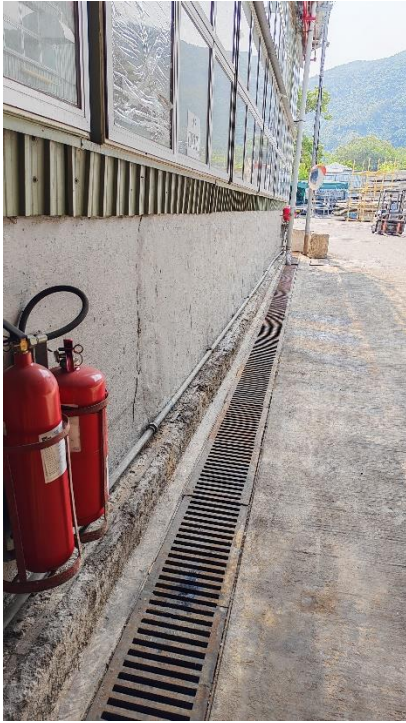
Photo No. 11: Existing 225 U/C Condition

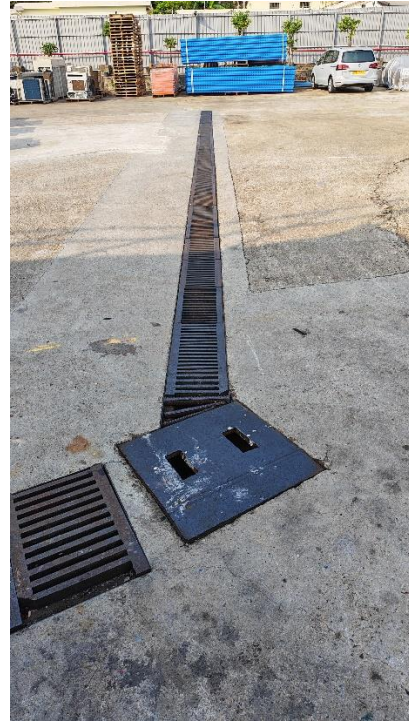
Photo 12: Existing 225 U/C Condition

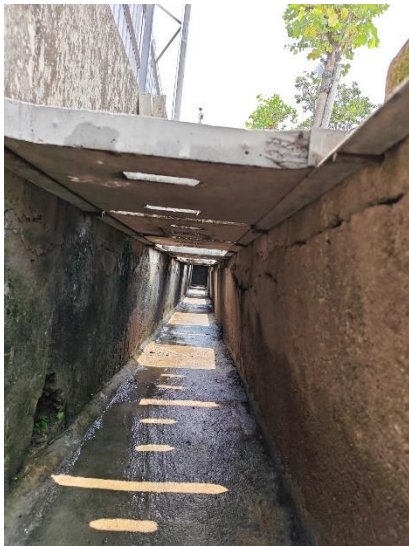
Photo 13: Existing 600 U/C Condition

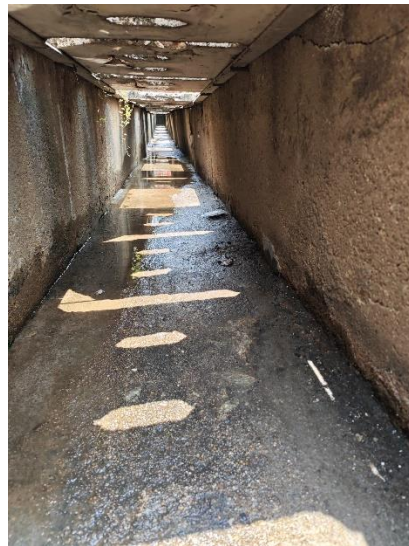
Photo 14: Existing 600 U/C Condition
