TREE GROUP INSPECTION REPORT FOR

LOT NO. 478 S.A. RP, 479, 487, 484 & 482 IN

D.D. 90

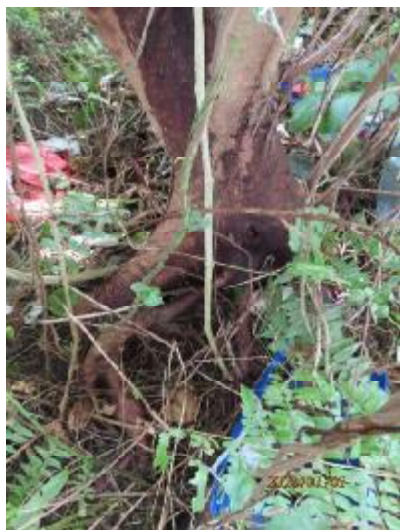
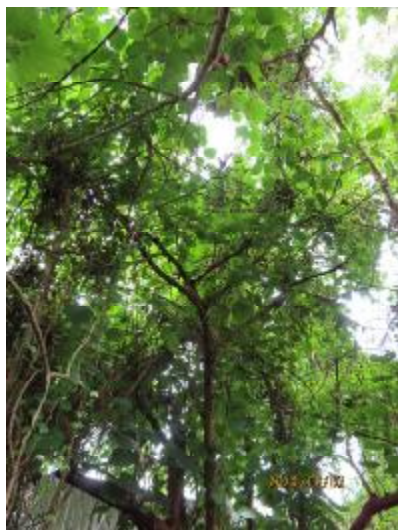
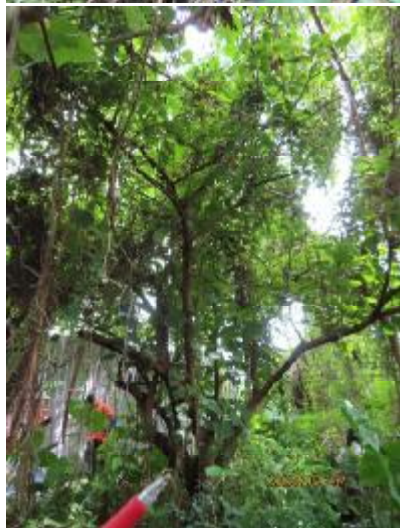
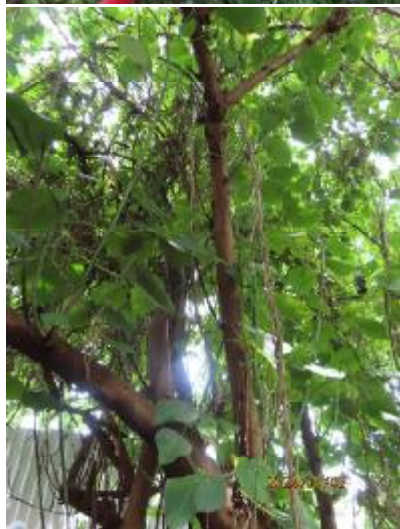
T6	<i>Macaranga tanarius</i> var. tomentosa	血桐	270	5	6	Low	Fair	Fair	Fair	Low	Native	wound (trunk), vine
T7	<i>Leucaena leucocephala</i>	銀合歡	100	7	4	Low	Fair	Fair	Fair	Low	Native	vine
T8	<i>Leucaena leucocephala</i>	銀合歡	376	9	8	Low	Fair	Fair	Fair	Low	Exotic	wound (trunk), restricted root, multi-trunks, vine
T9	<i>Leucaena leucocephala</i>	銀合歡	26	8	7	Low	Fair	Fair	Fair	Low	Exotic	restricted root, vine
T10	<i>Ficus hispida</i>	對葉榕	255	4	5	Low	Fair	Fair	Fair	Low	Native	restricted root, multitrunks, vine
T11	<i>Ficus hispida</i>	對葉榕	100	4	2	Low	Poor	Fair	Poor	Low	Native	wound (trunk), lean, bent (trunk), cracks, vine,
T12	<i>Ficus hispida</i>	對葉榕	194	4	4	Low	Poor	Fair	Poor	Low	Native	lean, codominant trunks, vine
T13	<i>Leucaena leucocephala</i>	銀合歡	270	8	7	Low	Poor	Fair	Poor	Low	Exotic	lean, restricted root, vine
T14	<i>Macaranga tanarius</i> var. tomentosa	血桐	470	7	9	Low	Poor	Fair	Poor	Low	Native	wound (trunk), fungal, cross branches, exposed root, dead branches

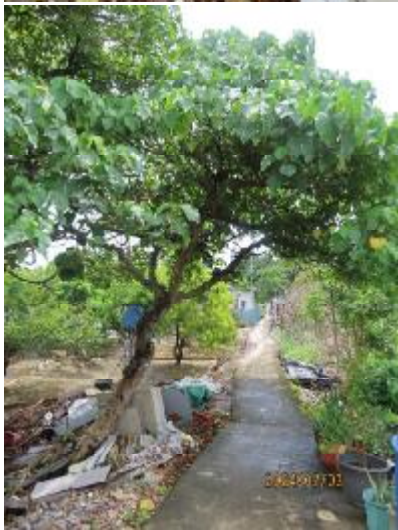
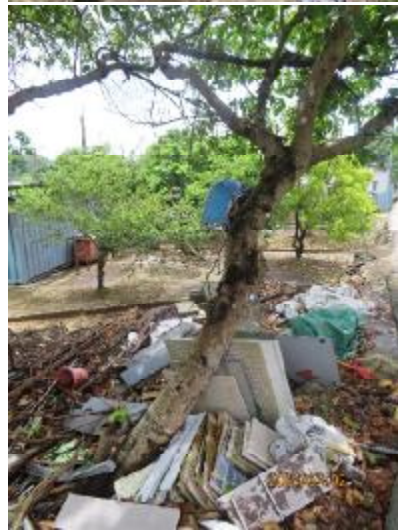
T15	<i>Macaranga tanarius</i> var. tomentosa	血桐	280	6	9	Low	Poor	Fair	Poor	Low	Native	wound (trunk), lean, exposed root
T16	<i>Macaranga tanarius</i> var. tomentosa	血桐	205	7	7	Low	Poor	Fair	Poor	Low	Native	wound (trunk), multi-trunks, vine
T17	<i>Ficus hispida</i>	對葉榕	223	3	5	Low	Poor	Poor	Poor	Low	Native	wound (trunk), much dead branches, multi-trunks
T18	<i>Ficus hispida</i>	對葉榕	559	5	5	Low	Poor	Poor	Poor	Low	Native	wound (trunk), exposed dead wood
T19	<i>Ficus hispida</i>	對葉榕	213	5	4	Low	Fair	Fair	Fair	Low	Native	wound (trunk), multi-trunks
T20	<i>Ficus hispida</i>	對葉榕	370	5	6	Low	Fair	Fair	Fair	Low	Native	wound (trunk), multi-trunks
T21	<i>Ficus hispida</i>	對葉榕	177	5	5	Low	Fair	Fair	Fair	Low	Native	included bark , multi-trunks, vine
T22	<i>Macaranga tanarius</i> var. tomentosa	血桐	15	4	4	Low	Fair	Fair	Fair	Low	Native	vine
T23	<i>Macaranga tanarius</i> var. tomentosa	血桐	156	4	5	Low	Fair	Fair	Fair	Low	Native	codominant trunks, bent (trunk), exposed root
