Natural Terrain Hazard Study
(Application number A/SK-CWBS/17)

**Natural Terrain Hazard Study
for Proposed Filling of Land and
Excavation of Land for Permitted 2-Storey on Farm
Domestic Structure at Lot No. 30 (Part)
in D.D. 233, East of Clear Water Bay Road,
Sai Kung,
New Territories**

CHUNG KWOK-FAI, EDWIN
MASc. B Eng C Eng FHKIE
Registered Structural Engineer
Registered Geotechnical Engineer

August 2014

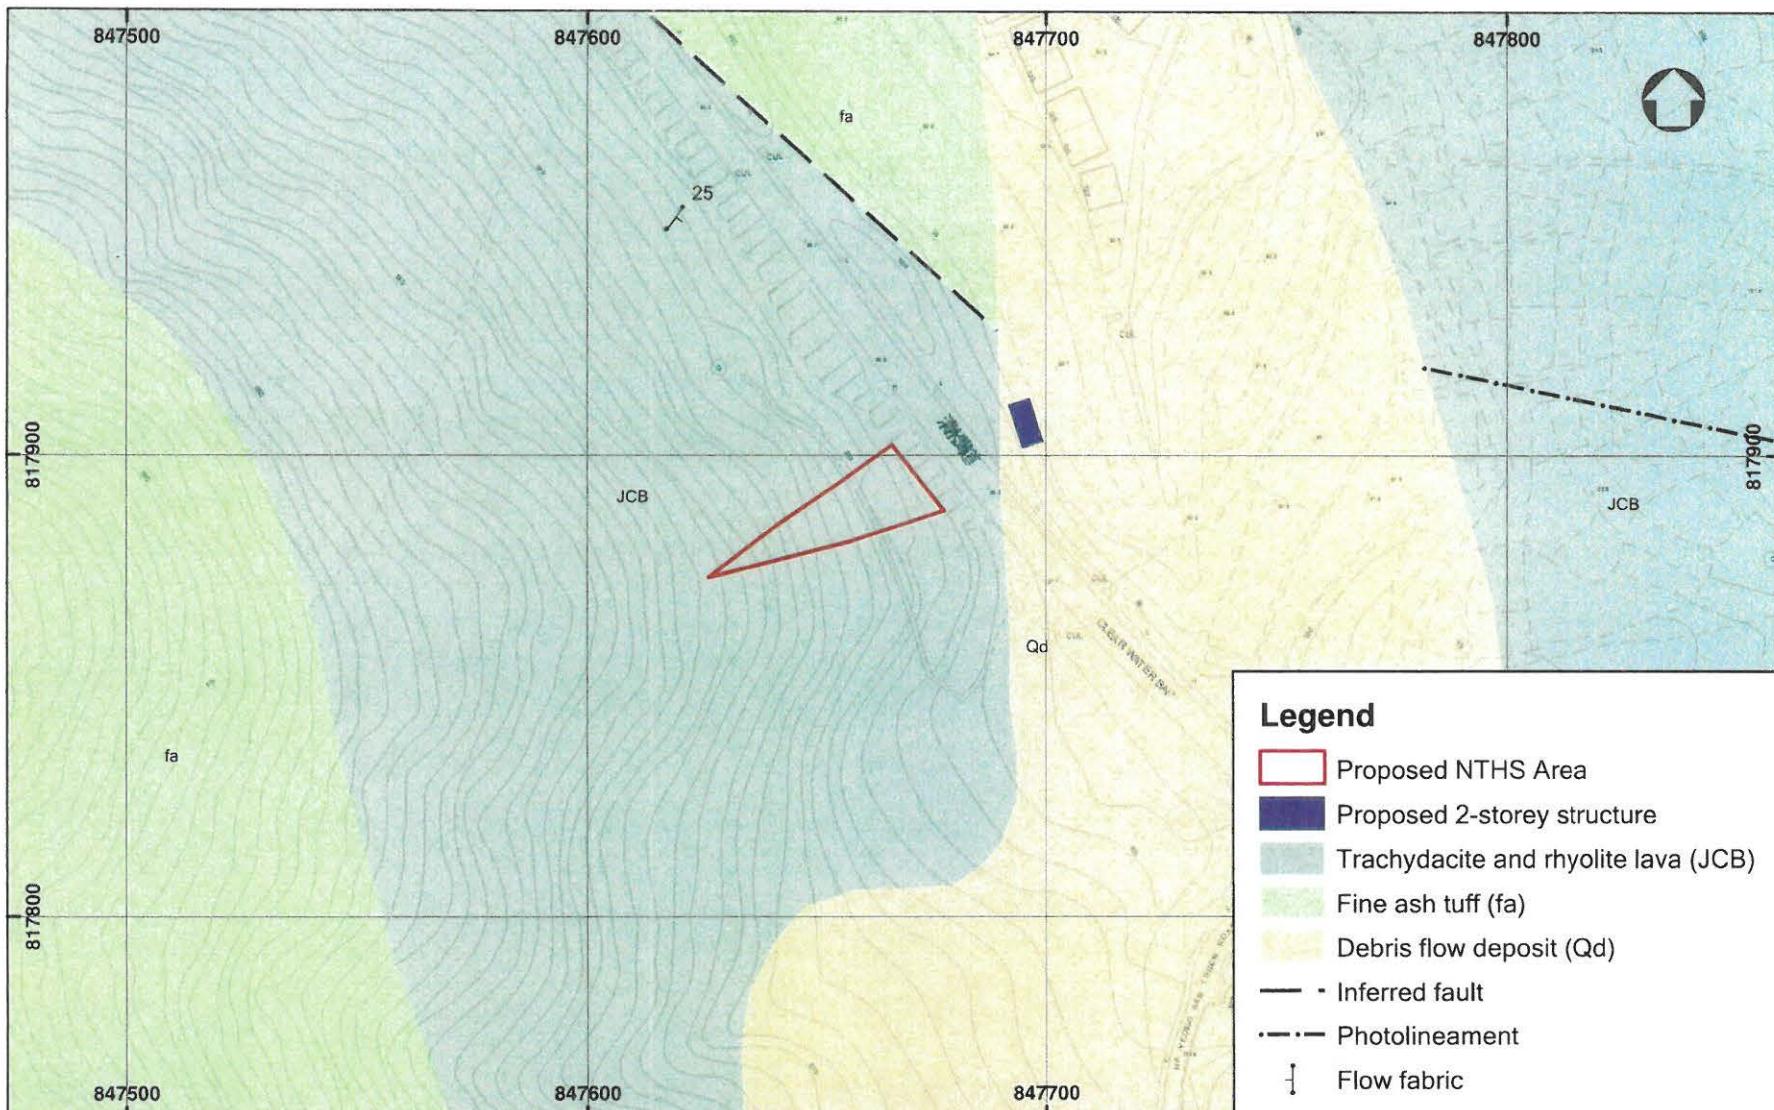
FIGURE NO :
FIGURE 3

The 1:20,000 scale geological map sheet 12 (HKGS, 1989) indicated that the Study Area is likely to be underlain by undivided, mainly trachydacite and rhyolite lava of Clear Water Bay Formation (JCB).

No superficial deposit has been marked within the Study Area indicating the possible thickness of superficial materials could be less than 2 m.

No fault or photolineament has been recorded within the Study Area. A NW-SE trending inferred fault is indicated 40 m to the northeast of the Study Area.

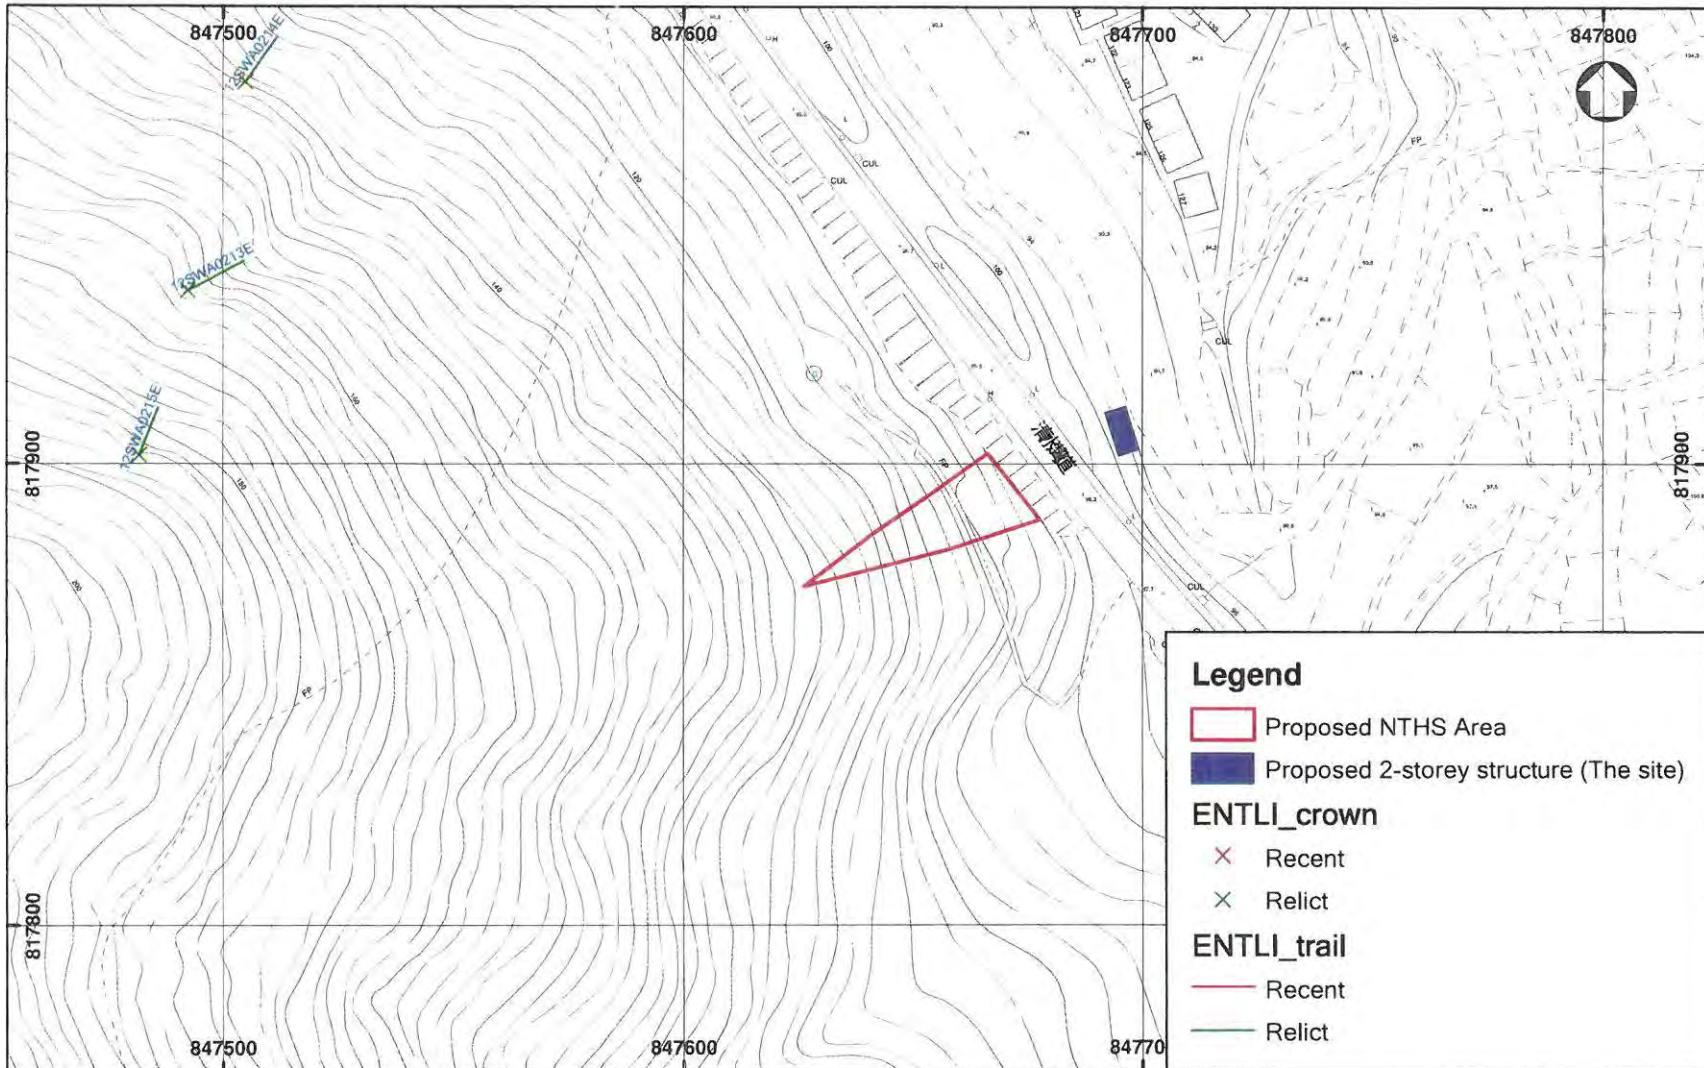
FIGURE NO :
FIGURE 4

The ENTLI has recorded no relict or recent natural terrain landslides within the Study Area. Three relict open hillside landslides were recorded at about 150 m to the northwest of the Study Area. Details of these ENTLIs are summarised in Table 3.1 and their approximate locations are shown in Figure 4.

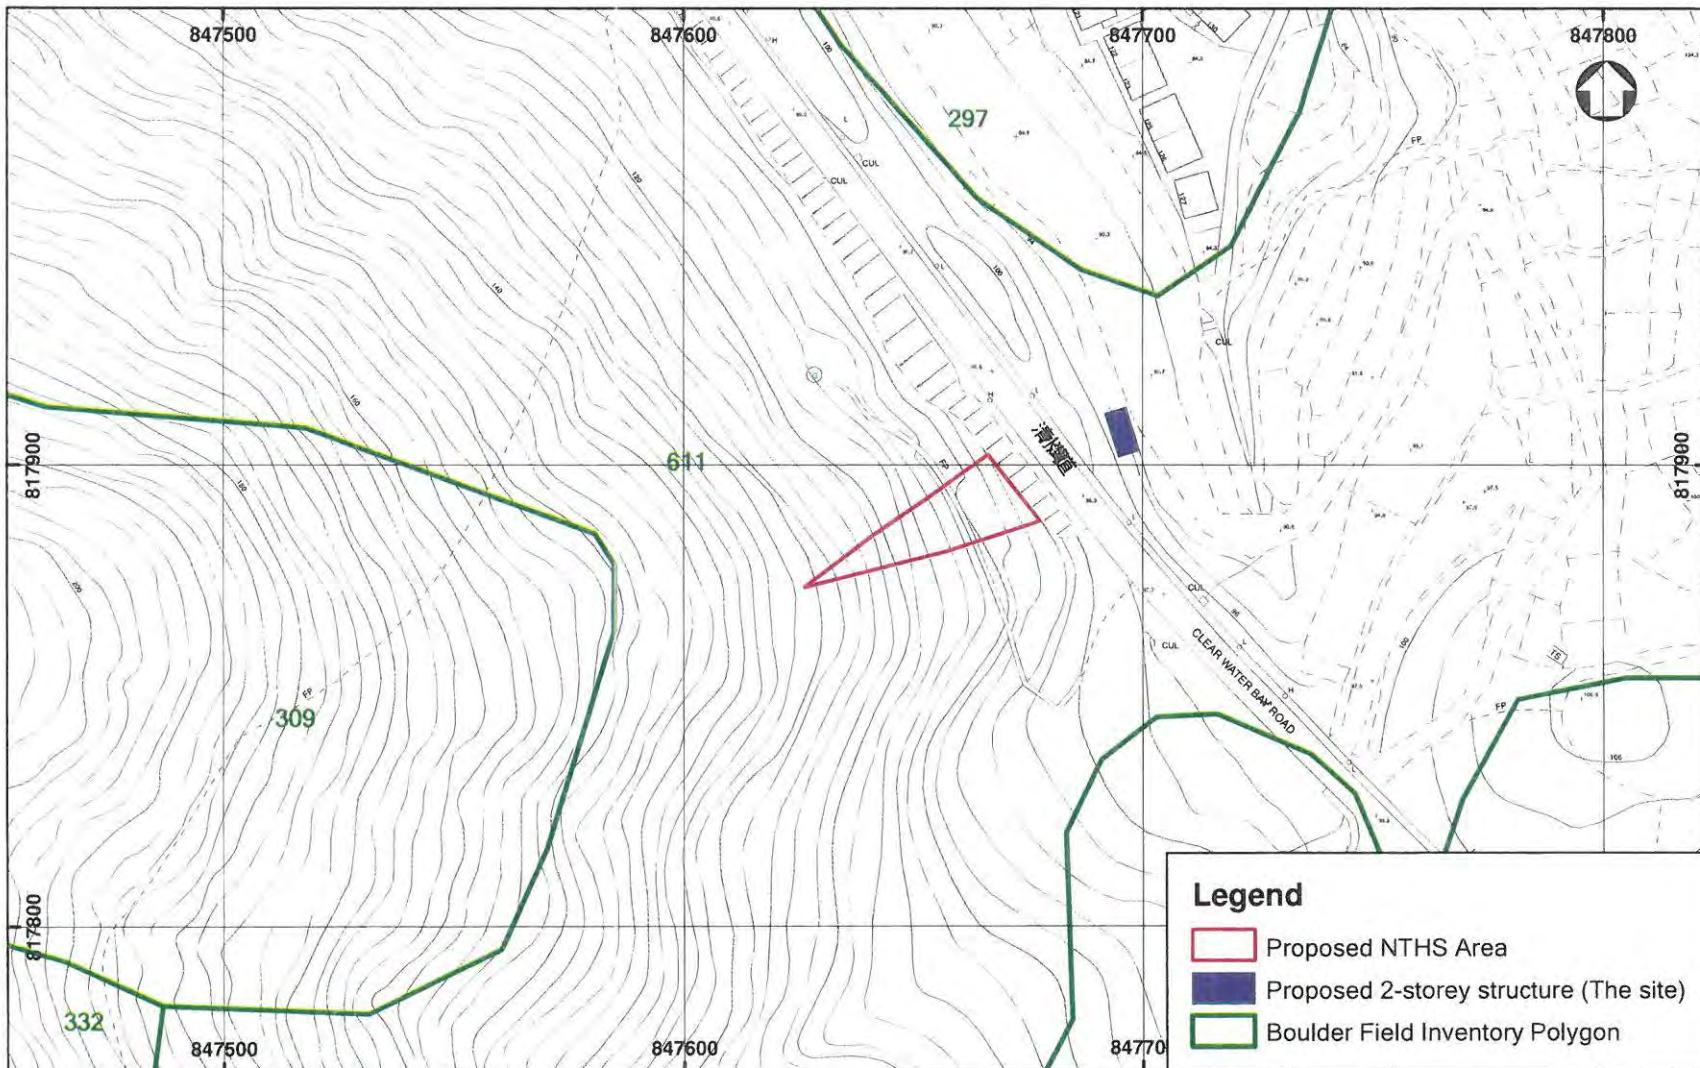
FIGURE NO :
FIGURE 5

The Boulder Field Inventory was compiled by MGSL. The inventory contains referenced polygons encompassing individual boulder fields. The Study Area lies within Polygon No. 611 (Figure 5) which indicates no boulder has been observed on the ground surface.

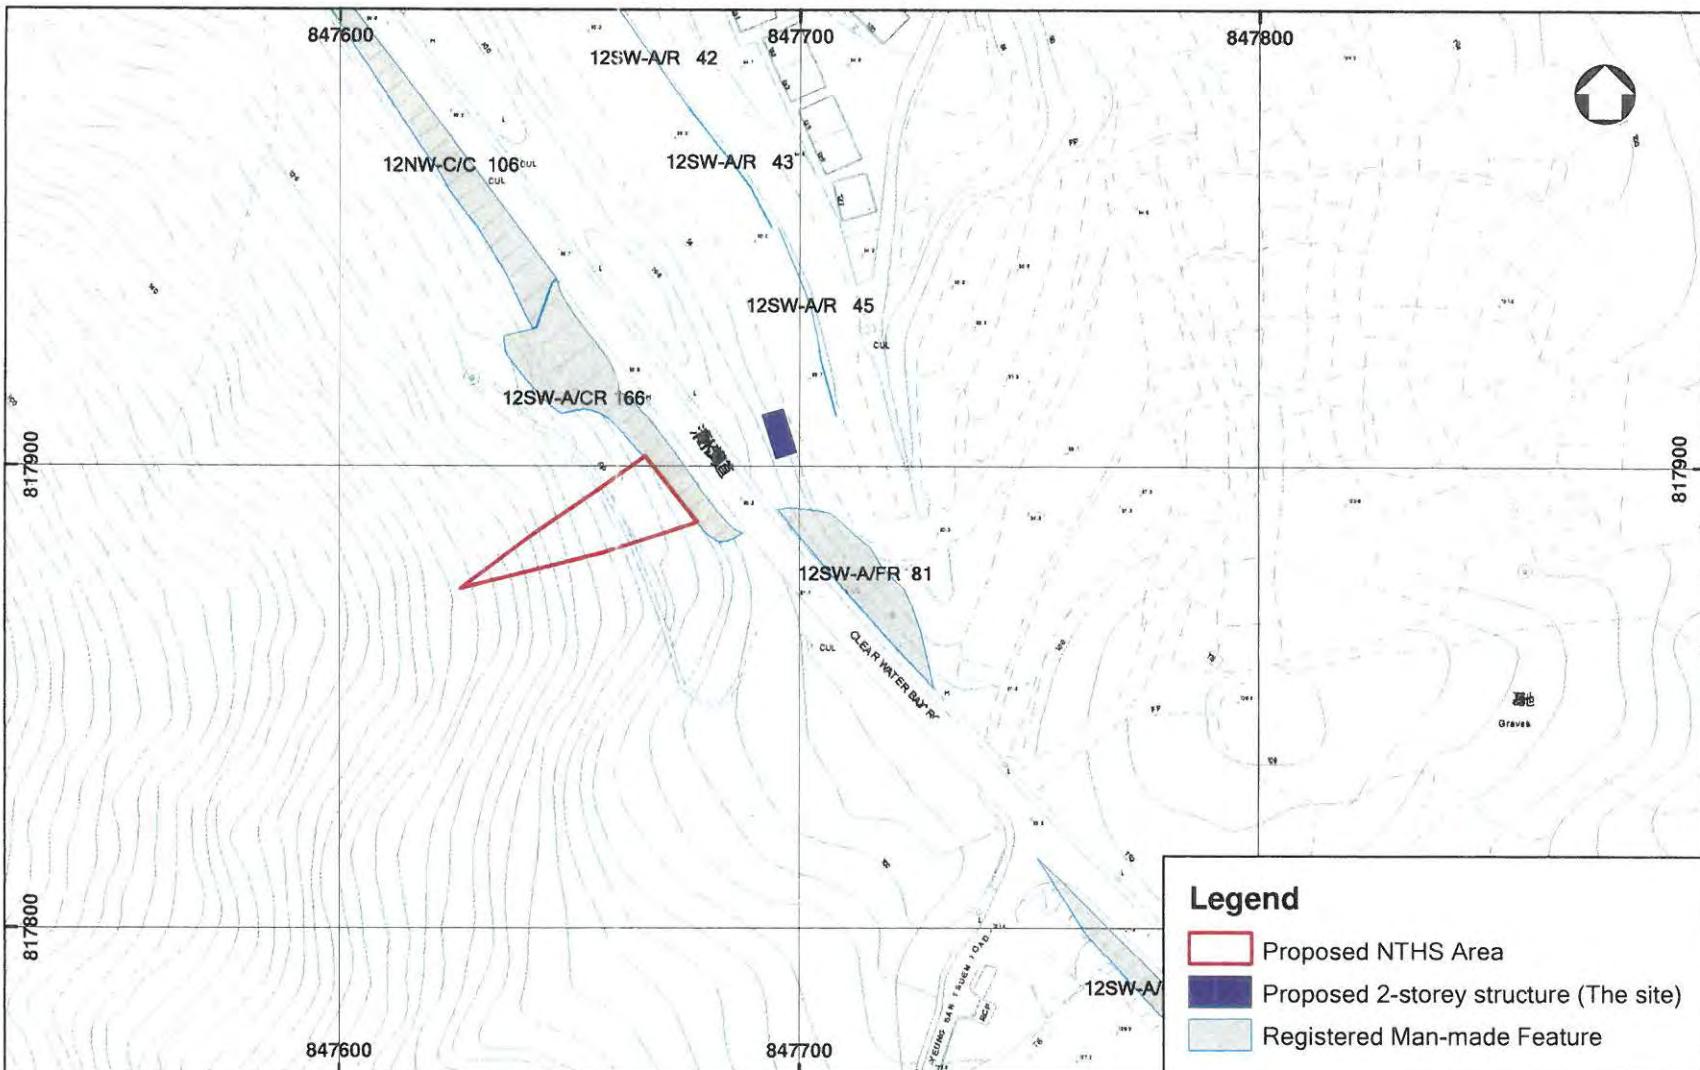
FIGURE NO :
FIGURE 7

A registered man-made Feature No. 12SW-A/CR166 is located immediately below the Study Area (Figure 7) on the upslope side of Clear Water Bay Road. According to the SIS record, the feature is a cut slope with maximum height and length of the feature is about 8.5 m and 70 m respectively. The average angle of the feature is only about 40°. There are retaining walls at the feature crest and toe along the northern portion of the feature. Detailed information of the feature extracted from SIS is presented in Appendix B.

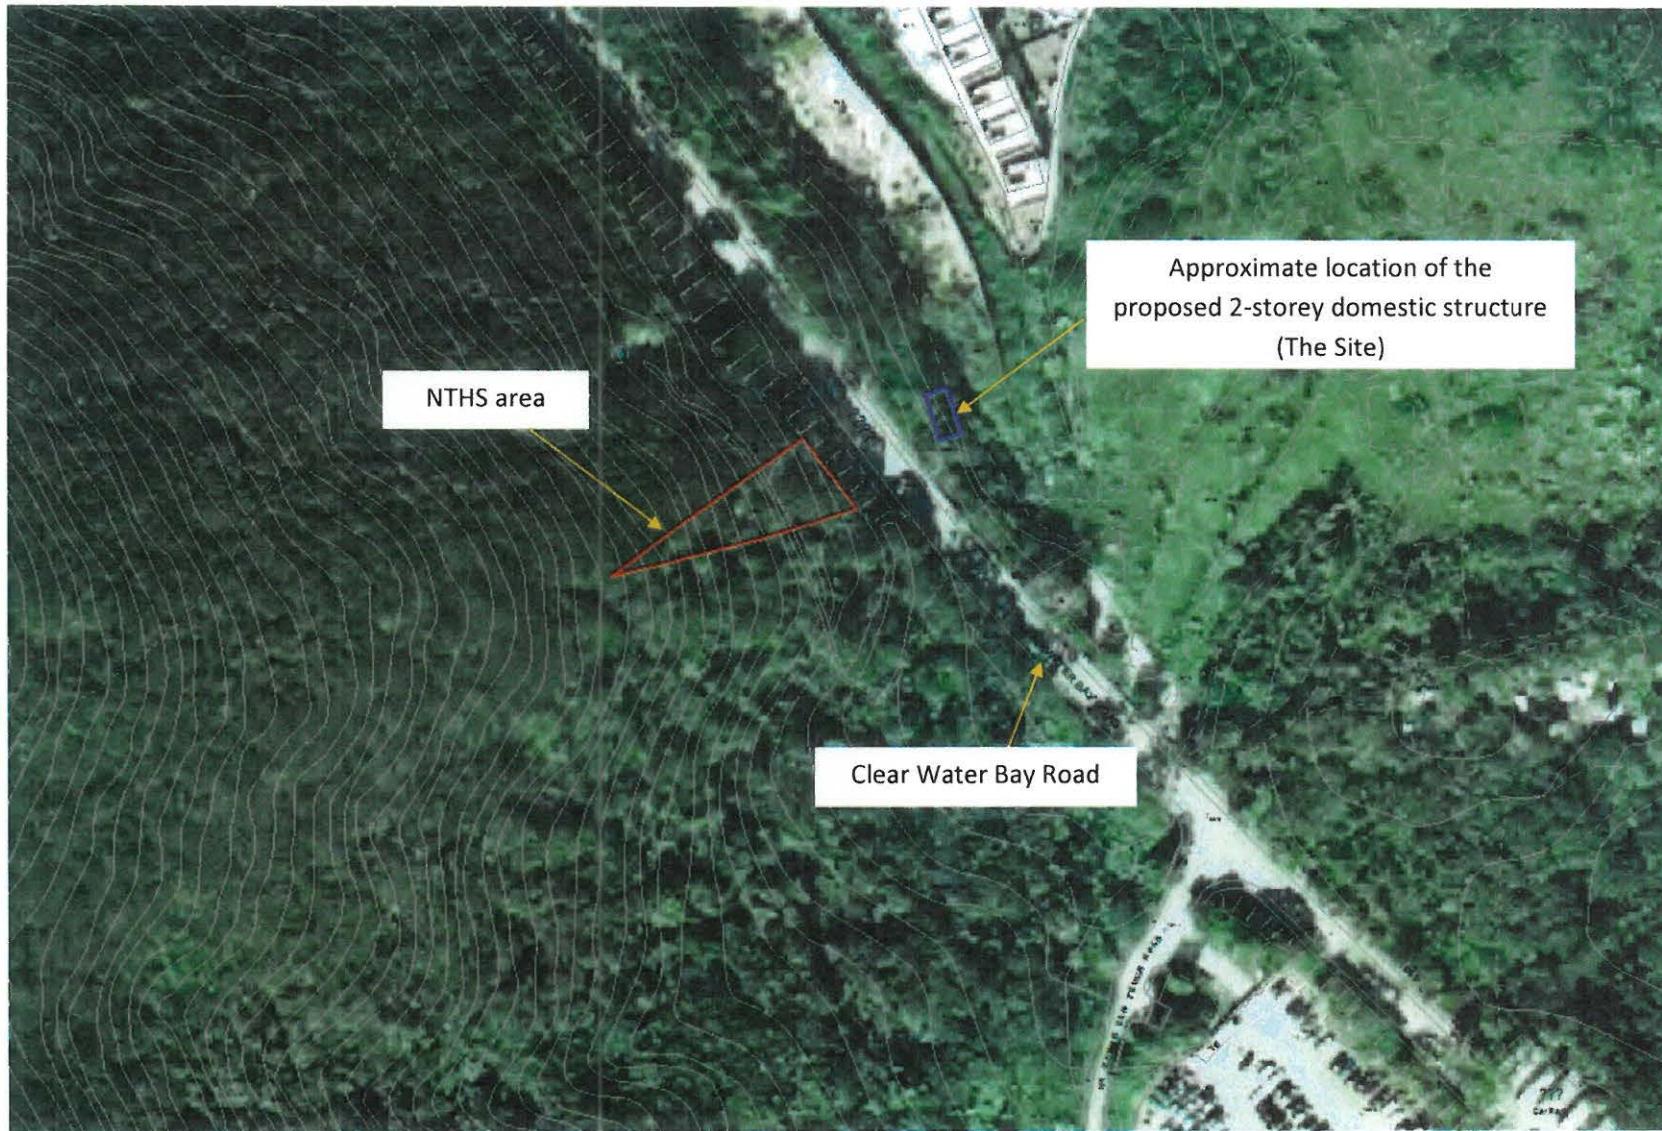
The NTHS Area comprises predominantly a gentle open hillslope covered with dense vegetation and has a small plan area of approximately 466 m² (Plate 2).

Plate 2 General view of the location of the NTHS area

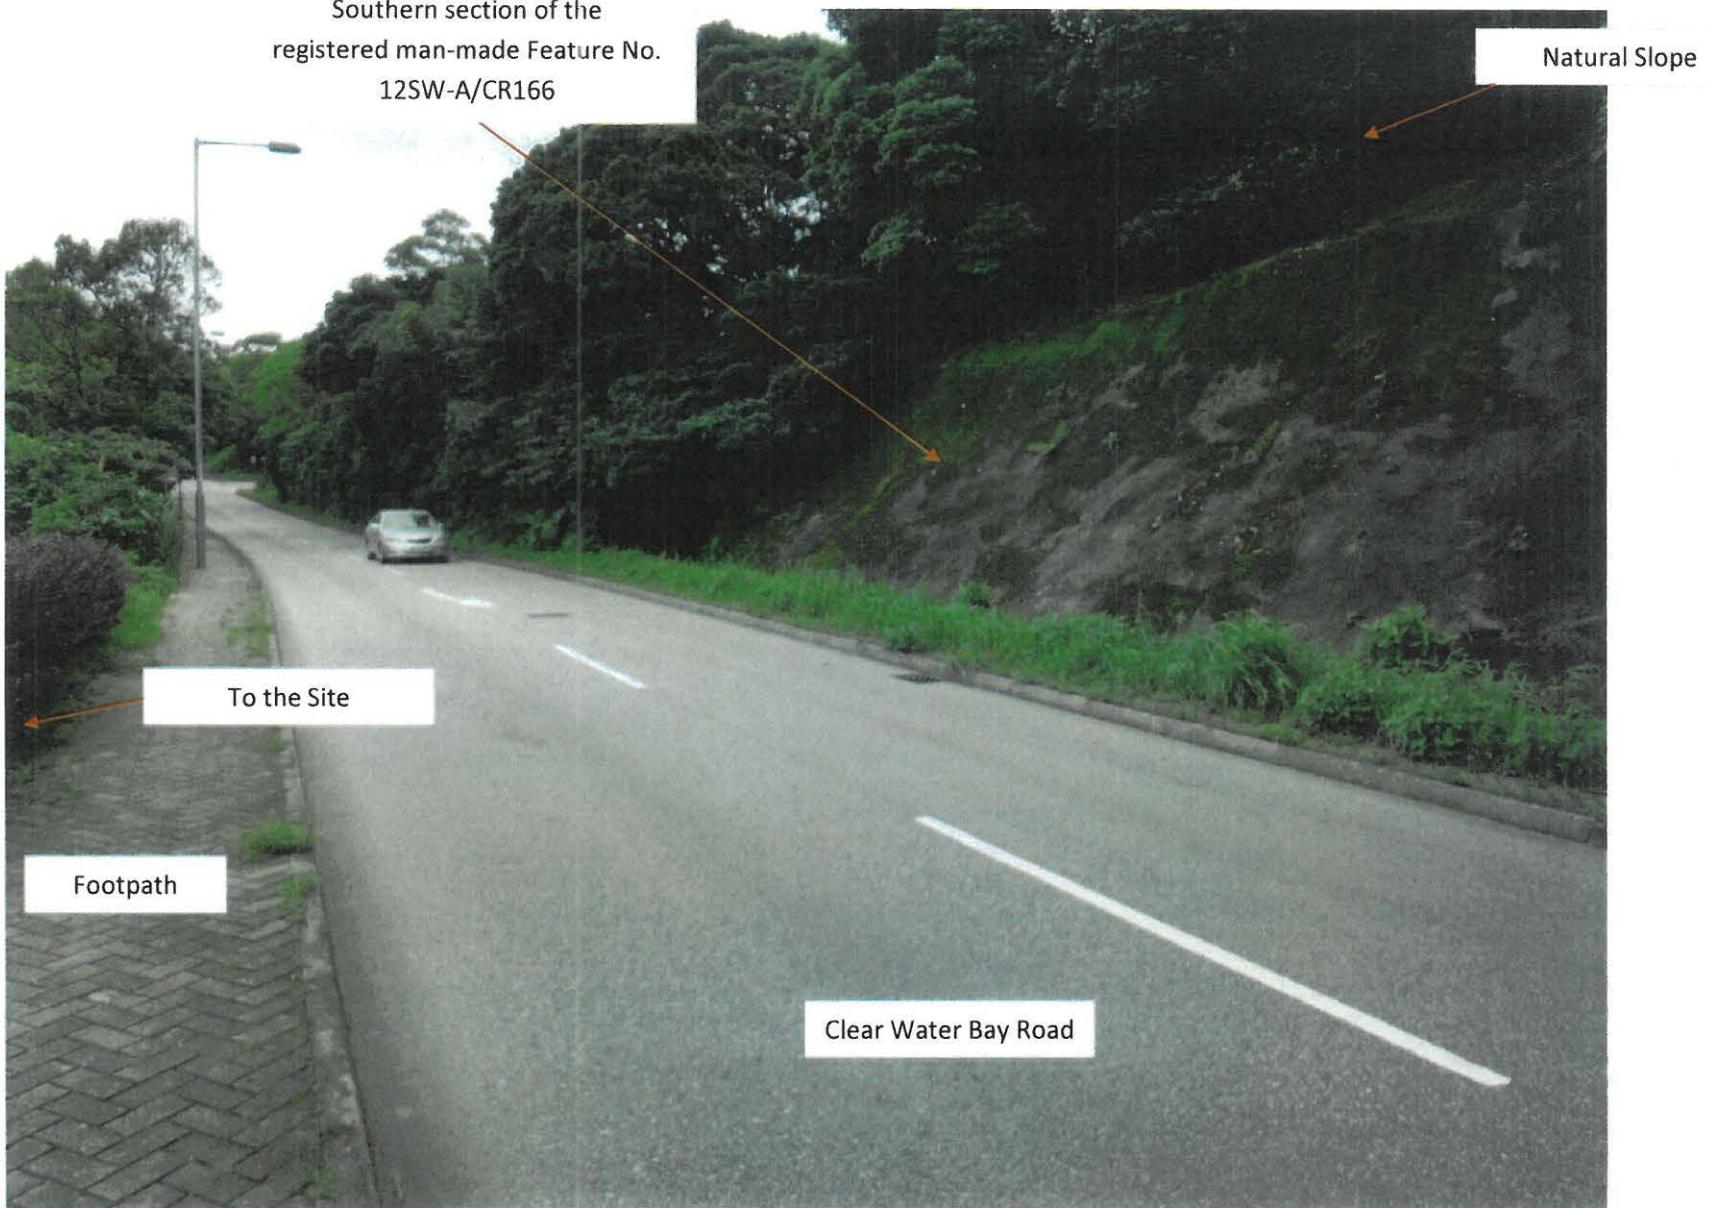
The existing facility immediately below the Study Area is the Clear Water Bay Road and footpath which has an approximately width of 12.5 m (Plate 3).

Plate 3 General view of the facilities below the Study Area

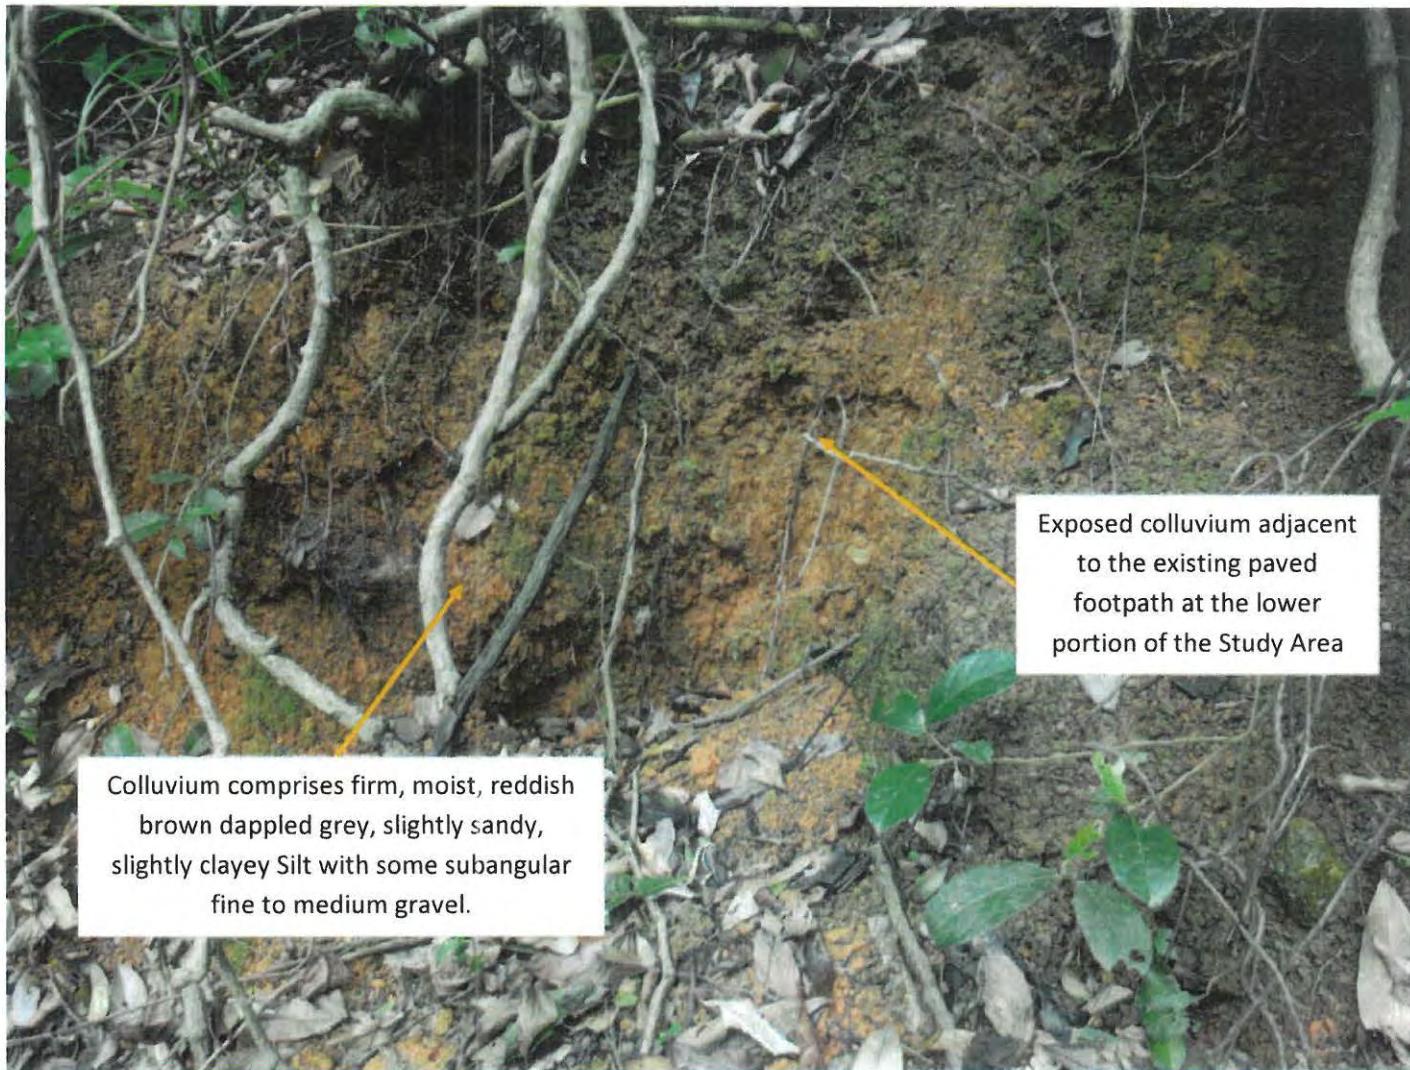
Plate 4 Exposed open hillslope colluvium

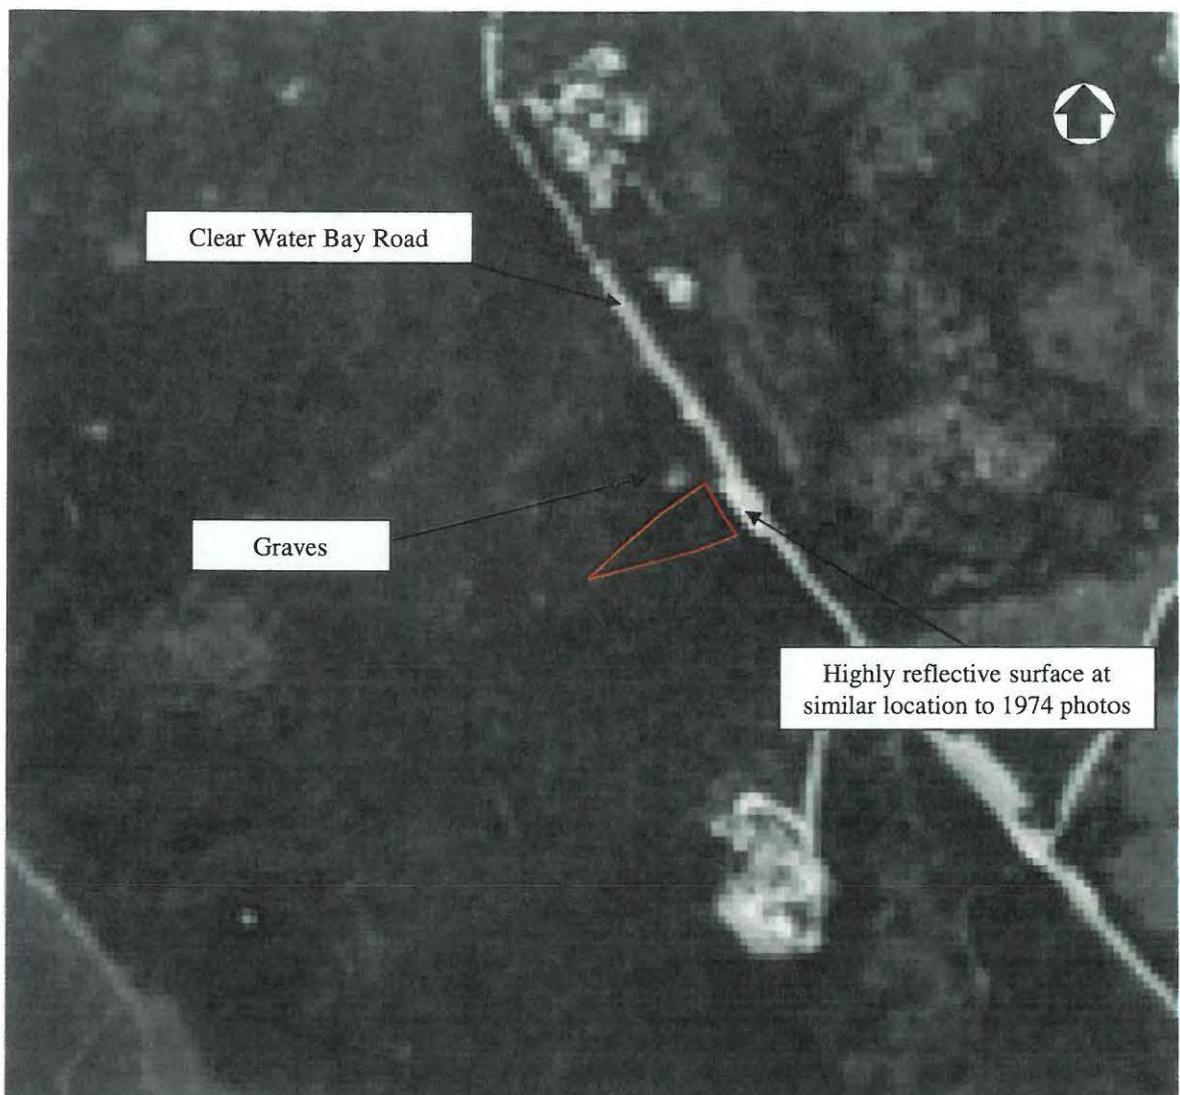
Photograph No.: A01724

1984 (20 Oct 1984)	High altitude and fair resolution stereo pair. No apparent change observed on the Study Area.
1985 (7 Jul 1985) Figure A3	High altitude and fair resolution stereo pair. Highly reflective surface could be observed on Feature 12SW-A/CR166 immediately below the Study Area on the similar area observed in 1974 photographs and may suggest slope work have been carried out on the slope portion again. No significant change could be observed across the Study Area.
1986 (22 Sep 1986)	Low altitude and high resolution stereo pair. No apparent change could be observed on the Study Area apart from a couple of square structures have been constructed immediately to the southeast of the grave. Bare soil surface could be observed on the highly reflective area on Feature 12SW-A/CR166 below the Study Area discerned in 1985 photographs.
1987	Low altitude and high resolution monograph.

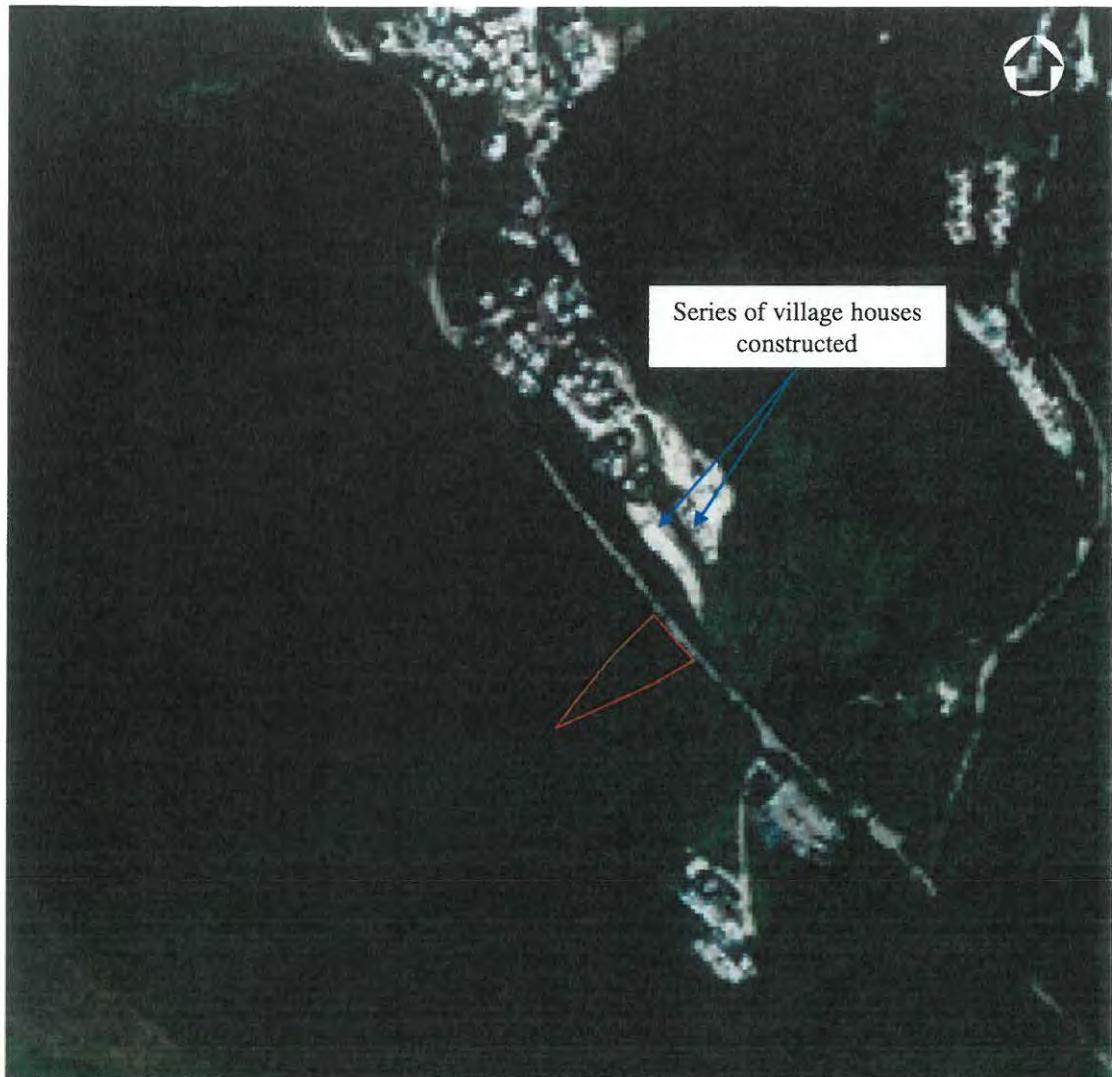
Photograph No.: CW75092

2006 (9 Nov 2006) Figure A5	High altitude and high resolution stereo pair. No significant change is observed on the Study Area. A series of village houses have been constructed on the building platform observed to in 2005 photography.
2007 (12 Jul 2007)	Low altitude and high resolution stereo pair. No significant change could be observed on the Study Area.
2008 (25 Nov 2008)	Low altitude and high resolution stereo pair. No significant change could be observed on the Study Area.
2010 (3 Nov 2010)	Low altitude and high resolution stereo pair. No significant change could be observed on the Study Area.
2011 (4 Aug 2011) Figure A6	Low altitude and high resolution stereo pair. No significant change could be observed on the Study Area. Vegetation
