**Geotechnical Planning Review Report  
for the columbaria license  
s.16 application,  
at Ten Thousand Buddhas Monastery,  
No. 221 Pai Tau Village,  
Sha Tin, New Territories,  
Hong Kong**

Job No.: HA971

Document No.: HA971/R05

Date: 24 July 2025

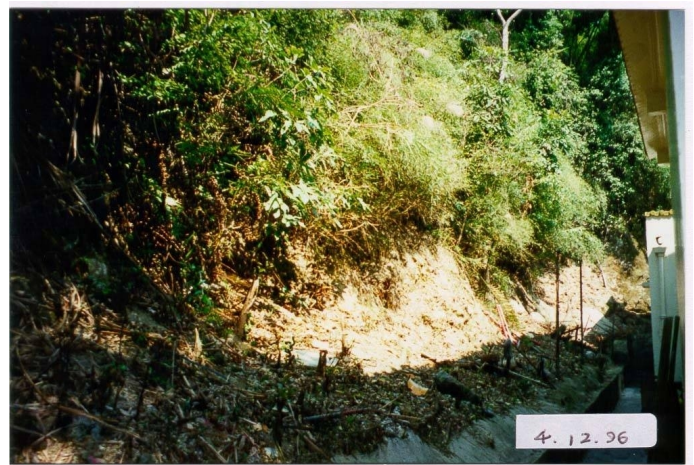
7SW-B/C113

DISTRESS (EROSION)

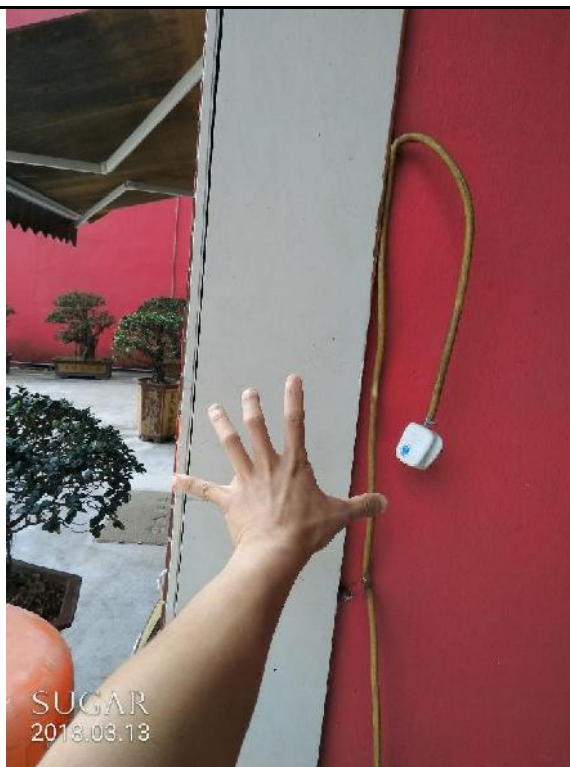
| Photo No.:<br>3 | Title: Approximate Width of External Column at Lung Wah Kok | Photo Date:<br>13/3/2018 |

Remark: 4 columns are located at all 4 corners to support the roof. Walls between columns

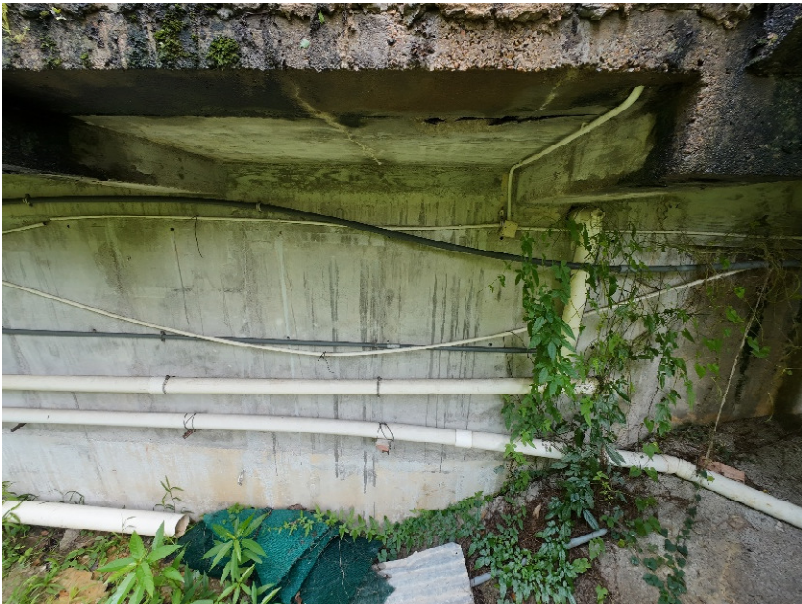
**Plate 1.5** (23/07/2025)

- Undesigned vegetation on the retaining wall.

- Remove undesigned vegetation on the retaining wall.

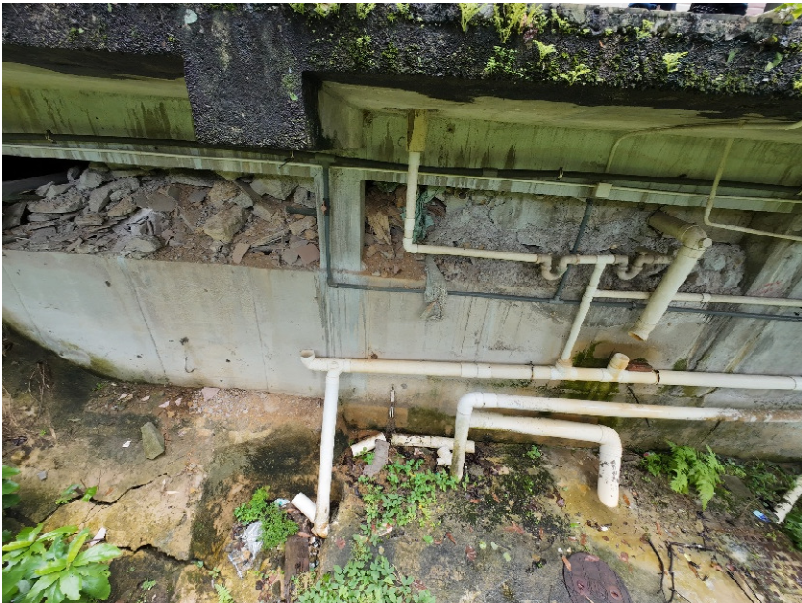
**Plate 1.6** (23/07/2025)

- Accumulated debris on the retaining wall.

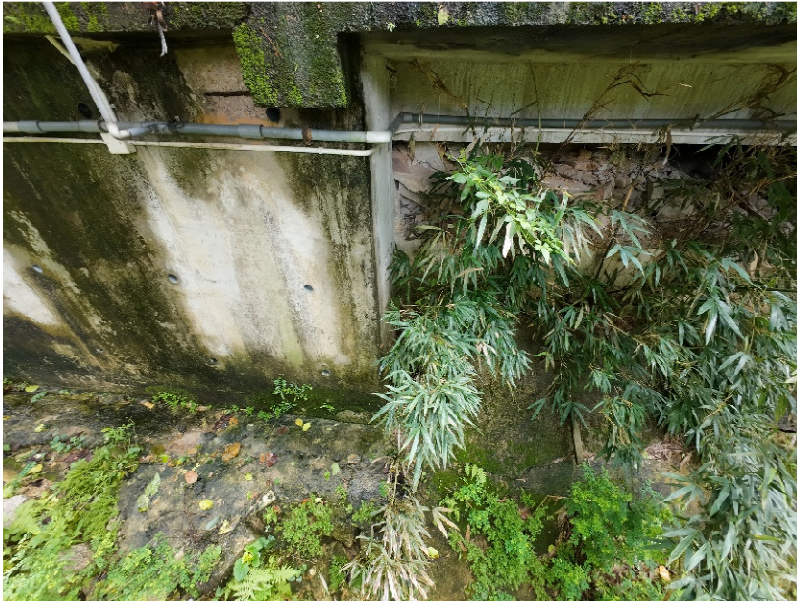
**Plate 1.7** (23/07/2025)

- Undesigned vegetation on the retaining wall.
- Accumulated debris on the retaining wall.

- Remove undesigned vegetation on the retaining wall.
- Remove accumulated debris on the retaining wall.

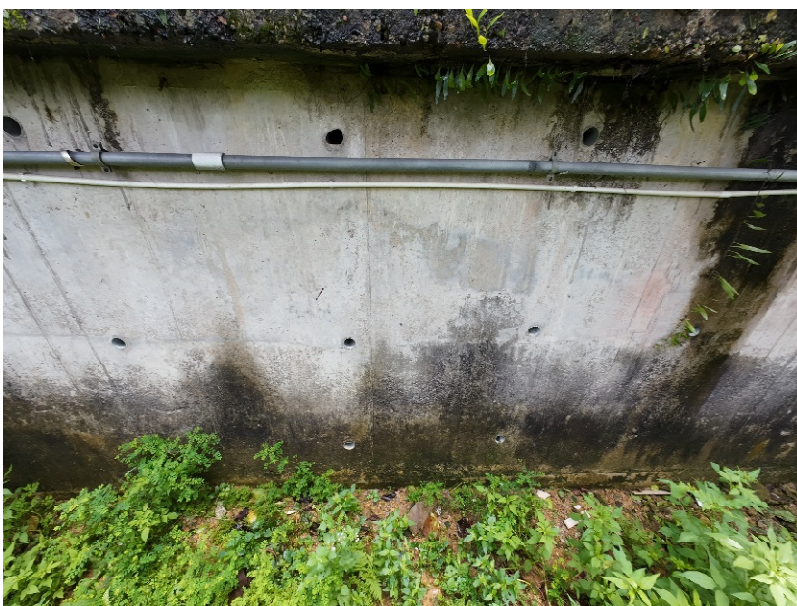
**Plate 1.8** (23/07/2025)

- Undesigned vegetation on the retaining wall.

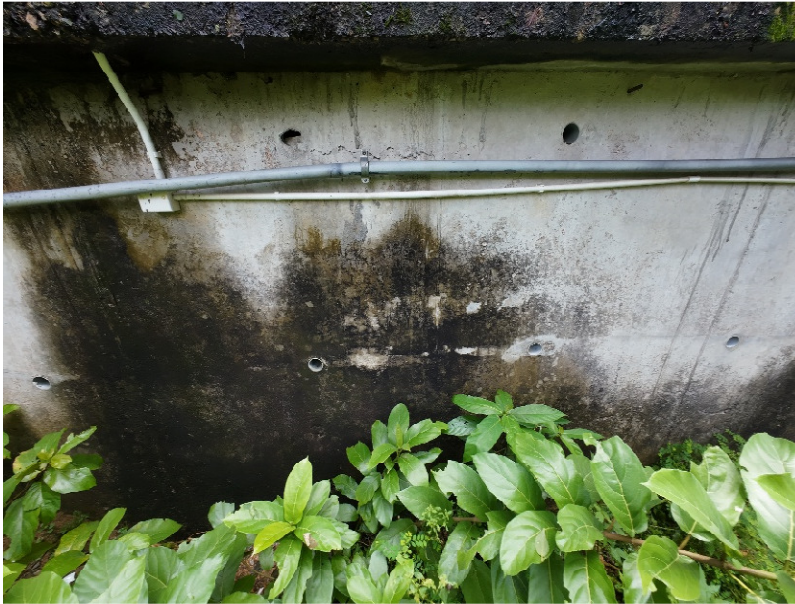
**Plate 1.9** (23/07/2025)

- Crack on the retaining wall.

- Repair crack by non-shrink cement mortar on the retaining wall.

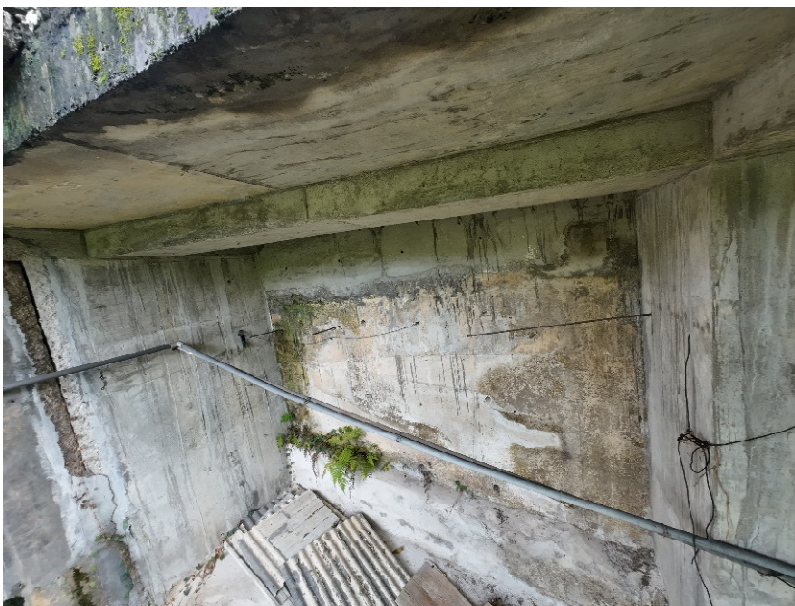
**Plate 1.10** (23/07/2025)

- Undesigned vegetation on the retaining wall.

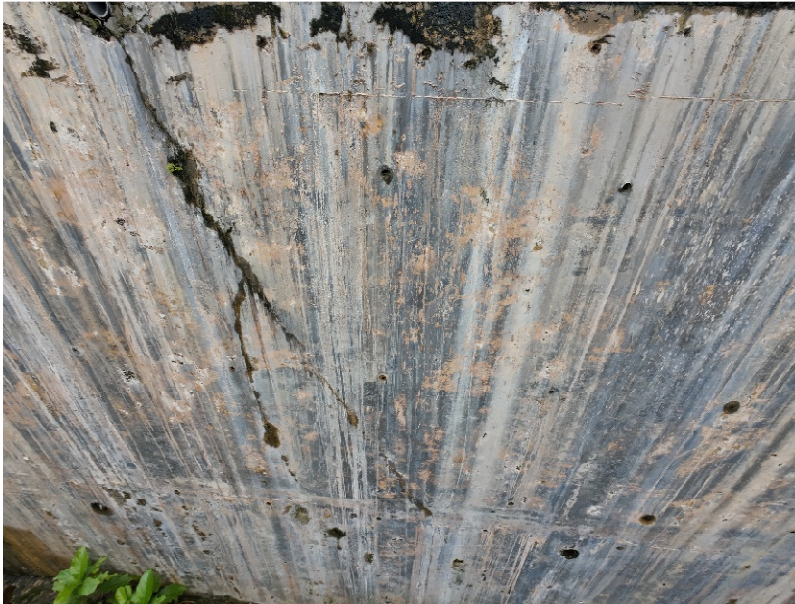
**Plate 2.3** (23/07/2025)

- Crack on the retaining wall.

- Repair crack by non-shrink cement mortar on the retaining wall.

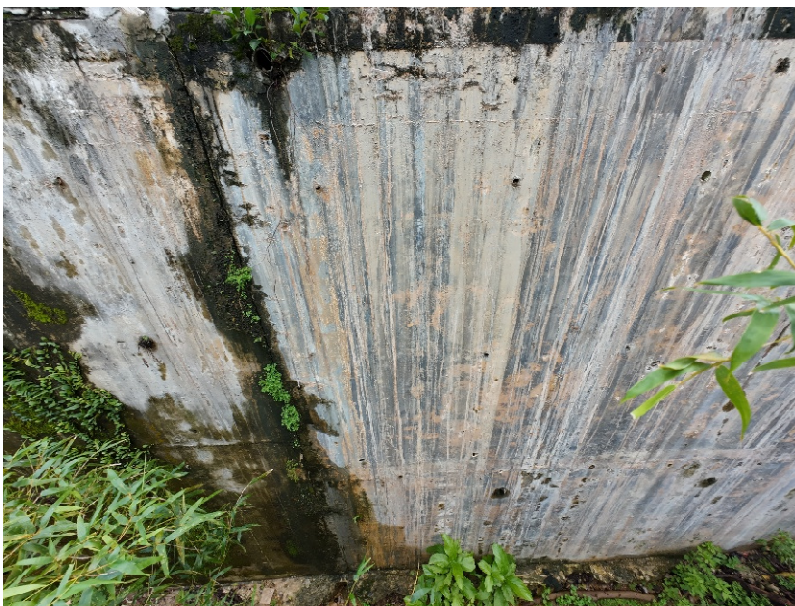
**Plate 2.4** (23/07/2025)

- Crack on the retaining wall.

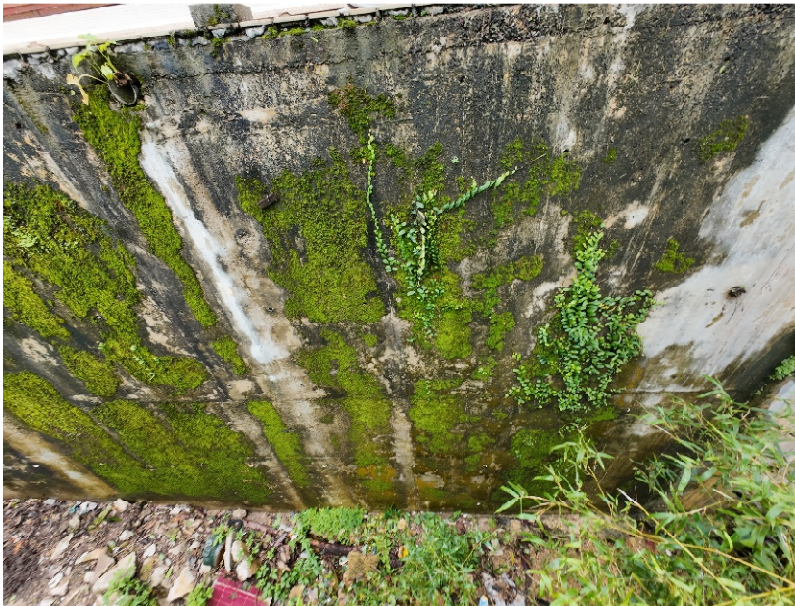
**Plate 2.5** (23/07/2025)

- Undesigned vegetation on the retaining wall.
- Undesigned vegetation in the weephole.
-

- Remove undesigned vegetation on the retaining wall.
- Remove undesigned vegetation in the weephole.

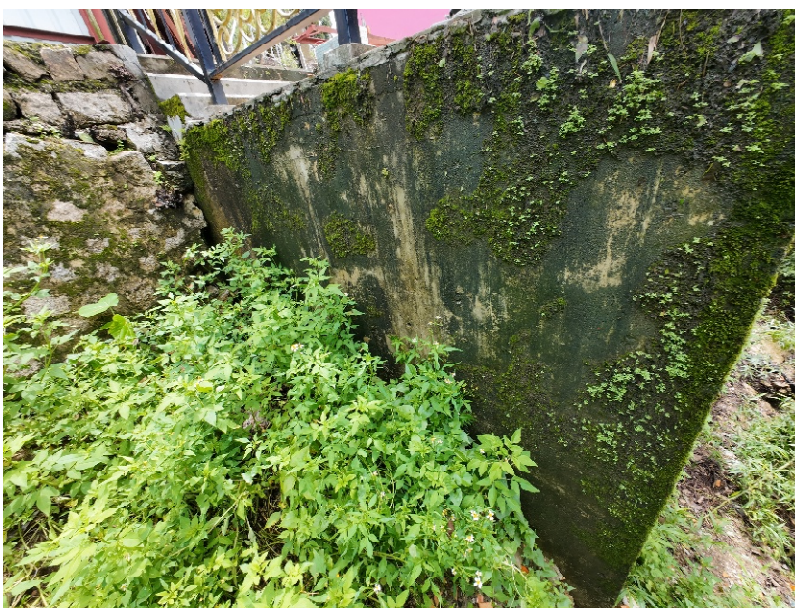
**Plate 2.6** (23/07/2025)

- Undesigned vegetation on the retaining wall.
