**Proposed Temporary Warehouse  
(Excluding Dangerous Goods Godown)  
For a Period of 3 Years in “Residential (Group D)” Zone,  
Lot Nos. 146 S.B. ss.1, 149, 150 (Part), 151, 152(Part) and 153  
in D.D.128, Ha Tsuen, Yuen Long, New Territories, Section 16A  
Application No. A/YL-HTF/1137-2**

**Drainage Impact Assessment on  
Proposed Surface Drainage Outflow  
(Rev. B)**

*(MWA/202308/DIA-02b)*

December 2023

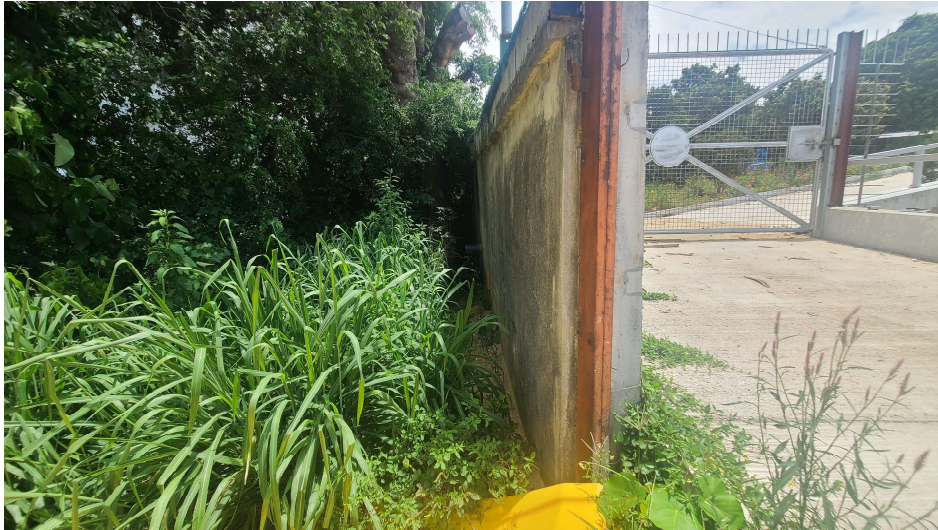
| Record Plate | Description/Findings | Time |
|---|---|---|
| 1 | The upper lot over the application site is discharged over the paved open space. | Current |

Plate 1 – The drainage runoff from the upper lot

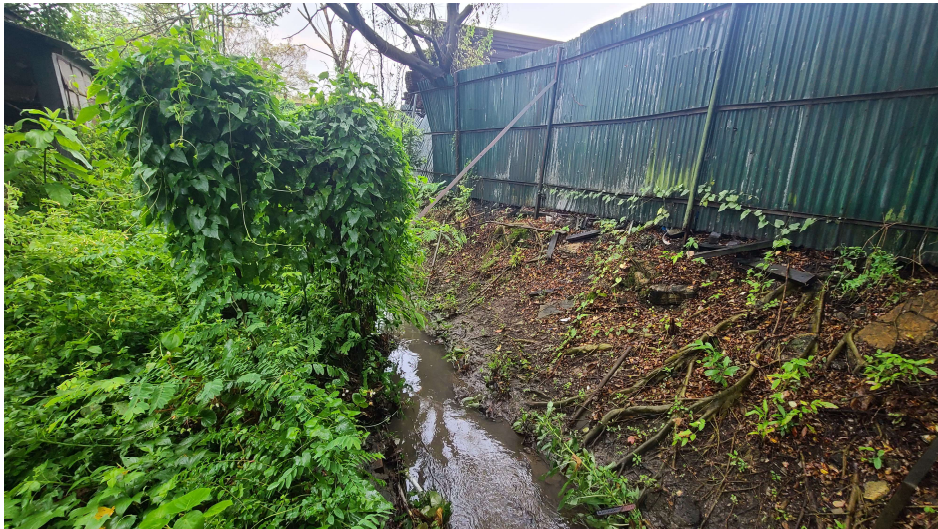
| Record Plate | Description/Findings | Time |
|---|---|---|
| 2 | The existing stream to the north of the application site collect most runoff for adjacent areas and roads. | Current |

Plate 2 – Surface Runoff collected by an existing open stream

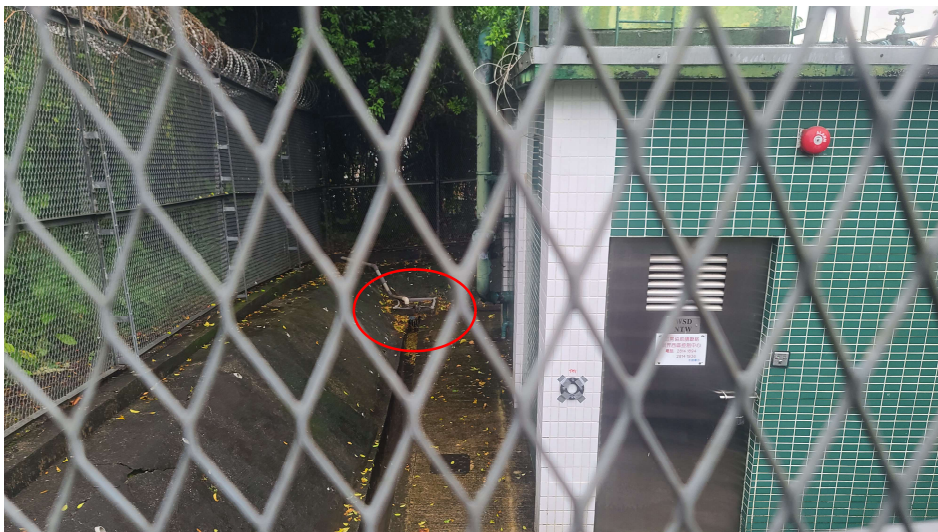
| Record Plate | Description/Findings | Time |
|---|---|---|
| 3 | The catchment include the surface runoff from a WSD pump room | Current |

Plate 3 – Adjacent WSD Catchpit

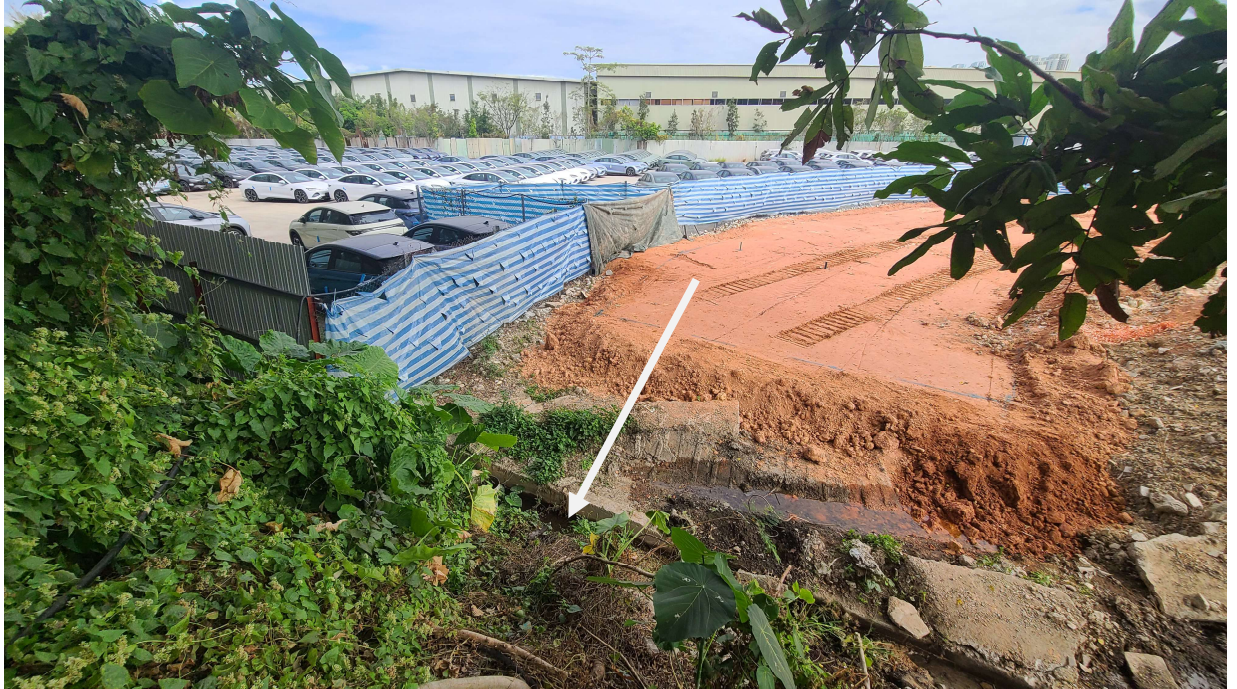
| Record Plate | Description/Findings | Time |
|---|---|---|
| 4a<br>4b | The existing drainage path is intercepted by CEDD project YL/2020/03 and to be collected by existing 600mm U-channel | Current |

Plate 4a Existing 600 UC

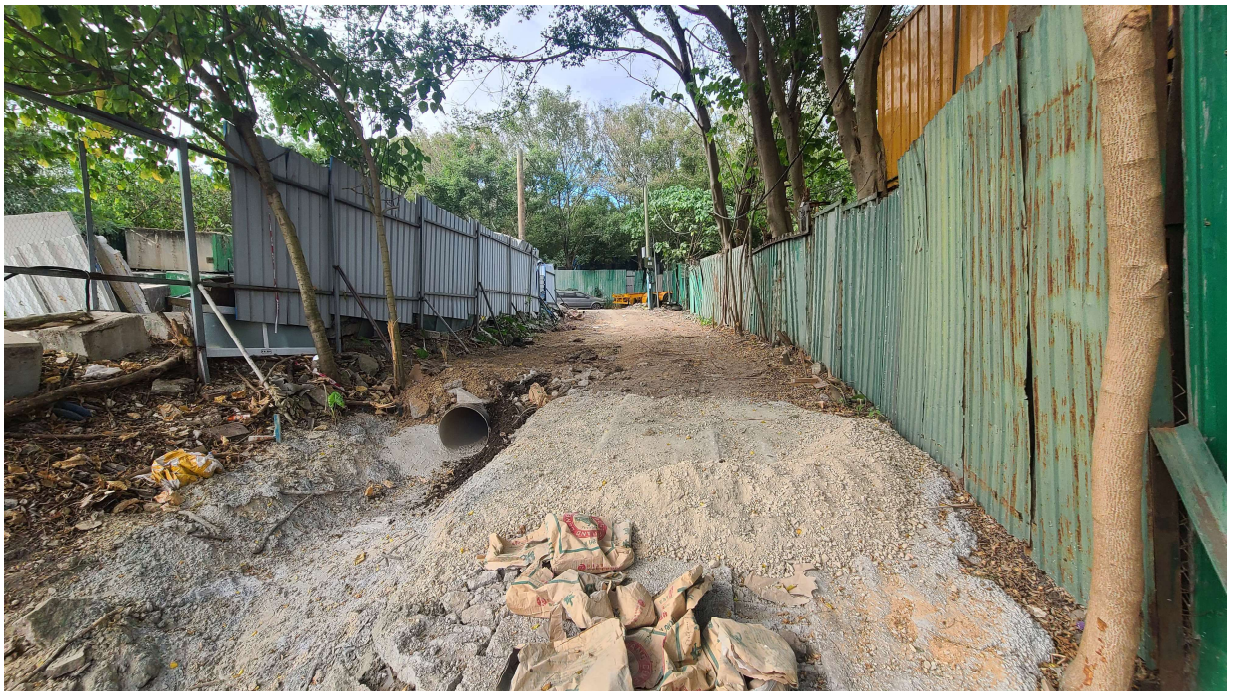
Plate 4b Existing Outlet in CEDD Site

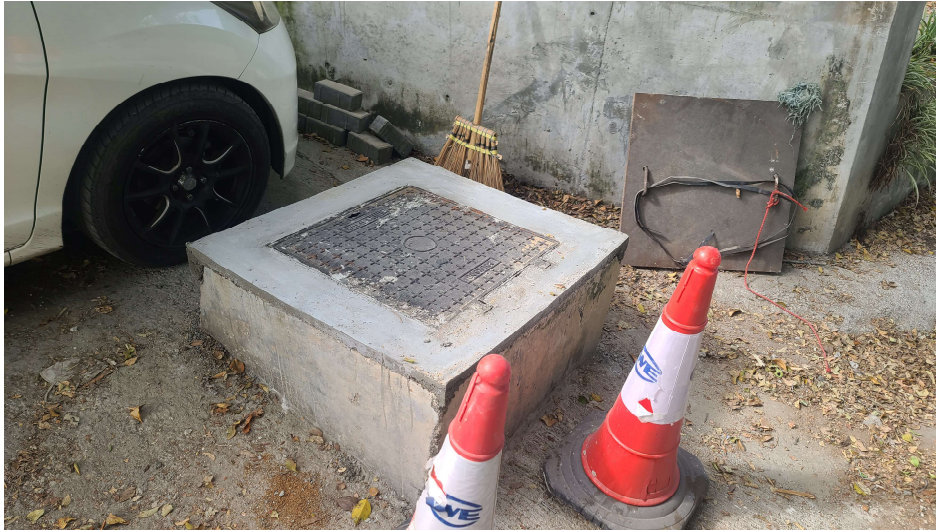
| Record Plate | Description/Findings | Time |
|---|---|---|
| 5a<br>5b<br>5c<br>5d | Existing Drainage within STT 3162 | Current |

Plate 5a Existing Terminal Manhole

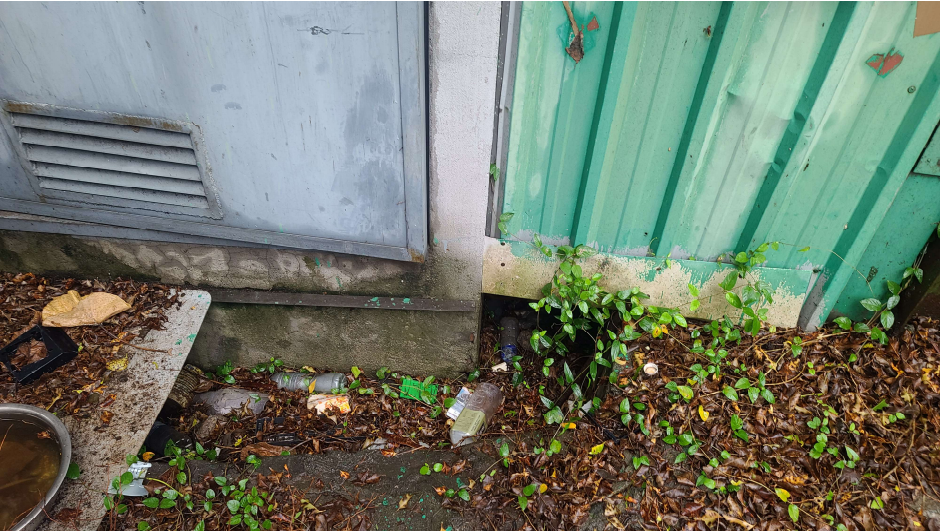
| Record Plate | Description/Findings | Time |
|---|---|---|
| 7 | 375UC downstream | Current |

Plate 7 – 375 UC in Lot 50

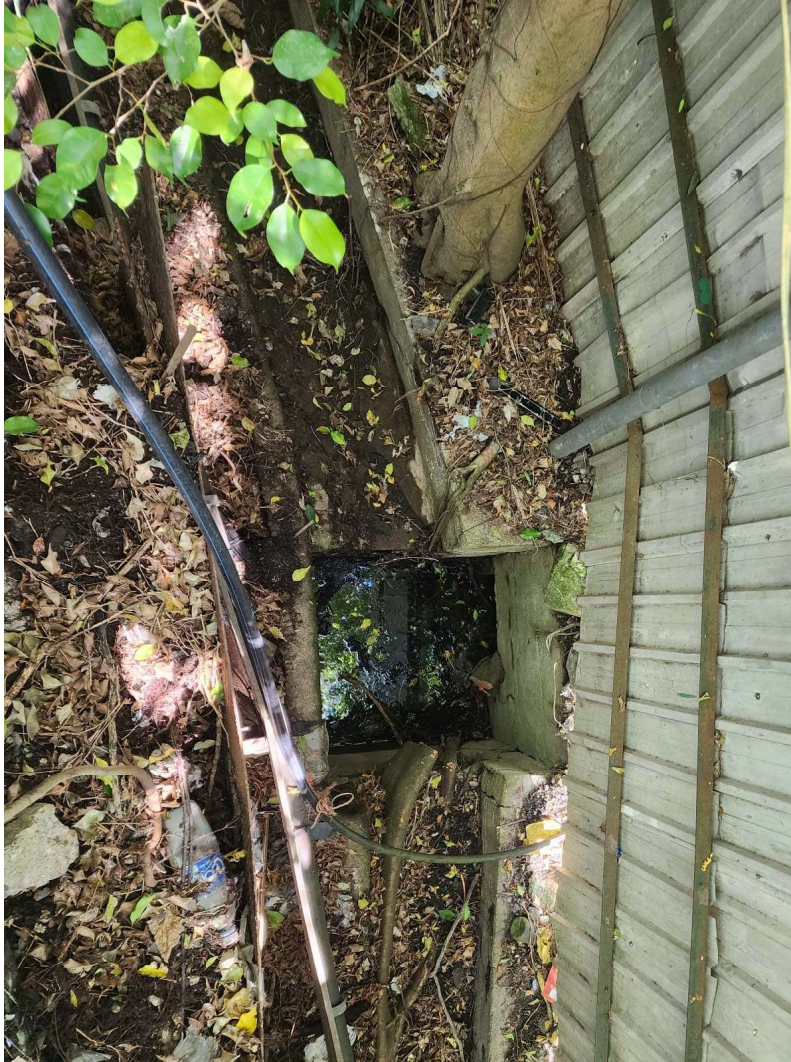
| Record Plate | Description/Findings | Time |
|---|---|---|
| 8 | Start of Existing 600 pipe | Current |

Plate 8 – Start of 600mm Pipe in Lot 50 (after cleaning)

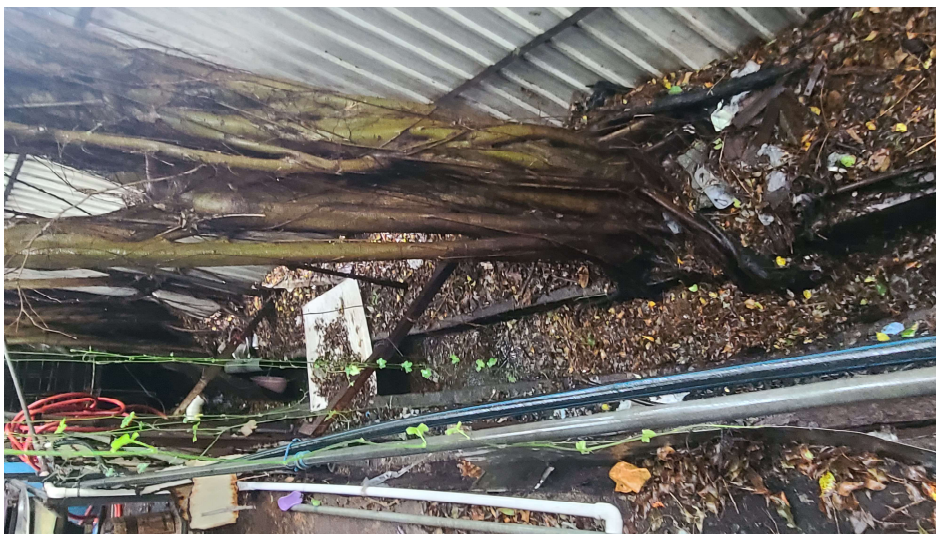
| Record Plate | Description/Findings | Time |
|---|---|---|
| 9 | 375 UC existing discharge route | Current |

Plate 9 – 375 UC in Lot 50

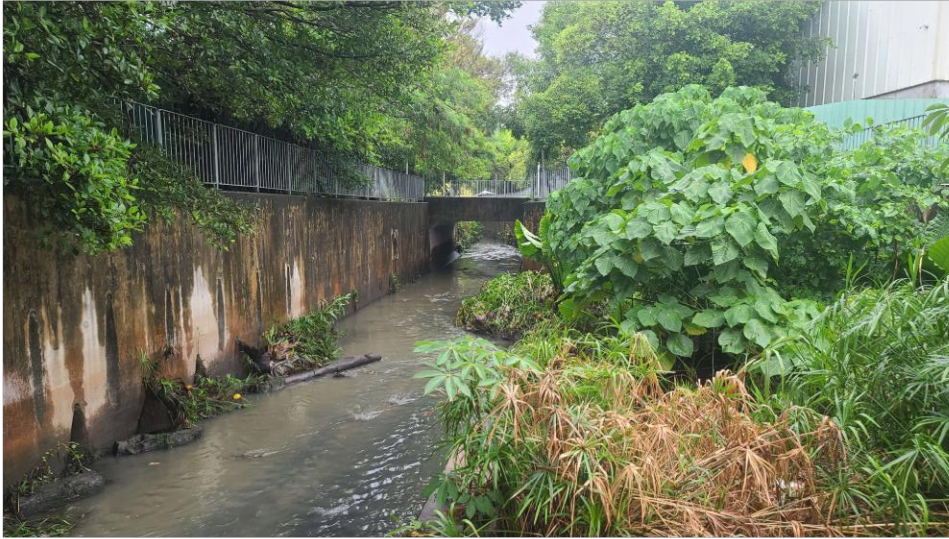
| Record Plate | Description/Findings | Time |
|---|---|---|
| 10 | Existing Nullah | Current |

Plate 10 – Existing Nullah

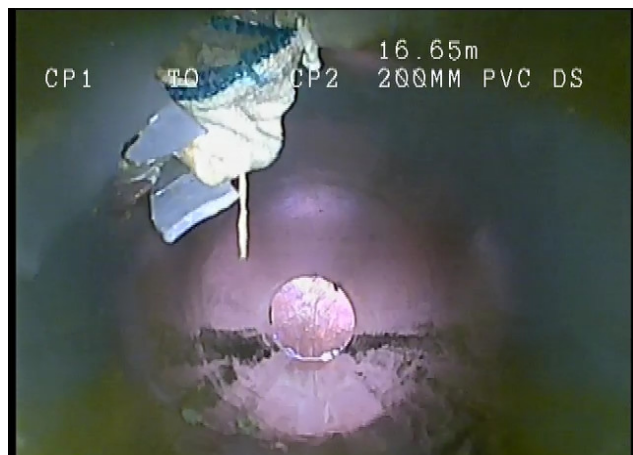
PHOTO NO.: 005  
MANHOLE NO.: CP1 to CP2  
DIA/SIZE: 200 mm  
CHAINAGE: 16.65 m  
DESCRIPTION:

| Serial No. | Sheet No. | Manhole No. | | Faults | | | | | SRM Grade | | Remedial Action Proposal |
|---|---|---|---|---|---|---|---|---|---|---|---|
| 1 | 1 | CP1 | CP2 | B | Broken Pipe | at | 16.65 | m | 4 | | Install Patch Lining |

Pipe broken from 10 o'clock to 12 o'clock.

The CCTV report giving the condition of the underground pipe from the application site to the 300UC is presented in **Appendix B**. As some part of the pipe was broken, the pipes are to be reconstructed in the drainage proposal with Figure 1 in **Appendix A**.

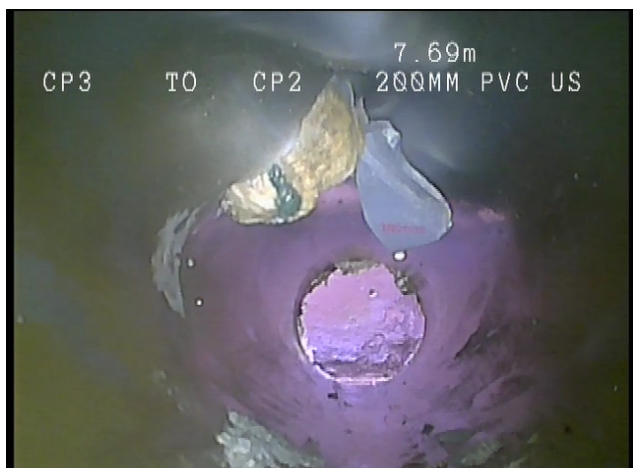
PHOTO NO.: 009  
MANHOLE NO.: CP3 to CP2  
DIA/SIZE: 200 mm  
CHAINAGE: 7.69 m  
DESCRIPTION:

| Serial No. | Sheet No. | Manhole No. | | Faults | | | | | SRM Grade | | Remedial Action Proposal |
|---|---|---|---|---|---|---|---|---|---|---|---|
| 2 | 2 | CP3 | CP2 | B | Broken Pipe | at | 7.69 | m | 4 | | Install Patch Lining |

Pipe broken from 10 o'clock to 12 o'clock.
