Appendix IIA
Tree Survey Report

Tree Survey Report

Date of Survey: 4th September 2025

Various Lots In D.D. 109, Kam Tin, Yuen Long, New Territories

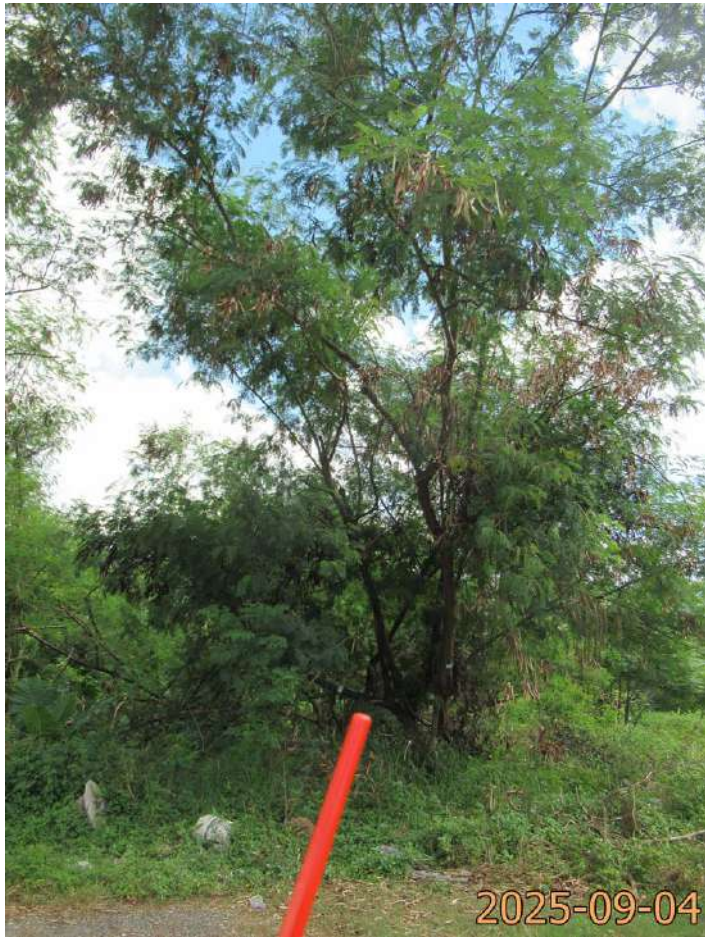
T1 (Overview)

Tree No.	Tree Species		Tree Size Measurements			Amenity Value	Form	Health Condition	Structural Condition	Suitability for Transplanting	Remarks
	Botanical Name	Chinese Name	Overall Height (m)	DBH (mm)	Average Crown Spread (m)	High /Med /Low	Good /Fair /Poor	Good /Fair /Poor /Dead	Good /Fair /Poor	High /Med /Low	
T1	<i>Leucaena leucocephala</i>	銀合歡	8.0	130	6.0	Low	Poor	Poor	Poor	Low	leaning, co-dominant trunks
T2	<i>Leucaena leucocephala</i>	銀合歡	8.0	160	7.0	Low	Poor	Poor	Poor	Low	co-dominant trunks
T3	<i>Leucaena leucocephala</i>	銀合歡	7.0	430	5.0	Low	Poor	Poor	Poor	Low	multi-trunks
T4	<i>Leucaena leucocephala</i>	銀合歡	6.0	310	5.0	Low	Poor	Poor	Poor	Low	leaning, multi-trunks
T5	<i>Leucaena leucocephala</i>	銀合歡	5.0	95	4.0	Low	Poor	Poor	Poor	Low	leaning
T6	<i>Leucaena leucocephala</i>	銀合歡	8.0	230	4.0	Low	Poor	Poor	Poor	Low	leaning
T7	<i>Leucaena leucocephala</i>	銀合歡	7.0	120	5.0	Low	Poor	Poor	Poor	Low	leaning, co-dominant trunks

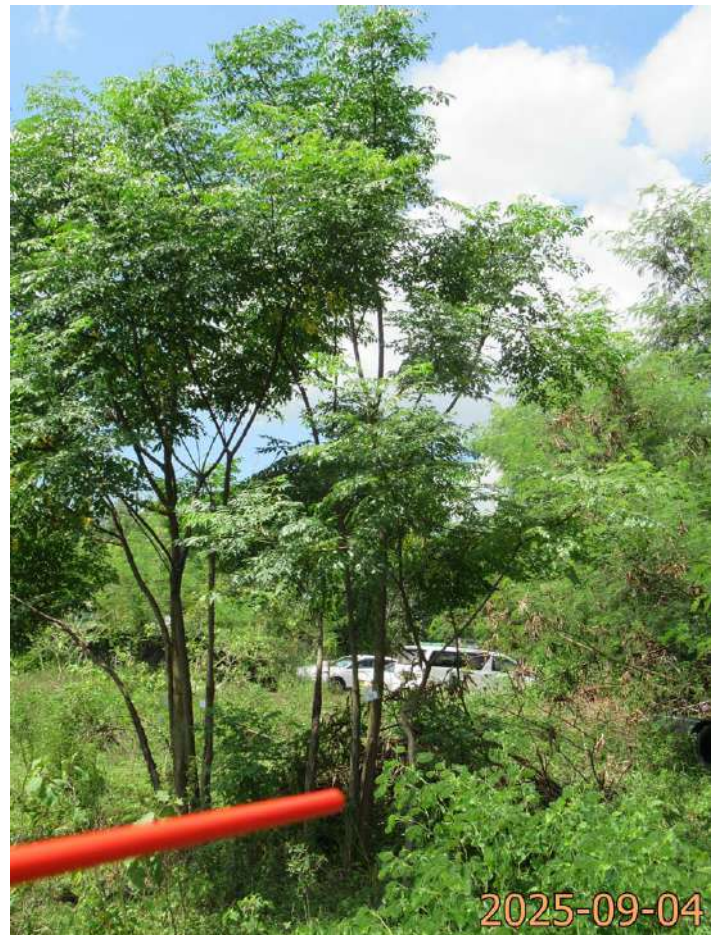
T8 (Overview)

T8	<i>Melia azedarach</i>	楝(苦楝)	6.0	95	3.0	Low	Poor	Poor	Poor	Low	co-dominant trunks
T9	<i>Melia azedarach</i>	楝(苦楝)	6.0	95	2.0	Low	Poor	Poor	Poor	Low	co-dominant trunks
T10	<i>Melia azedarach</i>	楝(苦楝)	6.0	95	2.0	Low	Poor	Poor	Poor	Low	co-dominant trunks
T11	<i>Leucaena leucocephala</i>	銀合歡	7.0	100	3.0	Low	Poor	Poor	Poor	Low	crooked trunk
T12	<i>Leucaena leucocephala</i>	銀合歡	6.0	95	2.0	Low	Poor	Poor	Poor	Low	cross branches
T13	<i>Leucaena leucocephala</i>	銀合歡	6.0	130	5.0	Low	Poor	Poor	Poor	Low	leaning
T14	<i>Leucaena leucocephala</i>	銀合歡	5.0	110	2.0	Low	Poor	Poor	Poor	Low	broken trunk
T15	<i>Leucaena leucocephala</i>	銀合歡	8.0	120	2.0	Low	Poor	Poor	Poor	Low	leaning, uprooted, wound on trunk
T16	<i>Leucaena leucocephala</i>	銀合歡	8.0	130	2.0	Low	Poor	Poor	Poor	Low	leaning
T17	<i>Leucaena leucocephala</i>	銀合歡	8.0	130	2.0	Low	Poor	Poor	Poor	Low	leaning
T18	<i>Leucaena leucocephala</i>	銀合歡	8.0	210	3.0	Low	Poor	Poor	Poor	Low	leaning, uprooted

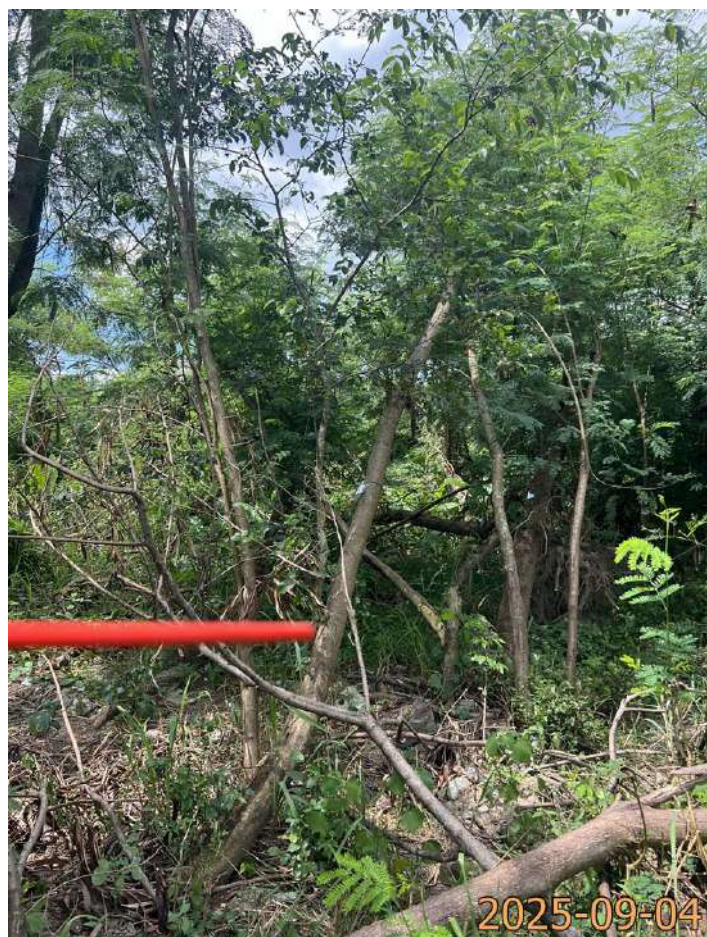
T19 (Overview)

T19	<i>Leucaena leucocephala</i>	銀合歡	8.0	150	3.0	Low	Poor	Poor	Poor	Low	leaning, uprooted
T20	<i>Leucaena leucocephala</i>	銀合歡	7.0	200	3.0	Low	Poor	Poor	Poor	Low	leaning, uprooted
T21	<i>Leucaena leucocephala</i>	銀合歡	6.0	260	7.0	Low	Poor	Poor	Poor	Low	collapsed, uprooted
T22	<i>Leucaena leucocephala</i>	銀合歡	9.0	170	4.0	Low	Poor	Poor	Poor	Low	leaning
T23	<i>Leucaena leucocephala</i>	銀合歡	8.0	130	3.0	Low	Poor	Poor	Poor	Low	leaning
T24	<i>Leucaena leucocephala</i>	銀合歡	8.0	290	6.0	Low	Poor	Poor	Poor	Low	multi-trunks
T25	<i>Leucaena leucocephala</i>	銀合歡	8.0	130	2.0	Low	Poor	Poor	Poor	Low	leaning
T26	<i>Leucaena leucocephala</i>	銀合歡	8.0	140	2.0	Low	Poor	Poor	Poor	Low	leaning
T27	<i>Leucaena leucocephala</i>	銀合歡	8.0	130	3.0	Low	Poor	Poor	Poor	Low	co-dominant trunks
T31	<i>Leucaena leucocephala</i>	銀合歡	7.0	120	4.0	Low	Poor	Poor	Poor	Low	leaning, uprooted
T32	<i>Leucaena leucocephala</i>	銀合歡	7.0	140	3.0	Low	Poor	Poor	Poor	Low	leaning, uprooted

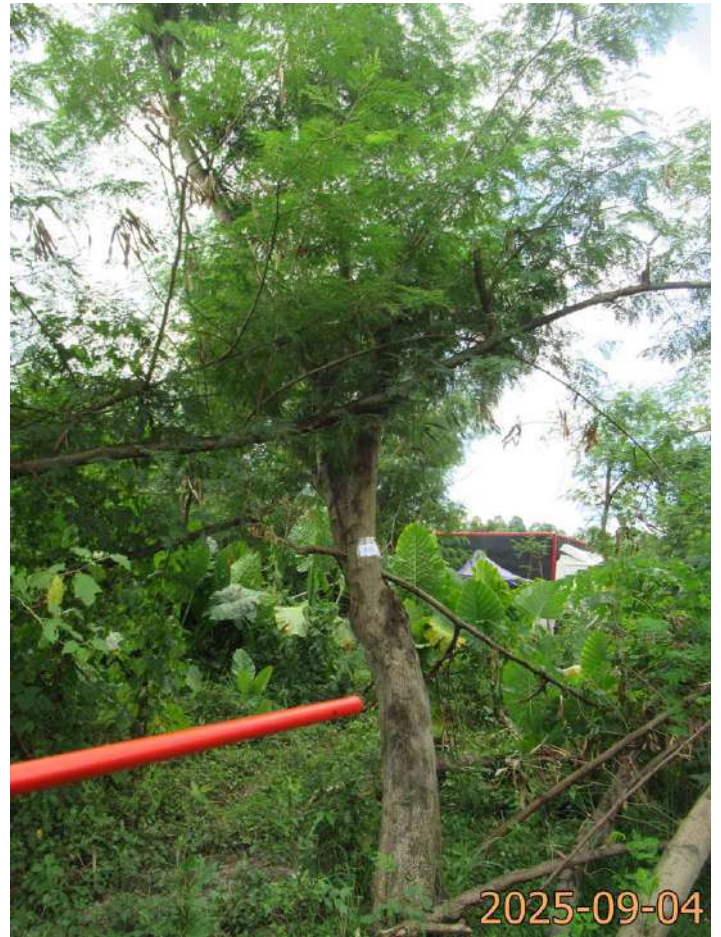
T34 (Overview)

Tree No.	Tree Species		Tree Size Measurements			Amenity Value	Form	Health Condition	Structural Condition	Suitability for Transplanting	Remarks
	Botanical Name	Chinese Name	Overall Height (m)	DBH (mm)	Average Crown Spread (m)	High /Med /Low	Good /Fair /Poor	Good /Fair /Poor /Dead	Good /Fair /Poor	High /Med /Low	
T34	<i>Leucaena leucocephala</i>	銀合歡	6.0	230	3.0	Low	Poor	Poor	Poor	Low	broken trunk
T35	<i>Leucaena leucocephala</i>	銀合歡	7.0	110	4.0	Low	Poor	Poor	Poor	Low	leaning
T36	<i>Leucaena leucocephala</i>	銀合歡	7.0	130	3.0	Low	Poor	Poor	Poor	Low	broken trunk
T37	<i>Leucaena leucocephala</i>	銀合歡	7.0	120	4.0	Low	Poor	Poor	Poor	Low	broken trunk
T38	<i>Leucaena leucocephala</i>	銀合歡	8.0	100	2.0	Low	Poor	Poor	Poor	Low	broken trunk
T39	<i>Leucaena leucocephala</i>	銀合歡	6.0	120	3.0	Low	Poor	Poor	Poor	Low	leaning
T40	<i>Leucaena leucocephala</i>	銀合歡	7.0	230	2.0	Low	Poor	Poor	Poor	Low	leaning
T41	<i>Leucaena leucocephala</i>	銀合歡	5.0	140	2.0	Low	Poor	Poor	Poor	Low	leaning

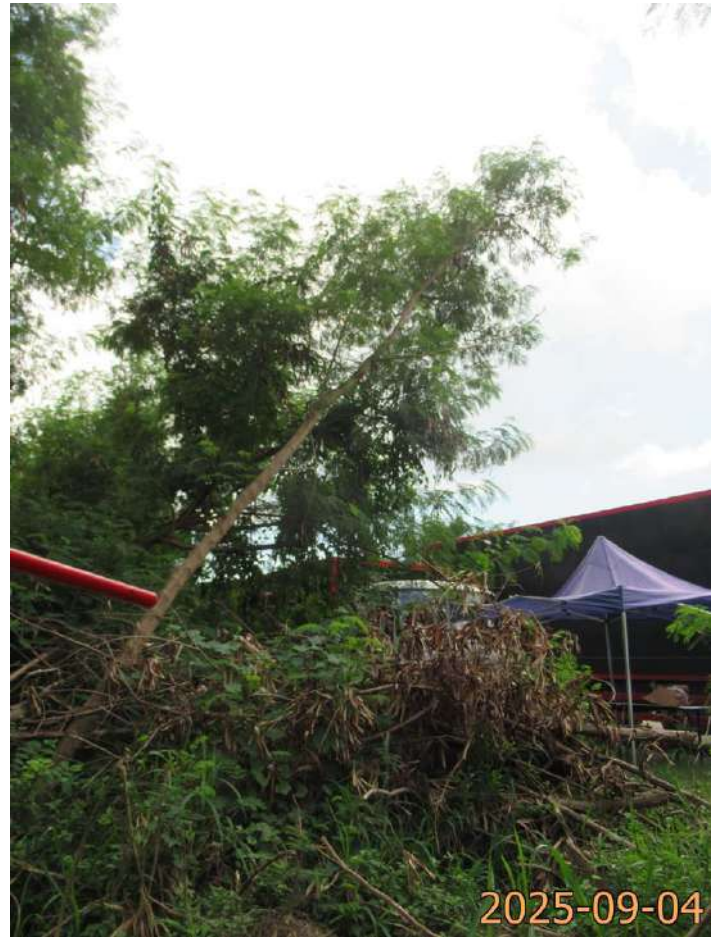
T42 (Overview)

T42	<i>Leucaena leucocephala</i>	銀合歡	5.0	150	3.0	Low	Poor	Poor	Poor	Low	leaning
