# Tree Survey Report

**Date of Survey: 25<sup>th</sup> October 2024**

**Lots 2063 And 2064 In D.D. 106 and Adjoining Government Land, Kam Tin, Yuen Long, New Territories (Former Shek Wu School)**

Registered Arborist

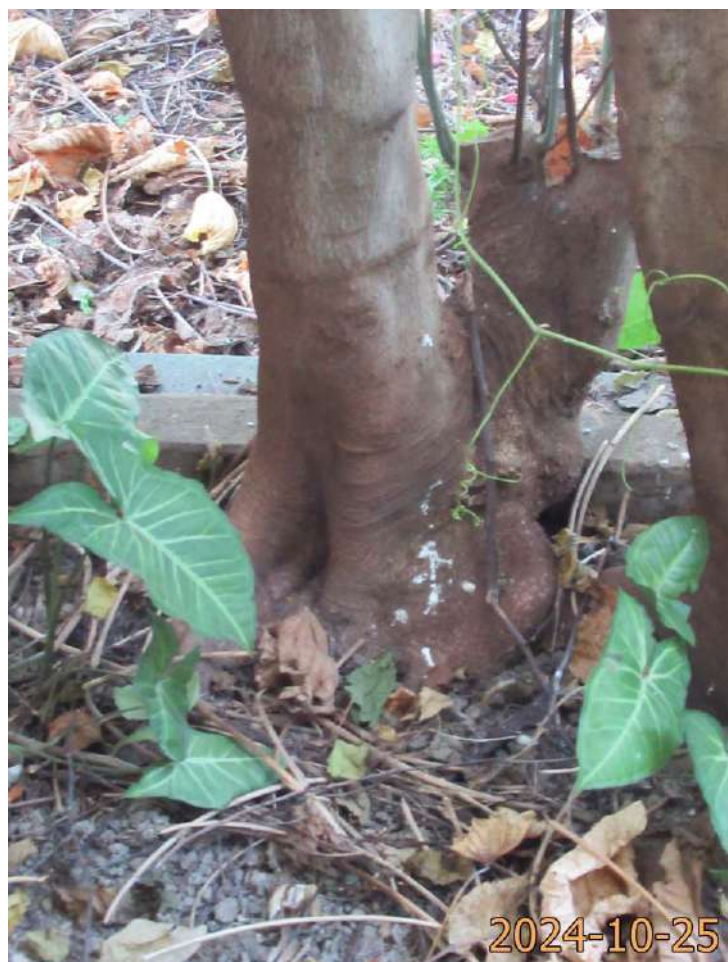
T2 Restricted root (Decay at trunk)

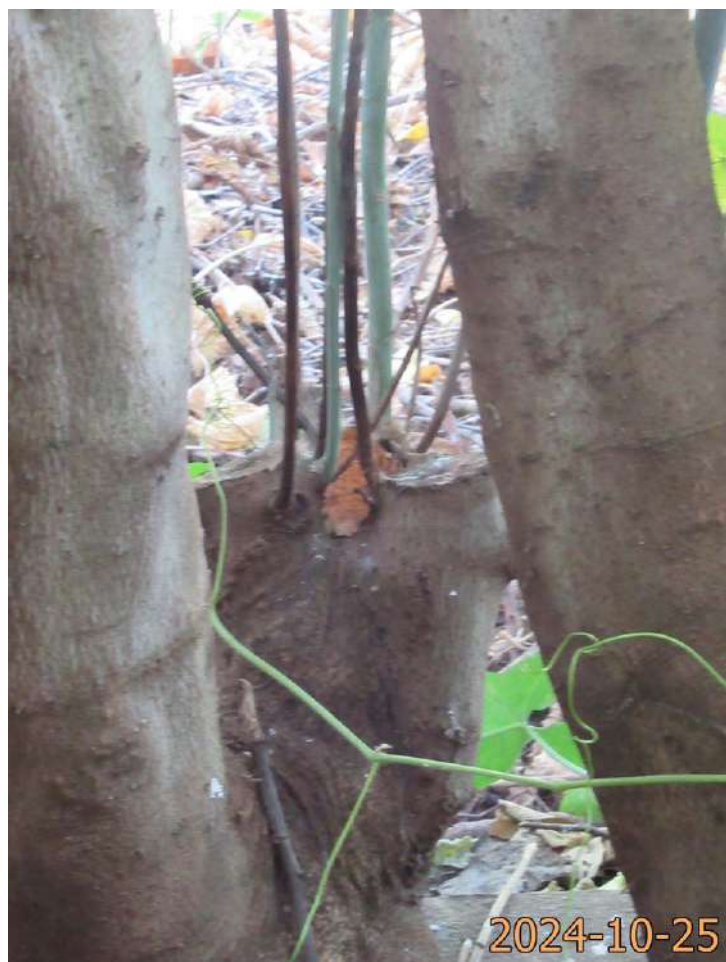
T2 Topped trunk

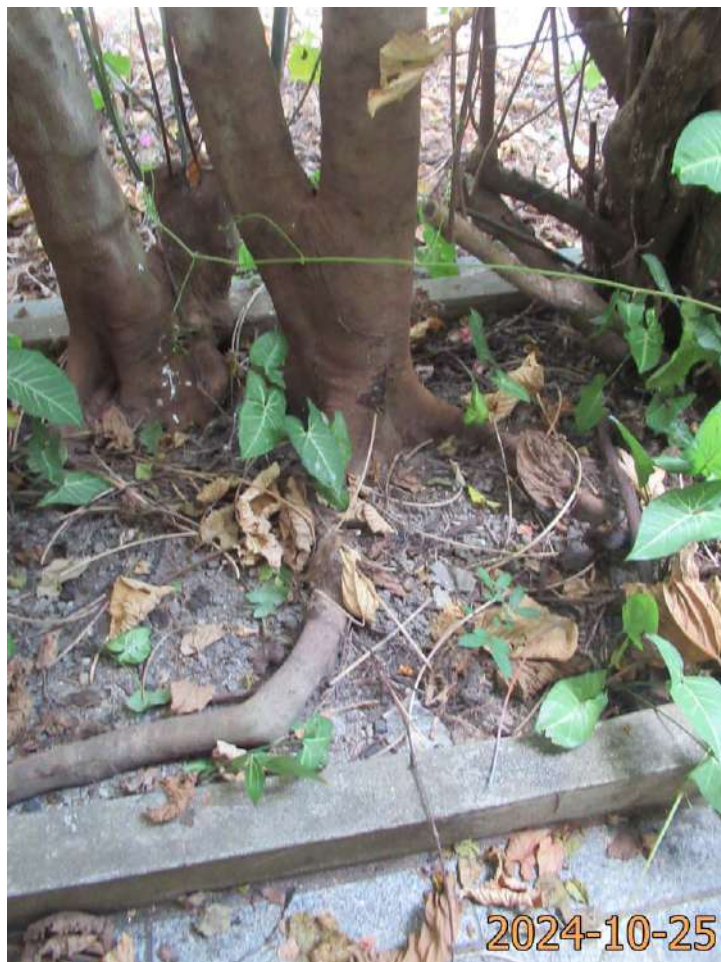
T3 Restricted root

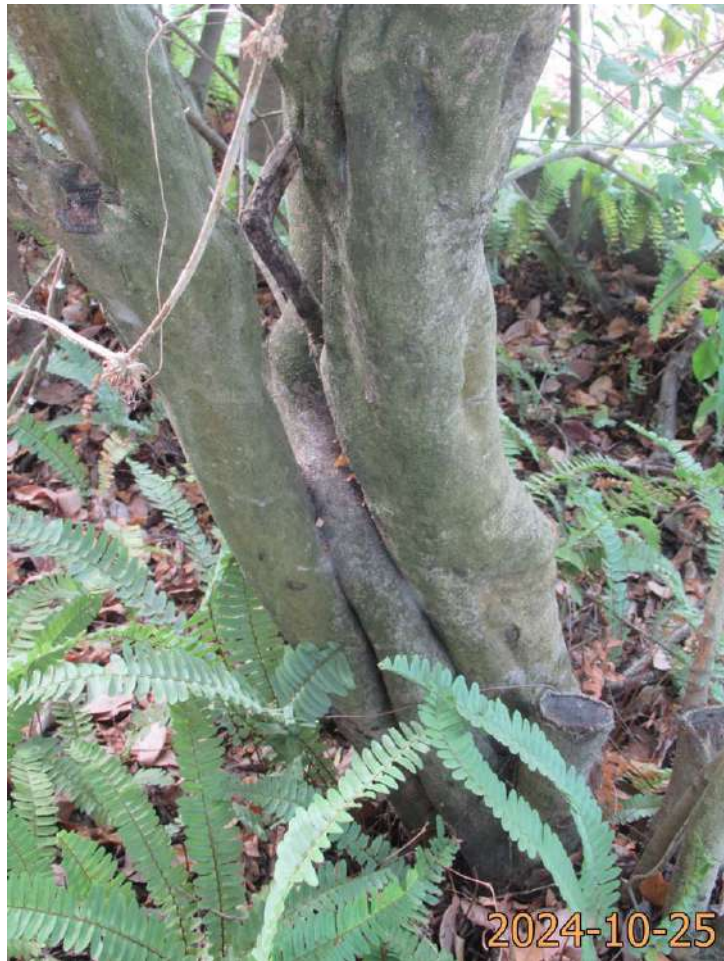
T12 Co-dominant trunks with included bark

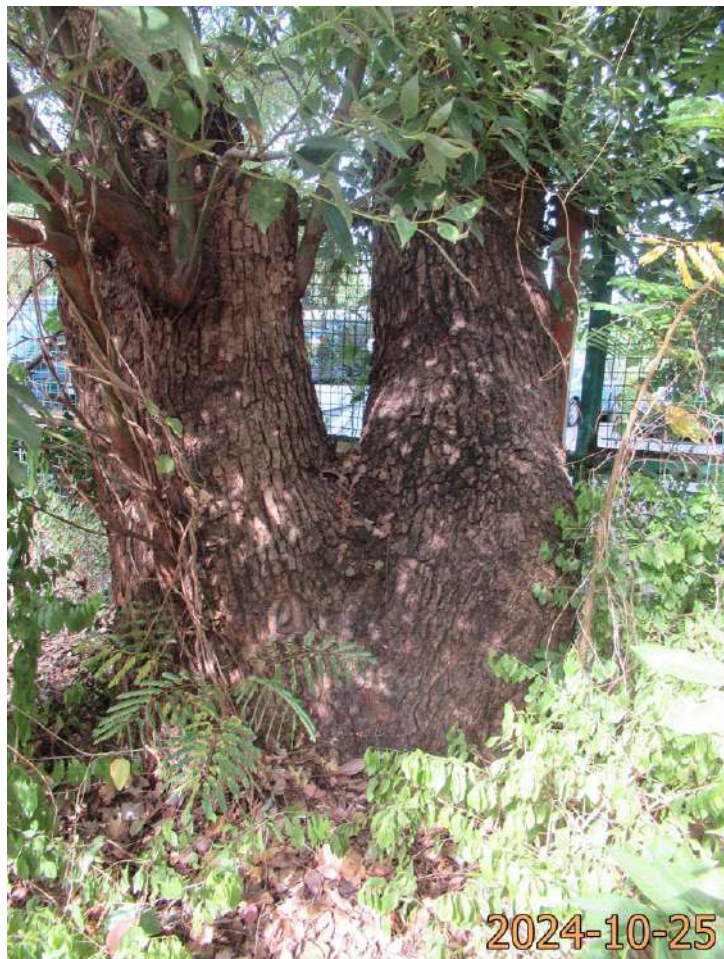
T13 Co-dominant trunks

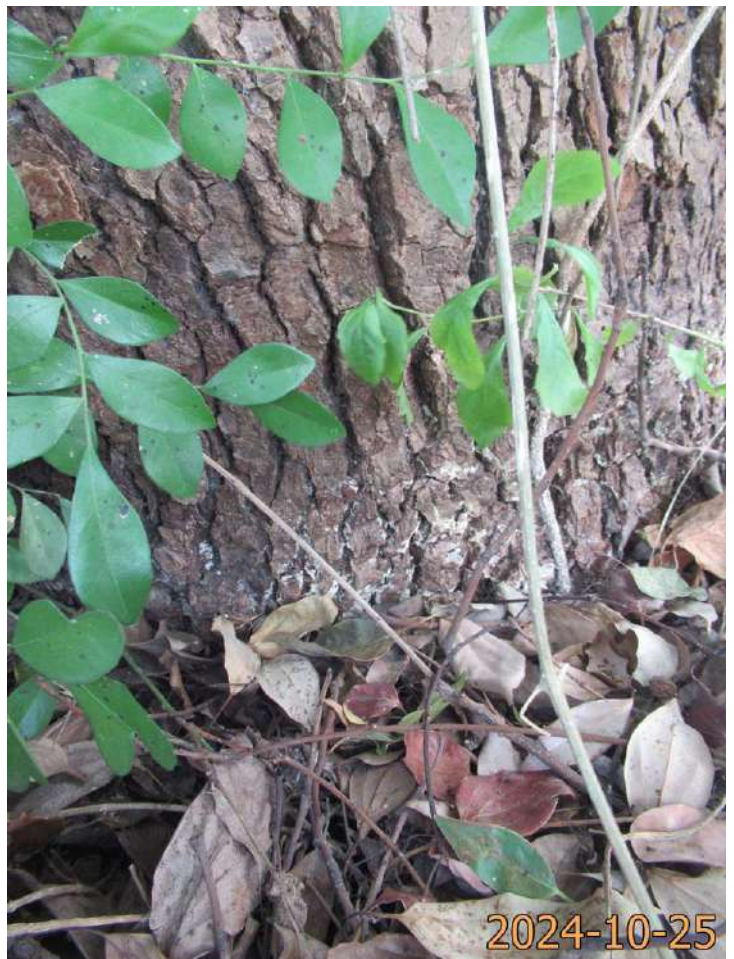
T13 Decay at trunk\_1

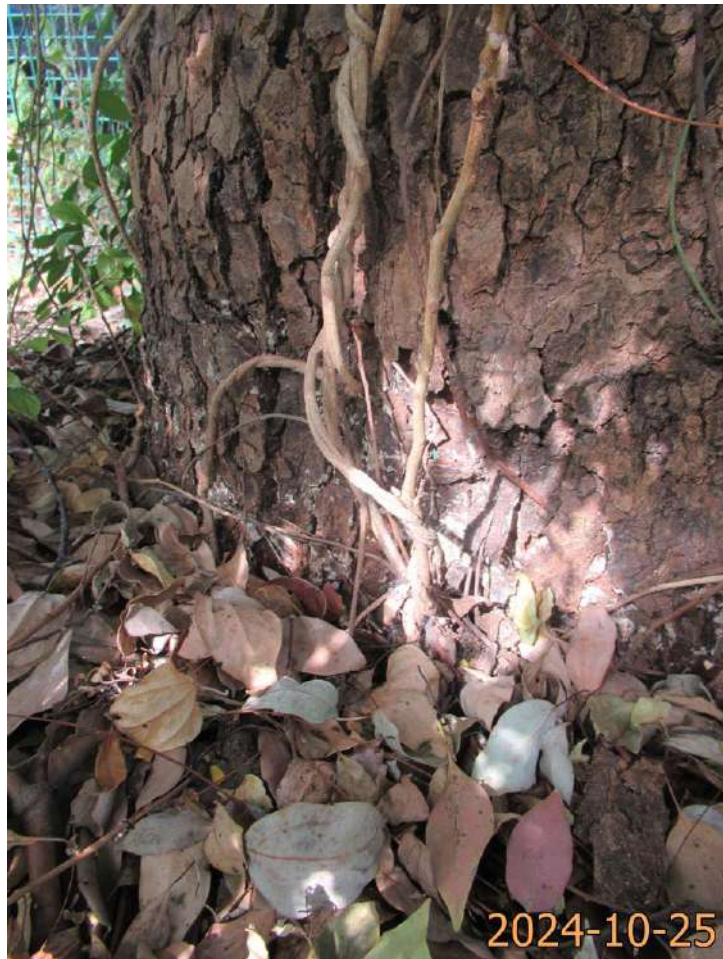
T13 Decay at trunk\_2

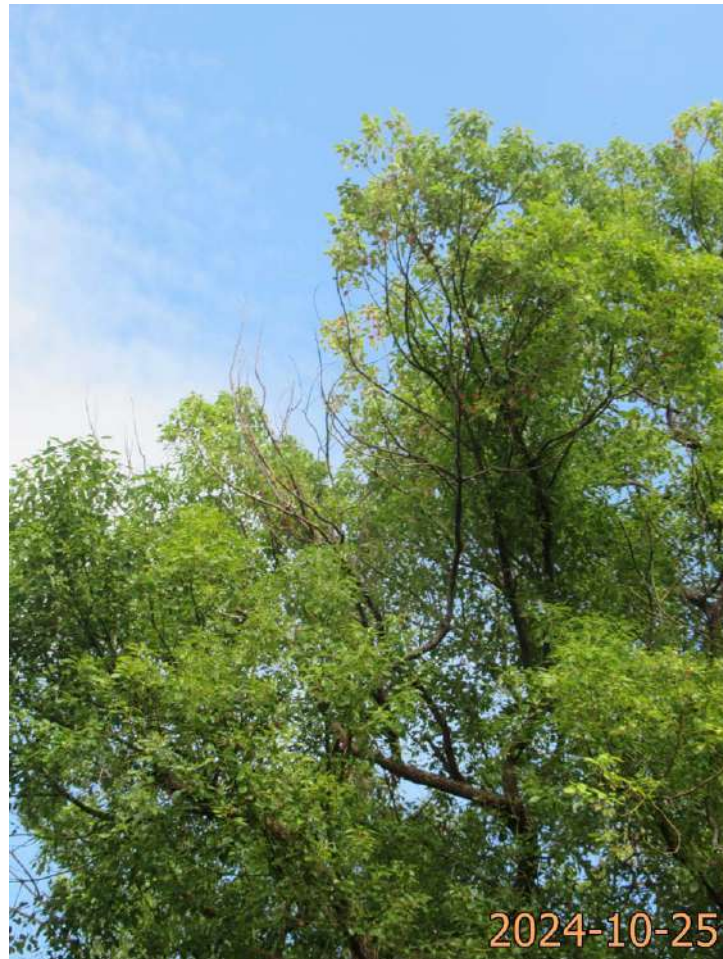
T13 Dieback twigs

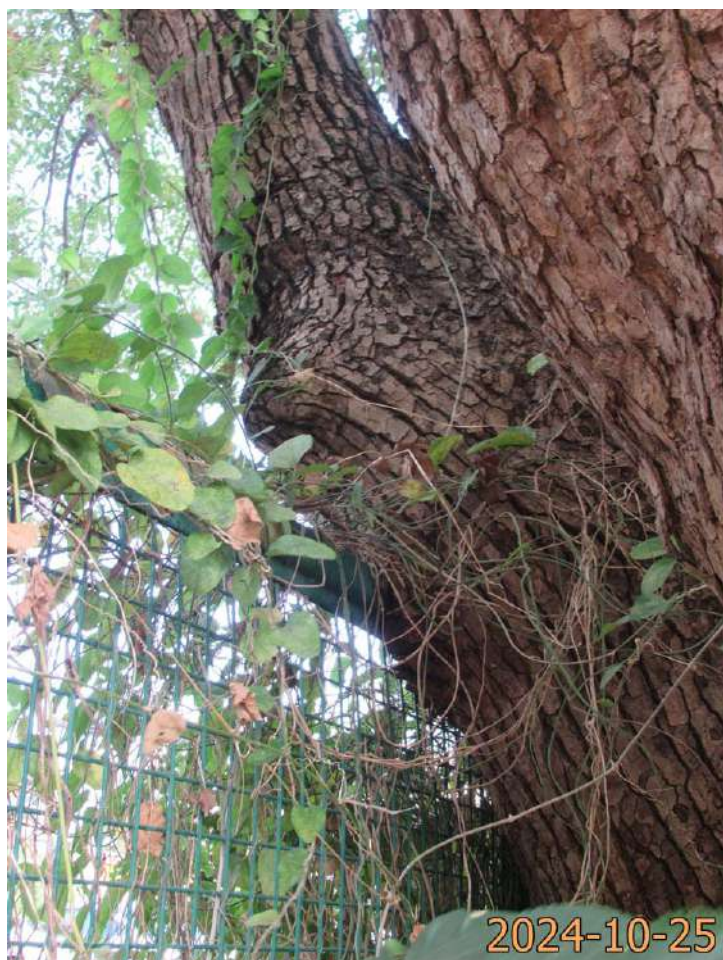
T13 Trunk conflict with fence

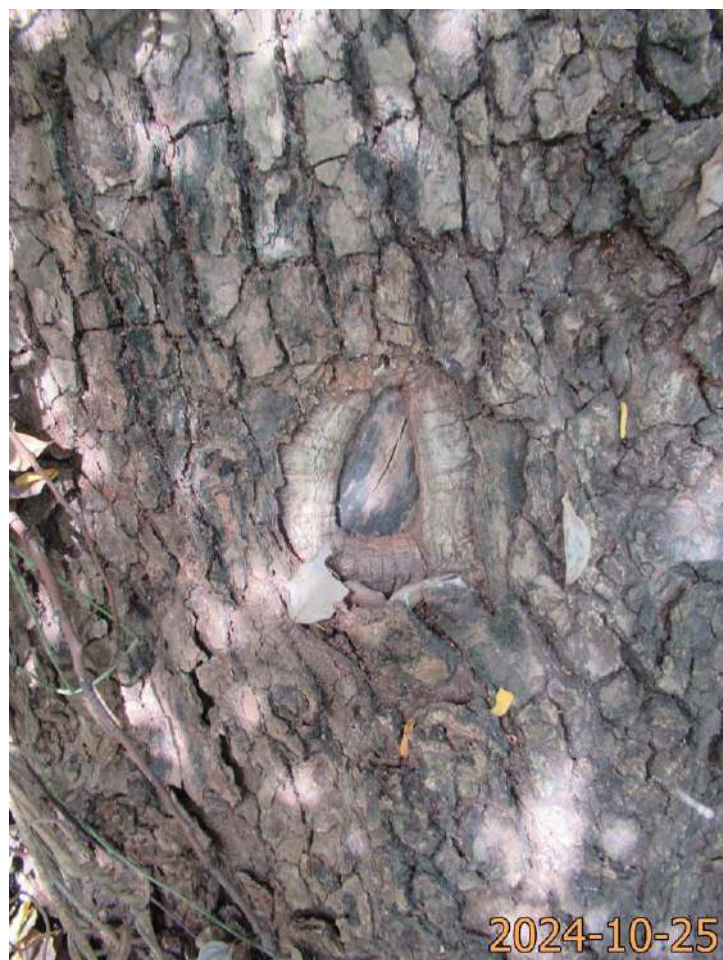
T13 Wound on trunk

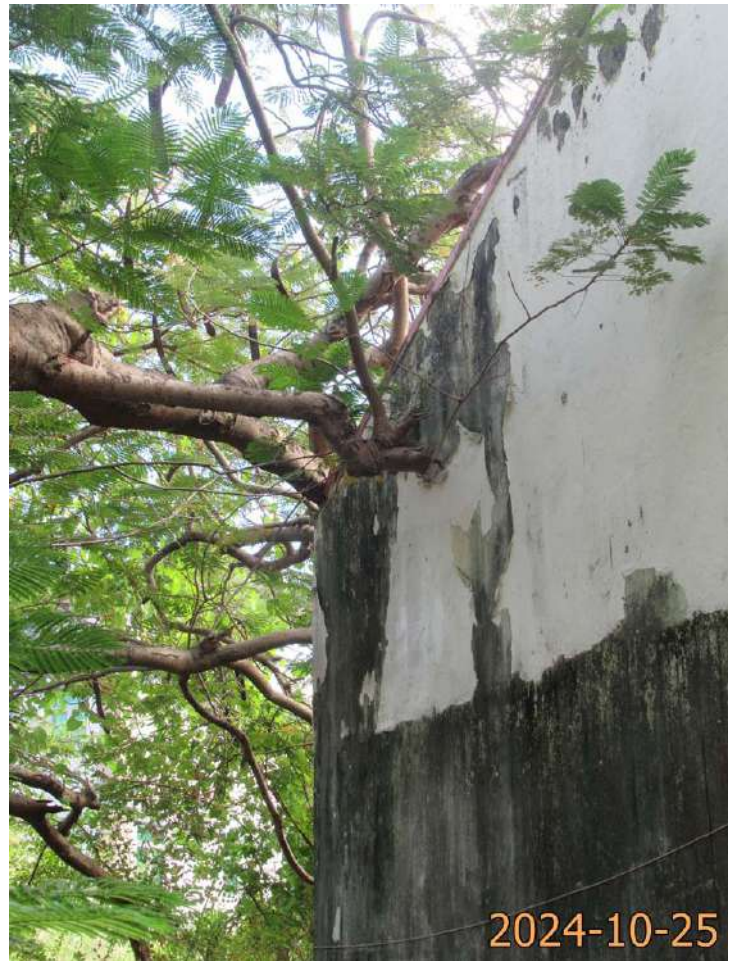
T14 Crown conflict with building

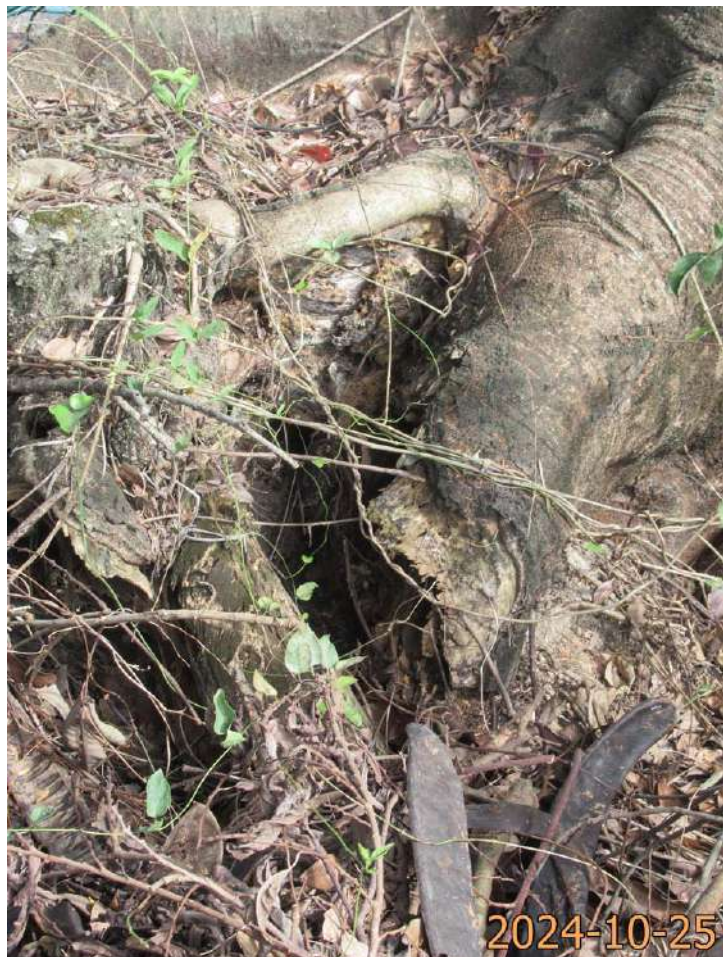
T14 Decay at root

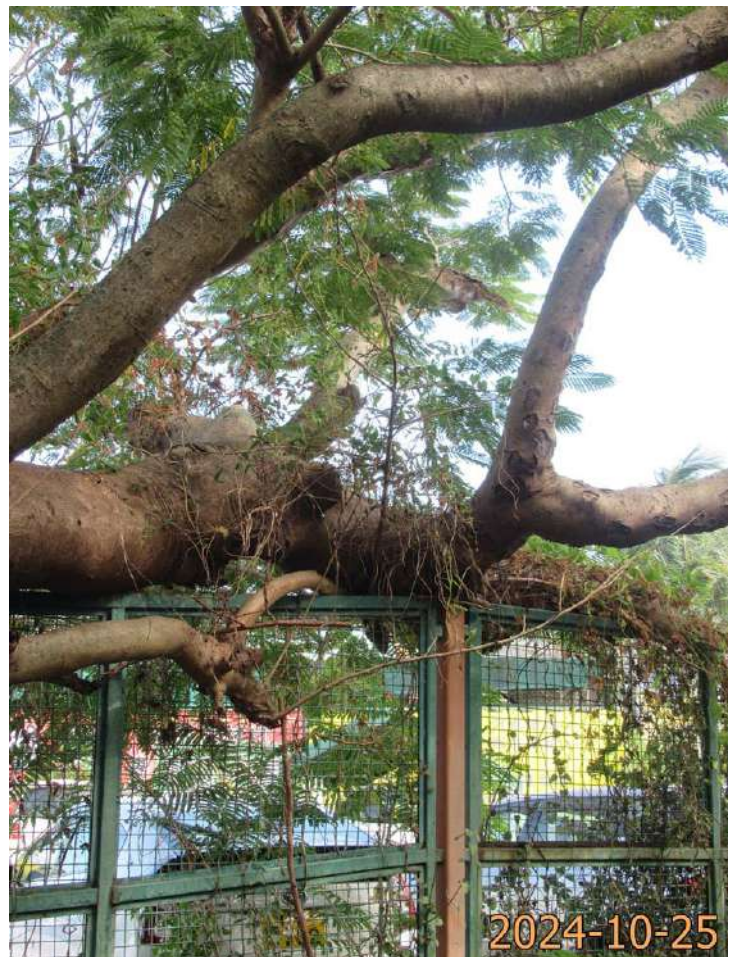
T14 Trunk conflict with fence

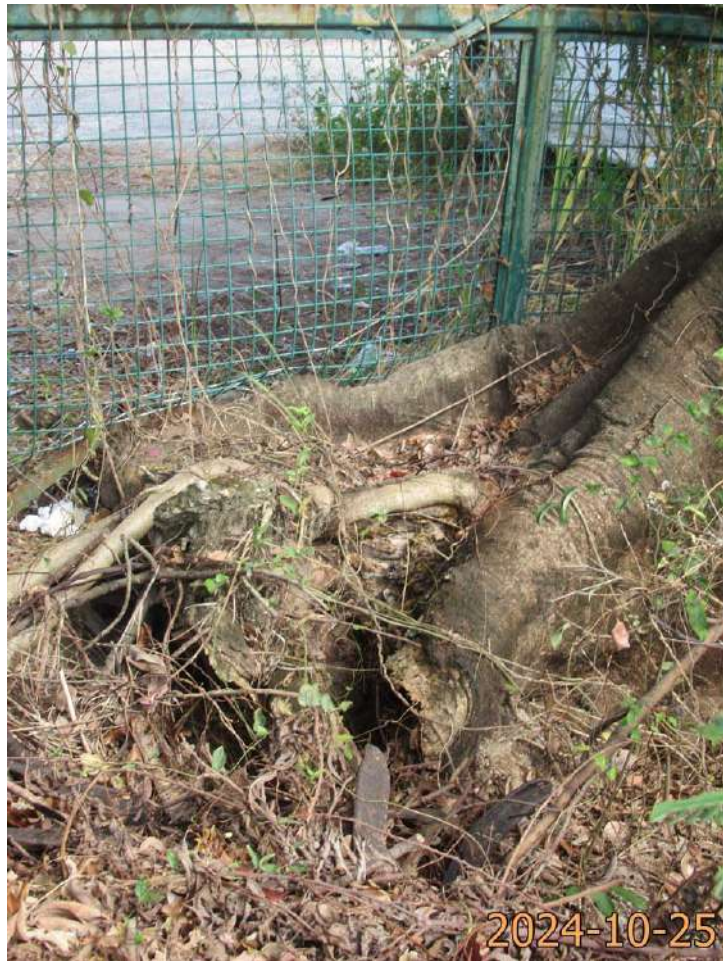
T14 Uprooted\_1

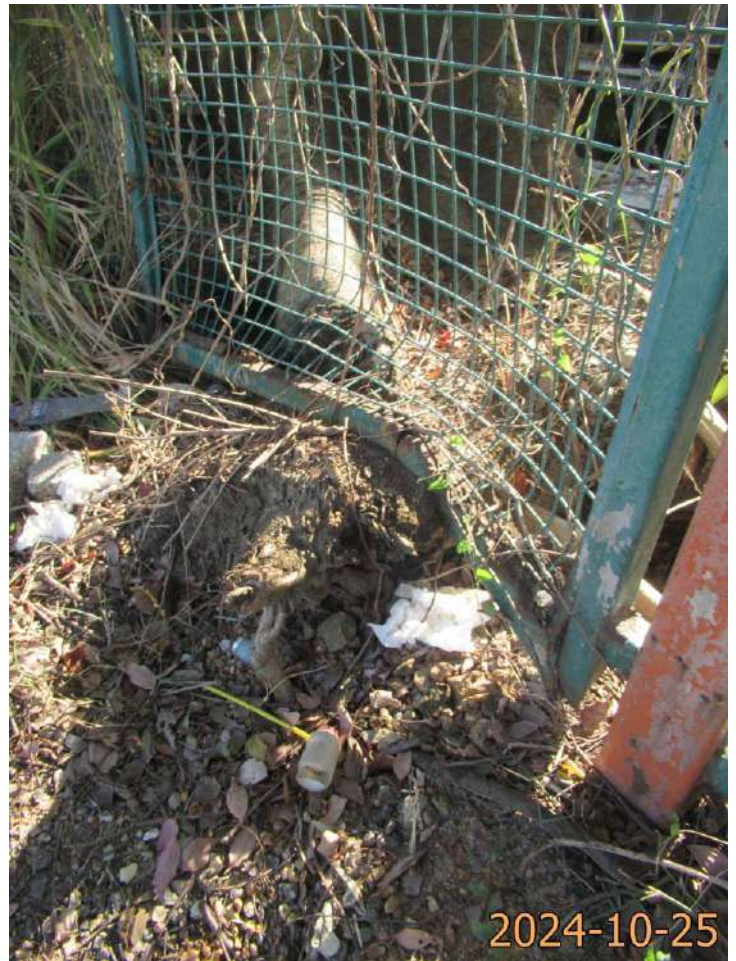
T14 Uprooted\_2

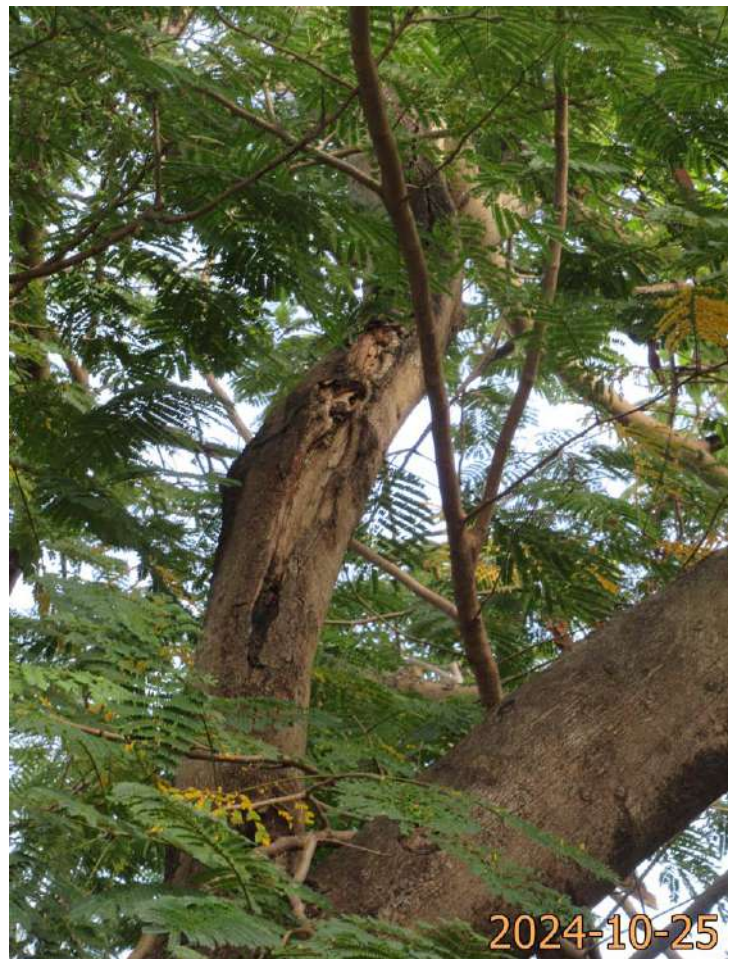
T14 Wound on branch\_1

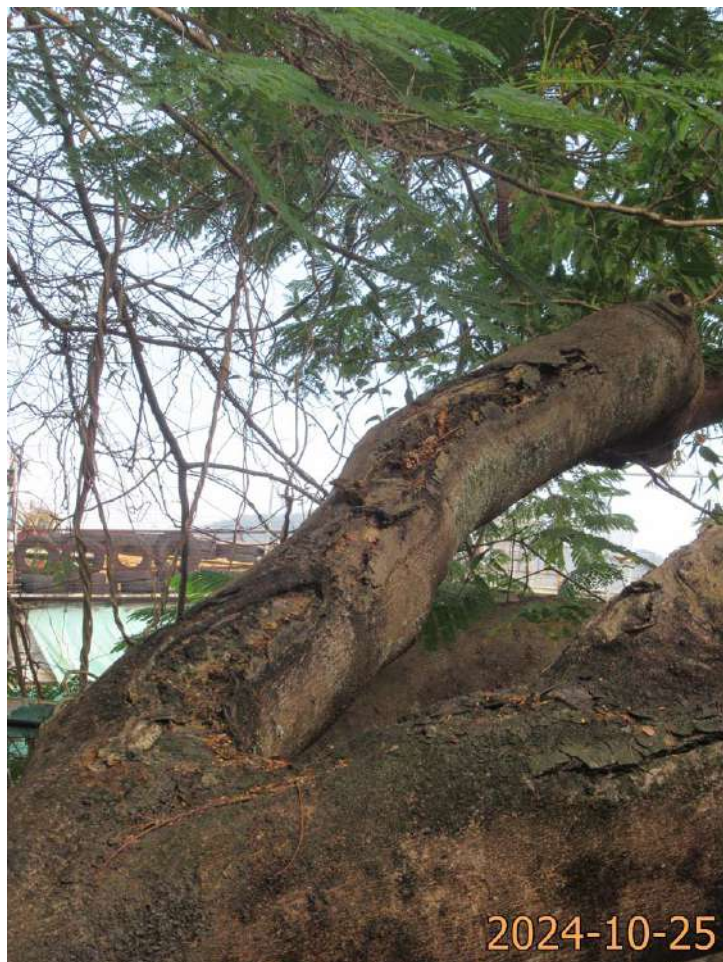
T14 Wound on branch\_2

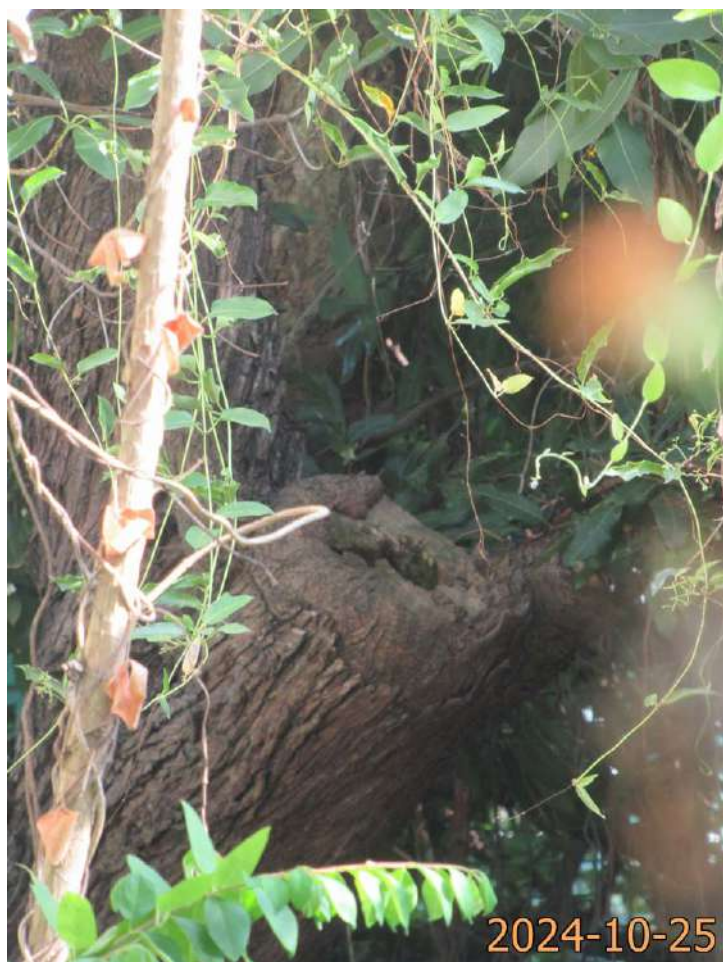
T15 Cavity at trunk

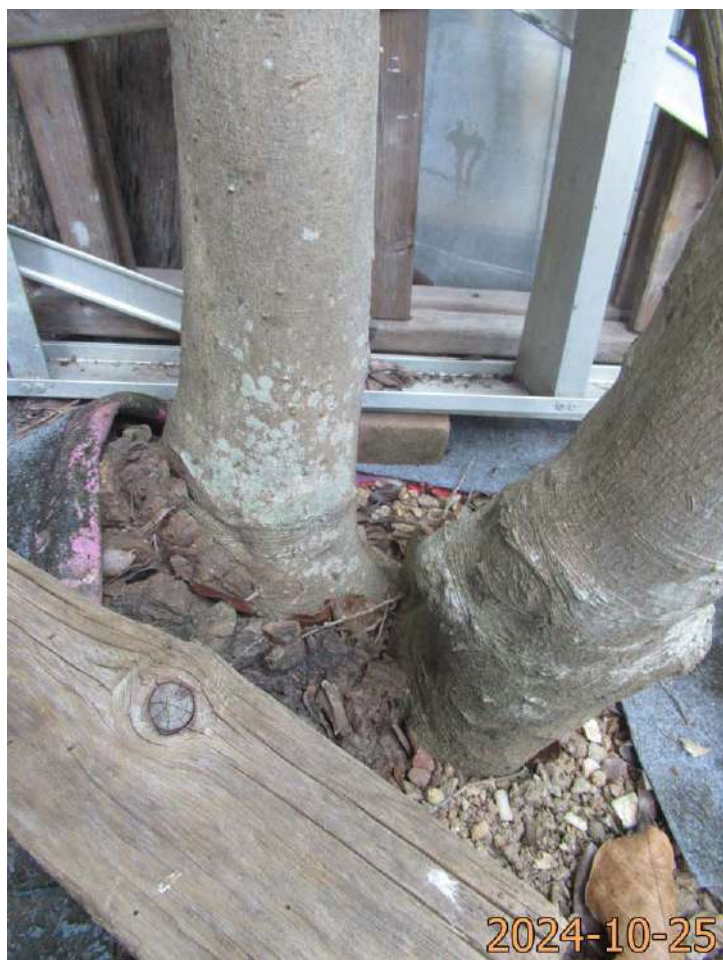
T16 Co-dominant trunks

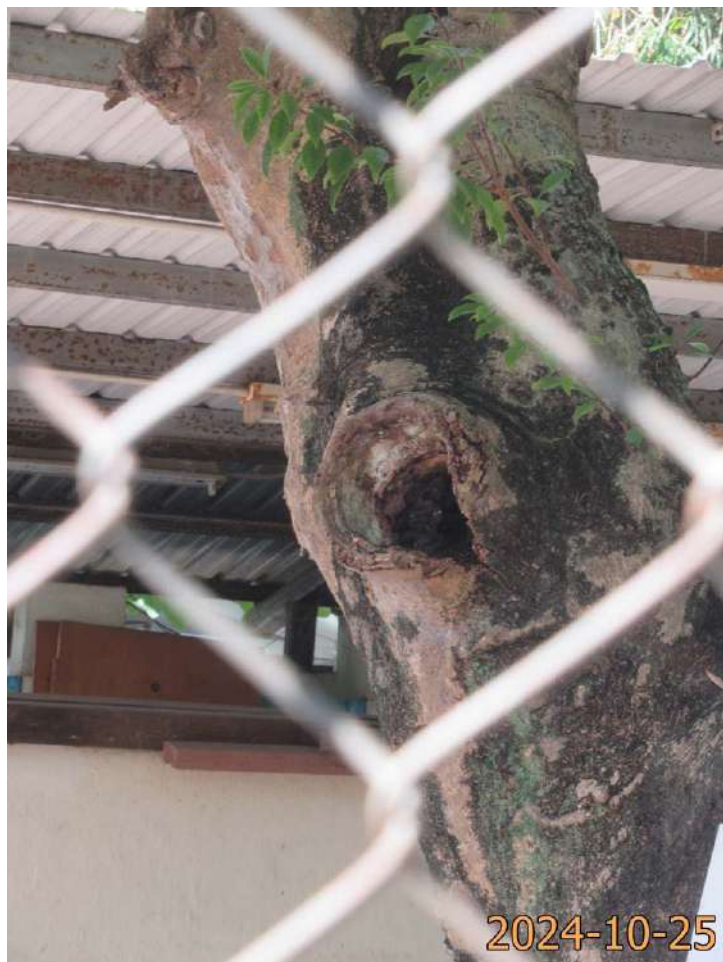
T17 Cavity at branch

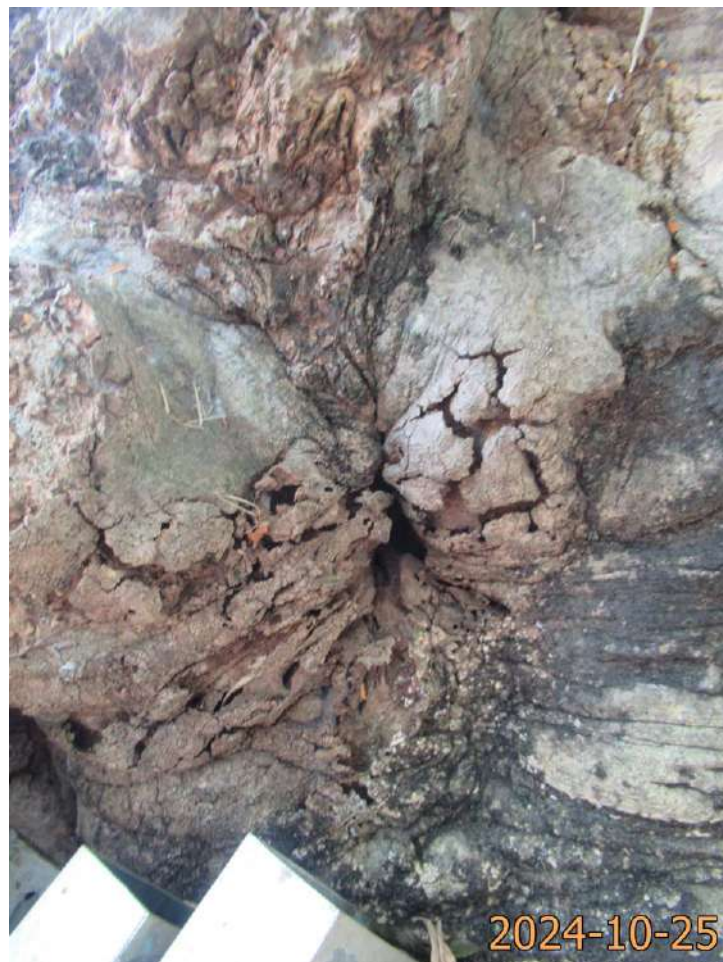
T17 Decay at trunk

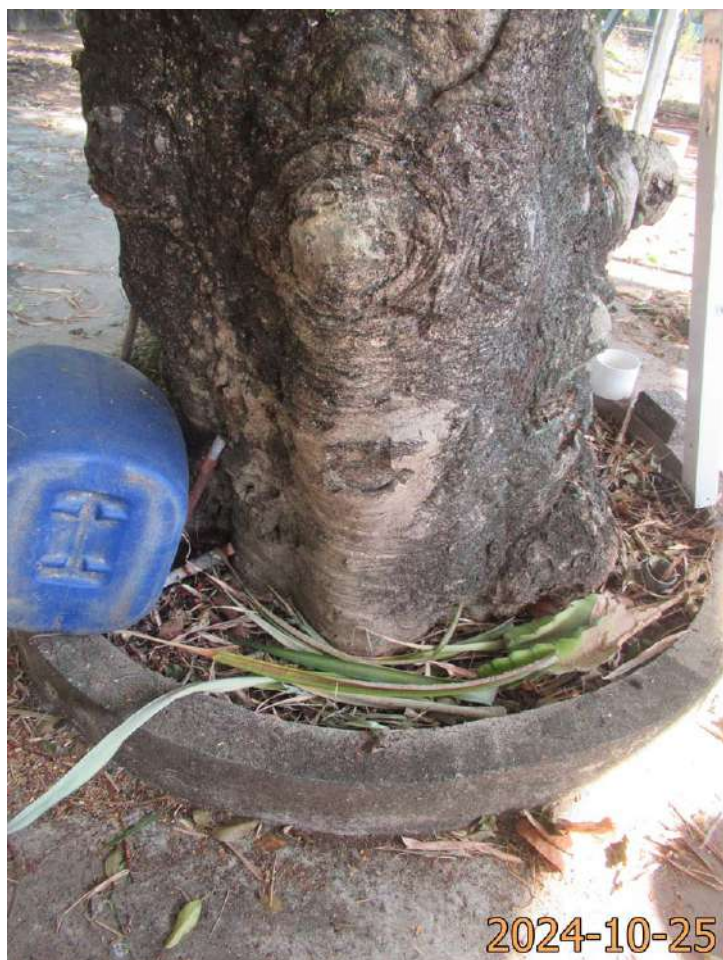
T17 Restricted root

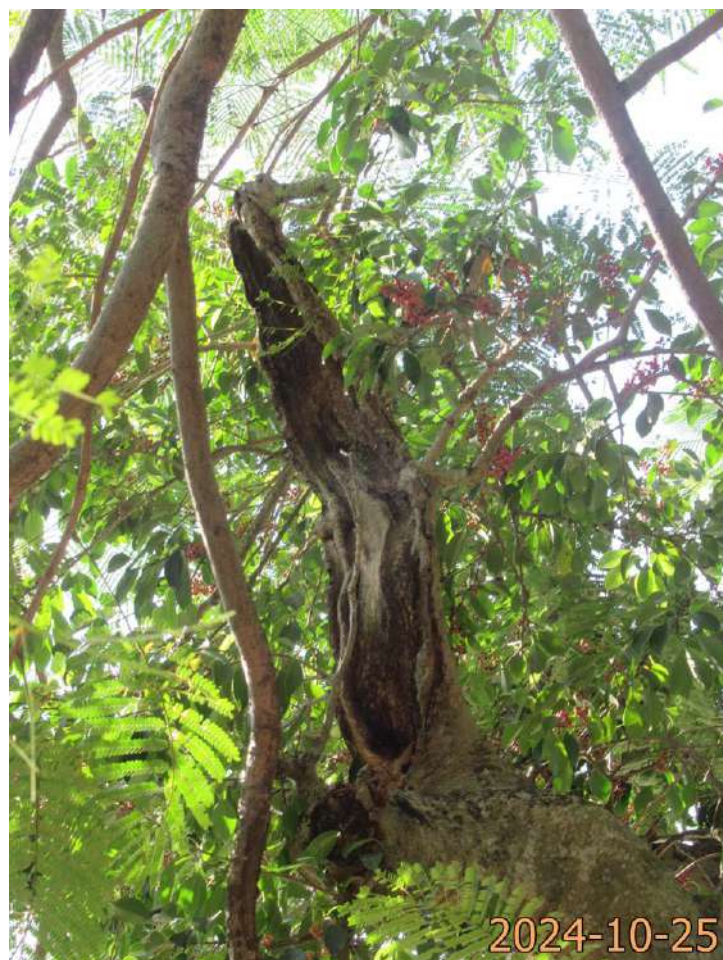
T17	<i>Ilex rotunda</i>	鐵冬青	11.0	540	9.0	Low	Fair	Poor	Poor	Low	split wound at branch, splited and decay at branch, decay at trunk, restricted root, cavity at branch
T18	<i>Dimocarpus longan</i>	龍眼	13.0	320	8.0	Med	Fair	Poor	Fair	Low	hanger, dead branch, decay at trunk
T19	<i>Dimocarpus longan</i>	龍眼	14.0	1100	8.0	Med	Fair	Poor	Poor	Low	decay at trunk, wound on trunk, trunk conflict with fence
T20	<i>Dimocarpus longan</i>	龍眼	13.0	600	8.0	Med	Fair	Poor	Poor	Low	co-dominant trunks with included bark, decay at branch, cavity at trunk, exposed root
T21	<i>Ficus microcarpa</i>	榕樹(細葉榕)	7.0	170	6.0	Low	Fair	Poor	Poor	Low	multi-trunks, trunk girdling, dead stub, bulge, cross branches, pruning wound with epicormics, drooping branches, wound on trunk, wire embedded in trunk
T22	<i>Ligustrum sinense</i>	山指甲	5.5	112	4.0	Low	Fair	Fair	Poor	Low	co-dominant trunks

T17 Split wound at branch

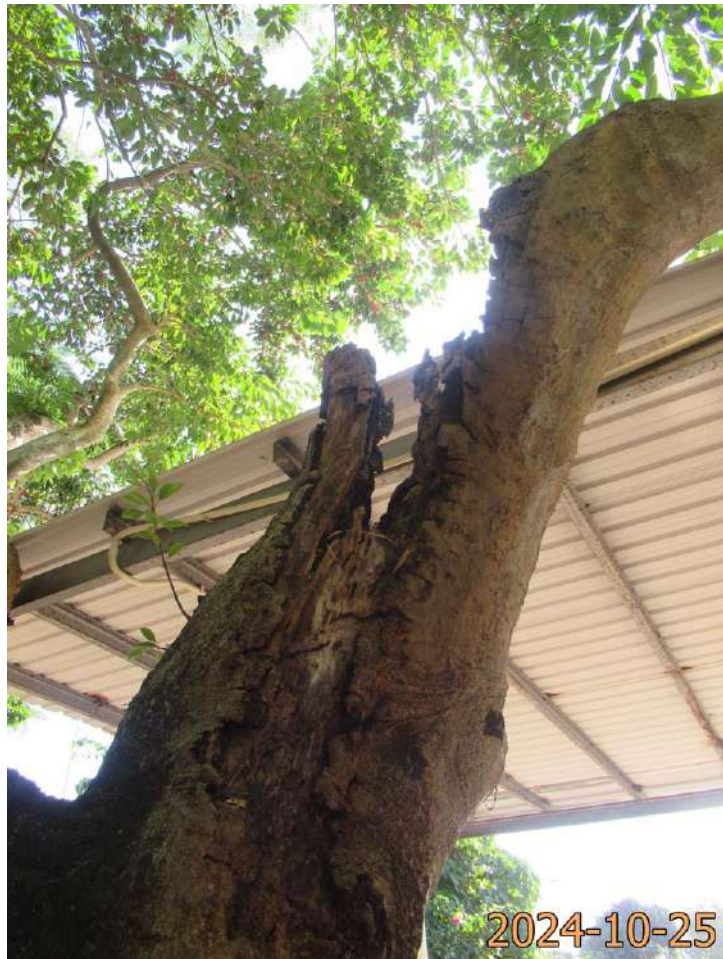
T17 Splited and decay at branch

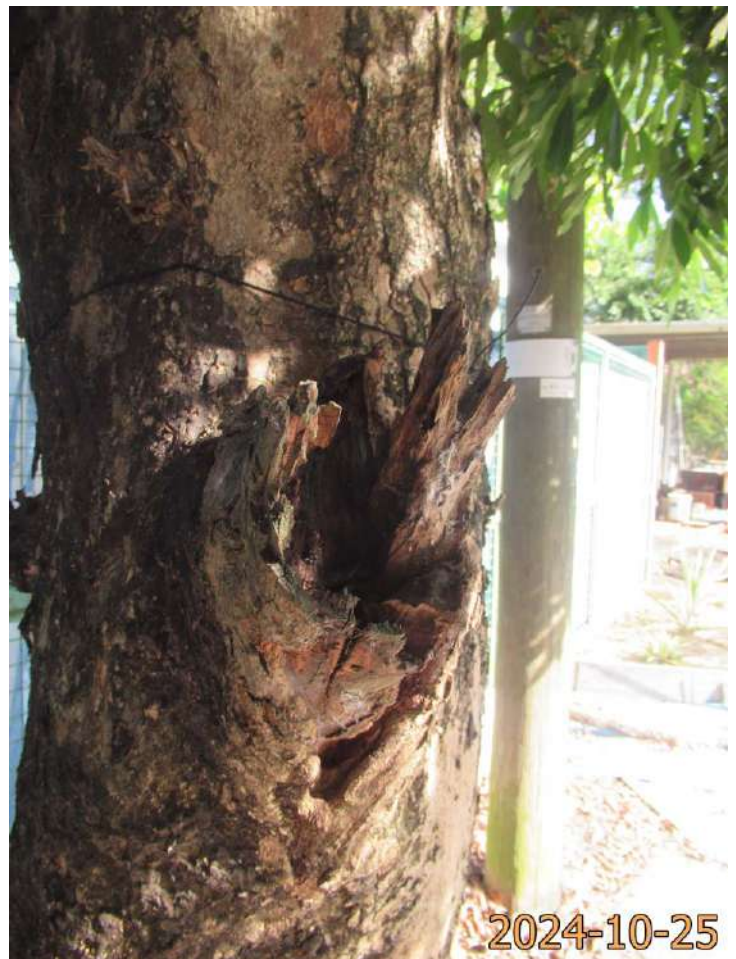
T18 Decay at trunk

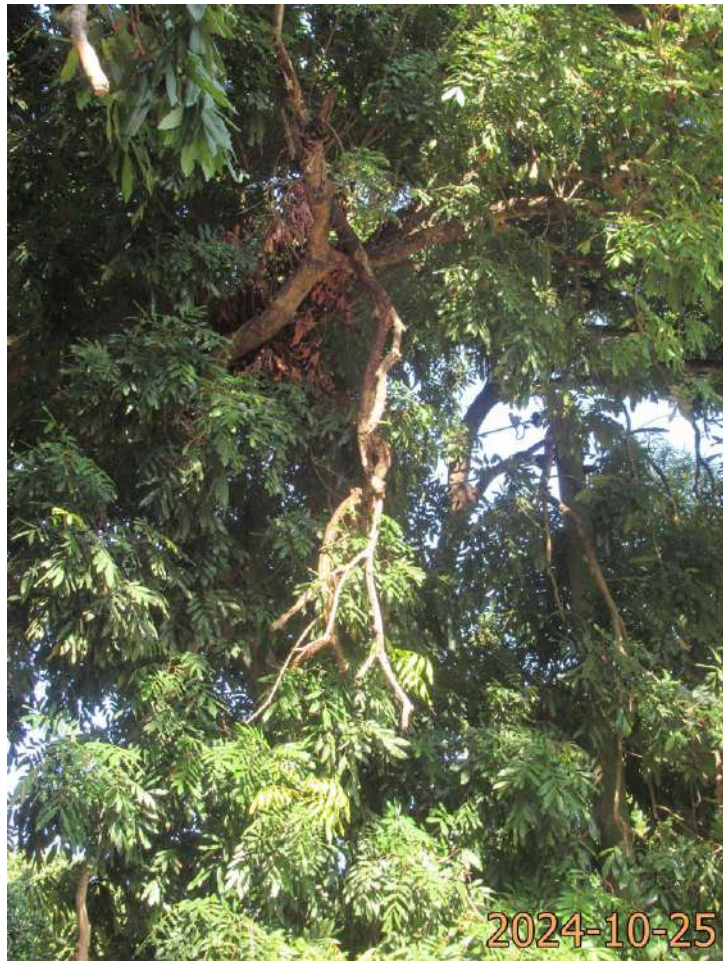
T18 Hanger

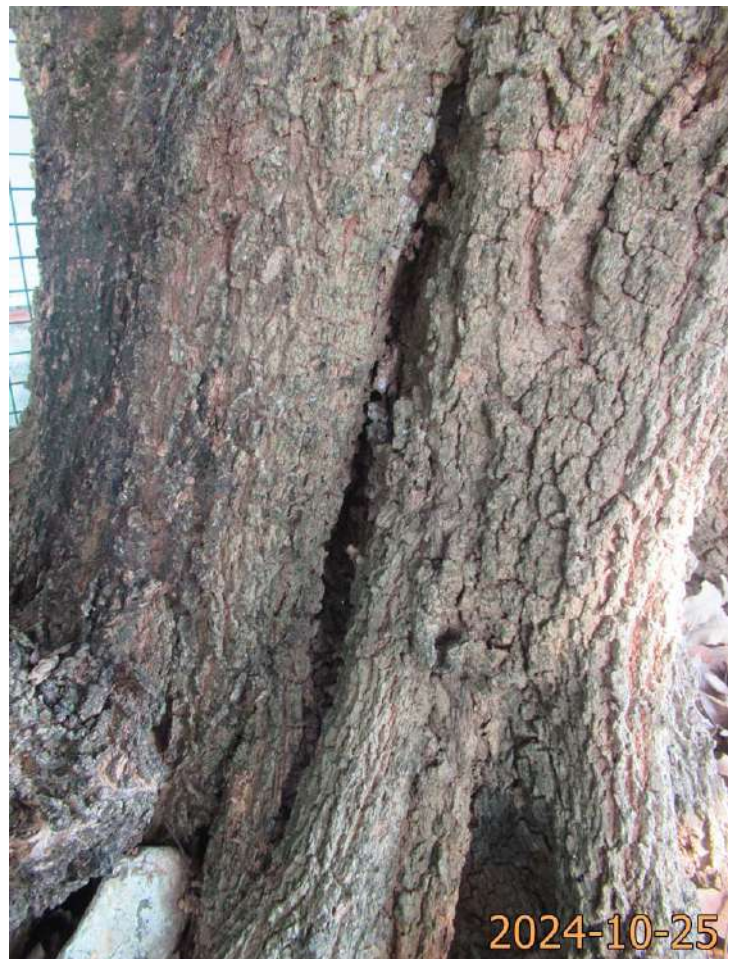
T19 Decay at trunk\_1

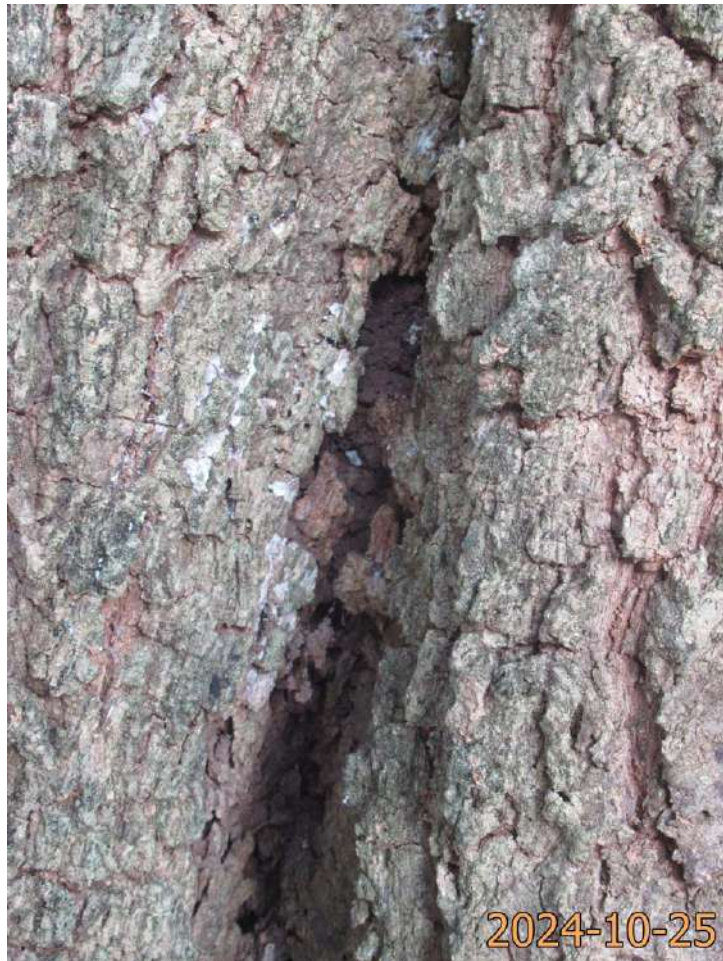
T19 Decay at trunk\_2

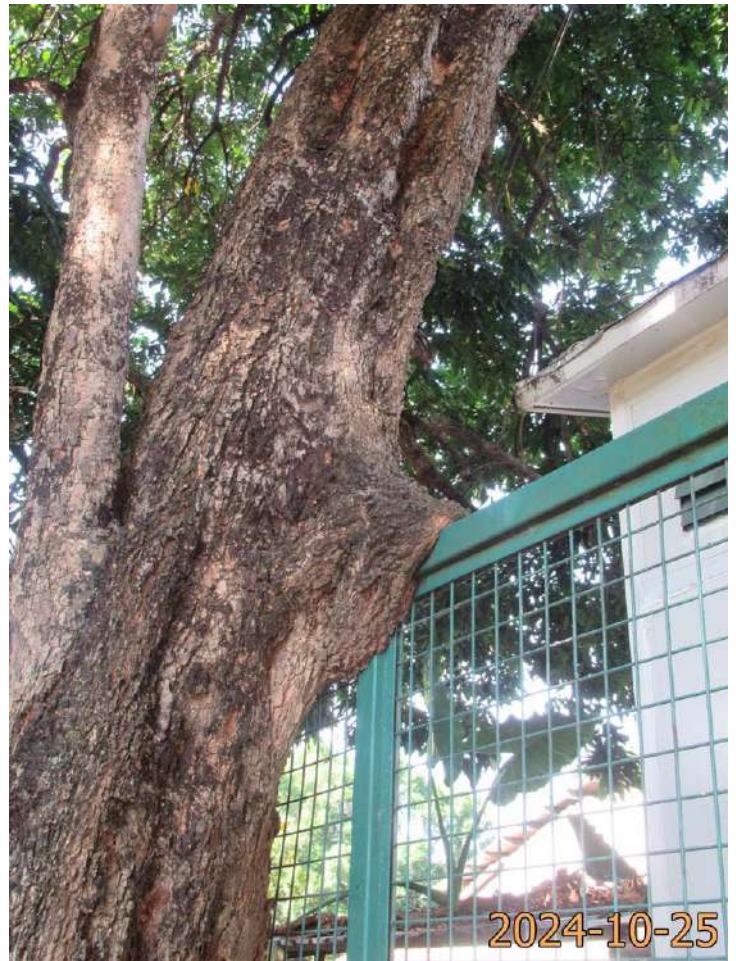
T19 Trunk conflict with fence

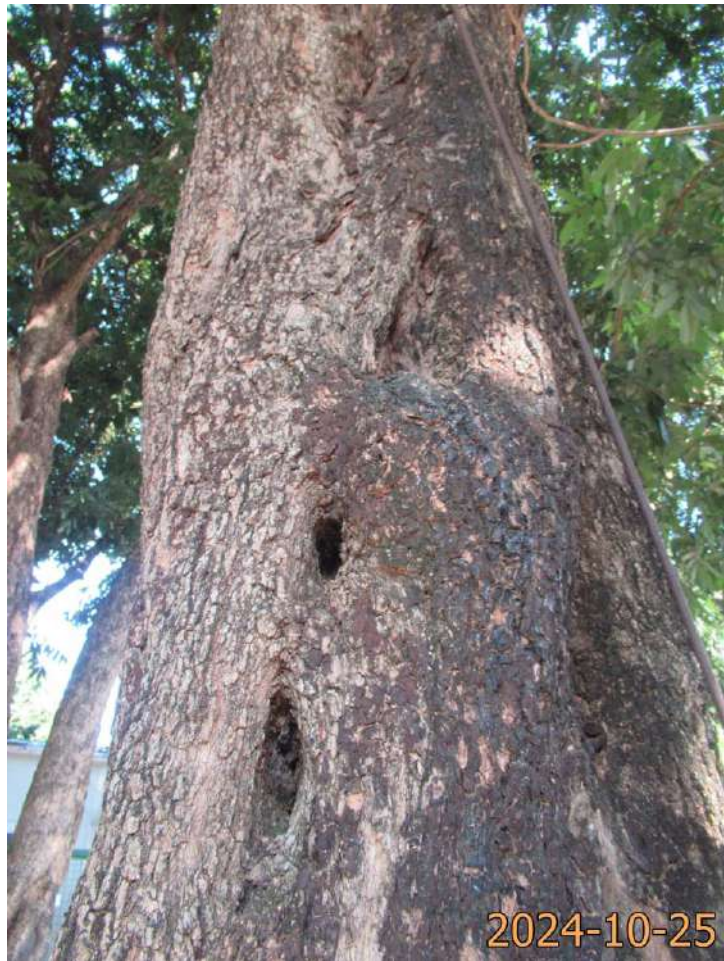
T20 Cavity at trunk

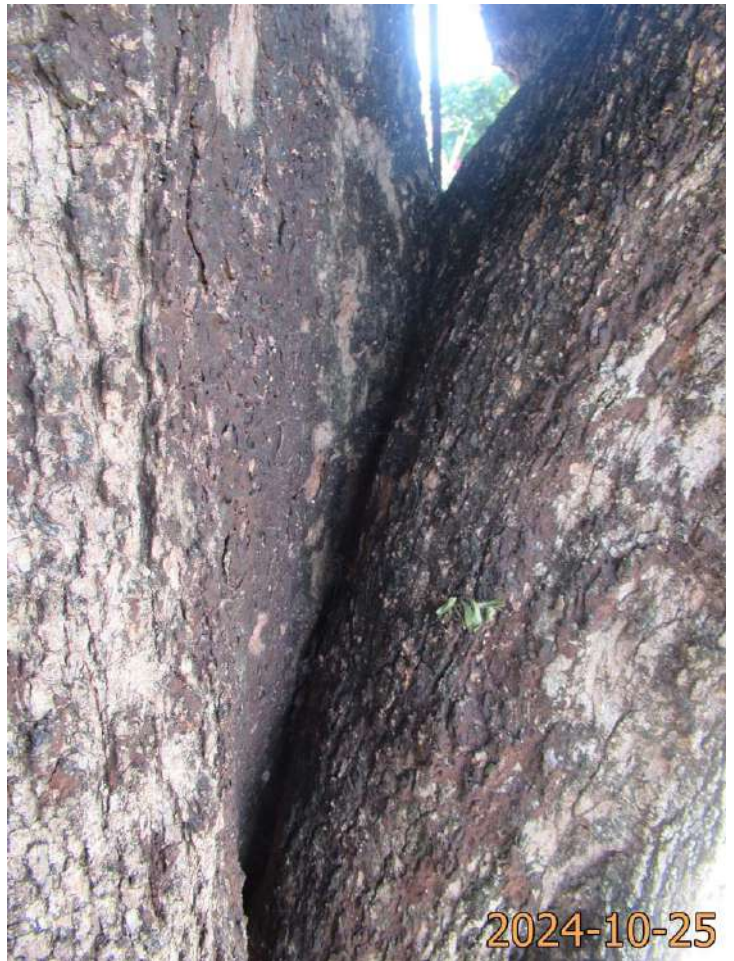
T20 Co-dominant trunks with included bark

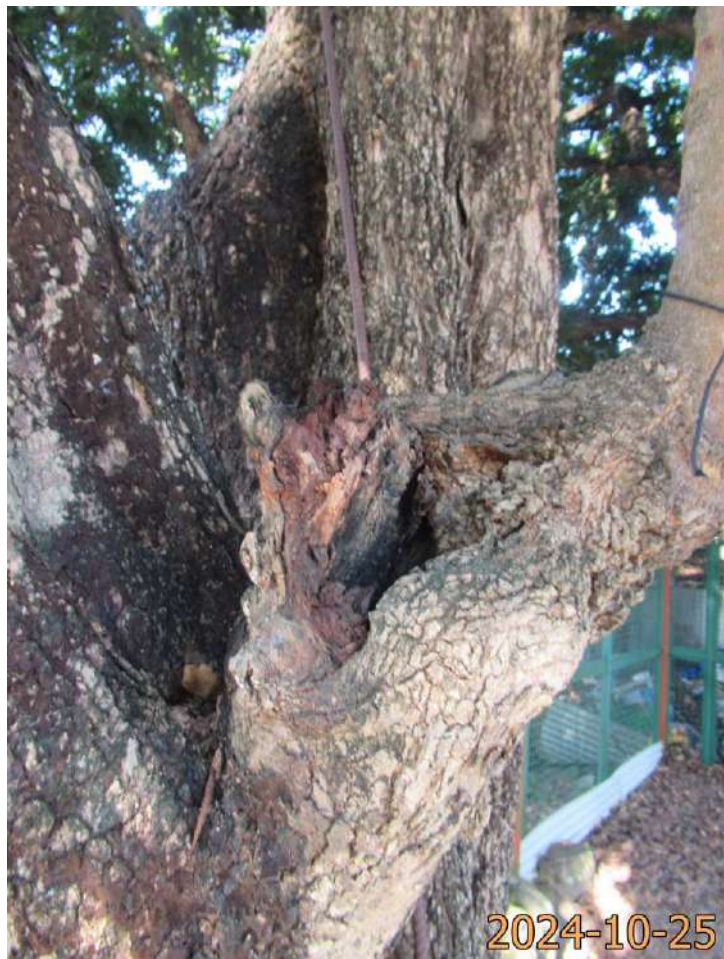
T20 Decay at branch
