# Tree Survey Report

**Date of Survey: 25<sup>th</sup> October 2024**

**Lots 2063 And 2064 In D.D. 106 and Adjoining Government Land, Kam Tin, Yuen Long, New Territories (Former Shek Wu School)**

Registered Arborist

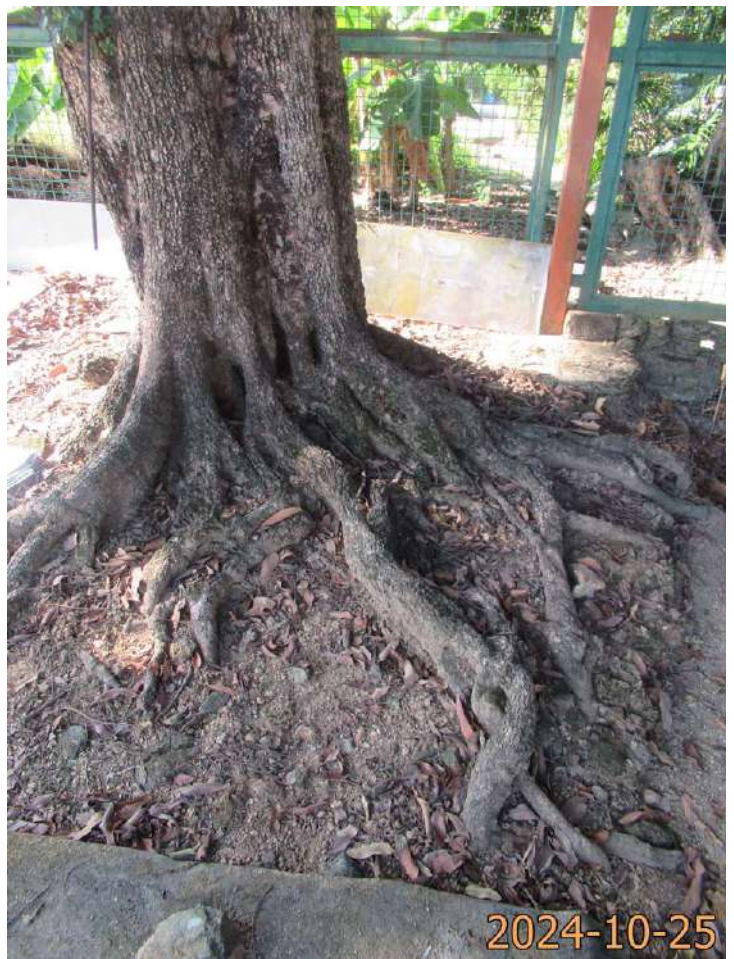
T20 Exposed root

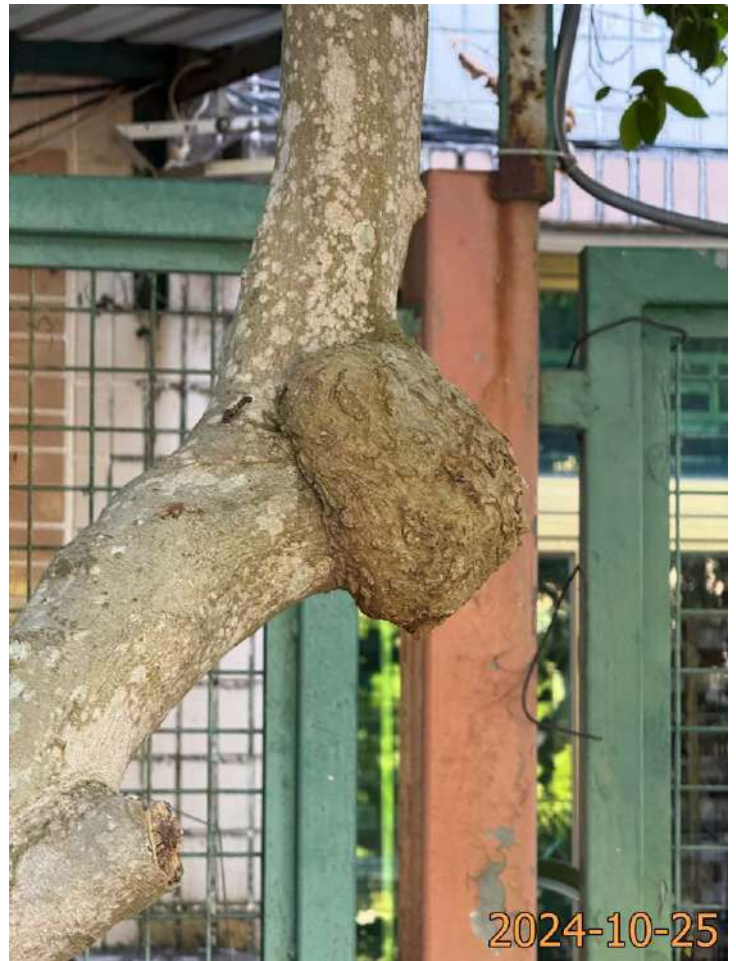
T21 Bulge

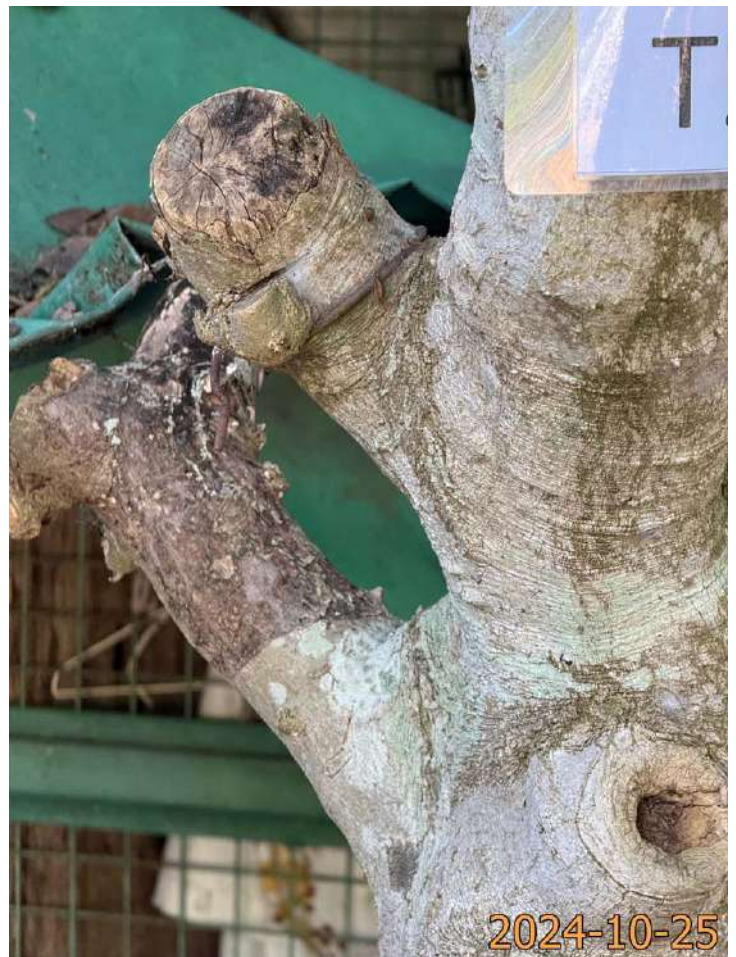
T21 Dead stub

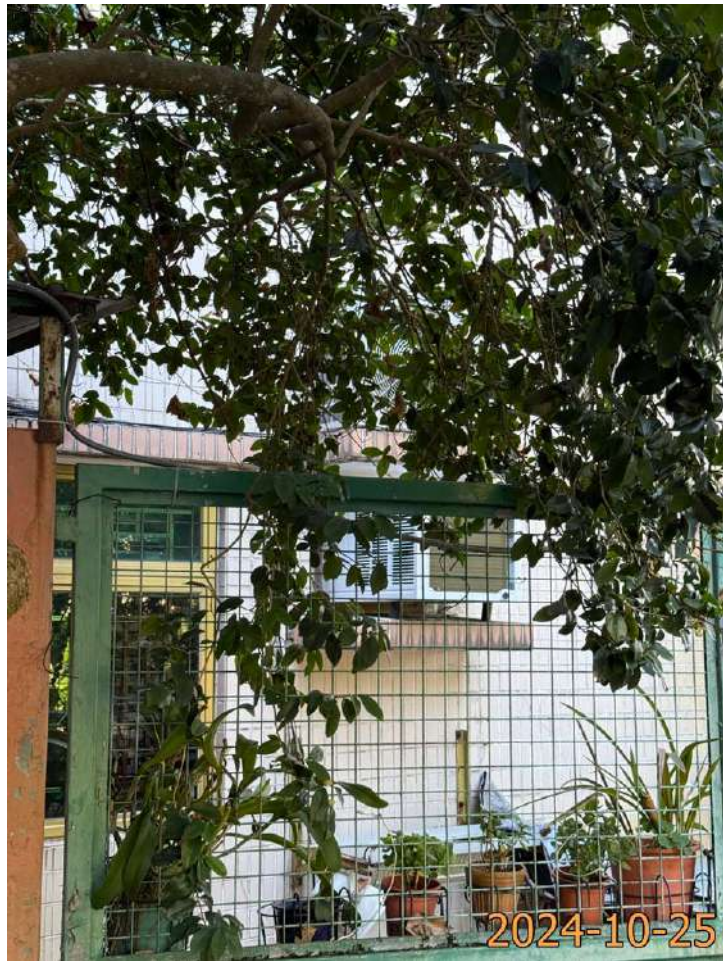
T21 Drooping branches

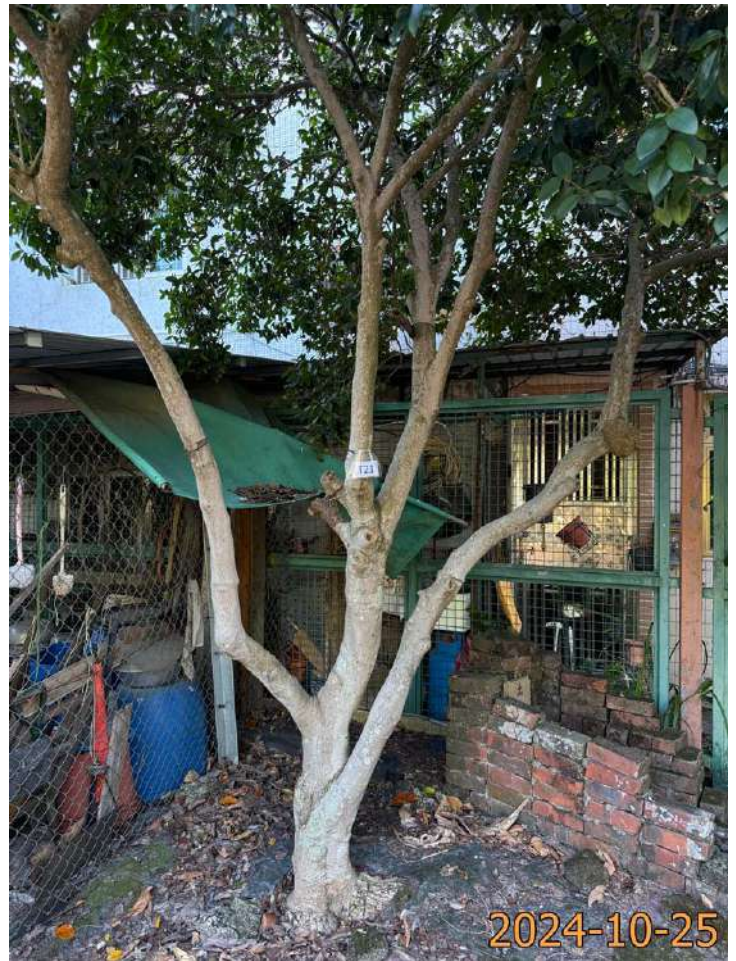
T21 Multi-trunks

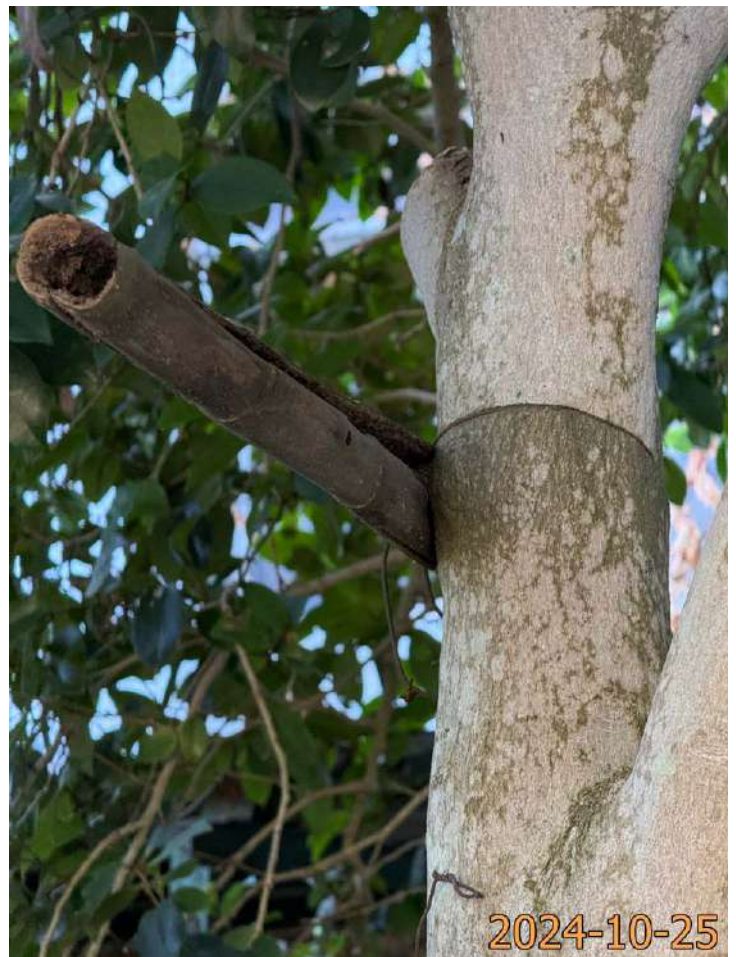
T21 Trunk girdling

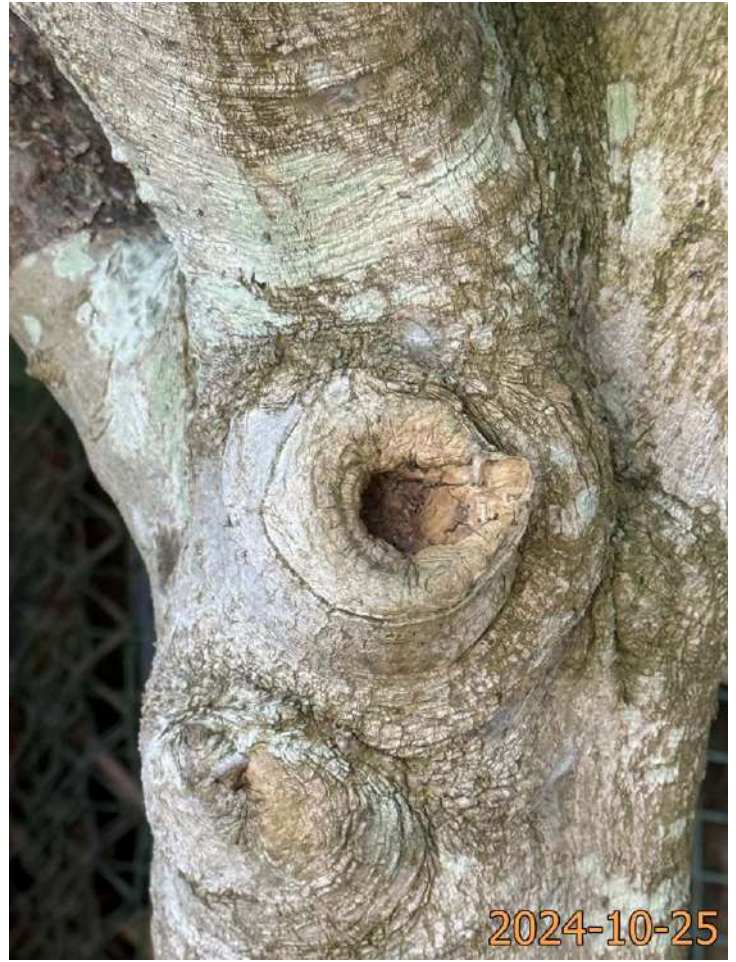
T21 Wound on trunk
