# Tree Survey Report

**Date of Survey: 6<sup>th</sup> October 2025**

**Lot 136 (Part) And 2149 In D.D. 106 And Adjoining  
Government Land, Kam Tin, Yuen Long, New Territories**

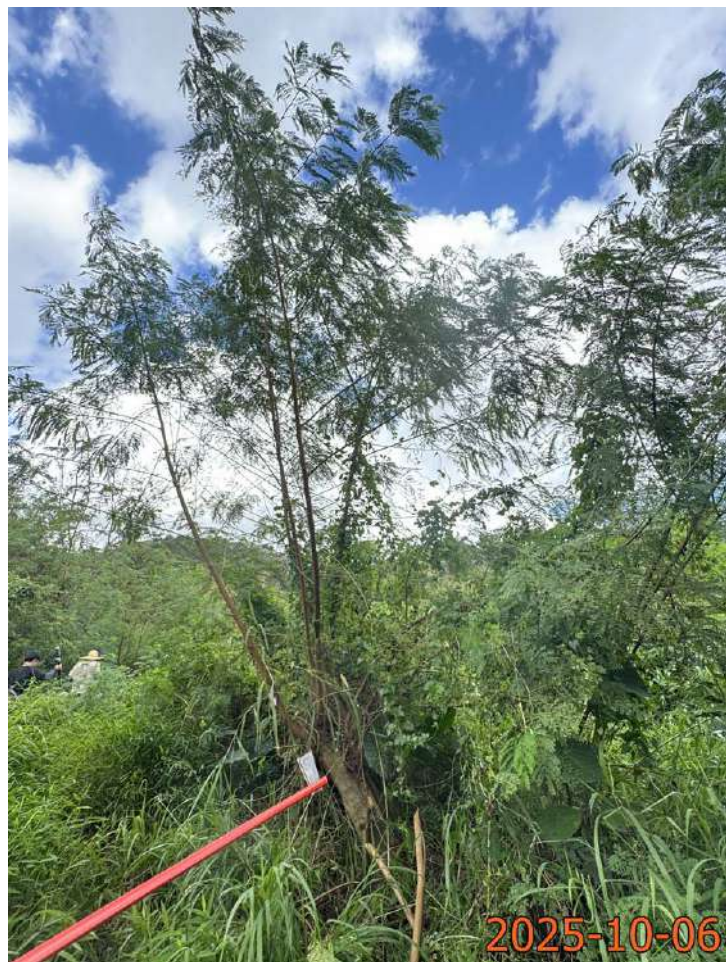
T3 (Overview)

| Tree No. | Tree Species | | Tree Size Measurements | | | Amenity Value | Form | Health Condition | Structural Condition | Suitability for Transplanting | Remarks |
|---|---|---|---|---|---|---|---|---|---|---|---|
| T3 | <i>Leucaena leucocephala</i> | 銀合歡 | 8.0 | 250 | 4.0 | Low | Poor | Poor | Poor | Low | broken trunk, uprooted |

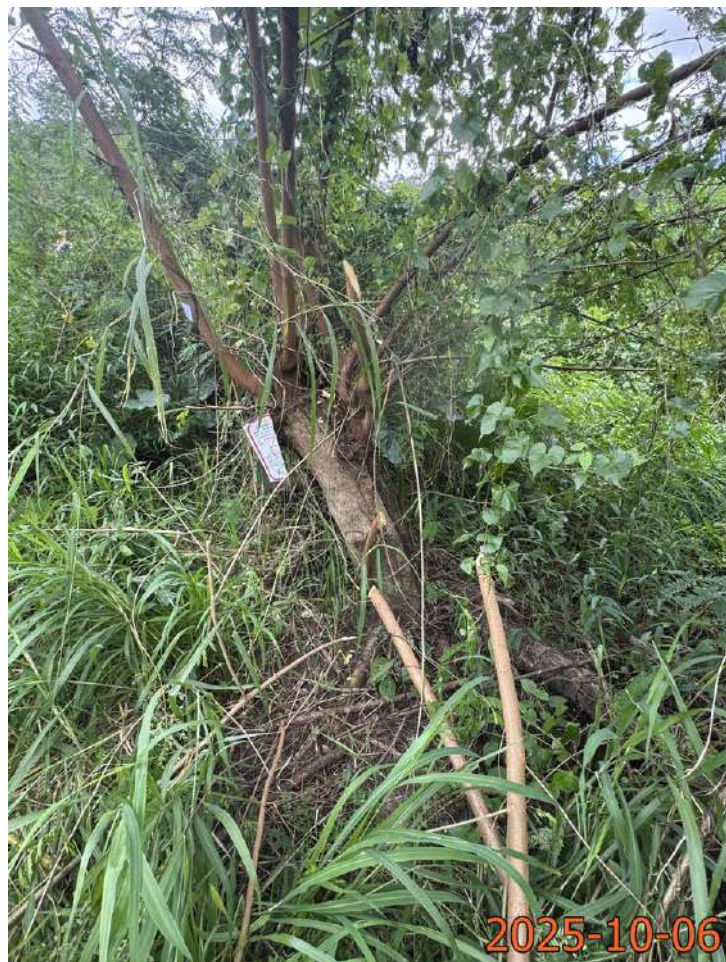
T3 Broken trunk

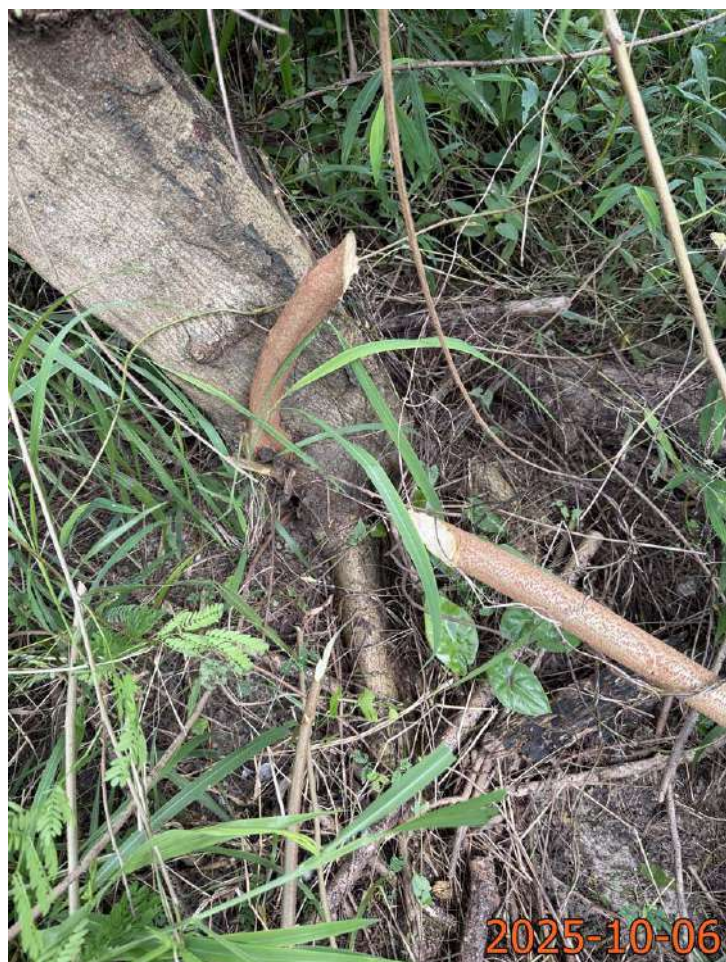
T3 Uprooted

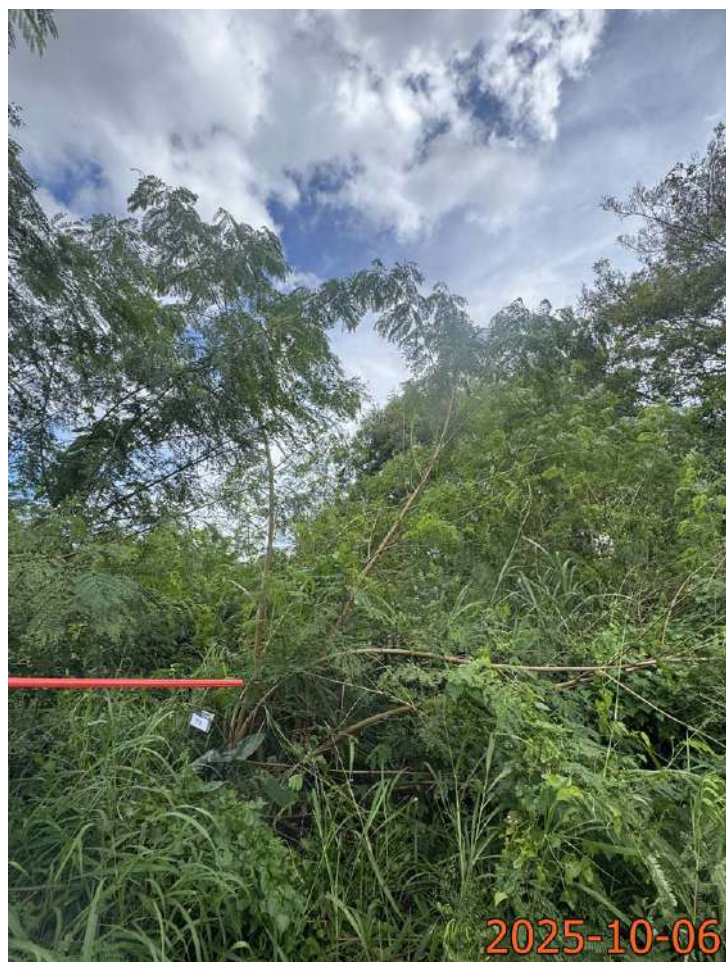
T4 (Overview)

| Tree No. | Tree Species | | Tree Size Measurements | | | Amenity Value | Form | Health Condition | Structural Condition | Suitability for Transplanting | Remarks |
|---|---|---|---|---|---|---|---|---|---|---|---|
| T4 | <i>Leucaena leucocephala</i> | 銀合歡 | 7.0 | 210 | 6.0 | Low | Poor | Poor | Poor | Low | broken trunk |

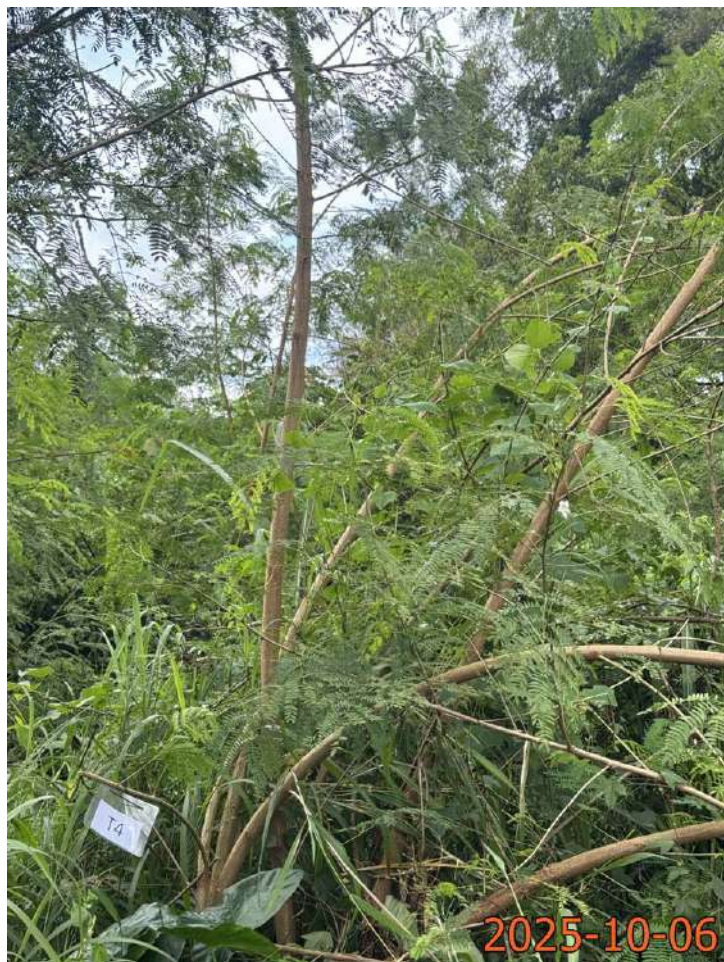
T4 Broken trunk

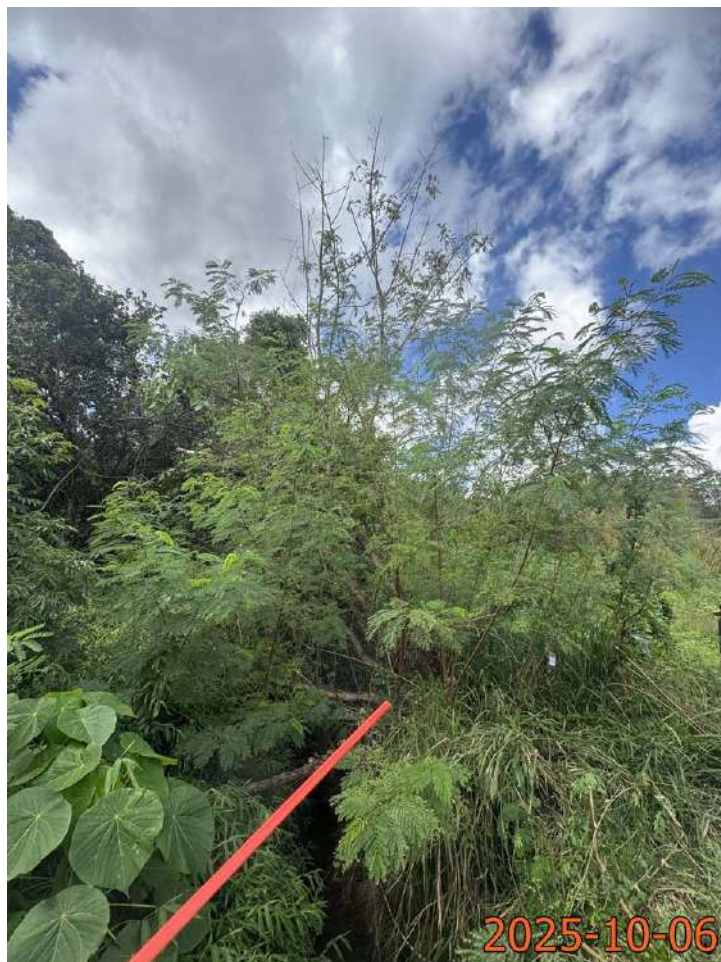
T5 (Overview)

| Tree No. | Tree Species | | Tree Size Measurements | | | Amenity Value | Form | Health Condition | Structural Condition | Suitability for Transplanting | Remarks |
|---|---|---|---|---|---|---|---|---|---|---|---|
| T5 | <i>Leucaena leucocephala</i> | 銀合歡 | 8.0 | 320 | 10.0 | Low | Poor | Poor | Poor | Low | collapsed |

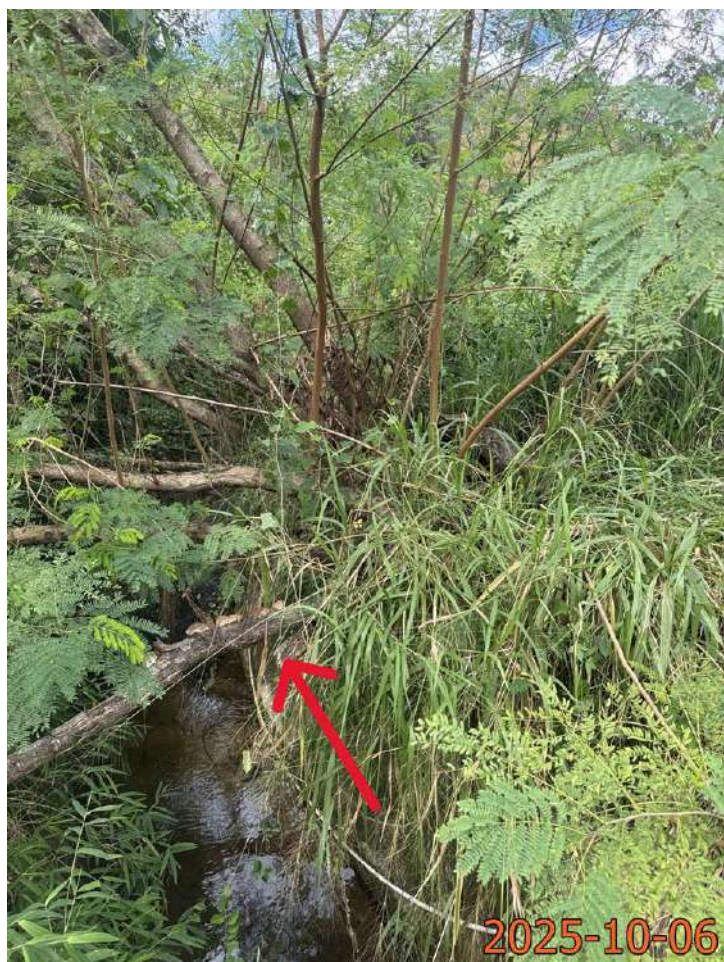
T5 Collapsed

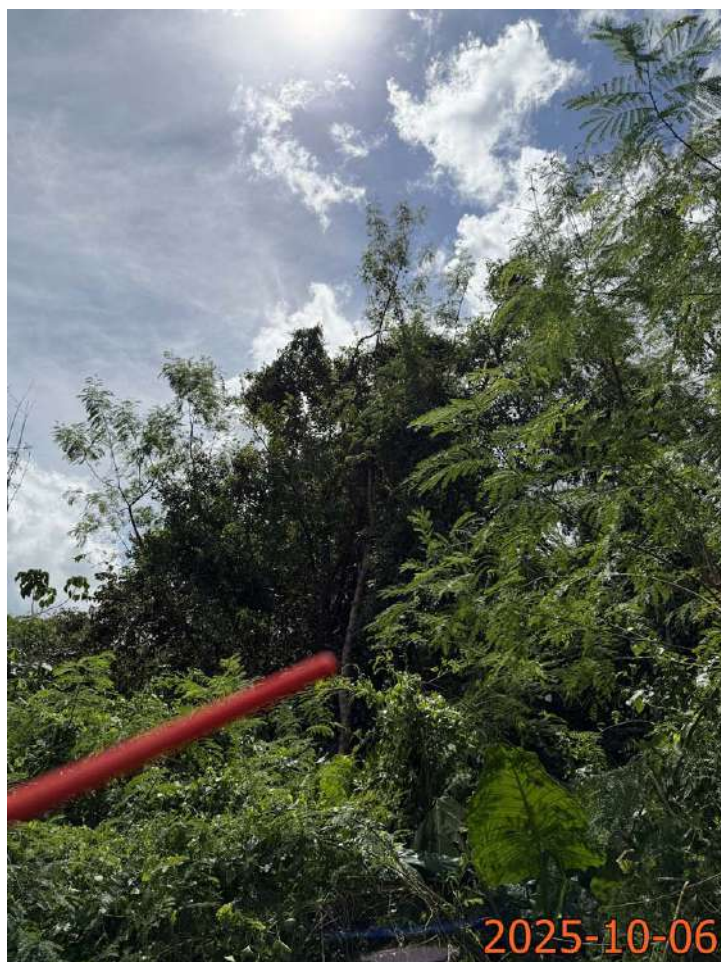
T6 (Overview)

| Tree No. | Tree Species | | Tree Size Measurements | | | Amenity Value | Form | Health Condition | Structural Condition | Suitability for Transplanting | Remarks |
|---|---|---|---|---|---|---|---|---|---|---|---|
| T6 | <i>Leucaena leucocephala</i> | 銀合歡 | 10.0 | 150 | 4.0 | Low | Poor | Poor | Poor | Low | |

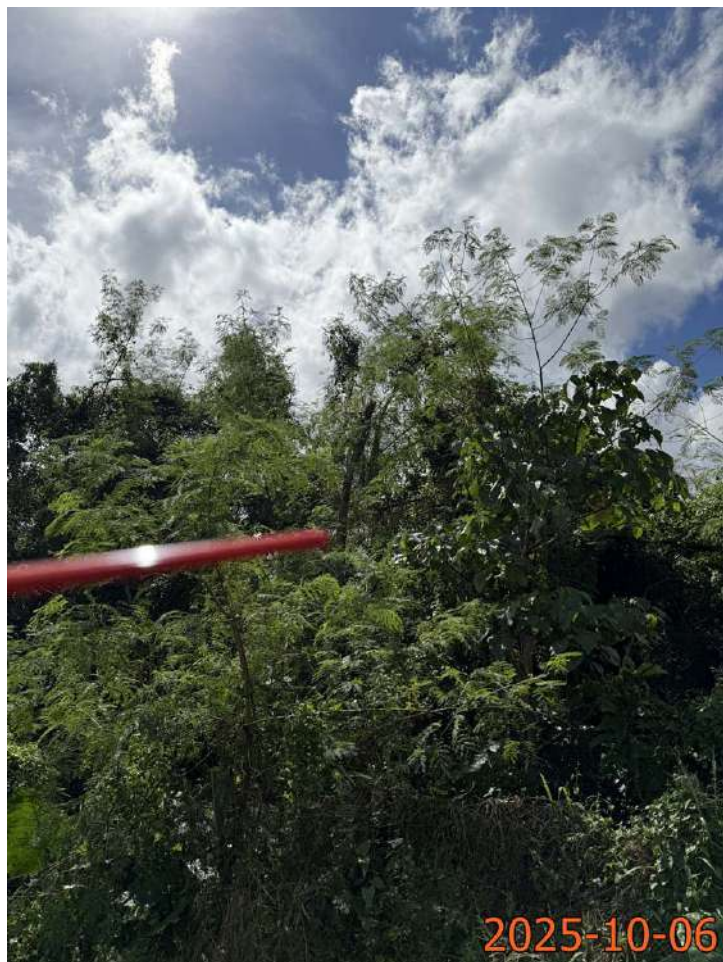
T7 (Overview)

| Tree No. | Tree Species | | Tree Size Measurements | | | Amenity Value | Form | Health Condition | Structural Condition | Suitability for Transplanting | Remarks |
|---|---|---|---|---|---|---|---|---|---|---|---|
| T7 | <i>Leucaena leucocephala</i> | 銀合歡 | 10.0 | 160 | 4.0 | Low | Poor | Poor | Poor | Low | broken trunk |

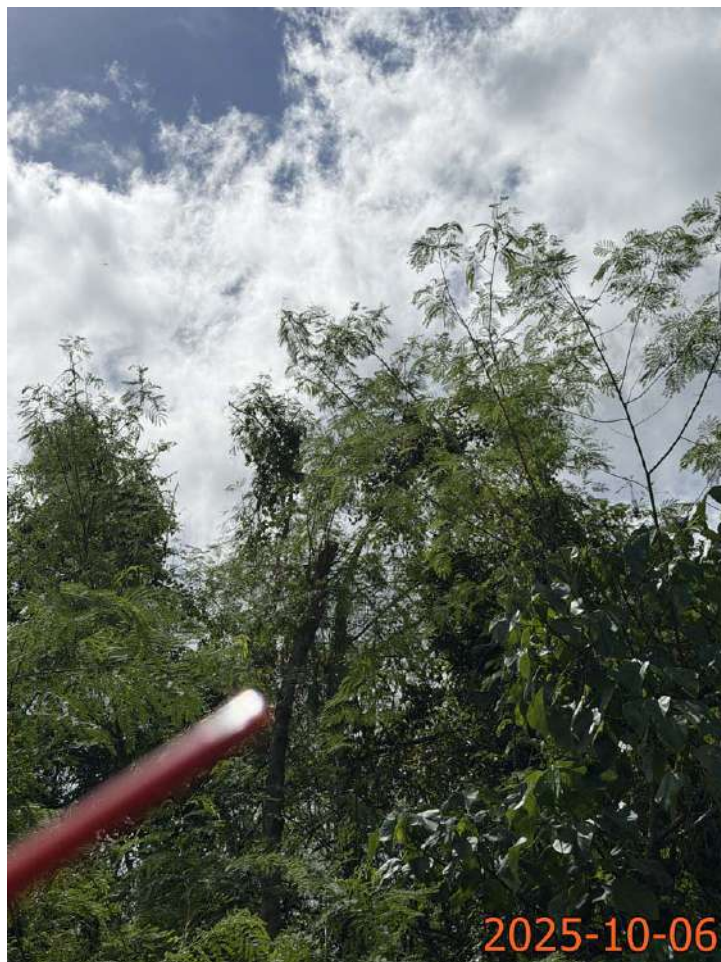
T7 Broken trunk

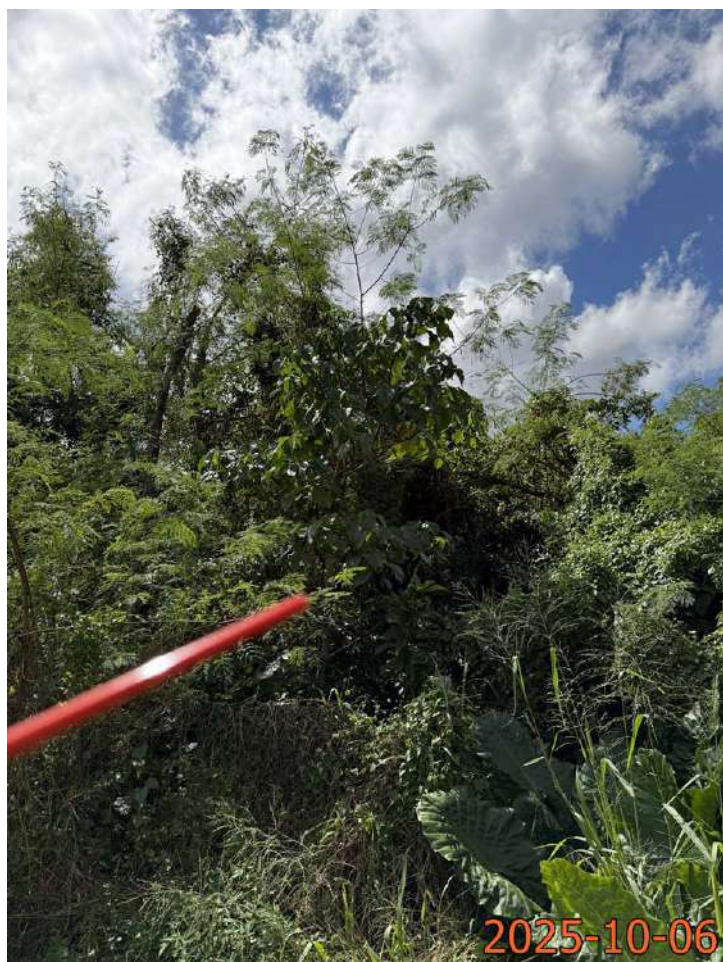
T8 (Overview)

| Tree No. | Tree Species | | Tree Size Measurements | | | Amenity Value | Form | Health Condition | Structural Condition | Suitability for Transplanting | Remarks |
|---|---|---|---|---|---|---|---|---|---|---|---|
| T8 | <i>Macaranga tanarius</i> var. | 血桐 | 7.0 | 120 | 2.0 | Low | Poor | Poor | Poor | Low | |

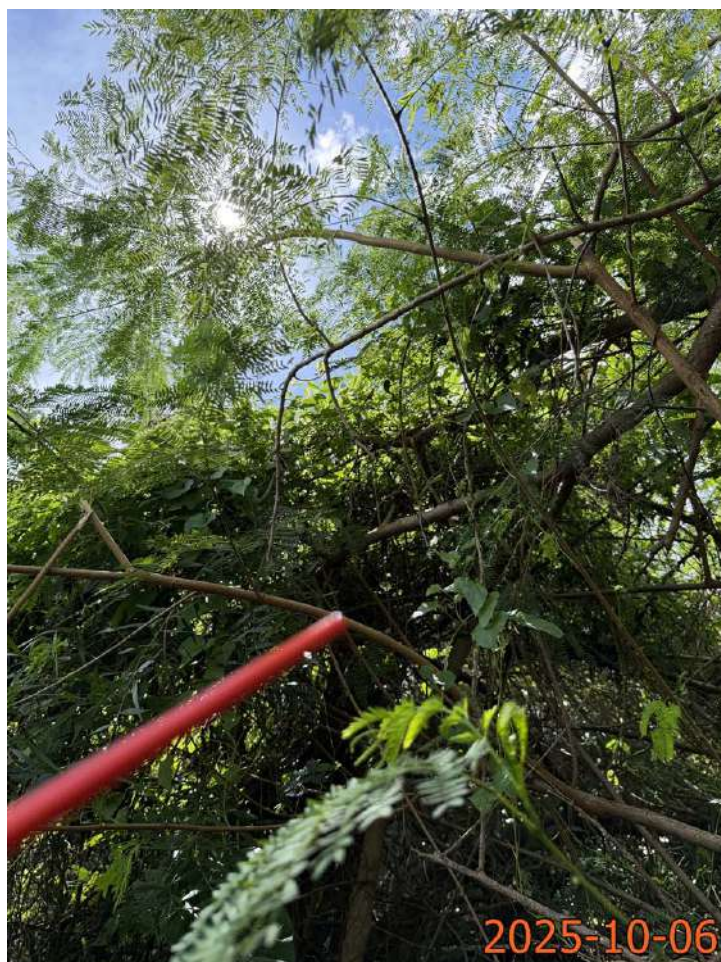
| Tree No. | Tree Species | | Tree Size Measurements | | | Amenity Value | Form | Health Condition | Structural Condition | Suitability for Transplanting | Remarks |
|---|---|---|---|---|---|---|---|---|---|---|---|
| T9 | <i>Leucaena leucocephala</i> | 銀合歡 | 4.0 | 160 | 2.0 | Low | Poor | Poor | Poor | Low | broken trunk |

T9 (Overview) (Broken trunk)

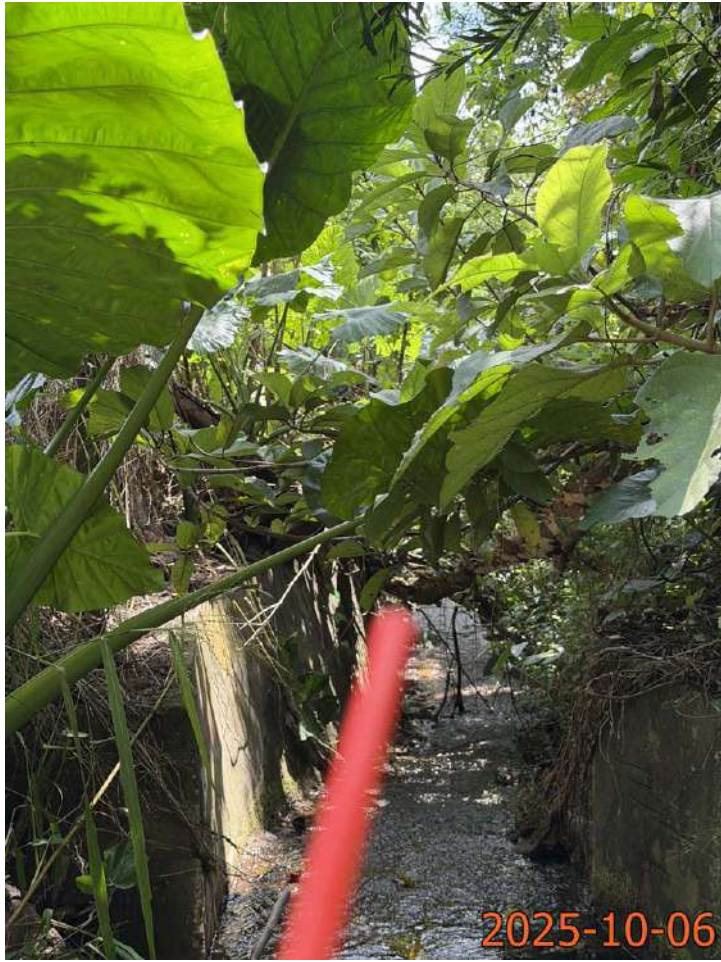
| Tree No. | Tree Species | | Tree Size Measurements | | | Amenity Value | Form | Health Condition | Structural Condition | Suitability for Transplanting | Remarks |
|---|---|---|---|---|---|---|---|---|---|---|---|
| T10 | <i>Leucaena leucocephala</i> | 銀合歡 | 2.0 | 150 | 8.0 | Low | Poor | Poor | Poor | Low | collapsed |

T10 (Overview) (Collapsed)
