Temporary Open Storage of Construction Materials for a Period of 3 Years at Lots 1700 (Part) & 1701 (Part) in D.D. 129, Lau Fau Shan, Yuen Long, N.T.

GEOTECHNICAL PLANNING REVIEW REPORT (GPRR)

**TEMPORARY OPEN STORAGE OF CONSTRUCTION
MATERIALS FOR A PERIOD OF 3 YEARS**

**LOT NO. 1700 (PART) & 1701 (PART) IN D.D. 129,
LAU FAU SHAN, YUEN LONG, N.T.**

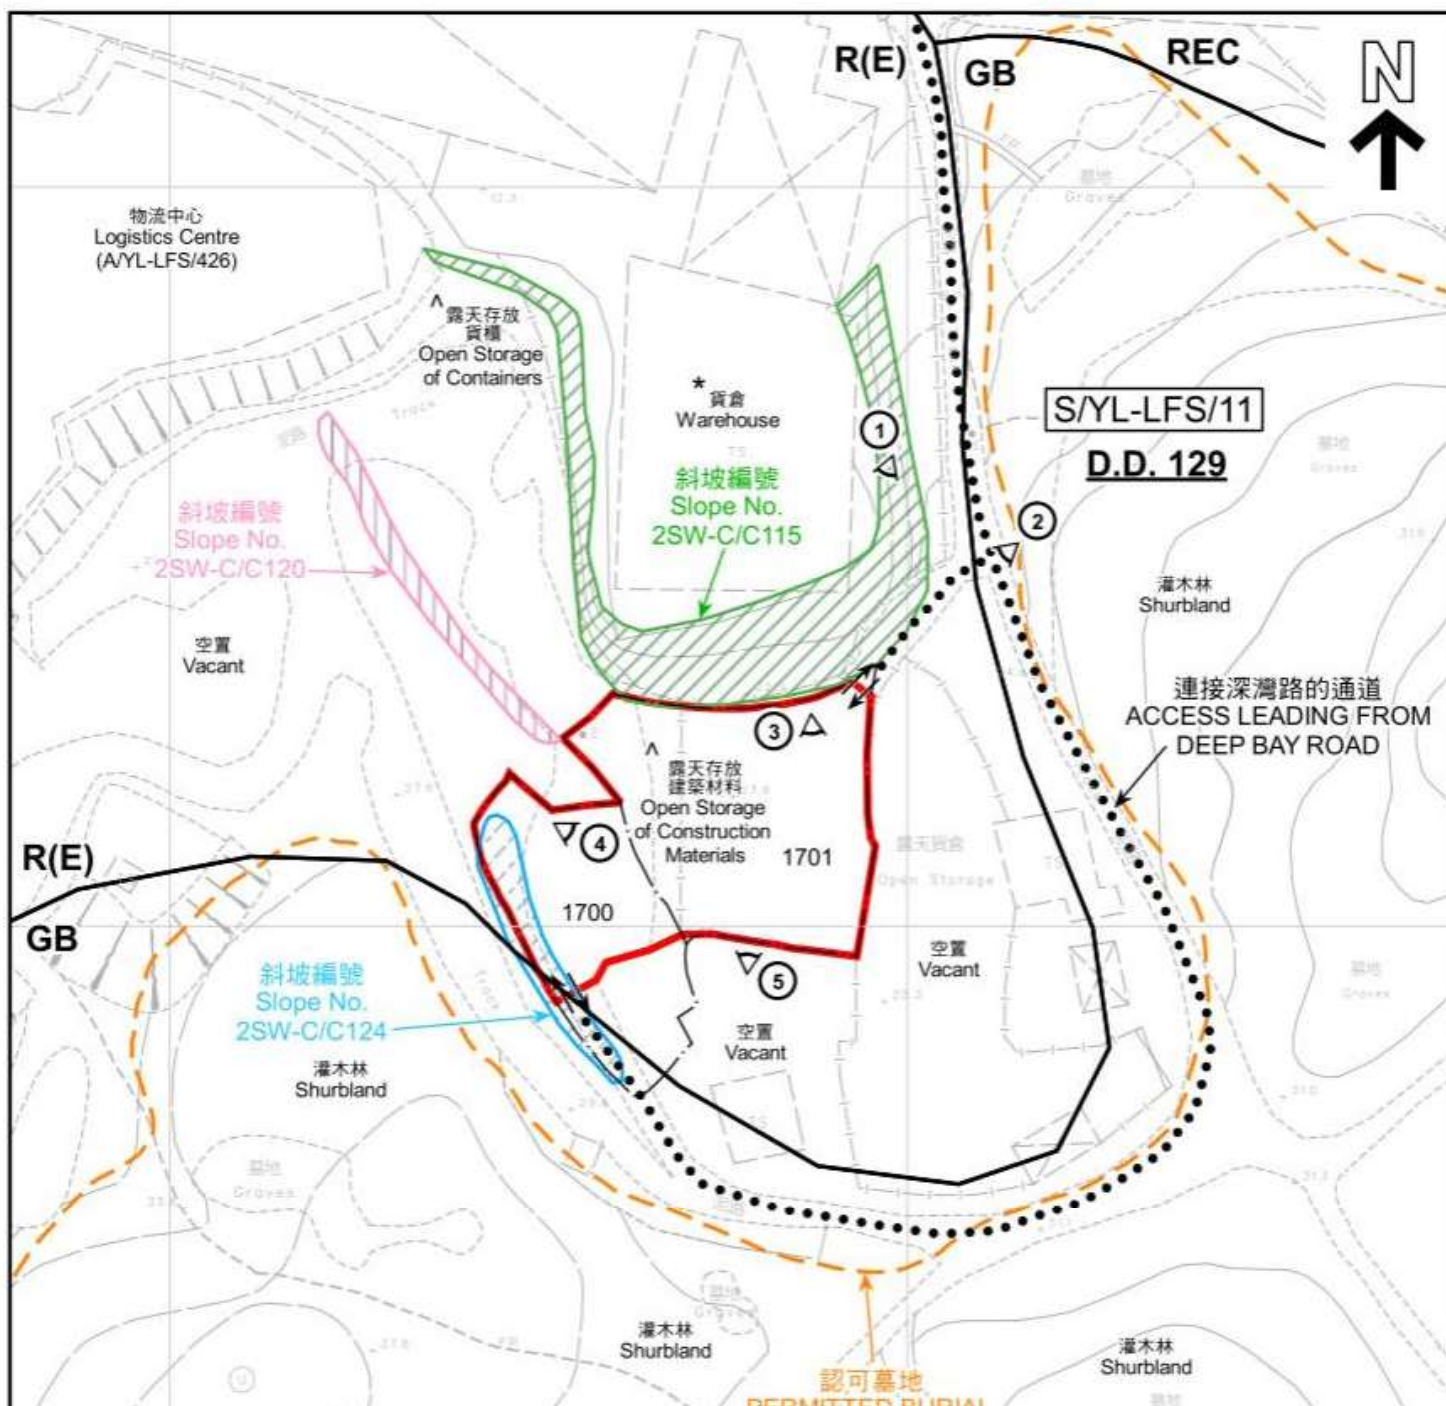
Figure 3

There are 3 registered features in the vicinity of the proposed development. The locations of the features are shown in Figure 3. Slope Information System (SIS) reports and Slope Maintenance Responsibility Information System (SIMAR) reports indicating the location of the features and their maintenance responsibility are attached in Appendix A and B. No record of slope instability can be found.

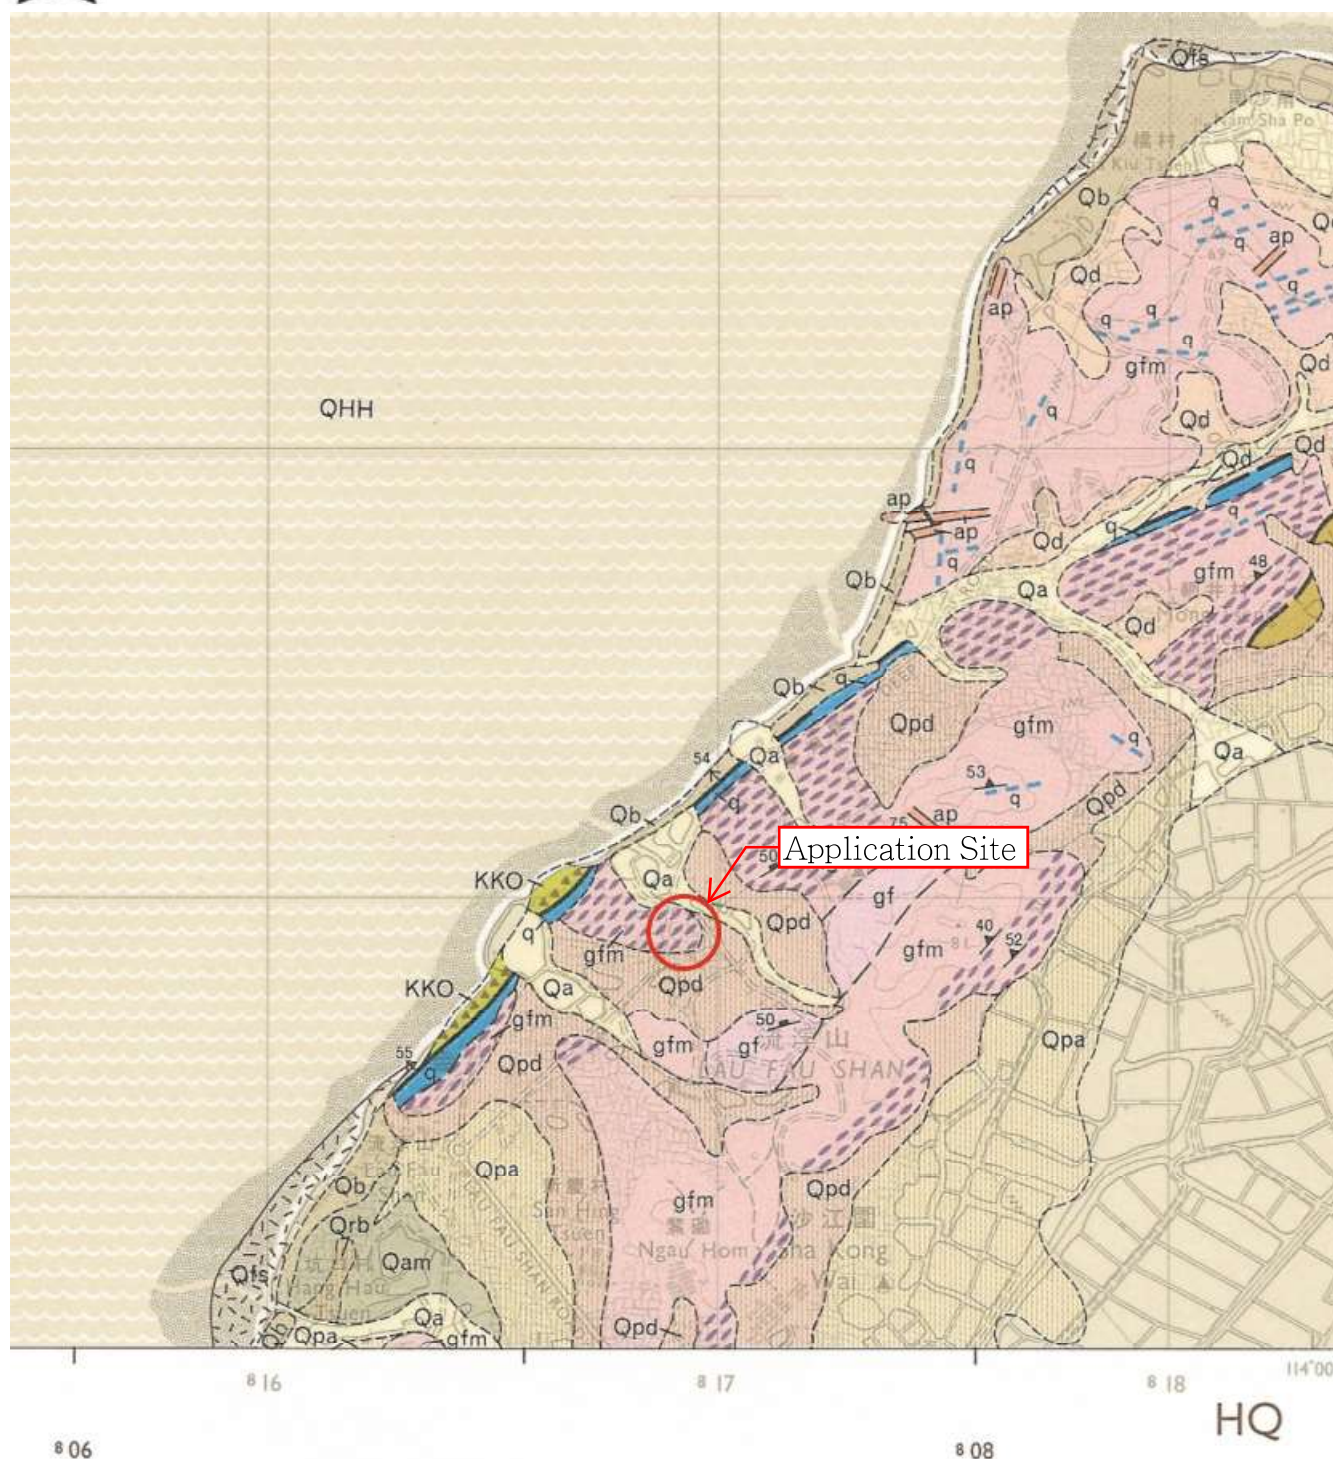
Figure 4

With reference to the 1:20,000 geological map published by the Geotechnical Control Office, Hong Kong Geological Survey Sheet No. 2, the site is located within the area of megacrystic fine-medium-grained granite (gfm), which is in line with the site observation. It is reasonably expected that the sursurface geology comprises a stratum of CDG. Extract from the geological survey sheet are shown on Figure 4.

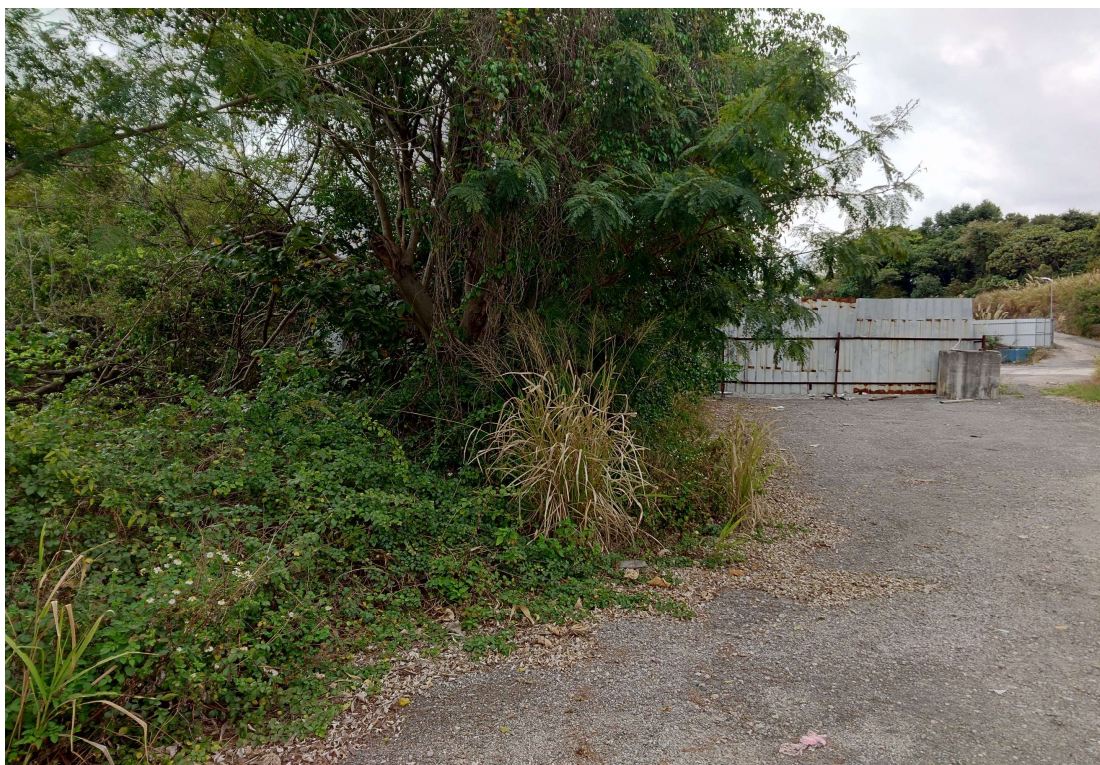
Feature No. 2SW-C/C115 (Outside boundary of application site)

This is a U-shape feature is located at the northern boundary of the site. It consists of a vegetated slope with a maximum 7.0m high and has a face angle of about 60°. This feature is about 160m long. The photo is shown in Plate A1.

This is a U-shape feature which located adjacent to the northern boundary of the site. This feature is about 99% area of the feature which outside the application site, only about 1% area which is the southern-west of the feature (part of crest of the feature) located inside the application site. Since the proposed development is a temporary open storage area for construction materials which

A1 - General view of the site (looking southern) Taken at: 4 March 2025

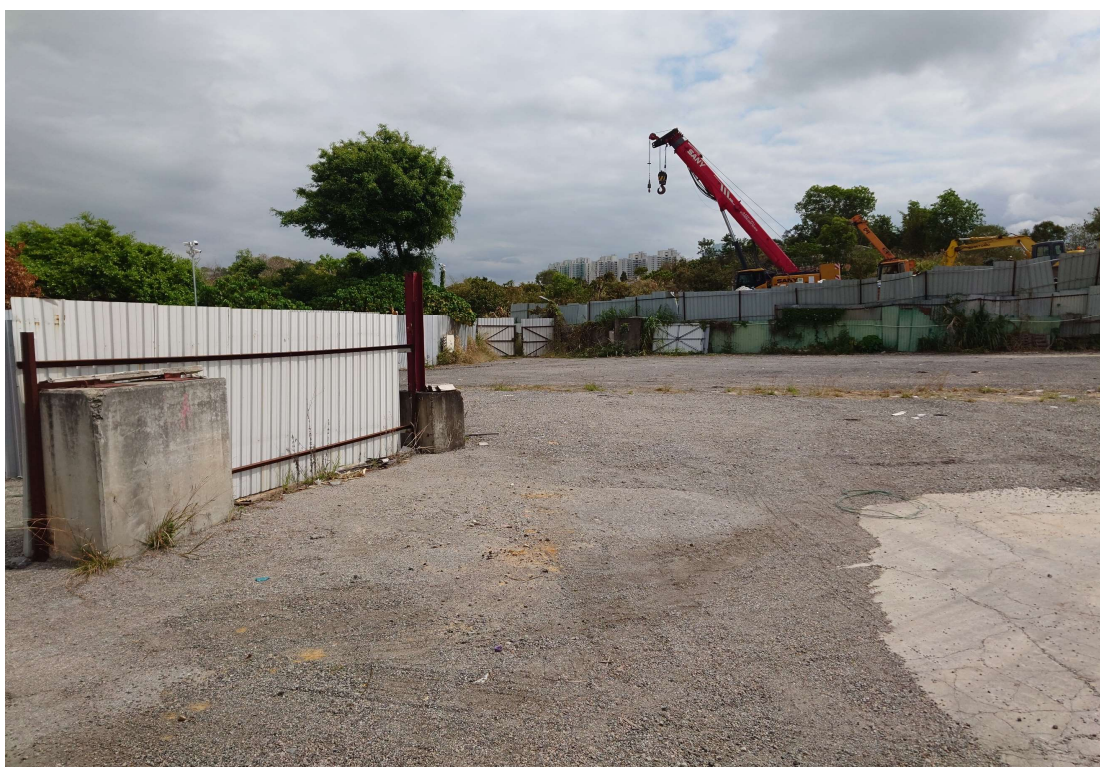
Feature No. 2SW-C/C115 (Within boundary of application site)

Part of 2SW-C/C115 (Sub-division Part 7) is located at the crest of the feature, it is a relatively small part of the feature and it is a vegetation area. The photo is shown in Plate A2.

A2 - General view of the site (looking northwestern) Taken at: 4 March 2025

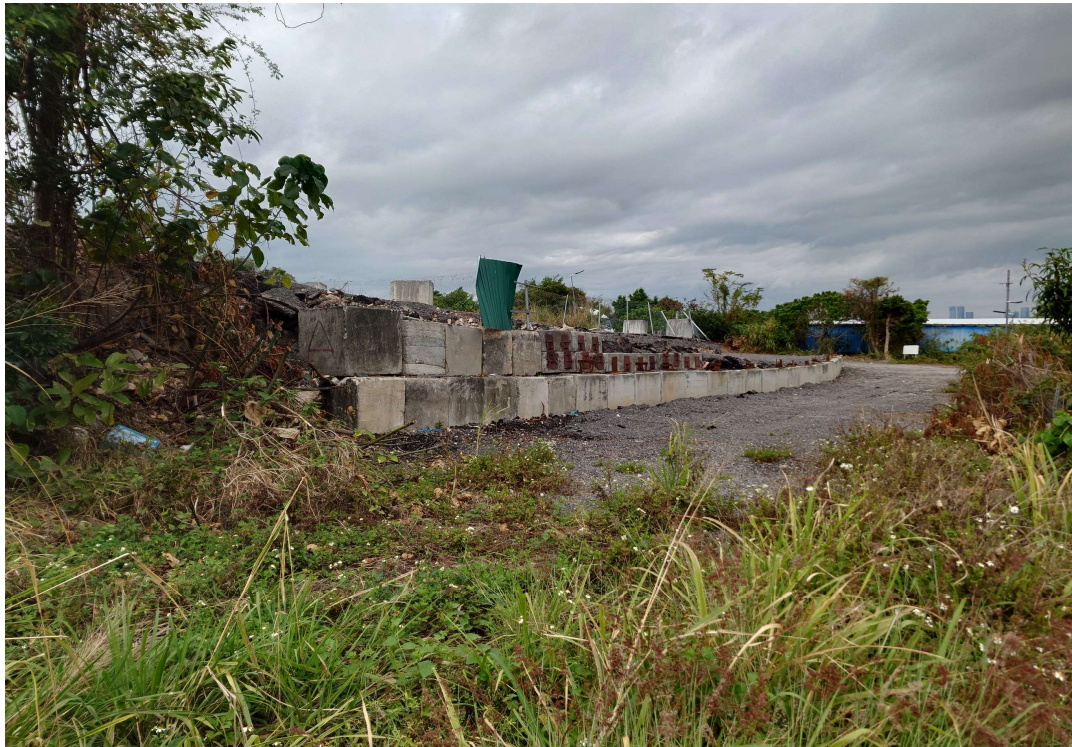
Feature No. 2SW-C/C120 (Outside boundary of application site)

The feature is located at the northern-west side boundary of the site. The feature is a slope with maximum 3.0m high and the slope angle is about 55°. The slope is dipping from west to east and the length of slope is about 55m.

During the site inspection carried out on 4 March 2025, 24 nos. of 1.0m x 1.0m x 1.0m concrete blocks have been placed along the northern part of slope toe, the photo is shown in Plate A3.

Feature No. 2SW-C/C120

The feature is located at the northern-west side and outside the boundary of the site, this feature is outside and perpendicular to the application site, the stability of feature would not be affected by proposed development and no sign of distress or instability was observed during the site visit, therefore, the proposed development is geotechnical feasible.

A3 - General view of the site (looking eastern)

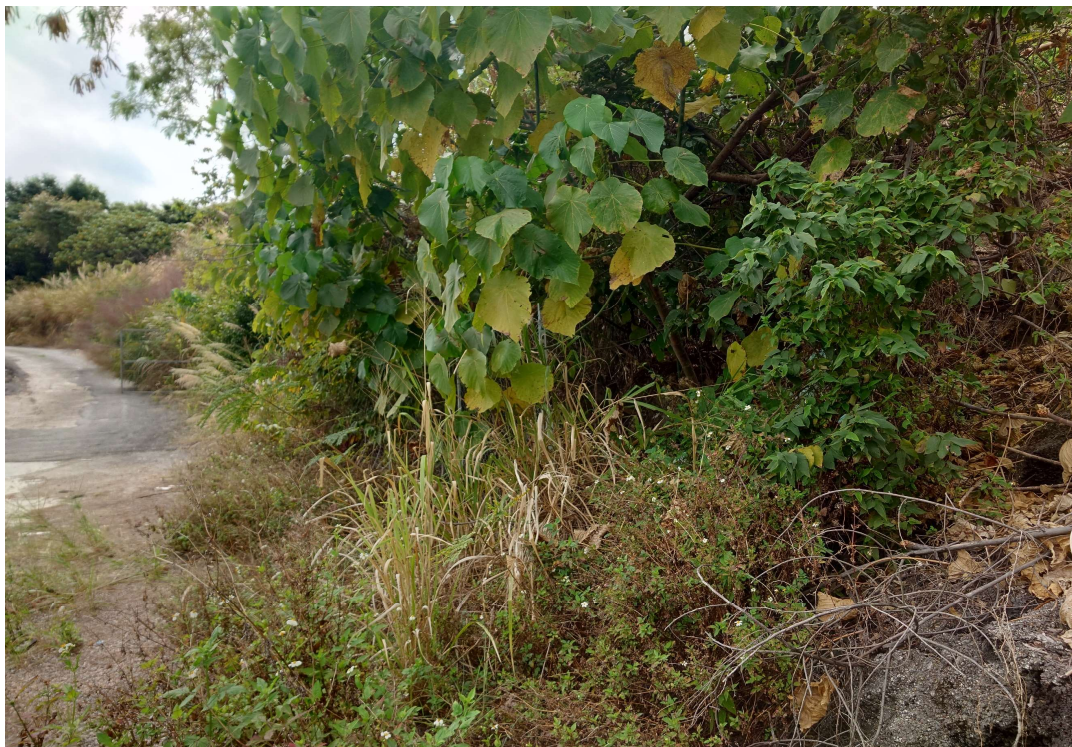
Feature No. 2SW-C/C124 (Within boundary of application site)

The feature is located at the southwestern side within the site. It is a soil and vegetated slope with a maximum 3.5m with the slope angle is about 68°. The feature is about 35m long and the slope is facing east. The photo is shown in Plate A4.

Feature No. 2SW-C/C124

The feature is located at the southwestern side within the site, the application site is located at the toe of this feature and no works will be carried out in the vicinity of this feature. In addition, no sign of distress or instability was found during the site reconnaissance, it concluded that the proposed development is geotechnical feasible.

A4 - General view of the site (looking southern)
