**Temporary Logistics Centre with Ancillary Office and Parking of Vehicles for a Period of 3 Years  
in "Residential (Group E)" Zone, Various Lots in D.D. 129 and Adjoining Government Land,  
Lau Fau Shan, Yuen Long, New Territories**

**(S.16 Planning Application No. A/YL-LFS/563)**

**Geotechnical Planning Review Report (GPRR)  
for  
Temporary Logistics Centre with  
Ancillary Office and Parking of Vehicles for  
a Period of 3 Years at  
Various Lots in D.D.129 & adjoining Government Land  
Lau Fau Shan, Yuen Long, N.T.  
(Application No. AYL-LFS/563)**

**Ref. No. : LFS002  
10 October 2025**

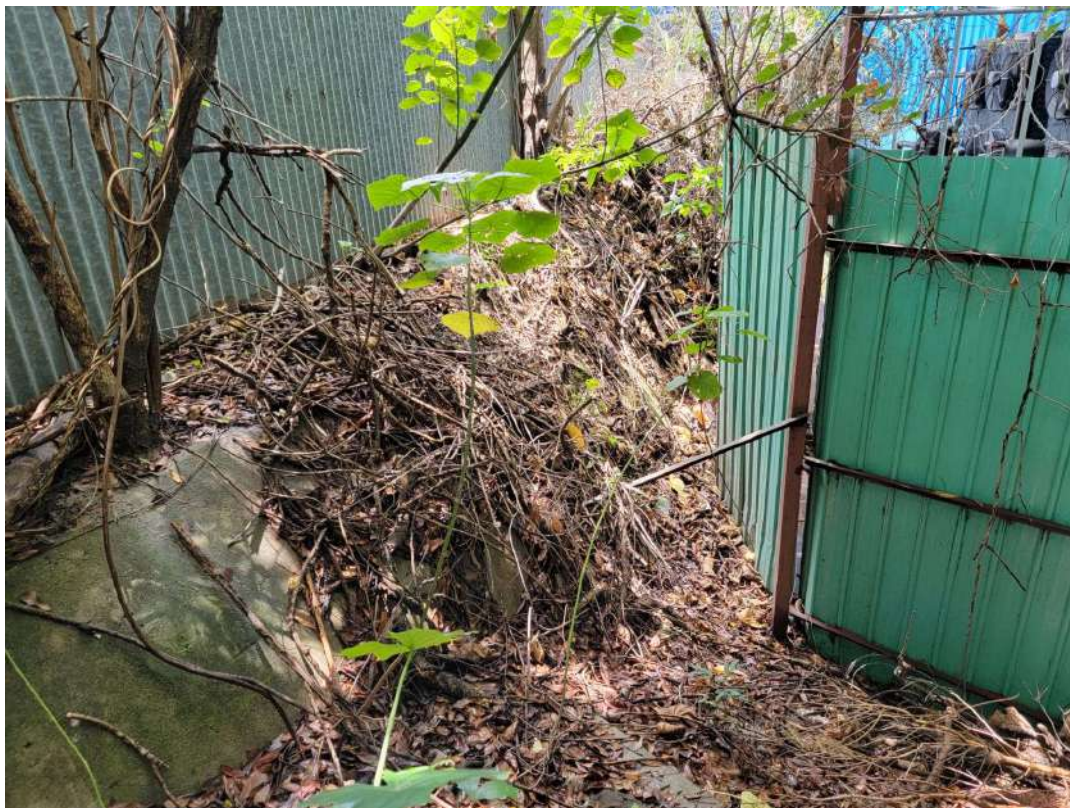
Plate 1: Site view of Unregistered Feature 1

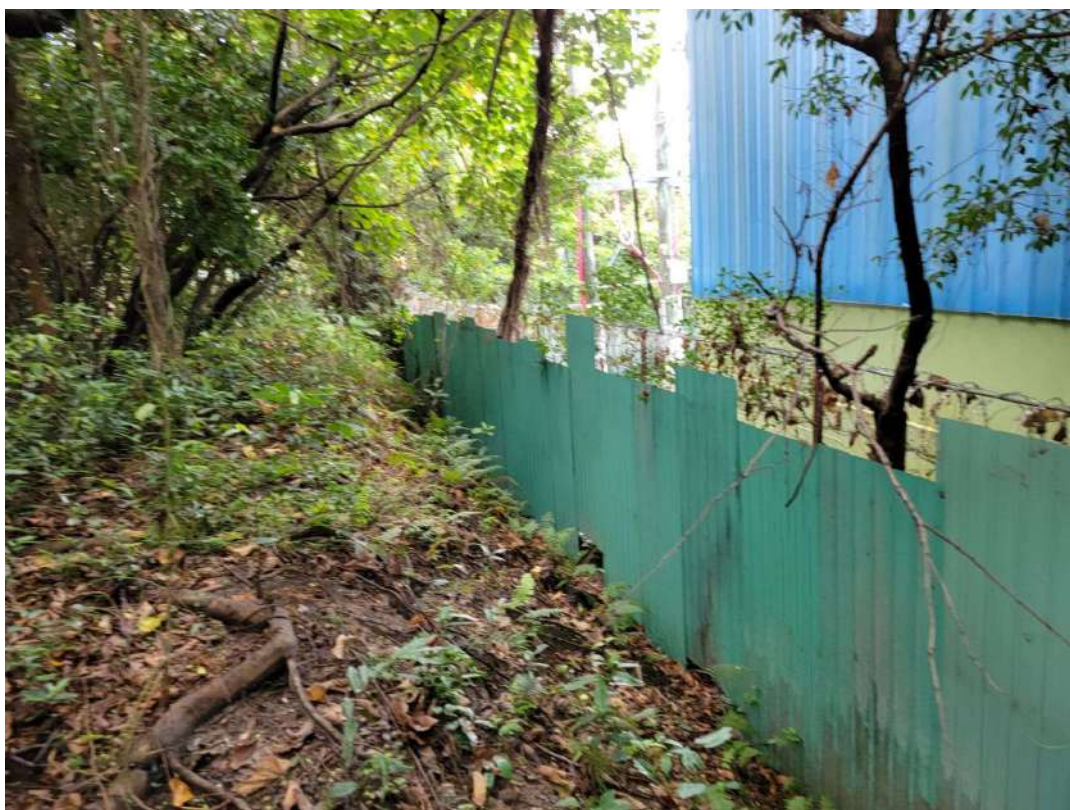
Plate 2: Site view of Unregistered Feature 1

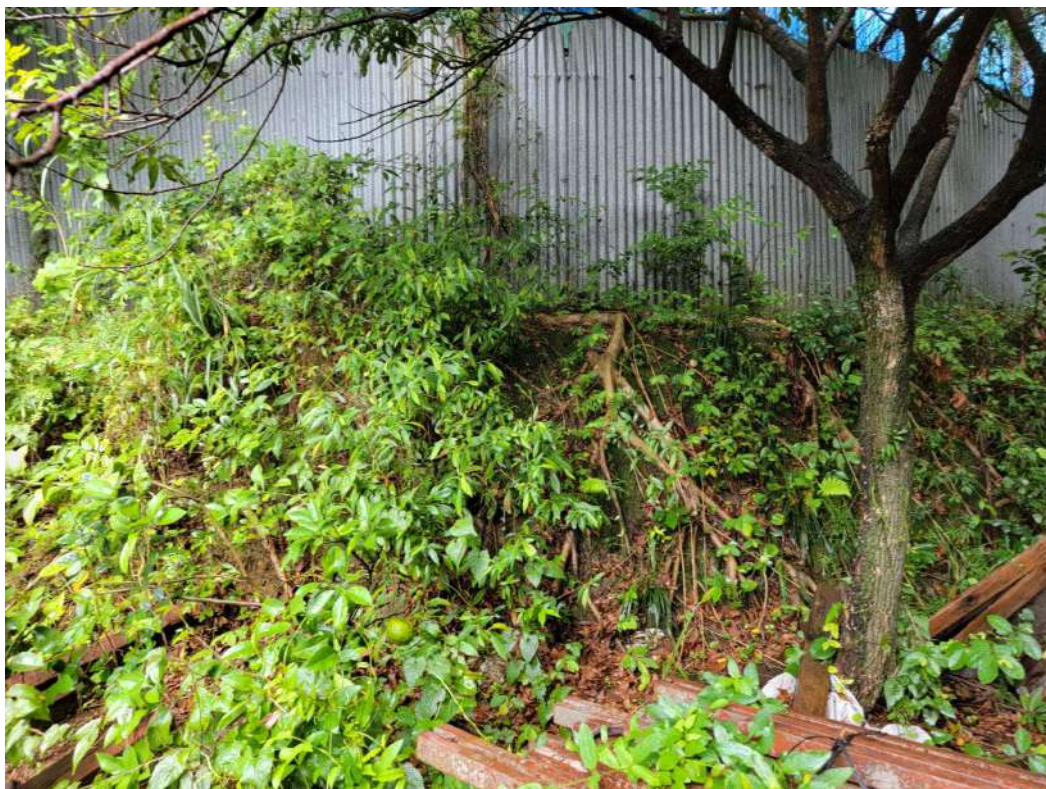
Plate 3: Site view of Unregistered Feature 2

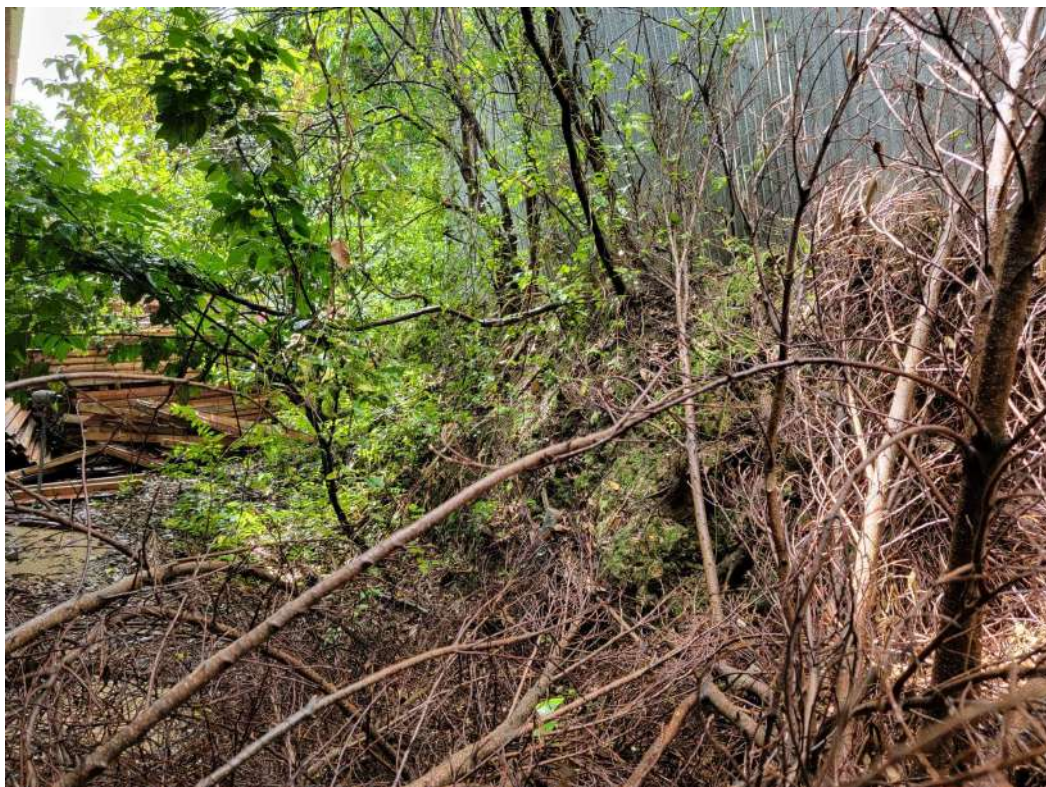
Plate 4: Site view of Unregistered Feature 2

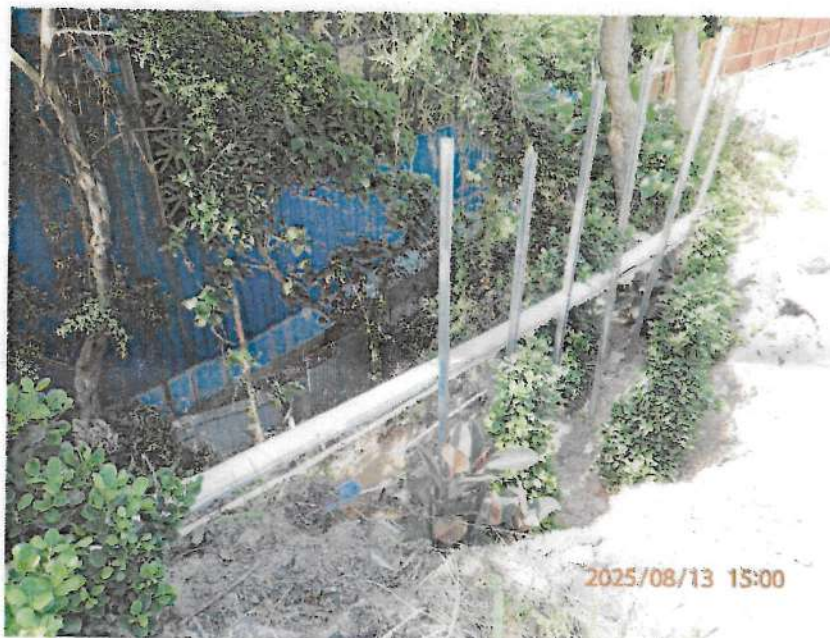
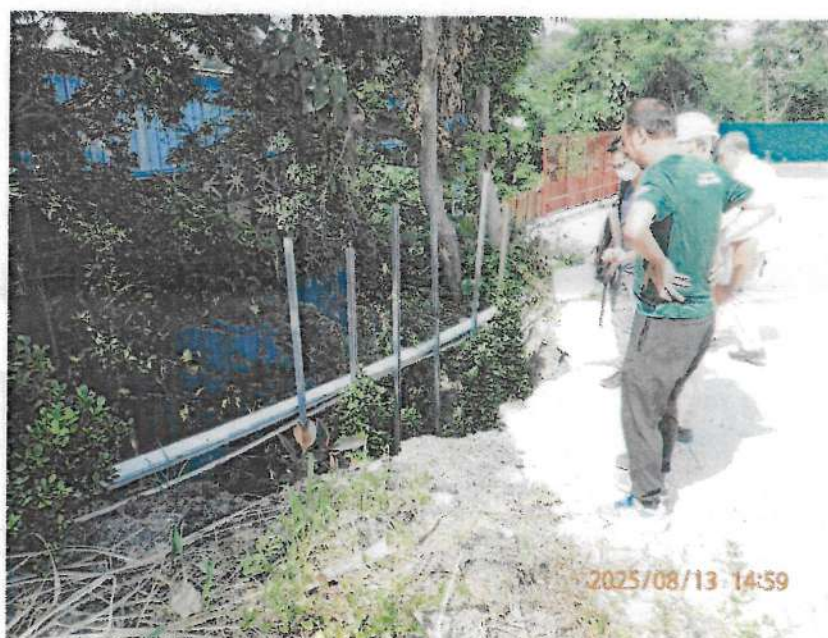
However, as mentioned in **Appendix E**, BD has issued an emergency slope repair works request on this feature (BD file ref: BD EB-SS-010-015-F02184-P001 dated 25 August 2025) regarding to the landslide scars at the northern extent of the feature. The emergency repair works as mentioned in this letter involves removal of landslide debris; removal of loose materials and minor trim back the failure surfaces; and provide hard surface cover with wire mesh and weepholes to the failure surface.

---

- (i) Remove the landslide debris;
- (ii) Remove loose materials on the failure scars and minor trim back the failure surfaces; and
- (iii) Provide hard surface cover with wire mesh and weepholes to the failure surfaces.

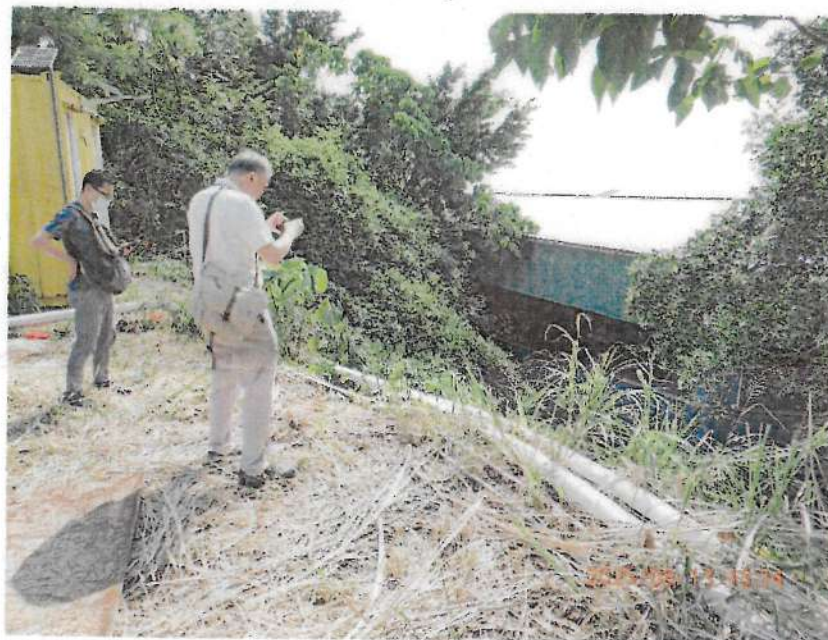
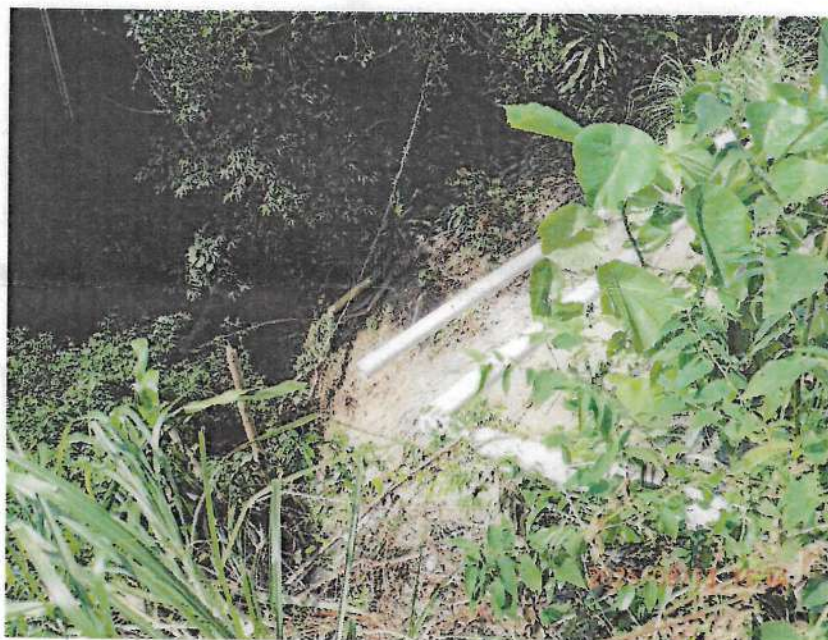
Figure 2.2 Aerial Photo showing the site and the features

2. As portion of Landslide Scar no.2 shown on the location plan rest on your private lot, you are requested to carry out the following emergency slope repair works within your lot immediately:-
