Appendix III
Geotechnical Planning Review Report

**Geotechnical Planning Review Report (GPRR)
for
Temporary Logistics Centre with
Ancillary Office and Parking of Vehicle for
a Period of 3 Years at
Various Lots in D.D.129 & adjoining Government Land
Lau Fau Shan, Yuen Long, N.T.
(Application No. A/YL-LFS/426)**

**Ref. No. : LFS002a
17 June 2022**

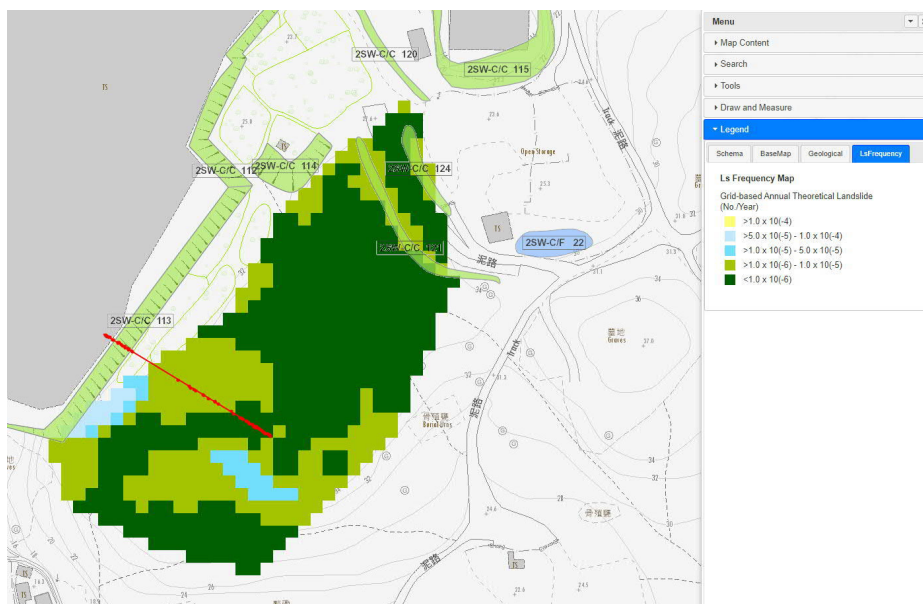
The feature has a face angle of 25° without any visible boulders on its surface. Based on the extract of landslide frequency map obtained from the GInfo System from the GIU library of GEO, its annual theoretical landslide is only between 5.0×10^{-5} to 1.0×10^{-4} , which is less likely than a 1 in 1000-year event. Consider the period of land use extension would be 3 years only, the risk of landslide would be minimal.

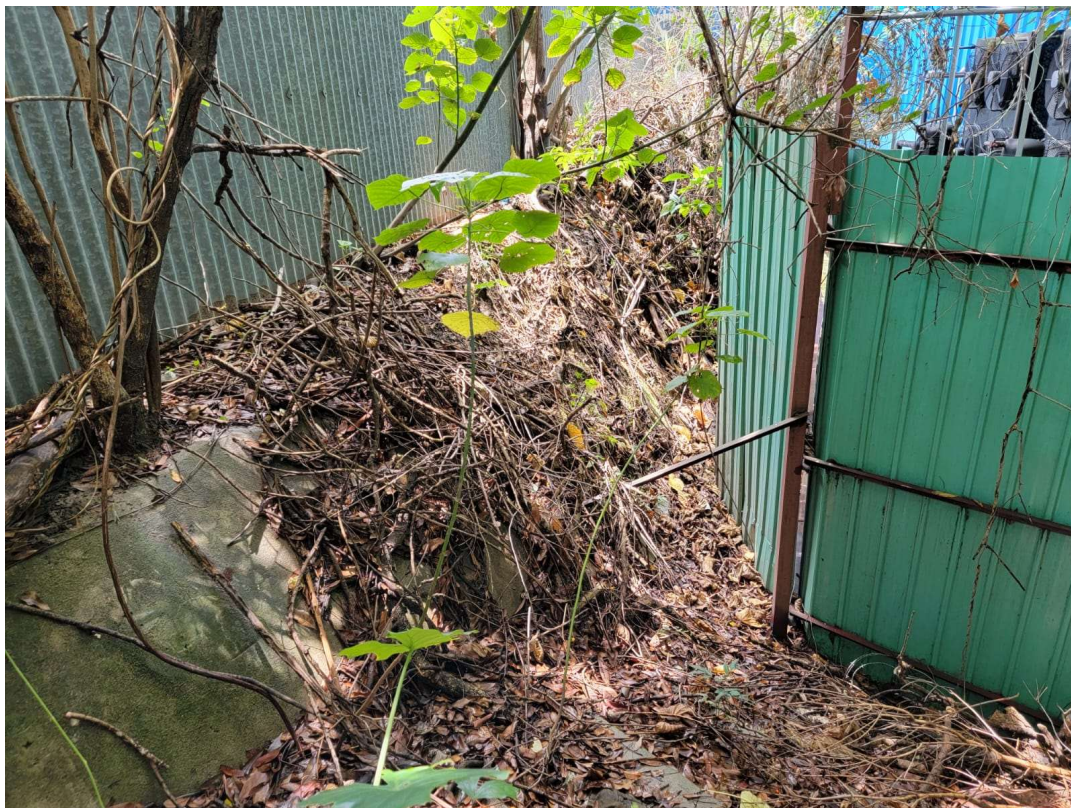
Plate 1: Site view of Unregistered Feature 1

This feature is located at about 4m from the north-western boundary of the site. It consists of a soil slope with a maximum retaining height of less than 3m. It is generally 100m long and has a maximum face angle of about 40° dipping towards the site.

The two features would not be modified by the extended period of tenancy. The site is located at the toe of the 2 features and therefore the proposed extended period would not have adverse effect on the stability of geotechnical feature. The slopes are located at about 2.5m from the boundary of the site and their retaining height are less than 3m. Due to their distance and the retaining height, no further studies or remedial actions would be required.

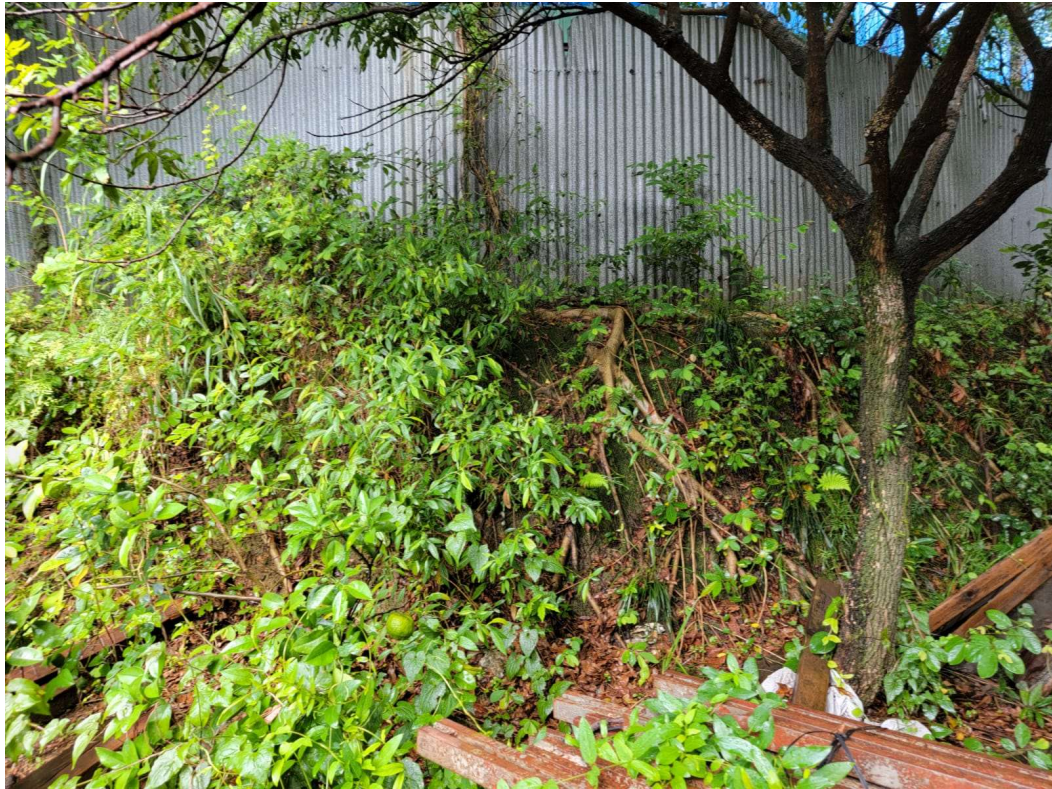
Plate 3: Site view of Unregistered Feature 2

This feature is located at about 2.5m from the north-eastern boundary of the site. It consists of a soil slope with a maximum retaining height of less than 3m. It is generally 30m long and has a face angle of about 40° dipping towards the site.
