**GEOTECHNICAL PLANNING REVIEW REPORT (GPRR)**

**TEMPORARY OPEN STORAGE OF CONSTRUCTION  
MATERIALS FOR A PERIOD OF 3 YEARS**

**LOT NO. 1703 (PART) & 1704 (PART) IN D.D. 129,  
LAU FAU SHAN, YUEN LONG, N.T.**

**Dec 2025**

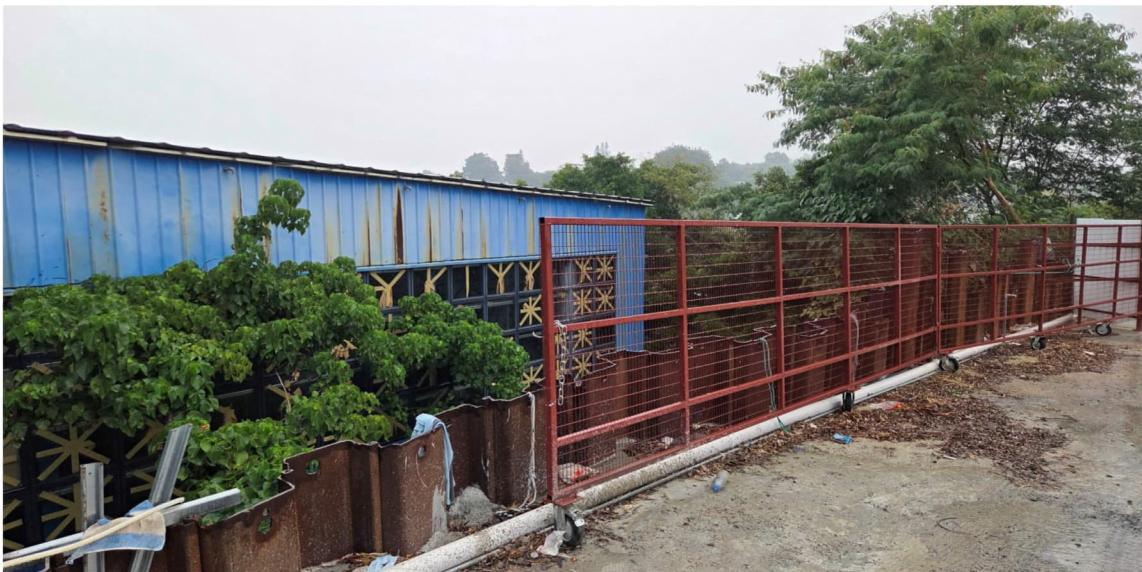
The feature is located at the north-west boundary of the site. It is a vegetated slope with a maximum height of 9 m, and the average slope angle is 54°. The feature length is 155 m. A 15 m long sheet pile wall on plan was found at the crest of Feature 2SW-C/C112 adjacent to the Application Site. Photos V2 and V10 show the location of the sheet pile.

Photo V2 - General view of the site (the north side)

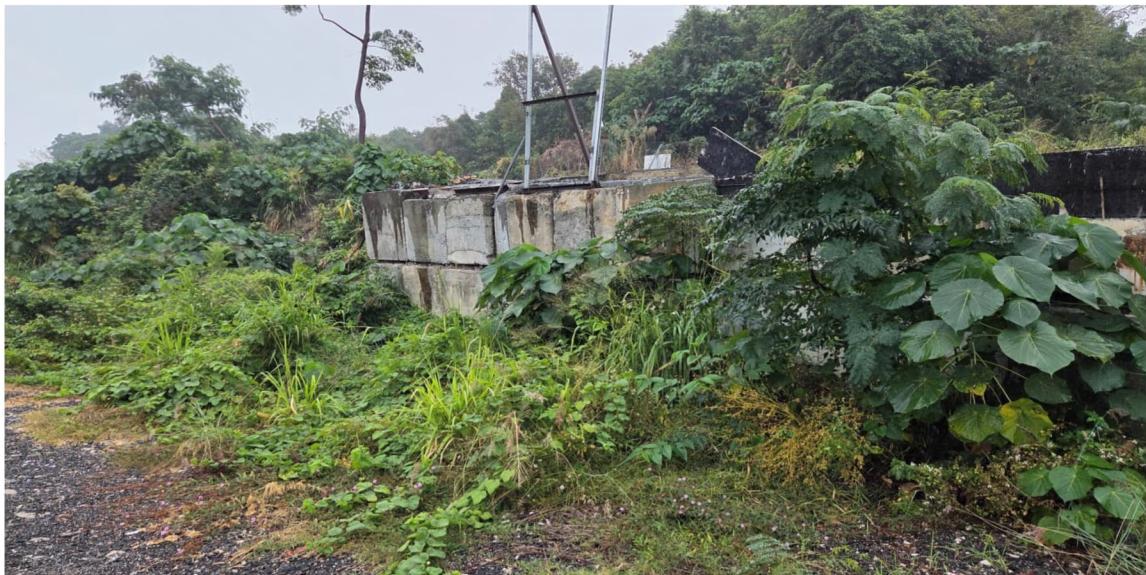
The feature is located at the southern-west side boundary of the site. The feature is a slope with a maximum 3 m high and the slope angle is about 55°. The slope is dipping from west to east, and the length of the slope is about 55 m. During the site inspection carried out on 10 December 2025, 24 nos. of 1.0m x 1.0m x 1.0m concrete blocks have been placed along the northern part of the slope toe; the photo is shown in Photo V3.

The feature could not be found at the location marked on the plan. However, a retaining wall can be found at around 6m west of the supposed location of the feature. This retaining wall is composed of a maximum of 2 mass concrete blocks and is around 2.5m high. The estimated toe influence zone of said structure is estimated at around 1m and will not cause a stability threat to the application site.

Photo V3 - General view of Feature 2SW-C/C120

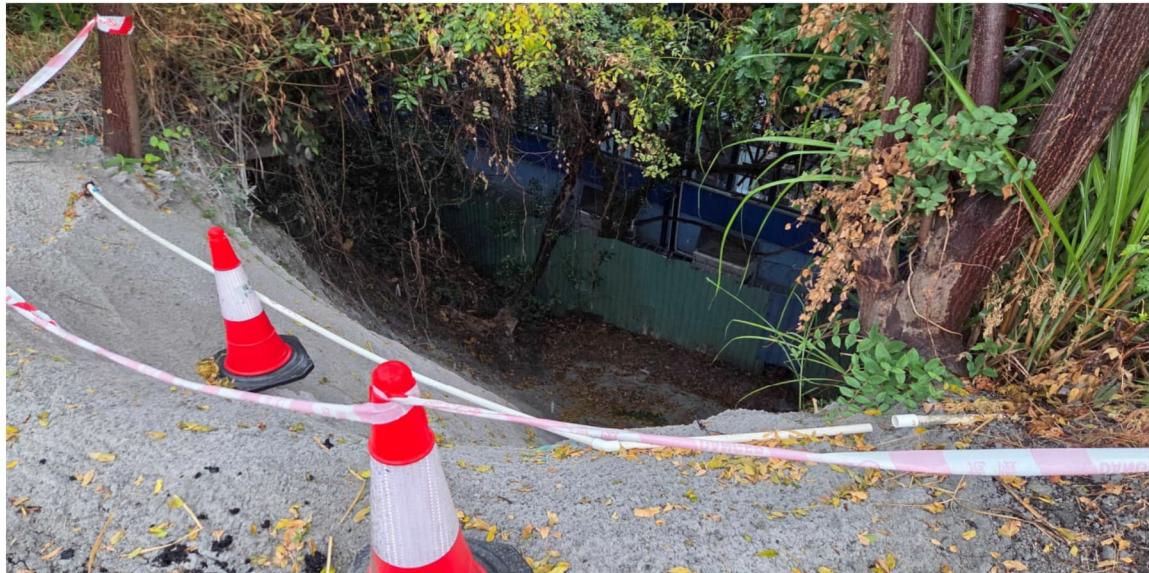
Feature 2SW-C/C112 was studied under S2R069/2018 in 2018. The study recommended the installation of drainage only; no action was required for the portion closest to our site. Landslide incident was recorded in Ginfo on 13 August 2025 at sub-division 4 & 6 of the feature. The location of the landslide scars is marked in the existing plan in Figure 2.

The feature is located at the northwestern side outside the site, the application site is located at the crest of this feature, and no works will be carried out within the crest influence zone of the feature. Although a landslip occurred on 13 August 2025, the location of the landslip is at a sufficient distance from the site location. No other signs of distress or instability were found at the portion adjacent to the site during site reconnaissance; it was concluded that the proposed development is geotechnical feasible provided that the boundary of the application site adjacent to the feature is set back 4m to avoid the crest influence zone.

Photo V5 - Landslide scar

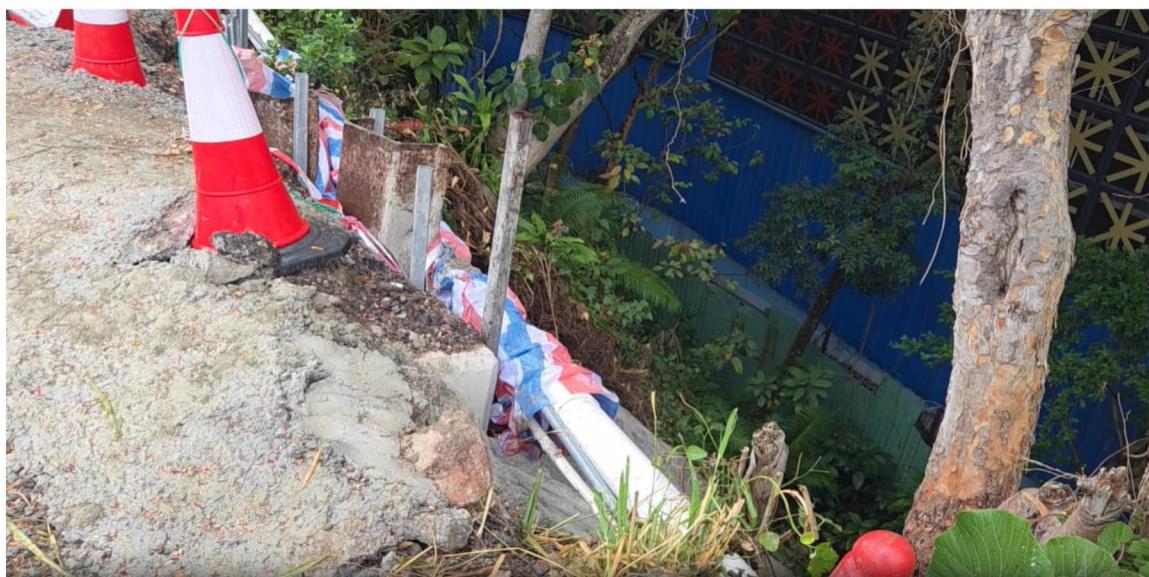
Photo V6 - Landslide scar

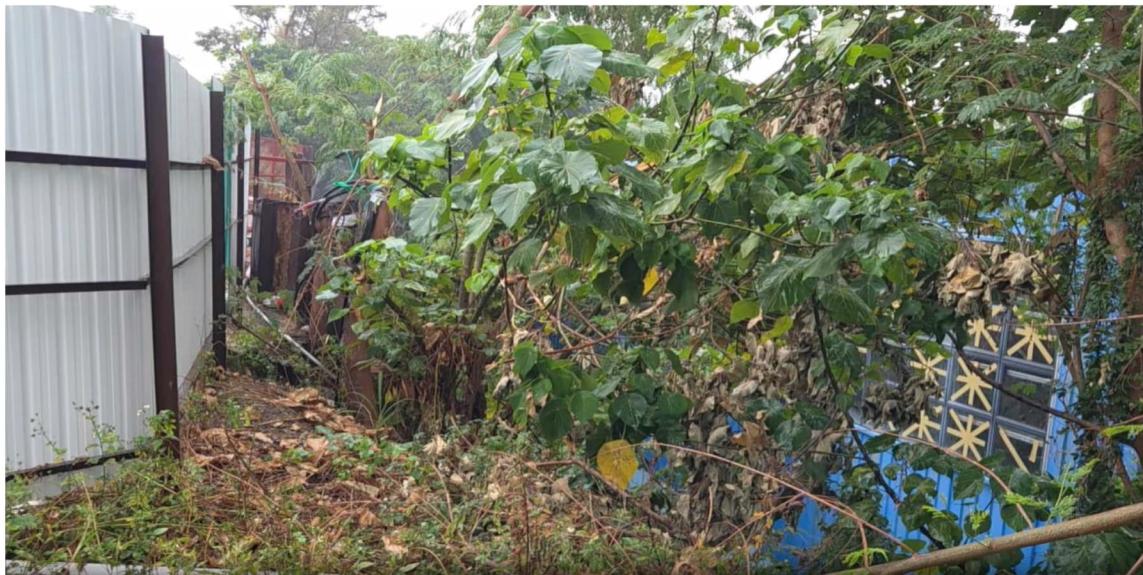
Photo V10 - General view of the site (the north side)

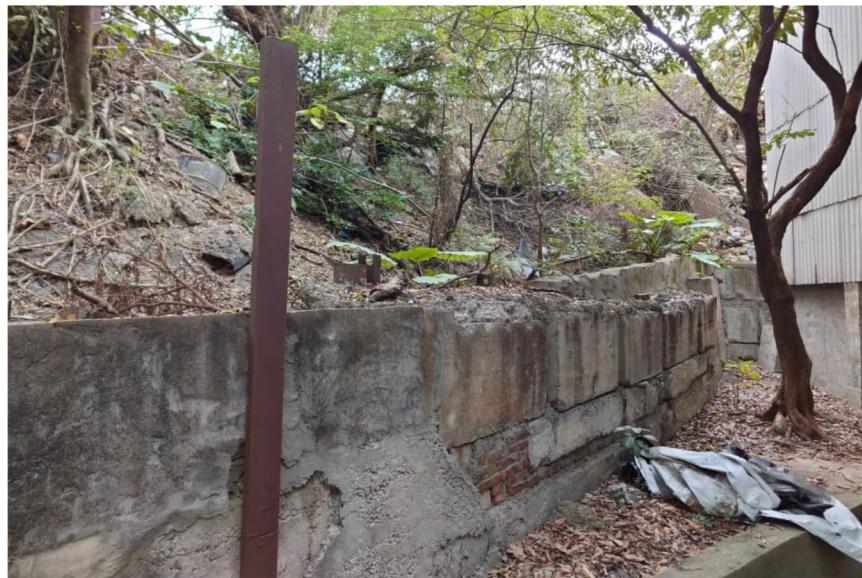
This is a U-shaped feature located at the eastern boundary of the site. It consists of a vegetated slope with a maximum height of 7 m and has a face angle of about 60°. This feature is about 160m long.

The cut slope height of the feature is 7.0m. According to Paragraph 5.3.1 in TGN 15, the estimated crest influence zone is not larger than 0.4 times the slope height. It is therefore, the crest influence zone is about 3.0m away from the existing slope crest.

Photo V11 - General view of the Feature 2SW-C/C115

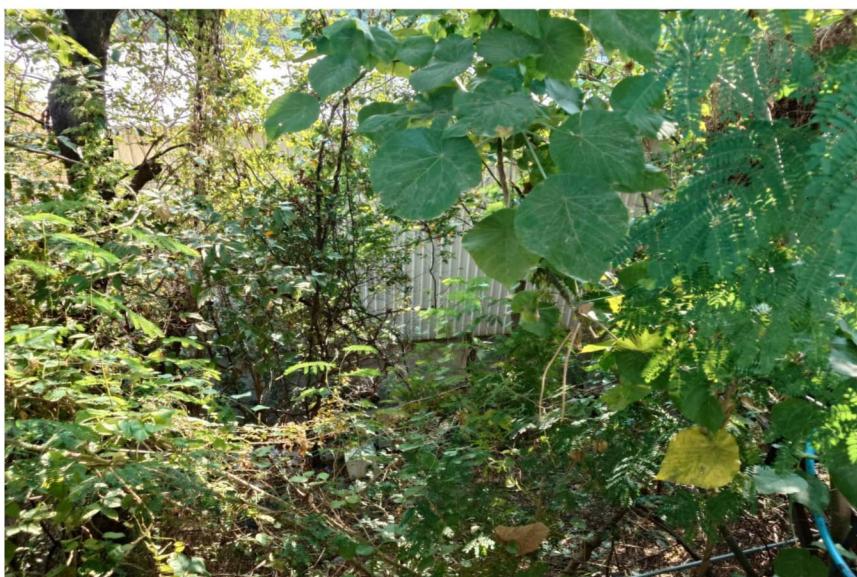
Photo V12 - General view of the Feature 2SW-C/C115

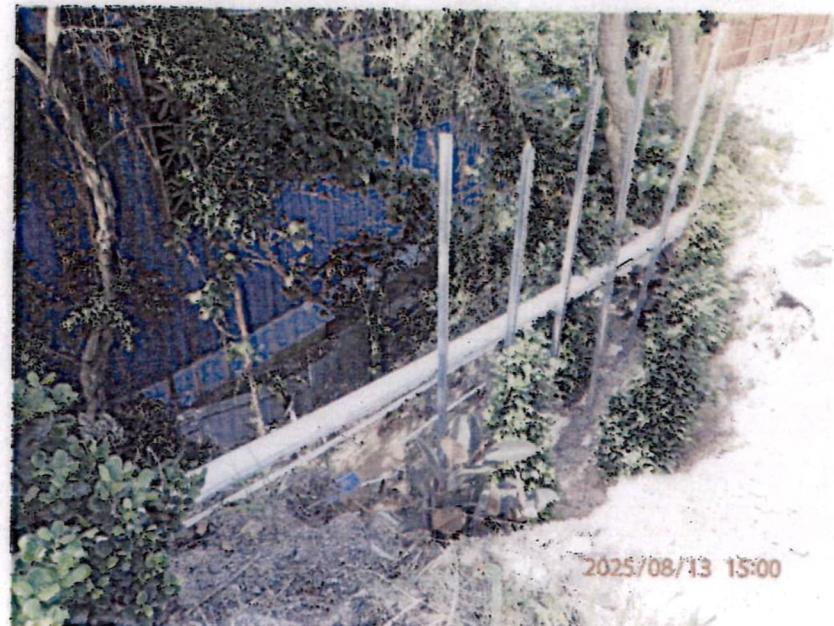
Photo 1 (Landslide Scar 1)

- (i) Remove the landslide debris;
- (ii) Remove loose materials on the failure scars and minor trim back the failure surfaces; and
- (iii) Provide hard surface cover with wire mesh and weepholes to the failure surfaces.

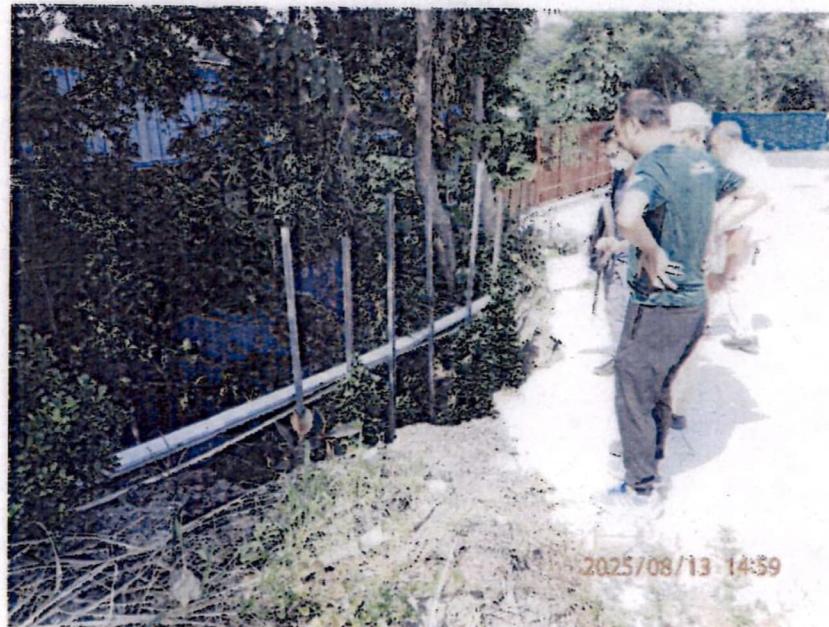
Photo 2 (Landslide Scar 1)

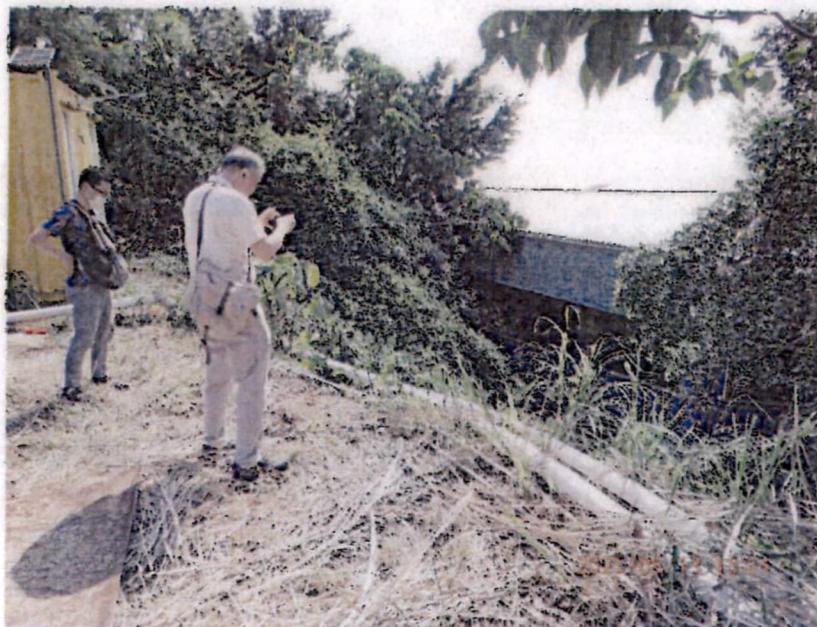
Photo 3 (Landslide Scar 2)

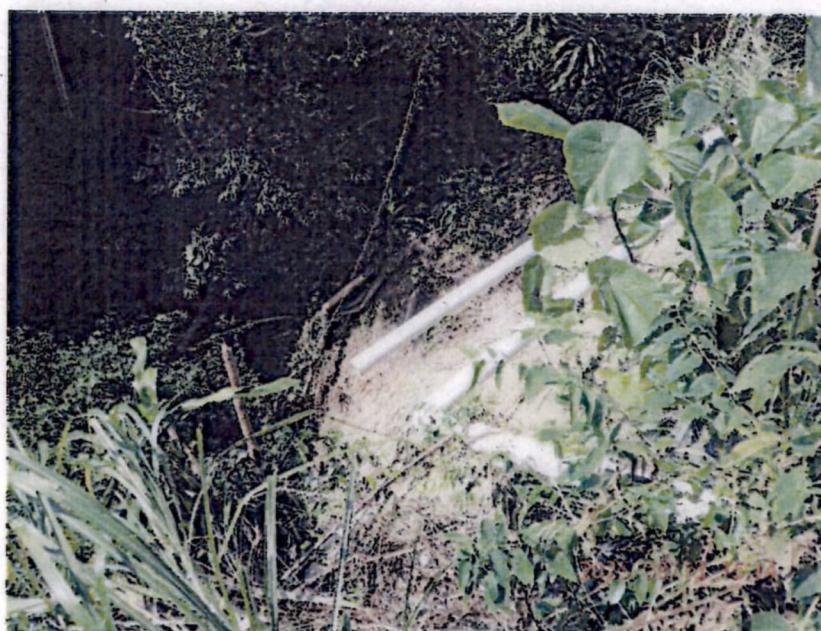
Photo 4 (Landslide Scar 2)

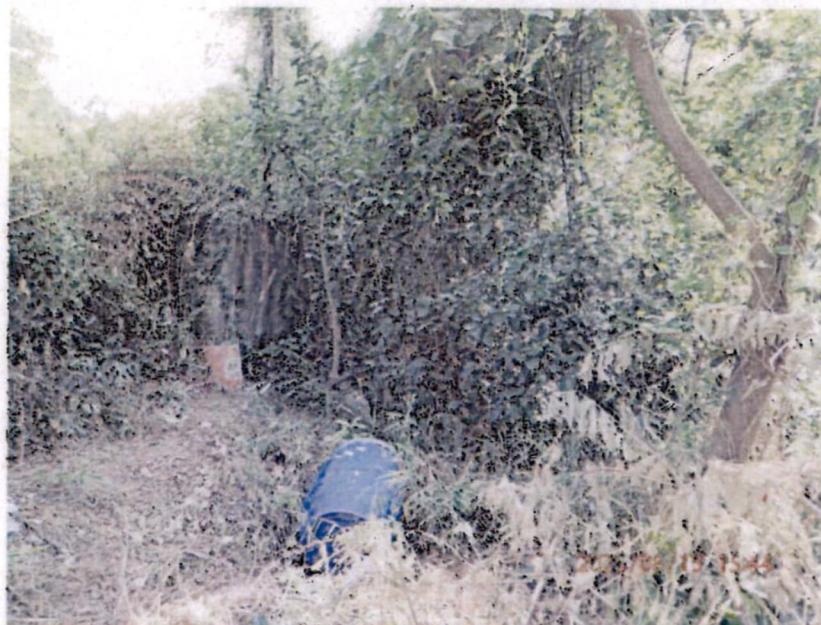
2. As Landslide Scar no.3 shown on the location plan rest on your private lot, you are requested to carry out the following emergency slope repair works within your lot immediately:-

Photo 5 (Landslide Scar 3)

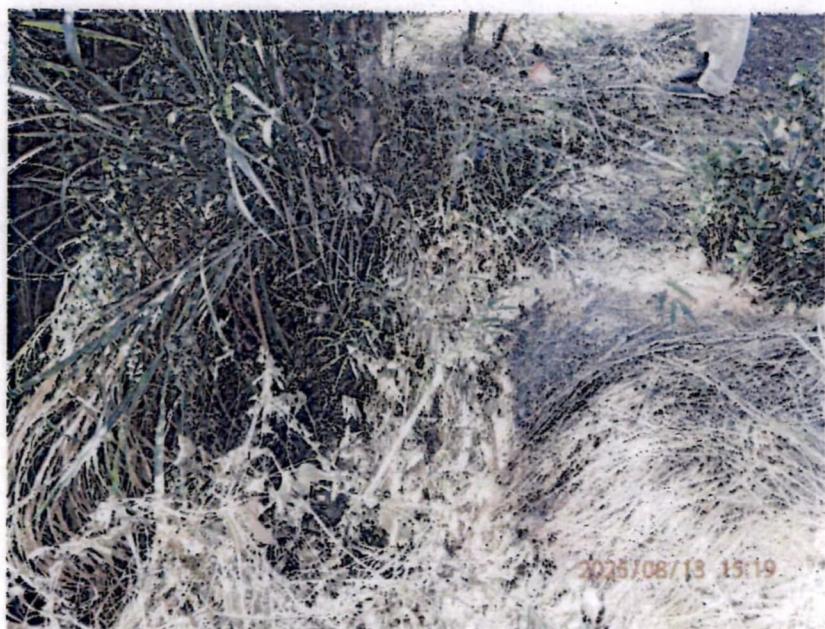
Photo 6 (Landslide Scar 3)
