GEOTECHNICAL PLANNING REVIEW REPORT (GPRR)

**TEMPORARY OPEN STORAGE OF CONSTRUCTION
MATERIALS FOR A PERIOD OF 3 YEARS**

**LOT NO. 1703 (PART) & 1704 (PART) IN D.D. 129,
LAU FAU SHAN, YUEN LONG, N.T.**

Feb 2026

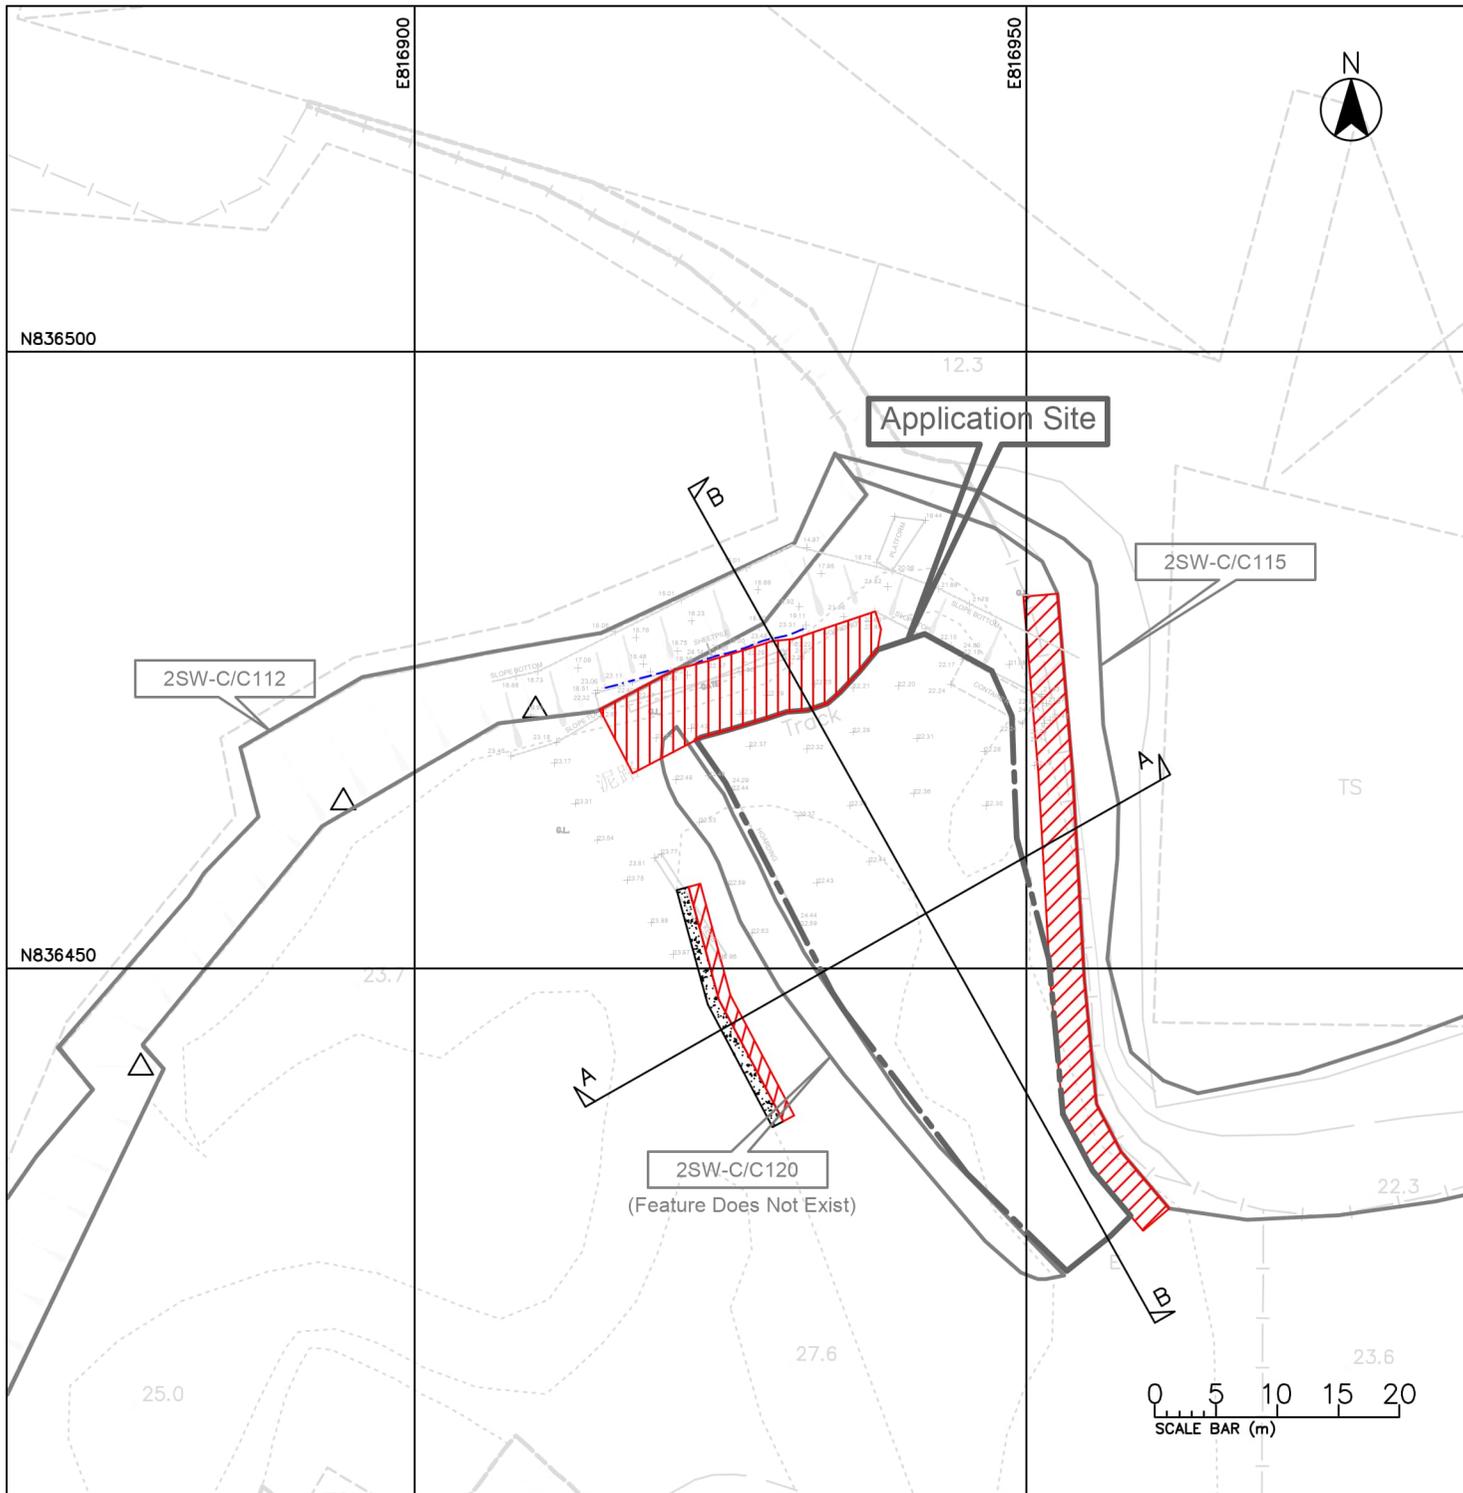
Drawing No.:
 Figure 4

There are 3 registered features in the vicinity of the proposed development. The locations of the features are shown in Figure 4. Slope Information System (SIS) reports, and Slope Maintenance Responsibility Information System (SIMAR) reports indicating the location of the features and their maintenance responsibility are attached in Appendix A and B. A landslide occurred at around 13m near the site area.

Feature 2SW-C/C112 was studied under S2R069/2018 in 2018. The study recommended the installation of drainage only; no action was required for the portion closest to our site. A landslide incident was recorded in Ginfo on 13 August 2025 at sub-division 4 & 6 of the feature. The location of the landslide scars is marked in the existing plan in Figure 4 and the incident records are shown in Appendix C.

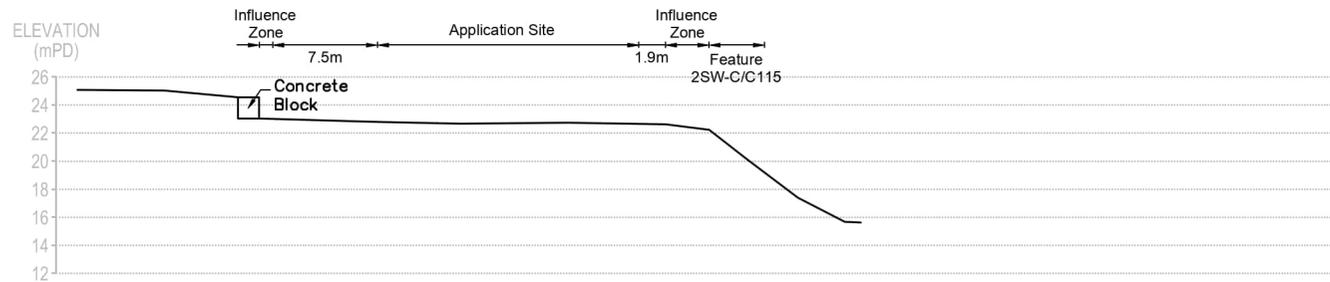
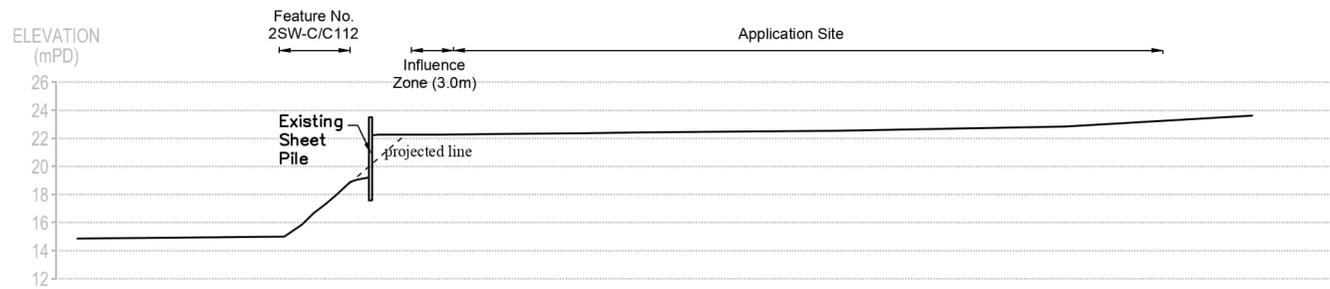
2. It is noted from Section B-B in Figure 5 of the GPRR that the sheet pile wall is supporting a newly formed platform located within the application site (see attached Plan B). The type of filling materials and extent of the newly formed platform should be investigated. The stability of the slope, sheet pile wall and the newly formed platform should be assessed and proposed rectification works should be provided, if found necessary.	As shown in Figure 3, only a short length of the sheetpile (i.e. 0.866m compared to the overall length of 16.8m) has entered into the Application Site. The boundary of the Application Site has then shifted back for a distance of 6.8m from the sheetpiles, which is beyond any newly platform formed and the crest zone recommended in GEO Technical Guidance Note No. 15 (TGN 15). In addition, drainage has been provided to avoid causing surface erosion to the slope.

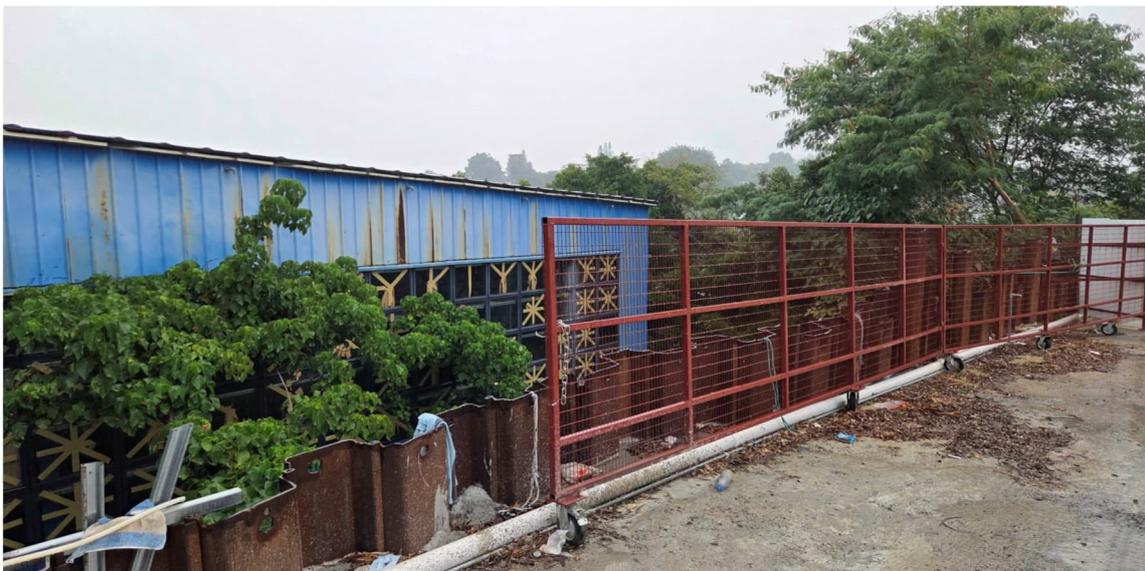
Photo V2 - General view of the site (the north side)

The feature is located at the north-west boundary of the site. It is a vegetated slope with a maximum height of 7.5 m in the vicinity of the application Site, and the average slope angle is 41°. The feature length is 155 m. A 16.8 m long sheet pile wall on plan was found at the crest of Feature 2SW-C/C112 adjacent to the Application Site with a retaining height of about 2.2m. Photos V2 and V10 show the location of the sheet pile.

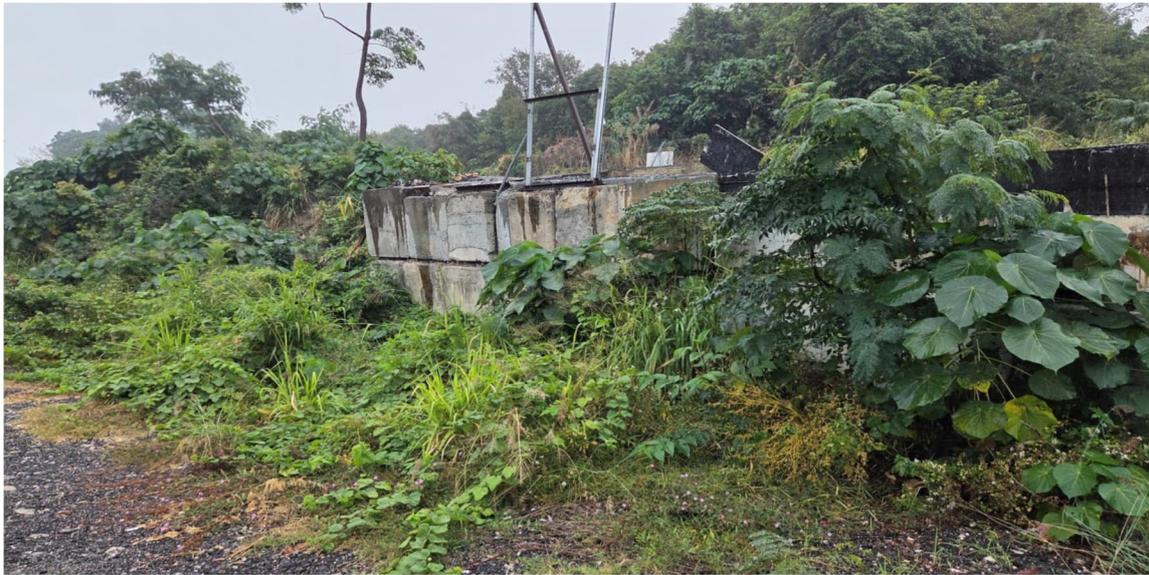
Photo V3 - General view of Feature 2SW-C/C120

The feature is located at the southern-west side boundary of the site. The feature is a slope with a maximum 3 m high and the slope angle is about 55°. The slope is dipping from west to east, and the length of the slope is about 55 m. During the site inspection carried out on 10 December 2025, 24 nos. of 1.0m x 1.0m x 1.0m concrete blocks have been placed along the northern part of the slope toe; the photo is shown in Photo V3.

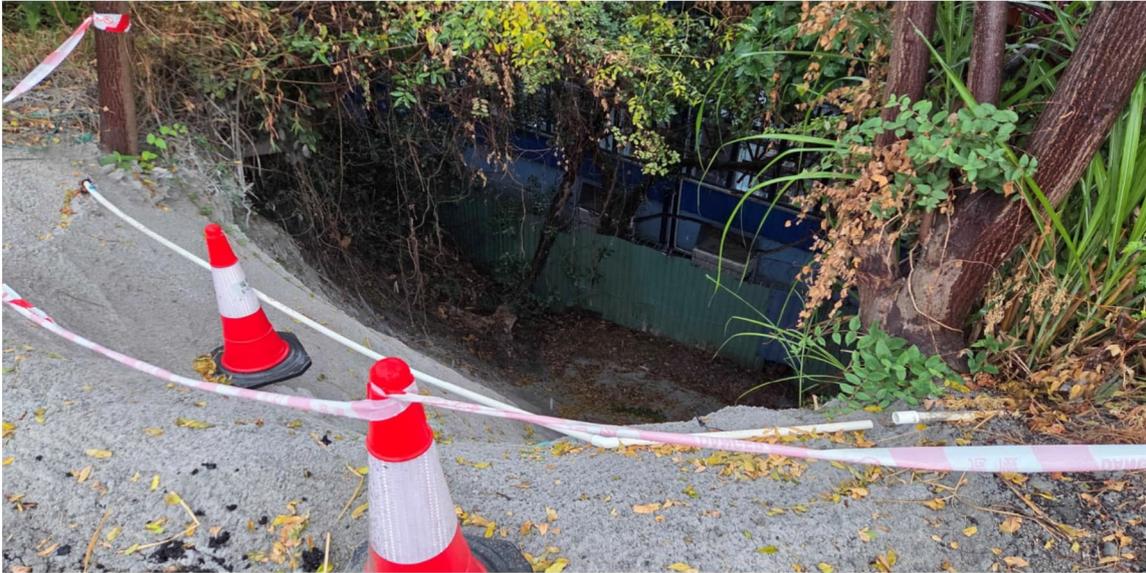
Photo V5 - Landslide scar

The feature is located at the northwestern side outside the site, the application site is located at the crest of this feature, and no works will be carried out within the crest influence zone of the feature. Although a landslip occurred on 13 August 2025, the location of the landslip is at a sufficient distance from the site location. No other signs of distress or instability were found at the portion adjacent to the site during site reconnaissance; it was concluded that the proposed development is geotechnical feasible provided that the boundary of the application site adjacent to the feature is set back 4m to avoid the crest influence zone.

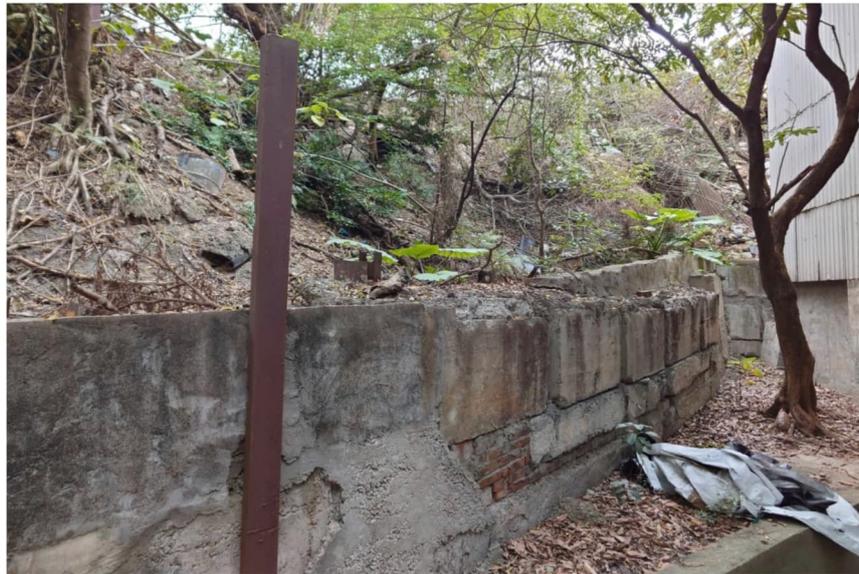
Photo V11 - General view of the Feature 2SW-C/C115

This is a U-shaped feature located at the eastern boundary of the site. It consists of a vegetated slope with a maximum height of 7 m and has a face angle of about 60°. This feature is about 160m long.

The cut slope height of the feature is 7.0m. According to Paragraph 5.3.1 in TGN 15, the estimated crest influence zone is not larger than 0.4 times the slope height. It is therefore, the crest influence zone is about 3.0m away from the existing slope crest.

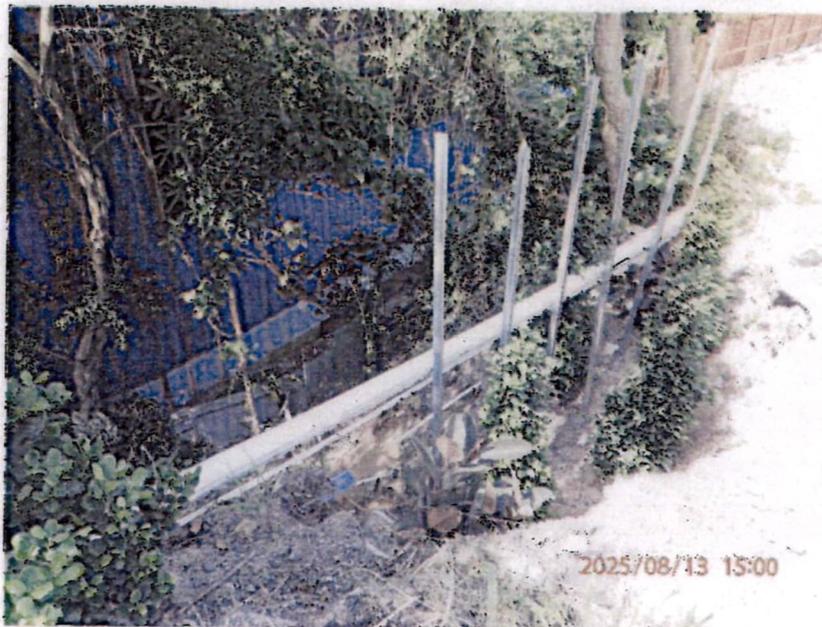
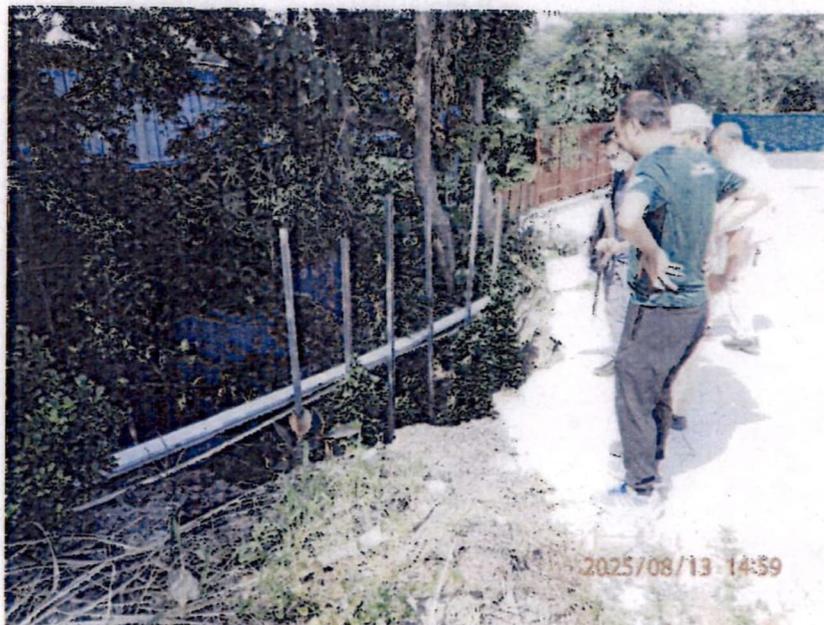
Photo 1 (Landslide Scar 1)

Photo 2 (Landslide Scar 1)

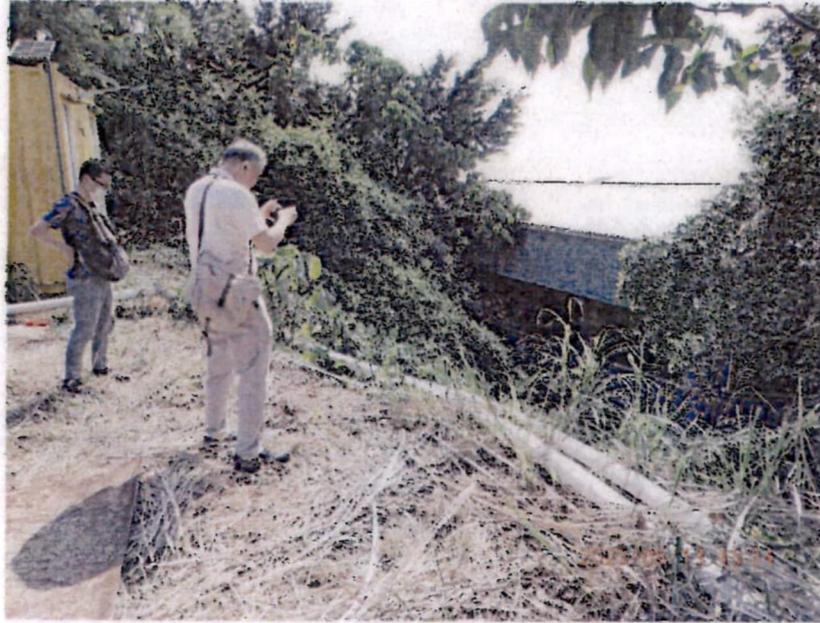
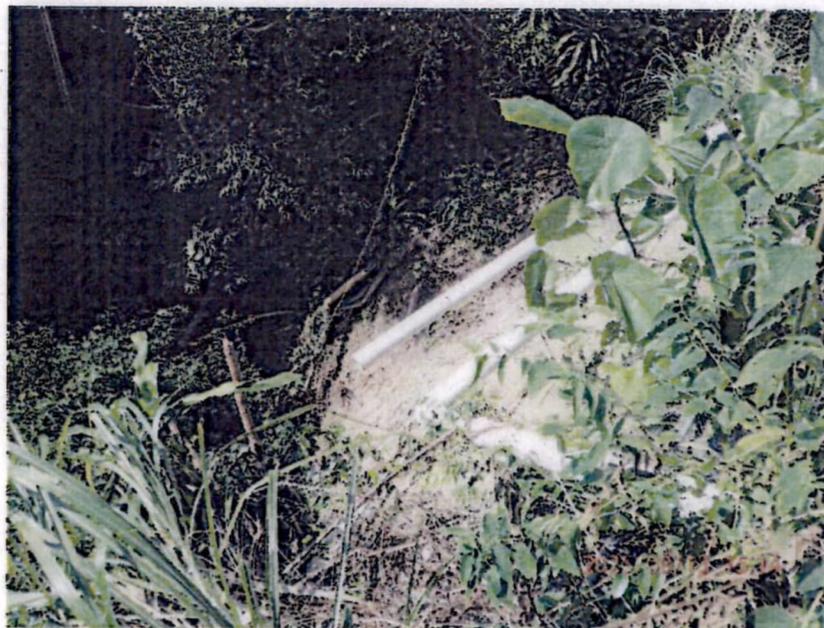
Photo 3 (Landslide Scar 2)

Photo 4 (Landslide Scar 2)

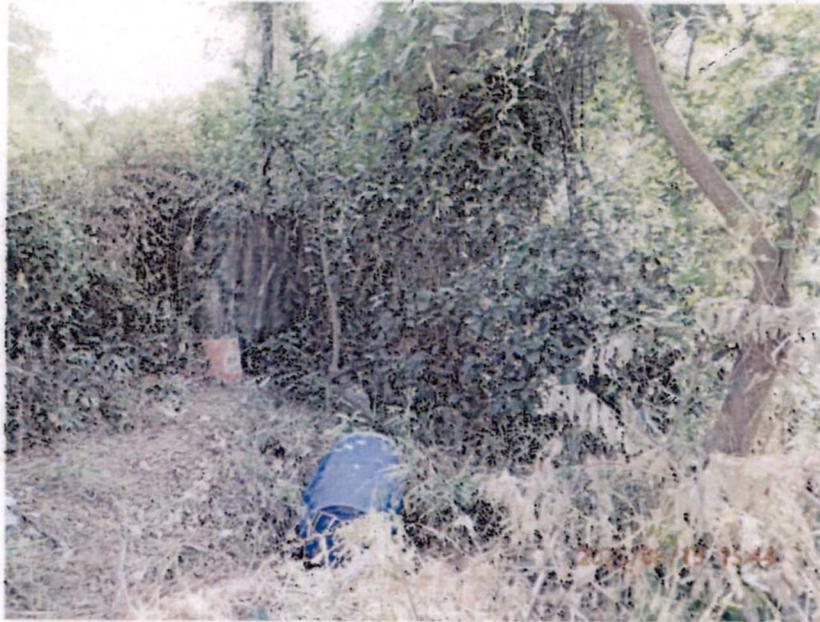
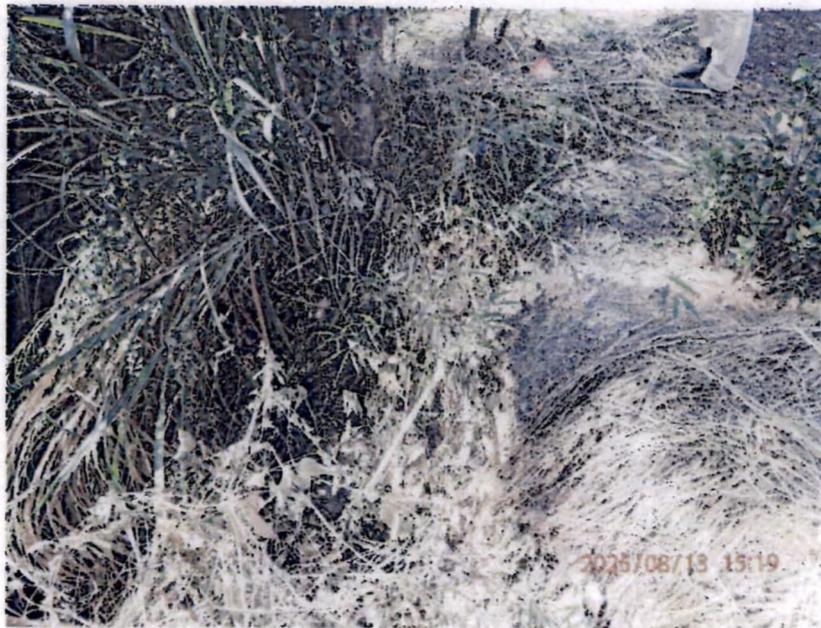
2. As Landslide Scar no.3 shown on the location plan rest on your private lot, you are requested to carry out the following emergency slope repair works within your lot immediately:-

Photo 5 (Landslide Scar 3)

Photo 6 (Landslide Scar 3)

- (i) Remove the landslide debris;
- (ii) Remove loose materials on the failure scars and minor trim back the failure surfaces; and
- (iii) Provide hard surface cover with wire mesh and weepholes to the failure surfaces.
