Appendix 5
Geotechnical Review Report

Addendum on Geotechnical Review Report

Final Geotechnical Review Report (Revised)

Inspection Record of Slope Feature No. 2SW-D/C24

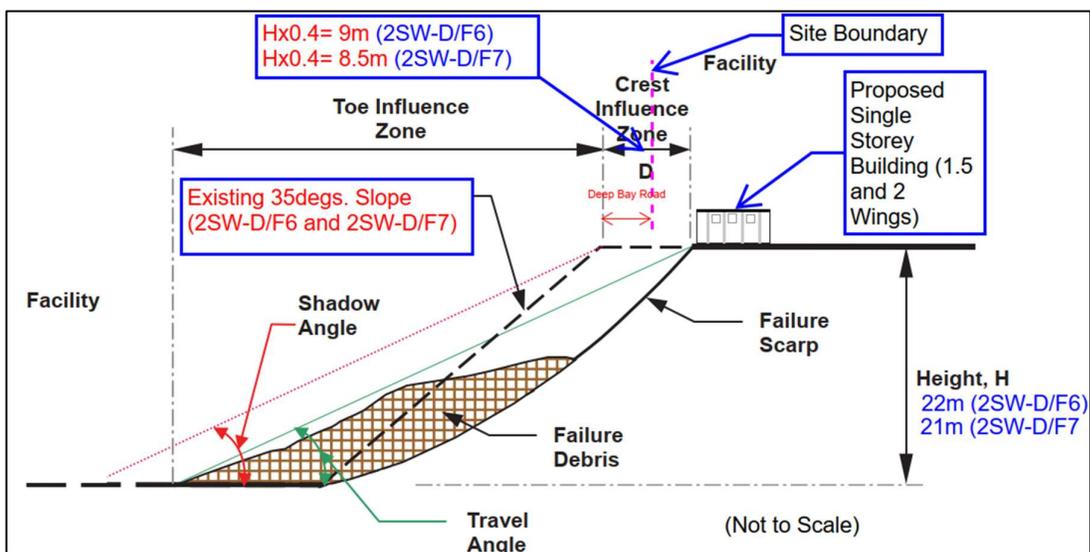
**Figure 1 – Relationship between New Development (both 1.5 and 2 wings)
and Crest Influence Zone (2SW-D/F6 and D/F7)**

For Feature Nos. 2SW-D/F6 and 2SW-D/F7, the expected influence zone, as defined in TGN 15, is about 9m (i.e. 0.4 times the slope height of 22m). Please refer to **Figure 1** below showing the relationship between proposed development (both 2 and 1.5 wings) and slope crest influence zone. Since the proposed building is located at least 9m away from the slope crest in South-East direction (not immediately behind crest of the feature), it falls outside the expected crest influence zone. Thus, the crest facility will remain as Cat 3 (“road/footpath with low traffic density” or “non-dangerous goods storage site”). The CTL/Economic Consequence and the required FOS will remain as Category 3/B and 1.2 respectively.

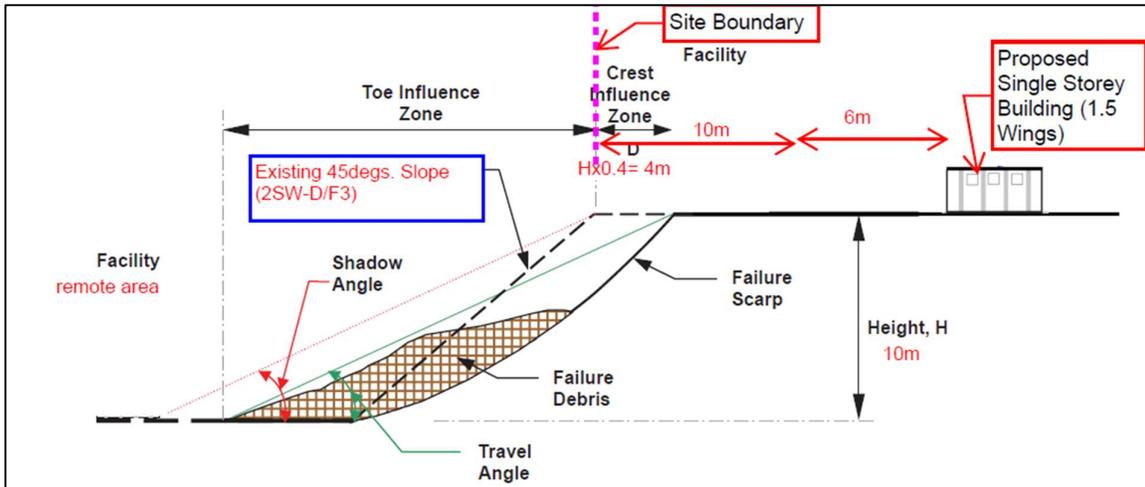
**Figure 2.1 – Relationship between New Development (1.5 Wings)
and Crest Influence Zone (2SW-D/F3)**

For Feature No. 2SW-D/F3, it is currently classified as a Category 3 feature and remains unchanged, since the crest facility (for both 1.5 and 2 wings) are still classified as the “road with low traffic density” and the CTL remains Category 3 after the development. The proposed single storey building structure will be 12m away from the crest influence zone, it will not affect or be affected by the slope feature. Please see below **Figure 2.1 (1.5 Wings)** and **Figure 2.2 (2 Wings)** showing the proposed fringe of building locate 12m from the crest influence zone of the concerned slope feature.

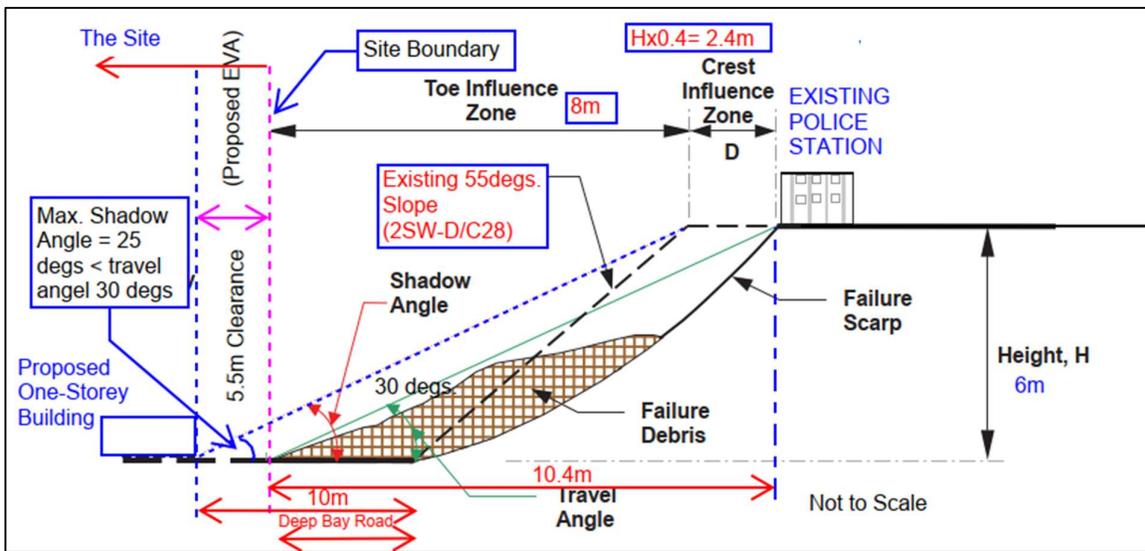
Figure 3 – Relationship between New Development and Crest Influence Zone (2SW-D/C28)

For Feature No. 2SW-D/C28, its CTL is currently identified as Category 3 with the toe facility classified as the “road with low traffic density”. With reference to Clause 5.2.2 in TGN 15, the travel angle for estimation of the possible extreme travel distance of landslide debris with volume less than 300 m³

The EVA is classified as Category 3 facility, the CTL of Feature No. 2SW- D/C28 remains Cat 3 in case Deep Bay Road forms part of the EVA.

In view of the above, the toe facility is still classified as the “road with low traffic density” and the CTL remains Category 3 after the development.

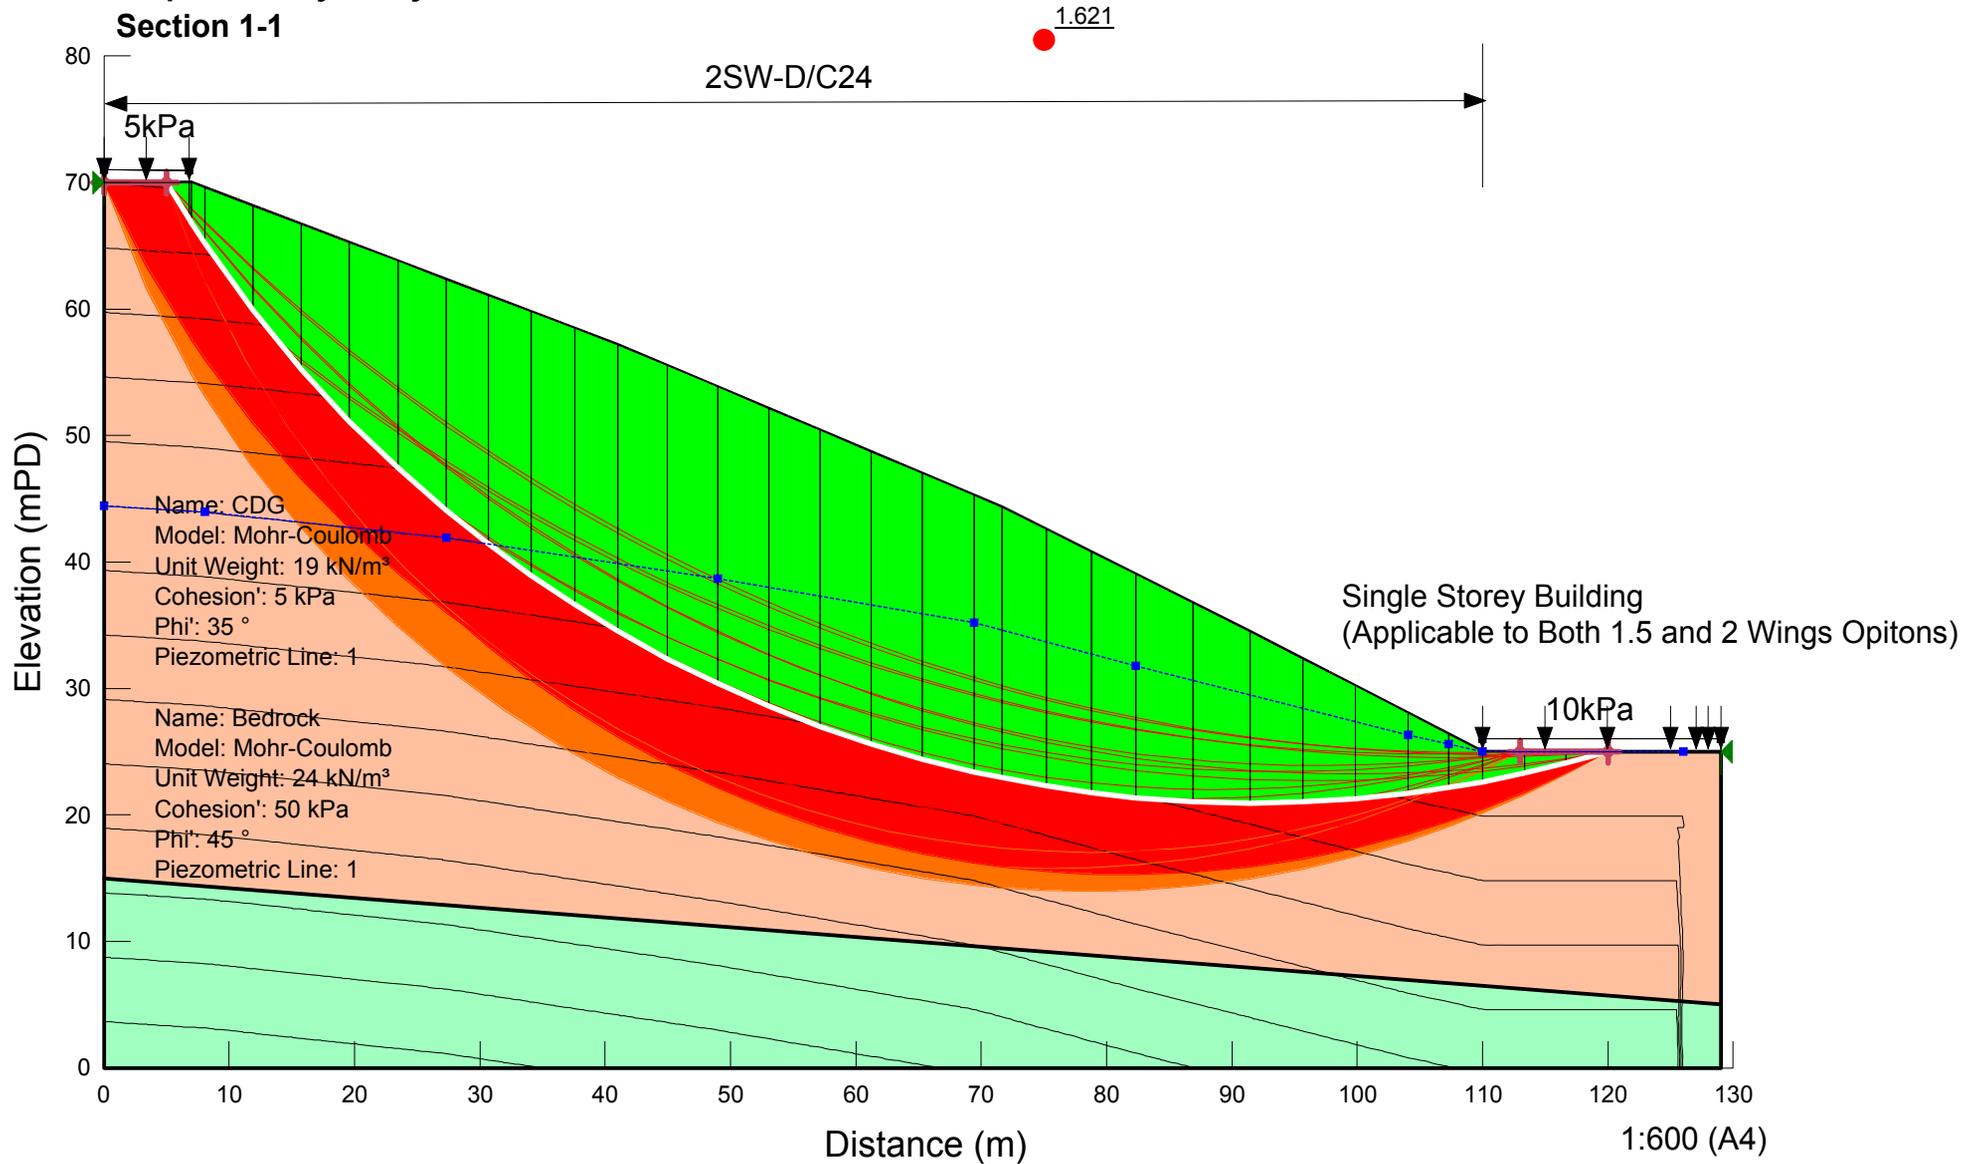
Section 1-1

The minimum calculated factor of safety of the slope feature is found to be 1.621 which is considered meets the current standard and no slope upgrading works is required.

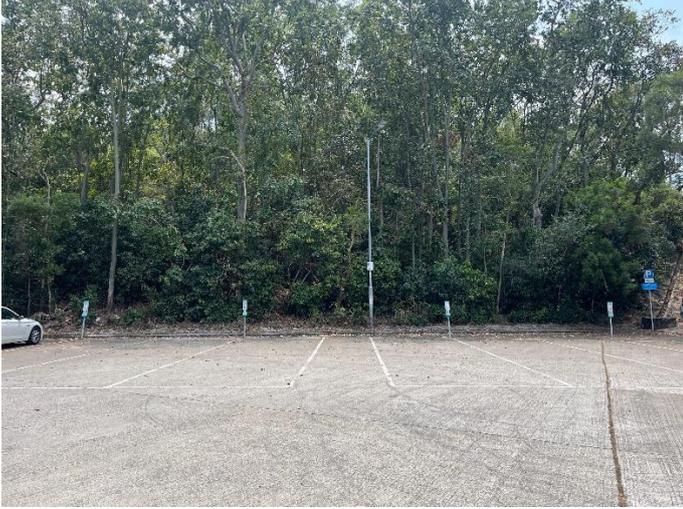
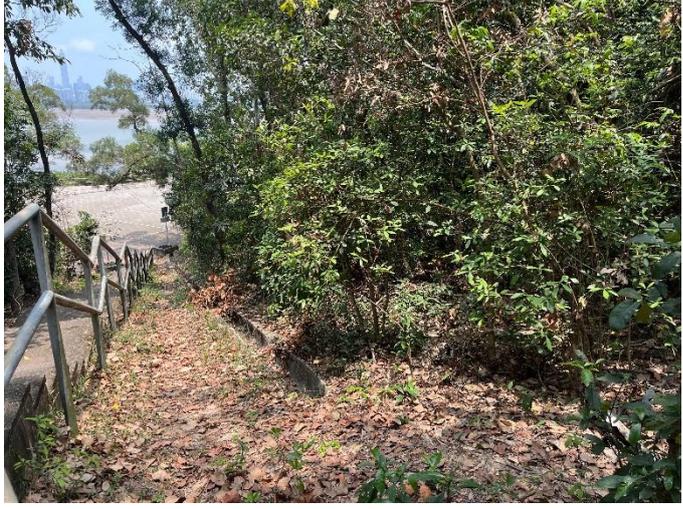
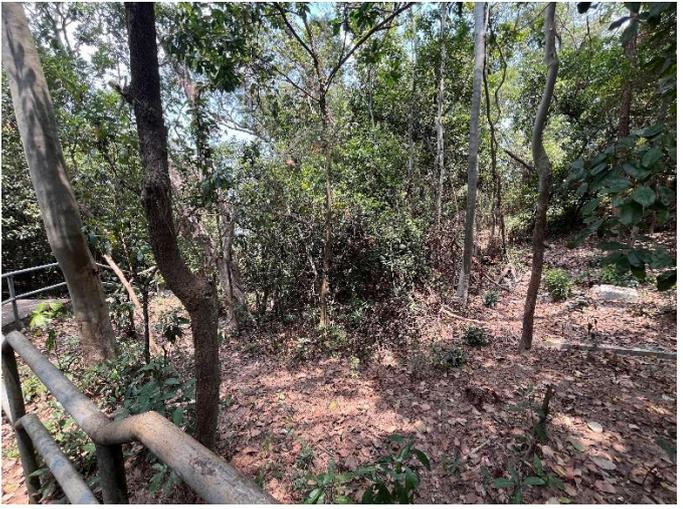
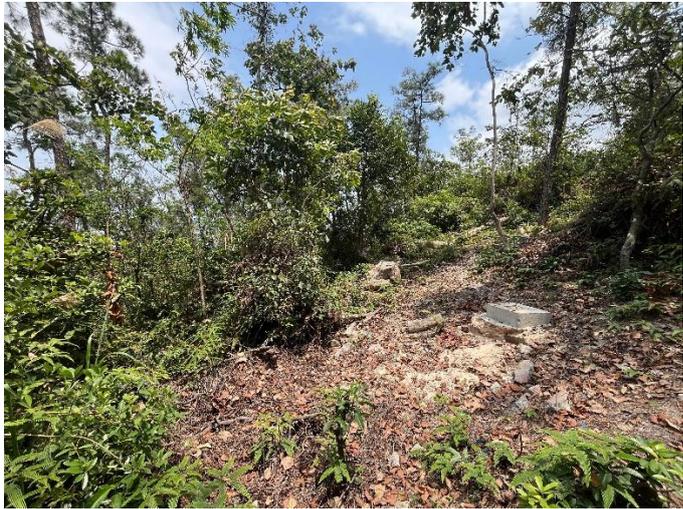
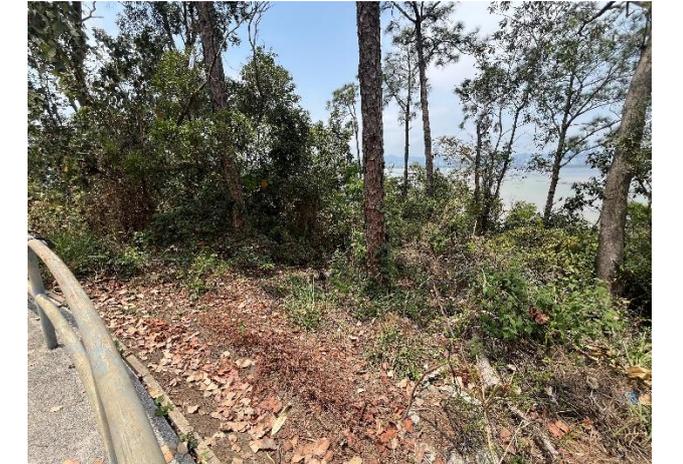
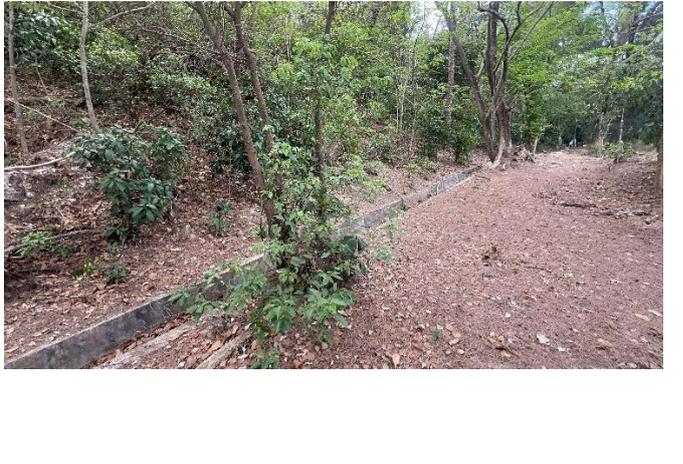
A site inspection on slope feature no. 2SW-D/C24 was conducted on 22nd April 2025, it is found that no sign of distress is observed. The photo records are enclosed in **Appendix J**.

Inspection Date: 22nd April 2025 Observation: No sign of distress is observed on slope feature no. 2SW-D/C24
