## **SECTION 12A APPLICATION**

**To rezone the Application Site from “Other Specified Uses” annotated “Business” to “Residential (Group E) 2” at Lot 316 in D.D. 444 and Kwai Chung Town Lot (KTCL) 146, 97-107 Wo Yi Hop Road, New Territories**

### **Land Contamination Review**

**September 2025**

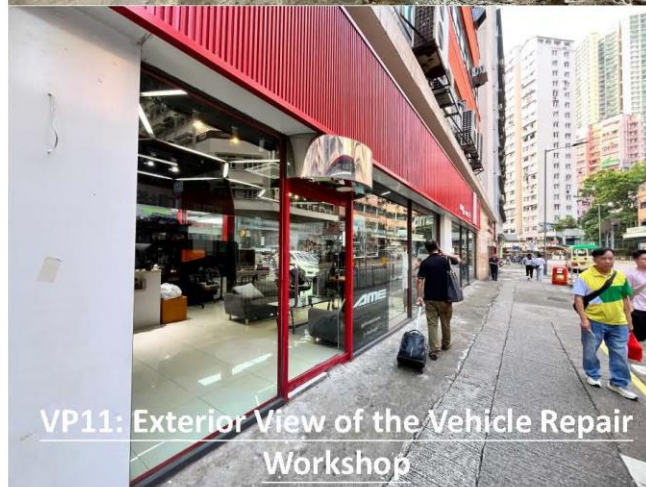
VP11: Exterior View of the Vehicle Repair Workshop

- 2.4.3. G/F is comprised of a public vehicle park on the west side of the Site, and a vehicle repair workshop on the east side with a shopfront facing Wo Yi Hop Road. According to **Appendix 6**, hydraulic fluids and cleaning solvents are stored on site, but there was no spillage / leakage / contamination on site and in the past.
