### Revised Land Contamination Review

**To rezone the Application Site from “Other Specified Uses” annotated “Business” to  
“Residential (Group E) 2” at Lot 316 in D.D. 444 and Kwai Chung Town Lot (KTCL) 146,  
97-107 Wo Yi Hop Road, New Territories**

### **Land Contamination Review**

September 2025

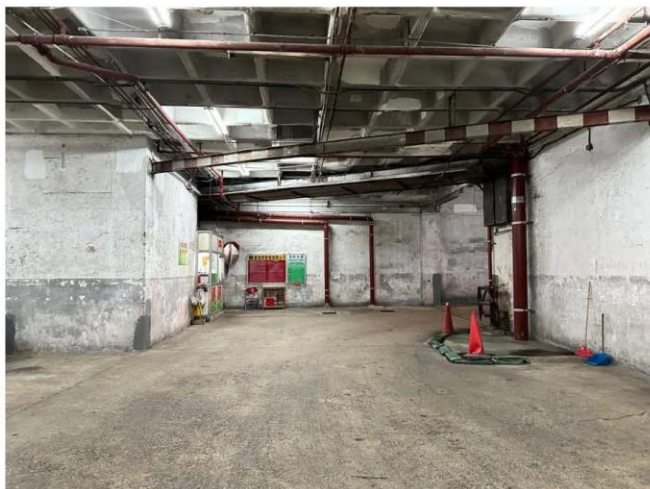
VP1

| V<br>P | Description | Potential Source of Pollution | Evidence of Spillage<br>/Leakage/Pollution | Free from<br>Contamination? |
|---|---|---|---|---|
| 1 | Landing of LG/F access with security guard box | Concrete walls and ground, and vehicles | No | Yes |

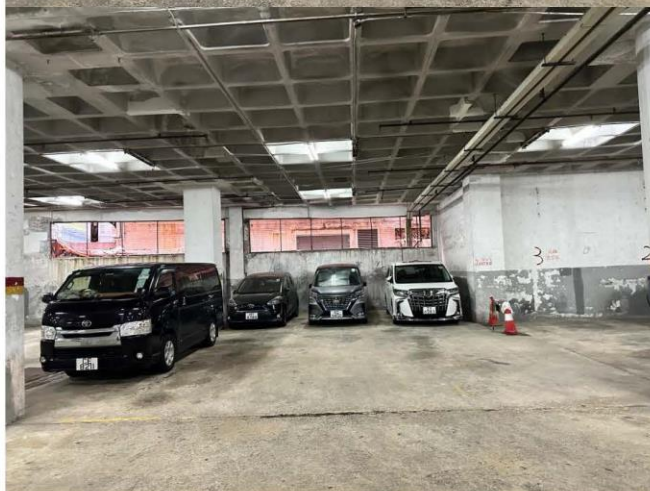
VP2

| V<br>P | Description | Potential Source of Pollution | Evidence of Spillage<br>/Leakage/Pollution | Free from<br>Contamination? |
|---|---|---|---|---|
| 2 | Parked private and goods vehicles | Concrete walls and ground, and vehicles | No | Yes |

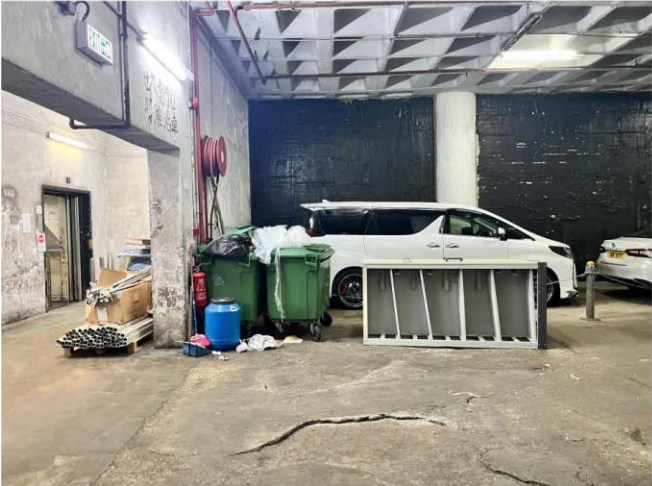
VP5

| V<br>P | Description | Potential Source of Pollution | Evidence of Spillage<br>/Leakage/Pollution | Free from<br>Contamination? |
|---|---|---|---|---|
| 5 | Private car parking, lift lobby<br>and garbage containers | Concrete walls, ground, vehicles,<br>garbage, and blue container | No (Blue container was<br>empty) | Yes |

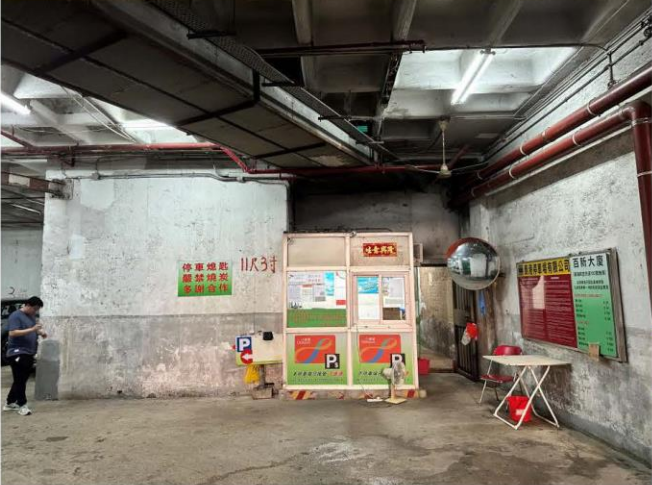
VP6

| V<br>P | Description | Potential Source of Pollution | Evidence of Spillage<br>/Leakage/Pollution | Free from<br>Contamination? |
|---|---|---|---|---|
| 6 | Security box | Concrete walls and ground, and<br>red bucket | No (Red bucket was<br>empty) | Yes |

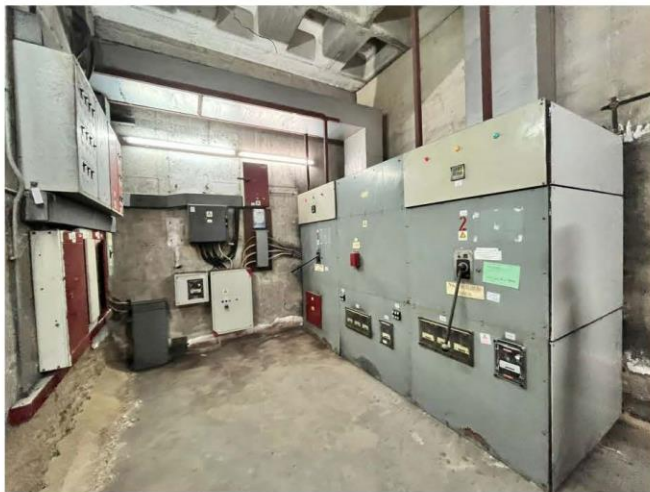
VP7

| V<br>P | Description | Potential Source of Pollution | Evidence of Spillage /Leakage/Pollution | Free from Contamination? |
|---|---|---|---|---|
| 7 | Switch Room | Concrete walls and ground, and electrical switches | No | Yes |

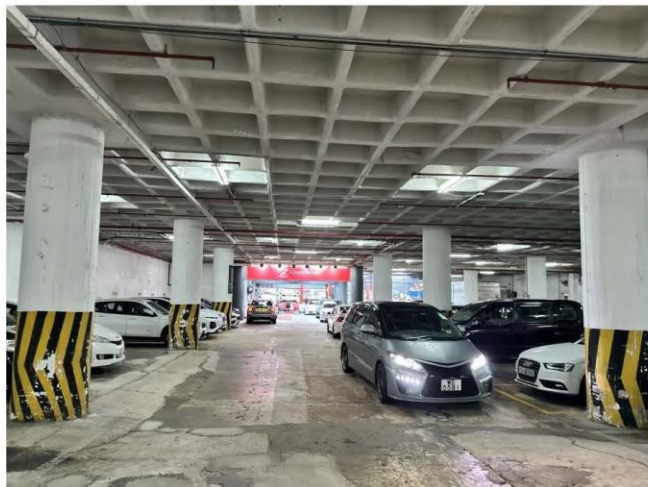
VP8

| V<br>P | Description | Potential Source of Pollution | Evidence of Spillage<br>/Leakage/Pollution | Free from<br>Contamination? |
|---|---|---|---|---|
| 8 | Private car parking | Concrete walls and ground, and vehicles | No | Yes |

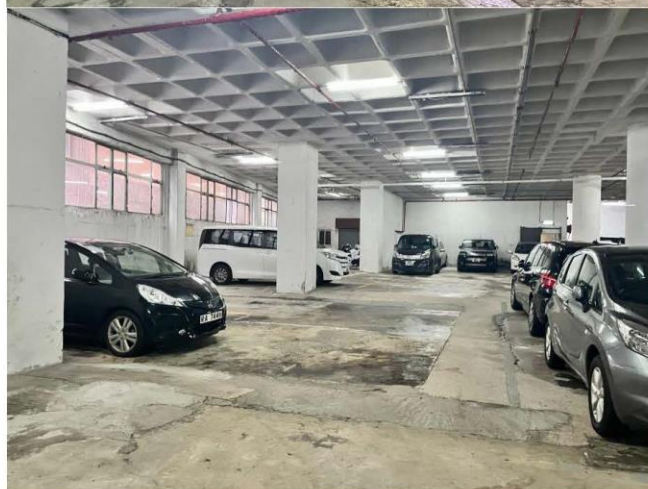
VP9

| V<br>P | Description | Potential Source of Pollution | Evidence of Spillage<br>/Leakage/Pollution | Free from<br>Contamination? |
|---|---|---|---|---|
| 9 | Private car parking | Concrete walls and ground, and vehicles | No | Yes |

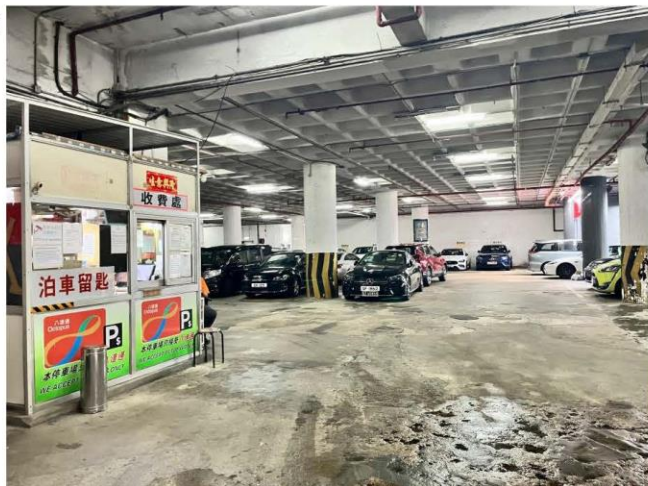
VP10

| VP | Description | Potential Source of Pollution | Evidence of Spillage /Leakage/Pollution | Free from Contamination? |
|---|---|---|---|---|
| 10 | Private car parking and security box | Concrete walls and ground, and vehicles | No | Yes |

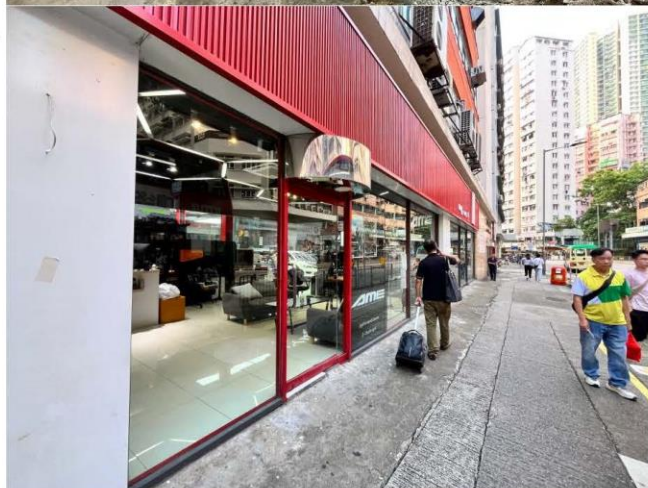
VP11

| VP | Description | Potential Source of Pollution | Evidence of Spillage /Leakage/Pollution | Free from Contamination? |
|---|---|---|---|---|
| 11 | Shopfront and reception of vehicle repair workshop | Concrete walls and ground | No | Yes |

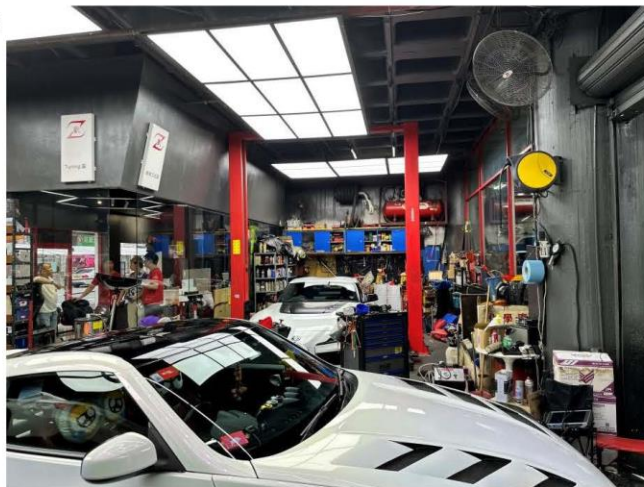
VP12

| VP | Description | Potential Source of Pollution | Evidence of Spillage /Leakage/Pollution | Free from Contamination? |
|---|---|---|---|---|
| 12 | Repair space of vehicle repair workshop | Vehicles, batteries, spray cans, and other chemicals | No | Yes |

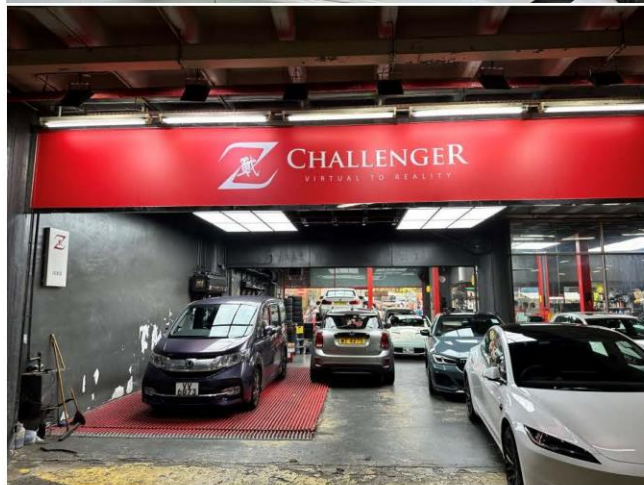
VP13

| VP | Description | Potential Source of Pollution | Evidence of Spillage /Leakage/Pollution | Free from Contamination? |
|---|---|---|---|---|
| 13 | Private parking of vehicle repair workshop | Concrete walls and ground, batteries, and other chemicals | No | Yes |
