S12A Amendment of Plan Application – Vario Yuen Long, N.T.	ous Lots in D.D. 110 and Adjoining Government Land, Shek Kong,
	Appendix 10
	Land Contamination Assessment

Land Contamination Assessment

Report No.: 22605-C1 Rev A

Date: **23 October 2025**

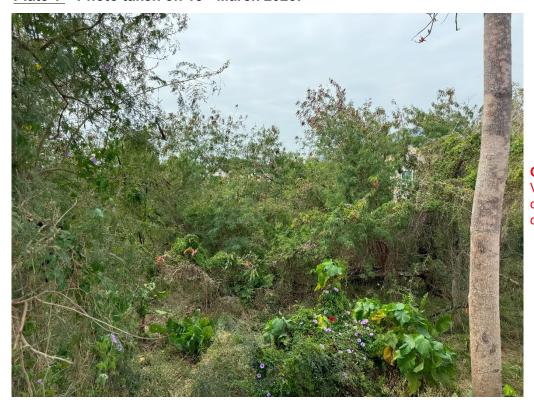
Plate 1 – Photo taken on 18th March 2025:

Observation: Vegetated, in clean condition. No sign of contamination.

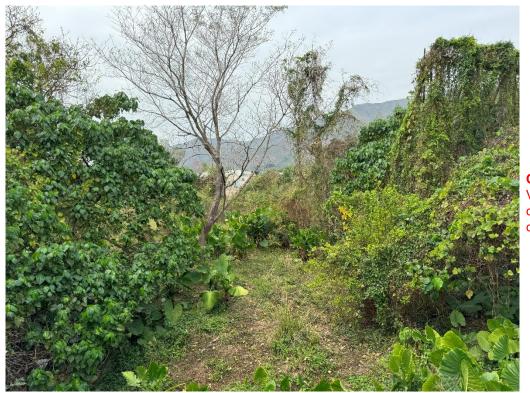
Plate 2 – Photo taken on 18th March 2025:

Observation: Vegetated, in clean condition. No sign of contamination.

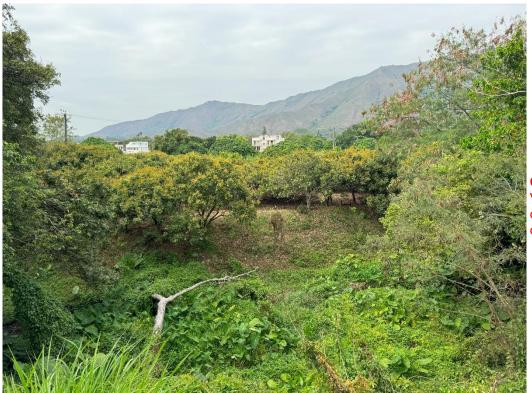
Plate 3 – Photo taken on 18th March 2025:

Observation: Vegetated, in clean condition. No sign of contamination.

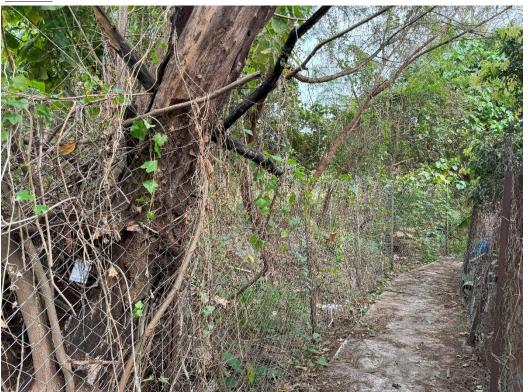
Plate 4 – Photo taken on 18th March 2025:

Observation: No sign of off-site contamination.

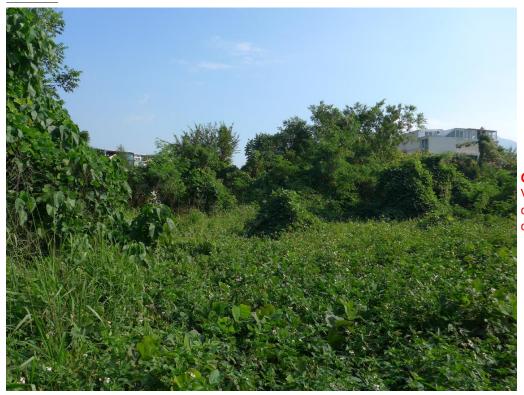
Plate 5 - Photo taken on 18th March 2025:

Observation: Vegetated, in clean condition. No sign of contamination.

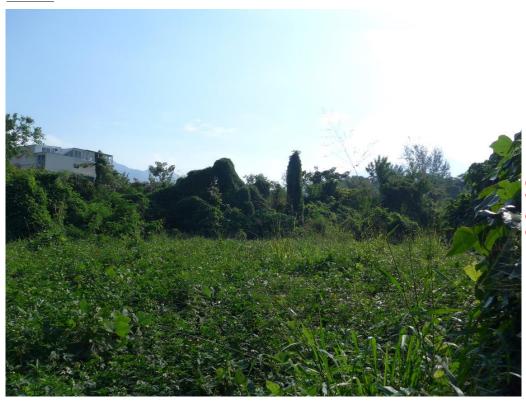
Plate 6 - Photo taken on 18th March 2025:

Observation: Vegetated, in clean condition. No sign of contamination.

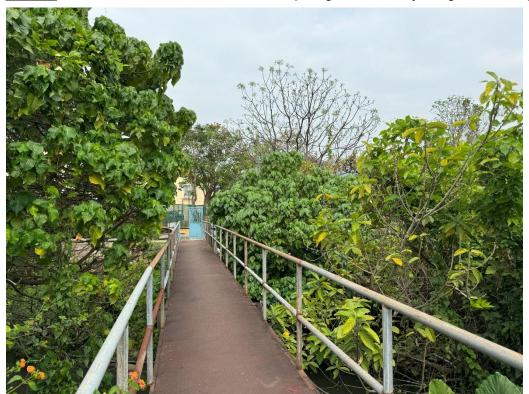
Plate 7 – Photo taken on 18th March 2025 (Village houses adjoining the development site):

Observation: No sign of off-site contamination.

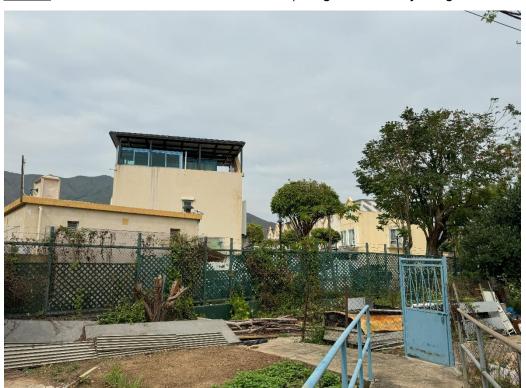
Plate 8 – Photo taken on 18th March 2025 (Village houses adjoining the development site):

Observation: No sign of off-site contamination.

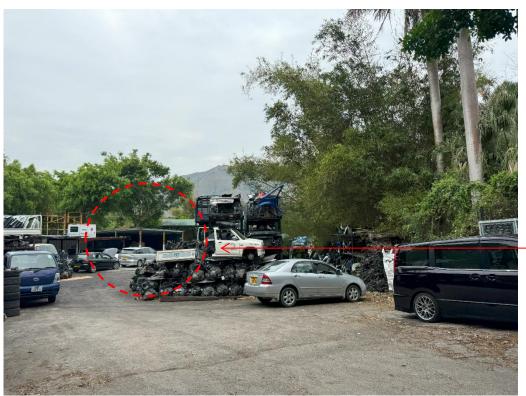
<u>Plate 9</u> – Photo taken on 18th March 2025 (The adjoining vehicle repairing workshop)

All industrial activities are conducted inside the temporary structure

The entire vehicle repairing workshop is paved.

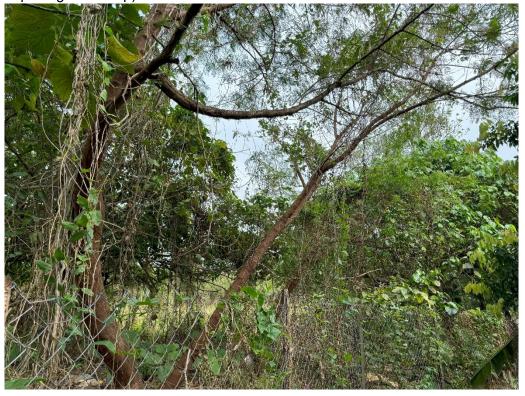
<u>Plate 10</u> – Photo taken on 18th March 2025 (Vegetations between site boundary and vehicle repairing workshop)

The site boundary adjoining the vehicle repairing workshop, with vegetations in between. No visual signs of contamination were observed.

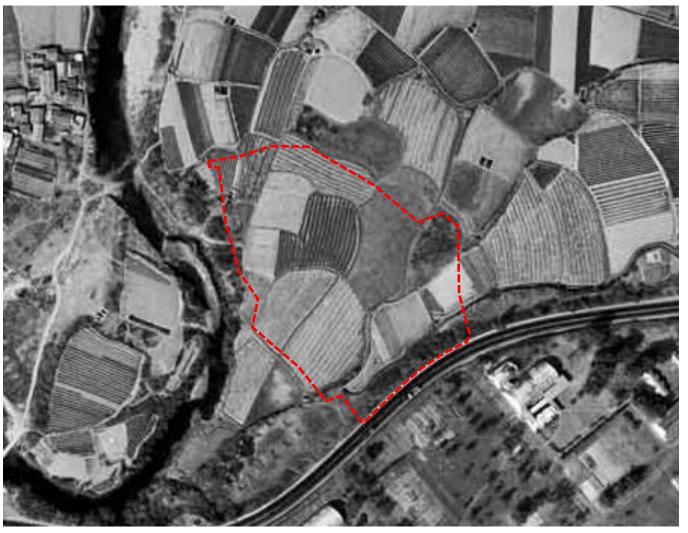
Year 1963 (ref: 1963-8455, height: 3900ft) – The Shek Kong area was under development. The development site appears to be farmland.

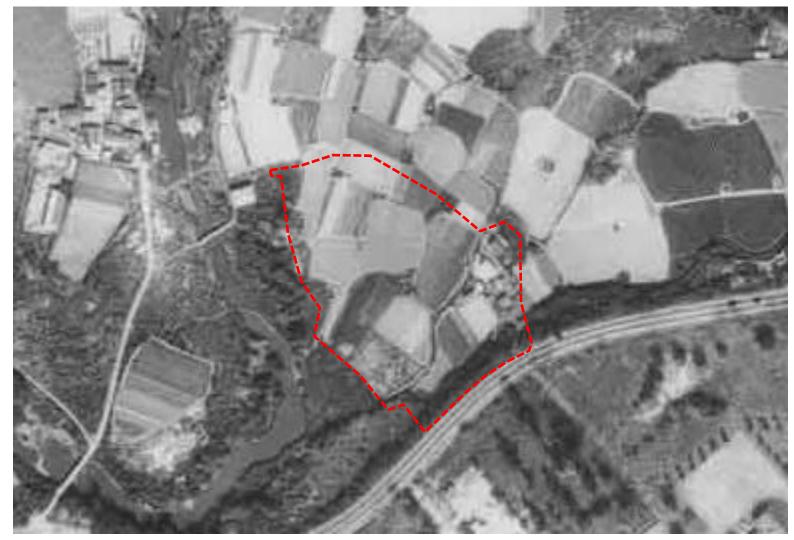
Year 1973 (ref: 03082, height: 5000ft) – The Shek Kong barracks were developed. The development site appears to be farmland and vegetation.

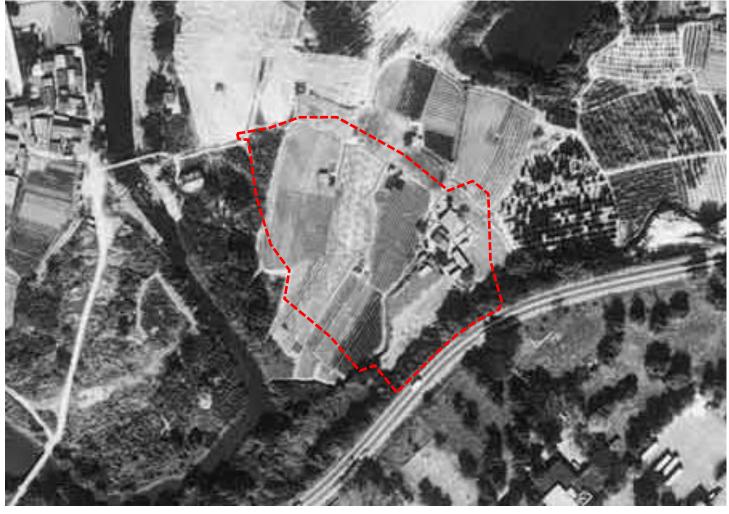
Year 1982 (ref: 46538, height: 4000ft) – The development of Pang Ka Tsuen was finished. No significant changes were noted in the development site.

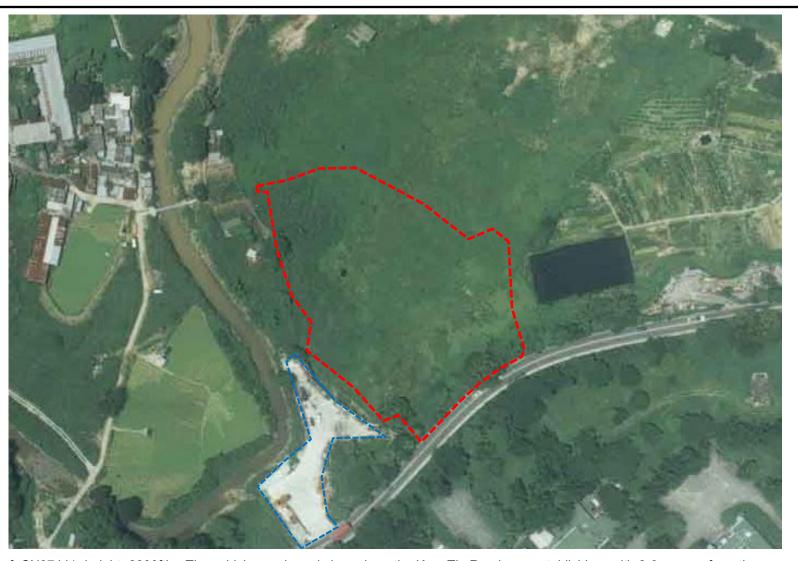
Year 1994 (ref: CN07441, height: 2800ft) – The vehicle repair workshop along the Kam Tin Road was establishing, with 2-3m away from the development site and vegetations in between. The development site was vacant with vegetation.

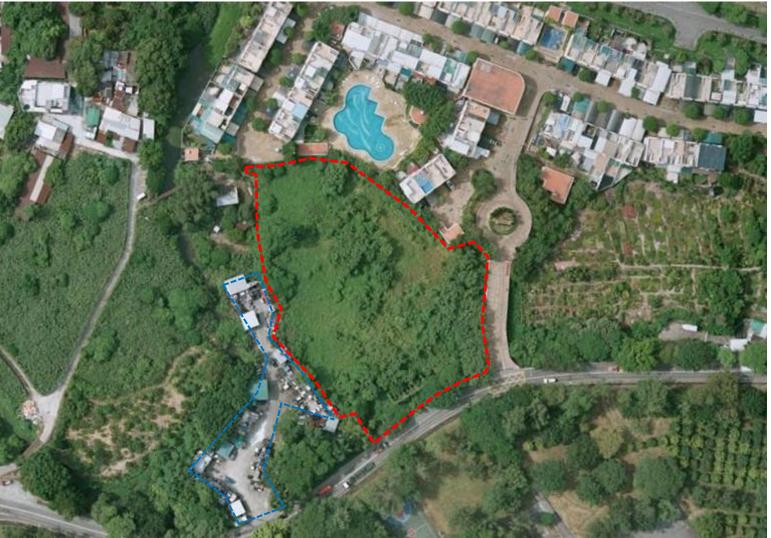
Year 2015 (ref: CW116414, height: 2500ft) – The development of Season Villas was completed. No significant changes were noted in the development site.

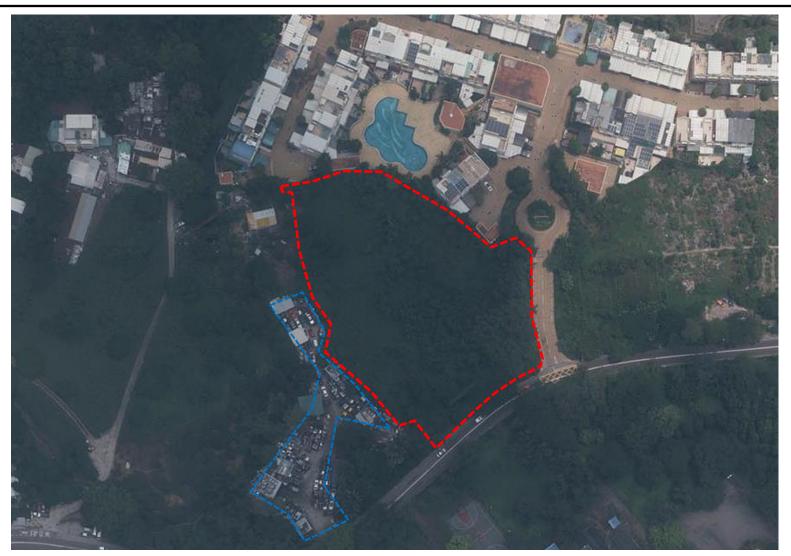
Year 2021 (ref: E140092C, height: 3000ft) – No significant changes were noted in the development site .

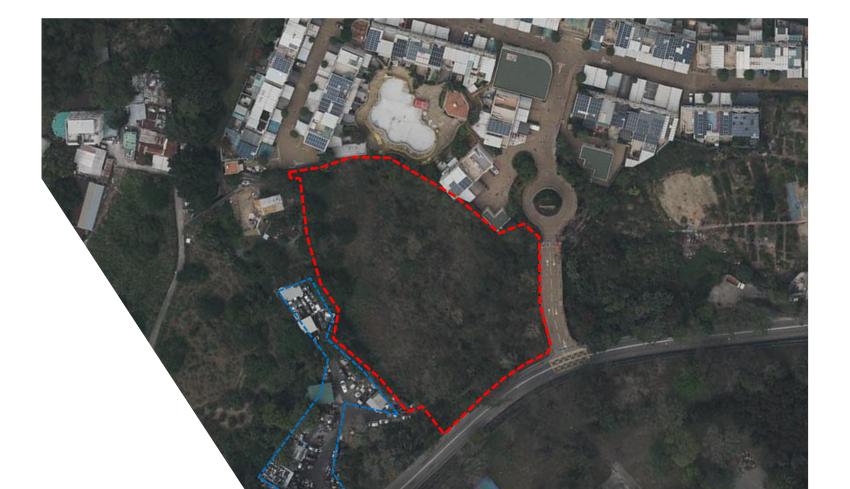
Year 2024 (ref: E219697C, height: 3000ft) – No significant changes were noted in the development site.
