**PLANNING APPLICATION FOR
PROPOSED UTILITY INSTALLATION FOR PRIVATE PROJECT
AT GOVERNMENT LAND ADJOINING 44 STANLEY VILLAGE ROAD,
STANLEY, HON KONG**

Tree Survey Report

Date: 13 November 2025

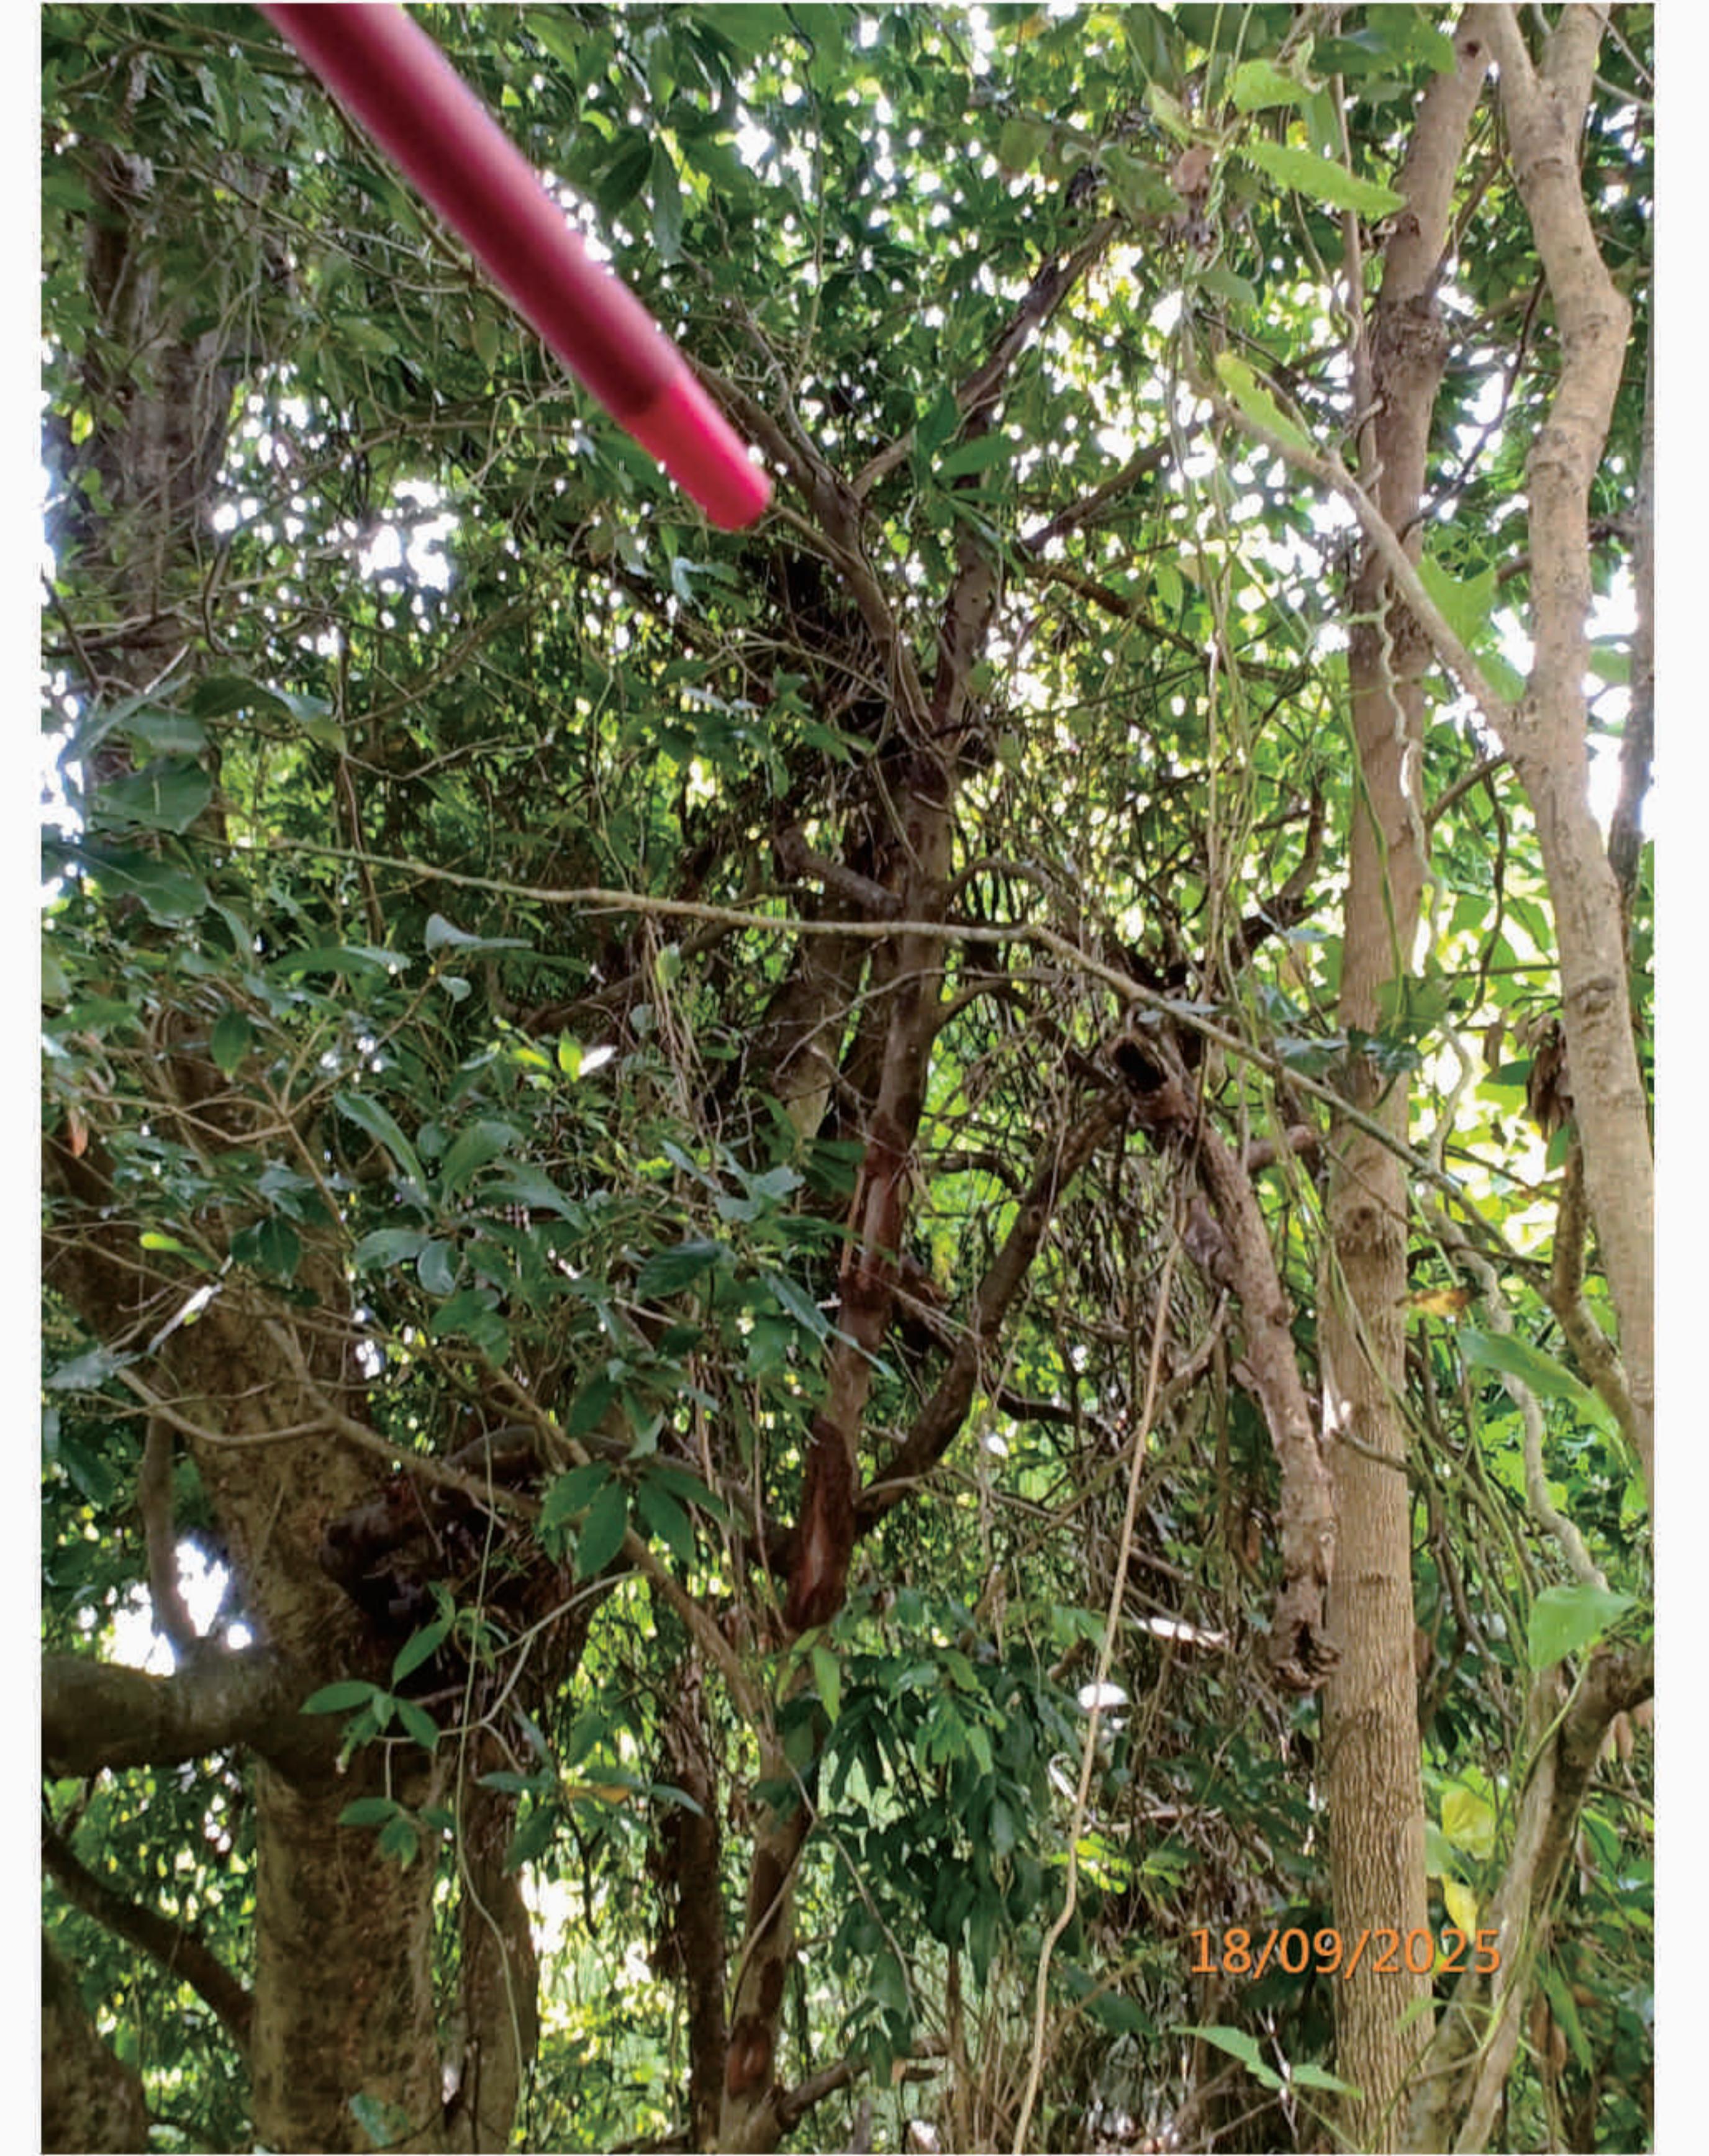
Tree	Species					Proposed Treatment	Remark ¹
No.	Scientific Name	Chinese Name	Height (m)	DBH ² (mm)	Crown Spread (m)	(Retain/Transplant/Fell)	
T244	<i>Litchi chinensis</i>	荔枝	12.0	750.00	10.0	Fell	multiple trunks, included bark, decay branch
T434	<i>Bauhinia purpurea</i>	紅花羊蹄甲	9.0	355.00	8.0	Fell	uproot, multiple trunks, included bark
T435	<i>Macaranga tanarius</i> var. <i>tomentosa</i>	血桐	9.0	278.00	6.0	Fell	restricted root, leaning trunk, abnormal bark crack on trunk
T439	<i>Delonix regia</i>	鳳凰木	9.0	243.00	6.0	Fell	restricted root, imbalanced crown
T440	<i>Lagerstroemia speciosa</i>	大花紫薇	8.0	124.00	5.0	Fell	restricted root
T441	<i>Delonix regia</i>	鳳凰木	12.0	422.00	8.0	Fell	restricted root, multiple attachments with included bark, imbalanced crown
T442	<i>Lagerstroemia speciosa</i>	大花紫薇	5.5	160.00	5.0	Fell	restricted root
T445	<i>Michelia x alba</i>	白蘭	18.0	318.00	8.0	Retain	scheduled under Cap. 96, restricted root, iron bar embedded in trunk

T244 - Decay Branch (F)

4.11 Apart from the above, **1** fruit tree, i.e. **T244** – *Lichi chinesis* will also be disturbed. Due to the nature of fruit tree, it's survival rate after transplantation is usually low. It is proposed to fell it, instead of transplanting it.

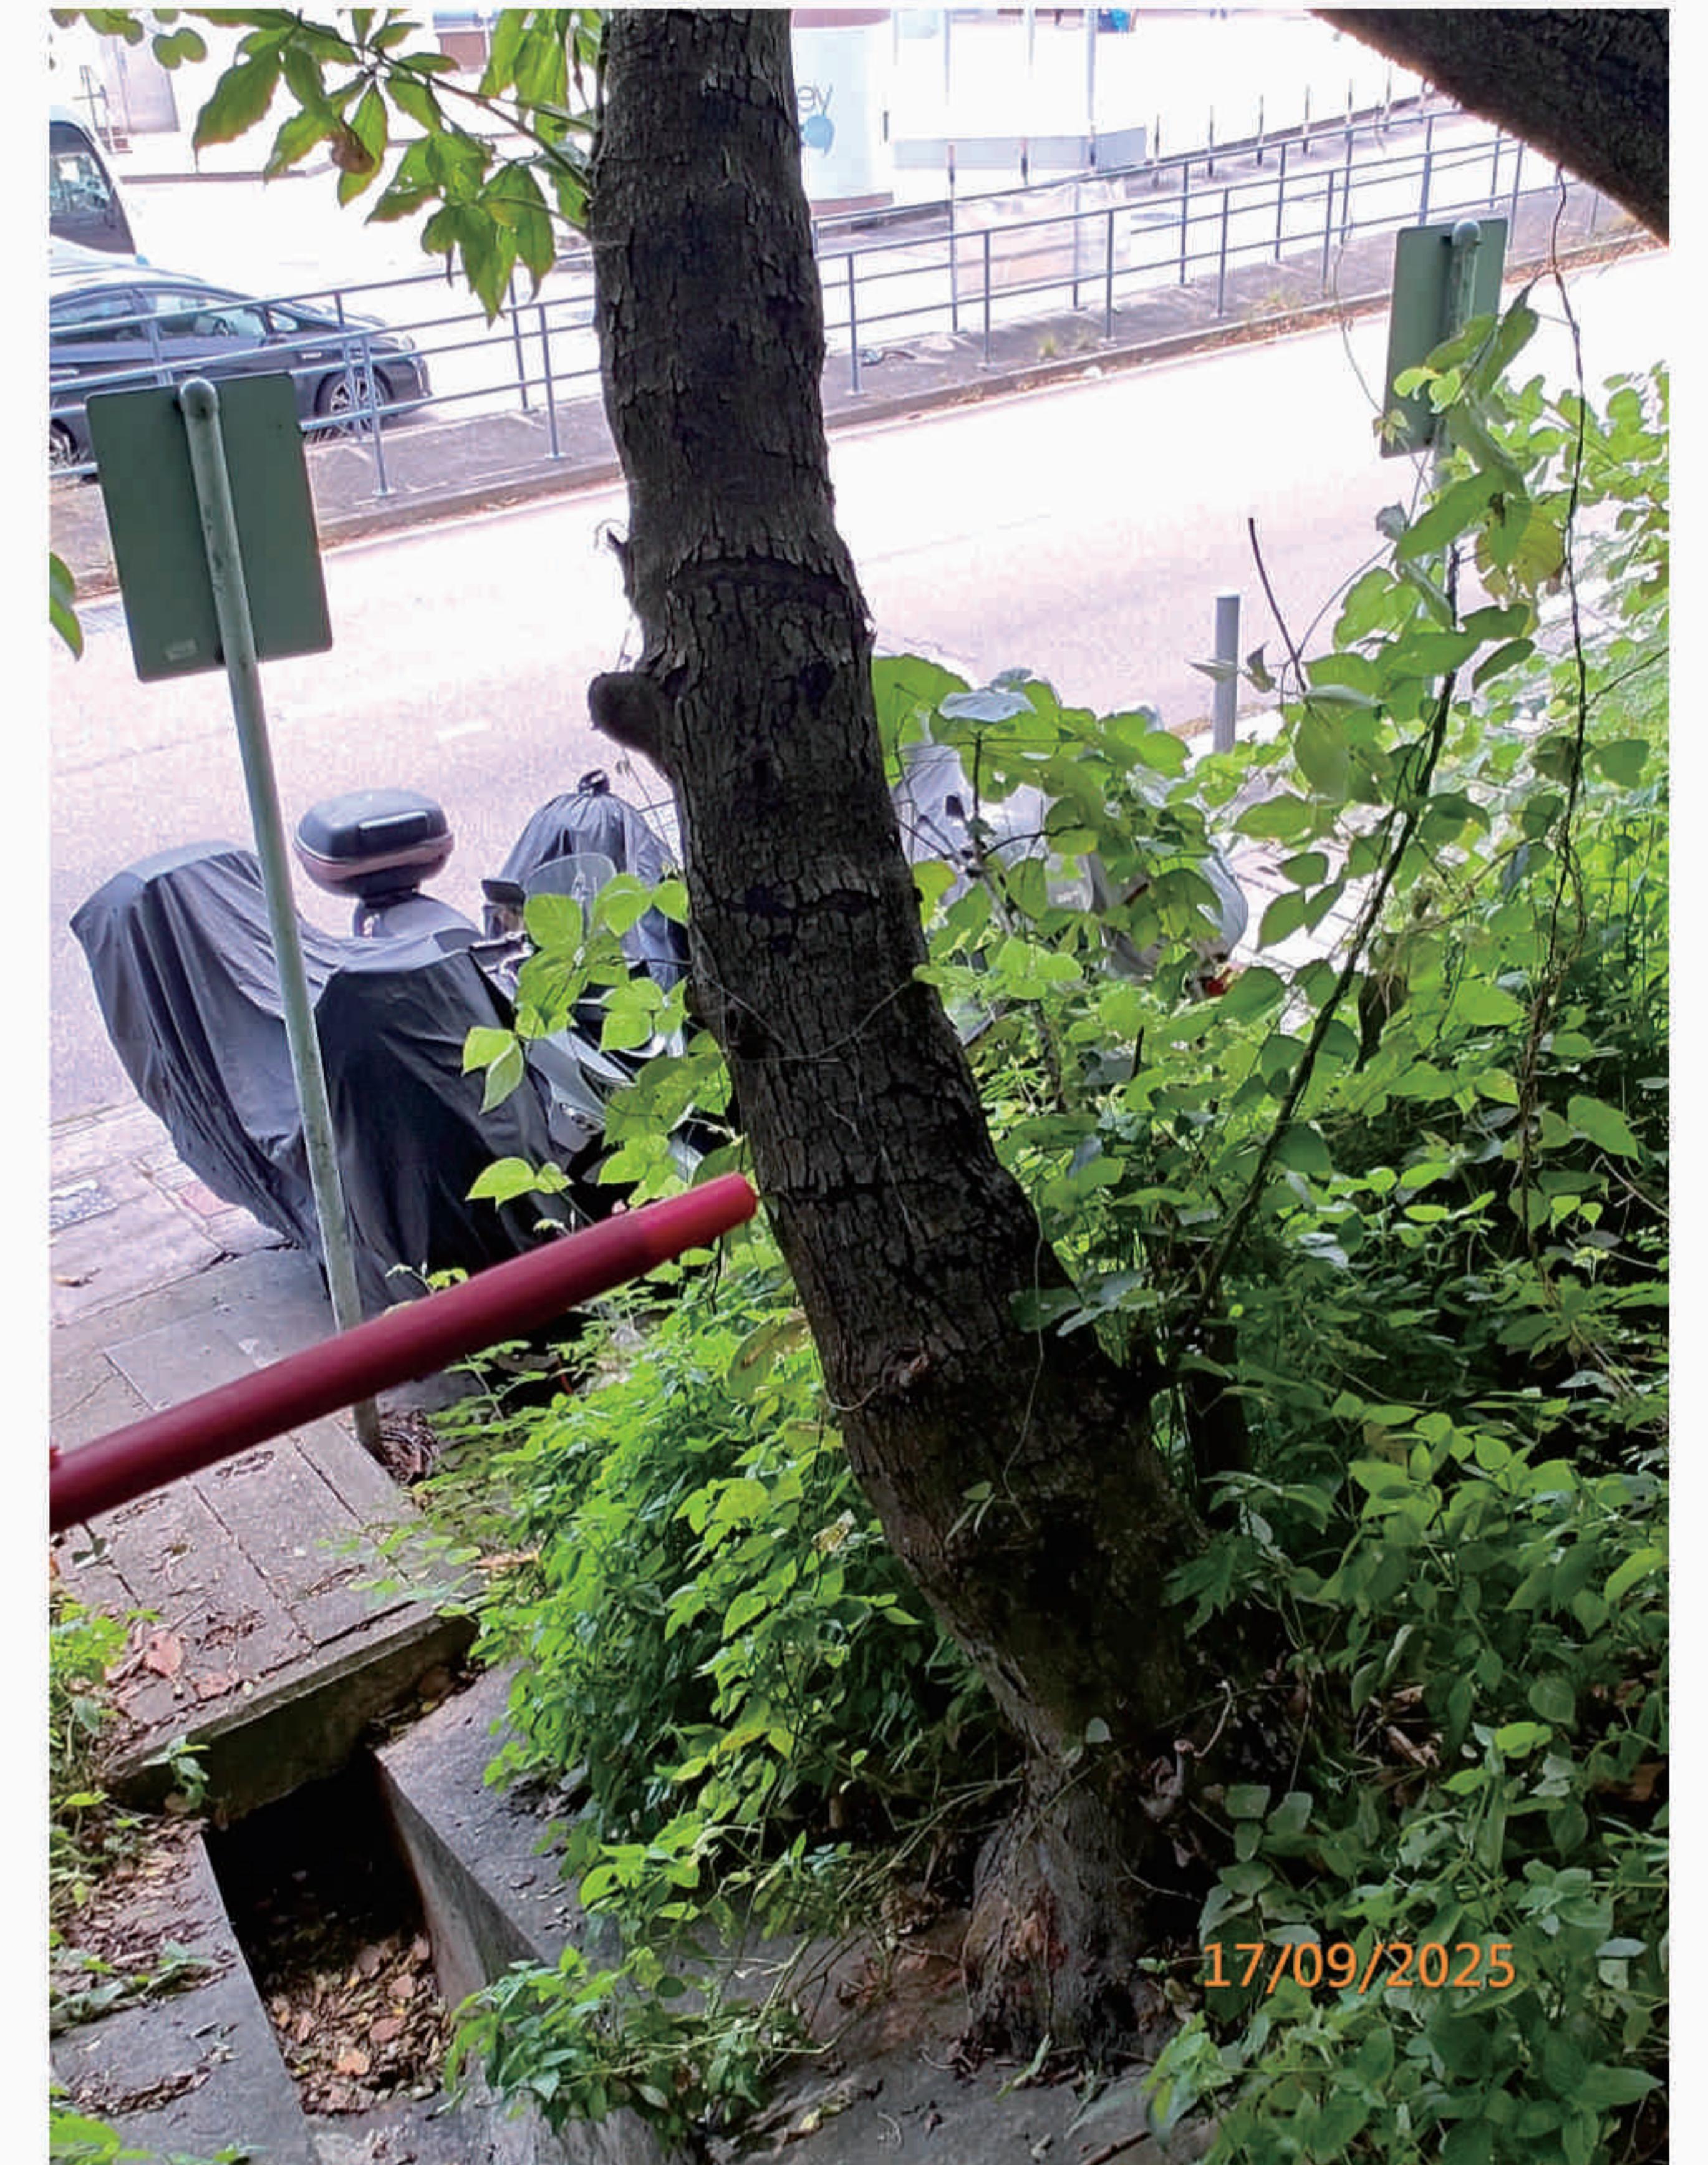
T435 - Abnormal Bark Crack on Trunk (F)

4.9 **3** affected trees, namely **T466** – *Ficus altissima*, **T435**, **A07** – *Macaranga tanarius* var. *tomentosa* are common hillside species in Hong Kong. As they are propagated from the adjacent hillsides, their root systems are very susceptible to environmental changes. This renders them a relatively low survival rate after transplantation. Hence, all of these trees are also proposed to be felled.

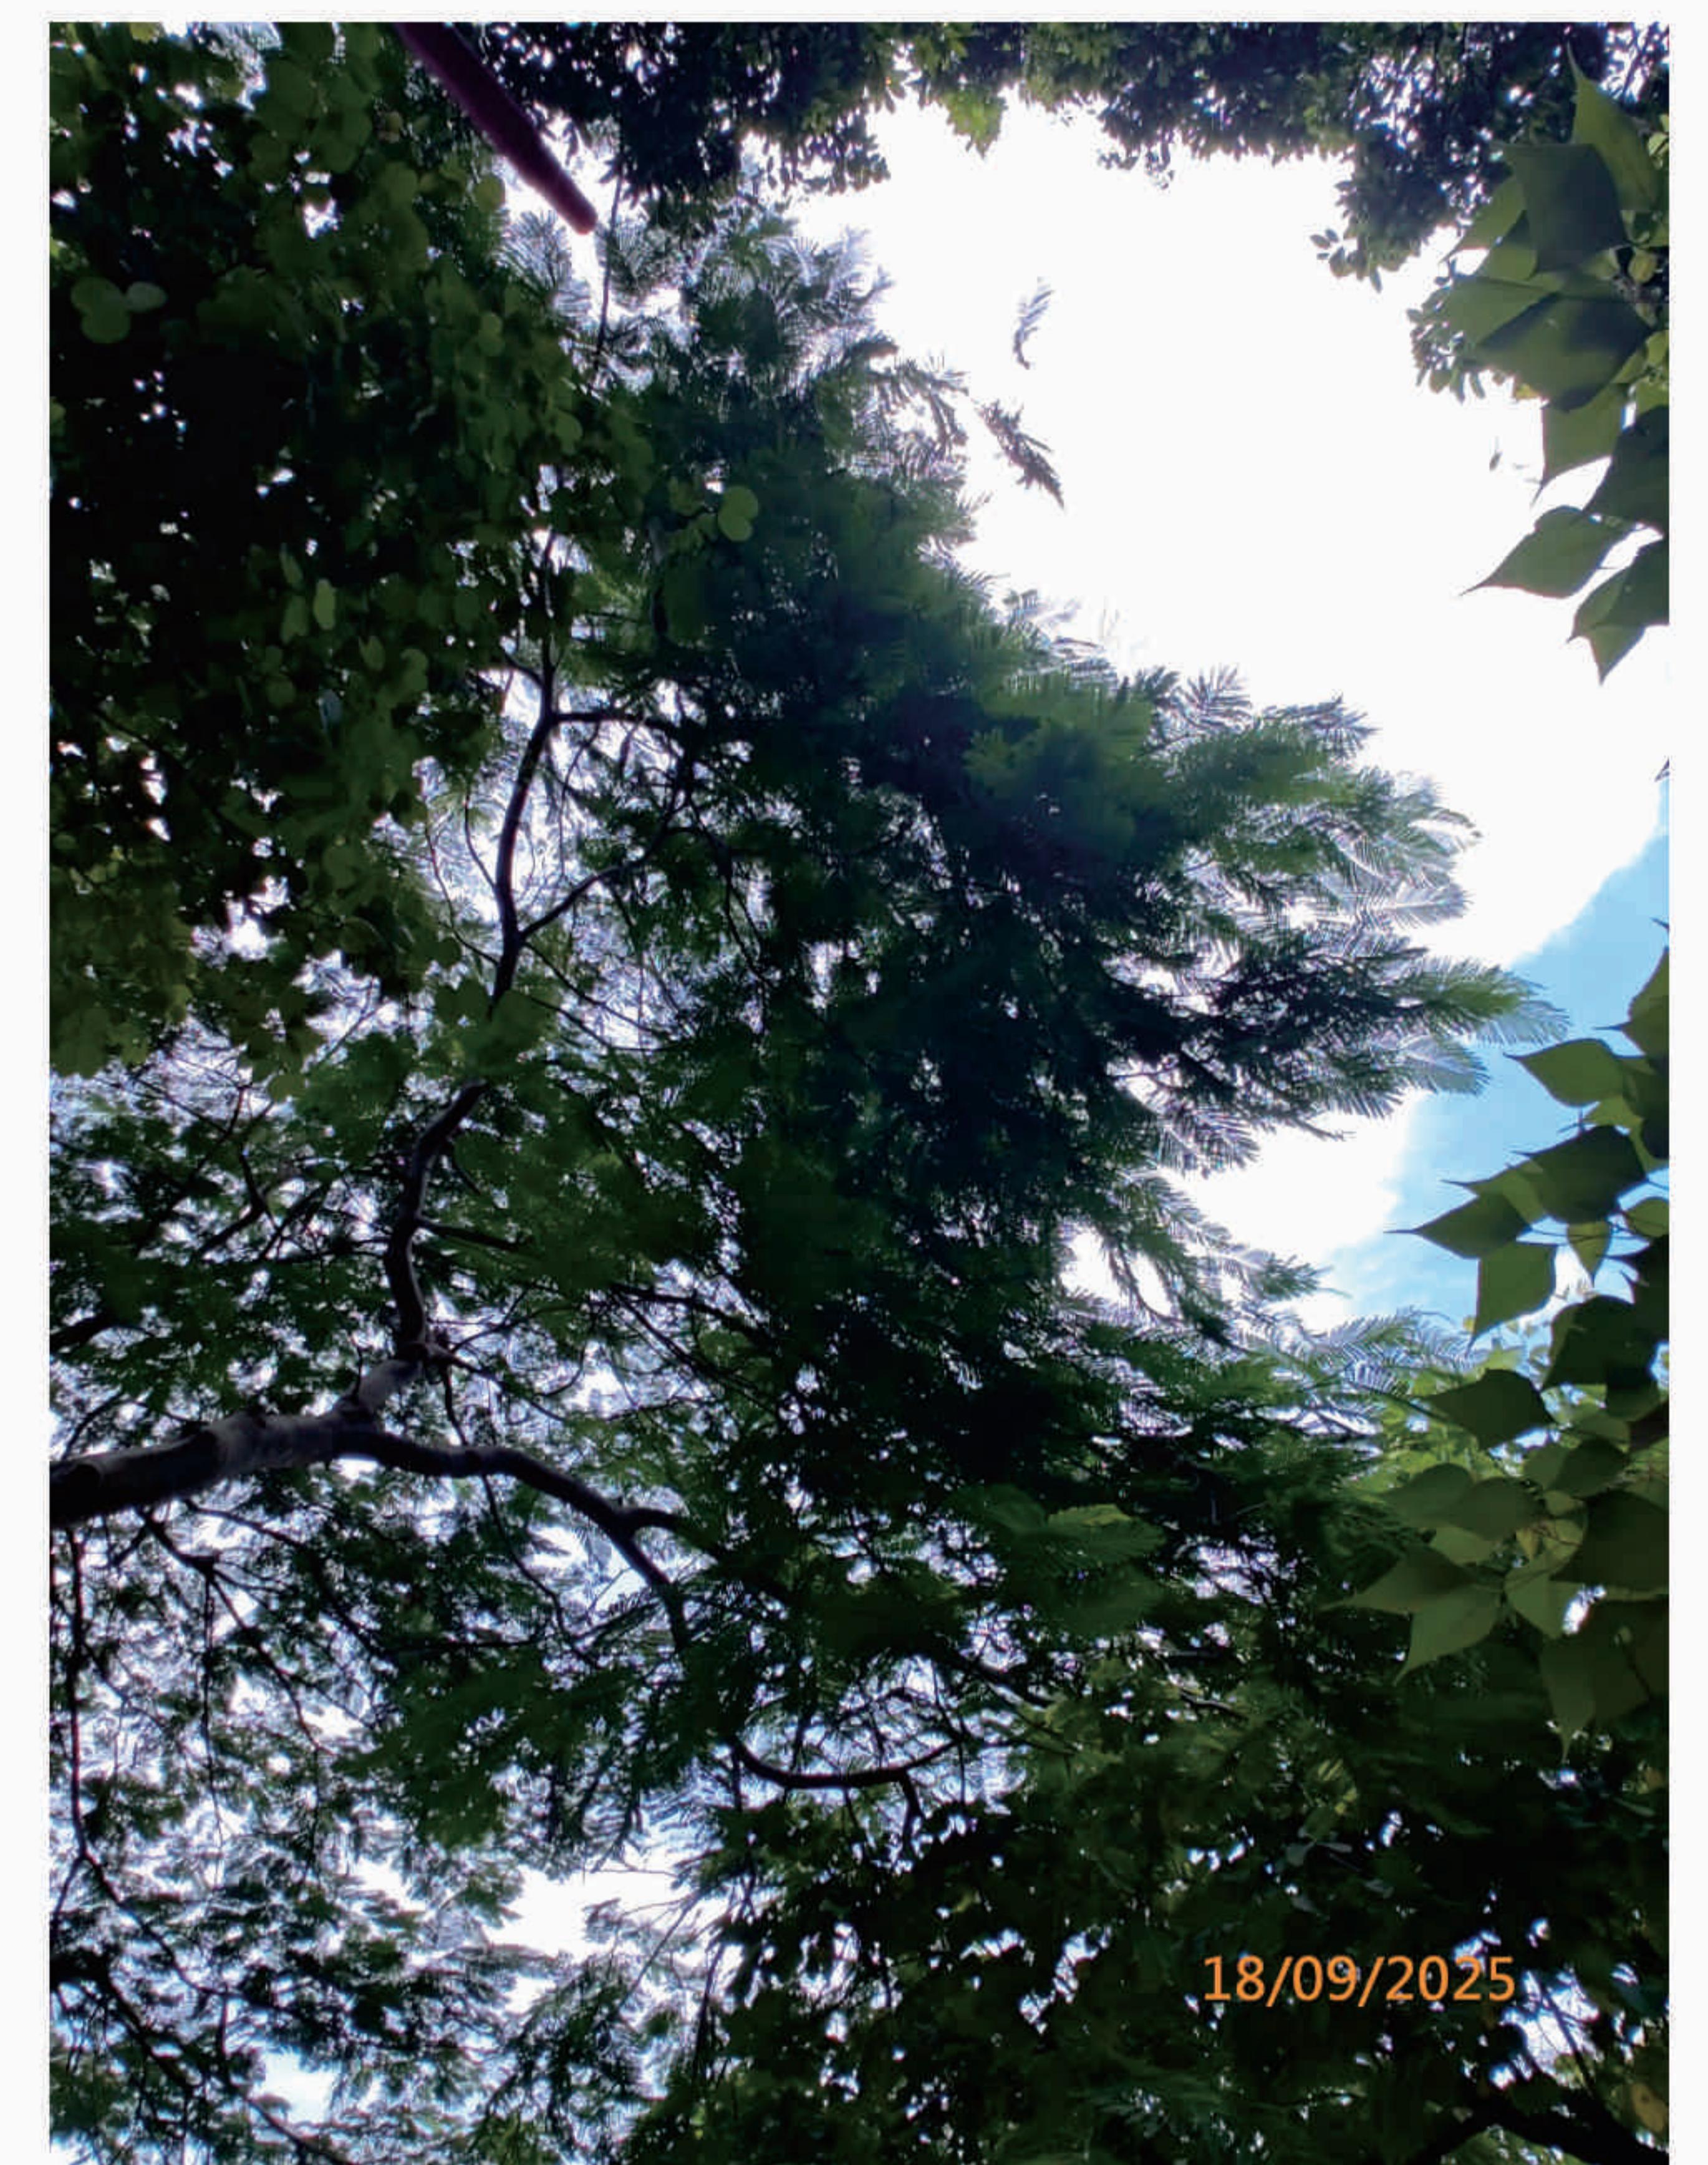
T439 - Imbalanced Crown (F)

4.10 Another **8** disturbed trees, namely **T434**, **A08**, **A09** – *Bauhinia purpurea*, **T439**, **T441**, **A06** – *Delonix regia* and **T440**, **T442** – *Lagerstroemia speciosa* have exhibited poor tree form or health conditions. Transplanting these trees would require significant deformation, which would likely result in irreversible damage to their form. It is proposed to fell these trees and compensate by planting high-quality replacements.

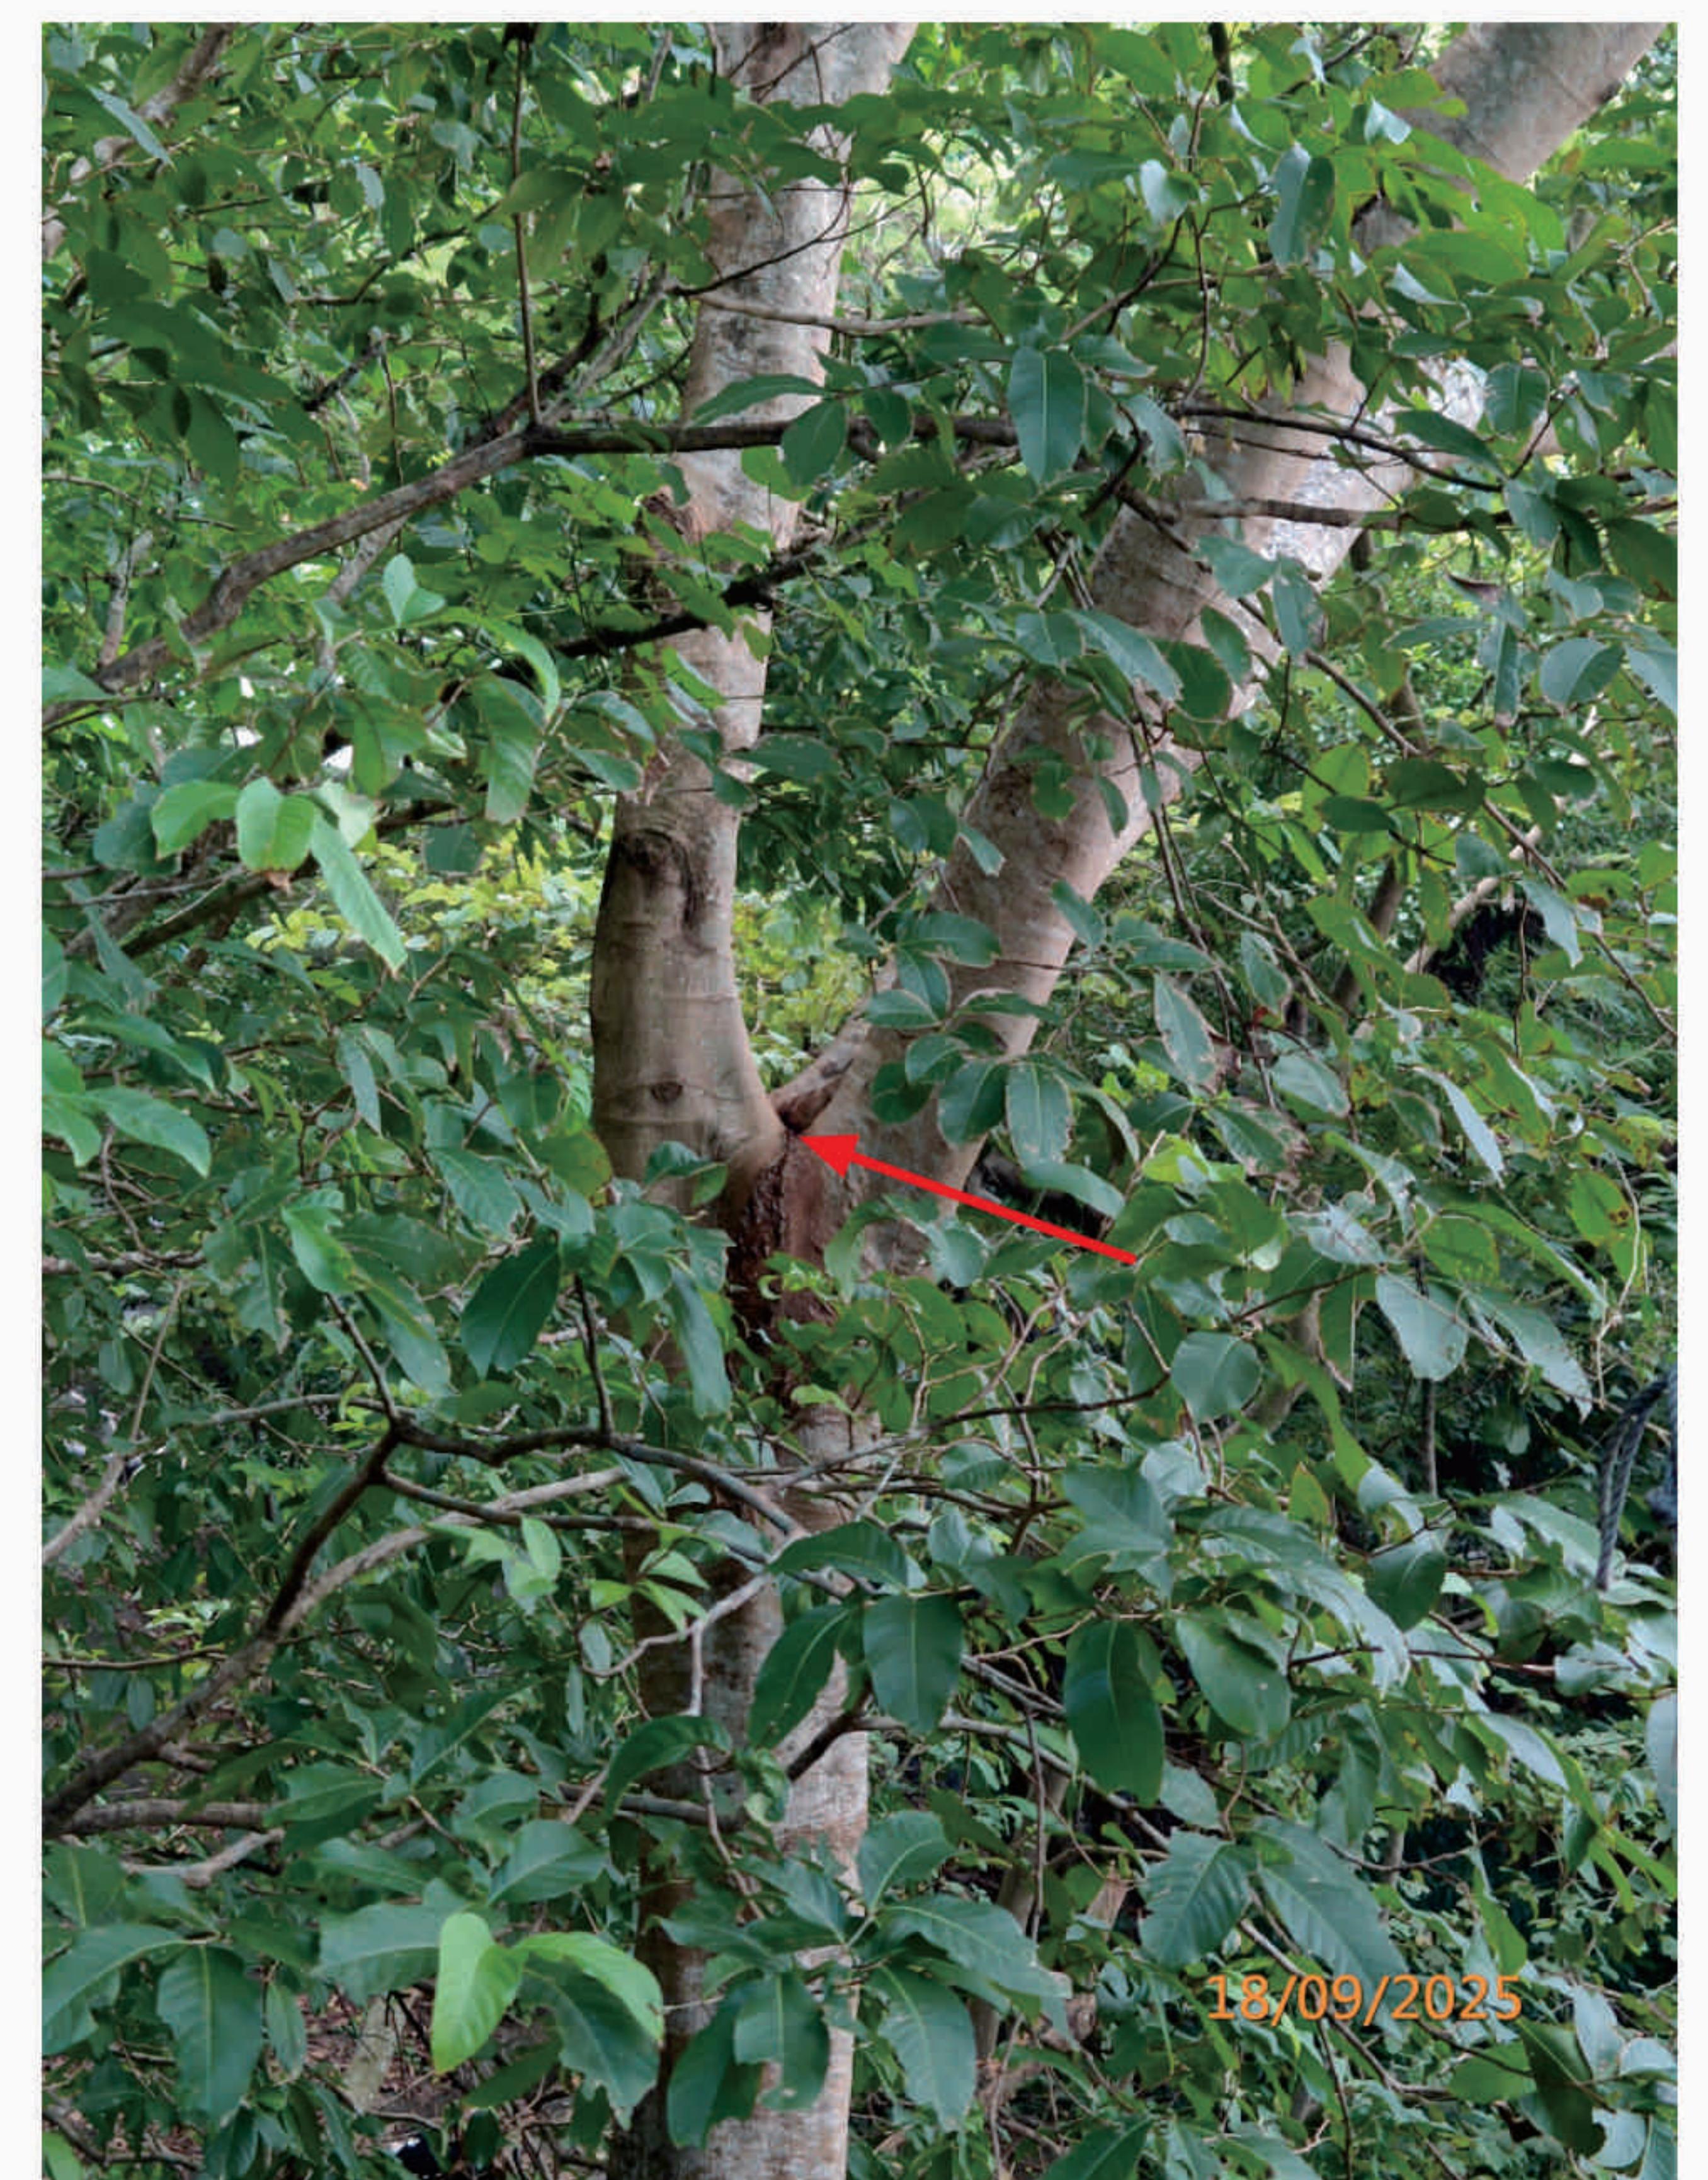
T441 - Multiple Attachments with Included Bark (F)

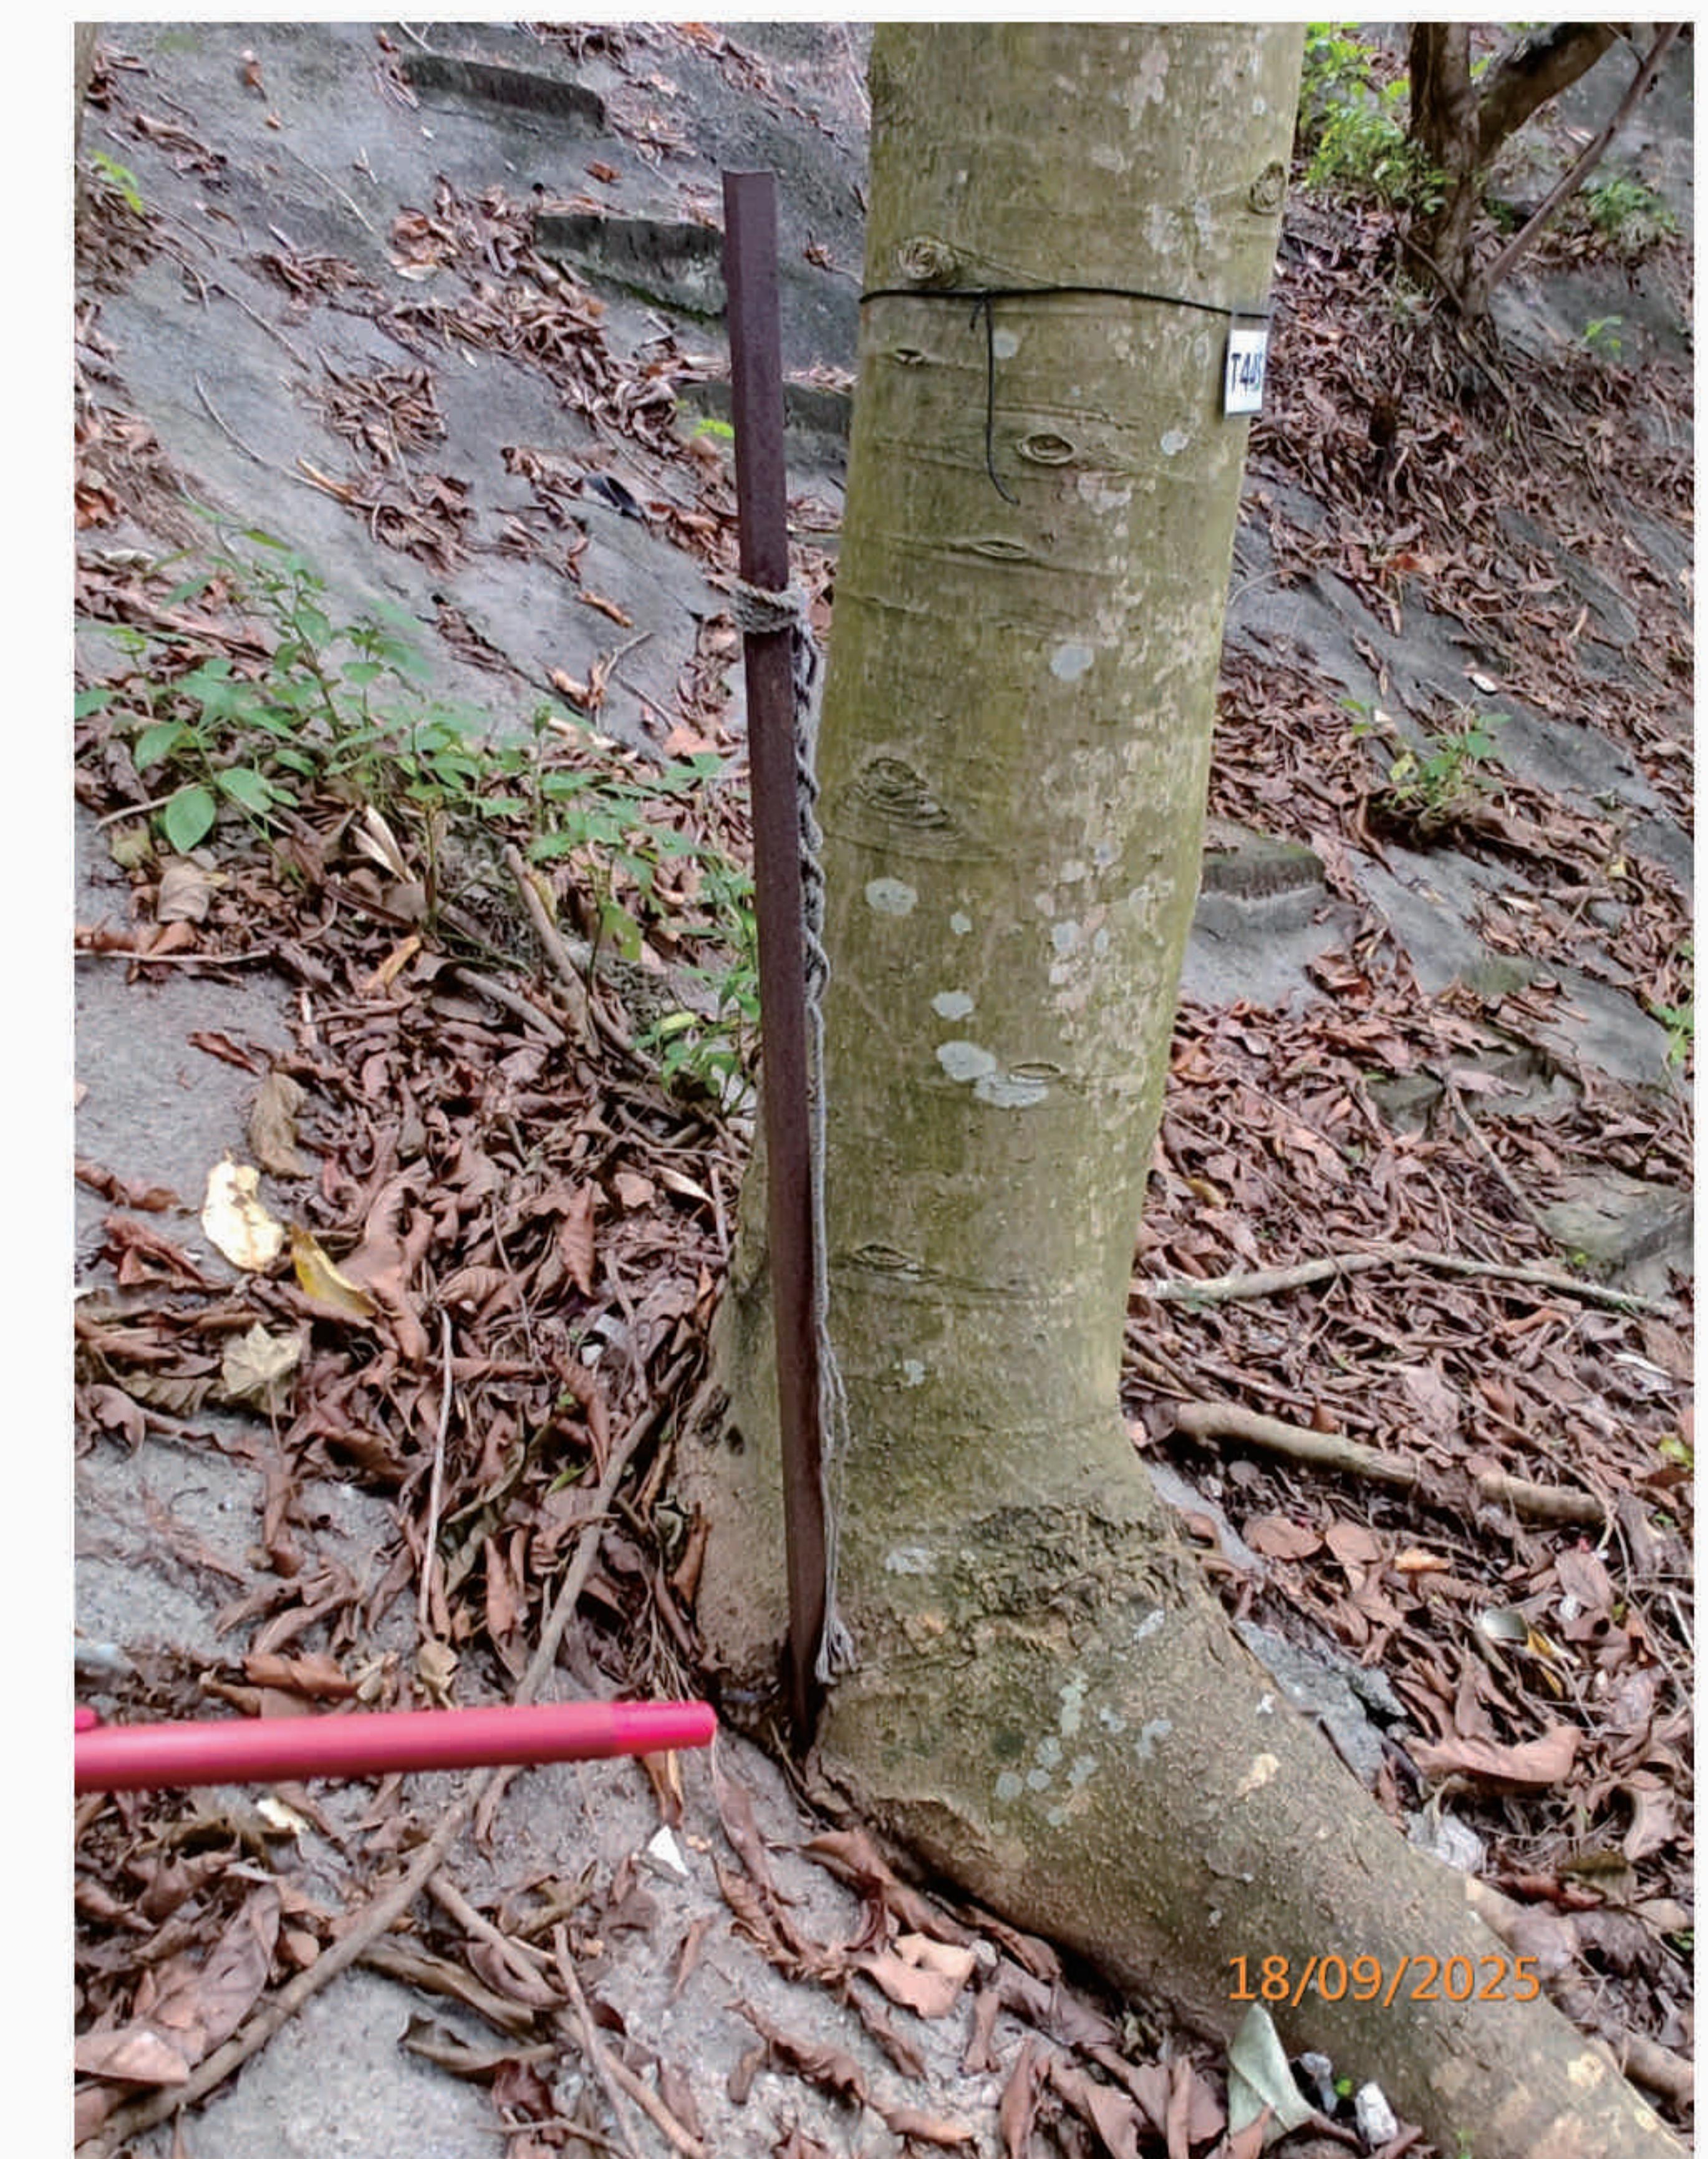
4.6 It is important to mention that tree no. **T455** – *Michelia x alba* is a protected species under Cap.96 and is a mature specimen, approx.. 18m high. Proper tree protection measures and close monitoring will be implemented to safeguard this tree.

T445 - Iron Bar Embedded in Trunk (R)

4.5 Due to the development activities and limited space remaining, only **5** trees including **A11, A12, A13 – Bauhinia purpurea, T445 – Michelia x alba** and **T459 – Dimocarpus longan** will be unaffected by the Proposed Utility Installation. The retained trees will be protected and maintained in accordance with the details specified in Section 25 – Landscape Work of the General Specification for Building (2022) and the relevant guidelines issued by DEVB. Please also refer to the **Tree Protection Plan** in **Appendix D**.
