**PLANNING APPLICATION FOR
PROPOSED UTILITY INSTALLATION FOR PRIVATE PROJECT
AT GOVERNMENT LAND ADJOINING 44 STANLEY VILLAGE ROAD,
STANLEY, HON KONG**

Tree Survey Report

Date: 13 November 2025

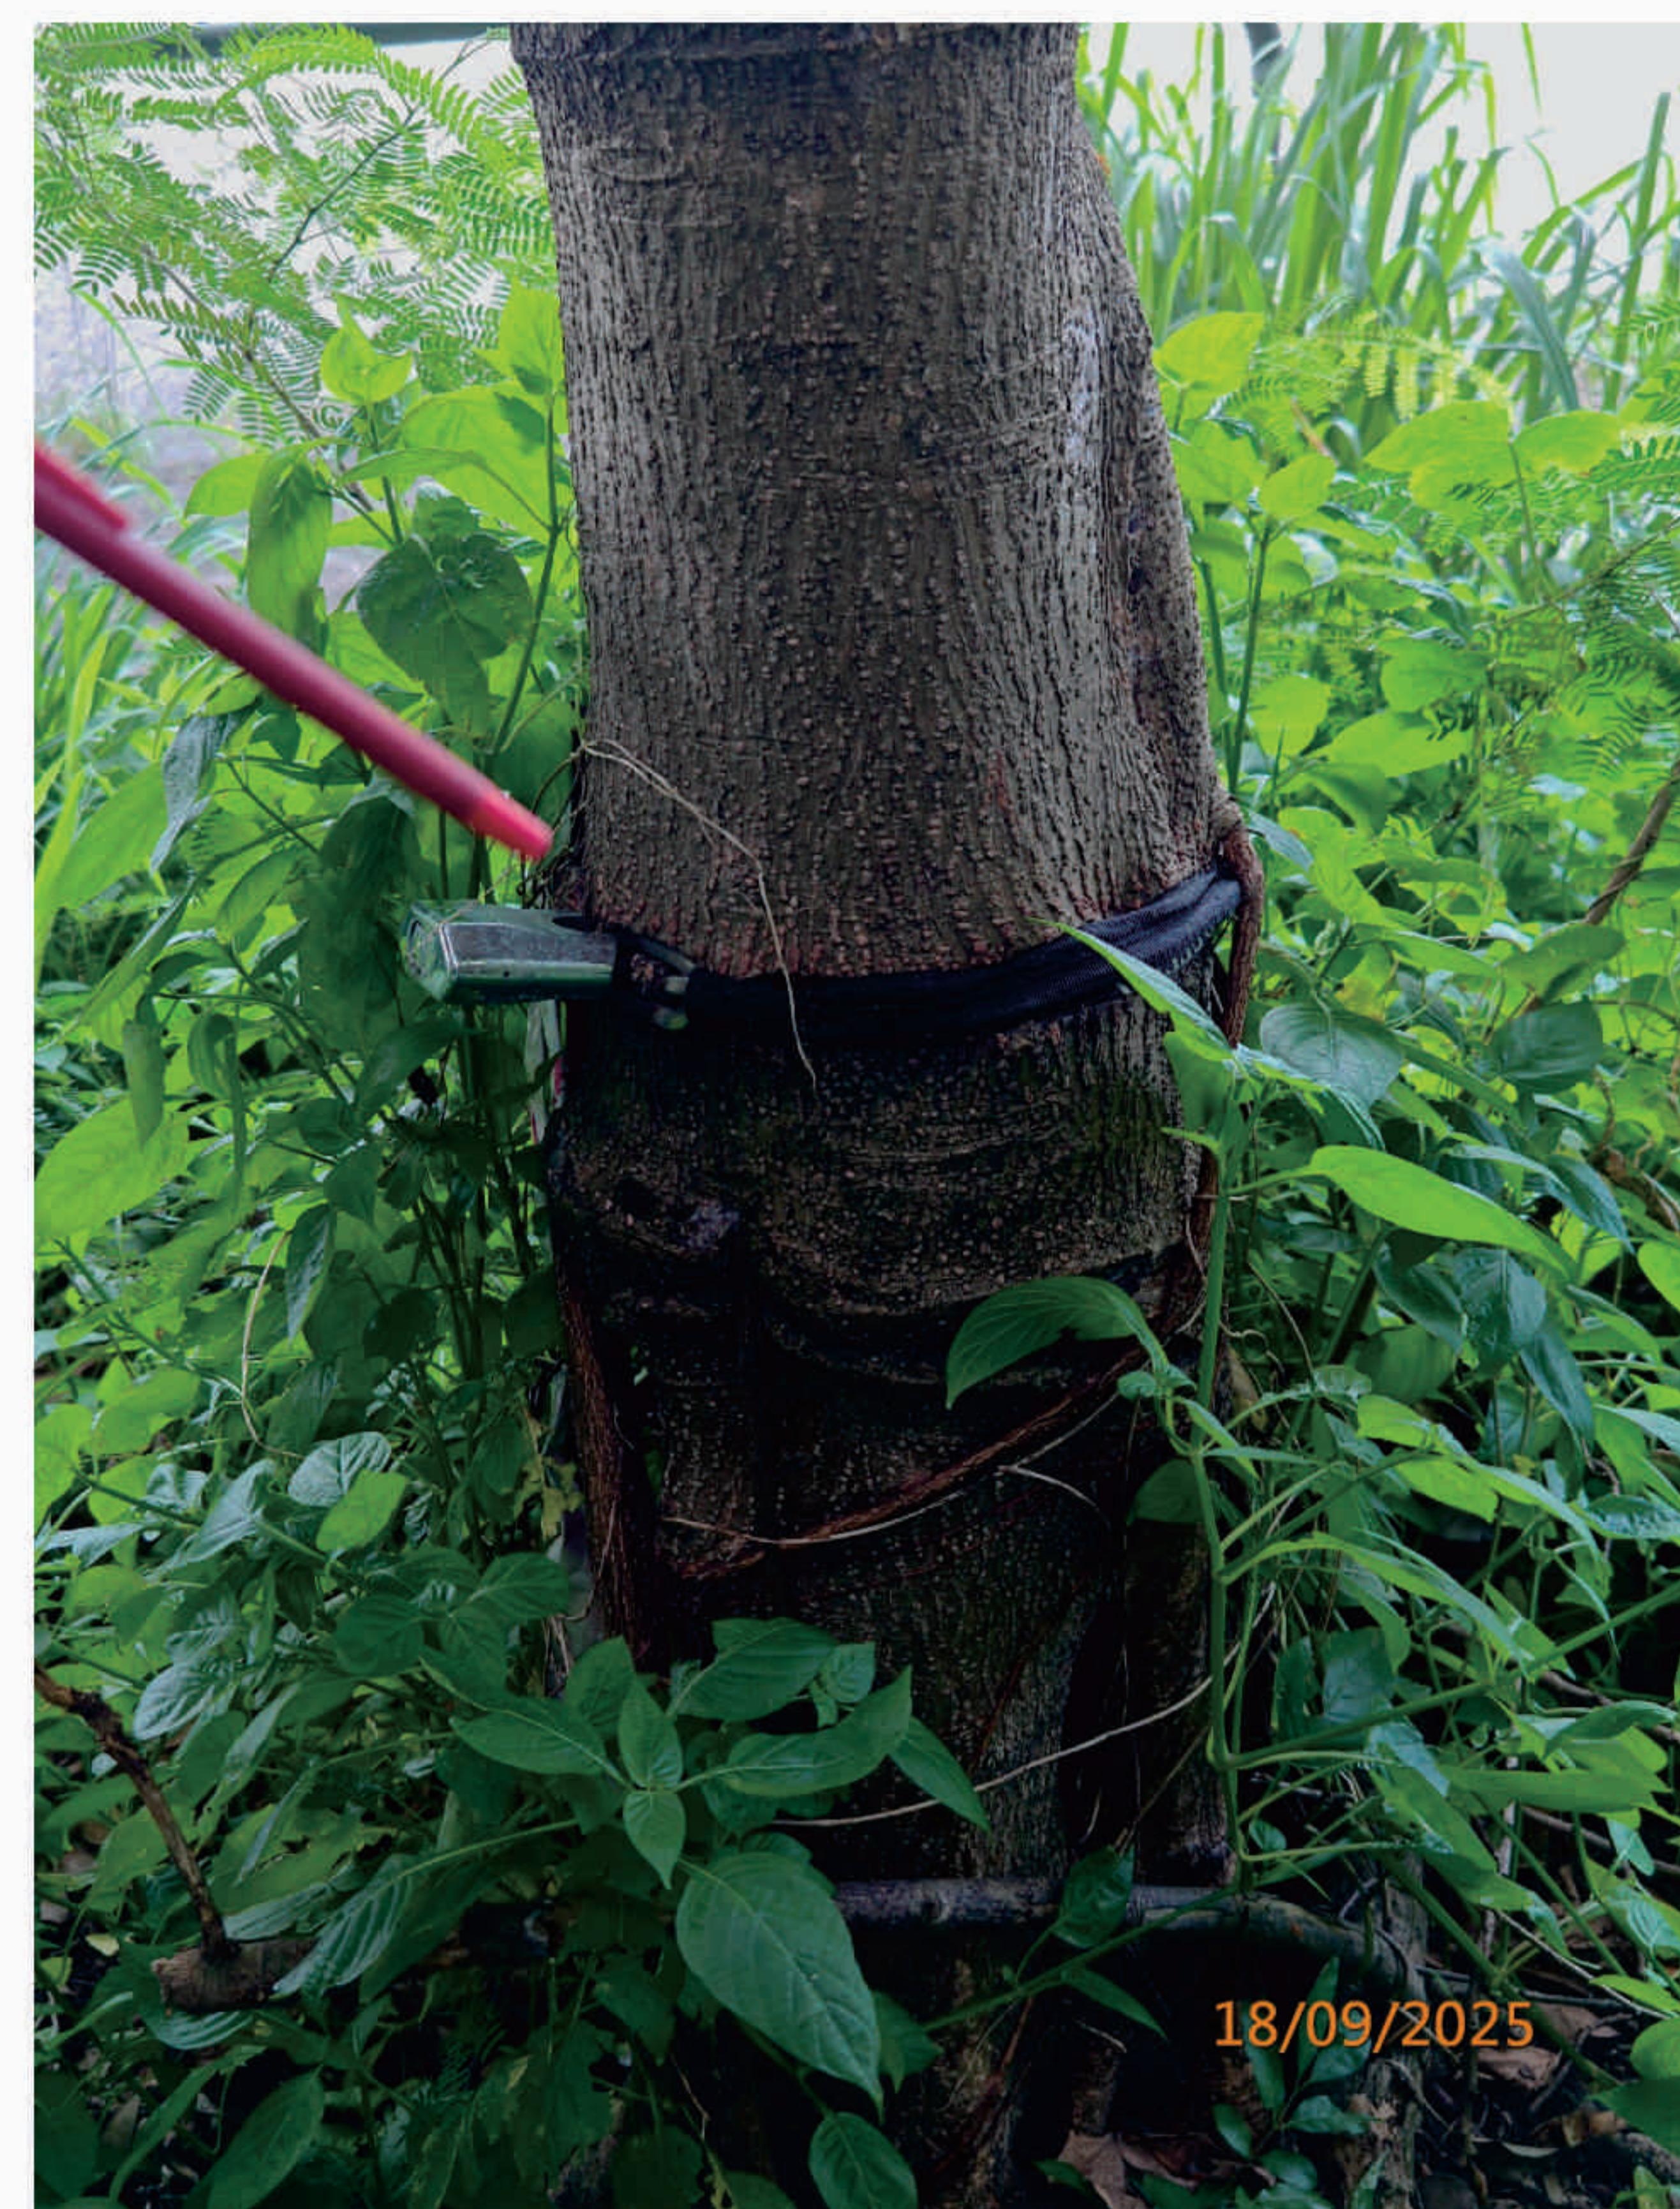
T459	<i>Dimocarpus longan</i>	龍眼	6.5	103.00	4.0	Retain	restricted root, leaning trunk
T466	<i>Ficus altissima</i>	高山榕	10.0	207.00	6.0	Fell	restricted root, leaning trunk, chain embedded in trunk
A06	<i>Delonix regia</i>	鳳凰木	9.0	144.00	6.0	Fell	restricted root, leaning trunk, imbalanced crown
A07	<i>Macaranga tanarius</i> var. <i>tomentosa</i>	血桐	9.0	240.00	6.0	Fell	restricted root, multiple trunks, included bark, decay in trunk base
A08	<i>Bauhinia purpurea</i>	紅花羊蹄甲	9.0	147.00	4.0	Fell	restricted root, leaning trunk
A09	<i>Bauhinia purpurea</i>	紅花羊蹄甲	8.0	328.00	7.0	Fell	restricted root, leaning trunk, multiple trunks, included bark, broken branch
A11	<i>Bauhinia purpurea</i>	紅花羊蹄甲	5.5	132.00	5.0	Retain	co-dominant trunks, included bark, imbalanced crown
A12	<i>Bauhinia purpurea</i>	紅花羊蹄甲	9.0	127.00	6.0	Retain	restricted root, decay in trunk
A13	<i>Bauhinia purpurea</i>	紅花羊蹄甲	10.0	162.00	5.0	Retain	restricted root

T466 - Chain Embedded in Trunk (F)

4.9 **3** affected trees, namely **T466** – *Ficus altissima*, **T435**, **A07** – *Macaranga tanarius* var. *tomentosa* are common hillside species in Hong Kong. As they are propagated from the adjacent hillsides, their root systems are very susceptible to environmental changes. This renders them a relatively low survival rate after transplantation. Hence, all of these trees are also proposed to be felled.

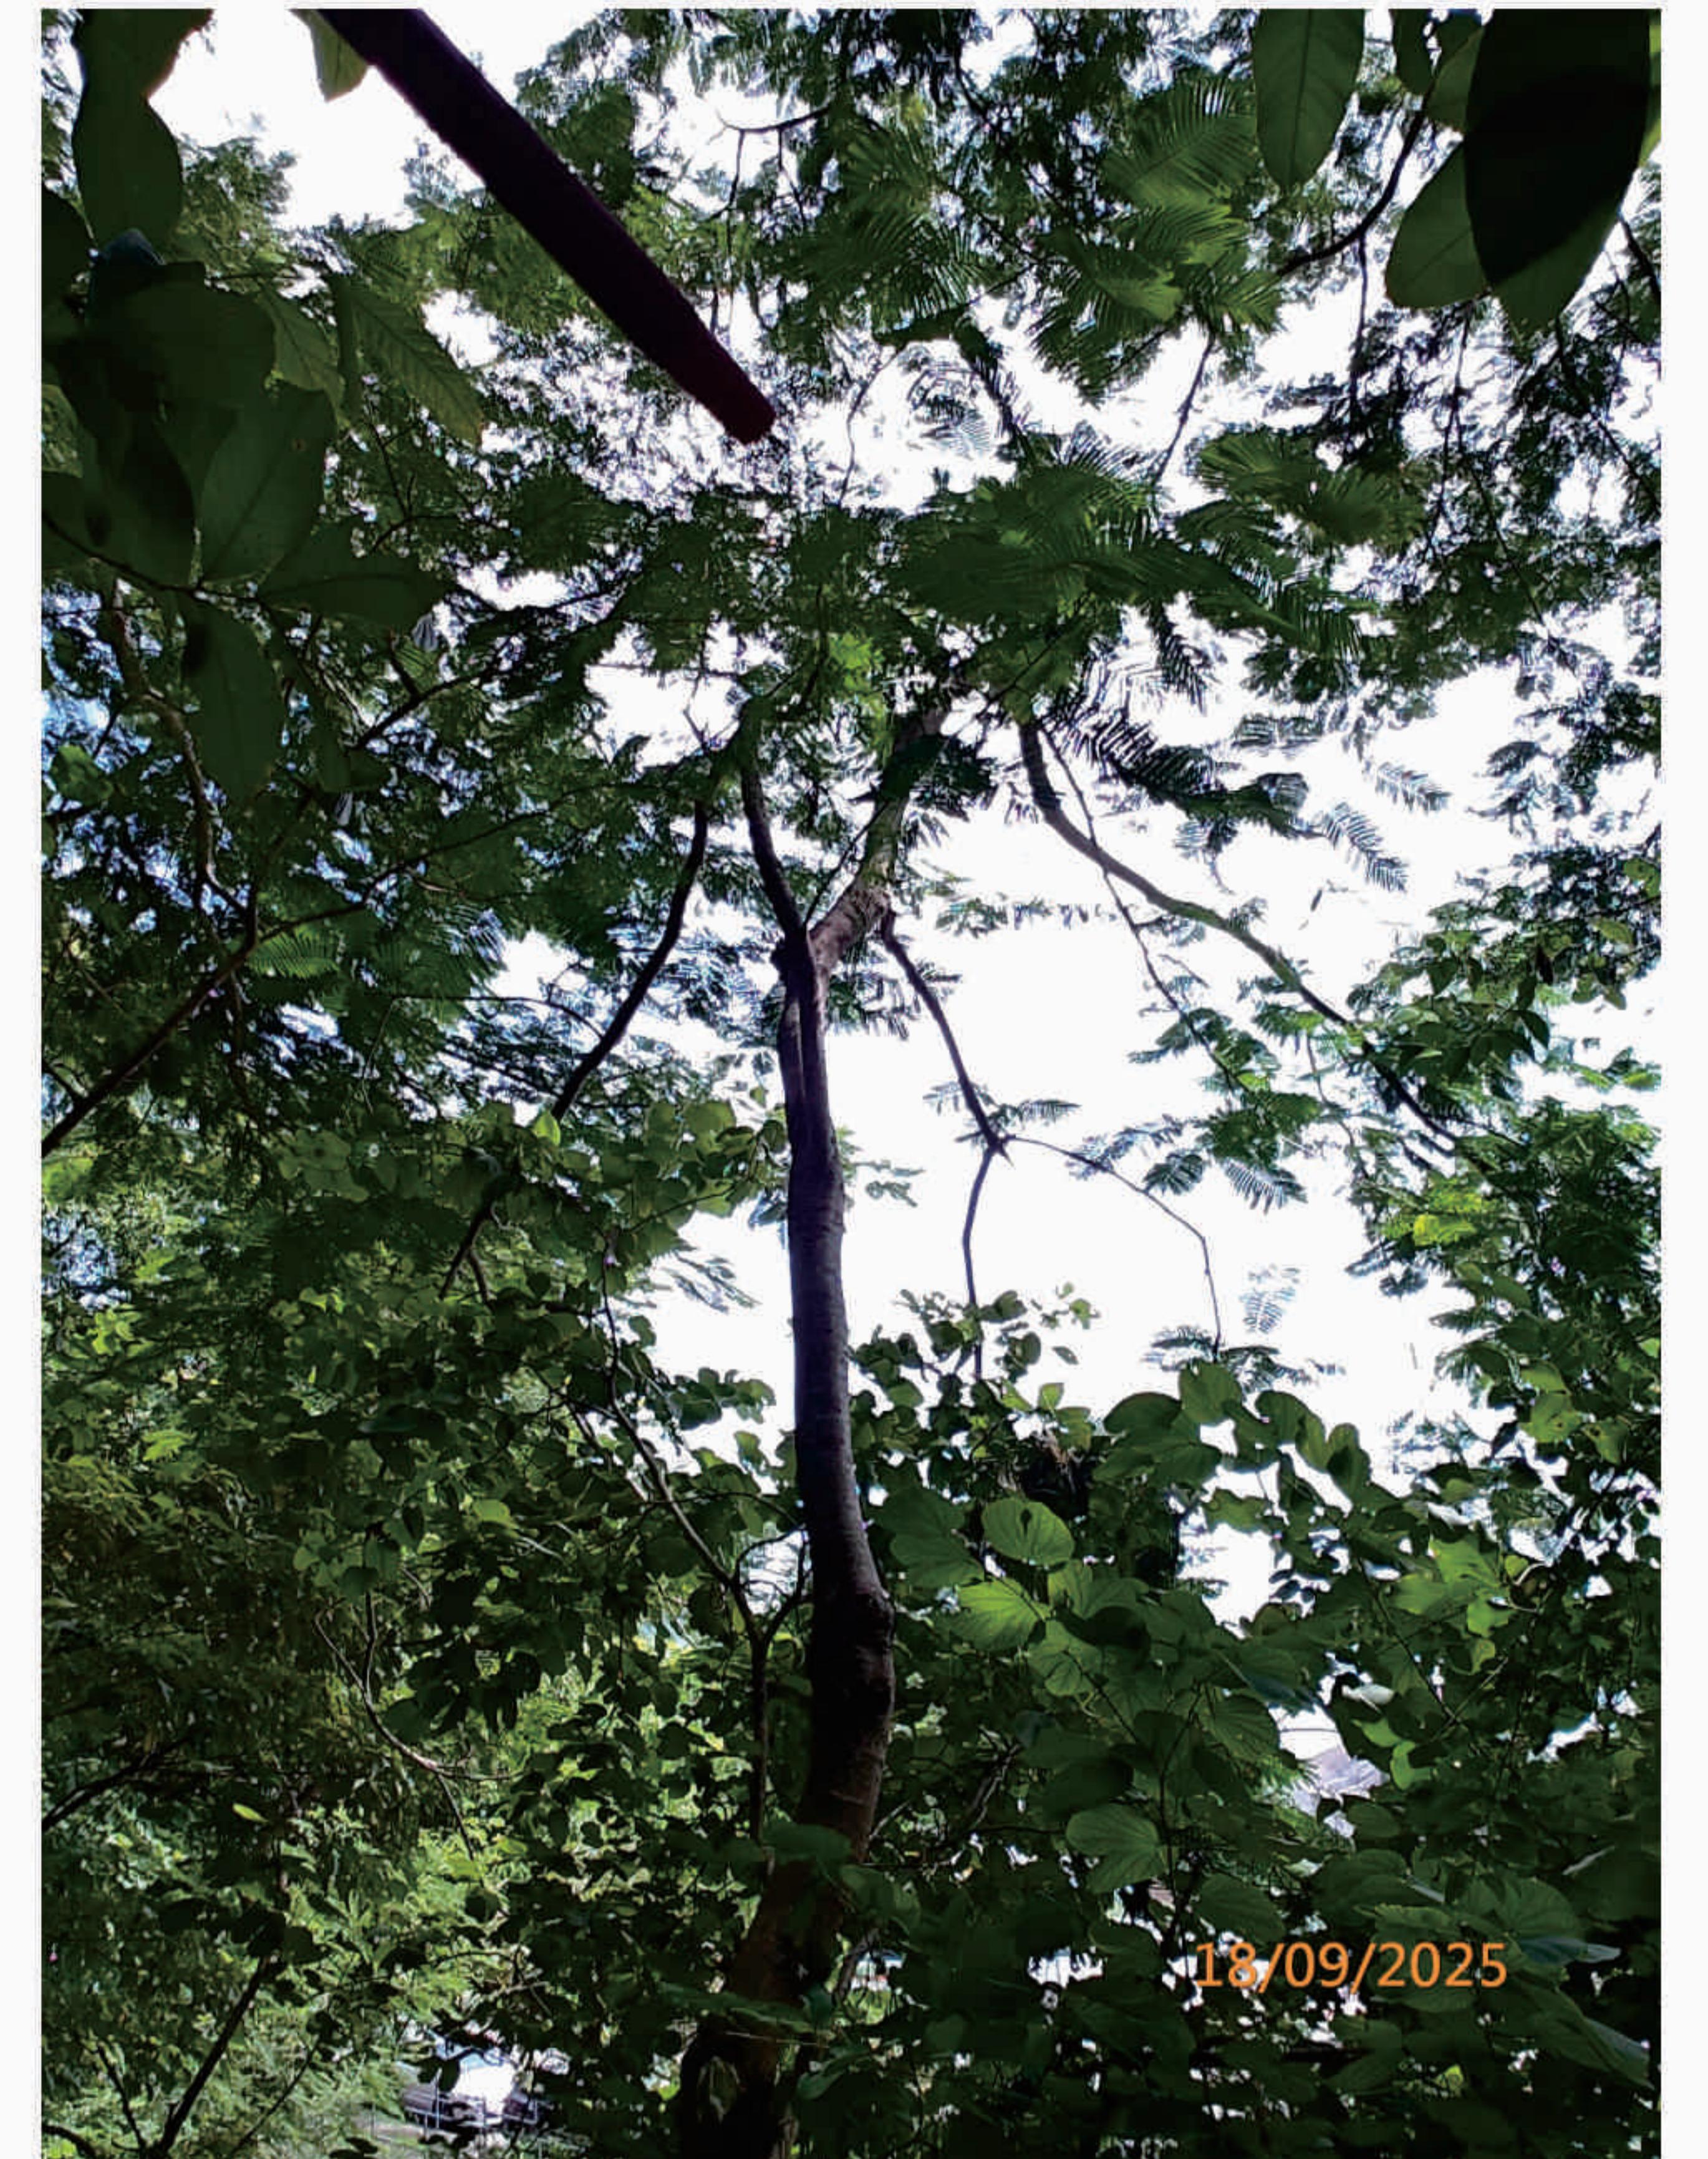
A06 - Imbalanced Crown (F)

4.10 Another **8** disturbed trees, namely **T434**, **A08**, **A09** – *Bauhinia purpurea*, **T439**, **T441**, **A06** – *Delonix regia* and **T440**, **T442** – *Lagerstroemia speciosa* have exhibited poor tree form or health conditions. Transplanting these trees would require significant deformation, which would likely result in irreversible damage to their form. It is proposed to fell these trees and compensate by planting high-quality replacements.

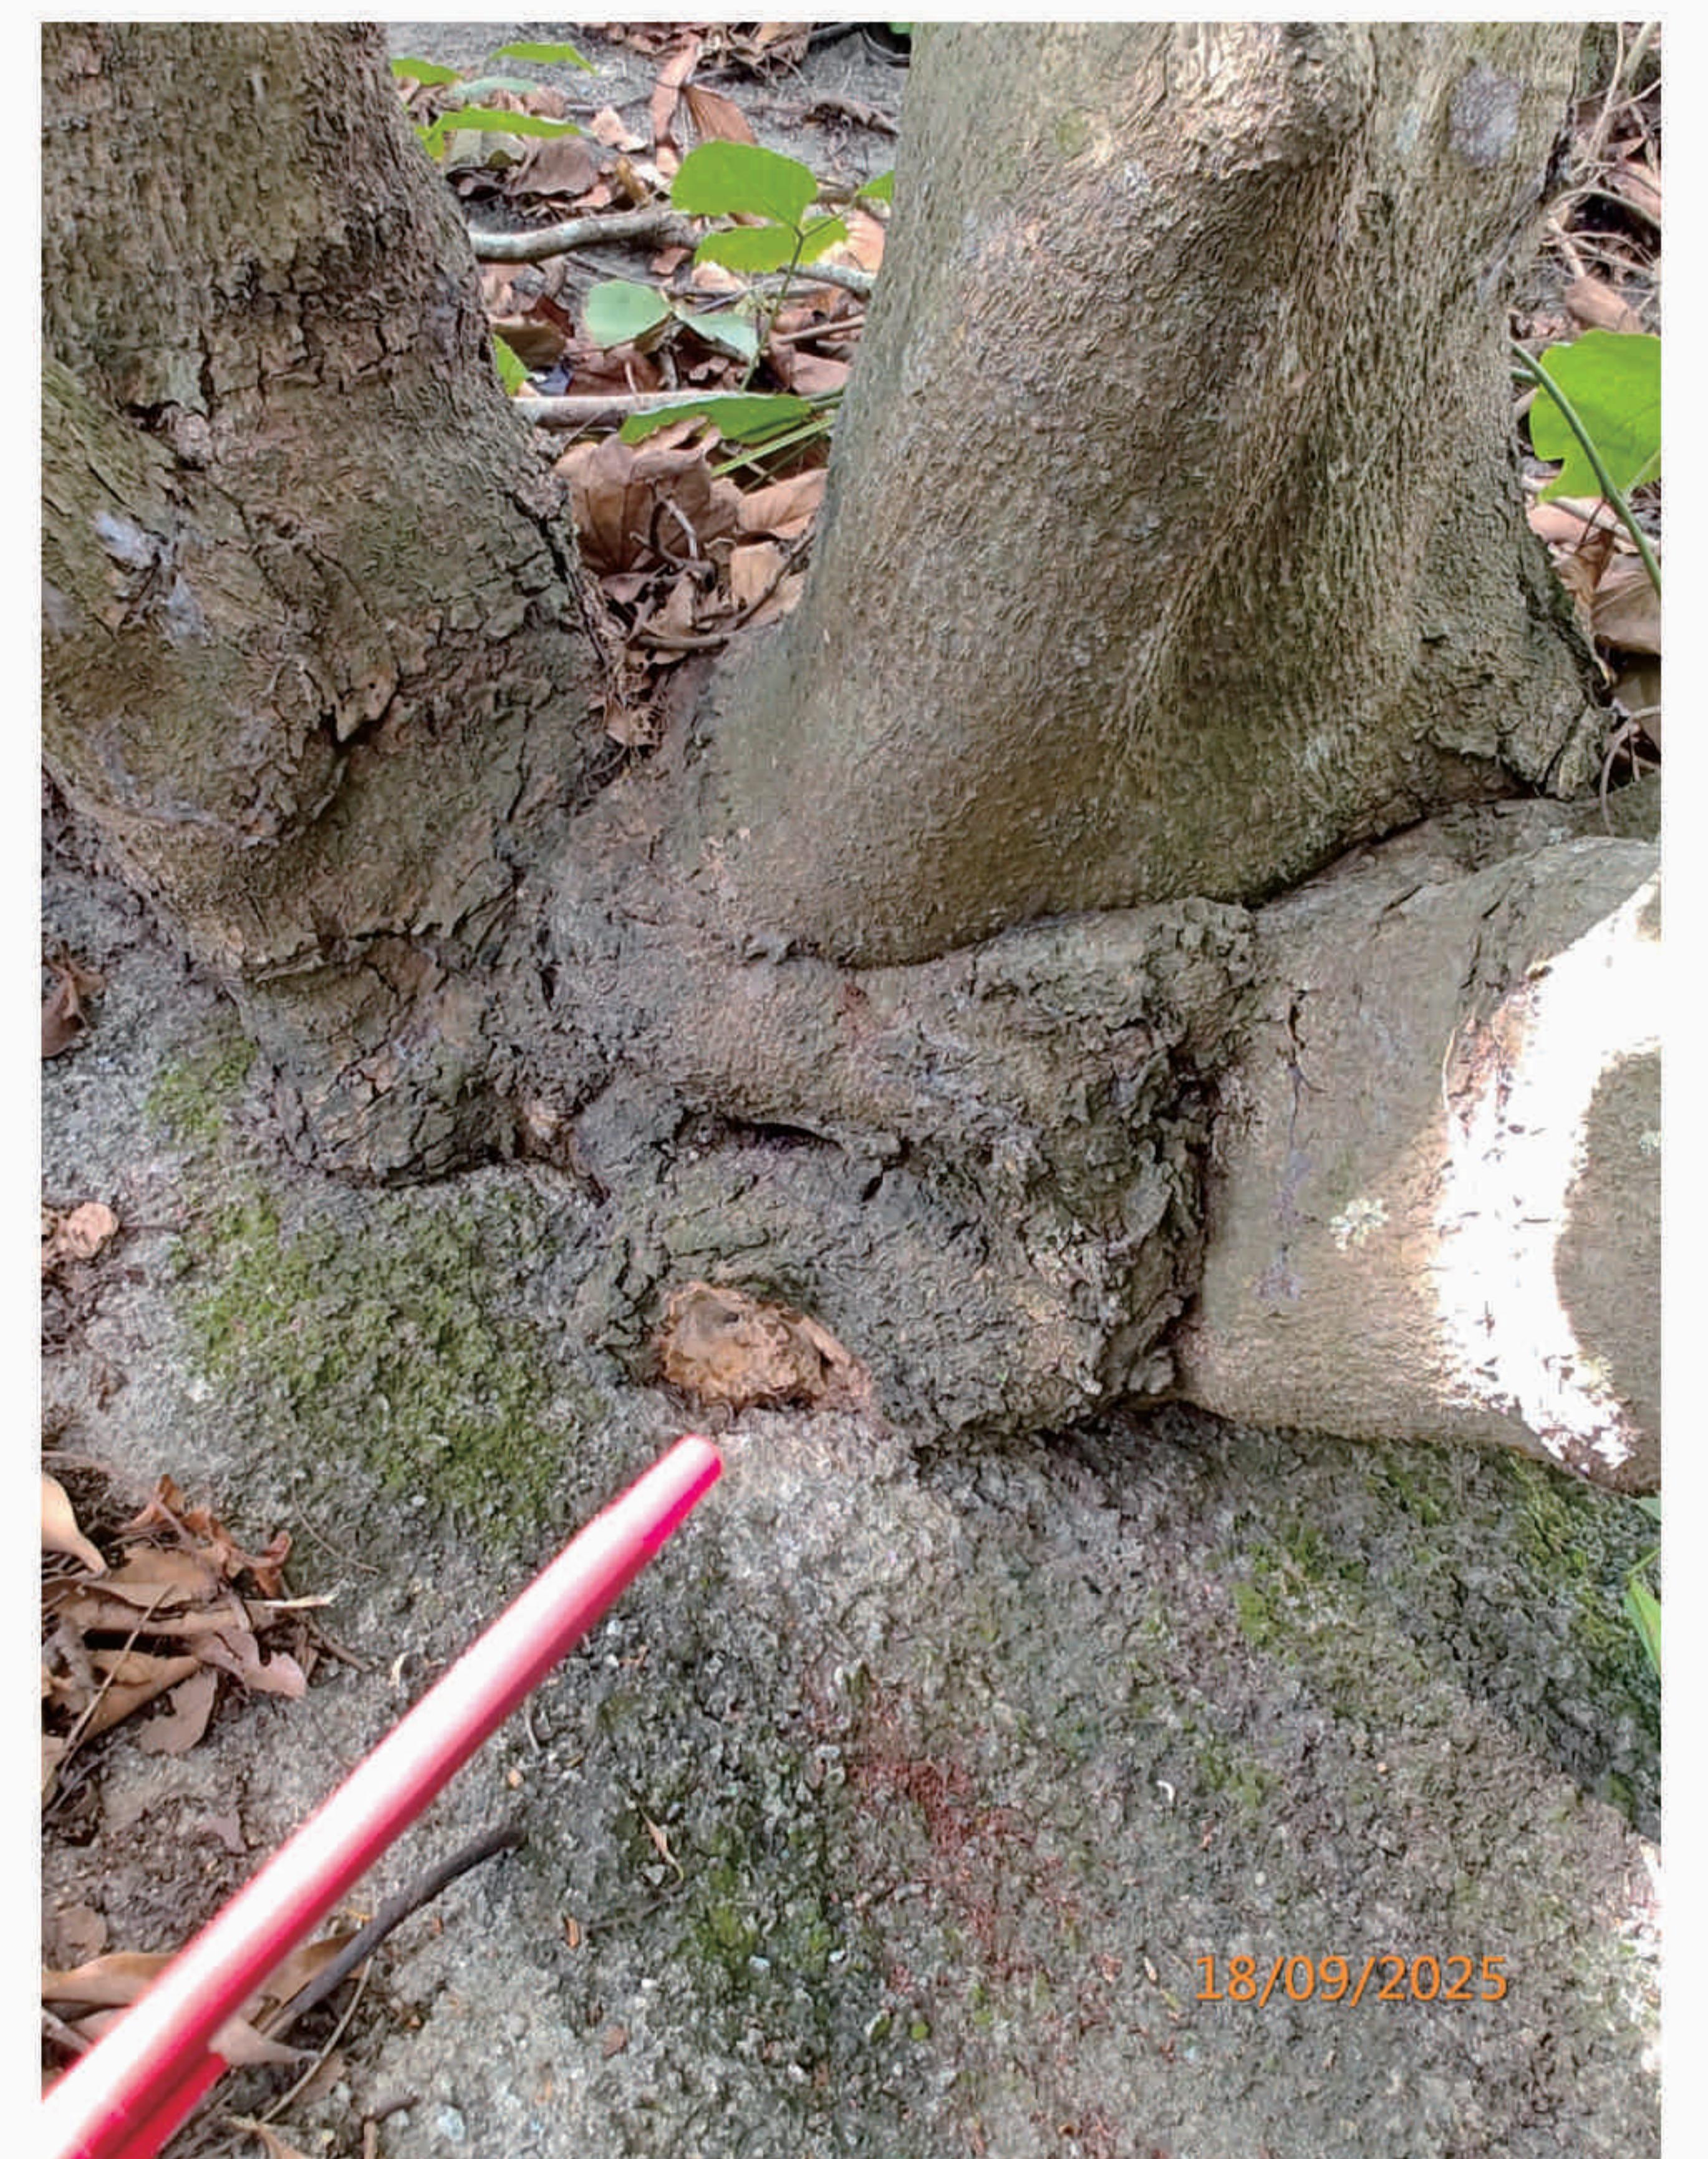
A07 - Decay in Trunk Base (F)

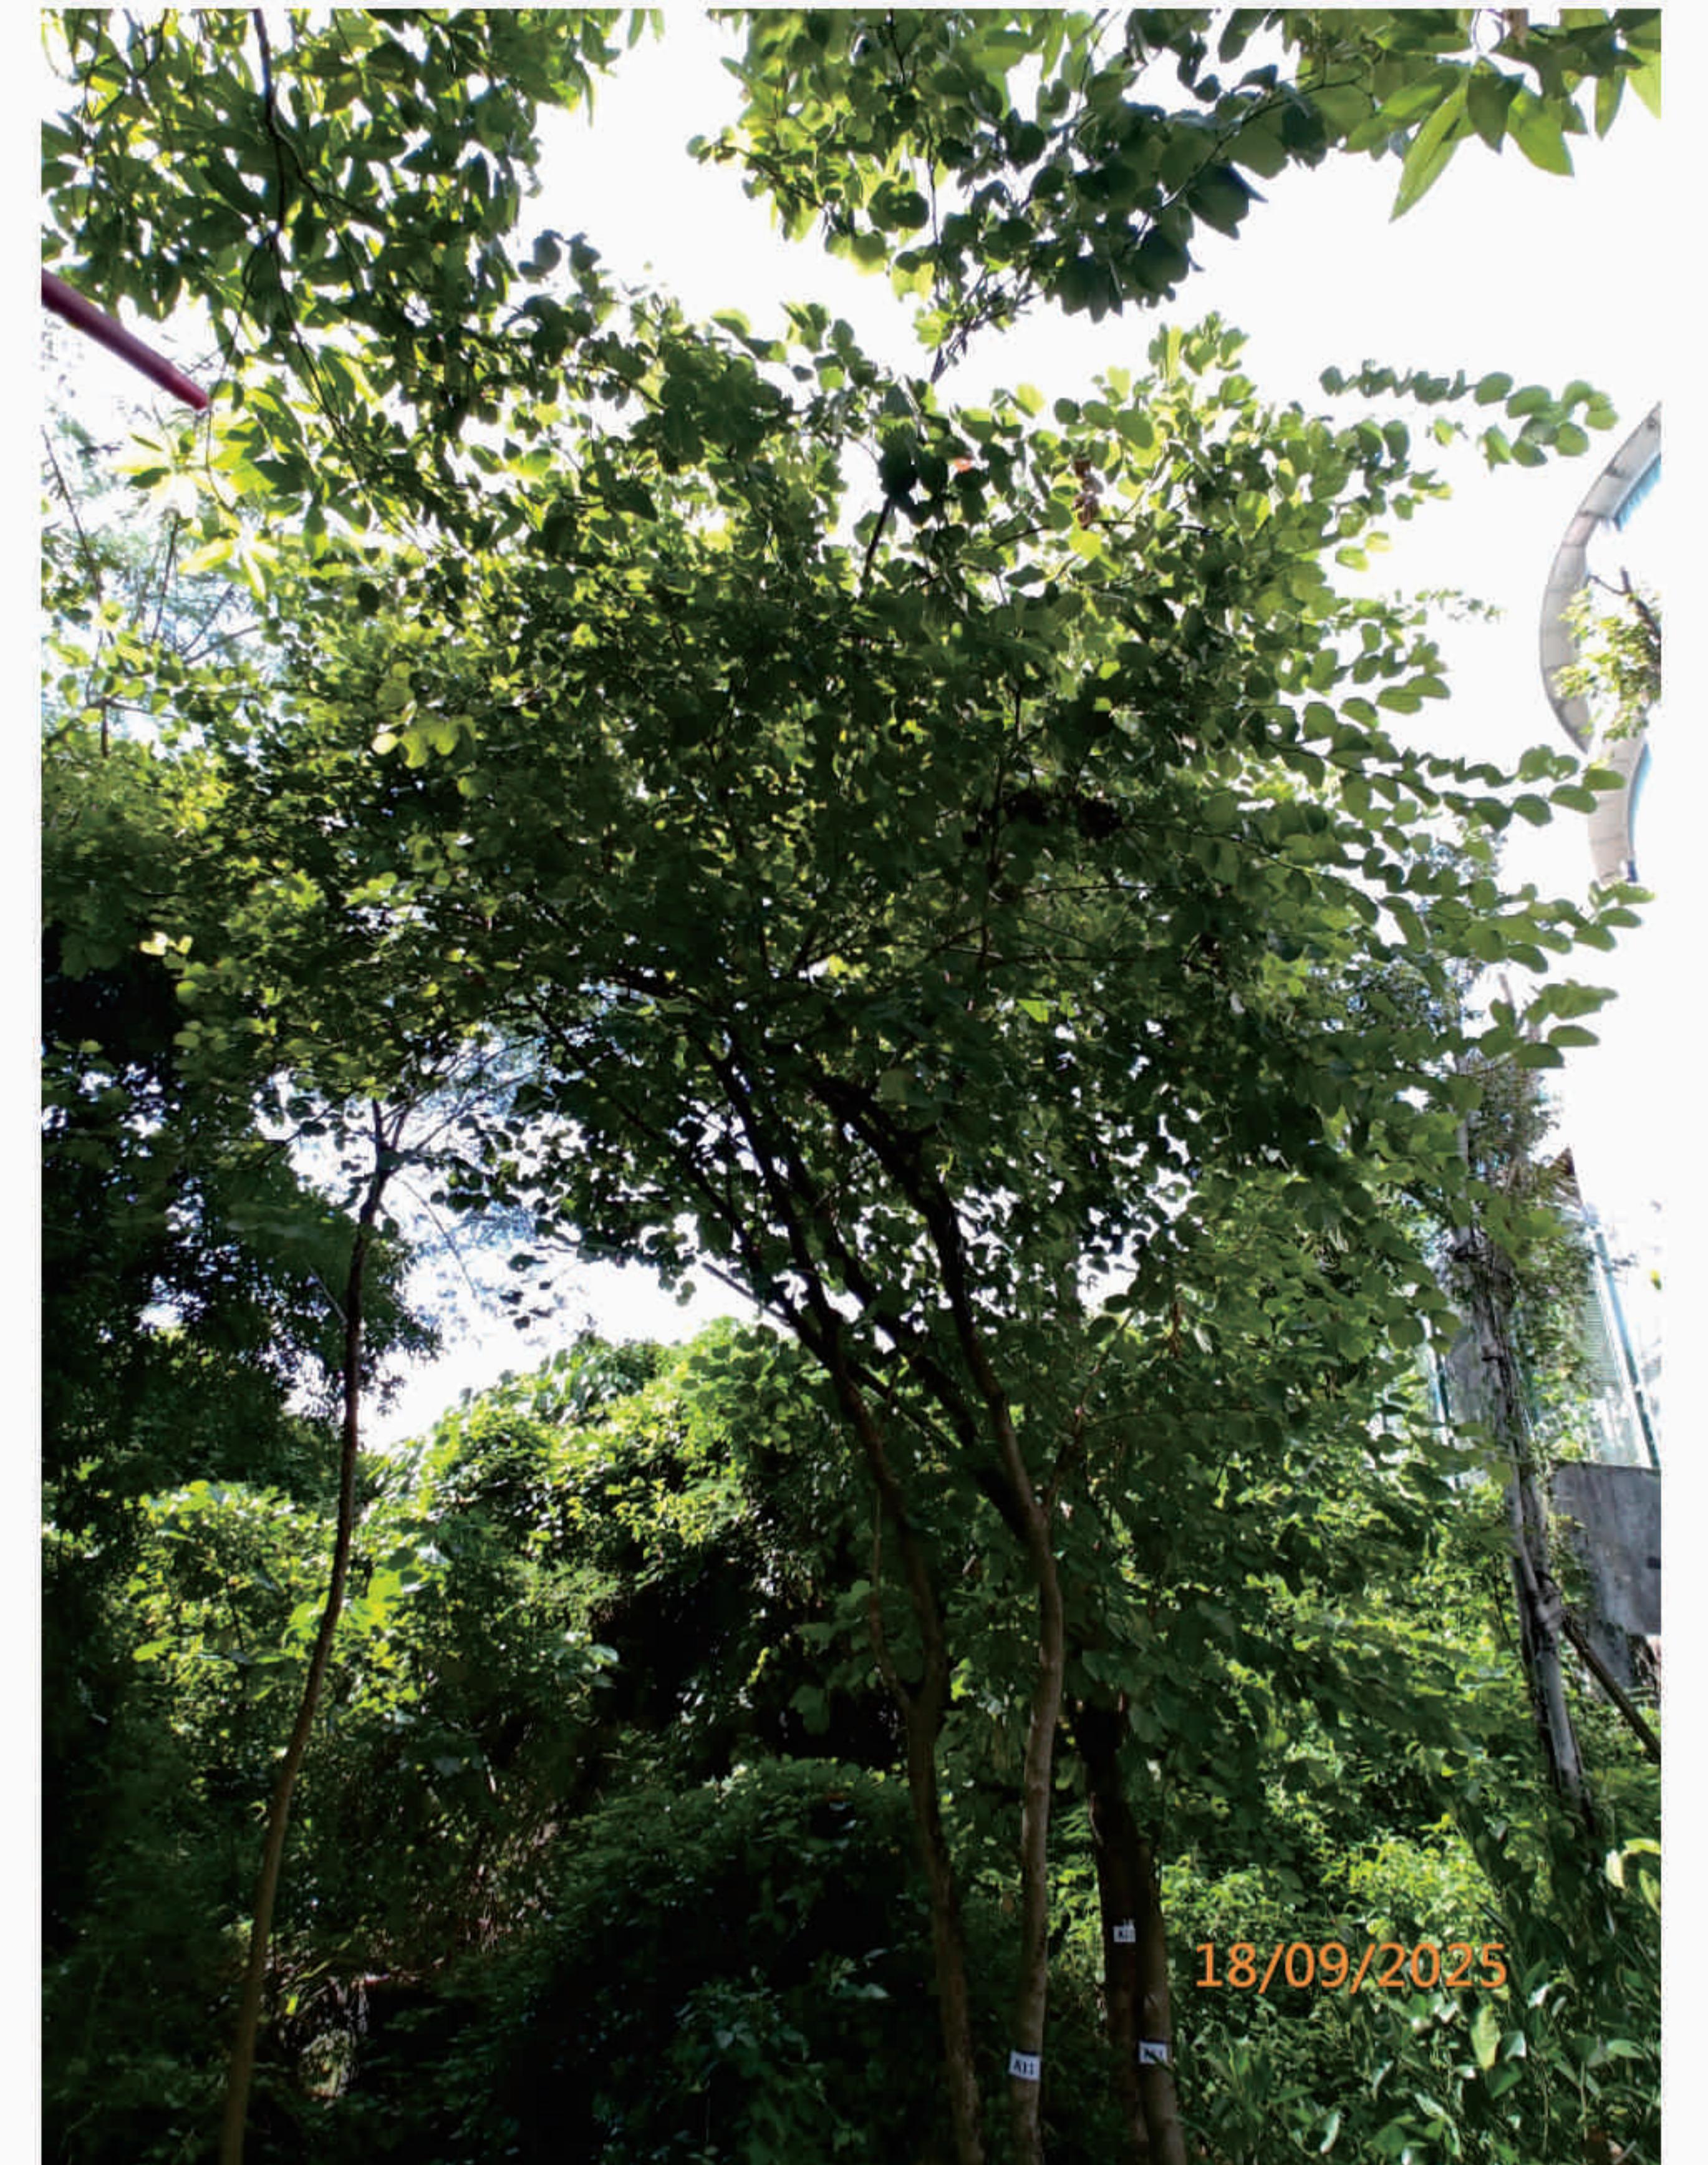
A11 - Imbalanced Crown (R)

4.5 Due to the development activities and limited space remaining, only **5** trees including **A11, A12, A13 – Bauhinia purpurea, T445 – Michelia x alba** and **T459 – Dimocarpus longan** will be unaffected by the Proposed Utility Installation. The retained trees will be protected and maintained in accordance with the details specified in Section 25 – Landscape Work of the General Specification for Building (2022) and the relevant guidelines issued by DEVB. Please also refer to the **Tree Protection Plan** in **Appendix D**.

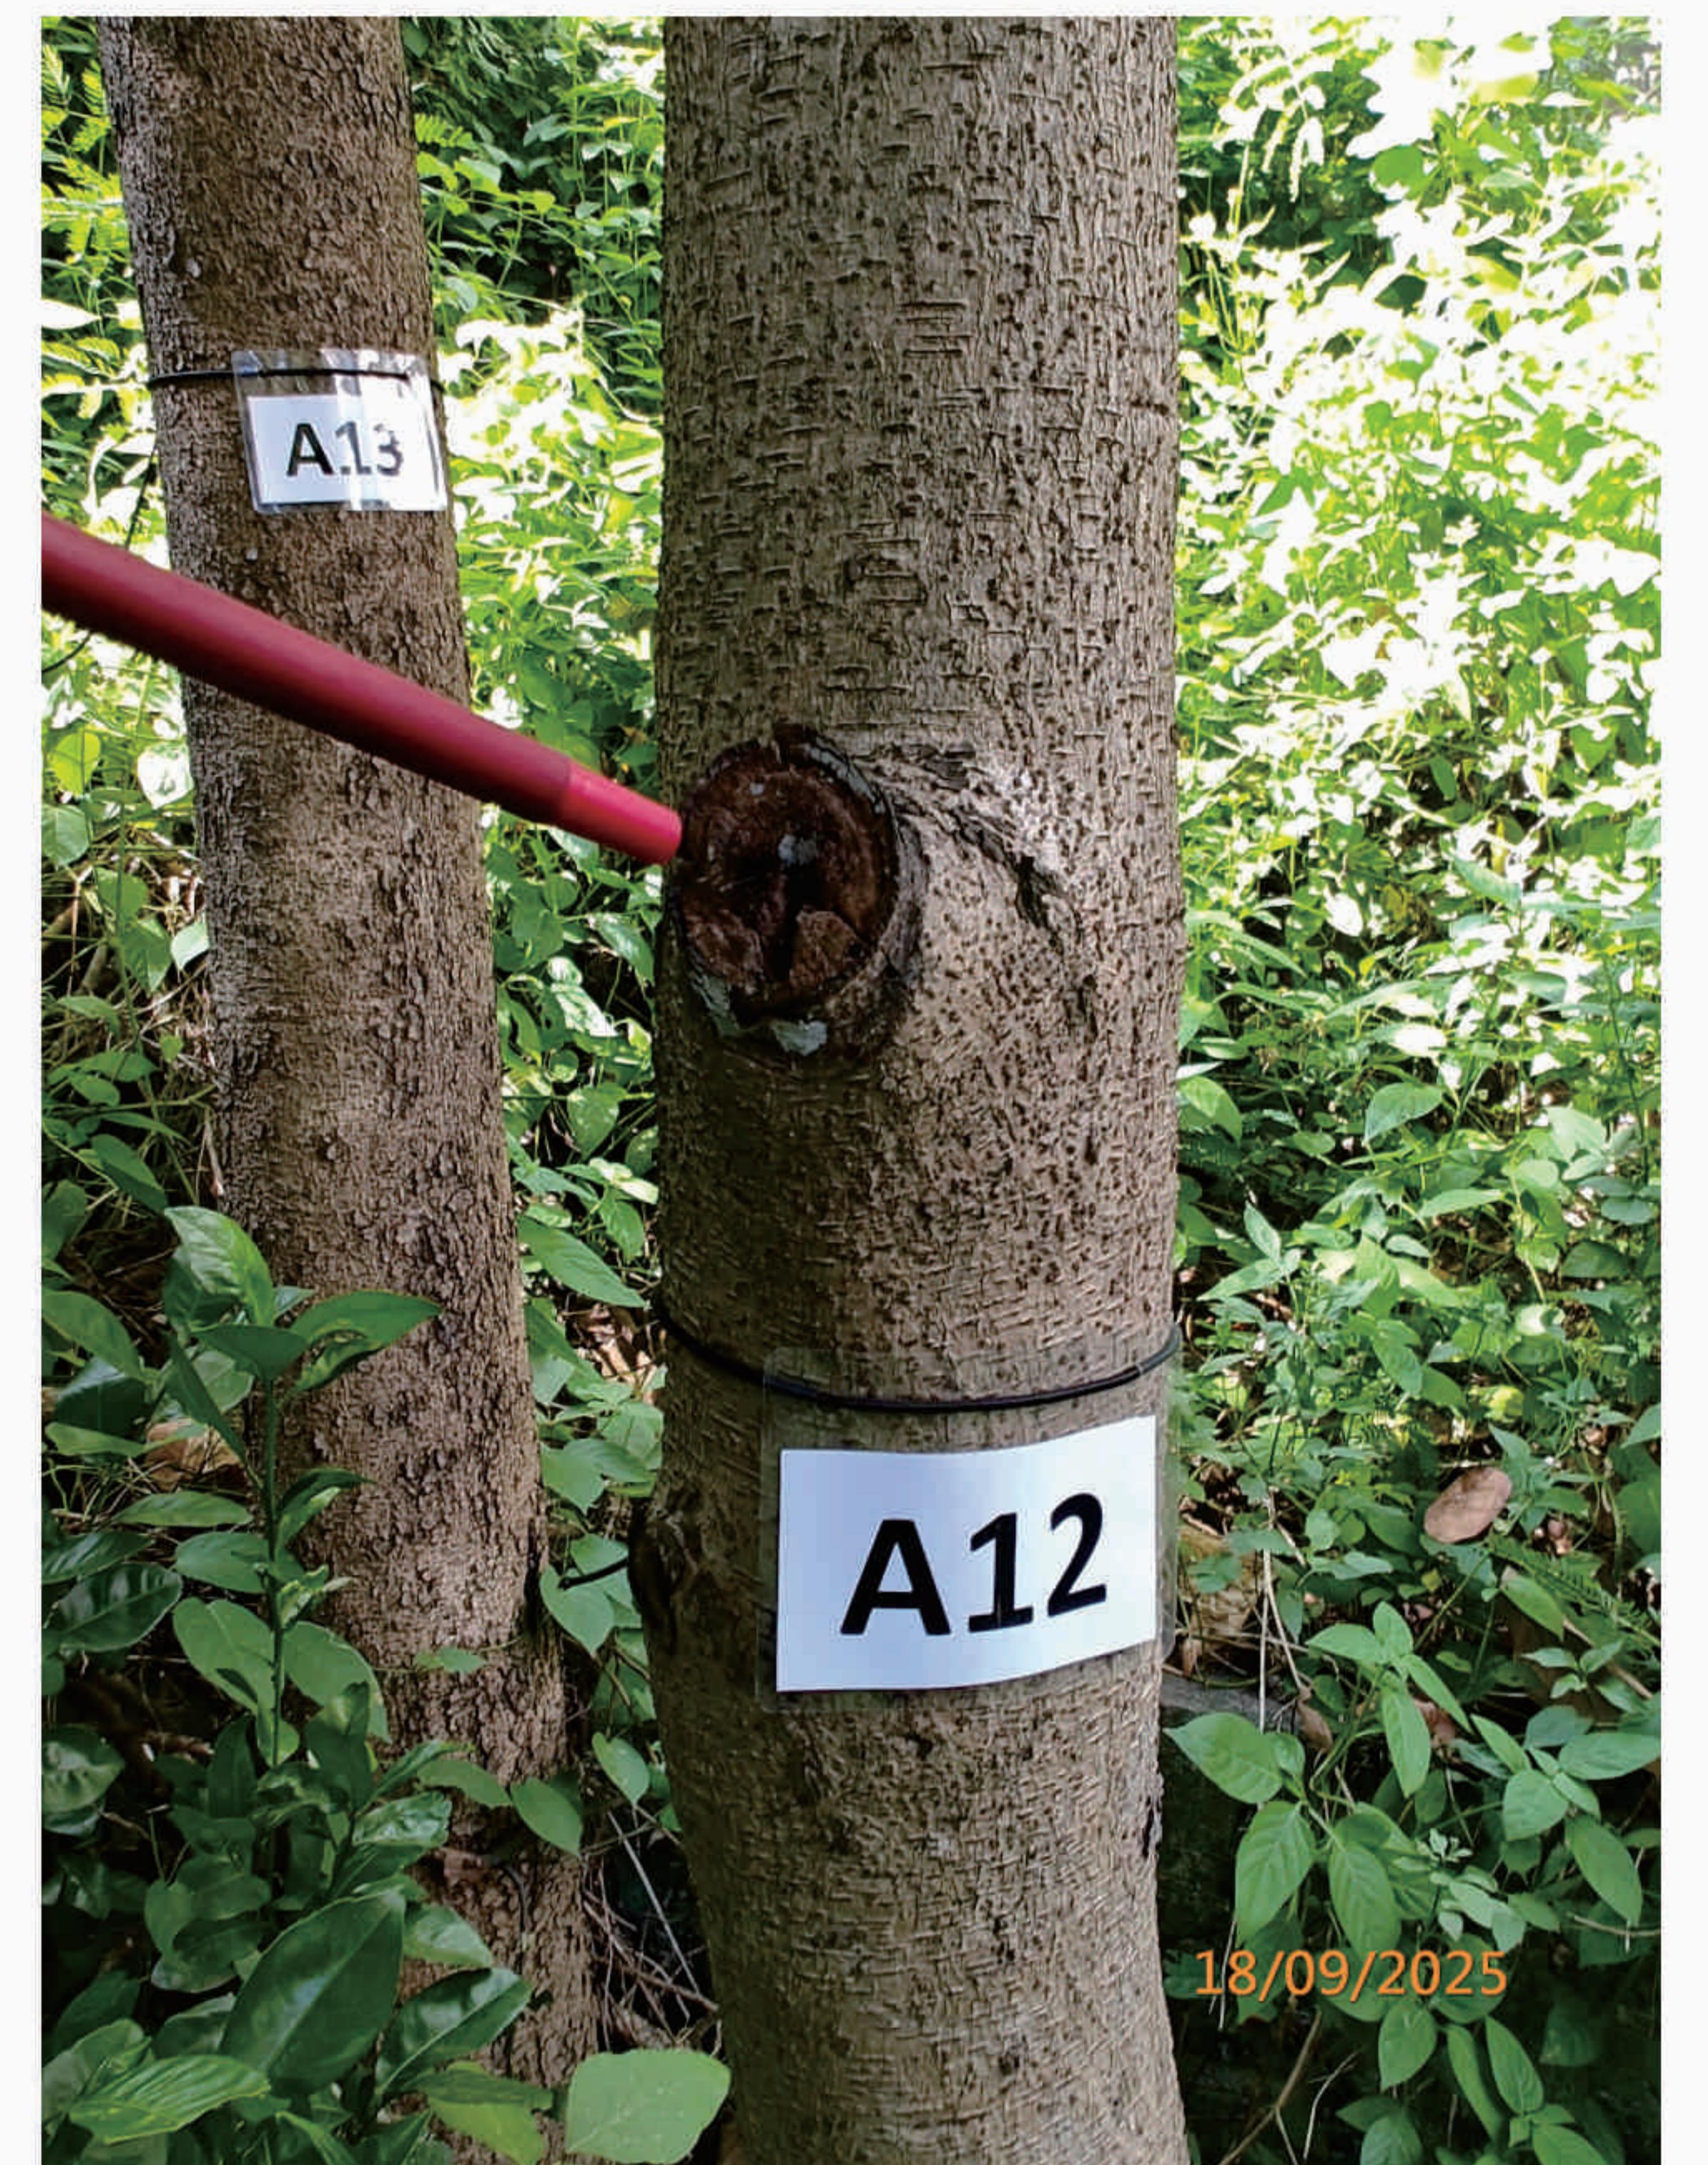
A12 - Decay in Trunk (R)
