**GEOTECHNICAL PLANNING REVIEW REPORT (GPRR)**

**PROPOSED TEMPORARY WAREHOUSE FOR STORAGE OF  
CONSTRUCTION MATERIAL, PLASTIC, MACHINERY,  
SPARE PART AND ANCILLARY PACKAGING WORKSHOP  
FOR A PERIOD OF 3 YEARS**

**ISSUE 1**

**DECEMBER 2025**

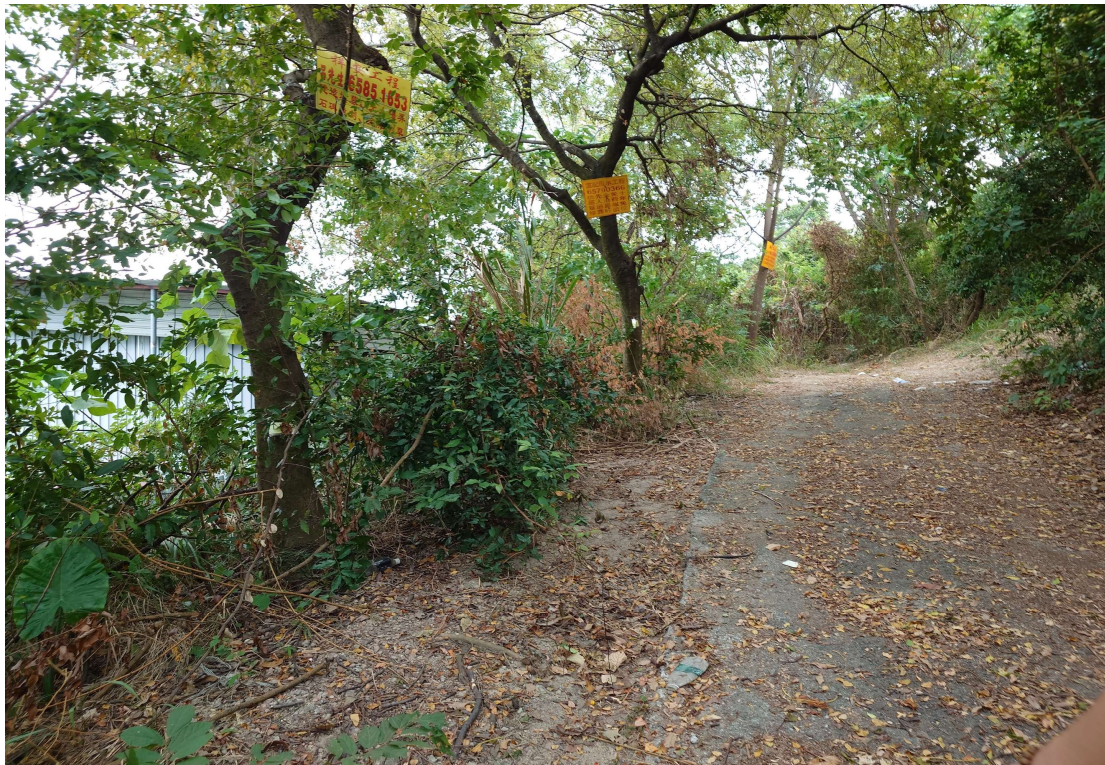
The feature is located at the western boundary of the site. It consists of a vegetated slope with about 3.0m high and has a face angle of about 45°. This feature is about 160m long, an access road is located at the slope crest and temporary structures are located at the toe of the feature. The photo is shown in Plate A1 and A2.

A1 - General view of the site (looking southern) Taken at: 7 November 2025

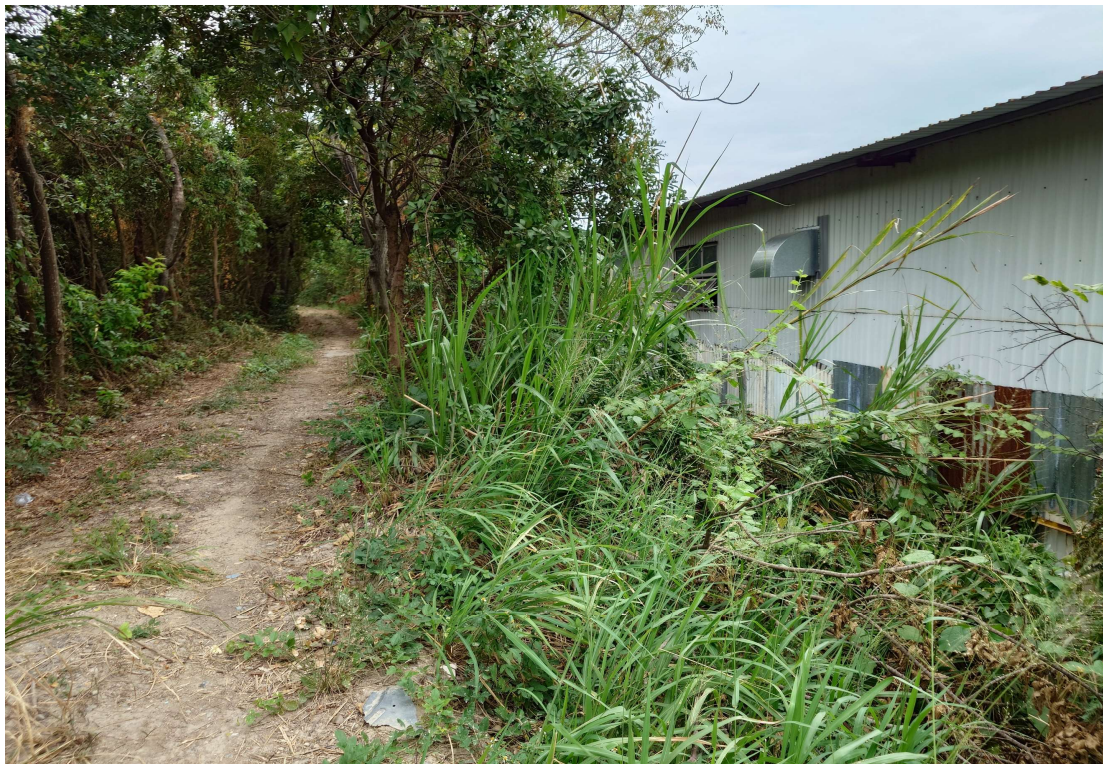
A2 - General view of the site (looking northern) Taken at: 7 November 2025

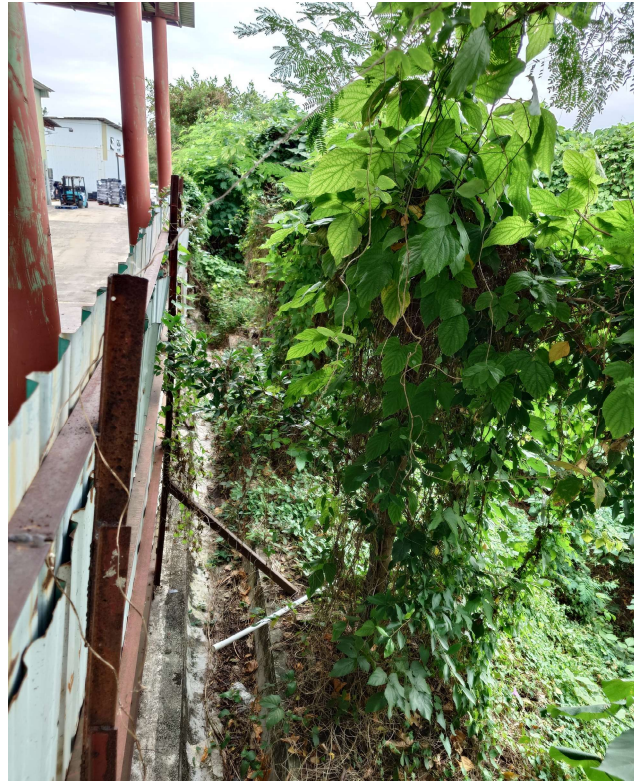
6NW-A/C35 (Sub-division Part 5) is located at the crest of the feature, it is a relatively small part of the feature and it is a vegetation area. The photo is shown in Plate A3.

A3 - General view of the site (looking northern)

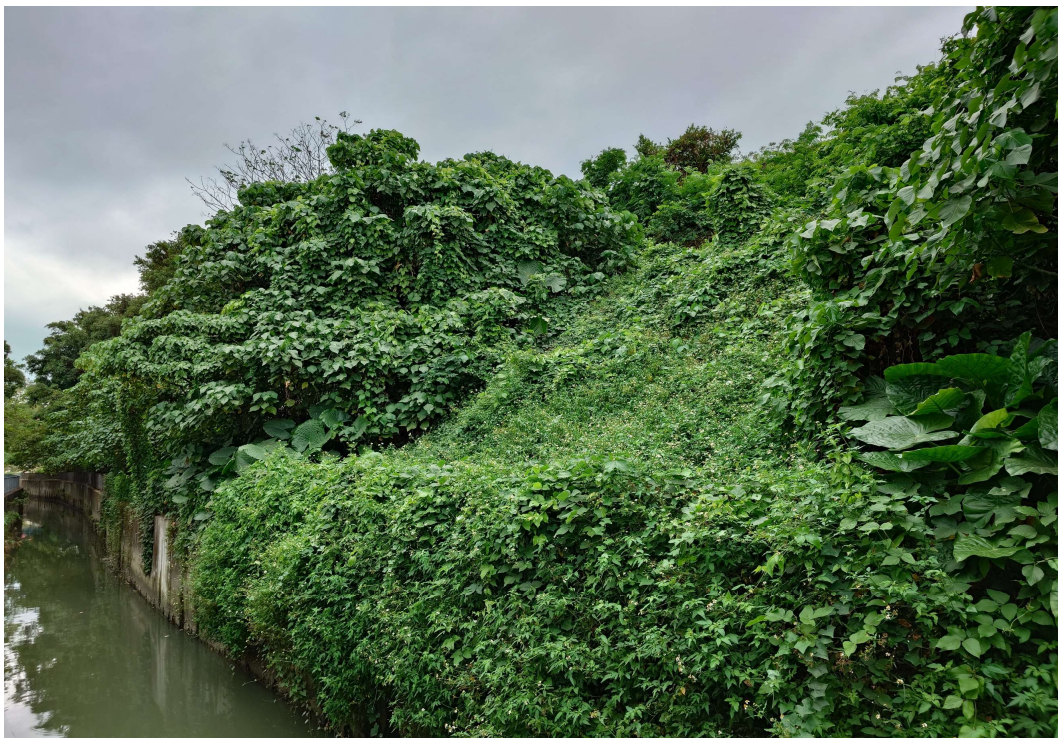
The feature is located at the southern-east side of the site. The feature is a vegetated slope about 4.0m high and the slope angle is about 45°. The slope is dipping from west to east and the length of slope is about 140m. The photo is shown in Plate A4.

A4 - General view of the site (looking southern)

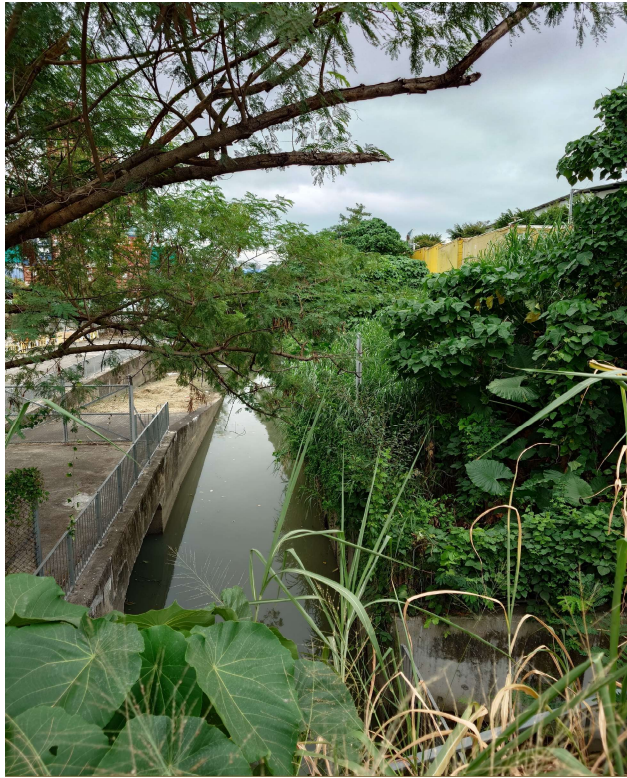
The feature is located at the eastern side and partly within the application site. It is a vegetated slope with about 6.0m high and the slope angle is about 35°. The feature is about 150m long and the slope is facing east. The photo is shown in Plate A5 and A6.

A5 - General view of the site (looking eastern)

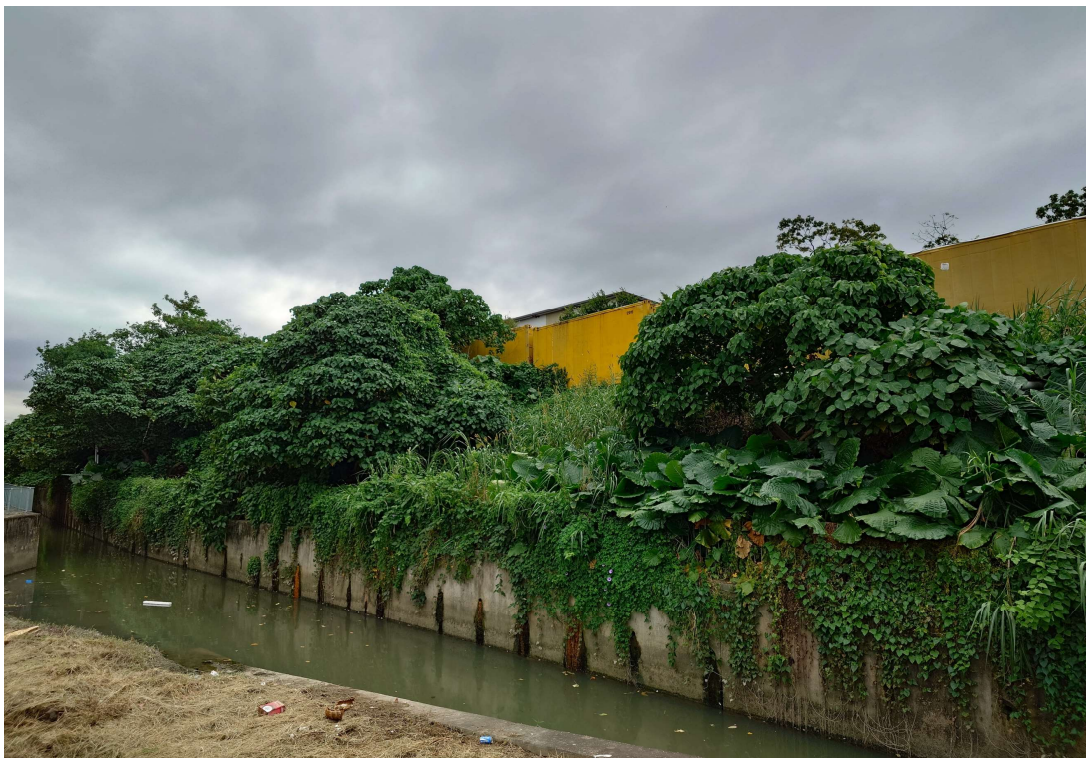
A6 - General view of the site (looking southern)
