**Proposed Data Centre at No. 7-11 Wing
Kin Road, Kwai Chung (K.C.T.L. 145)**

**Sewerage Impact Assessment
(V2.0)**

Manhole Internal Condition Survey at
Wing Kin Road

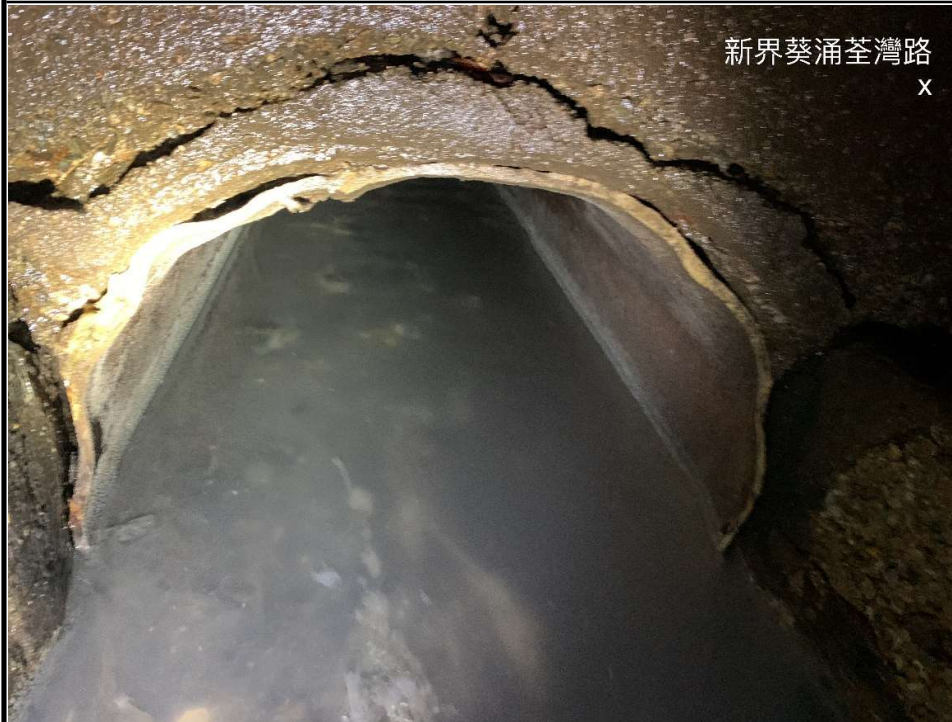
Broken chamber

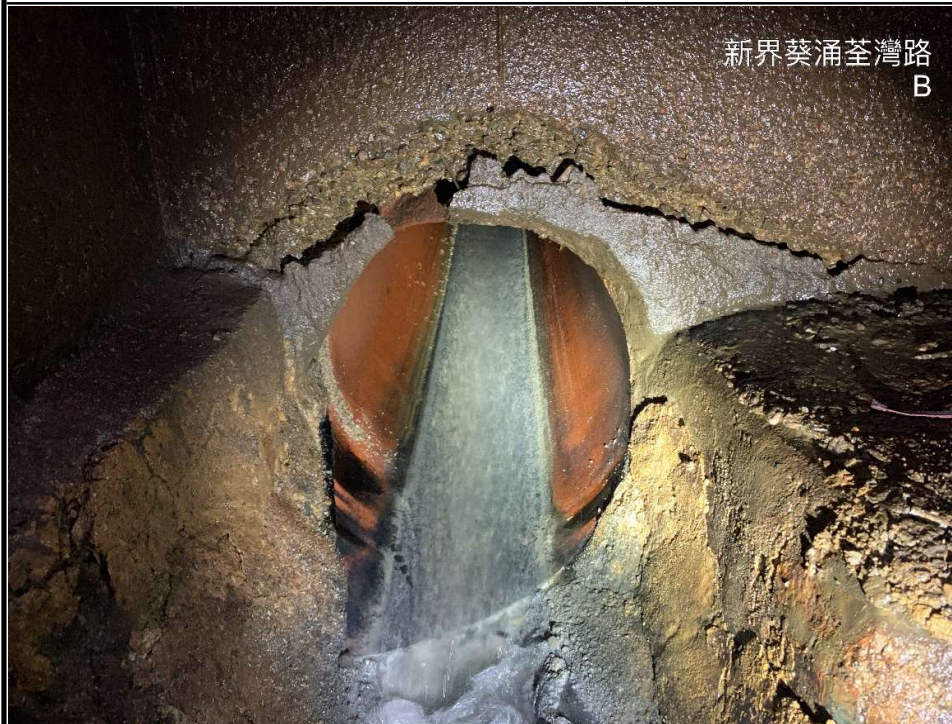
Broken chamber

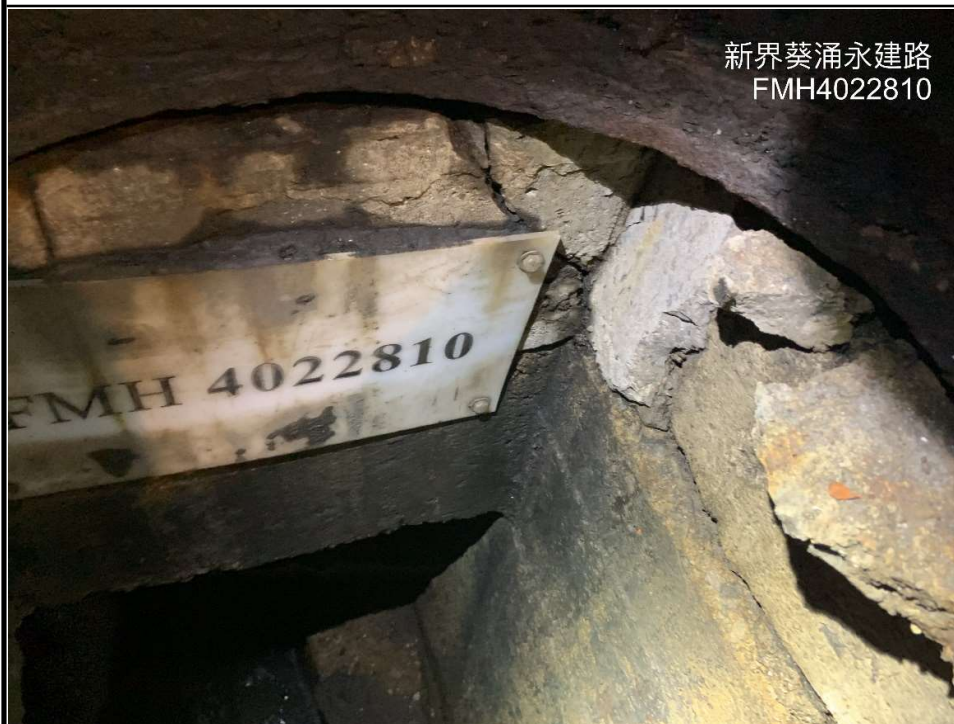
FMH4022810 -P5

Broken shaft

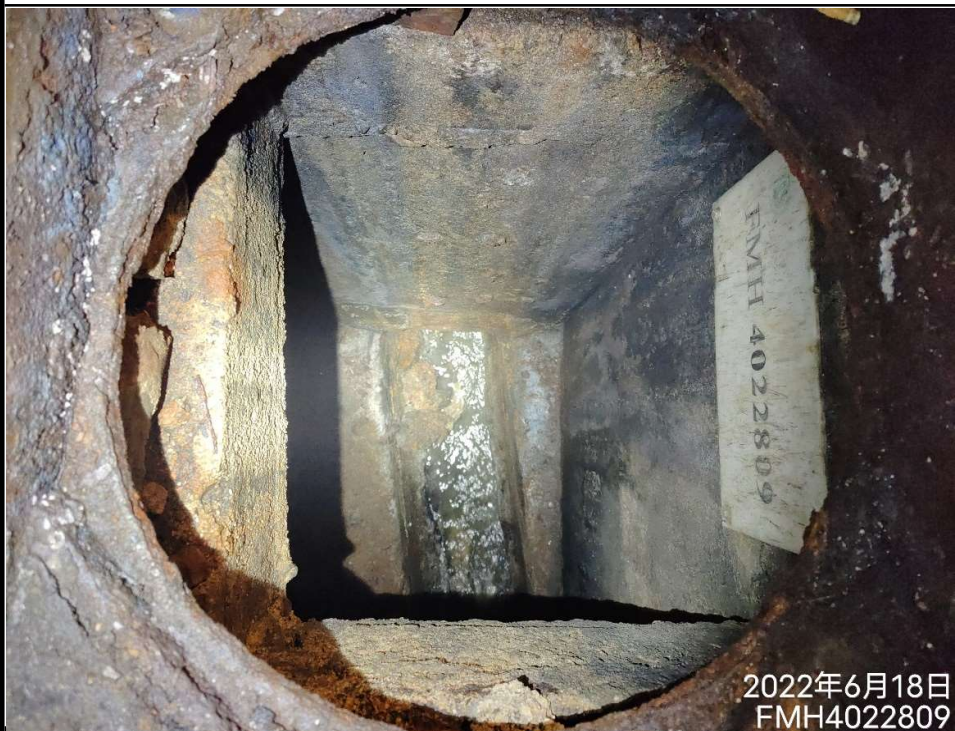
FMH4022809 -P6

(52) PHOTO NO.	--	P6	--	P8	P7	--									
(53) UTR	N	(59) LOACTION PHOTO No. 位置相	P1	(63) REMARKS Broken, chamber, benching and iron (4 nos.). Cover level of lowest reference point for manhole measurement is 8.142mPD.

Broken iron

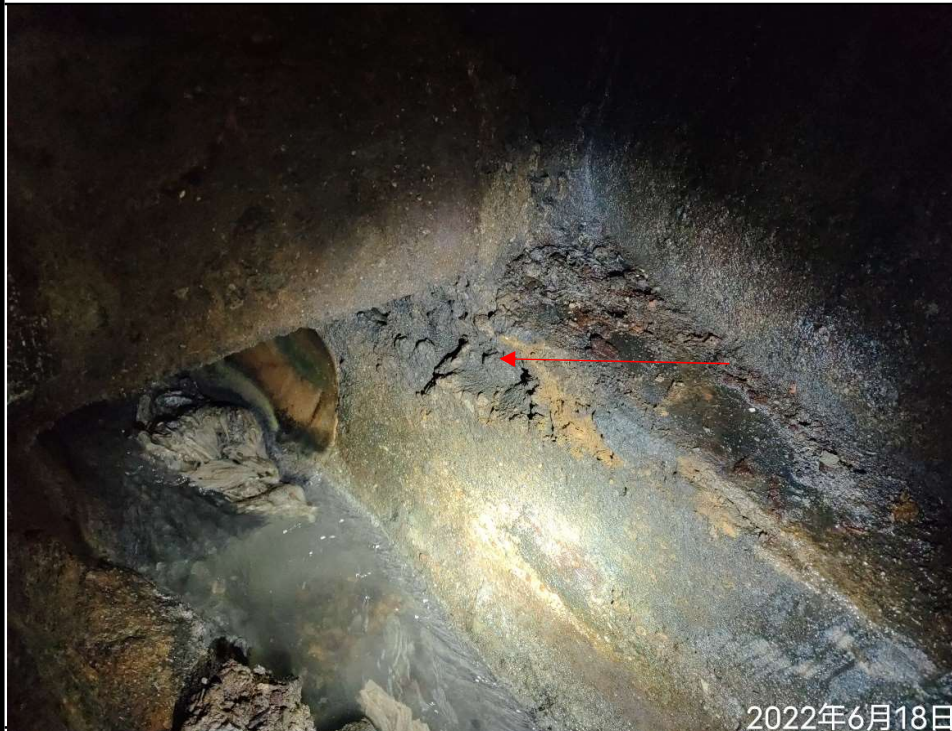
FMH4022809 -P7

Broken benching

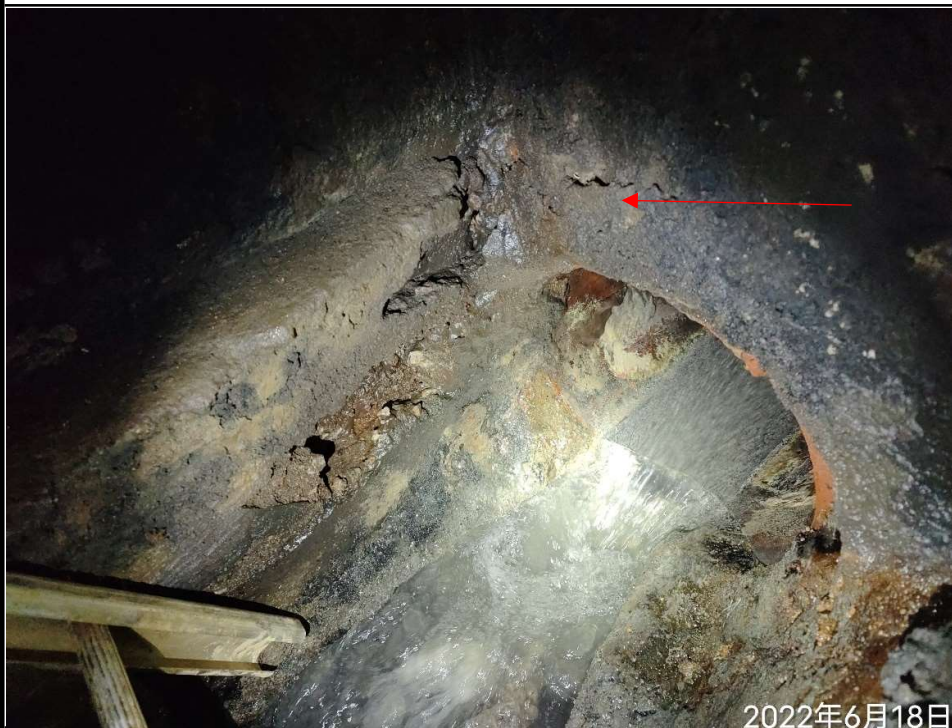
FMH4022809 -P8

Broken chamber

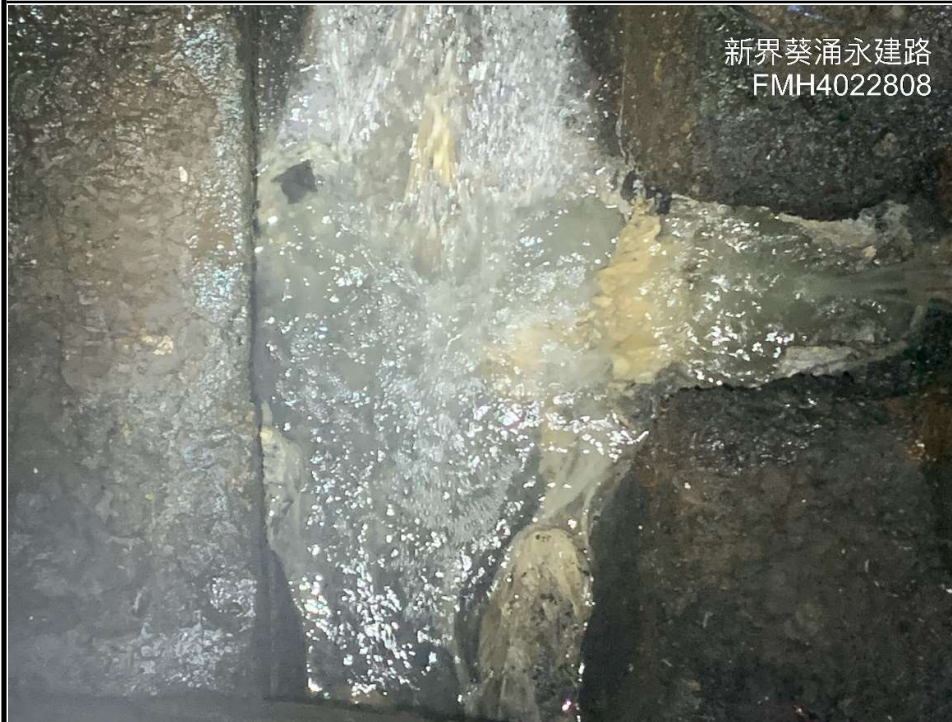
新界葵涌永建路
- FMH4022808

(52) PHOTO NO.	--		--		--		--		P7		--					
(53) UTR	N	(59) LOACTION PHOTO No. 位置相	P1		(63) REMARKS Broken benching. Cover level of lowest reference point for manhole measurement is 8.686mPD.

Broken benching

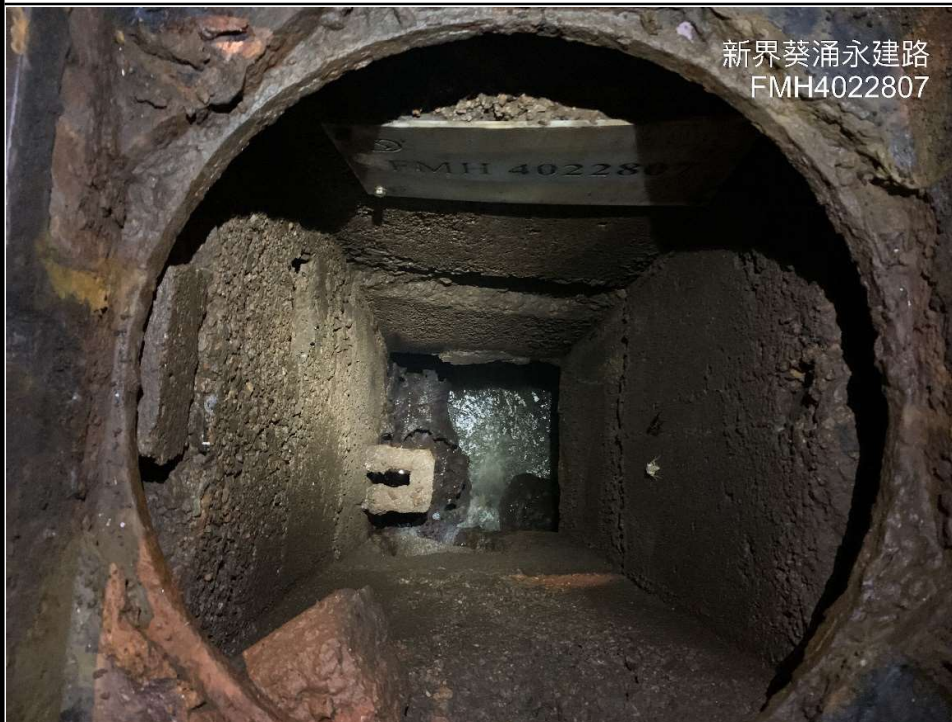
FMH4022807 -P7

(52) PHOTO NO.	--		P7		--		--		--		--	
(53) UTR	N	(59) LOACTION PHOTO No. 位置相	P1		(63) REMARKS Broken iron (2 nos.). Cover level of lowest reference point for manhole measurement is 9.580mPD.

Broken iron
