**Geotechnical Planning Review Report  
for  
Proposed Temporary Place of Recreation, Sports or  
Culture (Hobby Farm) with  
Ancillary Facilities and Associated Filling of Land  
for a Period of 5 Years  
at Lots 86, 90, 91(Part), 92(Part), 103(Part),  
147(Part), 148 S.A(Part), 148 S.B(Part),  
149(Part), 150 S.A, 151 S.A(Part), 153(Part),  
572(Part) and 576(Part) in D.D.16,  
Lam Tsuen, Tai Po, New Territories**

**September 2025**

***Philip So & Associates Consulting Civil & Geotechnical Engineers Ltd.***

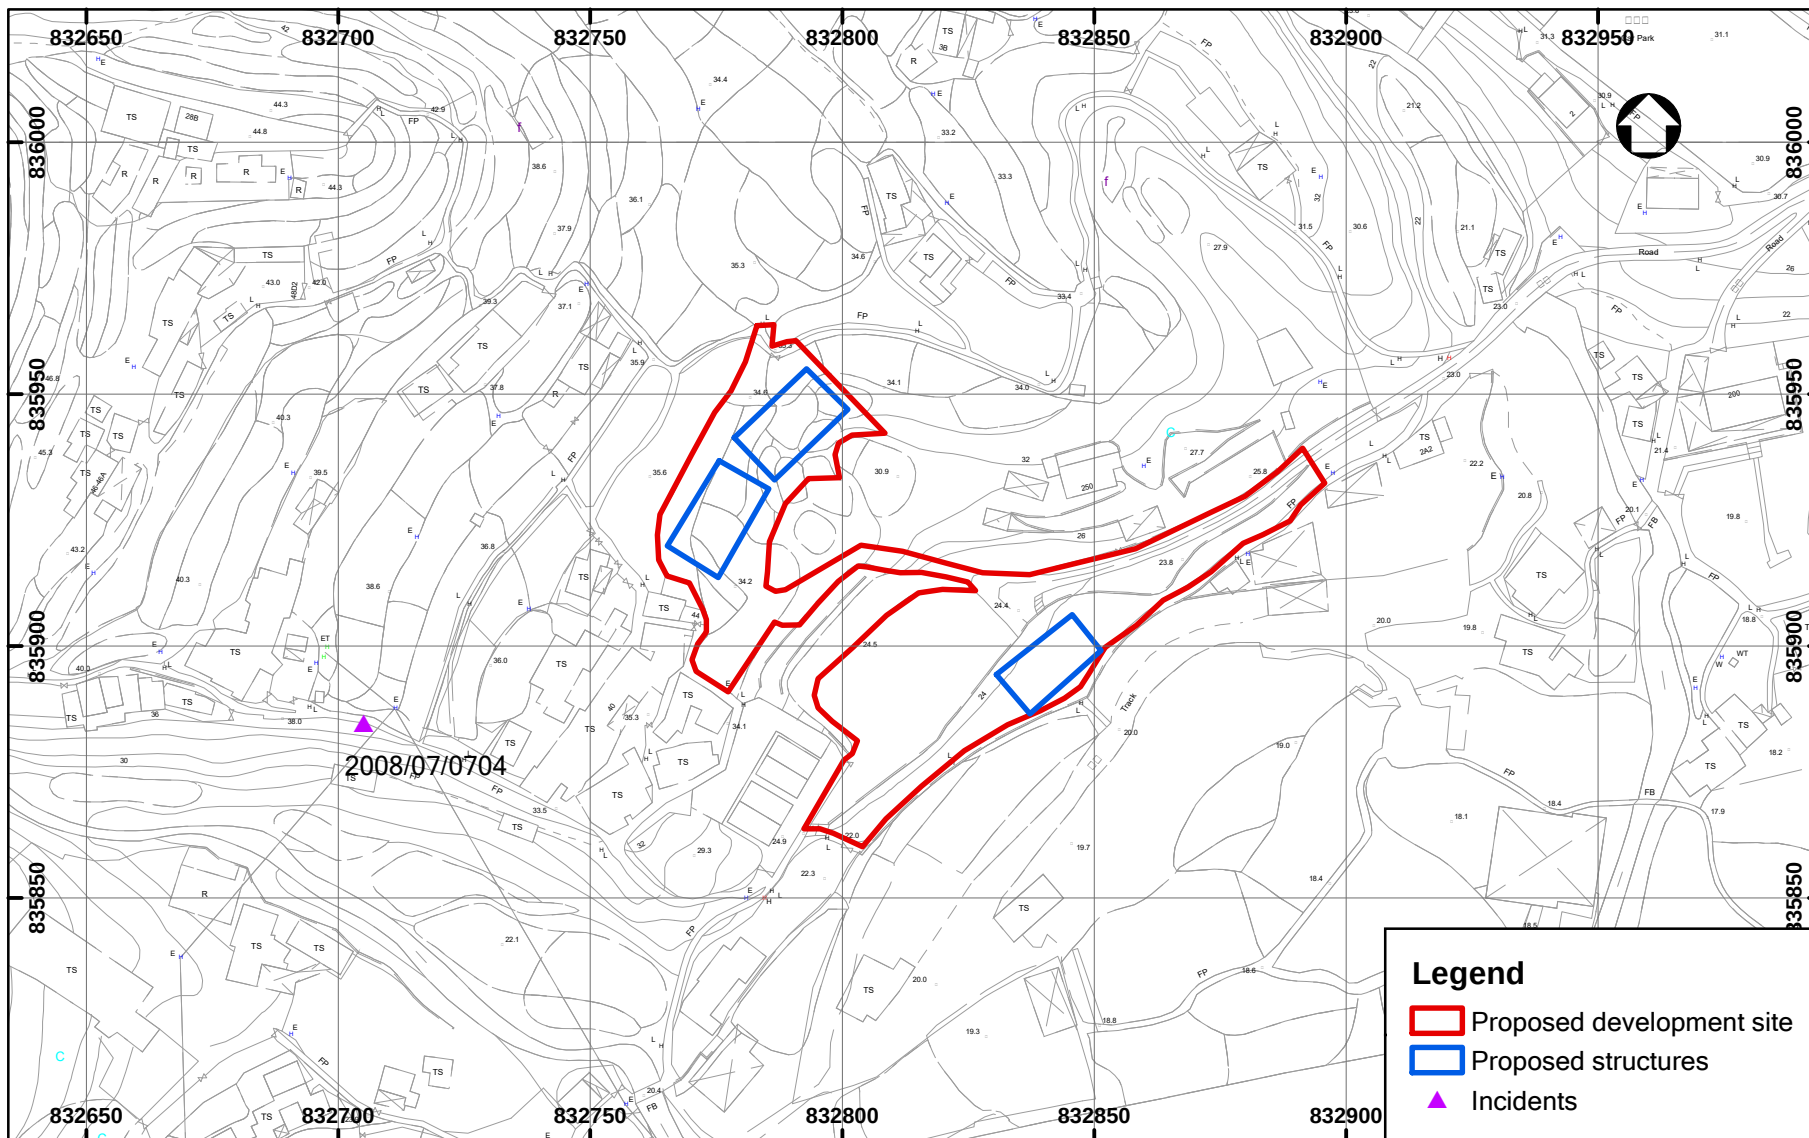
No landslide incident record has been recorded within the Site. However, one minor landslide incident has been reported at about 64m to the west of the Site. It involved a minor washout of about 3.0m<sup>3</sup> from the upper portion of the registered man-made cut-slope.

| GCO/GEO Incident No. | Report Date | Location of Failure | Approx. Failure Volume (m <sup>3</sup> ) | Possible Cause of Failure |
|---|---|---|---|---|
| 2008/07/0704<br>(about 64m to the west of the Site) | 2008/07/10 | 7NW-A/C97 | 3.0 | Washout |

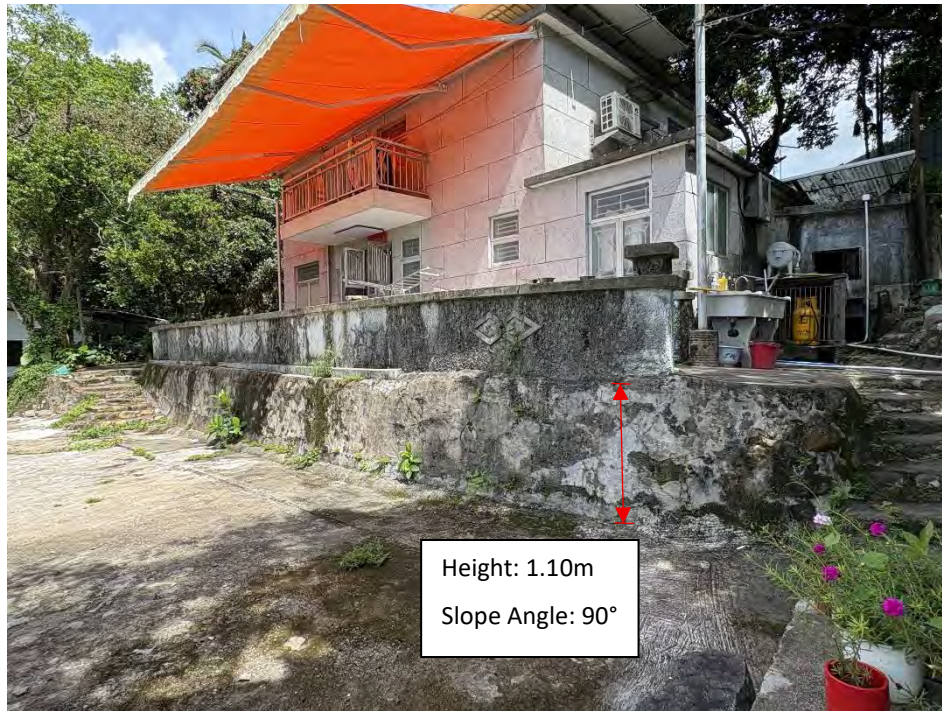
**Photo M – General View of the Unregistered Feature C**

Height: 1.10m  
Slope Angle: 90°

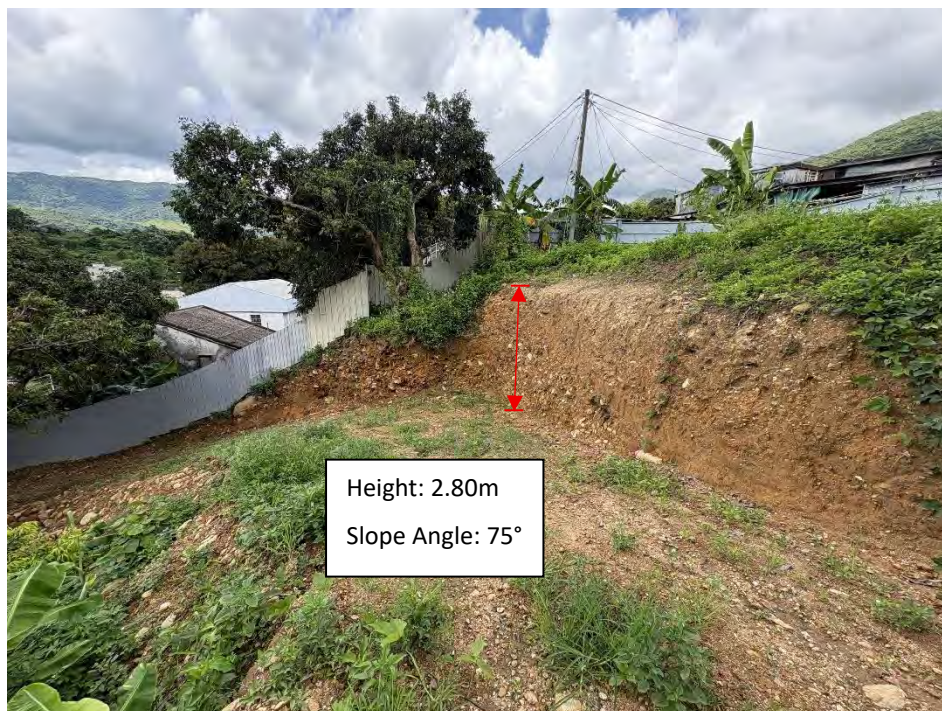
**Photo N – General View of the Unregistered Feature D**

Height: 2.80m  
Slope Angle: 75°

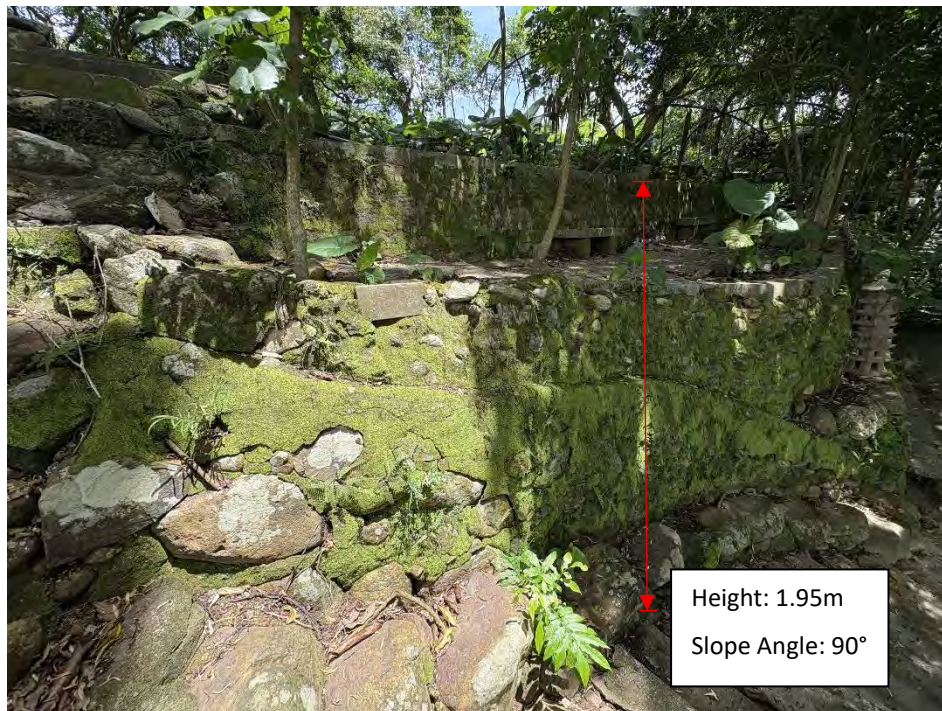
**Photo T – General View of the Unregistered Feature J**

| J (Photo T) | Rubble wall | 22 | 1.95 | 90 | Cracks and losing mortar |
