# Tree Survey Report

**Date of Survey: 11<sup>th</sup> February 2025**

**Various Lots in D.D. 91 And D.D.100, Lin Tong Mei, Fanling,  
New Territories**

PROJECT  
 PROPOSED TEMPORARY  
 WAREHOUSE (EXCLUDING  
 DANGEROUS GOODS GODOWN)  
 WITH ANCILLARY FACILITIES  
 FOR A PERIOD OF 3 YEARS AND  
 ASSOCIATED FILLING OF LAND

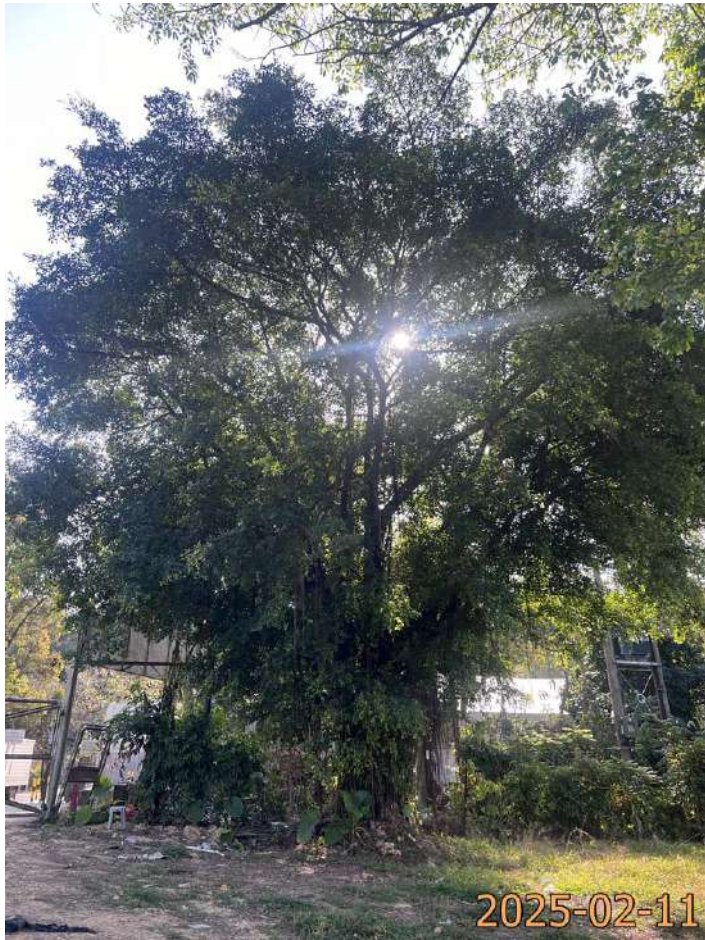
T1 (Overview)

| Tree No. | Tree Species | | Tree Size Measurements | | | Amenity Value | Form | Health Condition | Structural Condition | Suitability for Transplanting | Remarks |
|---|--|---|---|---|---|---|---|---|---|---|--|
| T1 | <i>Ficus microcarpa</i> | 榕樹(細葉榕) | 14.0 | 700 | 11.0 | Low | Fair | Fair | Poor | Low | epiphytic plants, restricted root |

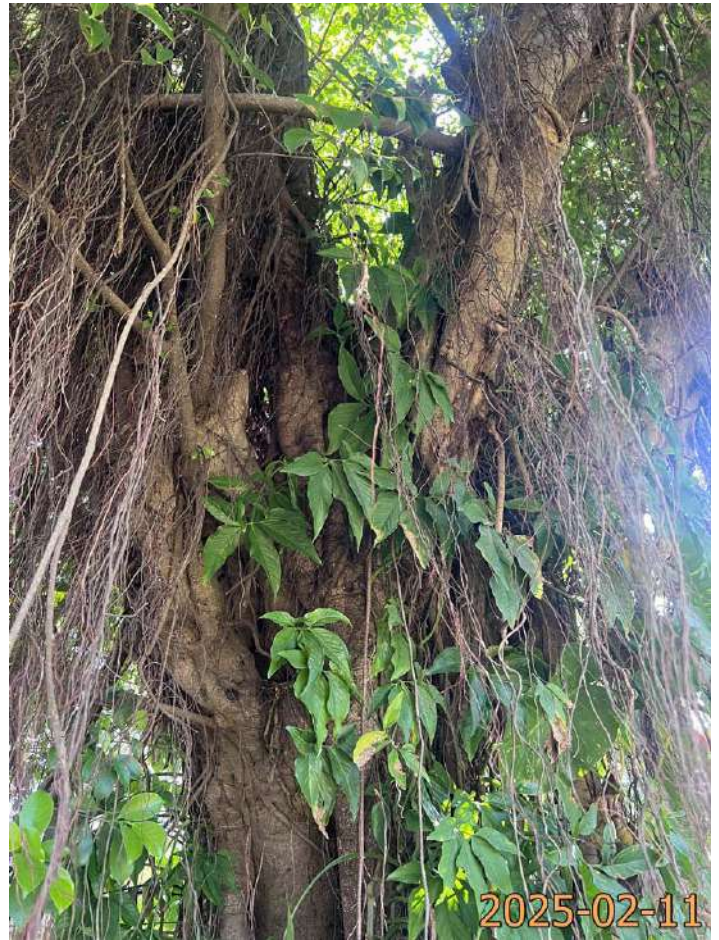
T1 Epiphytic plants

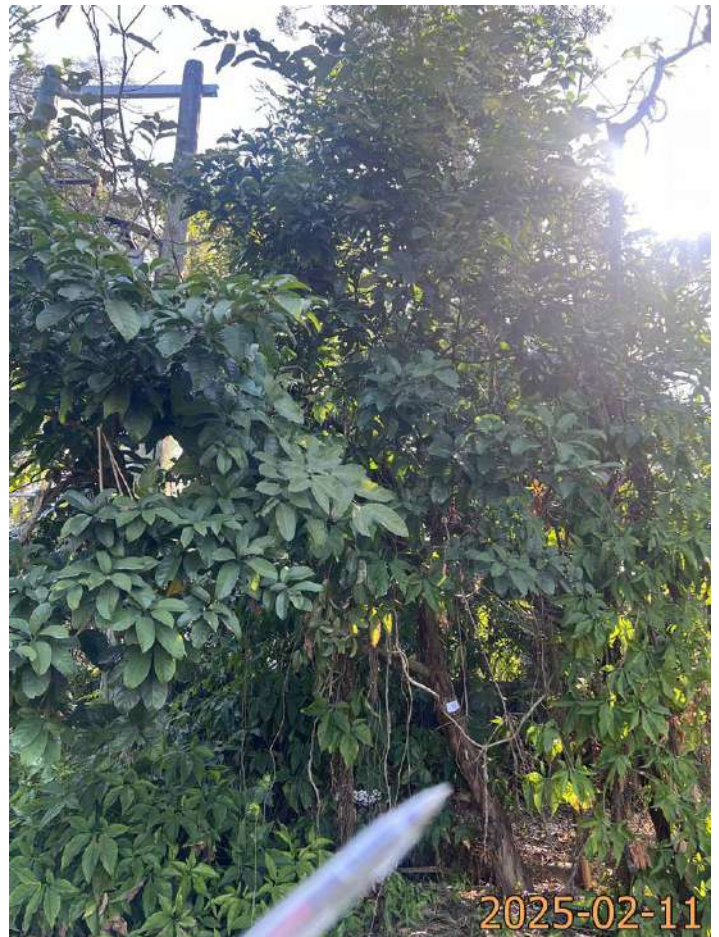
| Tree No. | Tree Species | | Tree Size Measurements | | | Amenity Value | Form | Health Condition | Structural Condition | Suitability for Transplanting | Remarks |
|---|--|---|---|---|---|---|---|---|---|---|--|
| T2 | <i>Sterculia lanceolata</i> | 假蘋婆 | 4.0 | 120 | 2.0 | Low | Fair | Fair | Poor | Low | leaning, wound on branch and trunk, epiphytic plants |

T2 (Overview)(Leaning)

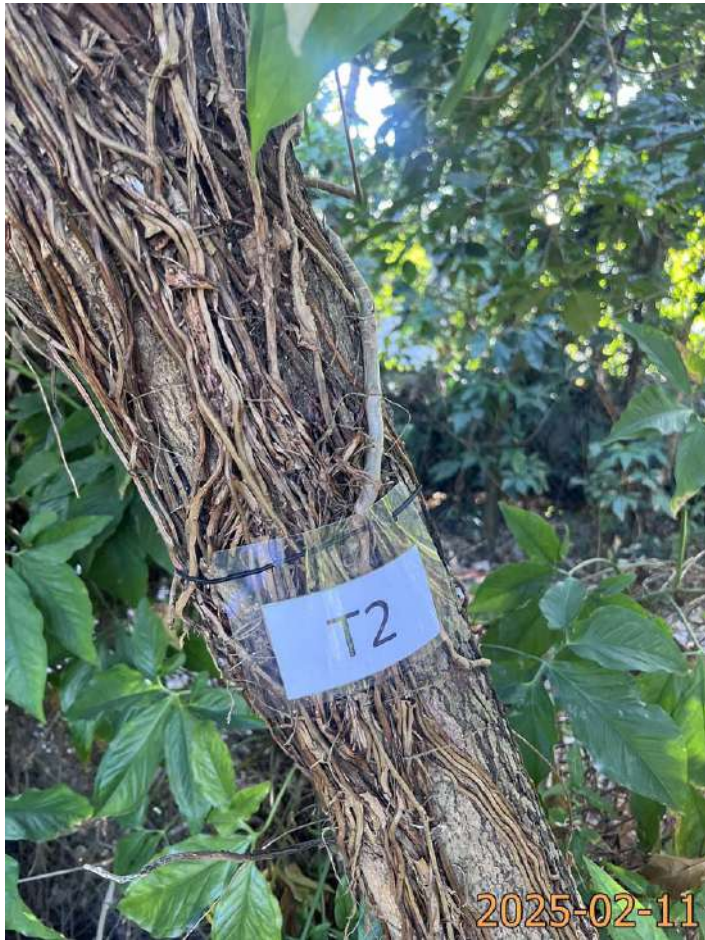
T2 Epiphytic plants

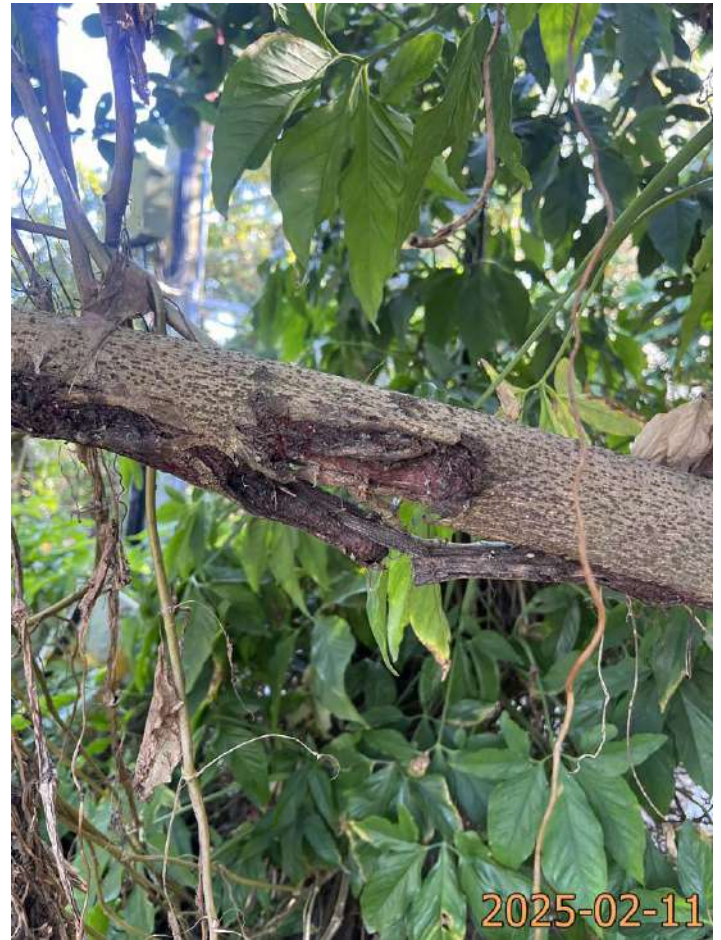
T2 Wound on branch

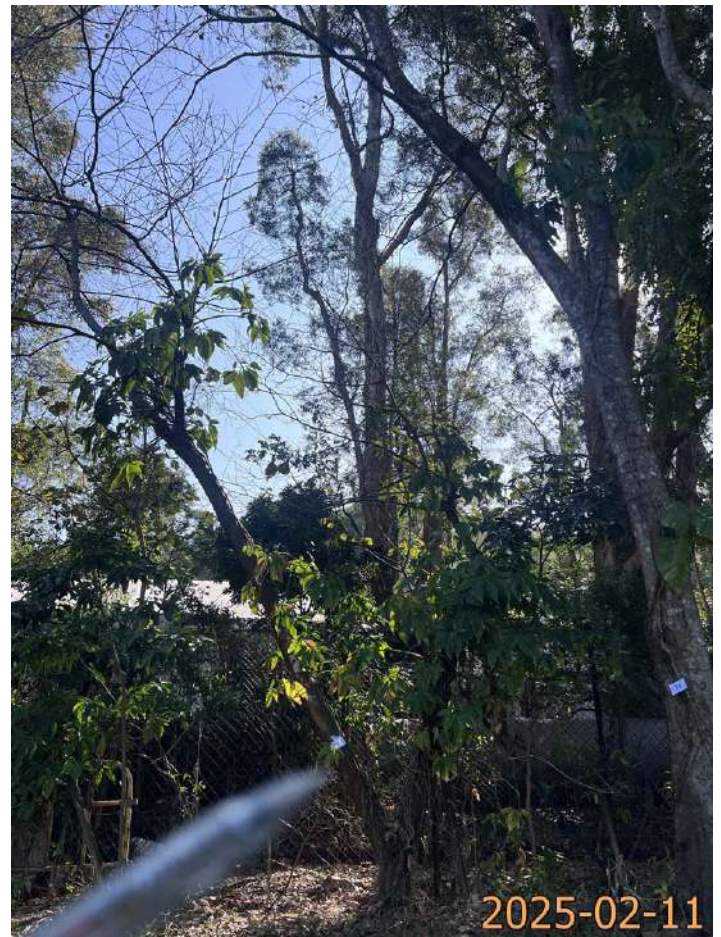
| Tree No. | Tree Species | | Tree Size Measurements | | | Amenity Value | Form | Health Condition | Structural Condition | Suitability for Transplanting | Remarks |
|---|--|---|---|---|---|---|---|---|---|---|--|
| T3 | <i>Celtis sinensis</i> | 朴樹 | 7.0 | 170 | 4.0 | - | - | Dead | - | - | dead tree, epiphytic plants |

T3 (Overview) (Dead tree)

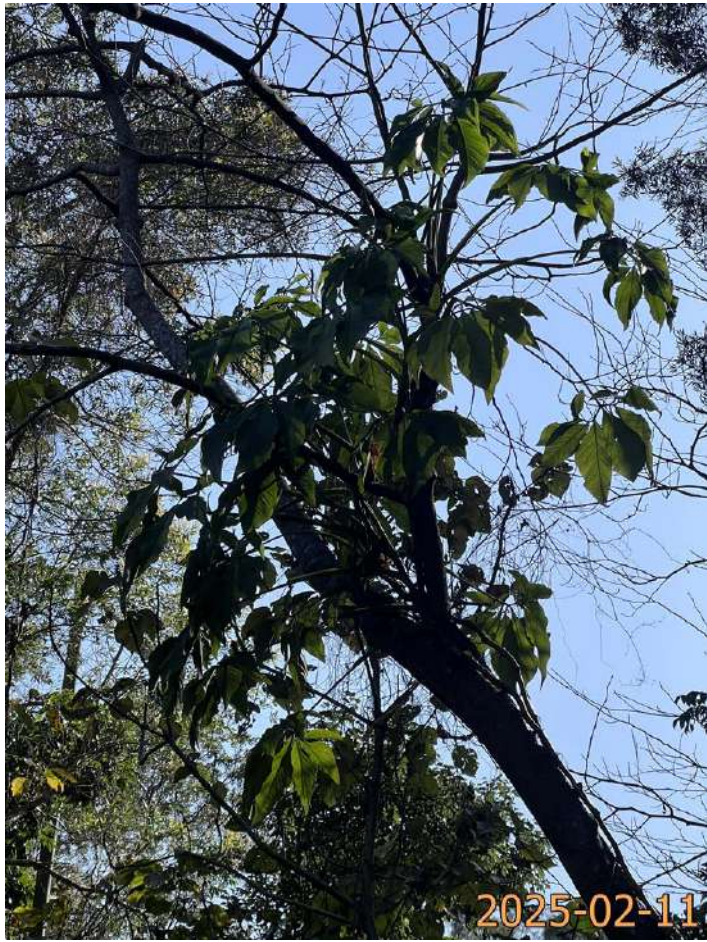
T3 Epiphytic plants

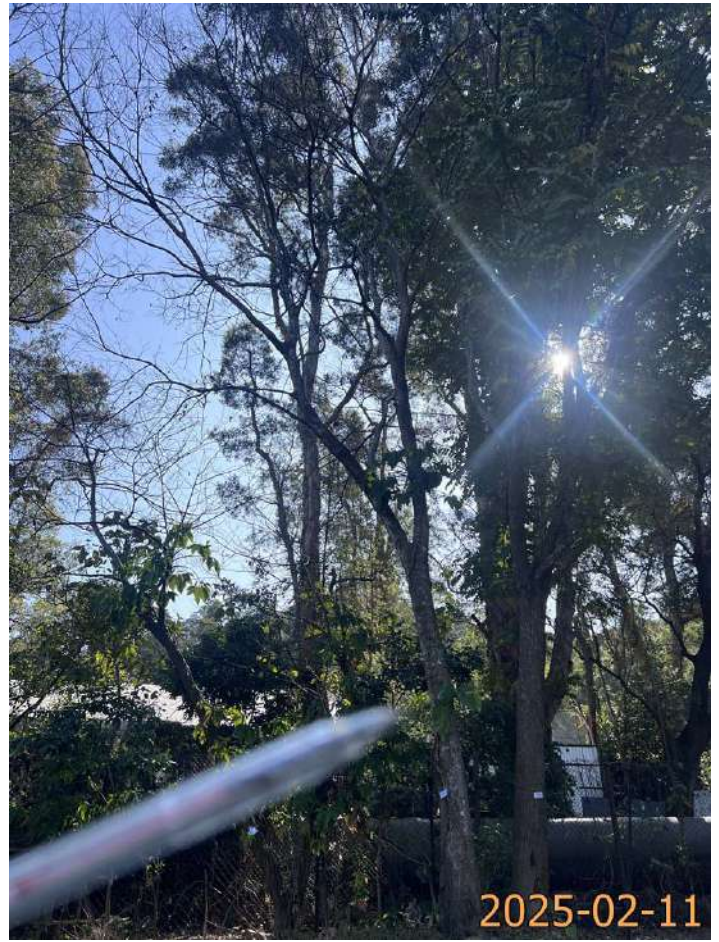
| Tree No. | Tree Species | | Tree Size Measurements | | | Amenity Value | Form | Health Condition | Structural Condition | Suitability for Transplanting | Remarks |
|---|--|---|---|---|---|---|---|---|---|---|--|
| T4 | <i>Celtis sinensis</i> | 朴樹 | 13.0 | 260 | 7.0 | Low | Fair | Fair | Poor | Low | co-dominant stems, exposed dead root, wound on trunk, epiphytic plants |

T4 (Overview) (Epiphytic plants)

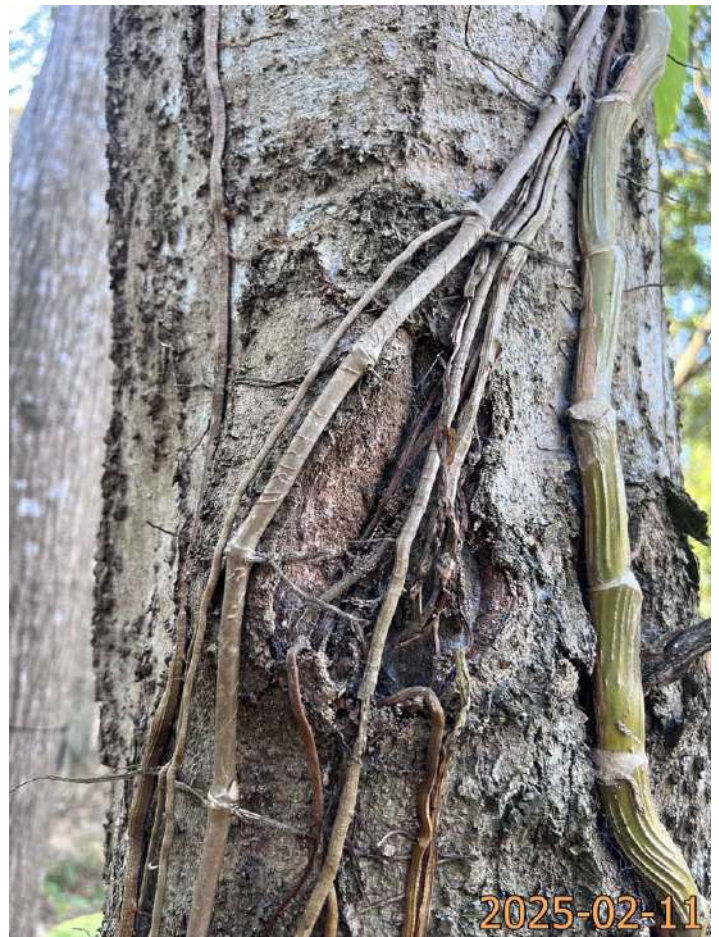
T4 Wound on trunk

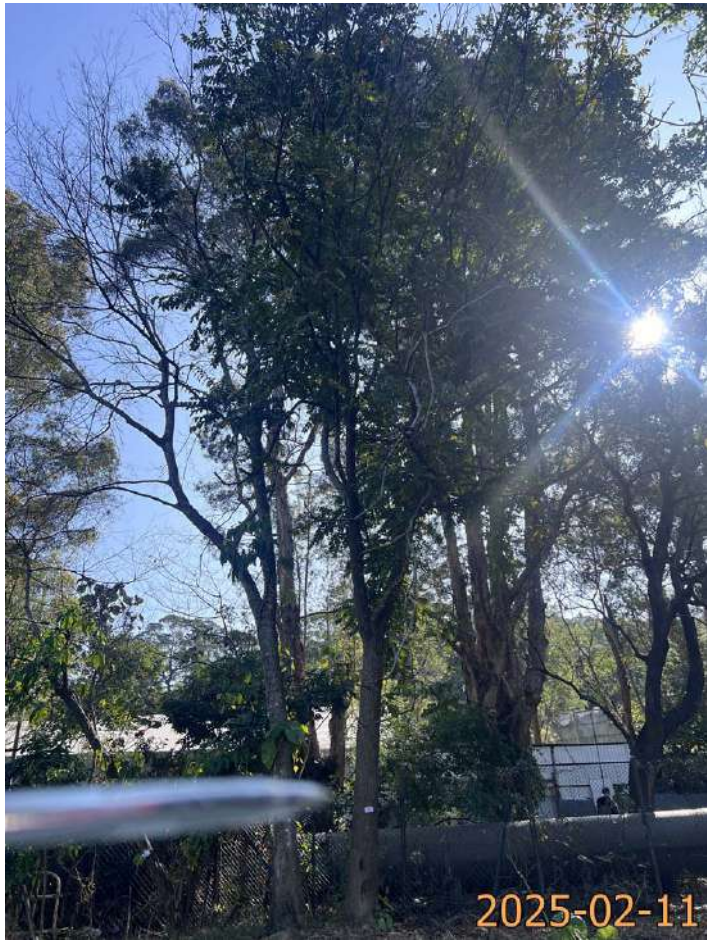
T5 (Overview)

| Tree No. | Tree Species | | Tree Size Measurements | | | Amenity Value | Form | Health Condition | Structural Condition | Suitability for Transplanting | Remarks |
|---|--|---|---|---|---|---|---|---|---|---|--|
| T5 | <i>Chukrasia tabularis</i> | 麻棟 | 13.0 | 320 | 5.0 | Low | Fair | Fair | Poor | Low | dead branch, wound on trunk, exposed dead root |

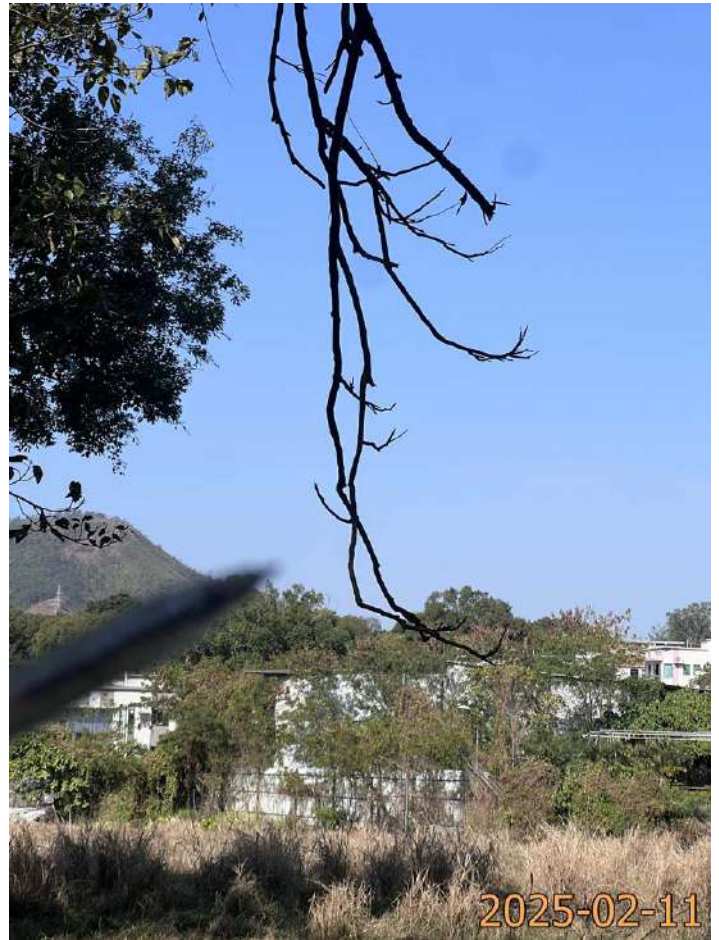
T5 Dead branch

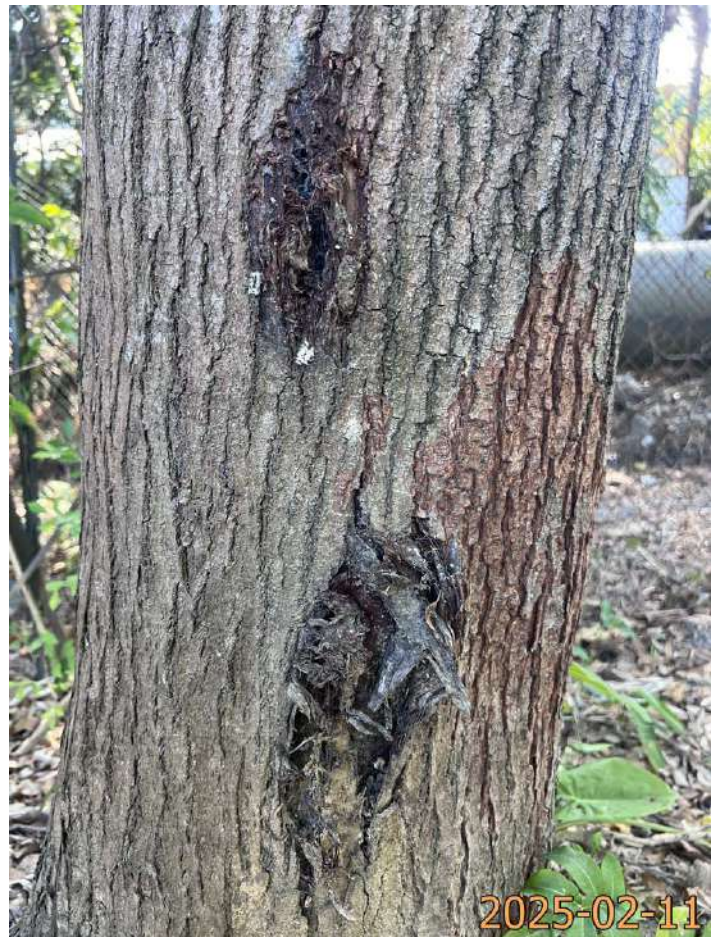
T5 Wound on trunk

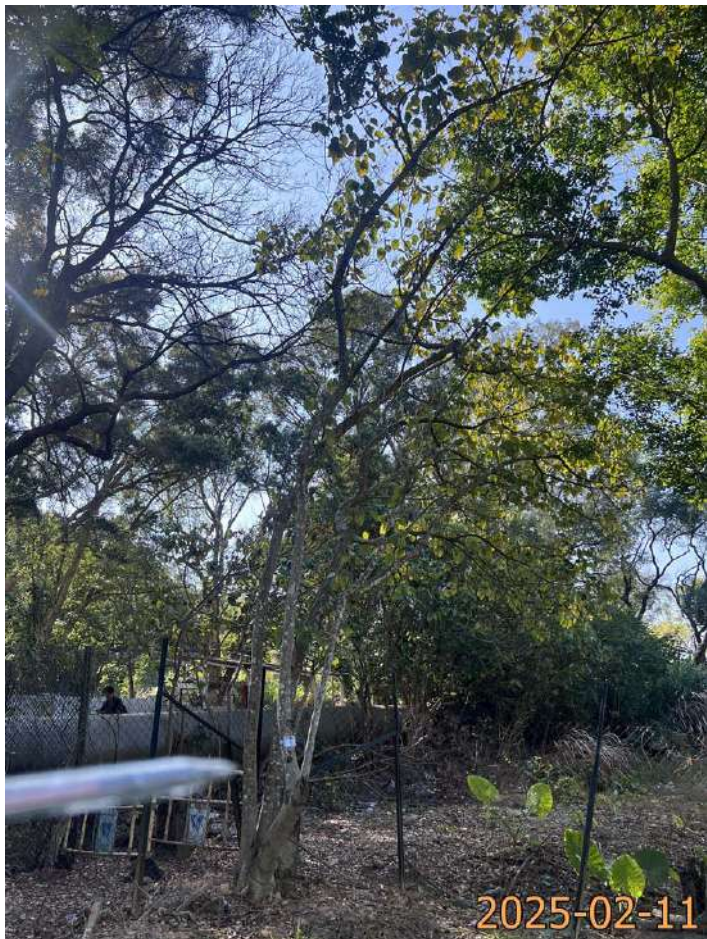
T6 (Overview)

| Tree No. | Tree Species | | Tree Size Measurements | | | Amenity Value | Form | Health Condition | Structural Condition | Suitability for Transplanting | Remarks |
|---|--|---|---|---|---|---|---|---|---|---|--|
| T6 | <i>Macaranga tanarius var. tomentosa</i> | 血桐 | 12.0 | 226 | 7.0 | Low | Poor | Poor | Poor | Low | multi-trunks, broken stub, abnormal leaf |

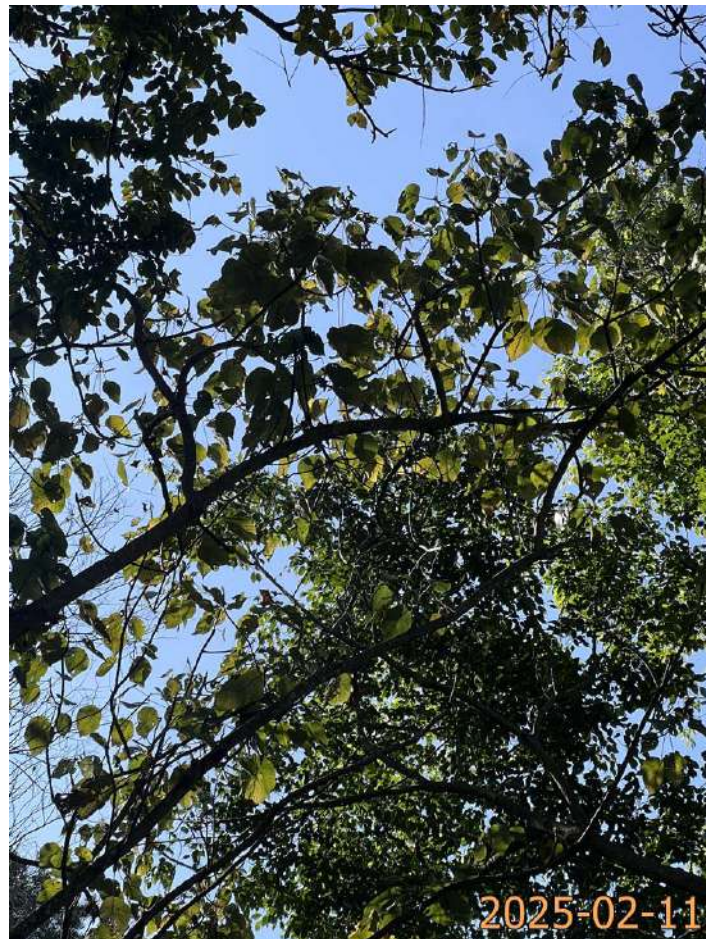
T6 Abnormal leaf size

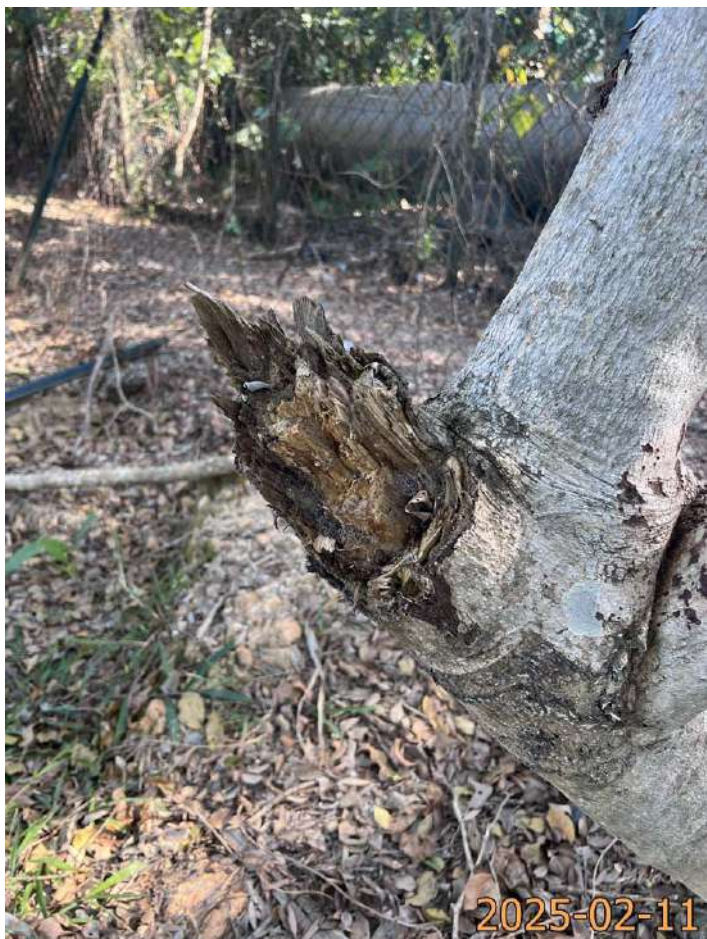
T6 Broken stub

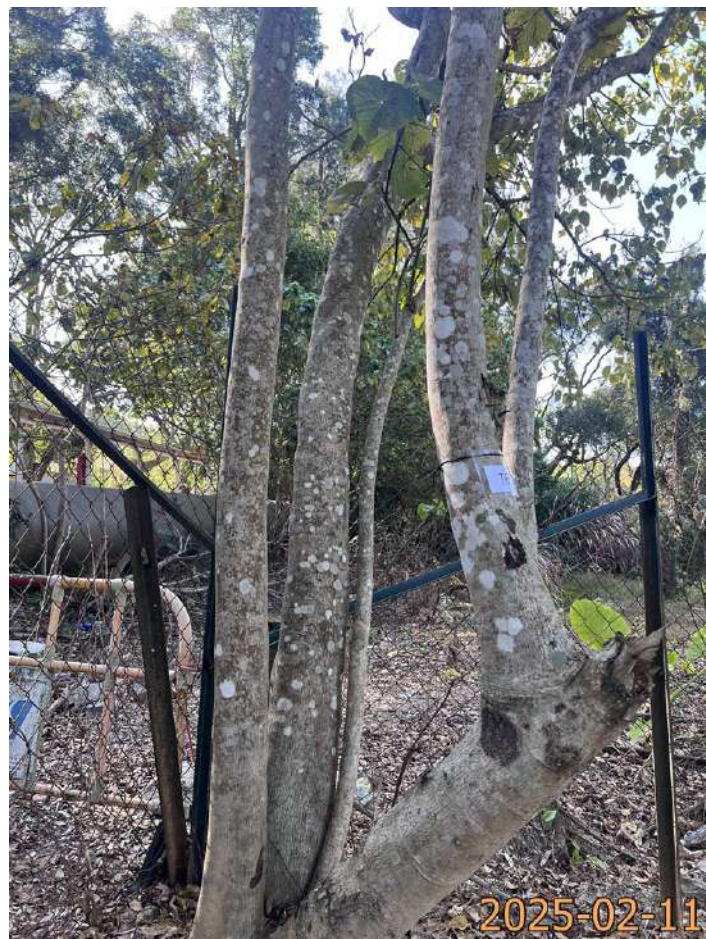
T6 Multi-trunks

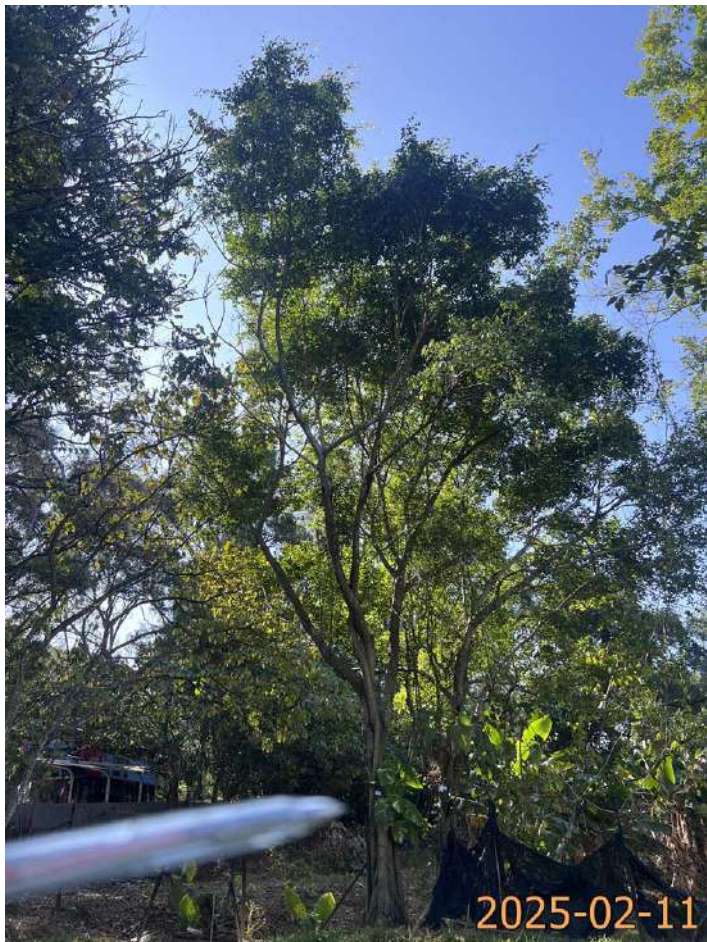
T7 (Overview)

| Tree No. | Tree Species | | Tree Size Measurements | | | Amenity Value | Form | Health Condition | Structural Condition | Suitability for Transplanting | Remarks |
|---|--|---|---|---|---|---|---|---|---|---|--|
| T7 | <i>Ficus benjamina</i> | 垂葉榕 | 11.5 | 350 | 8.0 | Low | Fair | Fair | Poor | Low | cross trunks, broken branch, metal bar embedded into trunk |

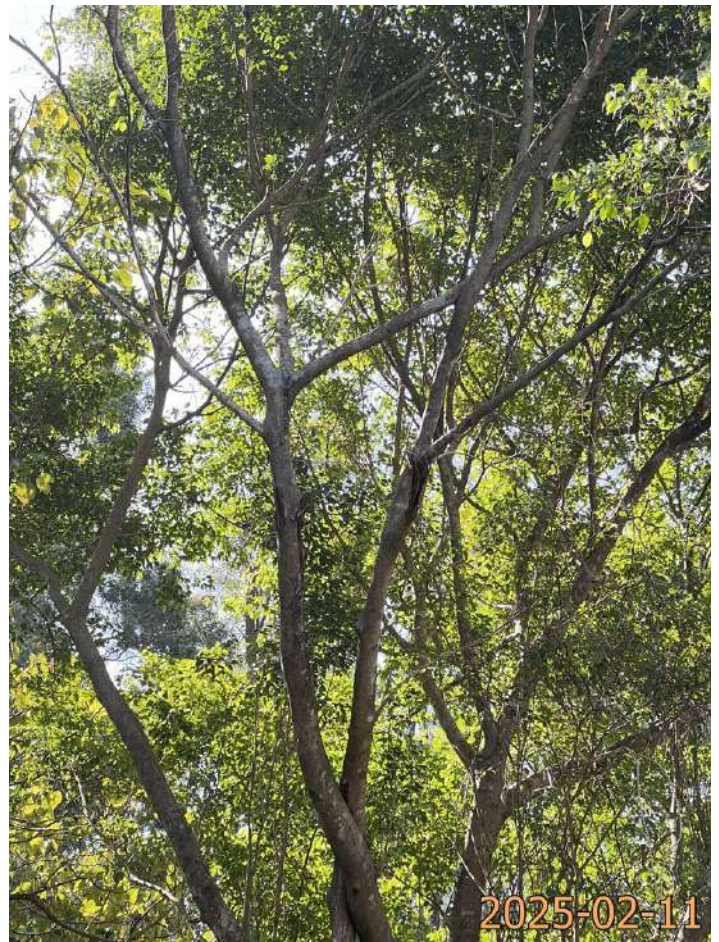
T7 Broken branch

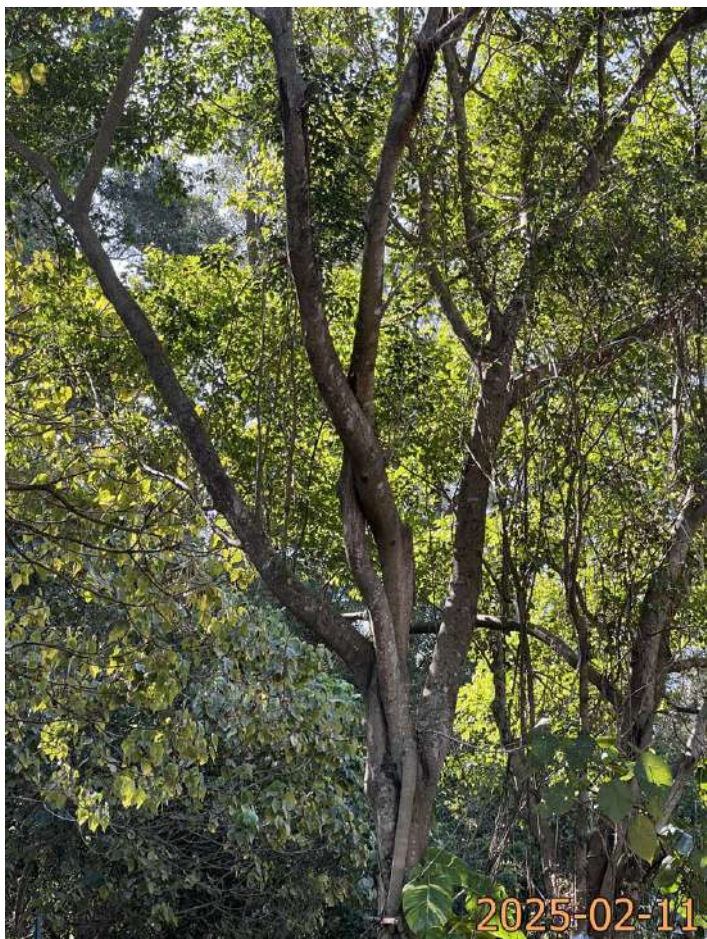
T7 Cross trunks

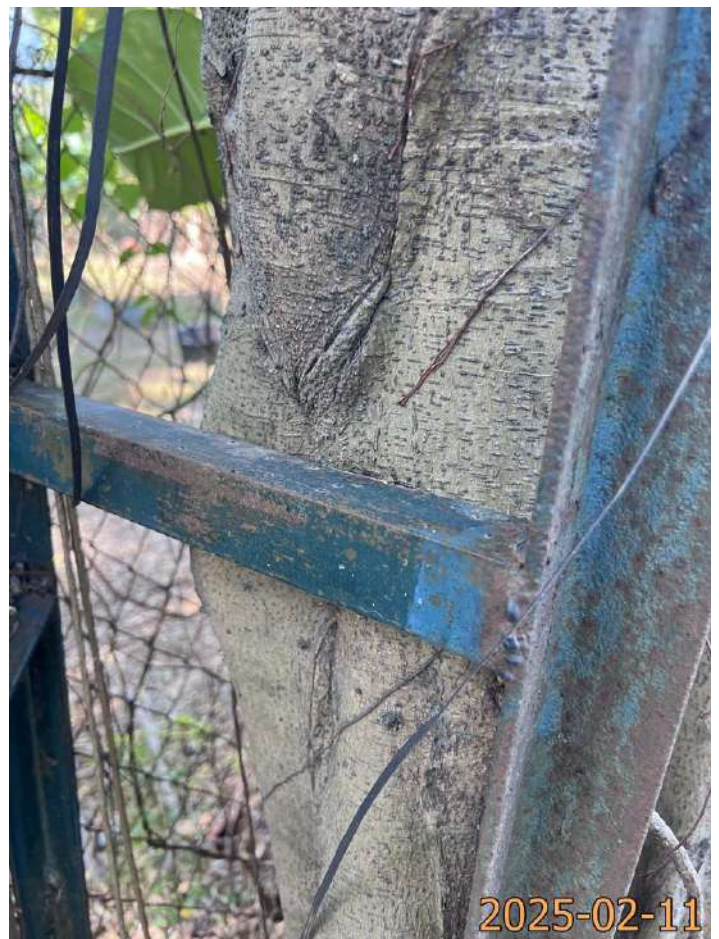
T7 Metal bar embedded into trunk\_1

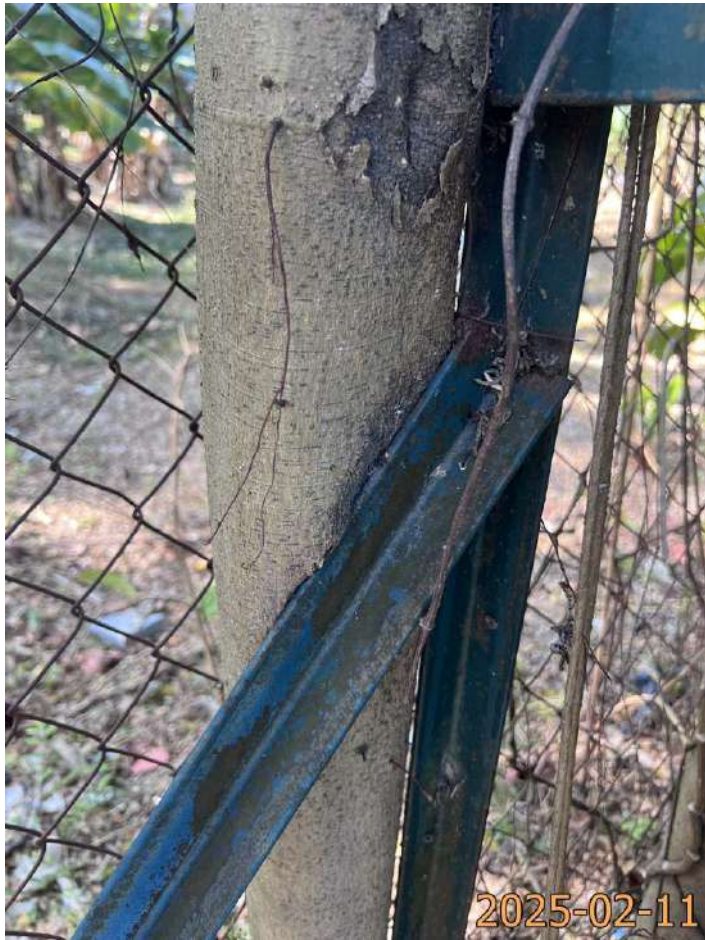
T7 Metal bar embedded into trunk\_2

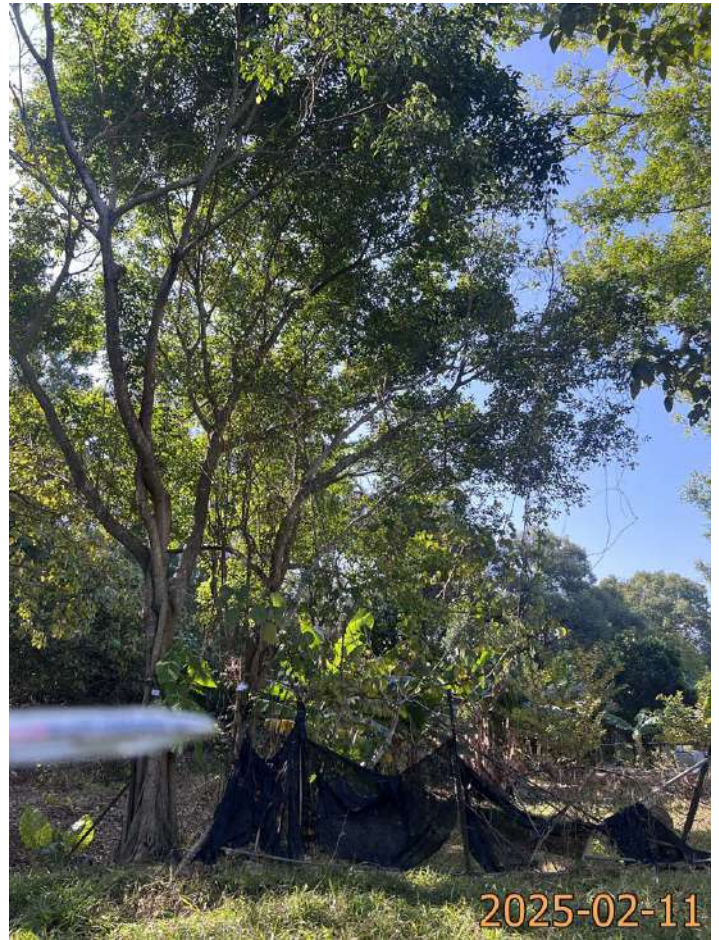
T8 (Overview)

| Tree No. | Tree Species | | Tree Size Measurements | | | Amenity Value | Form | Health Condition | Structural Condition | Suitability for Transplanting | Remarks |
|---|--|---|---|---|---|---|---|---|---|---|--|
| T8 | <i>Ficus benjamina</i> | 垂葉榕 | 9.0 | 250 | 6.0 | Low | Fair | Fair | Poor | Low | exposed dead root |

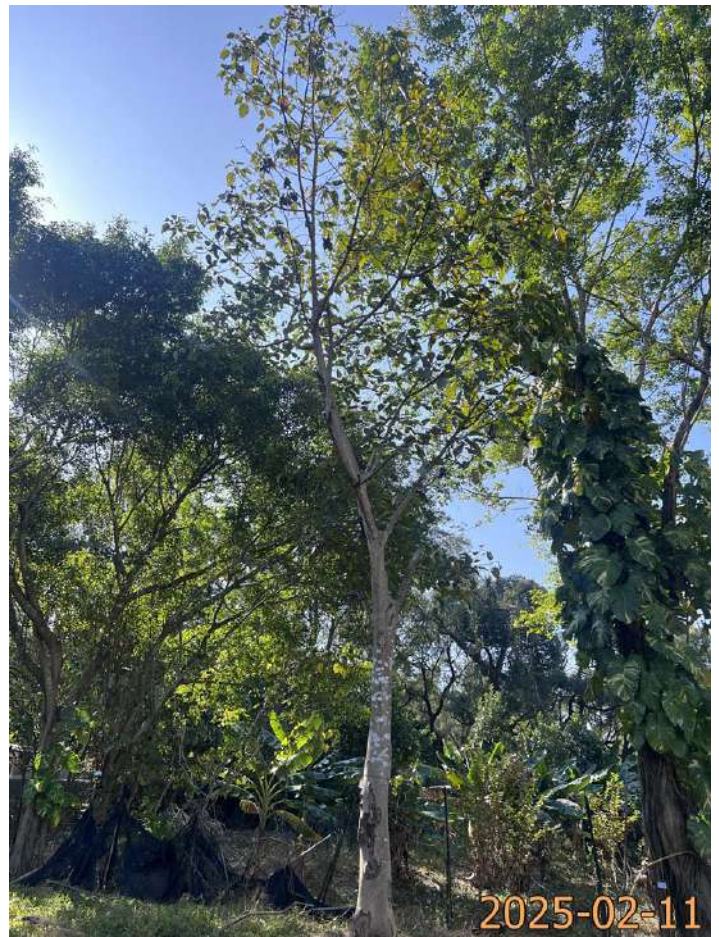
T9 (Overview)

| Tree No. | Tree Species | | Tree Size Measurements | | | Amenity Value | Form | Health Condition | Structural Condition | Suitability for Transplanting | Remarks |
|---|--|---|---|---|---|---|---|---|---|---|--|
| T9 | <i>Ficus variegata</i> | 青果榕 | 9.0 | 240 | 9.0 | Low | Poor | Fair | Poor | Low | wound on trunk, dead stub |

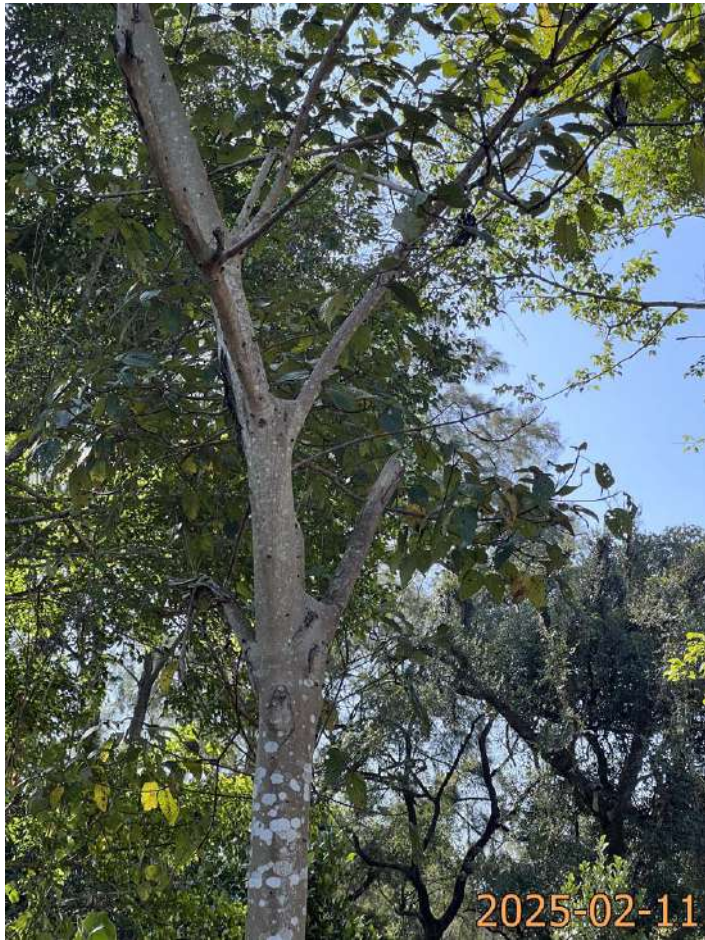
T9 Dead stub

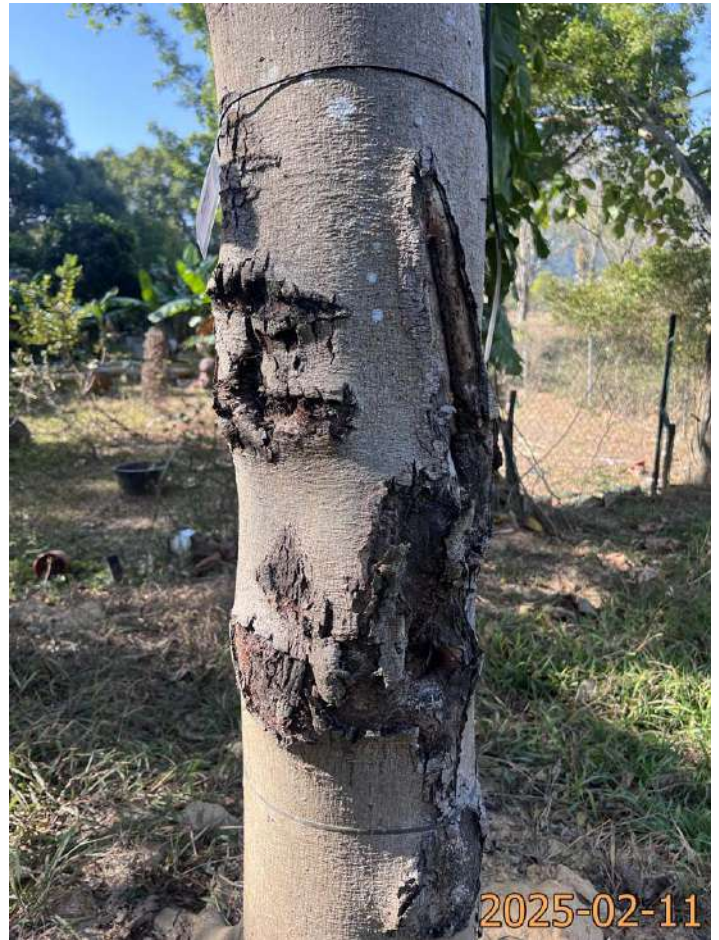
T9 Wound on trunk\_1

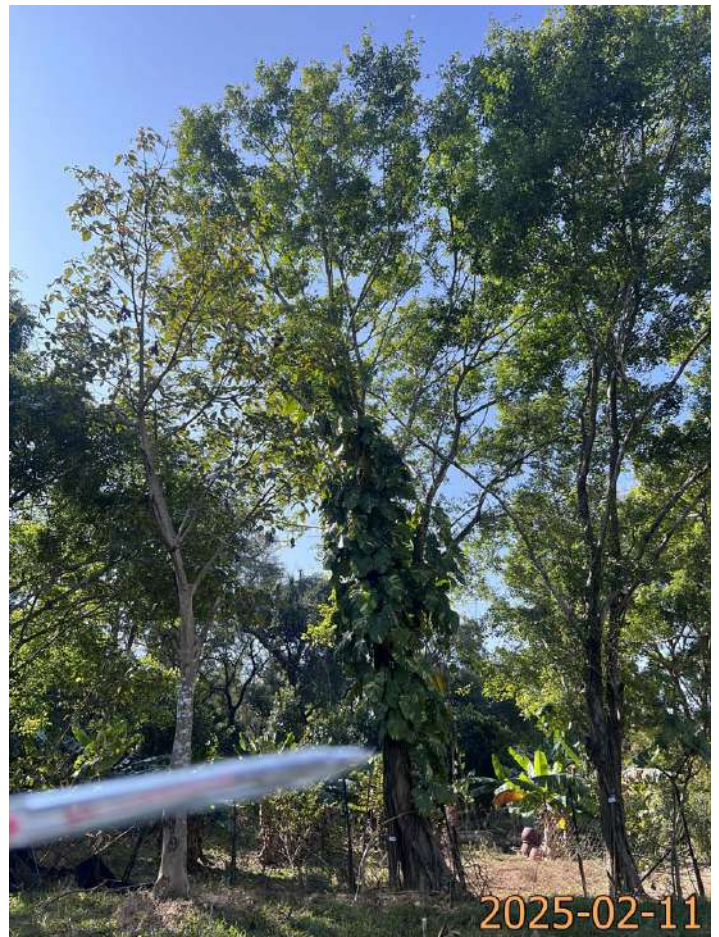
T10 (Overview)

| Tree No. | Tree Species | | Tree Size Measurements | | | Amenity Value | Form | Health Condition | Structural Condition | Suitability for Transplanting | Remarks |
|---|--|---|---|---|---|---|---|---|---|---|--|
| T10 | <i>Ficus benjamina</i> | 垂葉榕 | 12.0 | 470 | 6.0 | Low | Fair | Fair | Fair | Low | epiphytic plants |

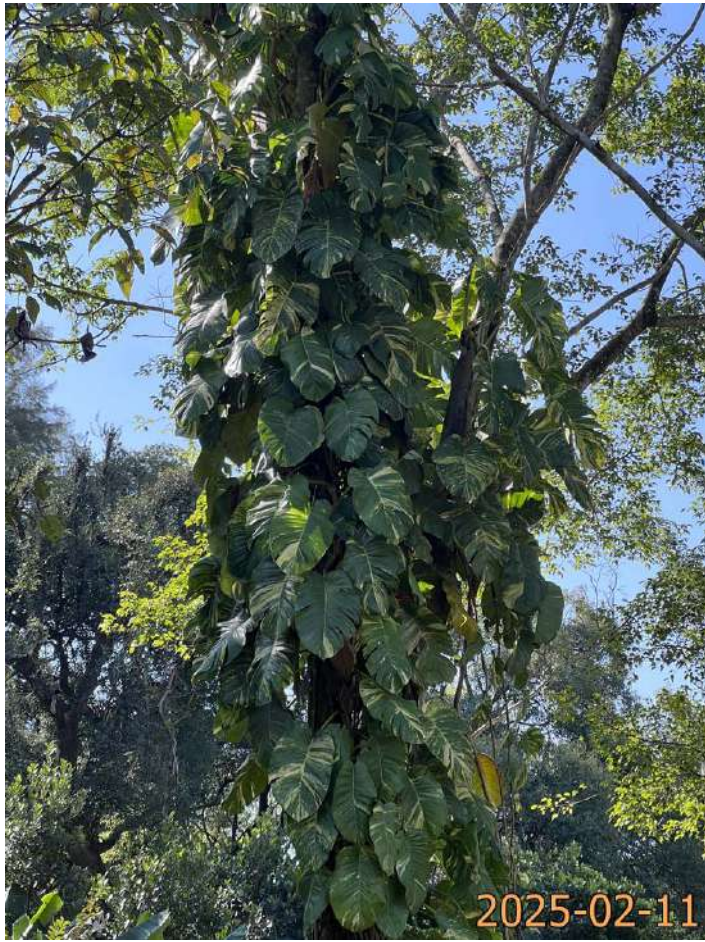
T10 Epiphytic plants

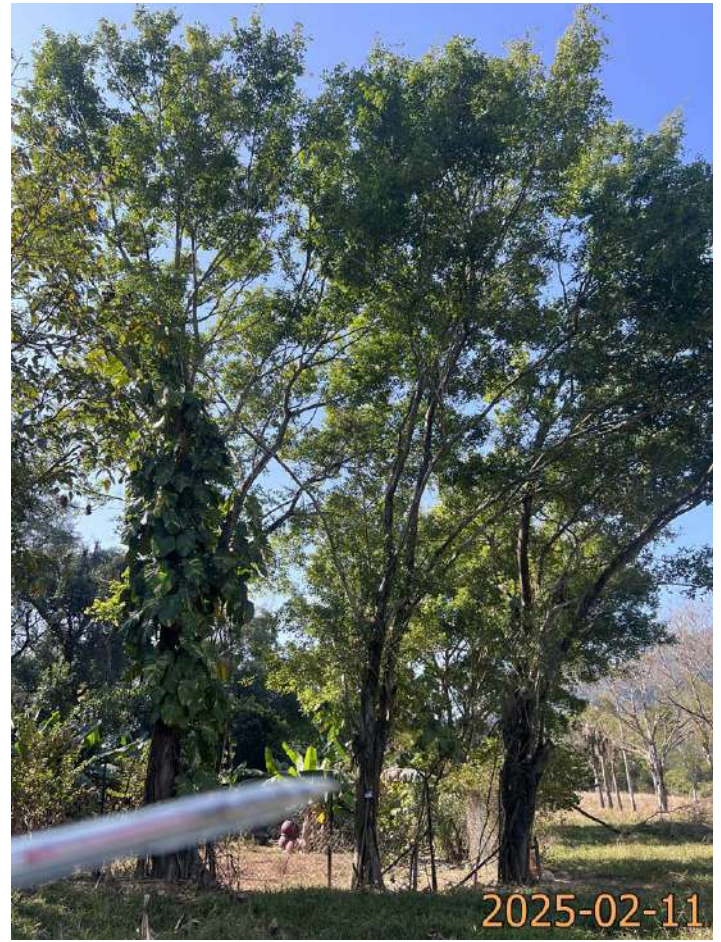
T11 (Overview)

| Tree No. | Tree Species | | Tree Size Measurements | | | Amenity Value | Form | Health Condition | Structural Condition | Suitability for Transplanting | Remarks |
|---|--|---|---|---|---|---|---|---|---|---|--|
| T11 | <i>Ficus benjamina</i> | 垂葉榕 | 12.0 | 420 | 7.0 | Low | Fair | Fair | Poor | Low | cross branches |

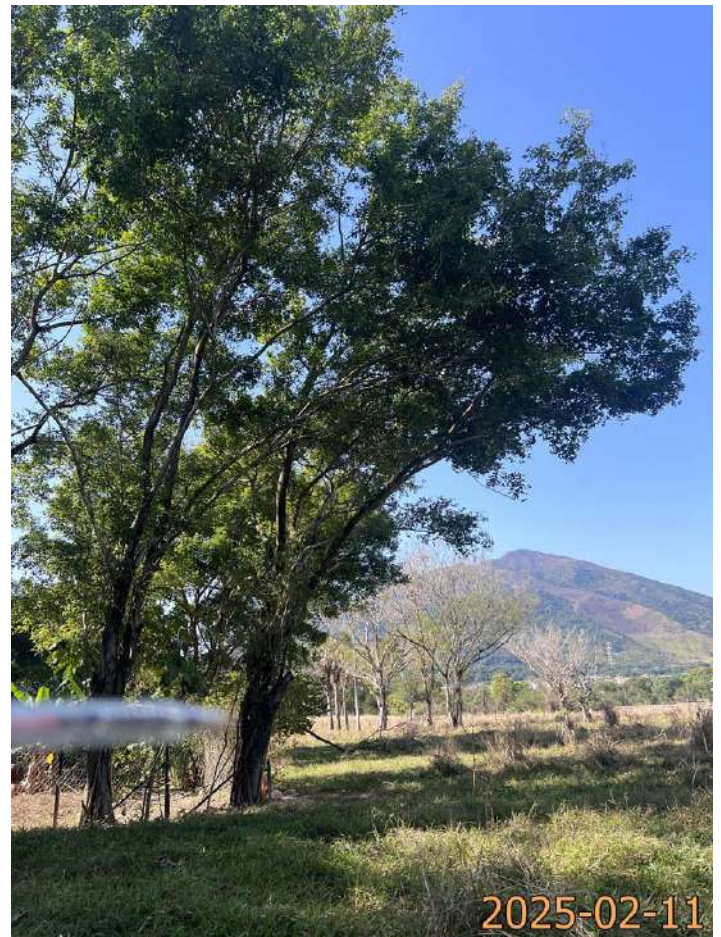
T12 (Overview)

| Tree No. | Tree Species | | Tree Size Measurements | | | Amenity Value | Form | Health Condition | Structural Condition | Suitability for Transplanting | Remarks |
|---|--|---|---|---|---|---|---|---|---|---|--|
| T12 | <i>Ficus benjamina</i> | 垂葉榕 | 12.0 | 450 | 7.0 | Low | Fair | Poor | Fair | Low | dead stub |

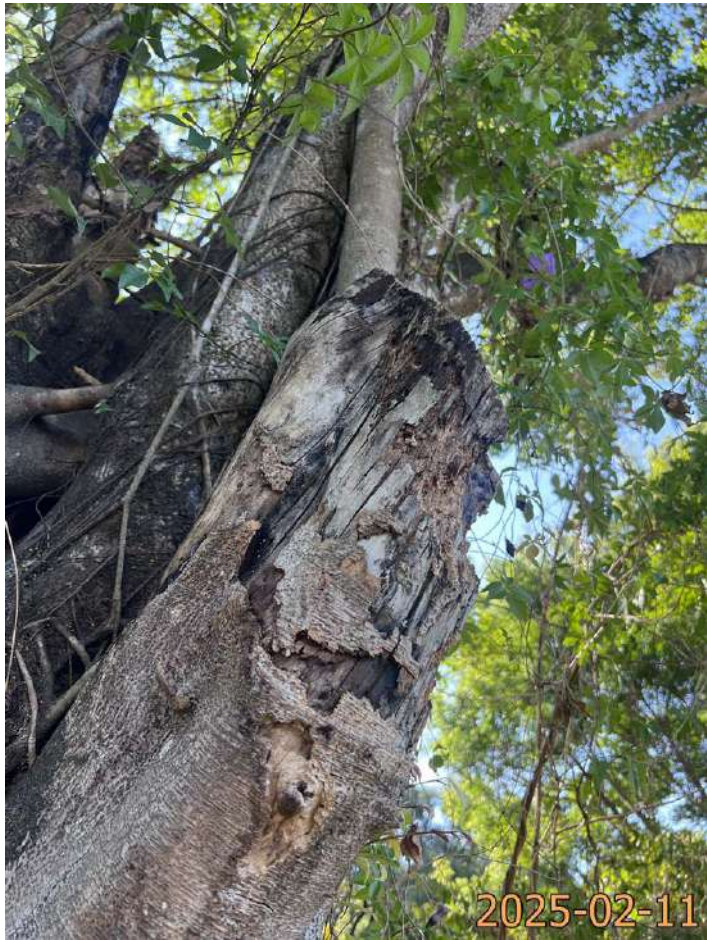
T12 Dead stub

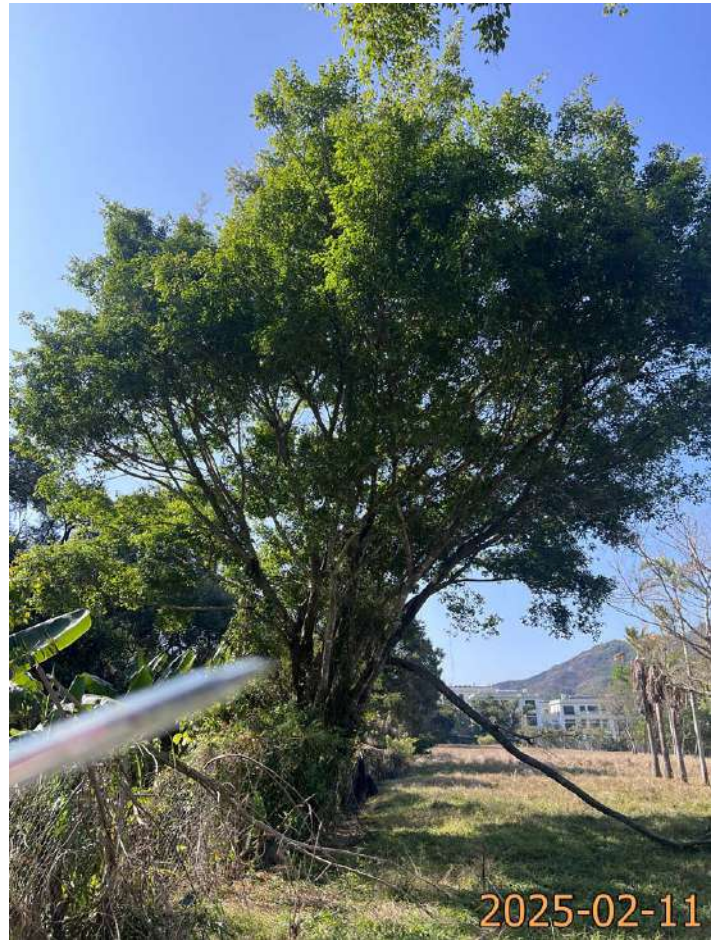
T13 (Overview)

| Tree No. | Tree Species | | Tree Size Measurements | | | Amenity Value | Form | Health Condition | Structural Condition | Suitability for Transplanting | Remarks |
|---|--|---|---|---|---|---|---|---|---|---|--|
| T13 | <i>Ficus benjamina</i> | 垂葉榕 | 12.0 | 480 | 9.0 | Low | Fair | Poor | Poor | Low | broken trunk, hanger, wound on trunk with exposed deadwood |

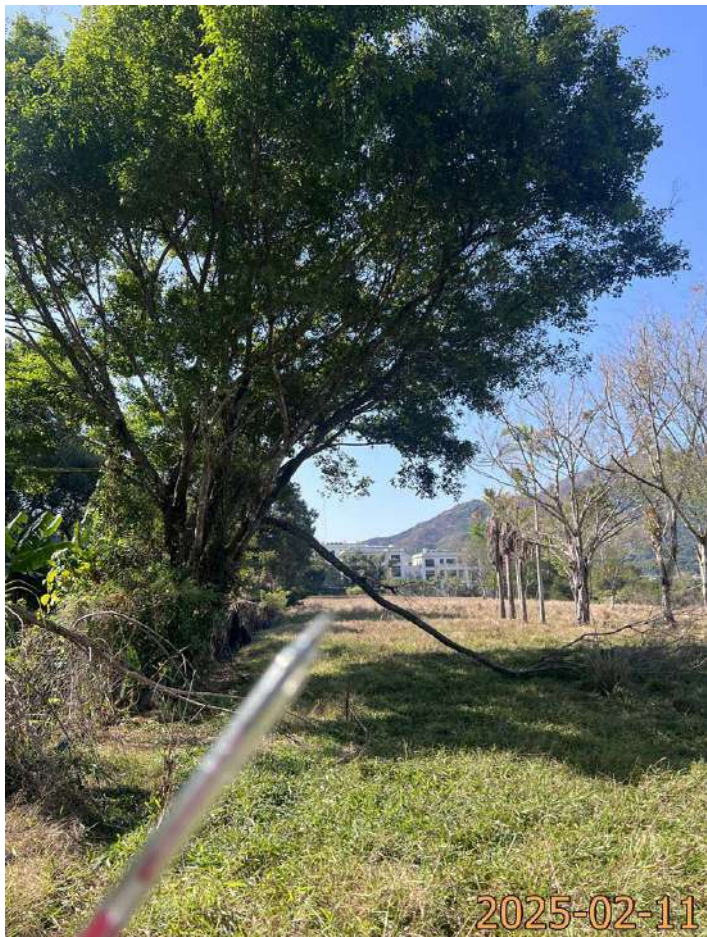
T13 Broken trunk (Hanger)
