# Tree Survey Report

**Date of Survey: 11<sup>th</sup> February 2025**

**Various Lots in D.D. 91 And D.D.100, Lin Tong Mei, Fanling,  
New Territories**

PROJECT  
 PROPOSED TEMPORARY  
 WAREHOUSE (EXCLUDING  
 DANGEROUS GOODS GODOWN)  
 WITH ANCILLARY FACILITIES  
 FOR A PERIOD OF 3 YEARS AND  
 ASSOCIATED FILLING OF LAND

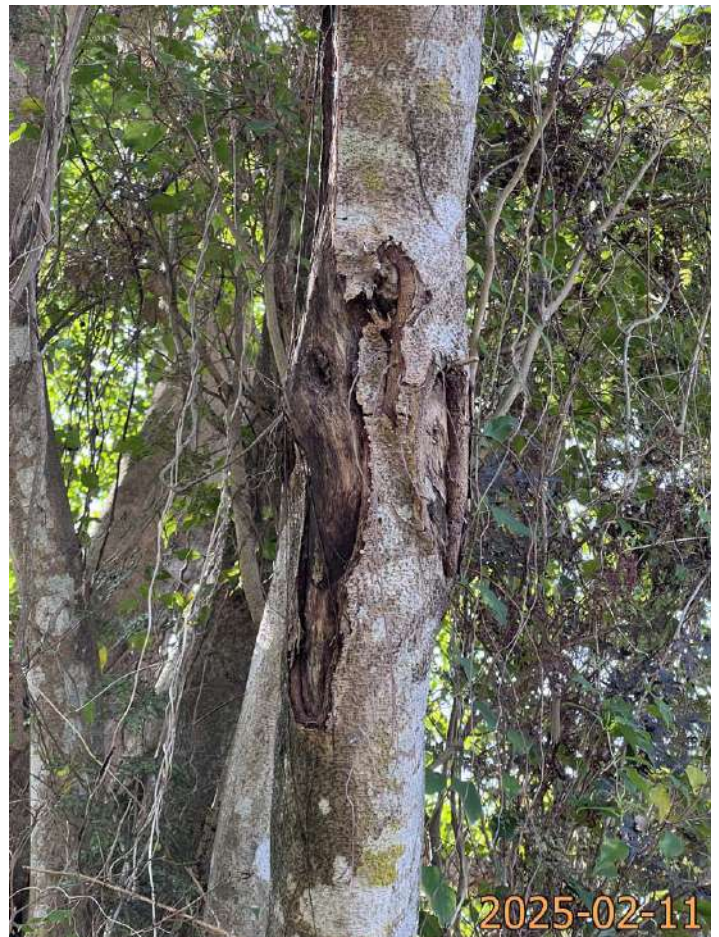
T13 Wound on trunk with exposed deadwood

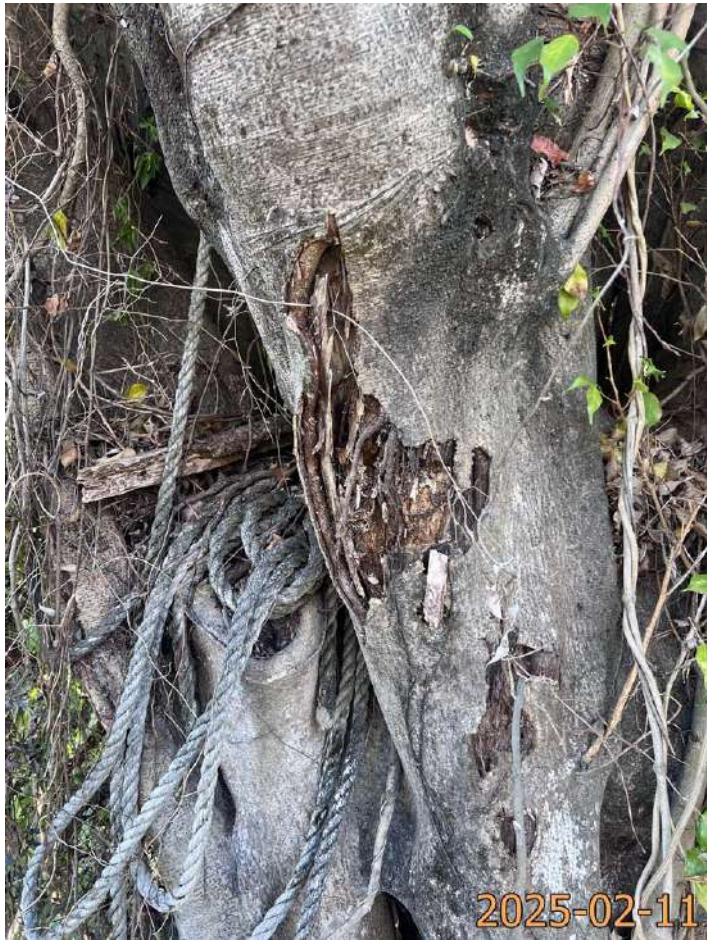
T13 Wound on trunk

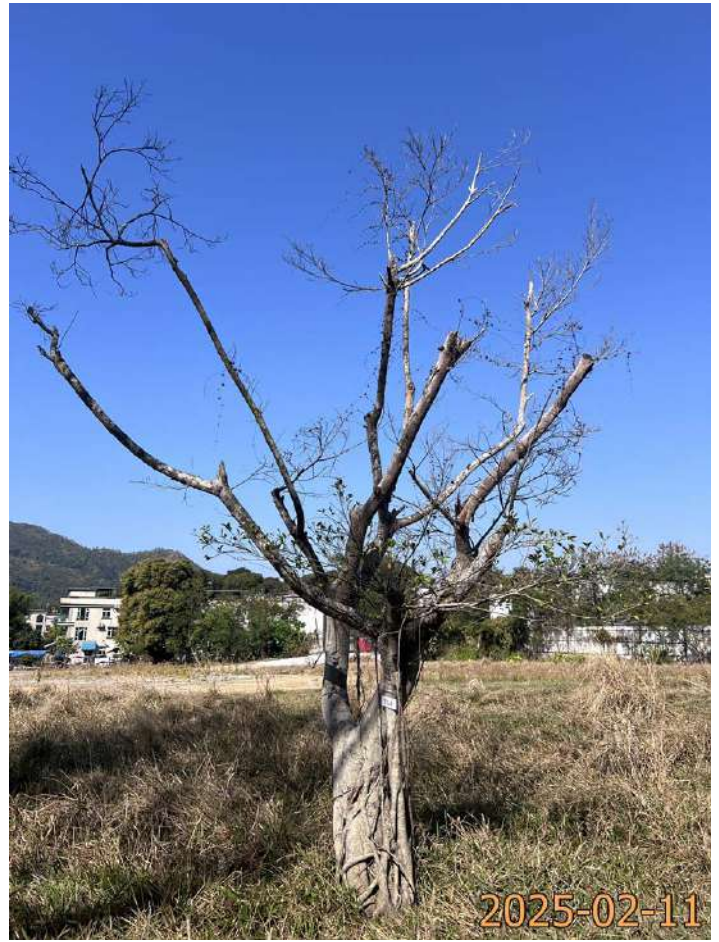
T14 (Overview)

| Tree No. | Tree Species | | Tree Size Measurements | | | Amenity Value | Form | Health Condition | Structural Condition | Suitability for Transplanting | Remarks |
|---|--|---|---|---|---|---|---|---|---|---|--|
| T14 | <i>Ficus microcarpa</i> | 榕樹(細葉榕) | 5.0 | 380 | 4.0 | Low | Poor | Poor | Poor | Low | dying tree, epicormics, dieback, topped |

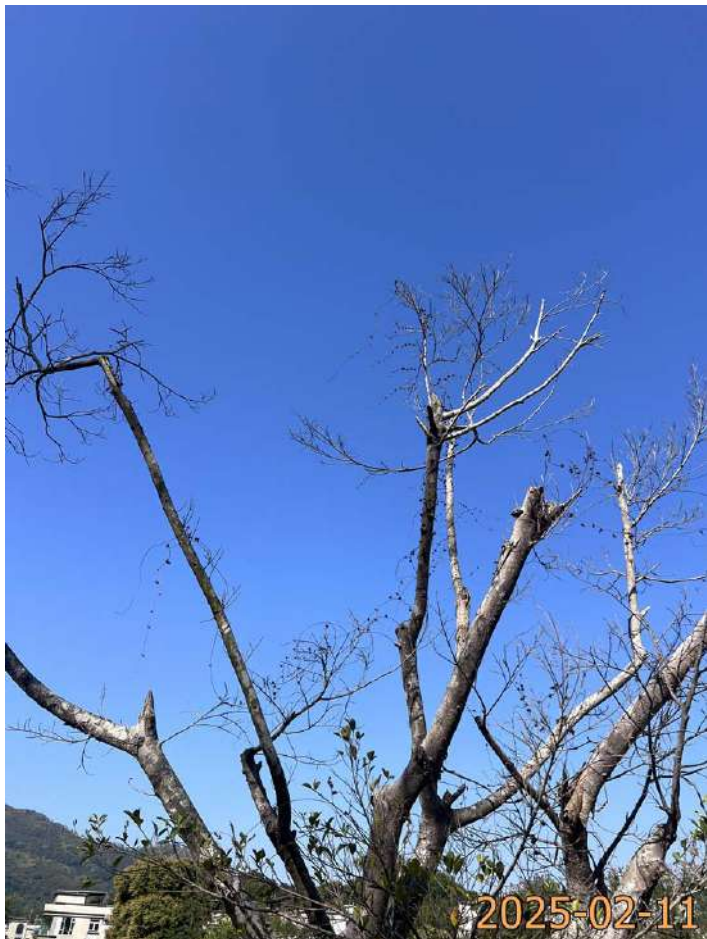
T14 Dieback (Topped)

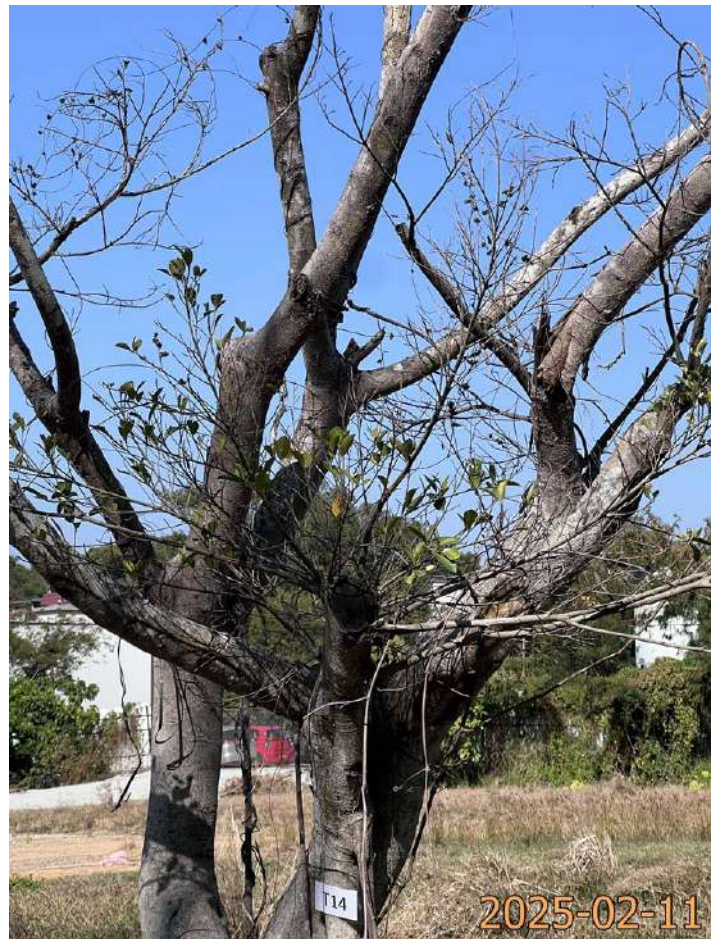
T14 Epicormics

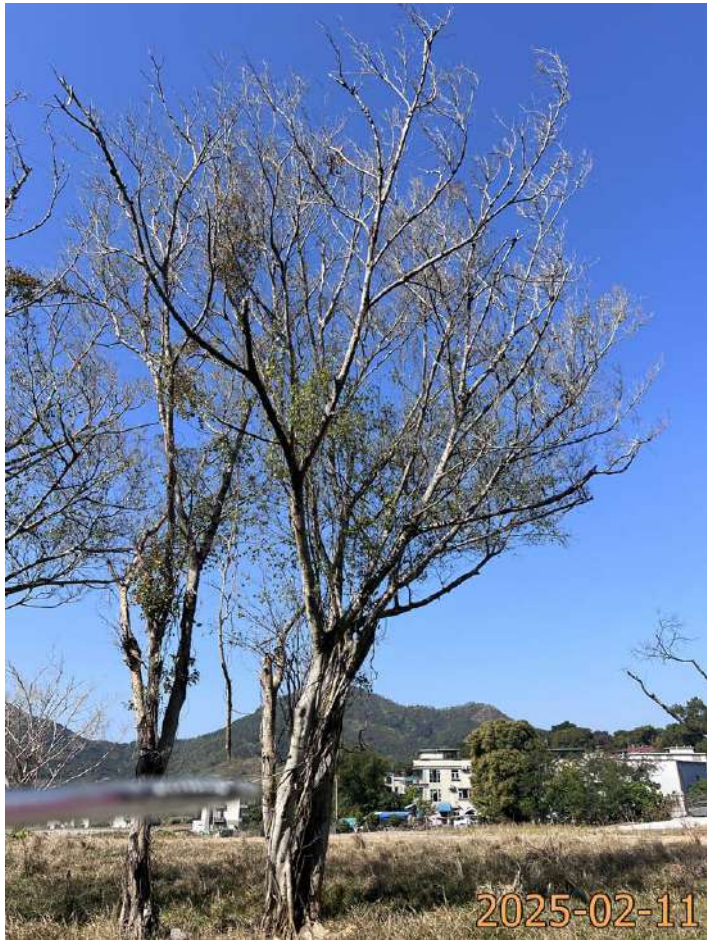
| Tree No. | Tree Species | | Tree Size Measurements | | | Amenity Value | Form | Health Condition | Structural Condition | Suitability for Transplanting | Remarks |
|---|--|---|---|---|---|---|---|---|---|---|--|
| T15 | <i>Ficus benjamina</i> | 垂葉榕 | 11.0 | 500 | 6.0 | Low | Poor | Poor | Poor | Low | dying tree, dieback, dead trunk, hanger, wound on trunk |

T15 (Overview) (Dieback)

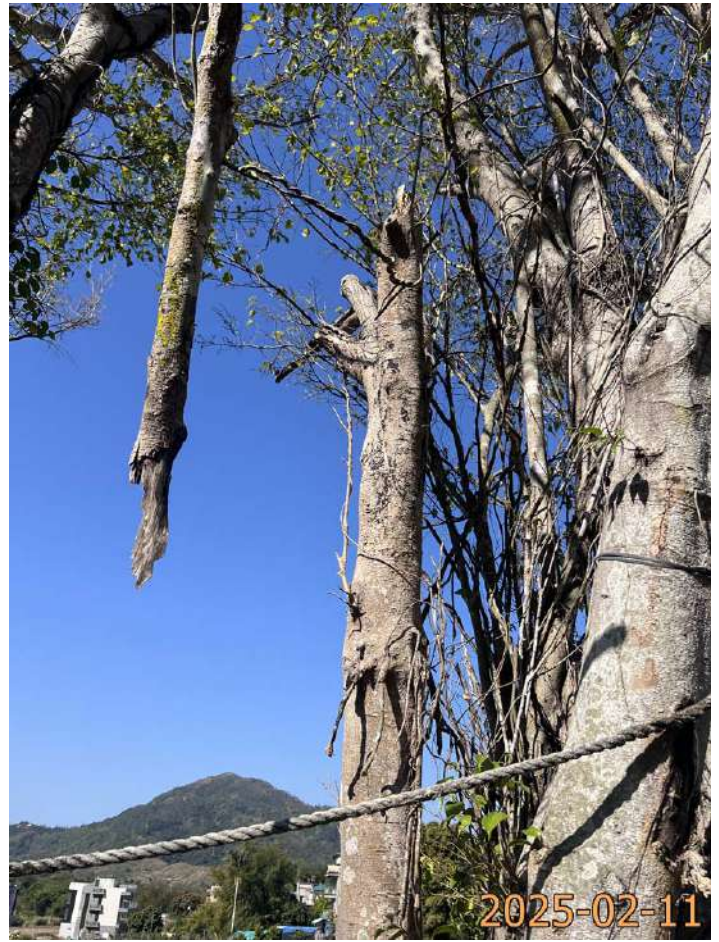
T15 Dead trunk

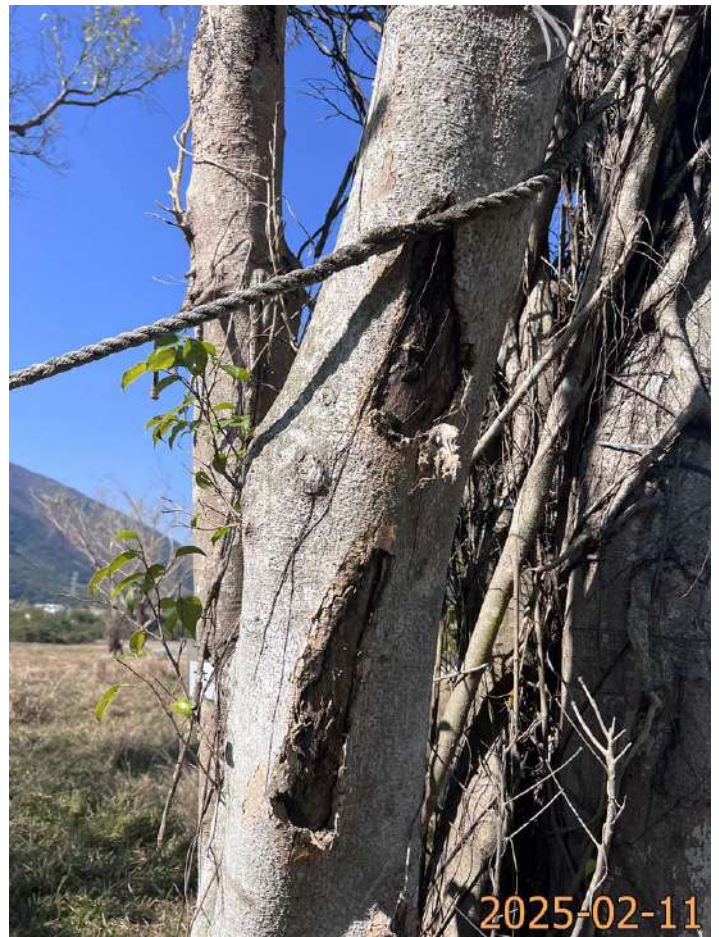
T15 Wound on trunk

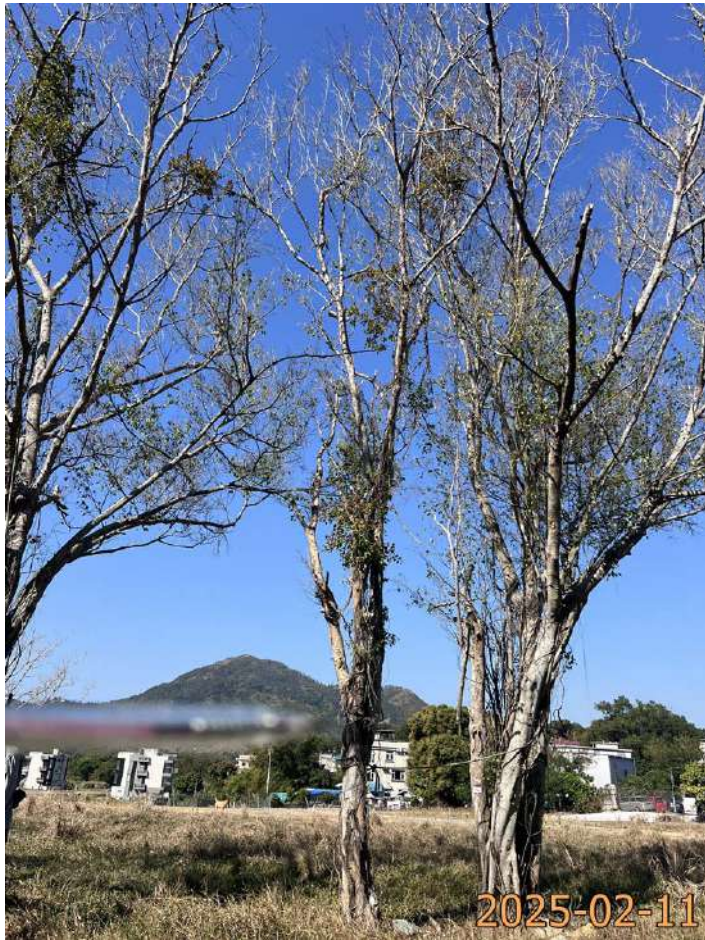
| Tree No. | Tree Species | | Tree Size Measurements | | | Amenity Value | Form | Health Condition | Structural Condition | Suitability for Transplanting | Remarks |
|---|--|---|---|---|---|---|---|---|---|---|--|
| T16 | <i>Ficus benjamina</i> | 垂葉榕 | 11.0 | 280 | 3.0 | Low | Poor | Poor | Poor | Low | dying tree, dieback, dead trunk, wound on trunk with exposed deadwood, trace of termite |

T16 (Overview) (Dieback)

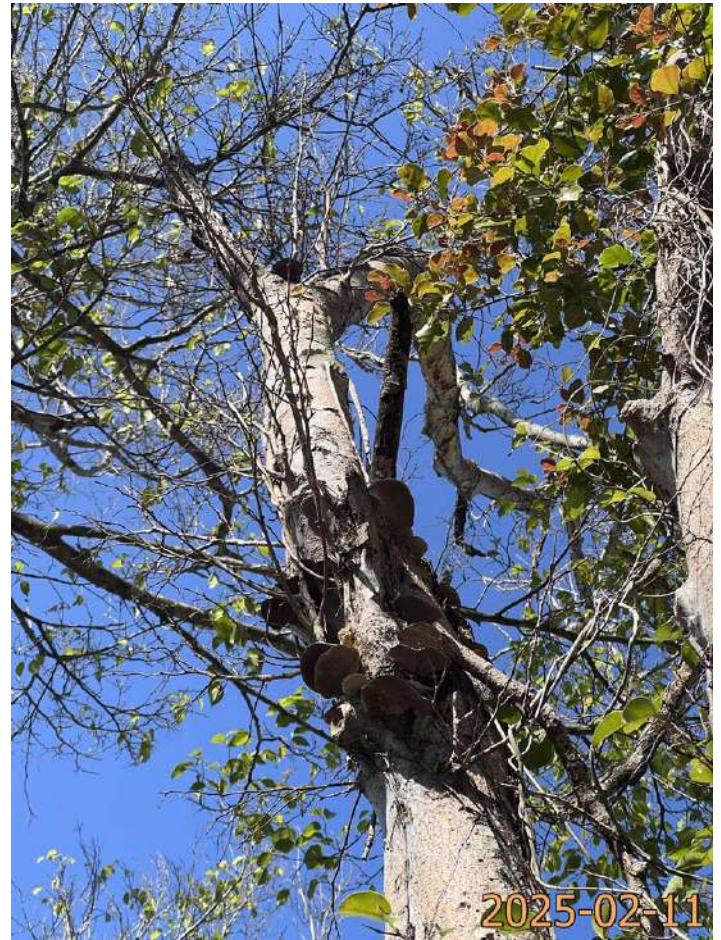
T16 Dead trunk

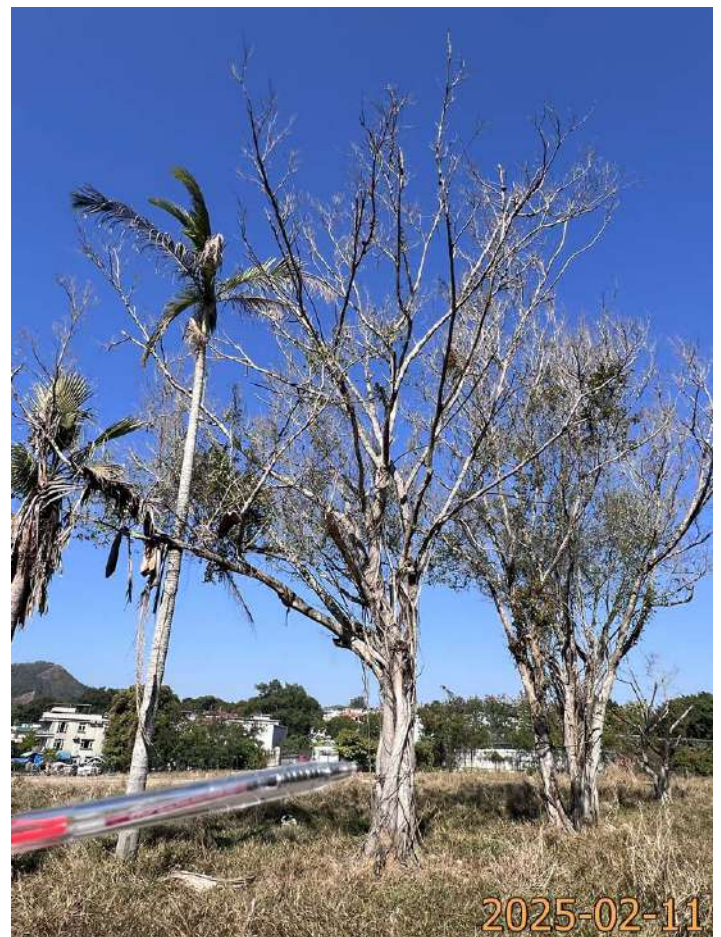
| Tree No. | Tree Species | | Tree Size Measurements | | | Amenity Value | Form | Health Condition | Structural Condition | Suitability for Transplanting | Remarks |
|---|--|---|---|---|---|---|---|---|---|---|--|
| T17 | <i>Ficus benjamina</i> | 垂葉榕 | 10.0 | 490 | 6.0 | Low | Poor | Poor | Poor | Low | dying tree, dieback, trace of termite, branch conflict with trunk of T18 and crown of T19, dead stub with fungal fruiting bodies |

T17 (Overview) (Dieback)

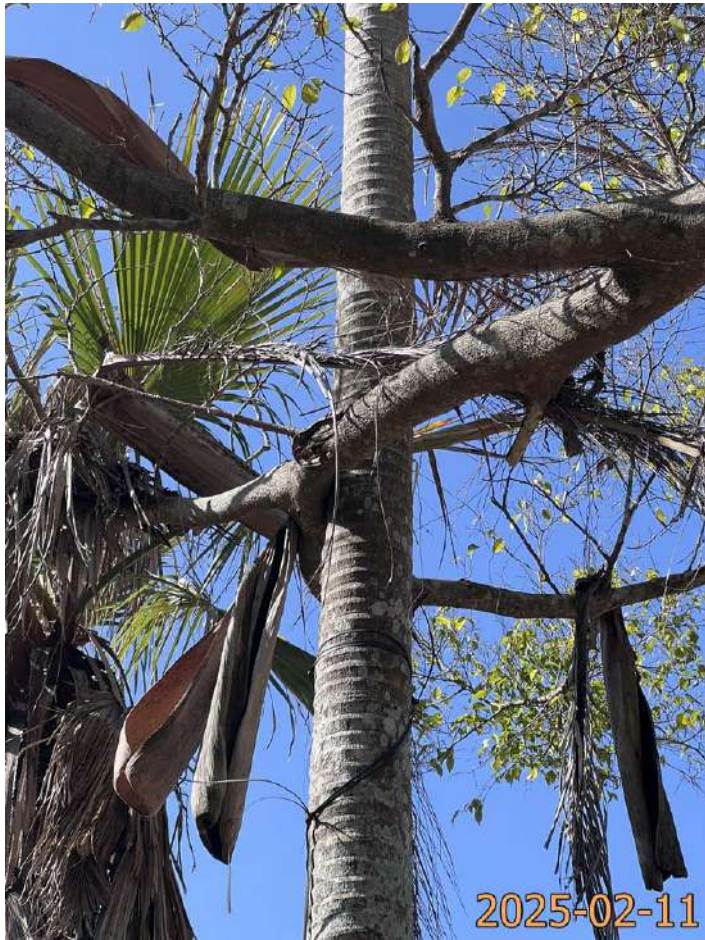
T17 Branch conflict with trunk of T18

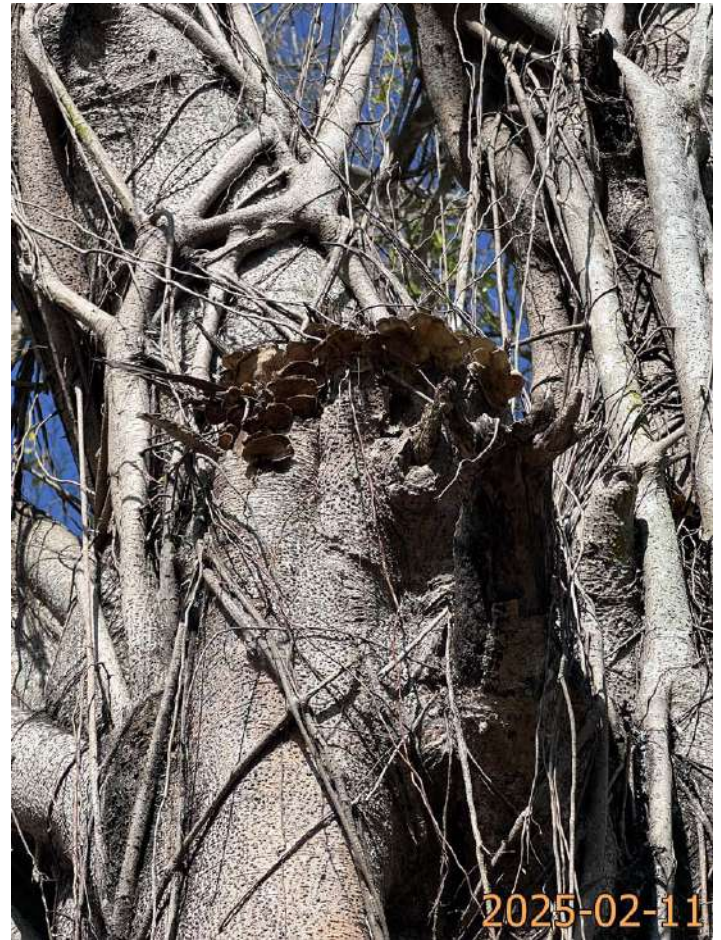
T17 Dead stub with fungal fruiting bodies

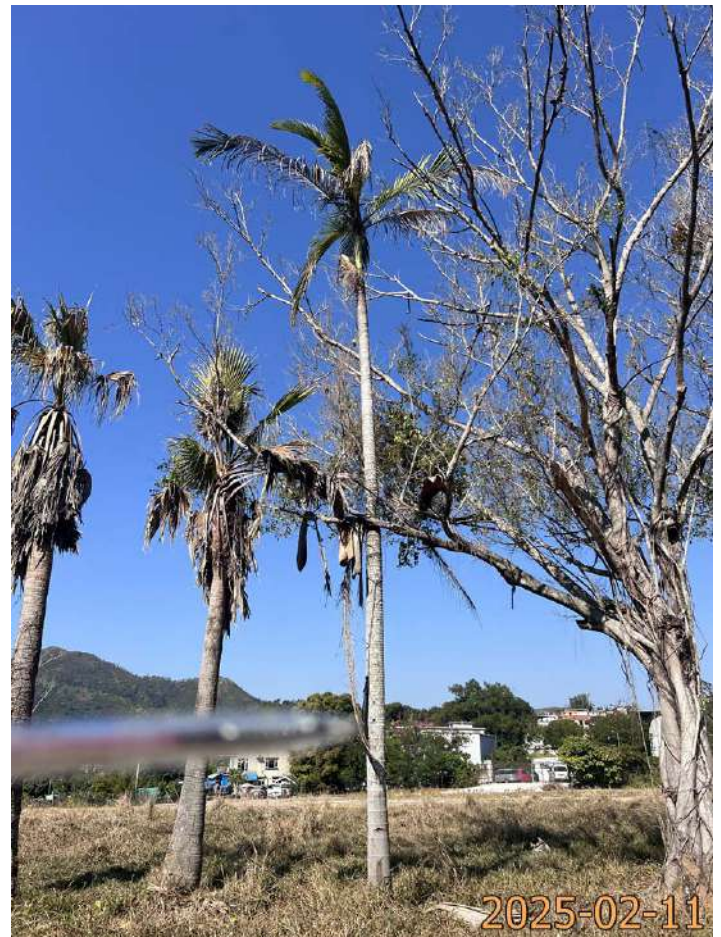
T18 (Overview)

| Tree No. | Tree Species | | Tree Size Measurements | | | Amenity Value | Form | Health Condition | Structural Condition | Suitability for Transplanting | Remarks |
|---|--|---|---|---|---|---|---|---|---|---|--|
| T18 | <i>Archontophoenix alexandrae</i> | 假檳榔 | 10.0 | 140 | 1.5 | Low | Fair | Fair | Fair | Low | dead fronds, trunk conflict with branch of T17 |

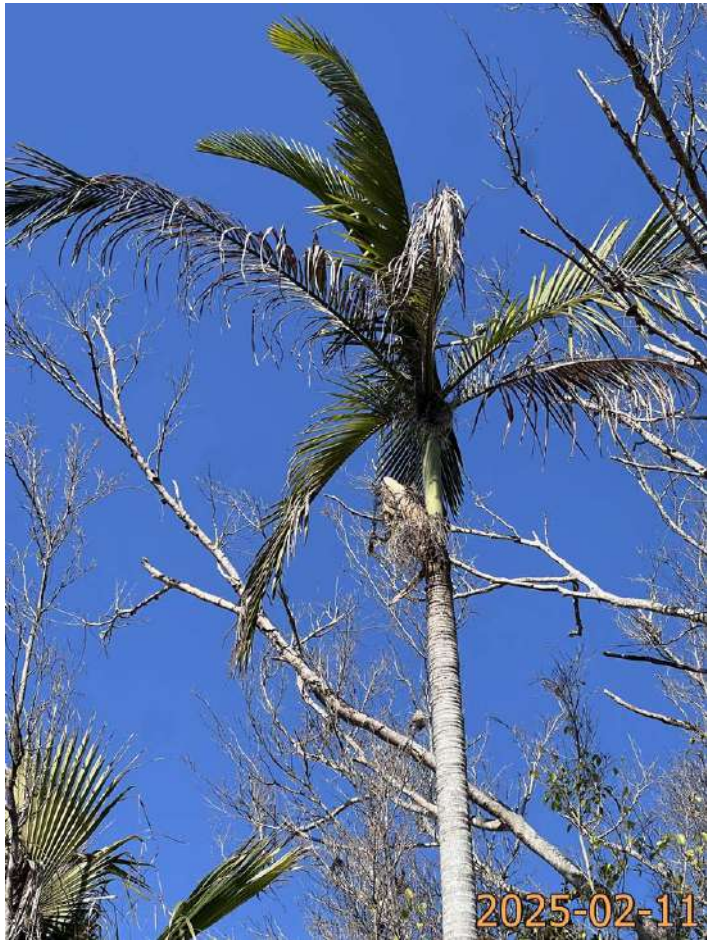
T18 Dead fronds

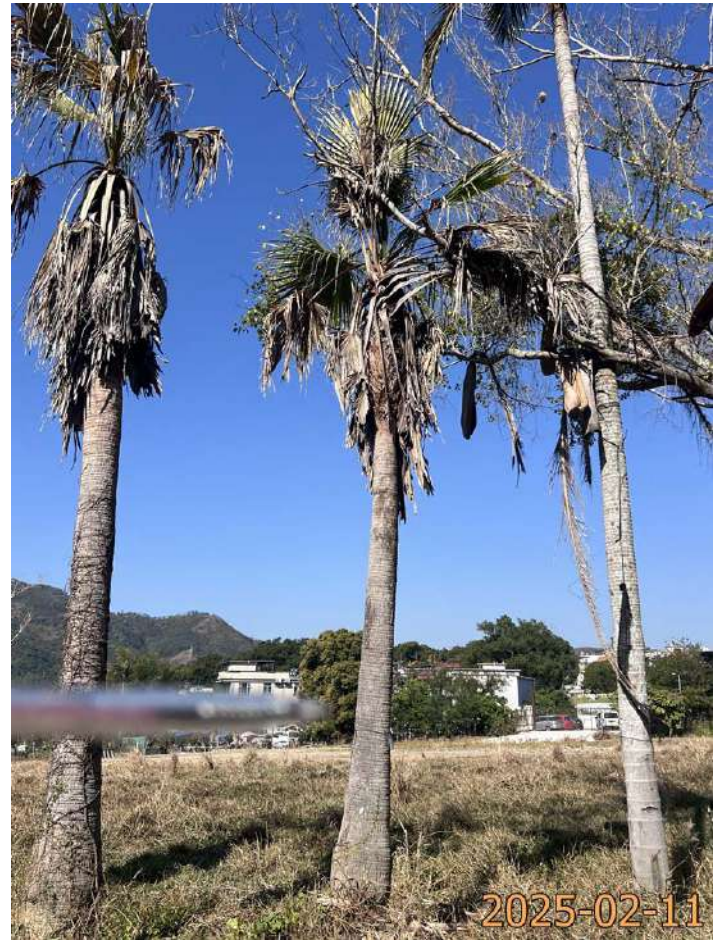
T19 (Overview)

| Tree No. | Tree Species | | Tree Size Measurements | | | Amenity Value | Form | Health Condition | Structural Condition | Suitability for Transplanting | Remarks |
|---|--|---|---|---|---|---|---|---|---|---|--|
| T19 | <i>Livistona chinensis</i> | 蒲葵 | 10.0 | 150 | 1.0 | Low | Fair | Fair | Fair | Low | dead fronds, crown conflict with branch of T17 |

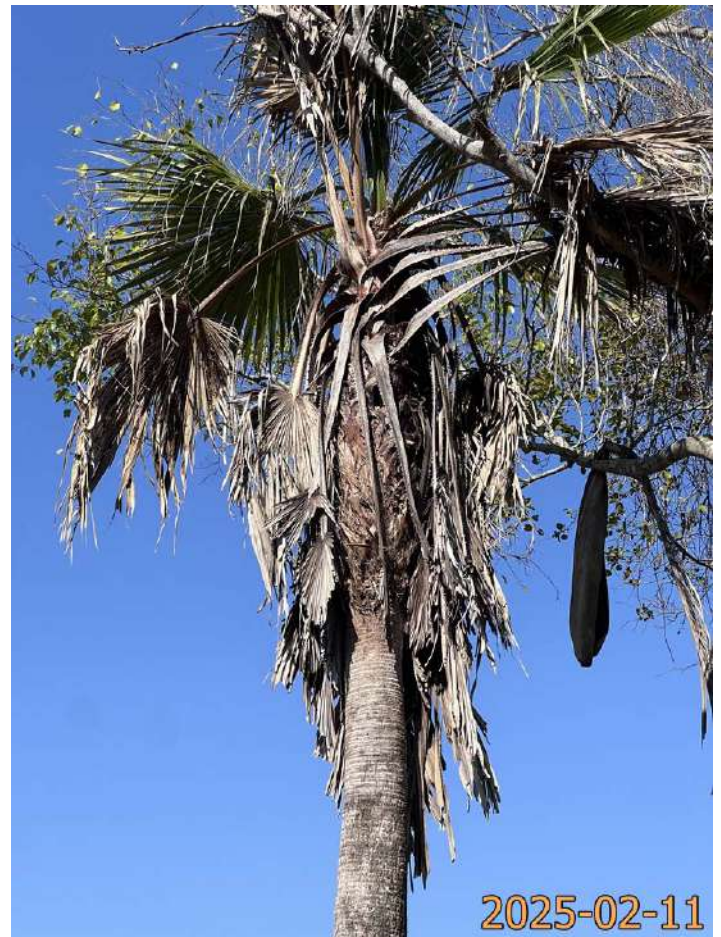
T19 Dead fronds

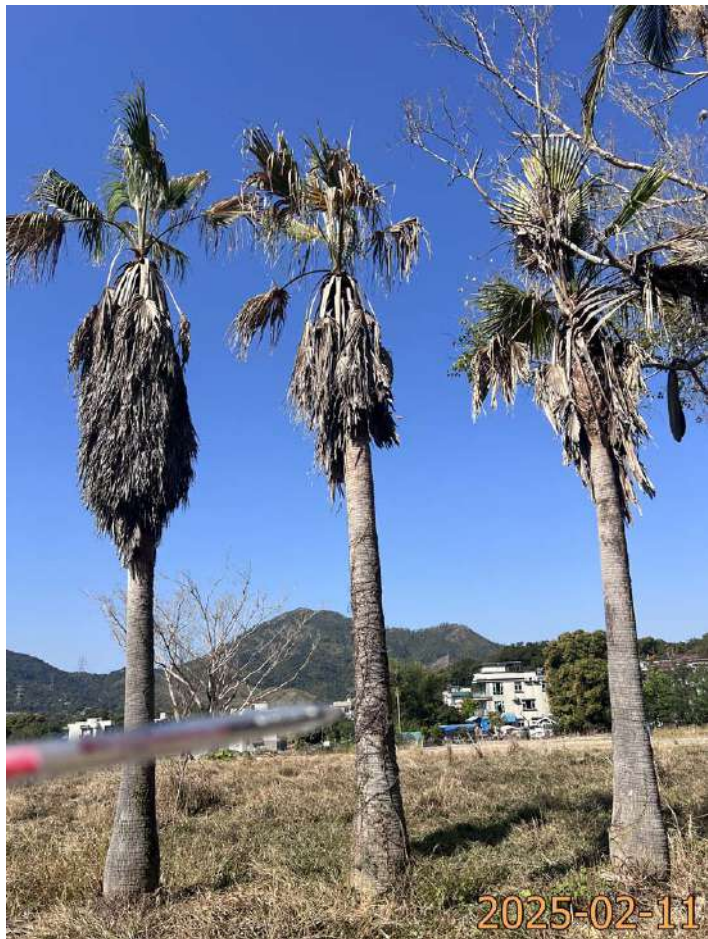
T20 (Overview)

| Tree No. | Tree Species | | Tree Size Measurements | | | Amenity Value | Form | Health Condition | Structural Condition | Suitability for Transplanting | Remarks |
|---|--|---|---|---|---|---|---|---|---|---|--|
| T20 | <i>Livistona chinensis</i> | 蒲葵 | 10.0 | 160 | 1.0 | Low | Fair | Fair | Fair | Low | dead fronds |

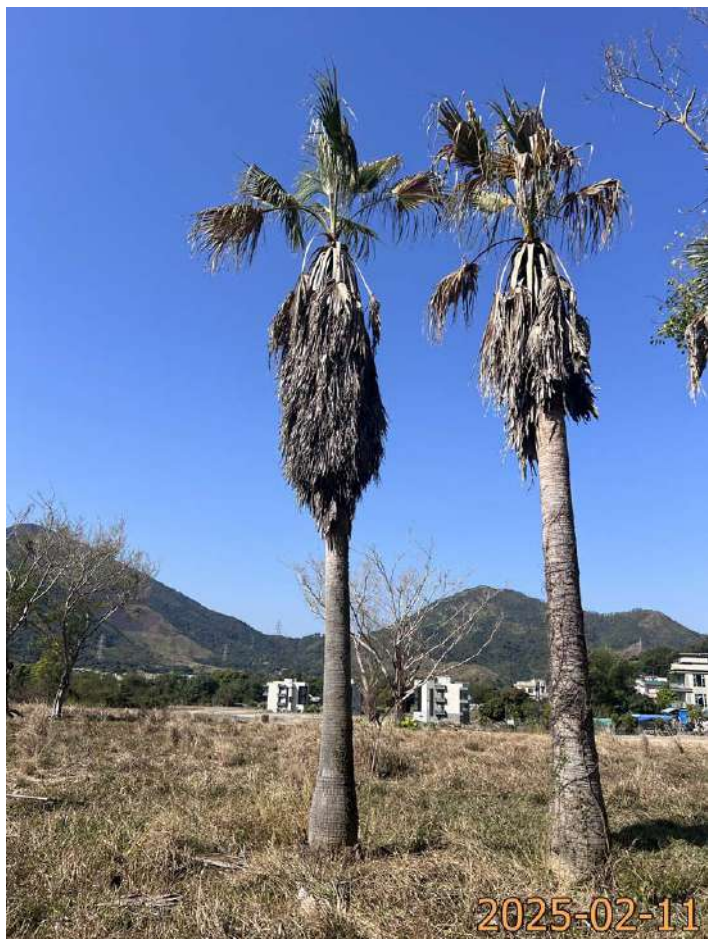
T21 (Overview)

| Tree No. | Tree Species | | Tree Size Measurements | | | Amenity Value | Form | Health Condition | Structural Condition | Suitability for Transplanting | Remarks |
|---|--|---|---|---|---|---|---|---|---|---|--|
| T21 | <i>Livistona chinensis</i> | 蒲葵 | 10.0 | 150 | 1.0 | Low | Fair | Fair | Fair | Low | dead fronds |

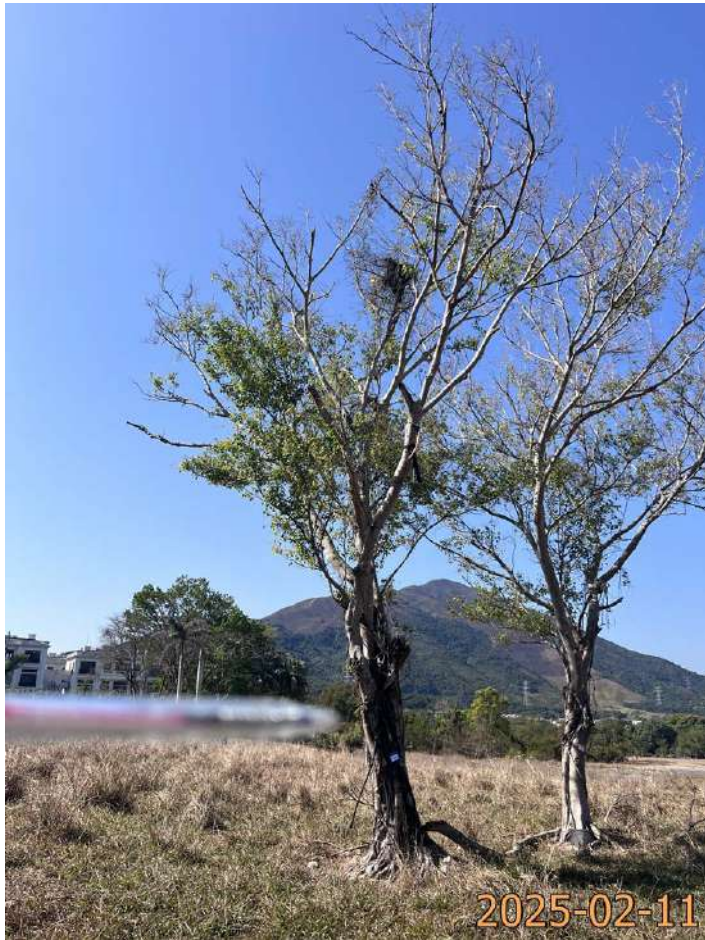
T22 (Overview)

| Tree No. | Tree Species | | Tree Size Measurements | | | Amenity Value | Form | Health Condition | Structural Condition | Suitability for Transplanting | Remarks |
|---|--|---|---|---|---|---|---|---|---|---|--|
| T22 | <i>Ficus microcarpa</i> | 榕樹(細葉榕) | 11.0 | 410 | 5.0 | Low | Poor | Poor | Poor | Low | dying tree, dieback, bird nest |

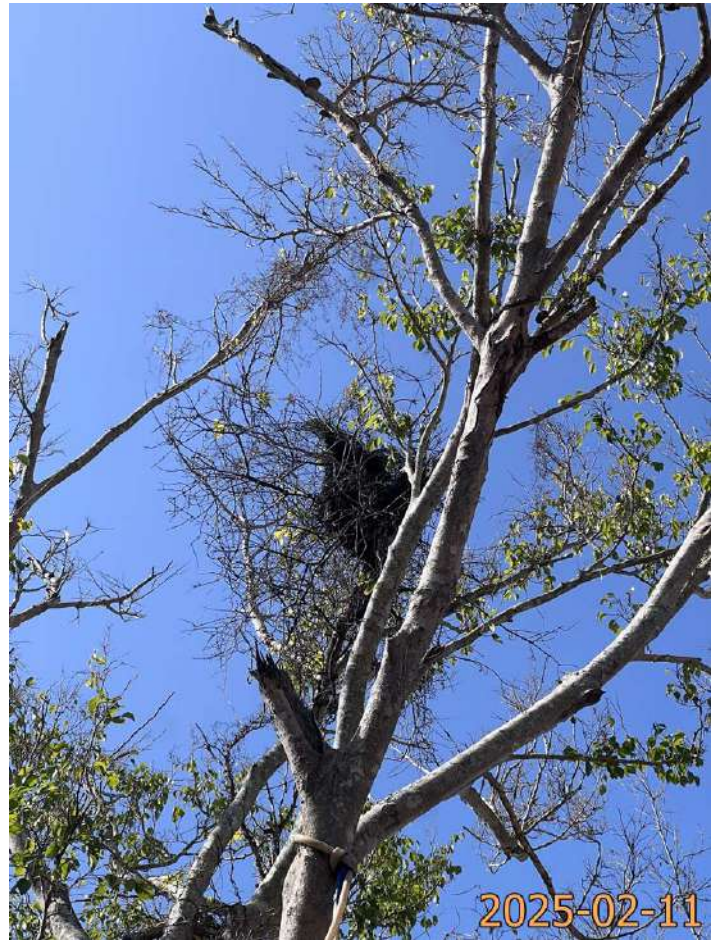
T22 Bird nest

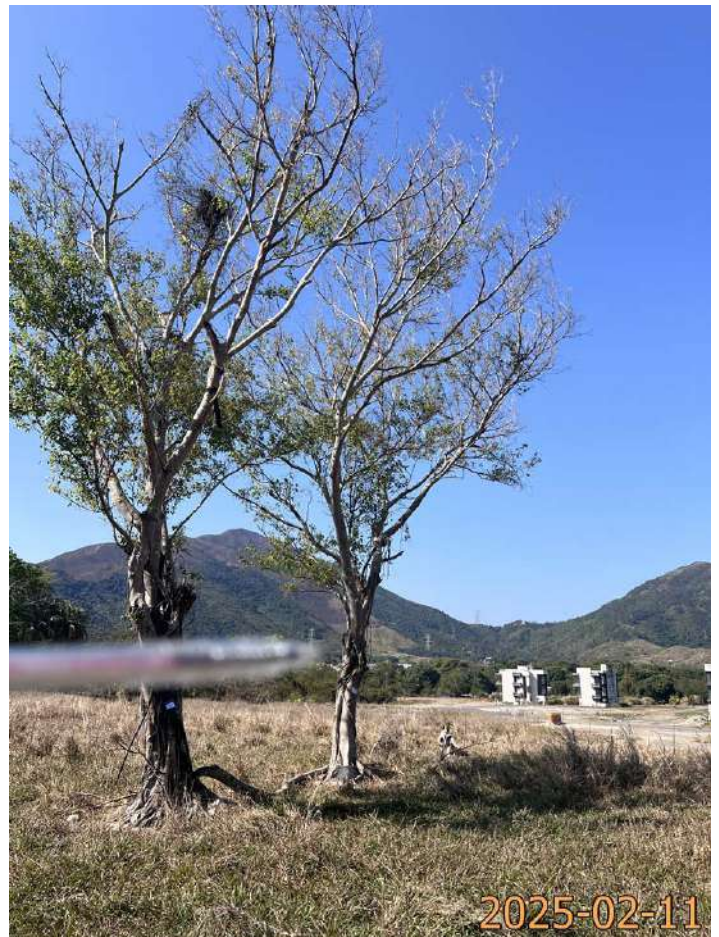
T23 (Overview)

| Tree No. | Tree Species | | Tree Size Measurements | | | Amenity Value | Form | Health Condition | Structural Condition | Suitability for Transplanting | Remarks |
|---|--|---|---|---|---|---|---|---|---|---|--|
| T23 | <i>Ficus microcarpa</i> | 榕樹(細葉榕) | 11.0 | 350 | 5.0 | Low | Poor | Poor | Poor | Low | dying tree, dieback, dead stub |

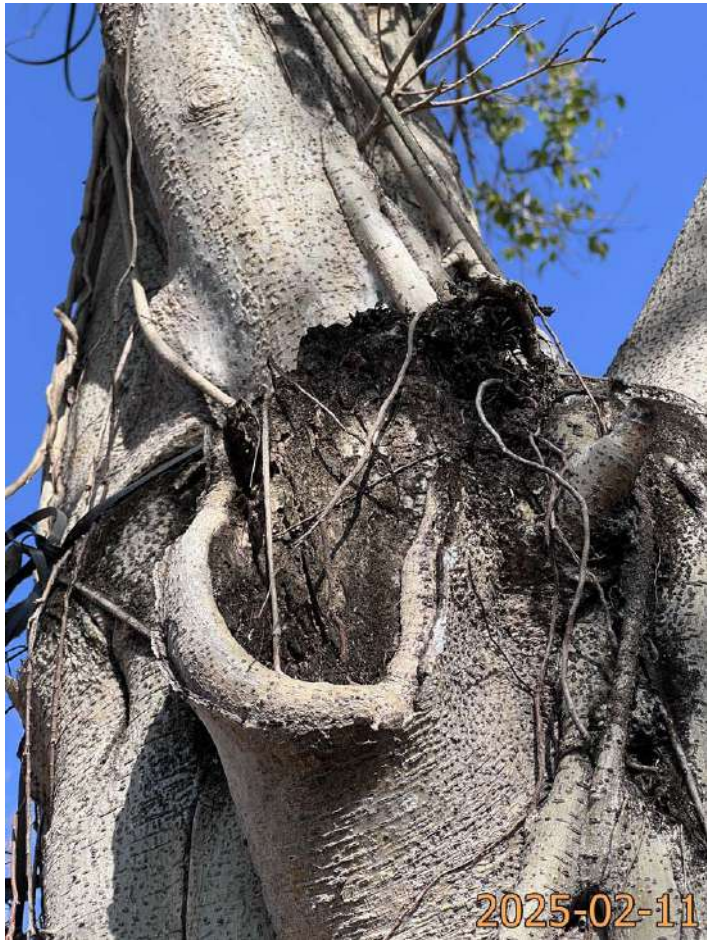
T23 Dead stub\_1

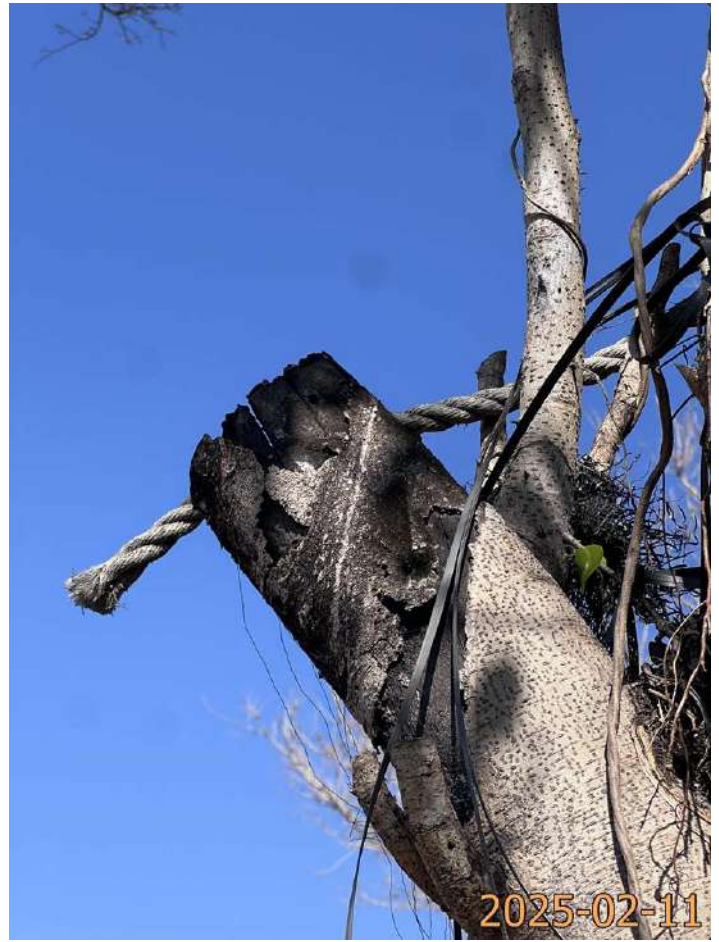
T23 Dead stub\_2

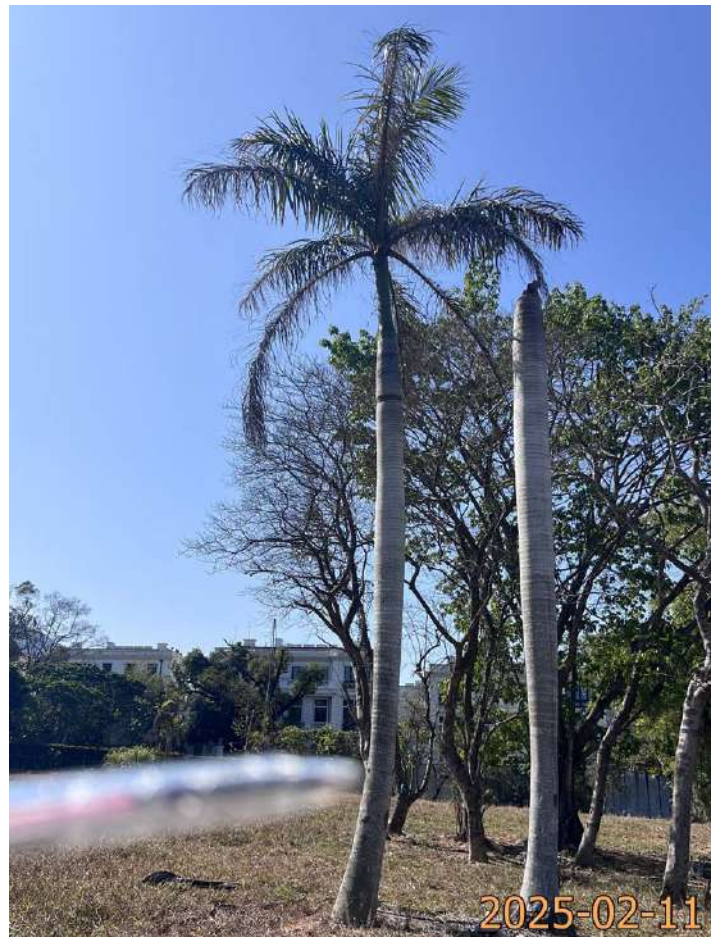
T24 (Overview)

| Tree No. | Tree Species | | Tree Size Measurements | | | Amenity Value | Form | Health Condition | Structural Condition | Suitability for Transplanting | Remarks |
|---|--|---|---|---|---|---|---|---|---|---|--|
| T24 | <i>Roystonea regia</i> | 大王椰子(王棕) | 10.0 | 270 | 2.0 | Low | Fair | Fair | Fair | Low | dead fronds |

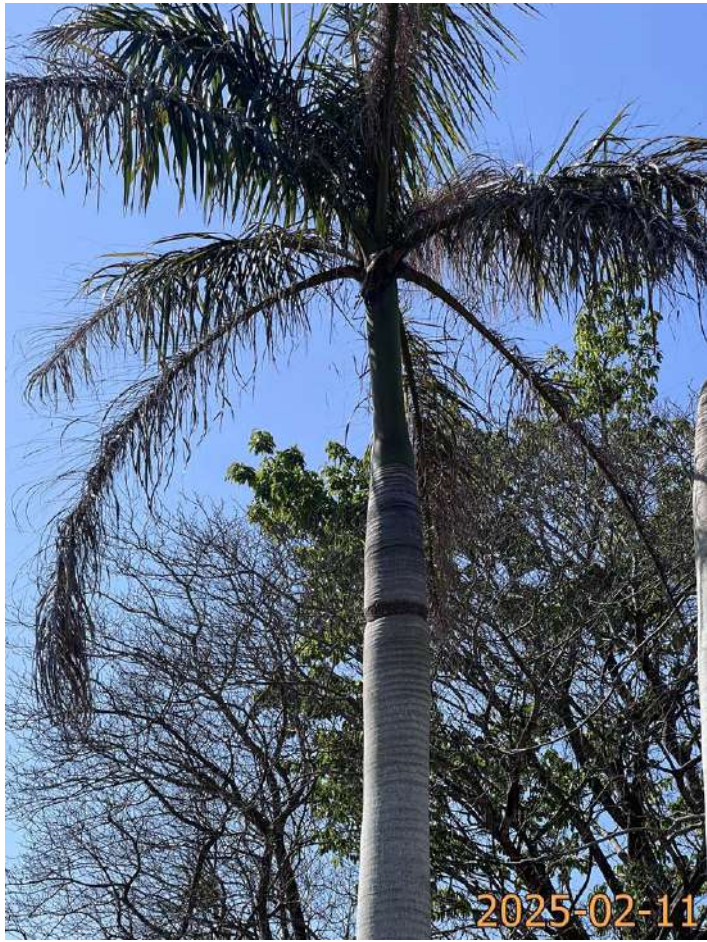
T24 Dead fronds

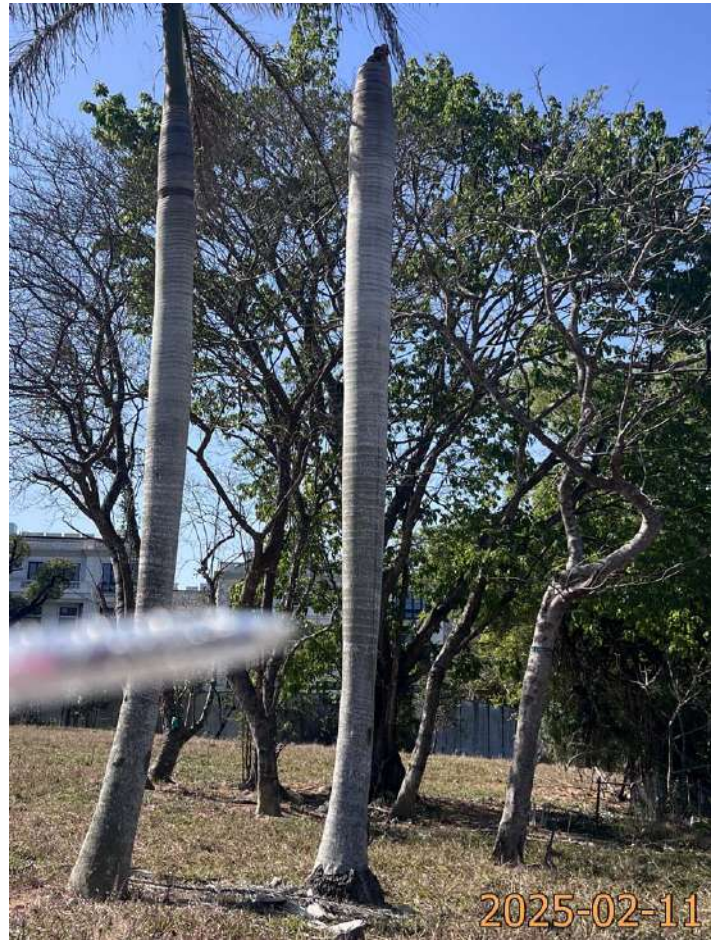
| Tree No. | Tree Species | | Tree Size Measurements | | | Amenity Value | Form | Health Condition | Structural Condition | Suitability for Transplanting | Remarks |
|---|--|---|---|---|---|---|---|---|---|---|--|
| T25 | <i>Roystonea regia</i> | 大王椰子(王棕) | 9.0 | 280 | 0.5 | - | - | Dead | - | - | dead tree |

T25 (Overview) (Dead tree)
