Geotechnical Planning Review Report

Geotechnical Planning
Review Report for
Application for Permission under Section 16
of The Town Planning Ordinance (Cap.131)
Proposed Temporary Place of Recreation, Sports or
Culture (Hobby Farm) with Ancillary Facilities for a
Period of 3 Years and Associated Filling of Land at
Lots 1275 (Part), 1279 (Part), 1280, 1281 (Part), 1282
and 1284 (Part) in D.D. 96, Ma Tso Lung, New
Territories

Feb 2026

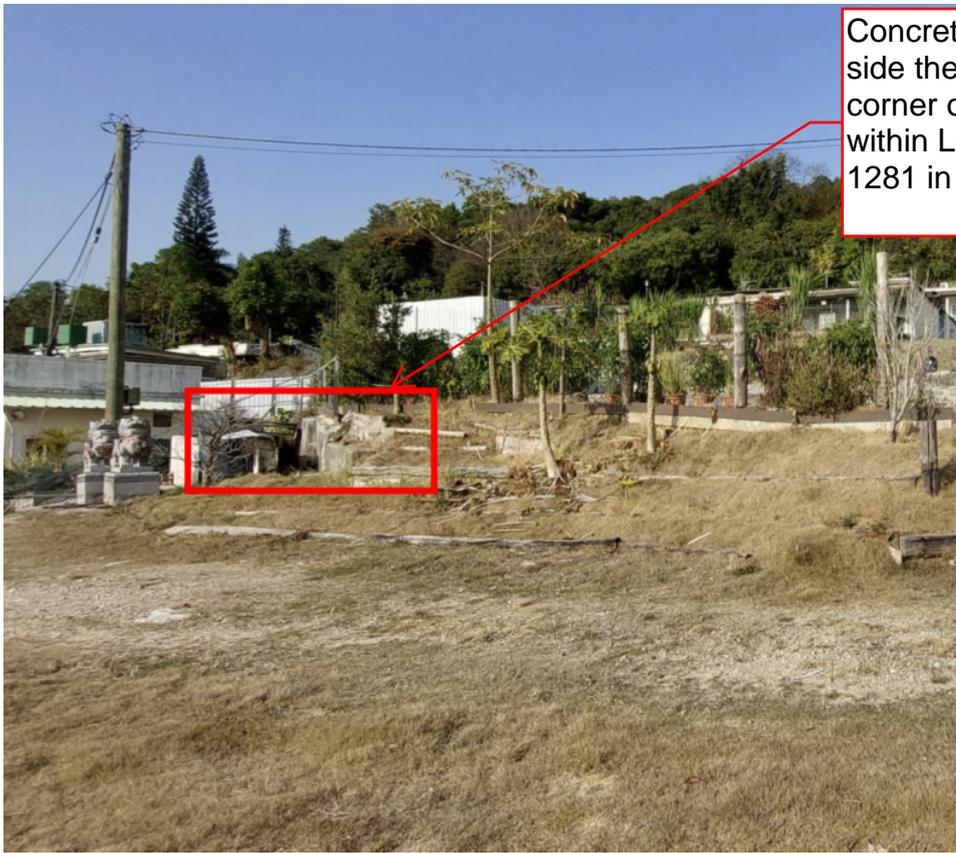
VIEW D2 General View of Entrance of Site

Regarding the topographic plan and Site Photo D2, concrete blocks were found and the concrete blocks do not face to our proposed application site and its function is staircase, which is not used for retaining soil. As a result, the blocks will not affect our proposed application even if the block fails in overturning/sliding. Besides, the hoarding will be erected to protect the application site.

Concrete Block (outside the northeastern corner of the Site within Lots 1275 and 1281 in D.D. 96)
