Updated Tree Preservation and Removal Proposal

**Application for Utilities Corridor of Various Lots in
DD 233, Clear Water Bay, Sai Kung, N.T.**

**TREE PRESERVATION AND REMOVAL PROPOSAL
(RESUBMISSION)**

JANUARY 2026

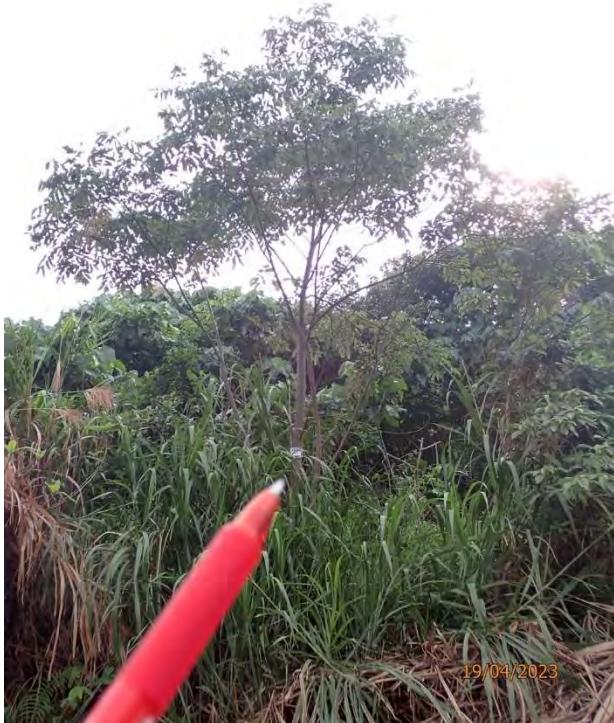
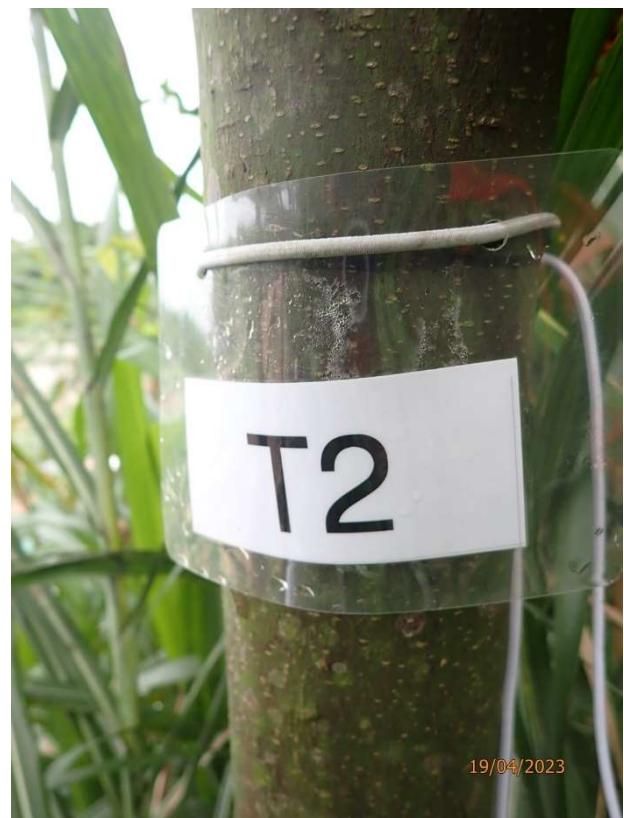
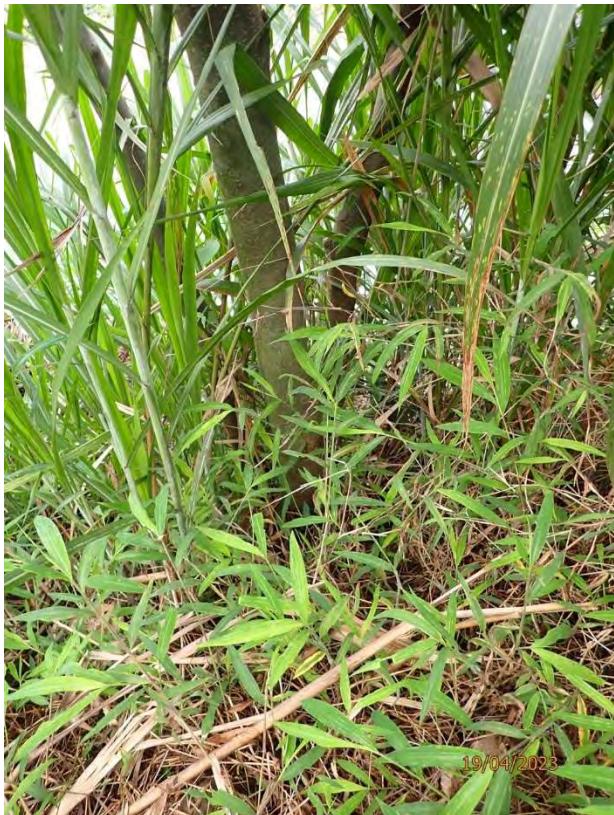
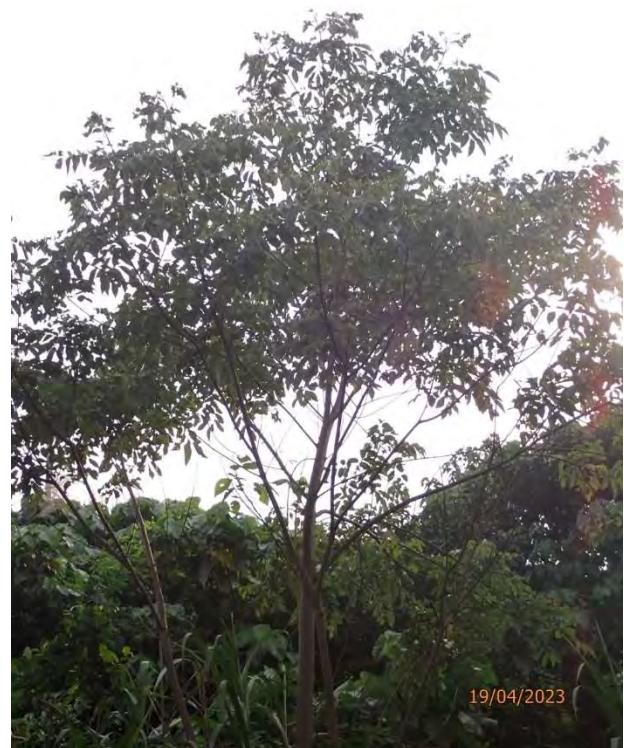
(T2) Overall View

(T2) Tree Tag

(T2) Close-Up

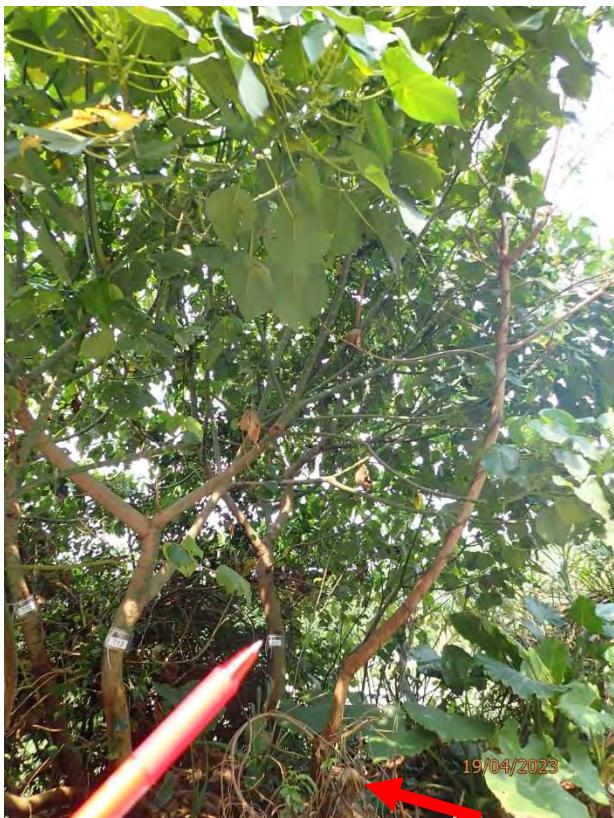
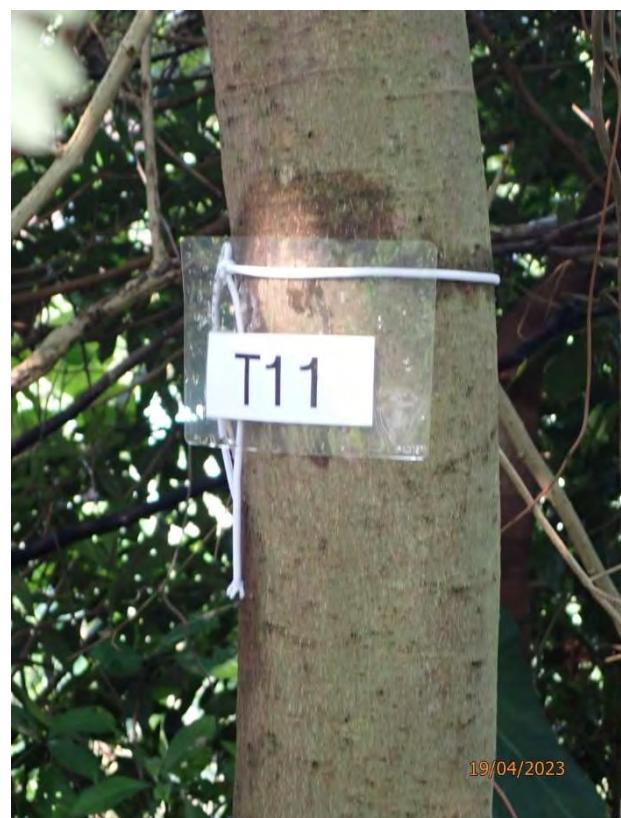
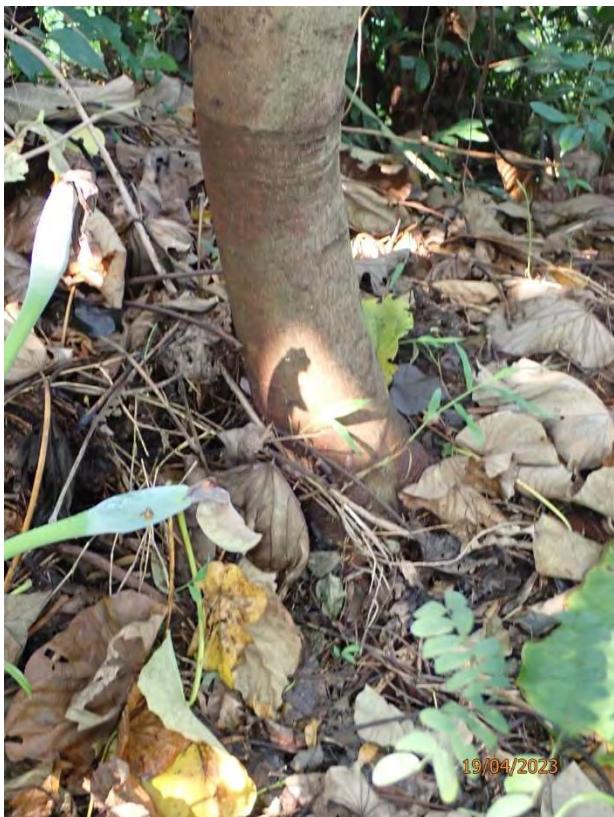
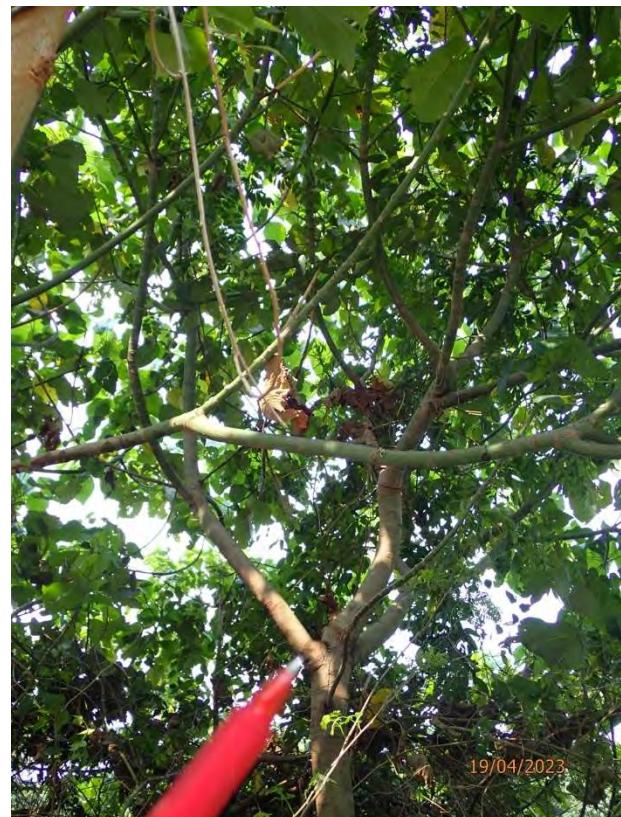
Tree ID number	Tree Species (in Scientific names)	Tree Species (in Chinese names)	Original Location (Lot/ GA/ YA/ GHBA, etc.)	Measurements			Amenity Value (High/Medium/Low)	Form (Good/Average/Poor)	Health Condition (Good/Average/Poor)	Structural Condition (Good/Average/Poor)	Suitability for Transplanting (High/ Medium/Low)	Conservation Status	Recommendation		Remarks (e.g. justification for proposed tree removal; anticipated root-ball size to be preserved (with Ø, x depth in mm), and any other on-site conditions, etc.)
				Height (m)	DBH (mm)	Crown Spread (m)							in initial/ approved application (Retain/ Transplant/ Fell)	in this revision, if applicable (Retain/ Transplant/ Fell)	
T2	<i>Melia azedarach</i>	棟	Lot	4	110	2	Low	Poor	Average	Poor	Low	-	Fell	-	a, b, c, d Slope tree
T11	<i>Macaranga tanarius var. Tomentosa</i>	血桐	Lot	4	122	4	Low	Poor	Average	Poor	Low	-	Fell	-	a, b, c, d Slope tree

(T11) Overall View

(T11) Tree Tag

(T11) Close-Up

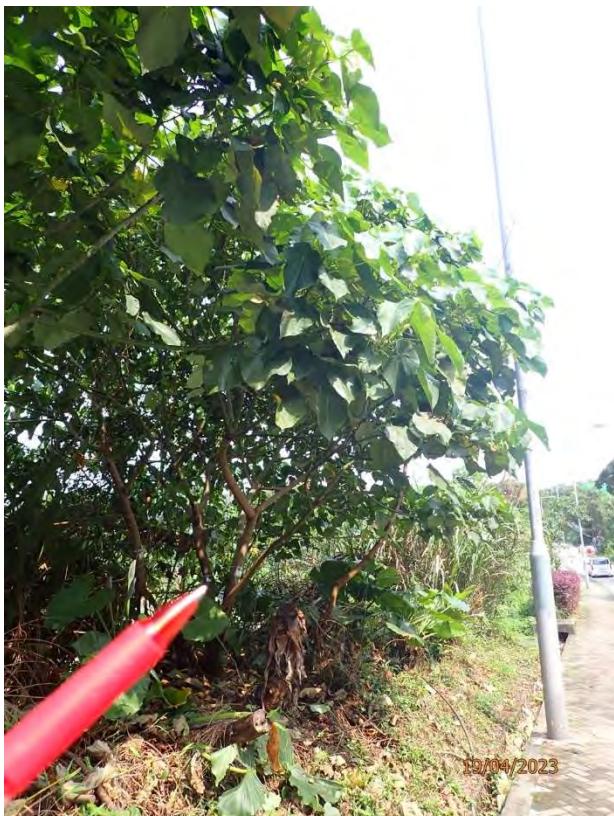
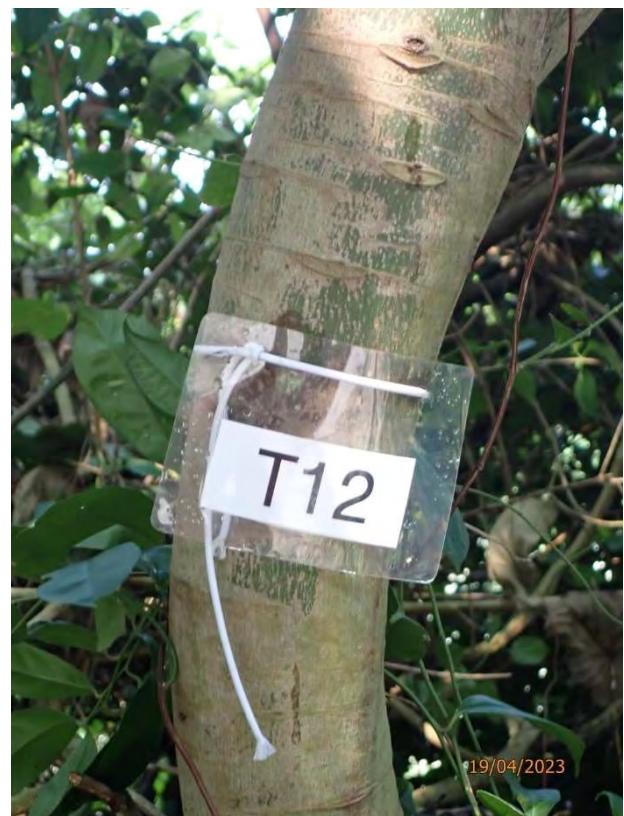
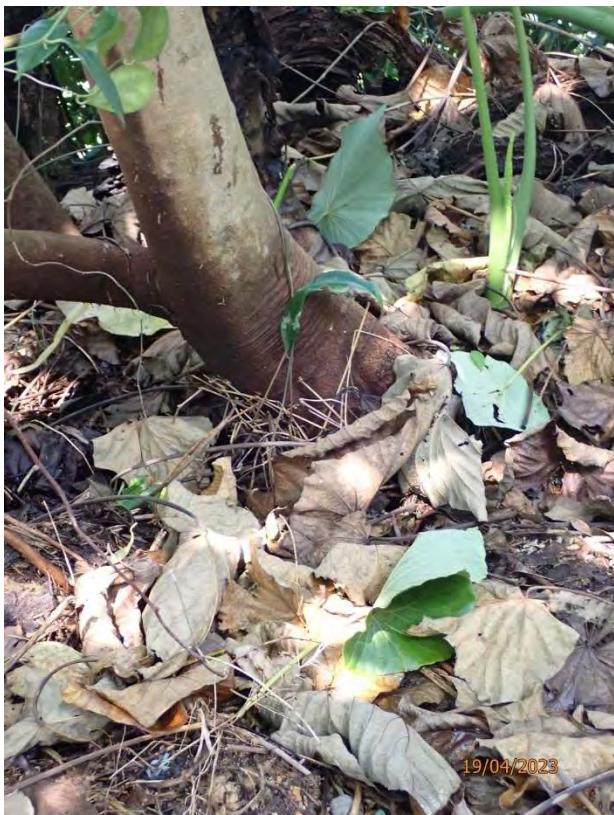
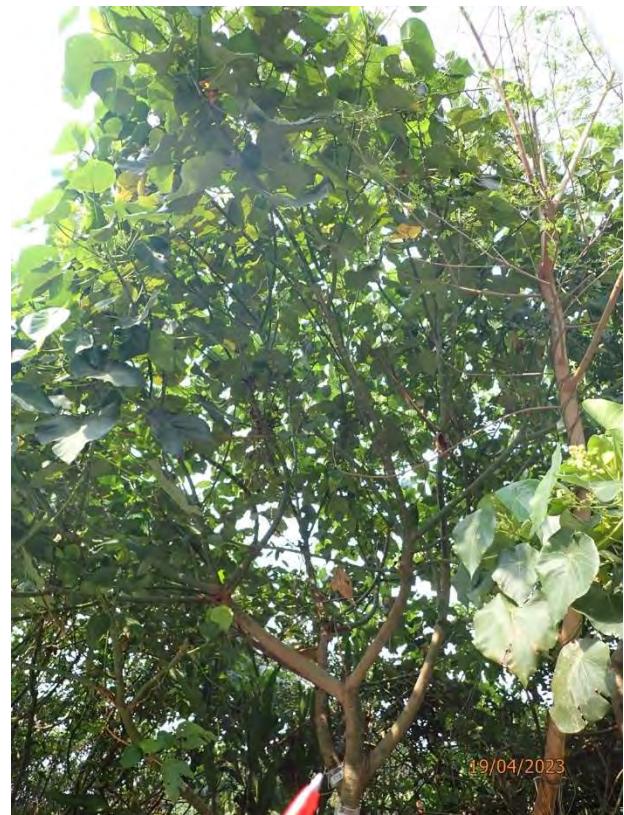
T12	<i>Macaranga tanarius var. Tomentosa</i>	血桐	Lot	4	119	3	Low	Poor	Average	Poor	Low	-	Fell	-	a, b, c, d Slope tree; Leaning 15 degree; Co-dominant trunks
T13	<i>Macaranga tanarius var. Tomentosa</i>	血桐	Lot	4	95	3	Low	Poor	Average	Poor	Low	-	Fell	-	a, b, c, d Slope tree; Leaning 5 degree; Climbers
T14	<i>Macaranga tanarius var. Tomentosa</i>	血桐	Lot	4	108	3	Low	Poor	Average	Poor	Low	-	Fell	-	a, b, c, d Slope tree; Co-dominant branches
T15	<i>Macaranga tanarius var. Tomentosa</i>	血桐	Lot	3	110	2	Low	Poor	Average	Average	Low	-	Fell	-	a, b, c, d Slope tree; Co-dominant trunks
T16	<i>Macaranga tanarius var. Tomentosa</i>	血桐	Lot	4	120	3	Low	Poor	Average	Average	Low	-	Fell	-	a, b, c, d Slope tree; Co-dominant trunks; Leaning 15 degree
T18	<i>Mallotus paniculatus</i>	白欖	Lot	5	120	3	Low	Poor	Average	Poor	Low	-	Fell	-	a, b, c, d Slope tree; Co-dominant trunks; Included bark; Climbers
T19	<i>Mallotus paniculatus</i>	白欖	Lot	4	119	3	Low	Poor	Average	Poor	Low	-	Fell	-	a, b, c, d Slope tree; Leaning 25 degree

(T12) Overall View

(T12) Tree Tag

(T12) Close-Up

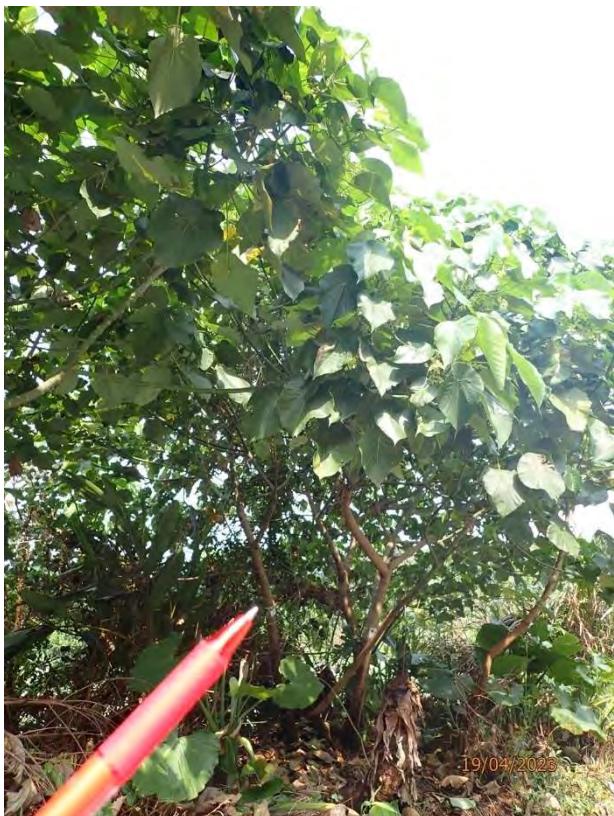
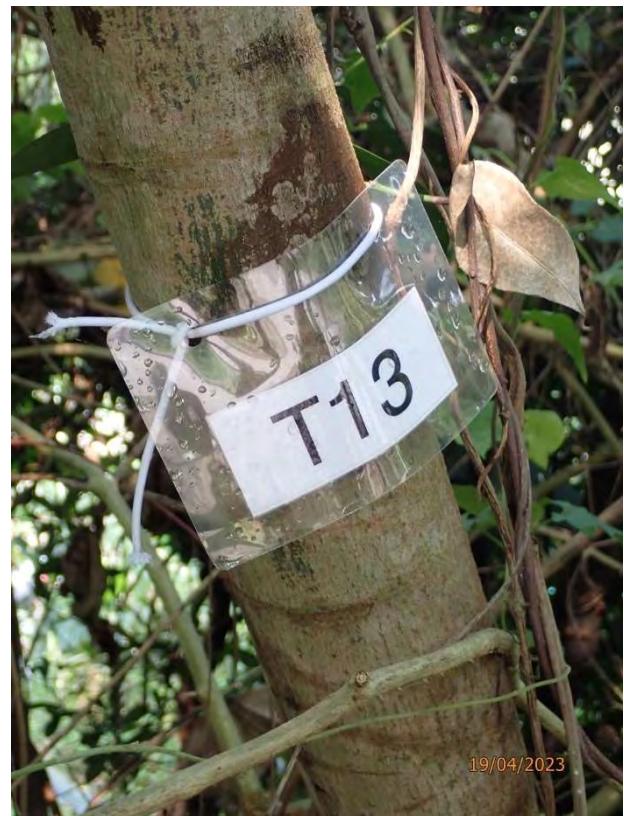
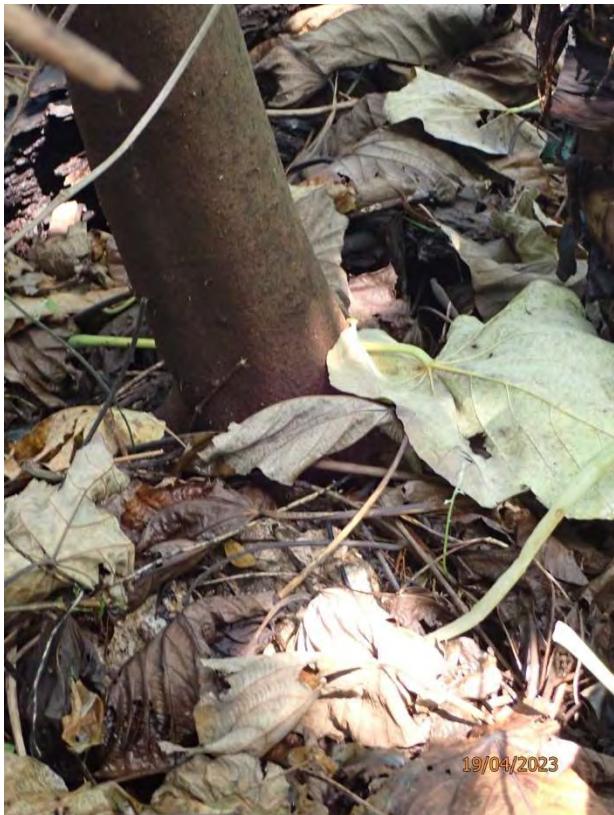
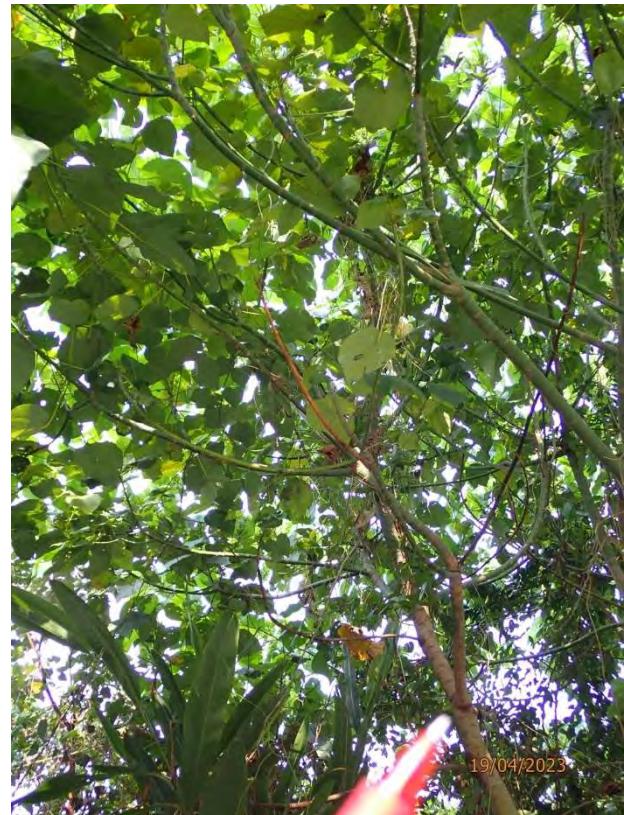
(T13) Overall View

(T13) Tree Tag

(T13) Close-Up

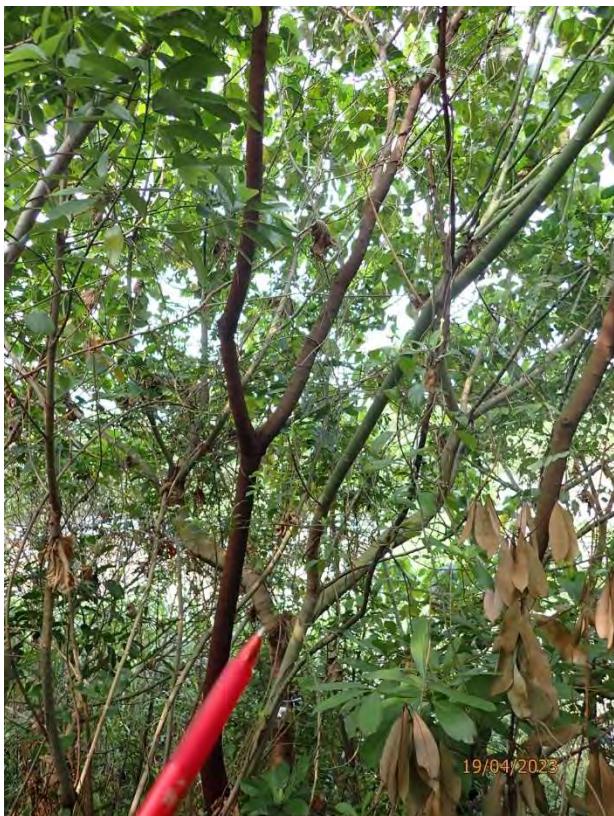
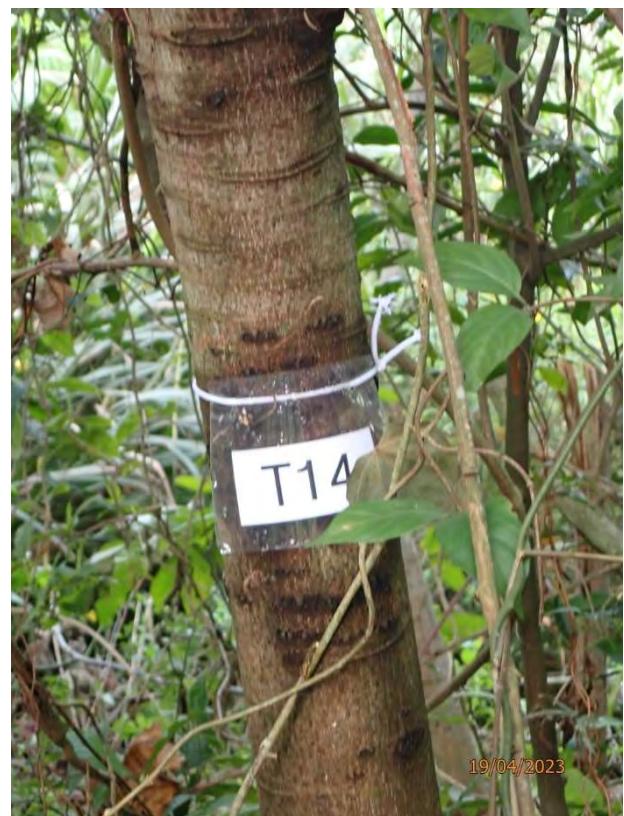
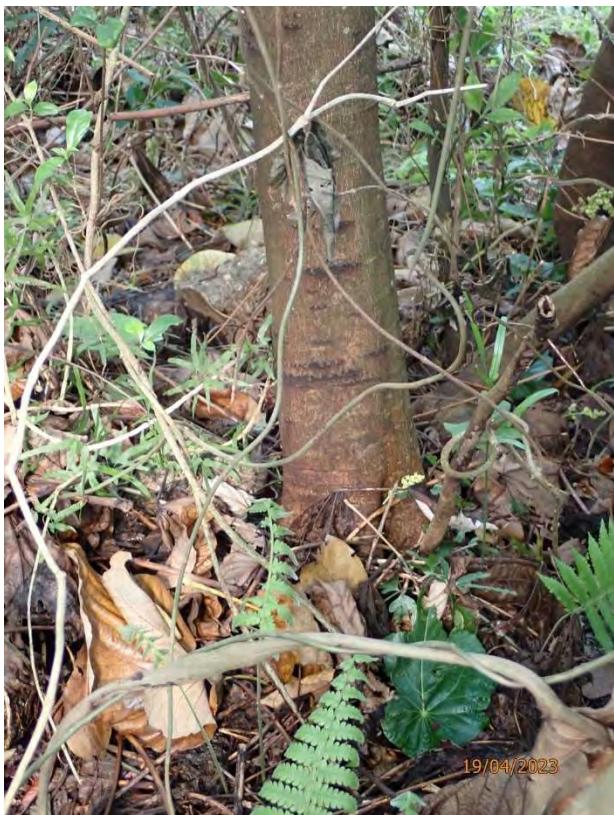
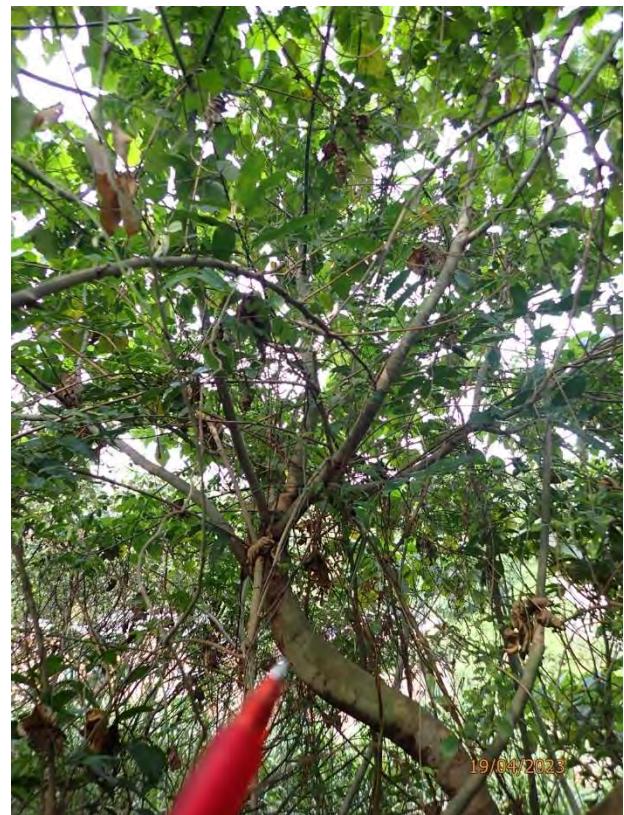
(T14) Overall View

(T14) Tree Tag

(T14) Close-Up

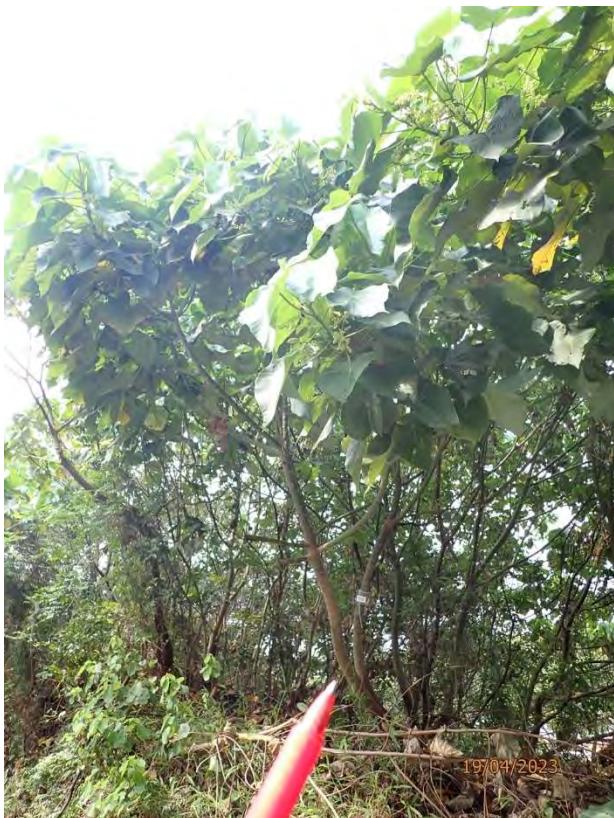
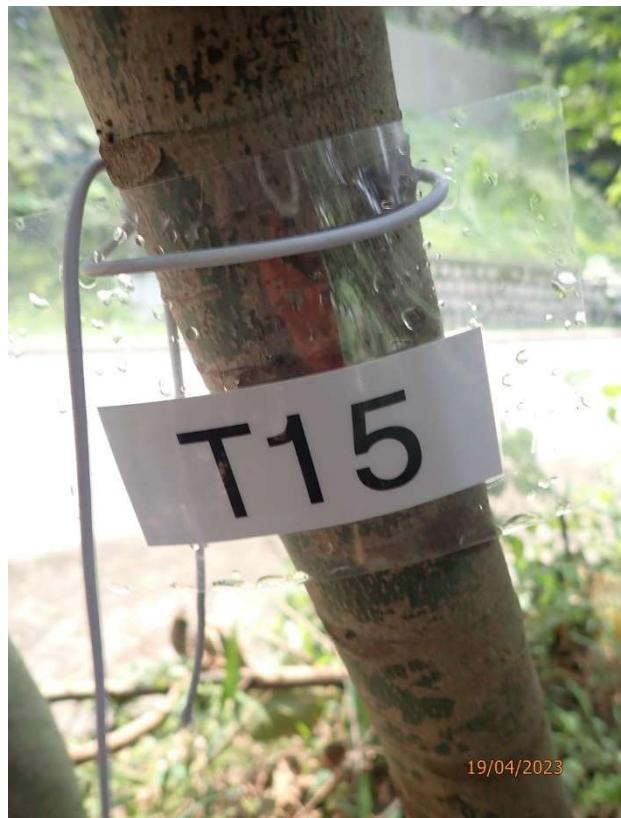
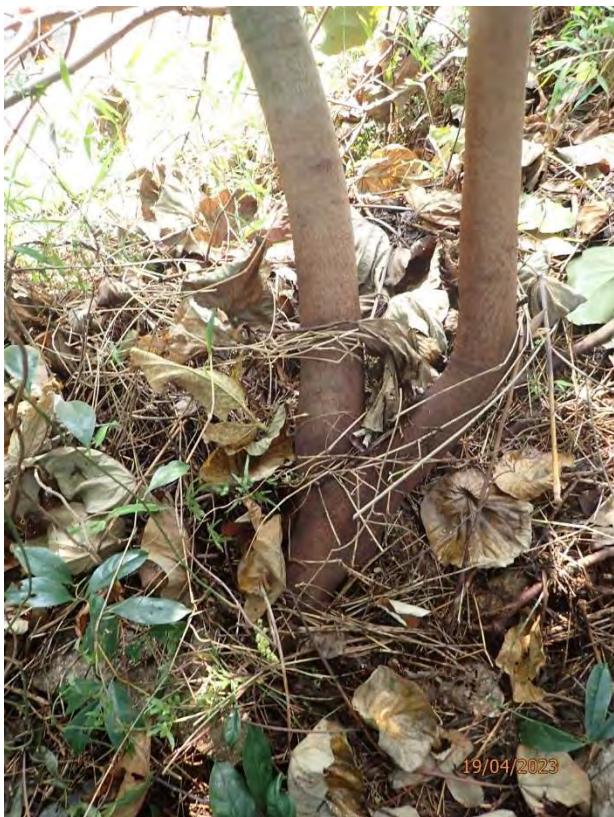
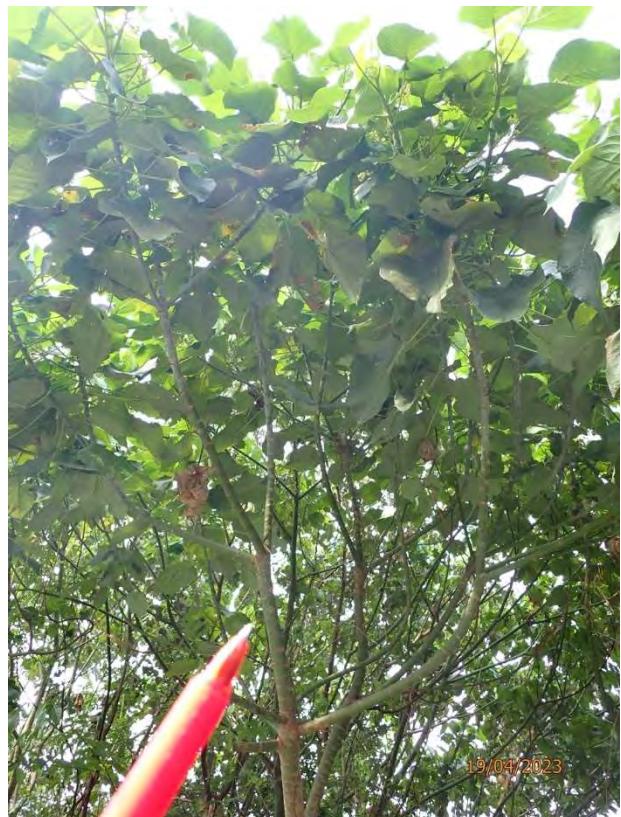
(T15) Overall View

(T15) Tree Tag

(T15) Close-Up

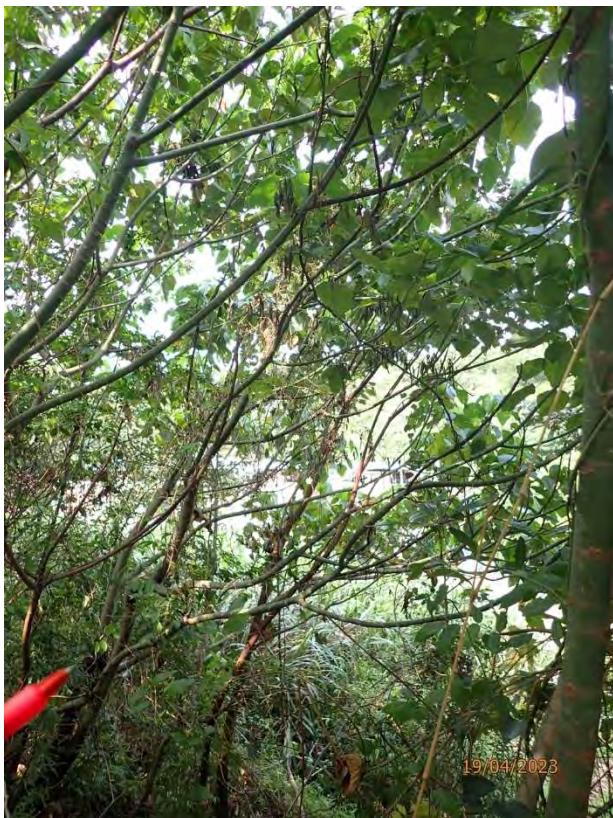
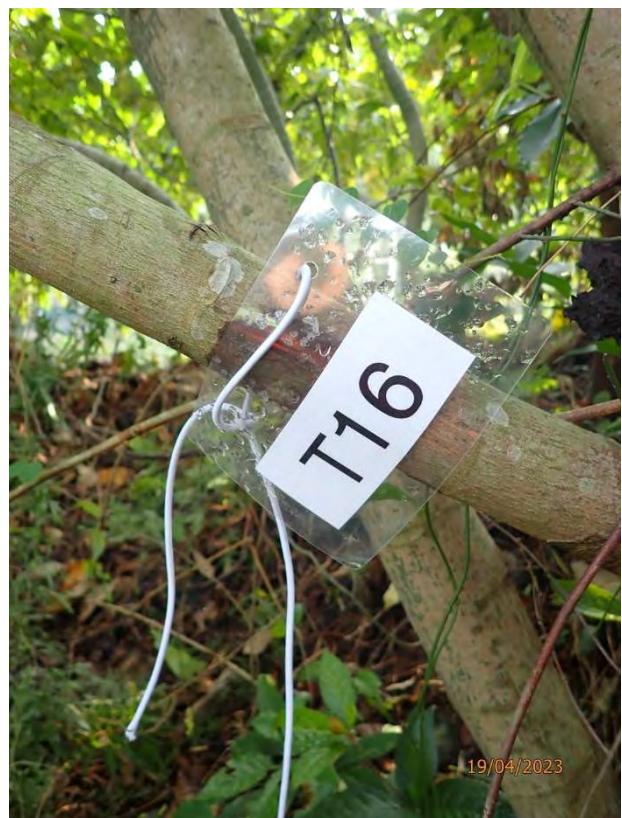
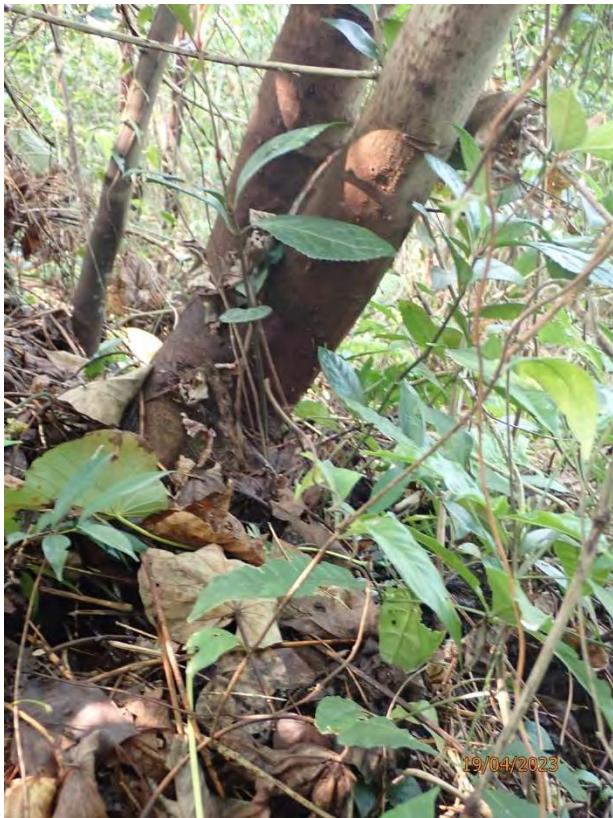
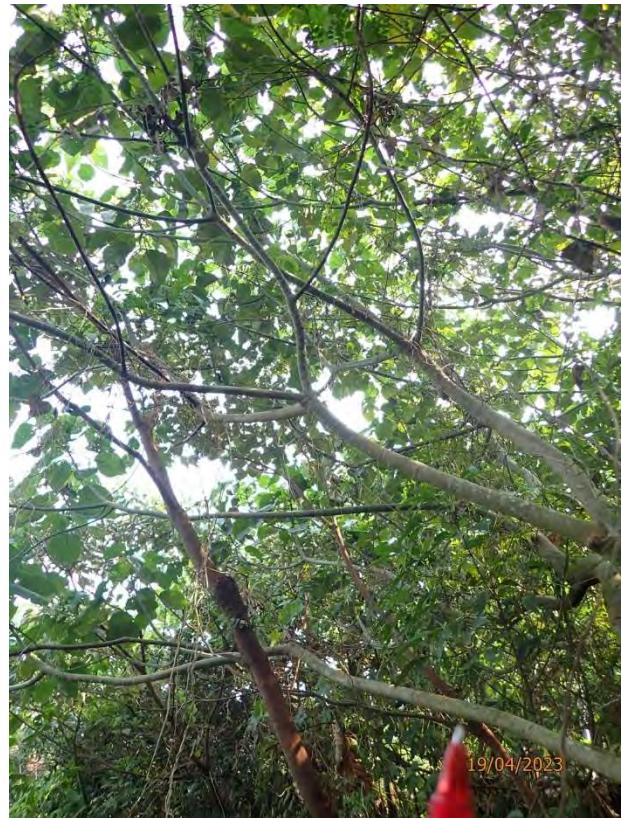
(T16) Overall View

(T16) Tree Tag

(T16) Close-Up

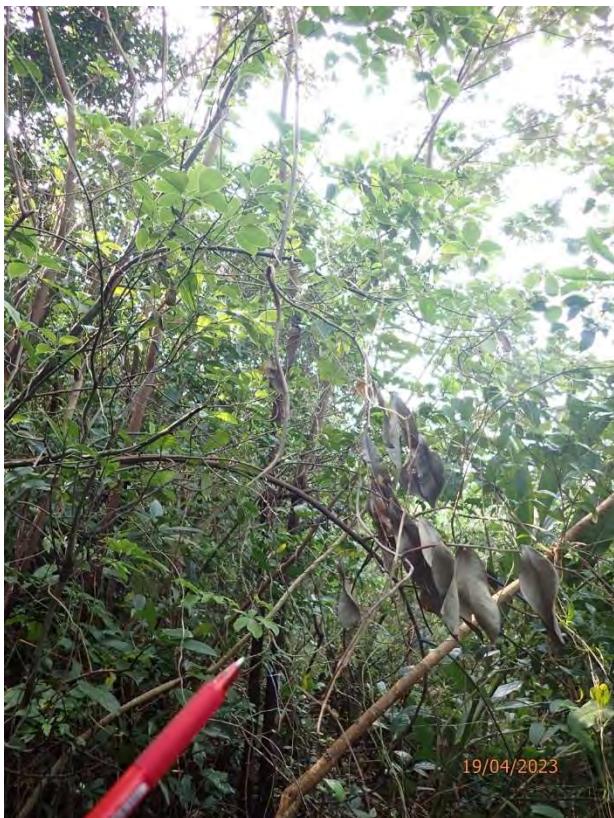
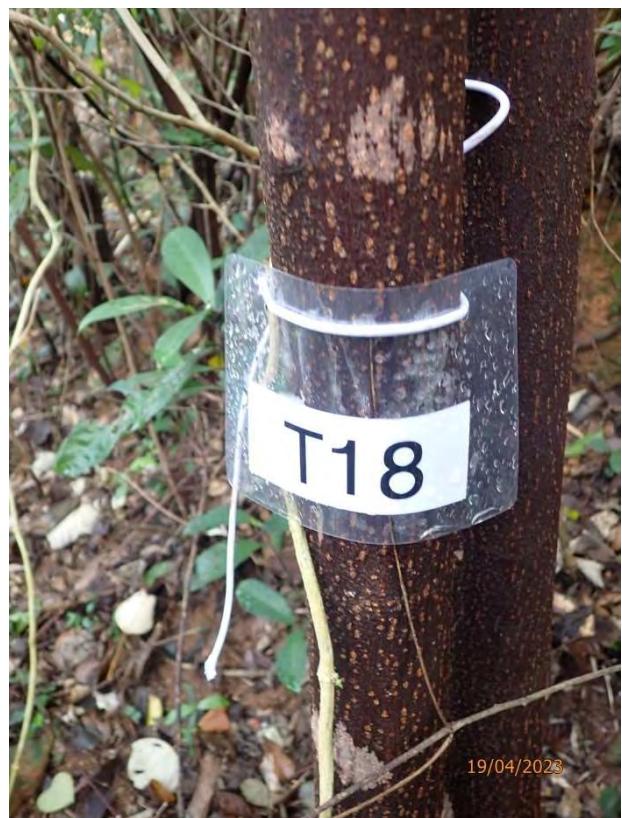
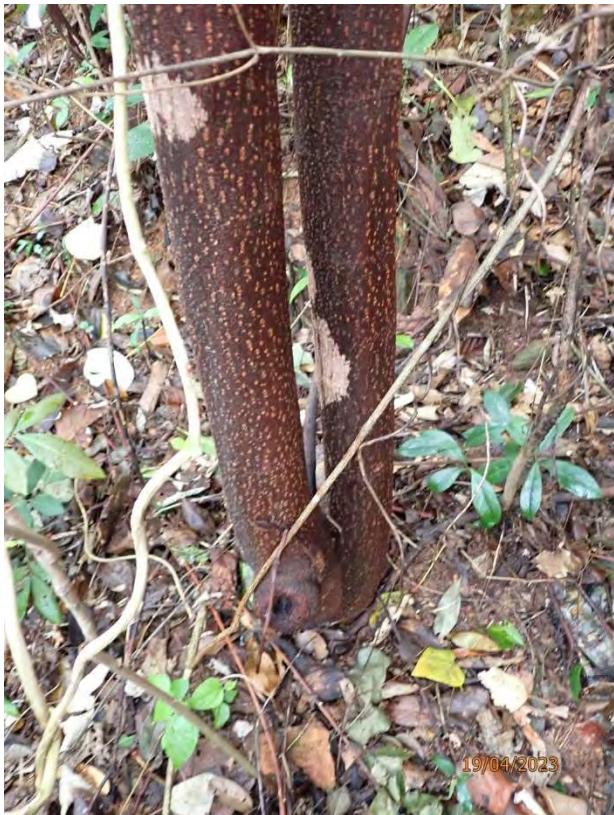
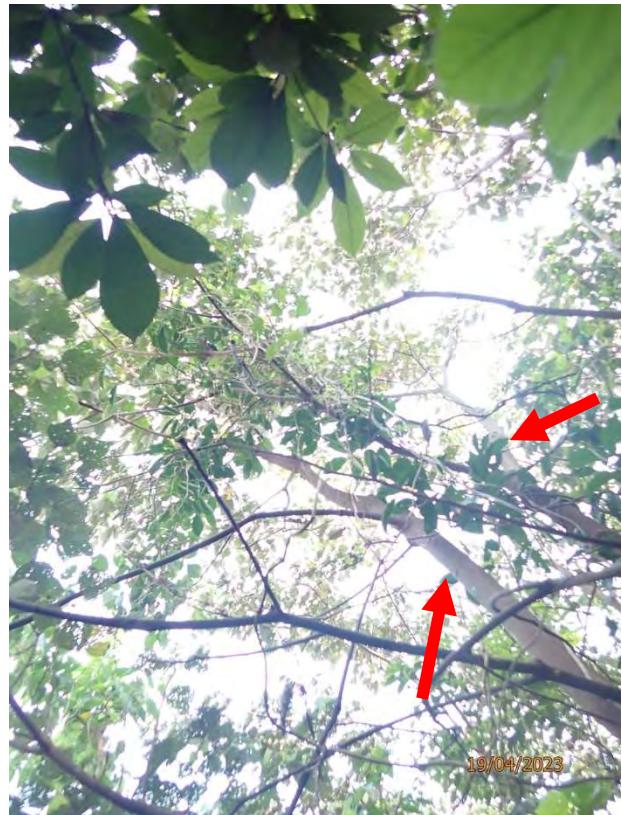
(T18) Overall View

(T18) Tree Tag

(T18) Close-Up

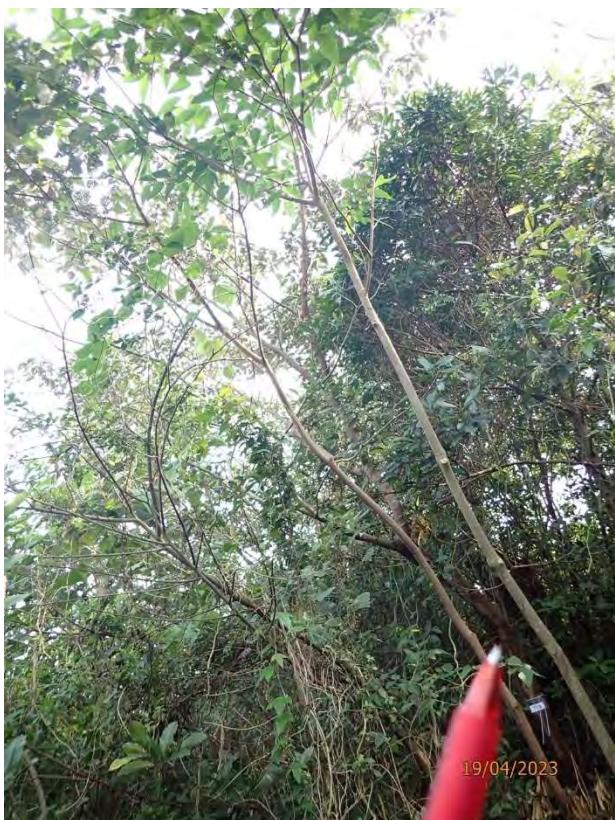
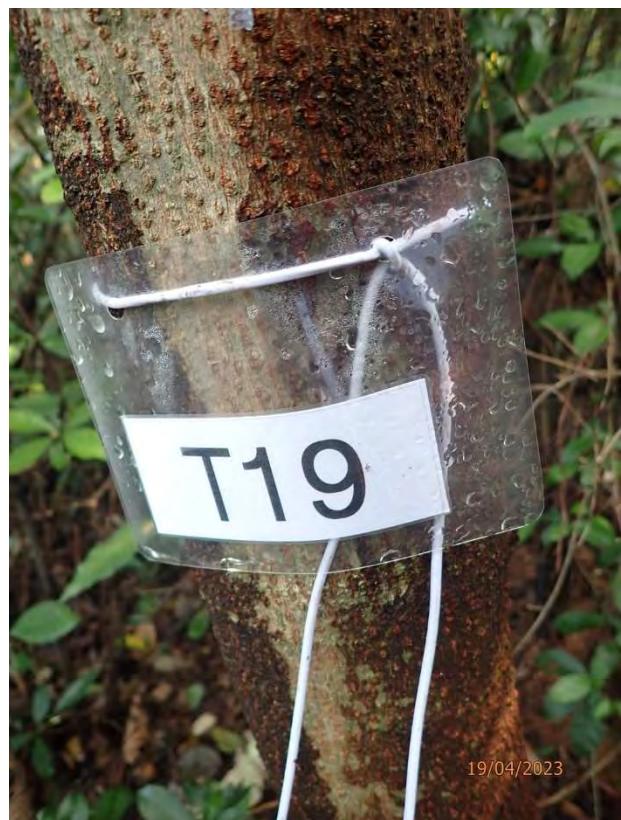
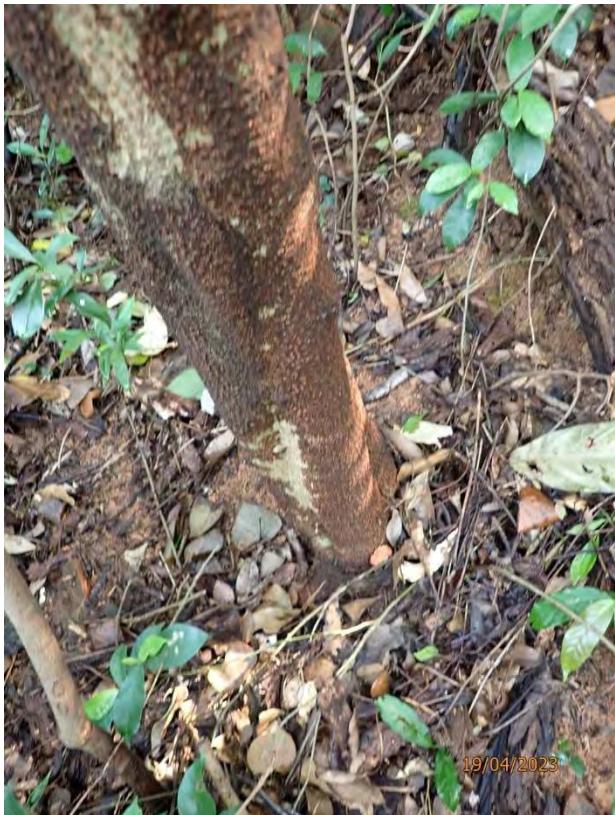
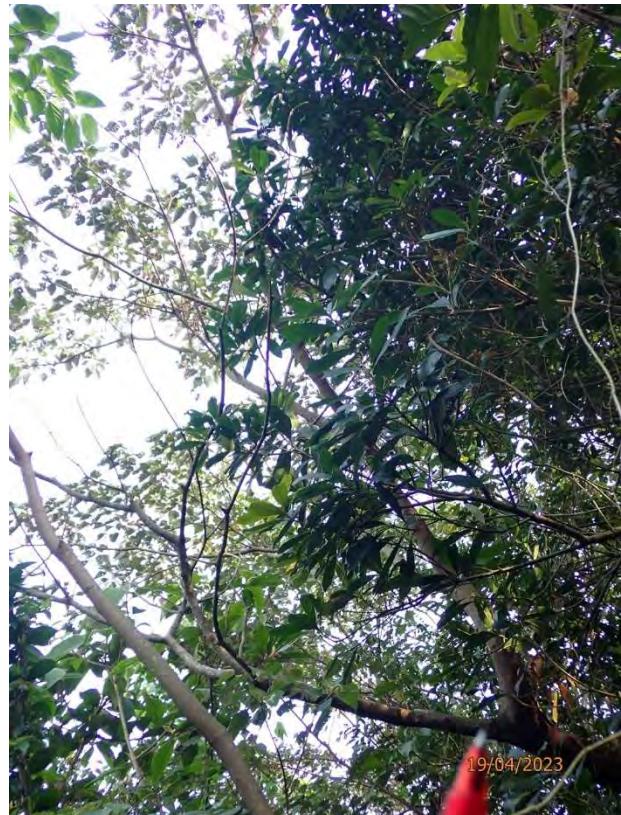
(T19) Overall View

(T19) Tree Tag

(T19) Close-Up

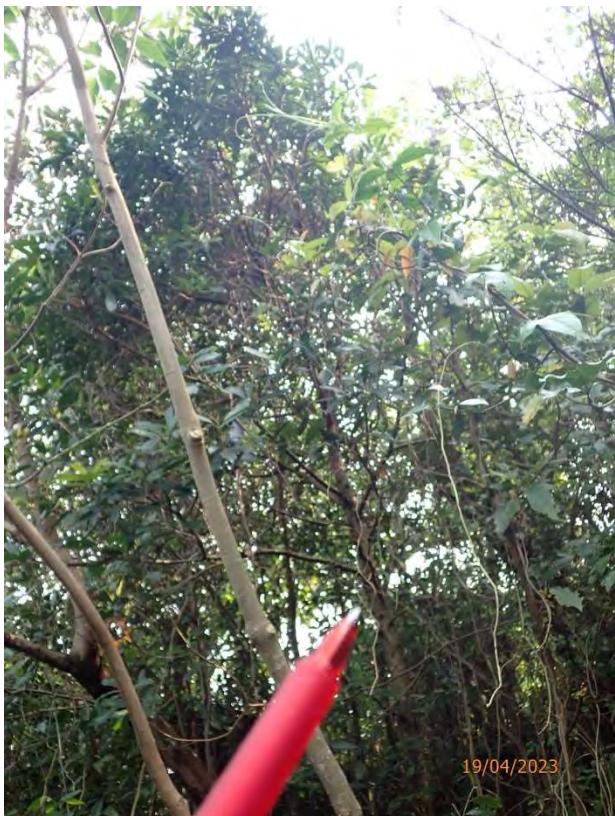
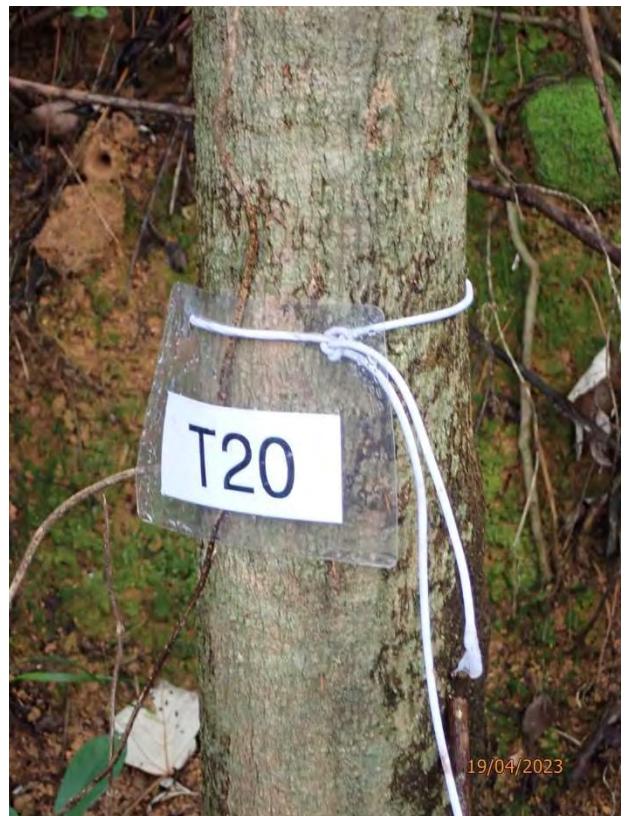
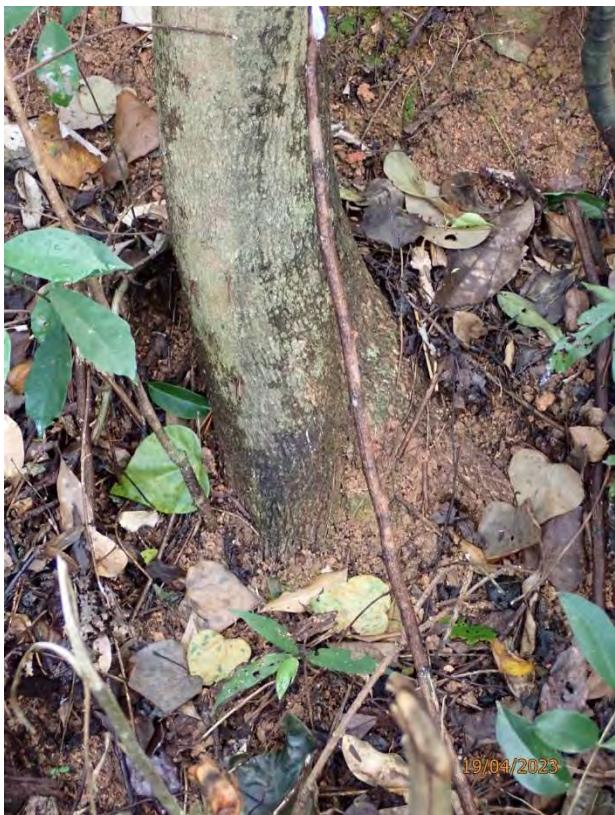
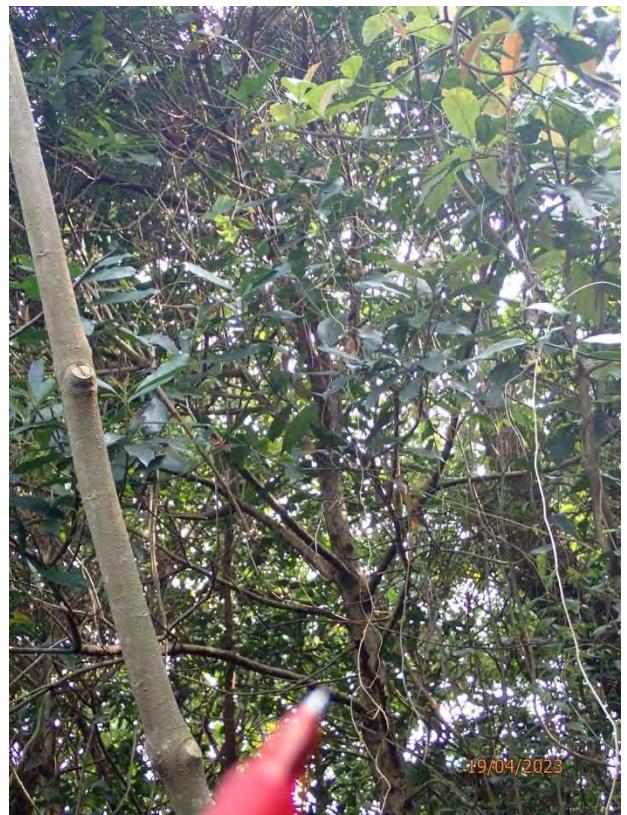
T20	<i>Sarcosperma laurinum</i>	肉實樹	Lot	4	115	3	Low	Poor	Average	Average	Low	-	Fell	-	a, b, c, d Slope tree; Climbers
T31	<i>Aporosa dioica</i>	銀柴	Lot	4	440	2	Low	Poor	Poor	Poor	Low	-	Fell	-	a, b, c, d Slope tree; Decay; Mechanical injury; Trunk failure

(T20) Overall View

(T20) Tree Tag

(T20) Close-Up

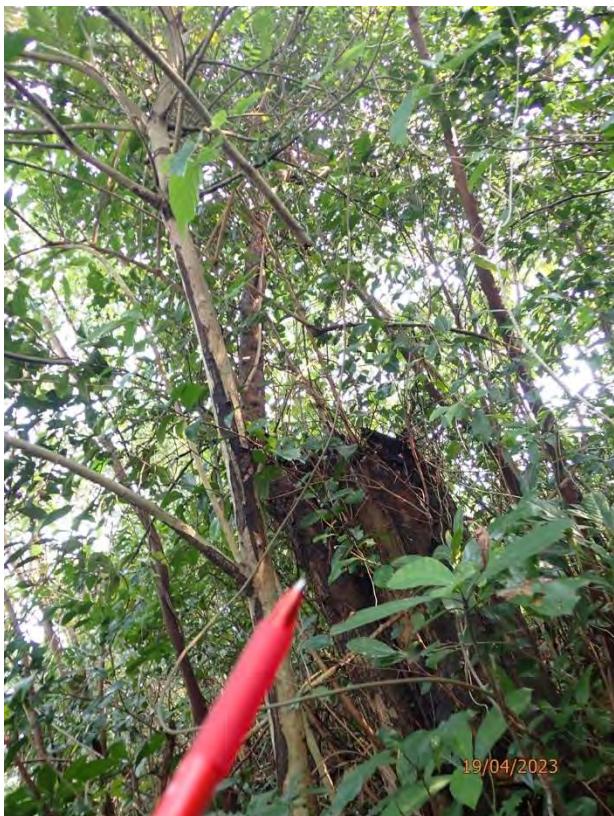
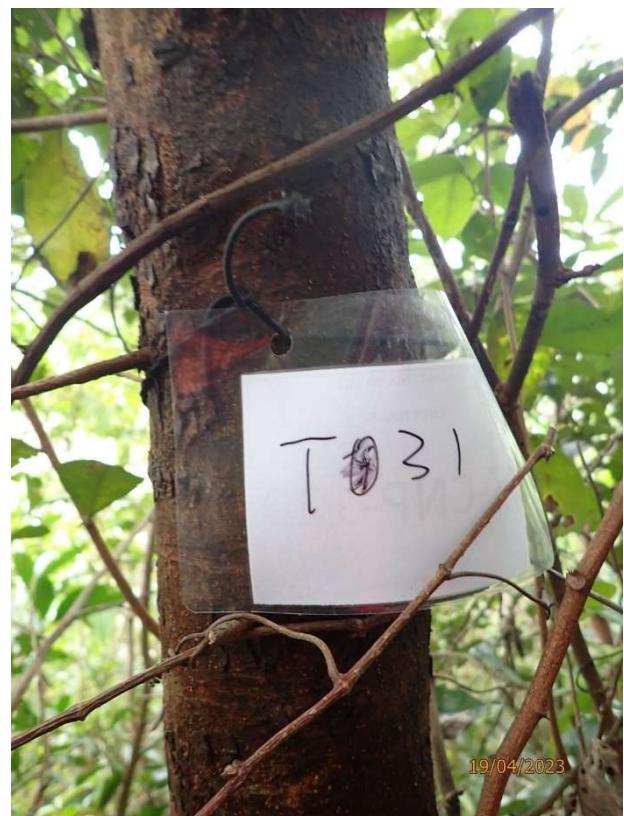
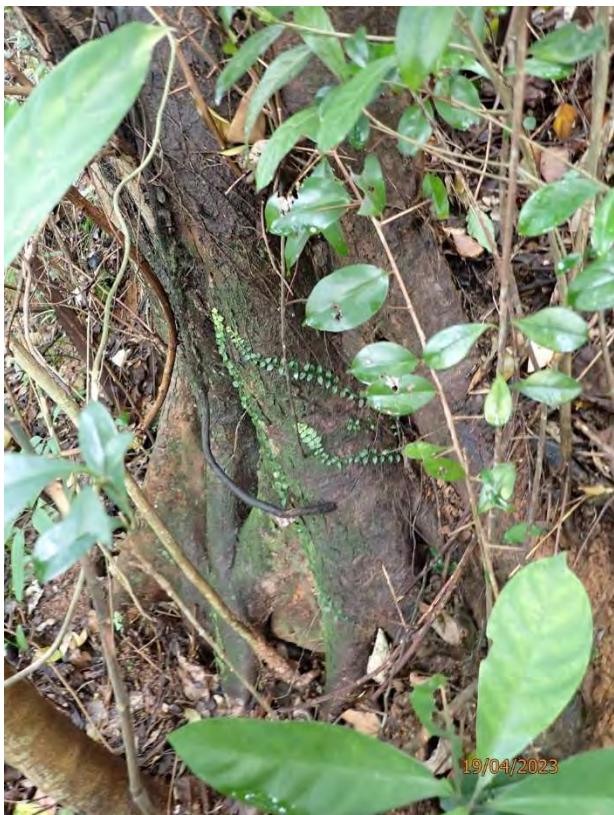
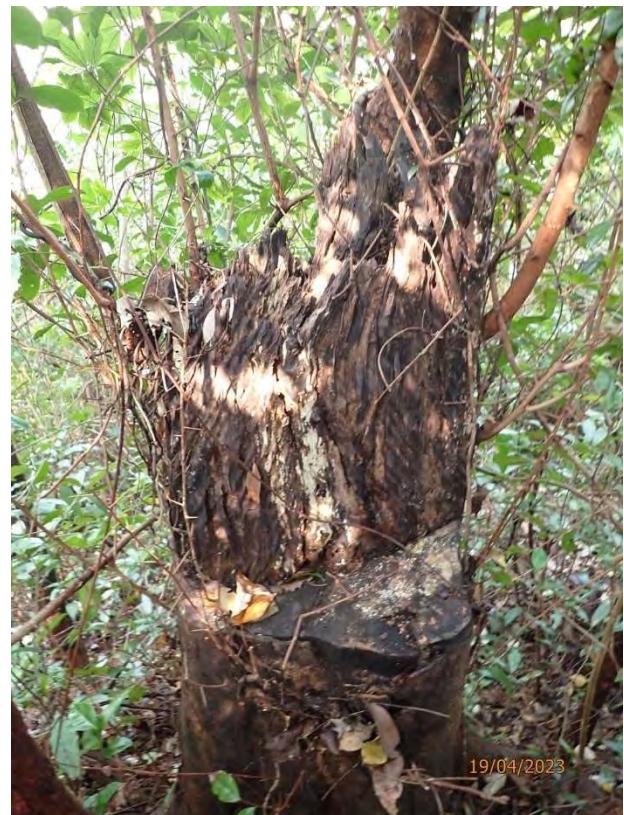
(T31) Overall View

(T31) Tree Tag

(T31) Close-Up
