# Geotechnical Planning Review Report

**Proposed Development of SKH St Christopher’s Complex  
at TLL T77 RP in D.D.34  
Tai Po, New Territories**

**REVISION 2**

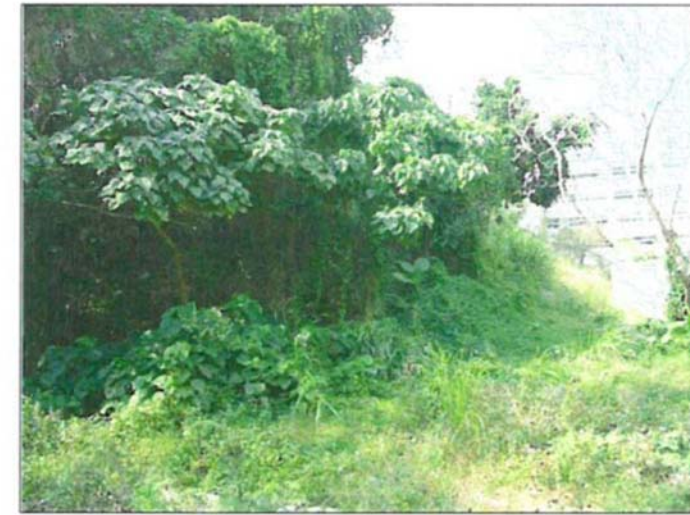
Feature No. 7NE-C/C440 is located within the site and running from the northern to southeastern boundary of the Site. Based on the SIMAR record, only sub-division no. 1 of the feature is located within the site. According to the SIS record, the feature is about 110m long and 6.5m high with average slope gradient of 30° to the horizontal.

GENERAL VIEW OF FEATURE NO. 7NE-C/C440

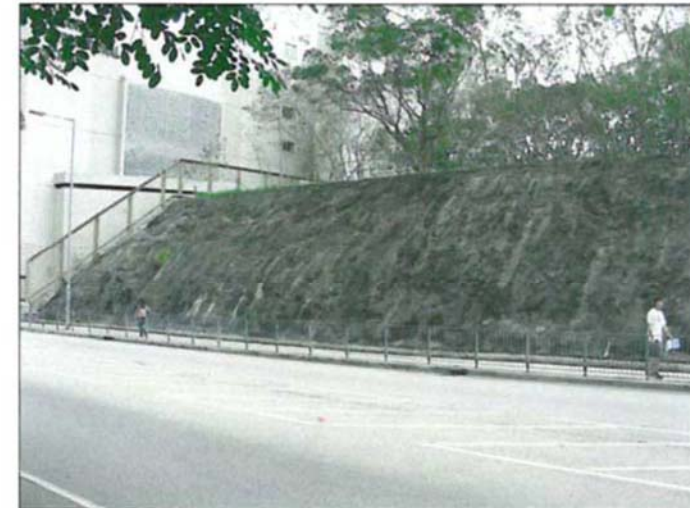
Feature No. 7NE-C/C392 is located at the southwestern boundary of the Site. Based on the SIMAR record, only sub-division no. 2 of the feature is located within the site. According to the SIS record, the feature is about 90m long and 6m high with average slope gradient of 40° to the horizontal.

GENERAL VIEW OF NORTHERN PORTION OF FEATURE NO. 7NE-C/C392

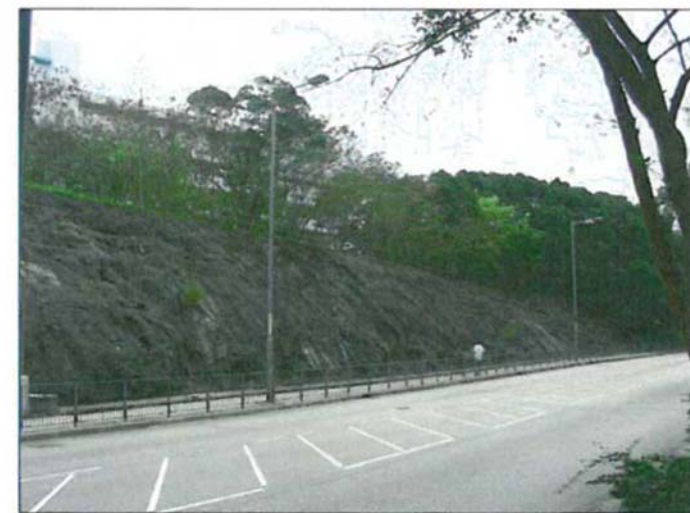
GENERAL VIEW OF SOUTHERN PORTION OF FEATURE NO. 7NE-C/C392

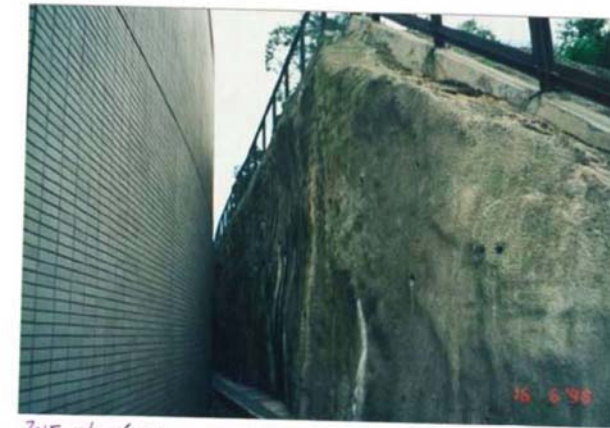
7NE-C/C 403 VIEW FROM F6

Feature No. 7NE-C/C403 is located abutting to the northwestern boundary of the Site. Based on the SIMAR record, the feature is located outside of the site and belong to Lot No. TPTL 156. According to the SIS record, the feature is about 70m long and 7m high with average slope gradient of 85° to the horizontal.

Scheme 1: Removal of Feature no. 7NE-C/C403 along the boundary of Japanese International School (JIS).

In case the lot owner of Feature no. 7NE-C/C403 does not agree the removal of this feature, strengthening works for this slope is required. Furthermore, to allow the minimum spacing for the slope for maintenance, the building in the Site is required to set back from the retained slope.

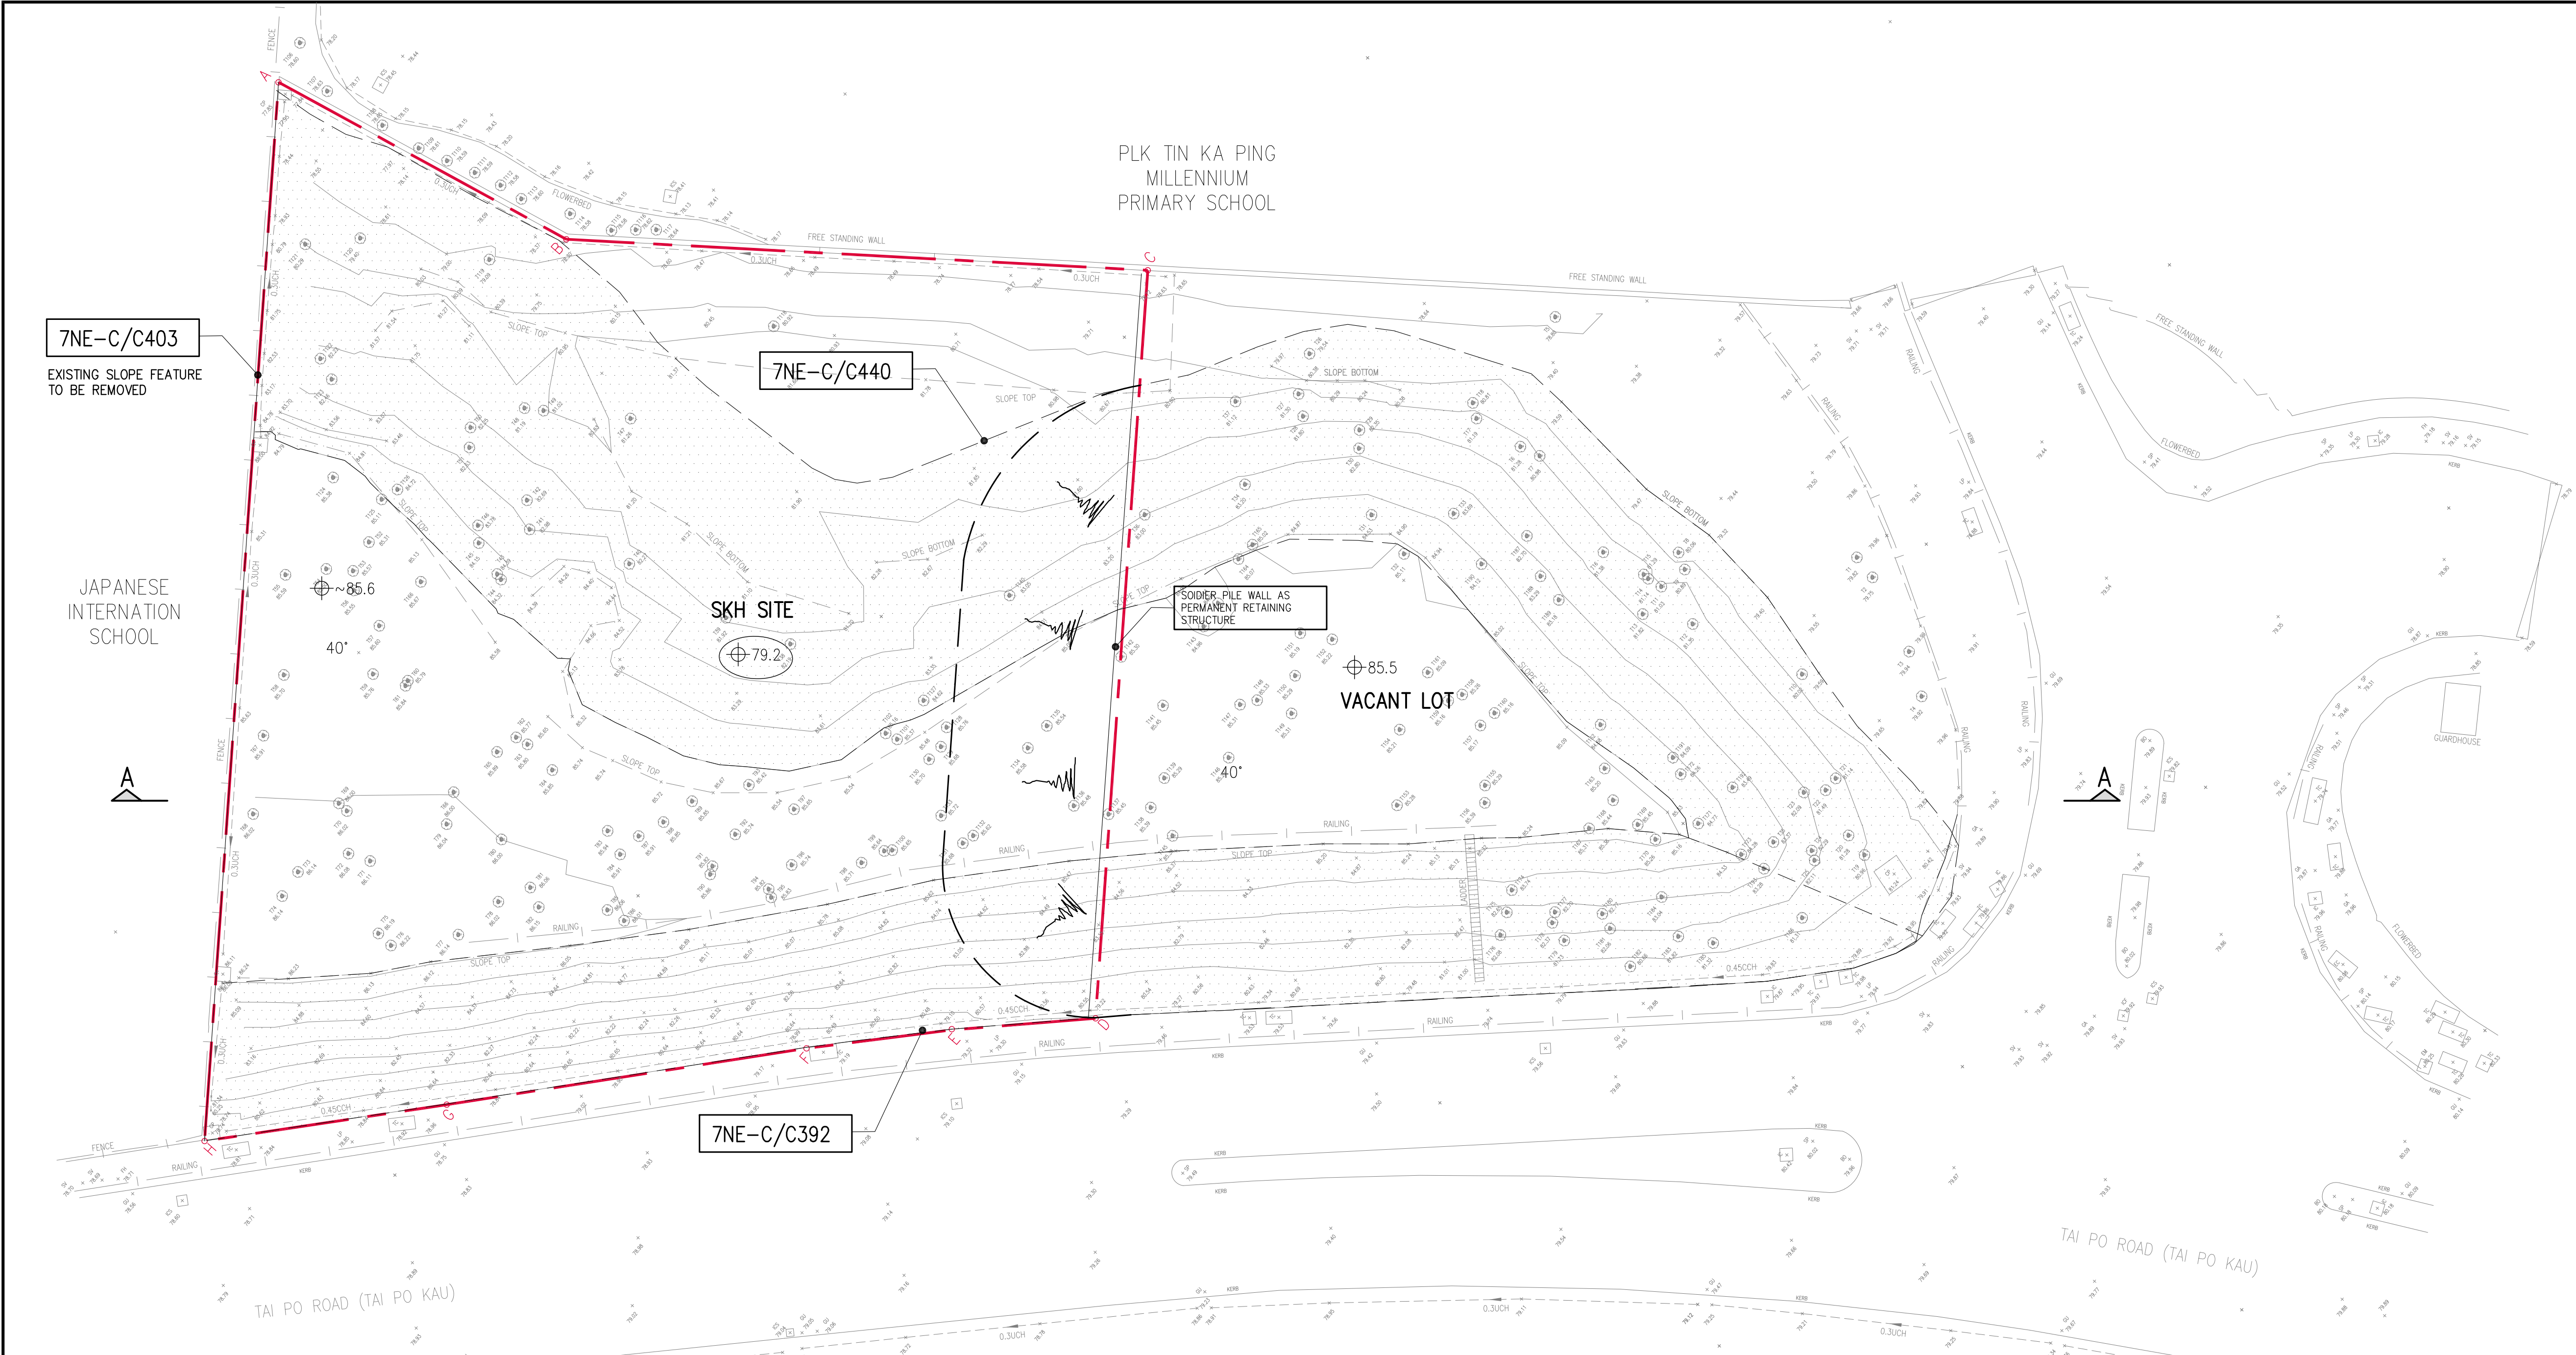
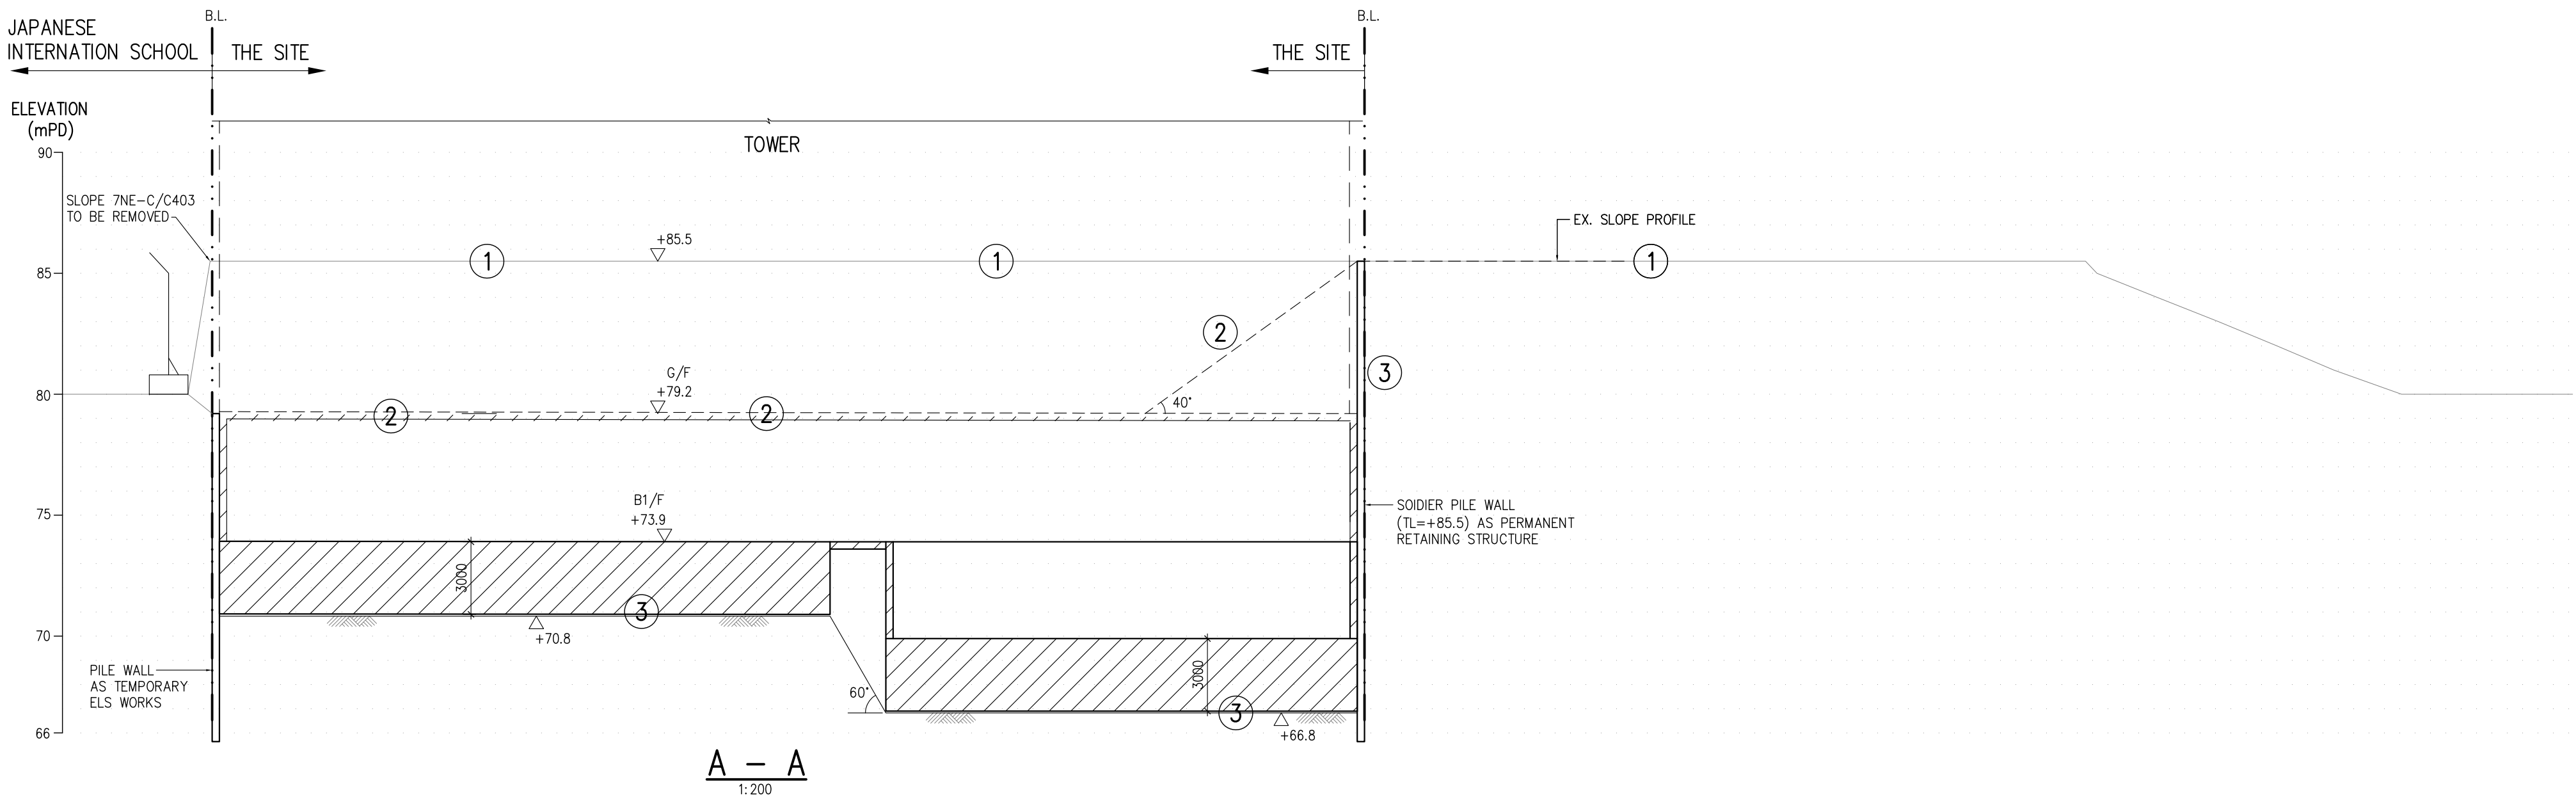
Title	
PRELIMINARY SITE FORMATION PLAN (SCHEME 3)	
Drq. No.	Rev.
2132/DSF/03	-
JMK JMK CONSULTING ENGINEERS LTD.

- 1 EX. SLOPE PROFILE
- 2 SITE FORMATION WORK TO BE CARRIED OUT WITH CUT-SLOPE WITH-IN SITE BOUNDARY
- 3 CARRY OUT TEMPORARY ELS SYSTEM AND EXCAVATE DOWN TO FOUNDING LEVEL. ELS SYSTEM TO FORM AS PERMANENT RETAINING STRUCTURE ALONG GOV. SITE
- 4 FORM BASEMENT STRUCTURE & TOWER

For the new development at the Site, it is proposed to form a flat ground land which meet with the level of adjoining public road of Tai Po Road, and carry out temporary excavation and lateral support works for construction of basement structure and foundation works at the Site. There is the proposed scheme of site formation works presented in Appendix E.

For the site formation works on the side adjoining the government land, since LandsD does not agree to permanently cut back the topographical feature, a new soldier pile wall within the subject site would be created to retain the topographical feature on the adjoining vacant government land.
