**GEOTECHNICAL PLANNING REVIEW REPORT (GPRR)**

**PROPOSED TEMPORARY TRAINING CENTRE (TREE  
CARE TRAINING CENTRE) FOR A PERIOD OF 3 YEARS**

**LOT NO. 230 & 581 (PART) IN D.D. 128,  
LAU FAU SHAN, YUEN LONG, N.T.**

**ISSUE 1**

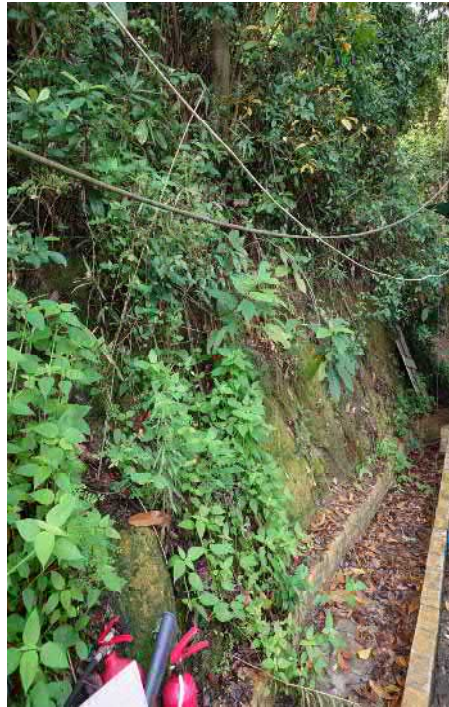
A1 - General view of the site (north side looking southern)

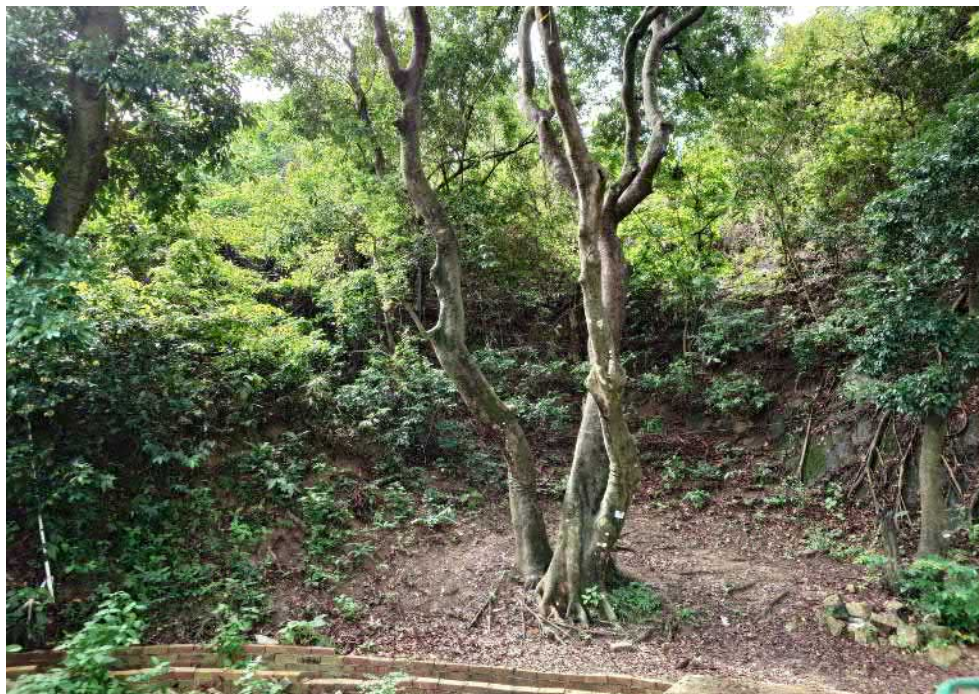
This is a rectangular shape feature partly located at the eastern boundary of the site. It consists of a vegetated slope with about 5.0m high and has a face angle of about 35°. This feature is about 68m long. The photo is shown in Plate A2 to A5.

A2 - General view of the site (north side looking eastern)

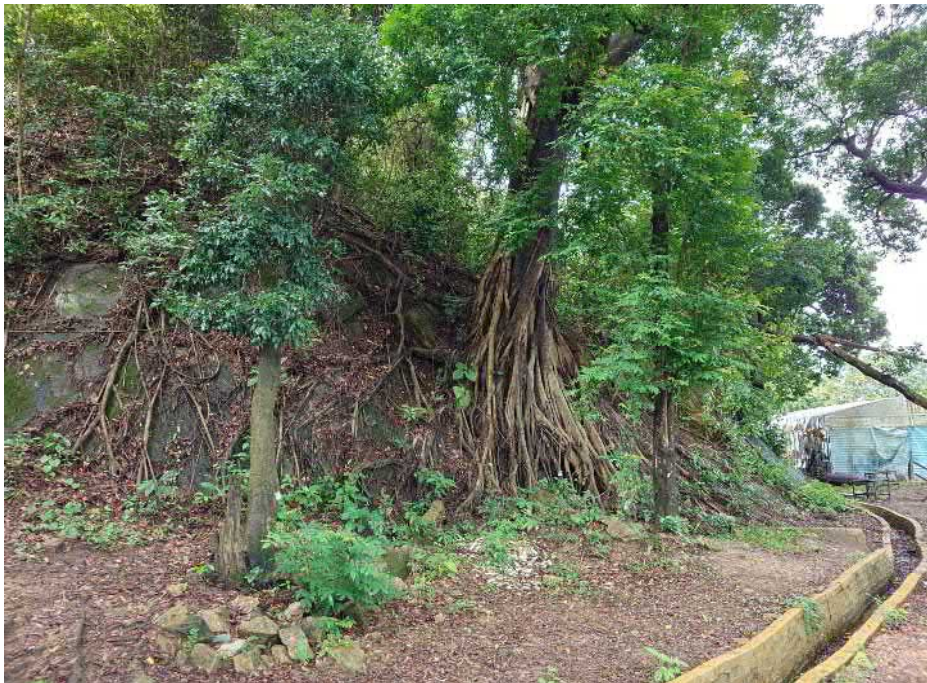
A3 - General view of the site (middle side looking southern)

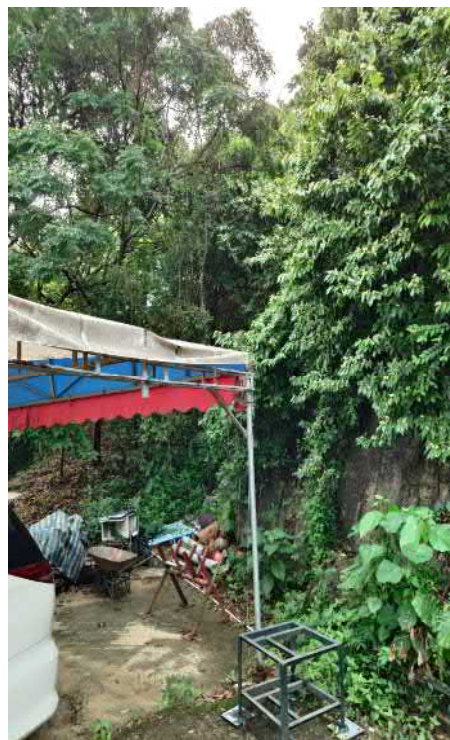
A4 - General view of the site (south side looking northern)

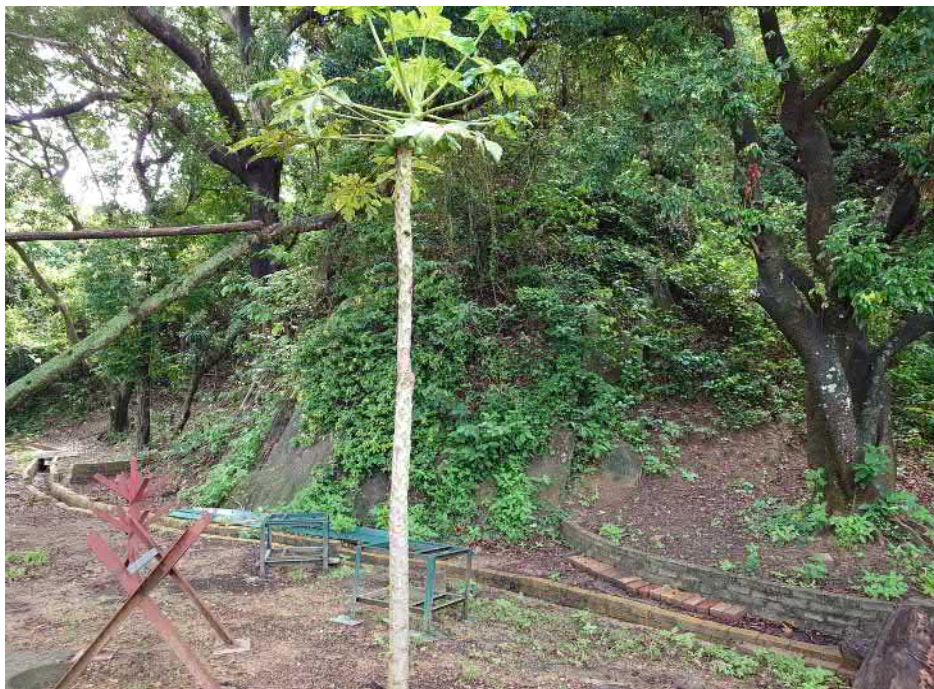
A5 - General view of the site (middle side looking eastern)

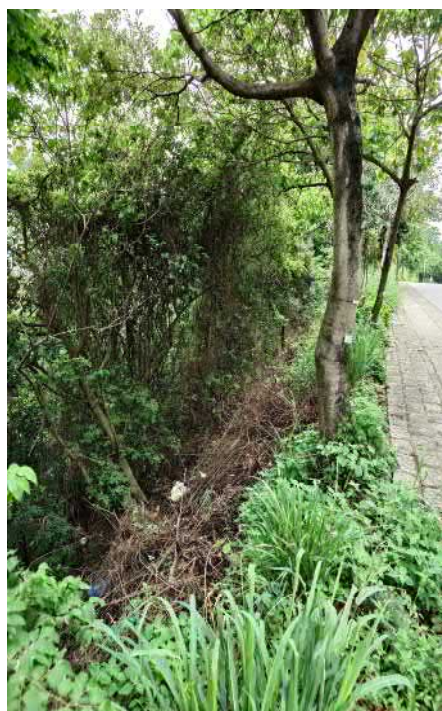
A6 - General view of the site (south side looking northern)

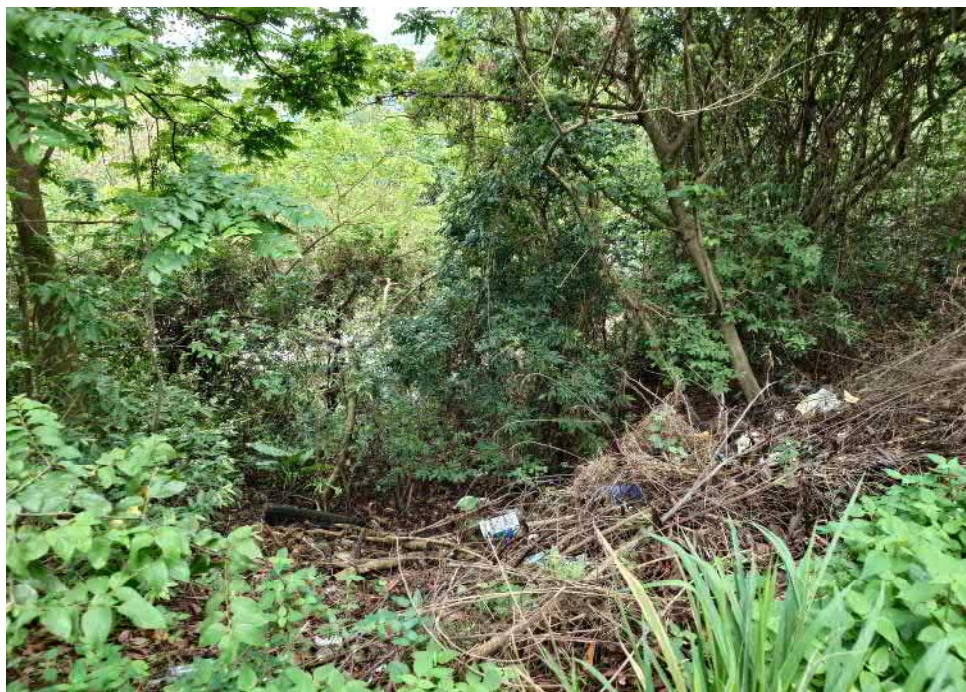
A7 - General view of the site (middle side looking northwestern)

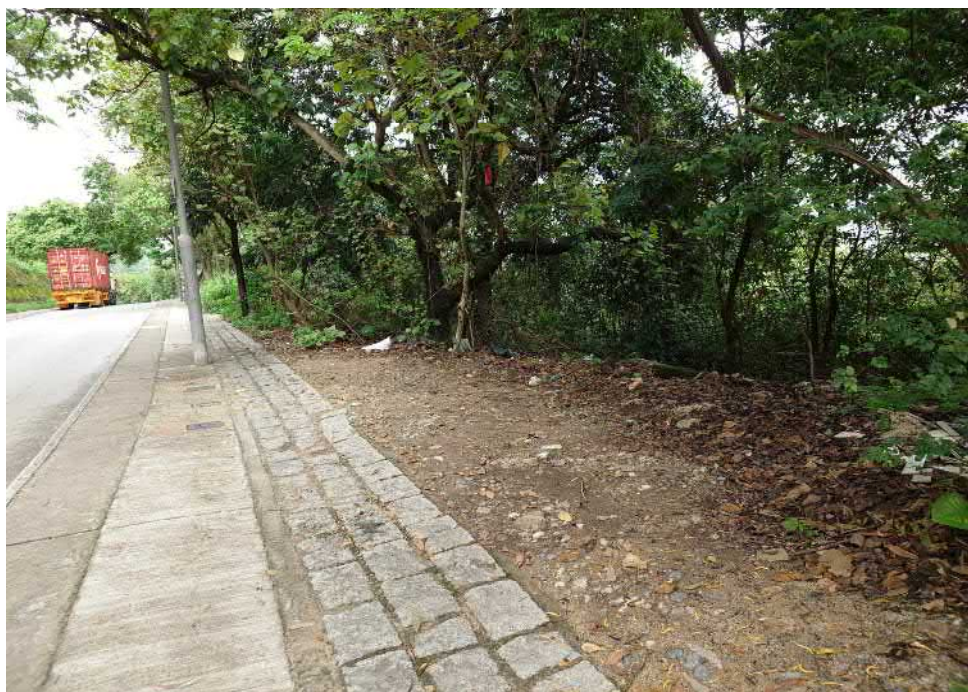
A8 - General view of the site (north side looking southwestern)
