Our Ref.: YL/TPN/2540C/L08

**Planning Application for  
Temporary Shop and Services (Vehicle Showroom, Sales of Second-Hand Private Car,  
Vehicle Parts and Accessories) with Ancillary Office and Storage Facilities  
Lots 3307RP(Part), 3308RP(Part), 3312RP and 3313RP in D.D. 104  
Long Ha, Yuen Long, New Territories  
(Planning Application No. A/YL-KTN/1102)**

### Response-to-Comments

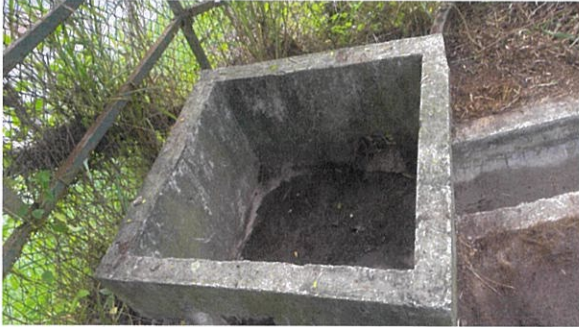
Departmental Comments	Responses
	<b><u>Drainage Services Department (DSD)</u></b> <b>(Contact: Mr. Terence TANG at 2300-1257)</b>	
	I have the following comments on the re-submitted condition record of existing drainage facilities.	
(i)	Photo A and B: Vegetation was found in existing surface channels connected to terminal catchpit that water flow might be obstructed. The applicant should remove the concerned vegetation and supplement more photos to show condition of existing surface channels connected to terminal catchpit.	Please note that the vegetation in the existing surface channels connected to terminal catchpit have been removed. Please, see the attached drainage photos for your reference.
