Various Lots in D.D. 107, Fung Kat Heung, Kam Tin, Yuen Long, New Territories

(AYL-KTN/1031)  
(Drainage Proposal)

**Proposed Temporary Warehouse (Excluding Dangerous Goods Godown)  
for a Period of Three Years and Associated Filling of Land in "Agriculture" Zone, Various  
Lots in D.D. 107, Fung Kat Heung, Kam Tin, Yuen Long, New Territories**  
**(Application No. A/YL-KTN/1031)**

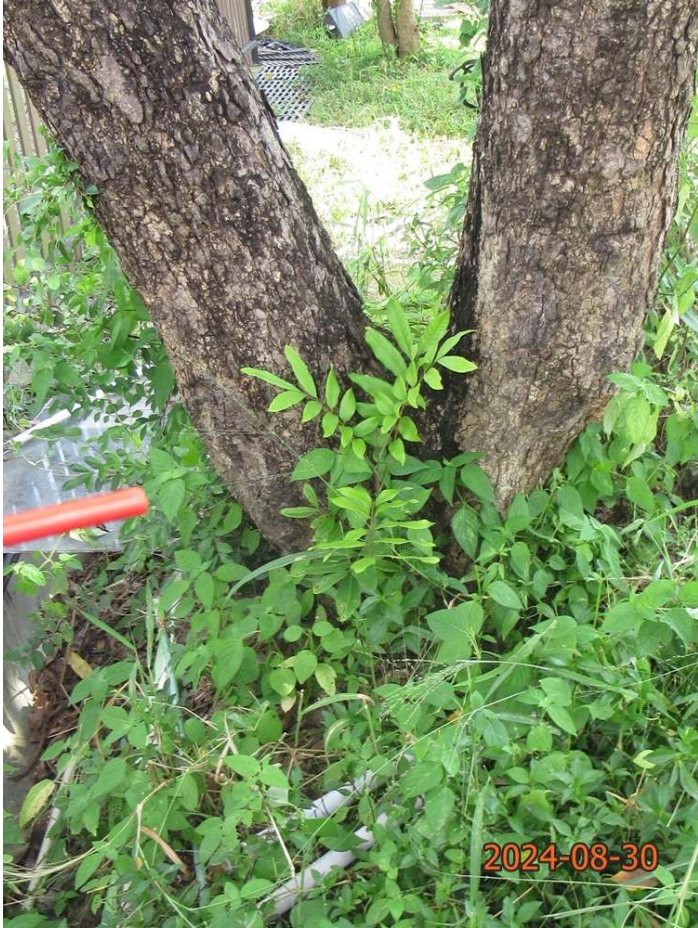
| Tree No. | Tree Species | | Tree Size Measurements | | | Amenity Value | Form | Health Condition | Structural Condition | Suitability for Transplanting | Remarks |
|---|---|---|---|---|---|---|---|---|---|---|---|
| T1 | <i>Dimocarpus longan</i> | 龍眼 | 9.0 | 420 | 5.0 | Low | Poor | Fair | Poor | Low | Co-dominant trunks forked at the base, dead broken branches, pruned wound with epicormics, pruned wound with exposed decay wood, tree wound with exposed dead and decay wood |

T1 Codominant trunk forked at the base

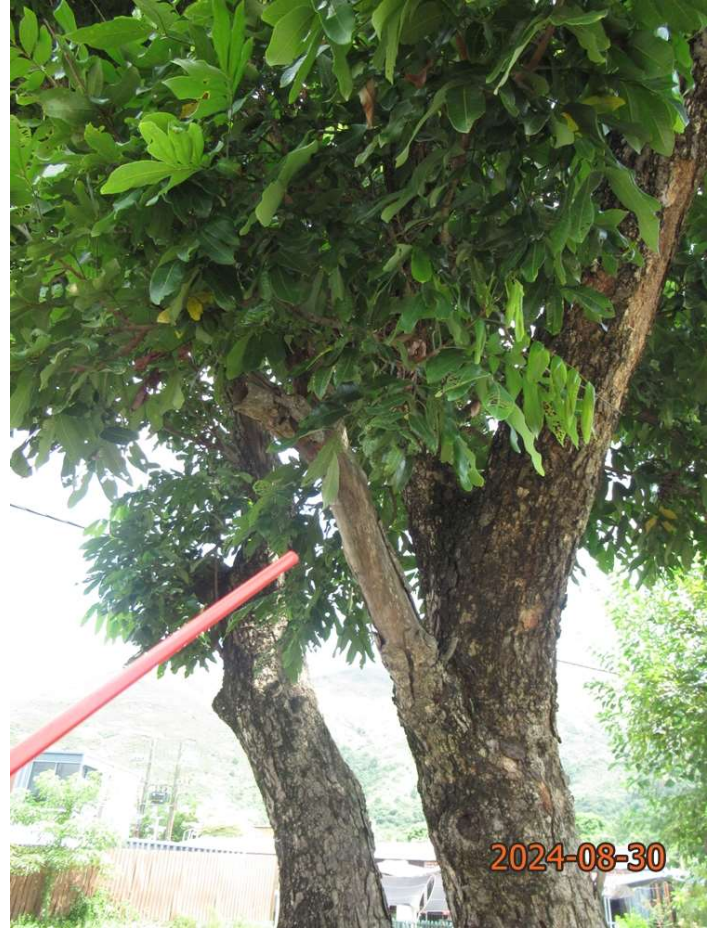
T1 Dead broken branches

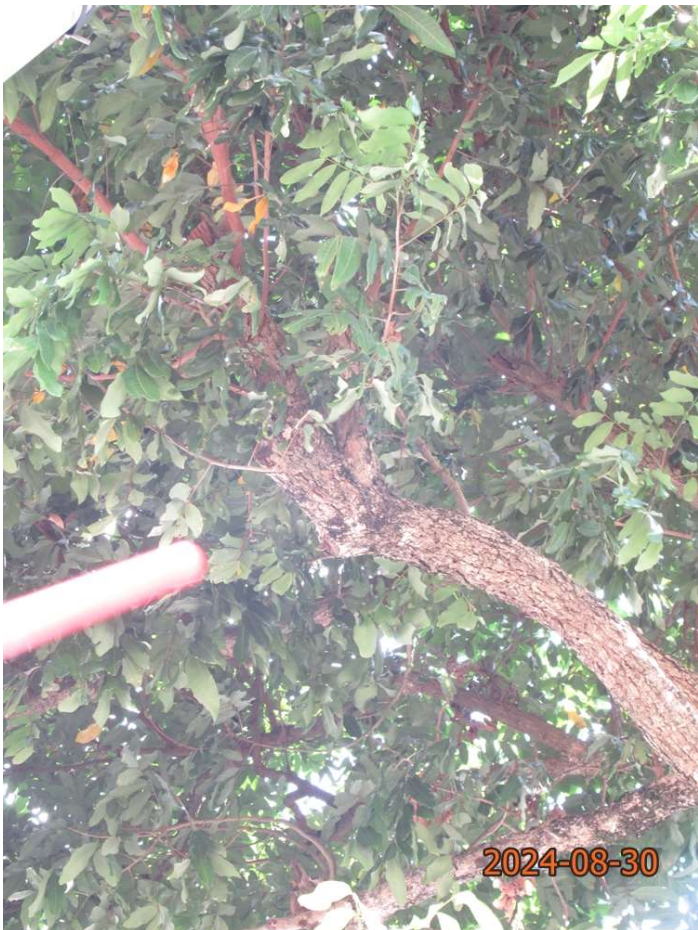
T1 Pruned wound with epicormics

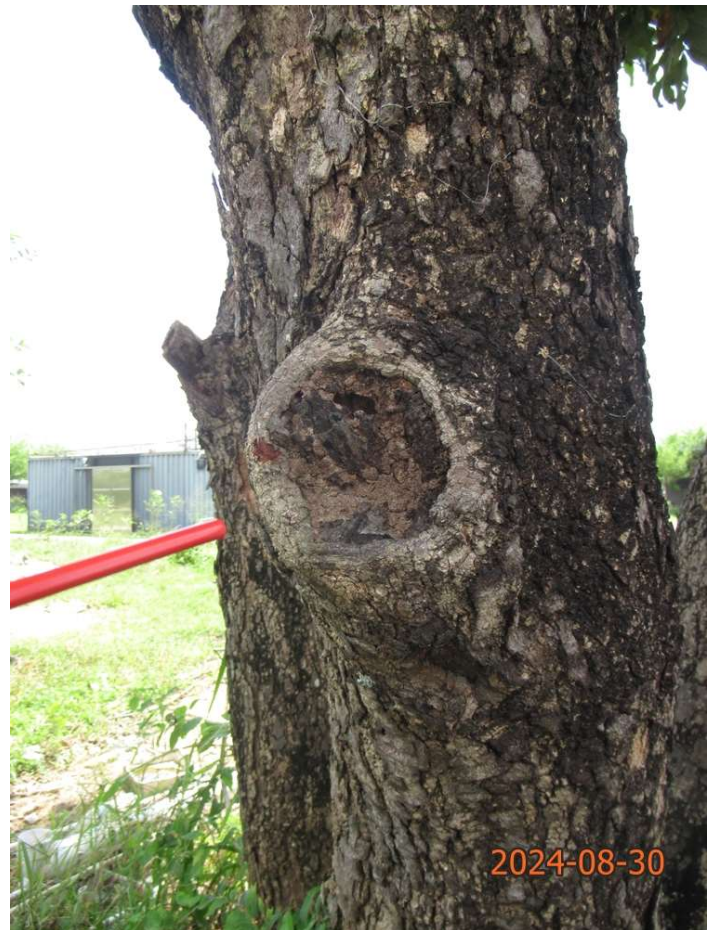
T1 Pruned wound with exposed decay wood

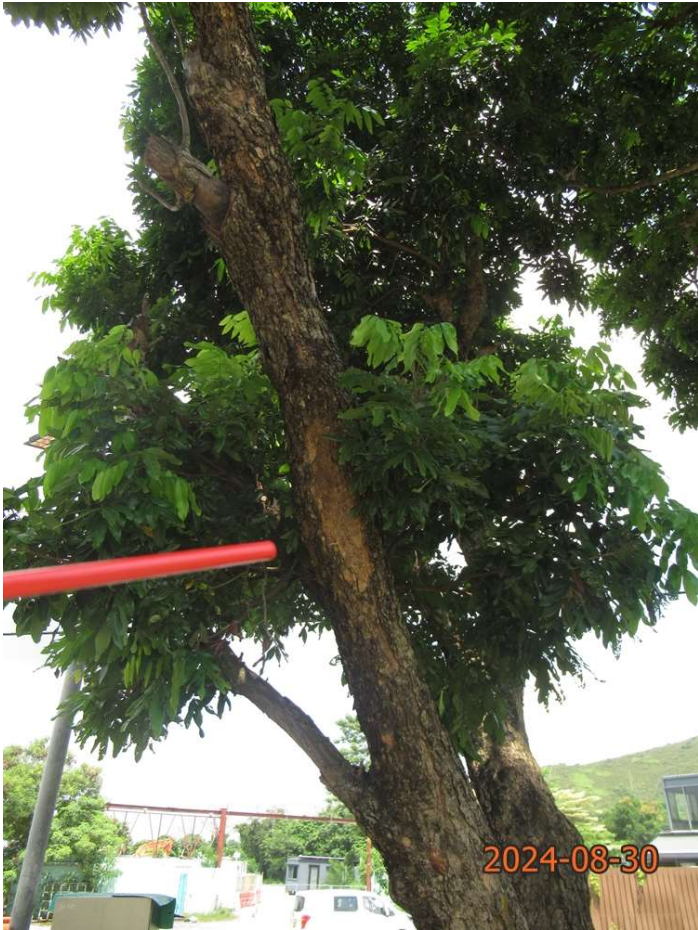
T1 Tree wound with exposed dead and decay wood

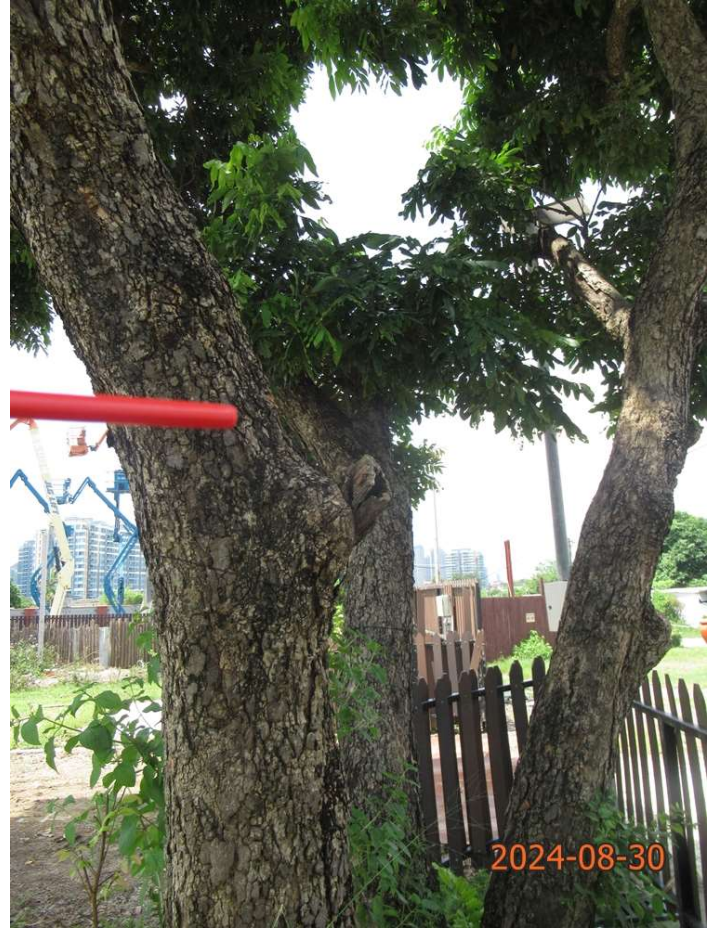
| Tree No. | Tree Species | | Tree Size Measurements | | | Amenity Value | Form | Health Condition | Structural Condition | Suitability for Transplanting | Remarks |
|---|---|---|---|---|---|---|---|---|---|---|---|
| T2 | <i>Dimocarpus longan</i> | 龍眼 | 8.0 | 359 | 4.0 | Low | Fair | Fair | Poor | Low | Broken stub on trunk, dead broken branches with dead and decay wood |

T2 Broken stub on trunk

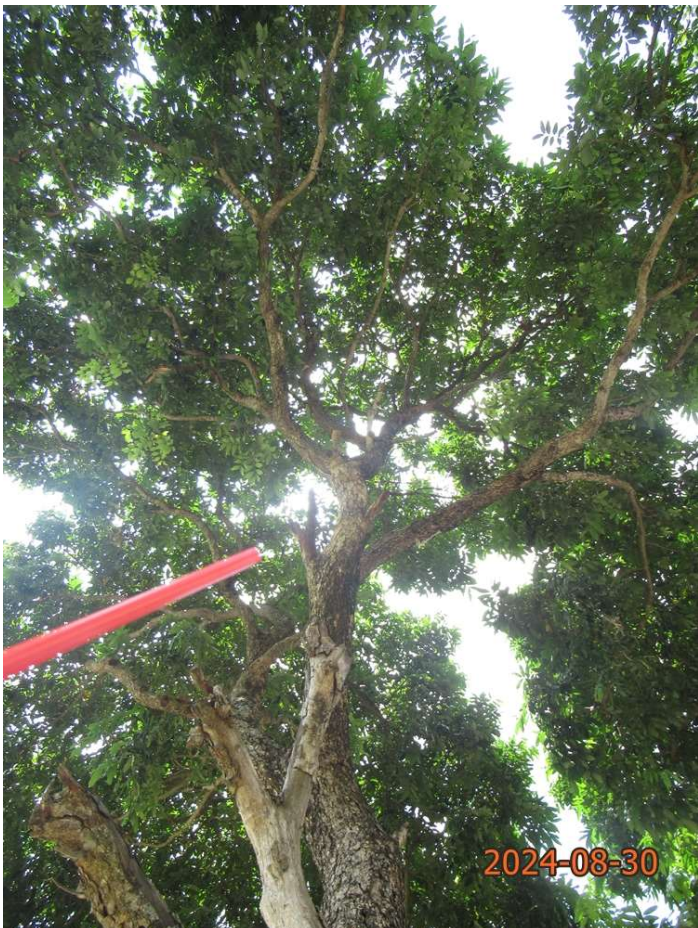
T2 Dead broken branches with dead and decay wood

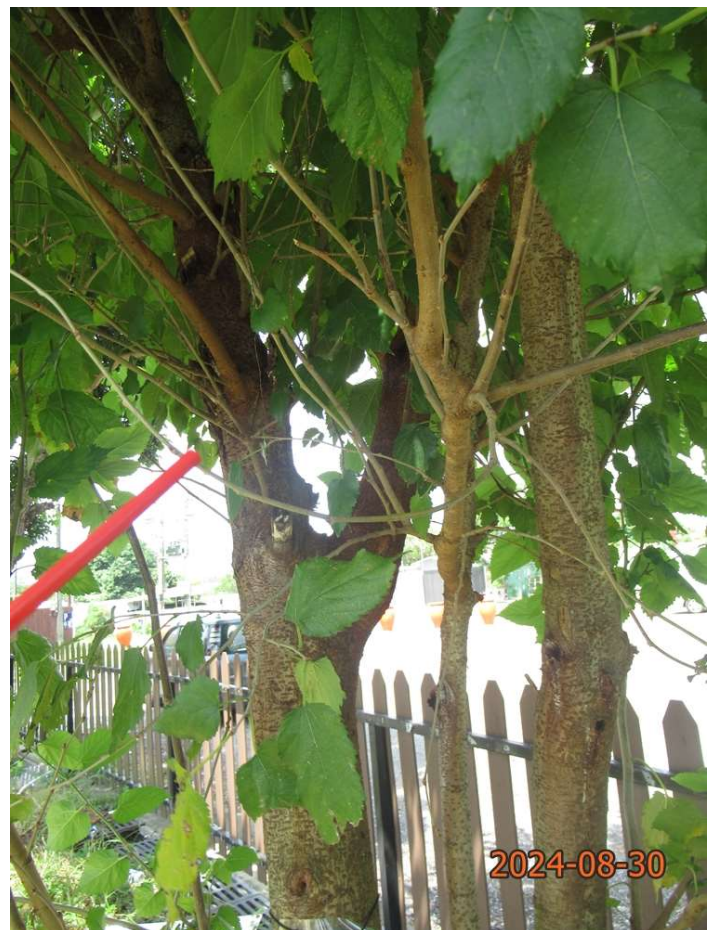
| Tree No. | Tree Species | | Tree Size Measurements | | | Amenity Value | Form | Health Condition | Structural Condition | Suitability for Transplanting | Remarks |
|---|---|---|---|---|---|---|---|---|---|---|---|
| T3 | <i>Broussonetia papyrifera</i> | 構樹 | 6.0 | 150 | 3.0 | Low | Fair | Fair | Poor | Low | Broken stub and epicormics on trunk, co-dominant trunks forked at the base, tree wound on branch, tree wound with decay wood on branch |

T3 Broken stub and epicormics on trunk

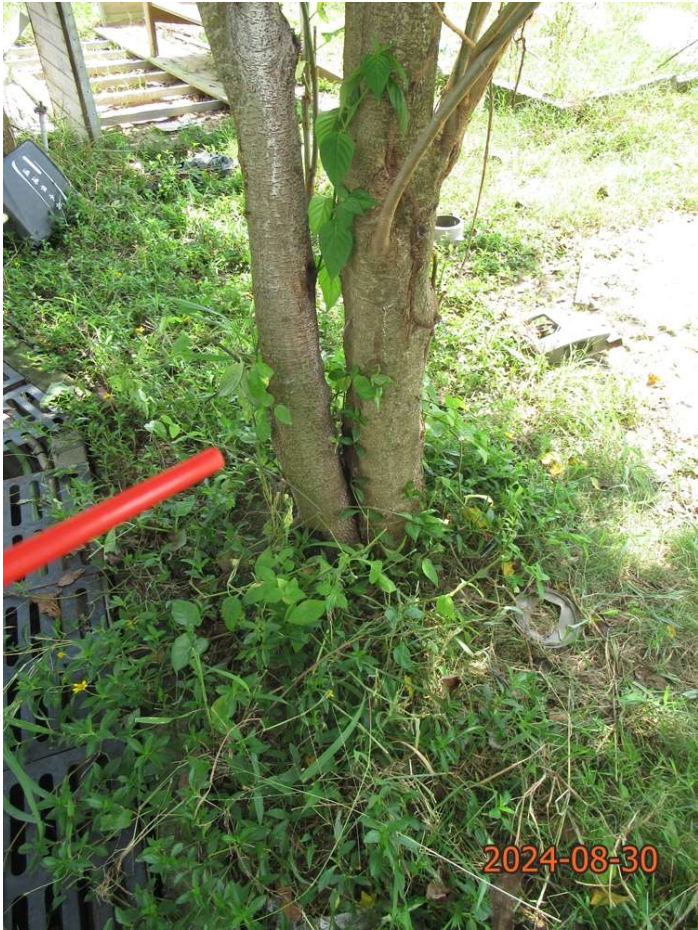
T3 Codominant trunk forked at the base

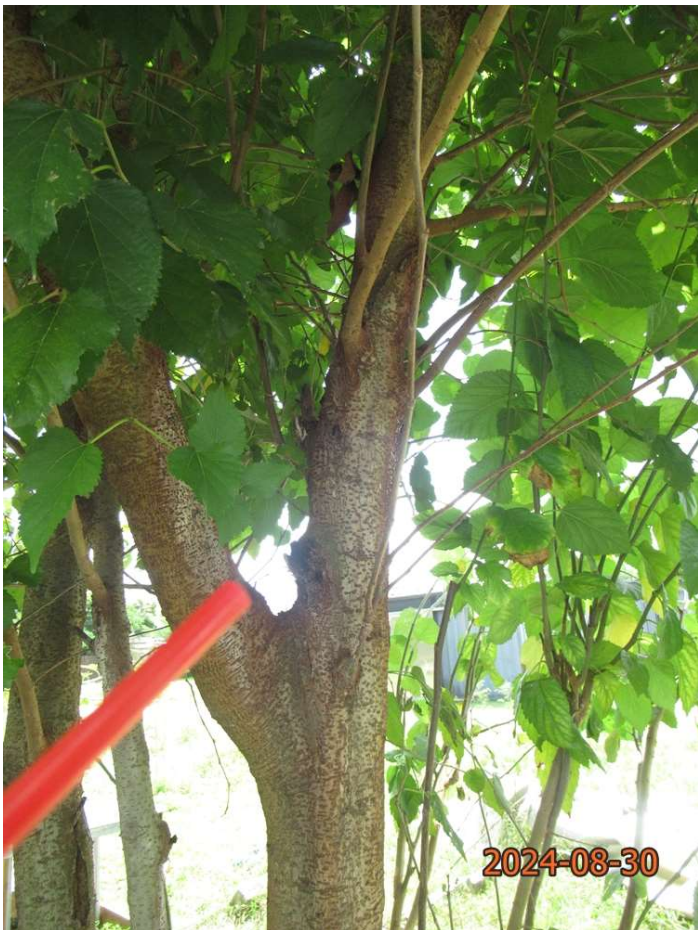
T3 Tree wound with decay wood on branch

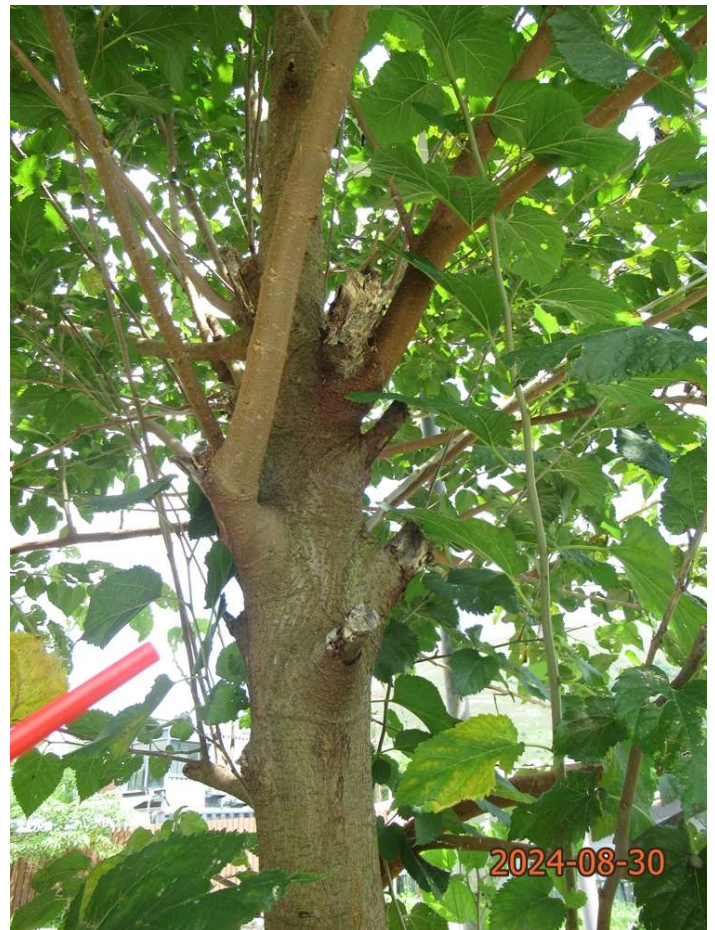
| Tree No. | Tree Species | | Tree Size Measurements | | | Amenity Value | Form | Health Condition | Structural Condition | Suitability for Transplanting | Remarks |
|---|---|---|---|---|---|---|---|---|---|---|---|
| T4 | <i>Broussonetia papyrifera</i> | 構樹 | 5.0 | 210 | 3.0 | Low | Fair | Fair | Poor | Low | Broken branch with decay wood and epicormics on trunk, co-dominant trunks, topped branch with epicormics |

T4 Broken branch with decay wood and epicormics

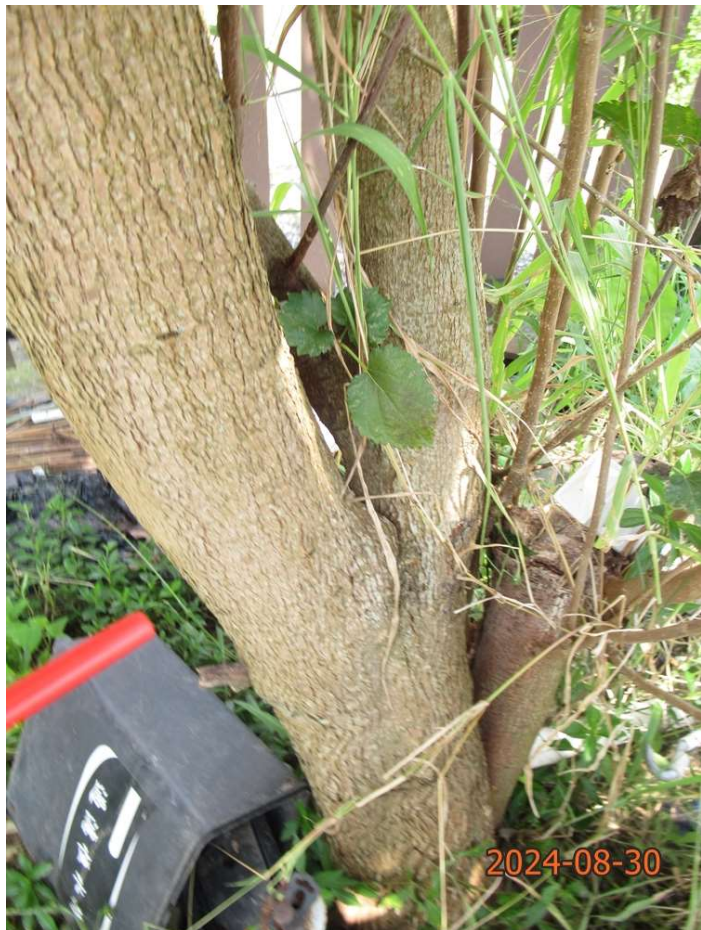
T4 Codominant trunk

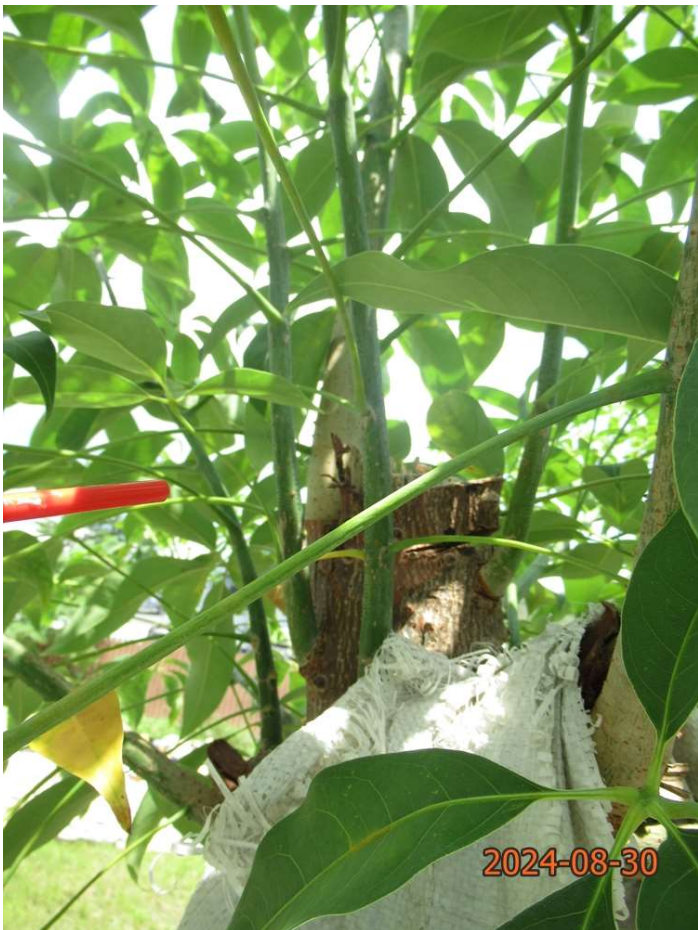
T5 Topped trunk with epicormics

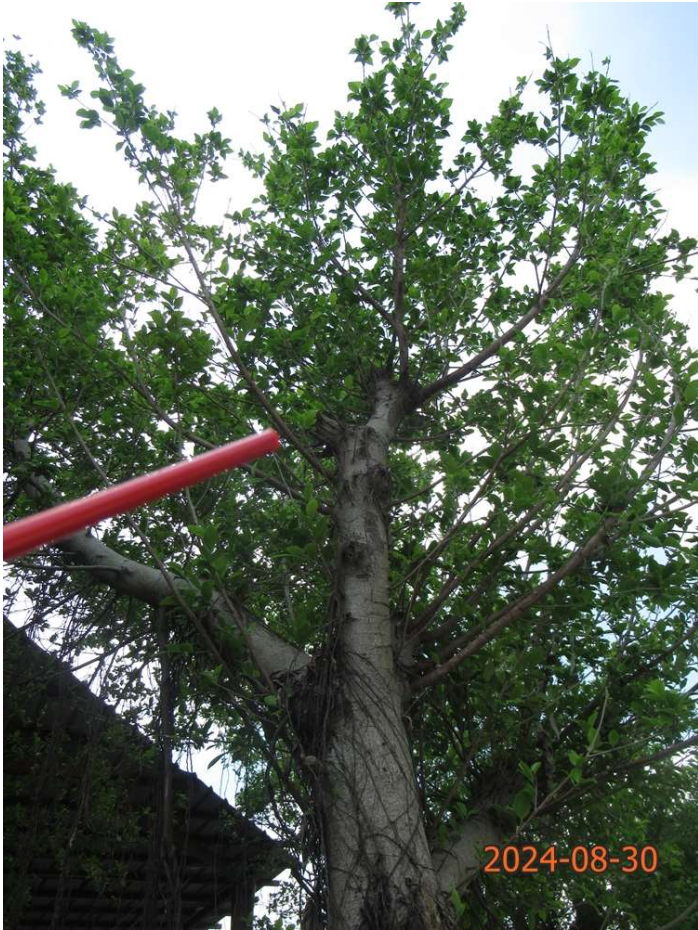
| Tree No. | Tree Species | | Tree Size Measurements | | | Amenity Value | Form | Health Condition | Structural Condition | Suitability for Transplanting | Remarks |
|---|---|---|---|---|---|---|---|---|---|---|---|
| T6 | <i>Ficus microcarpa</i> | 榕樹（細葉榕） | 5.0 | 450 | 4.0 | Low | Poor | Fair | Poor | Low | Broken branch with exposed dead wood, topped trunk with epicormics |

T6 Broken branch with exposed dead wood

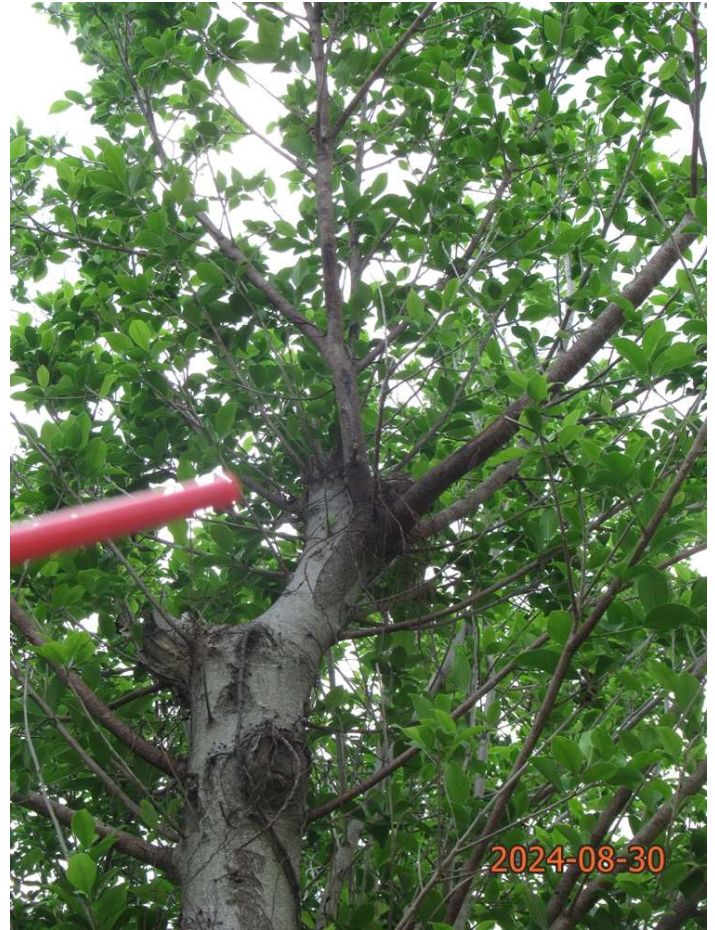
T6 Topped trunk with epicormics

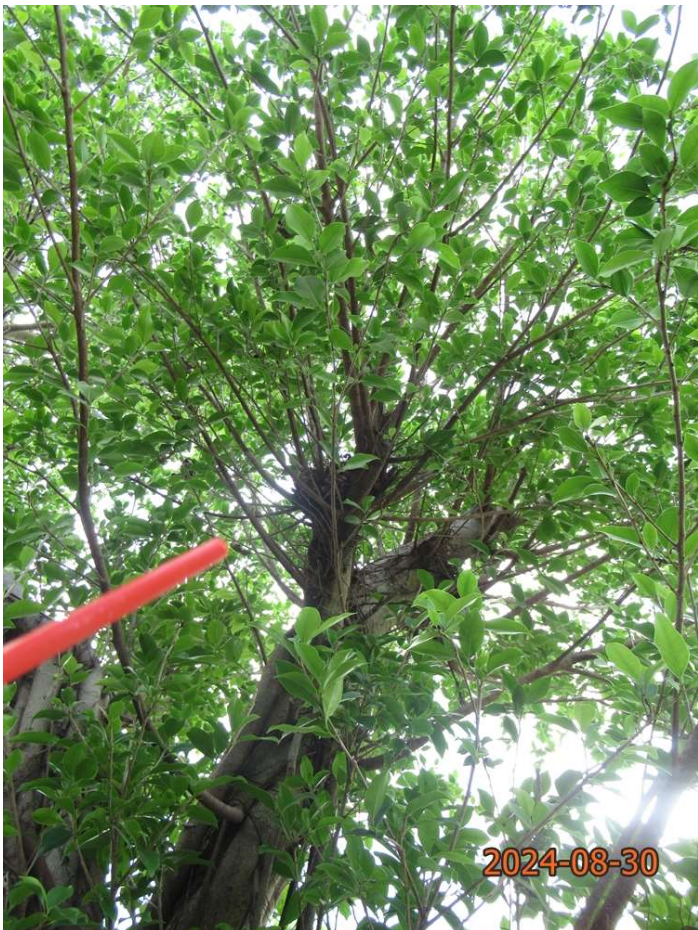
T7 Topped branch with epicormics

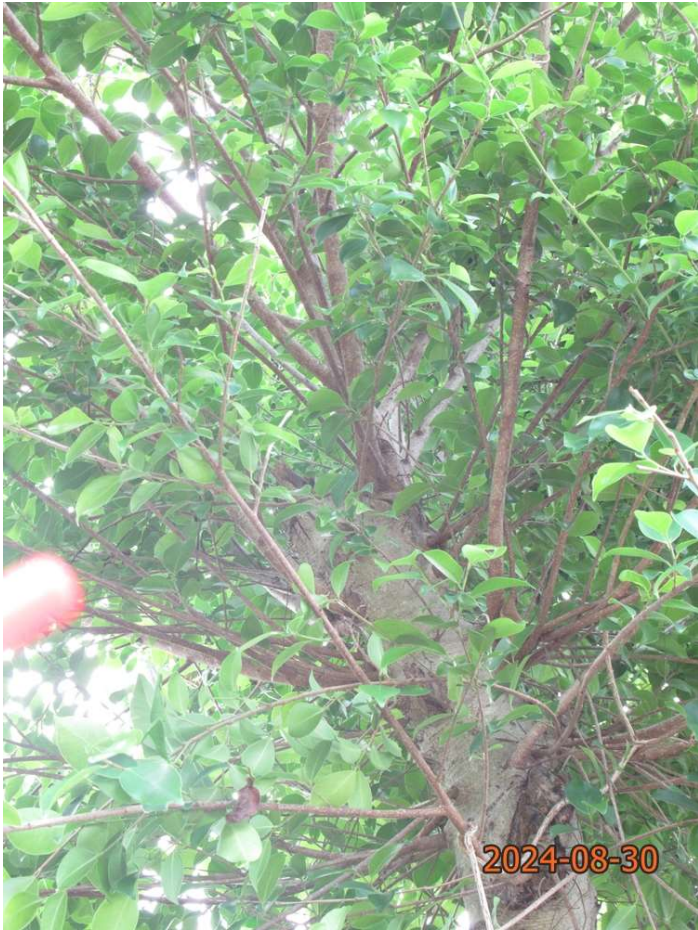
| Tree No. | Tree Species | | Tree Size Measurements | | | Amenity Value | Form | Health Condition | Structural Condition | Suitability for Transplanting | Remarks |
|---|---|---|---|---|---|---|---|---|---|---|---|
| T8 | <i>Ficus microcarpa</i> | 榕樹（細葉榕） | 5.0 | 250 | 2.0 | Low | Fair | Fair | Poor | Low | Broken branch with epicormics, topped branches |

T8 Broken branch with epicormics

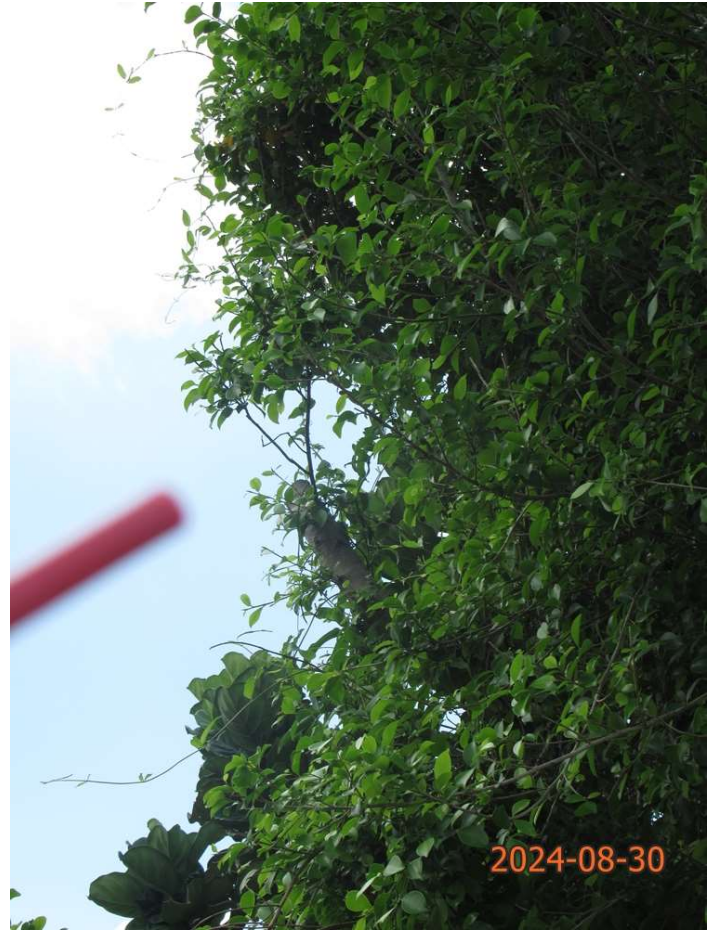
T8 Topped branches

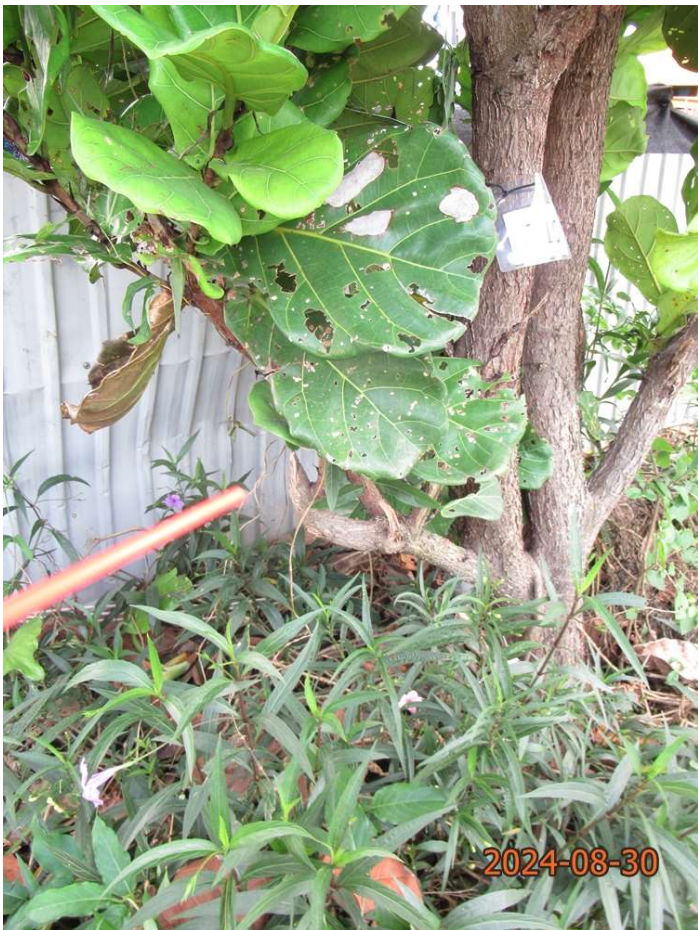
| Tree No. | Tree Species | | Tree Size Measurements | | | Amenity Value | Form | Health Condition | Structural Condition | Suitability for Transplanting | Remarks |
|---|---|---|---|---|---|---|---|---|---|---|---|
| T9 | <i>Ficus lyrata</i> | 大琴葉榕 | 6.0 | 200 | 4.0 | Low | Fair | Fair | Poor | Low | Broken branch, broken stub, forked trunk, tree wound on branch |

T9 Broken branch

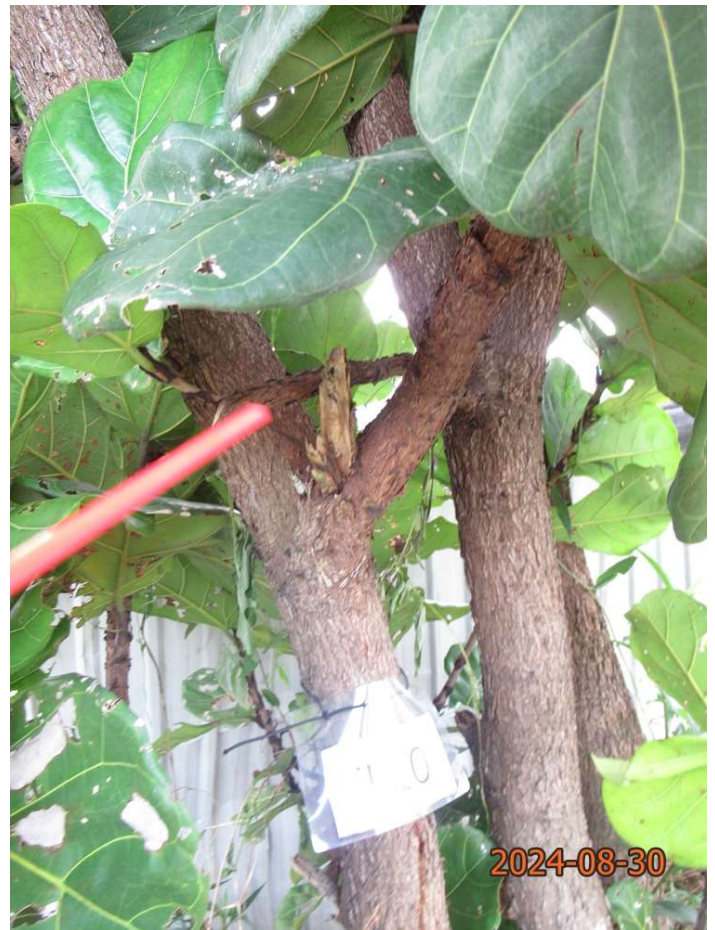
T9 Broken stub

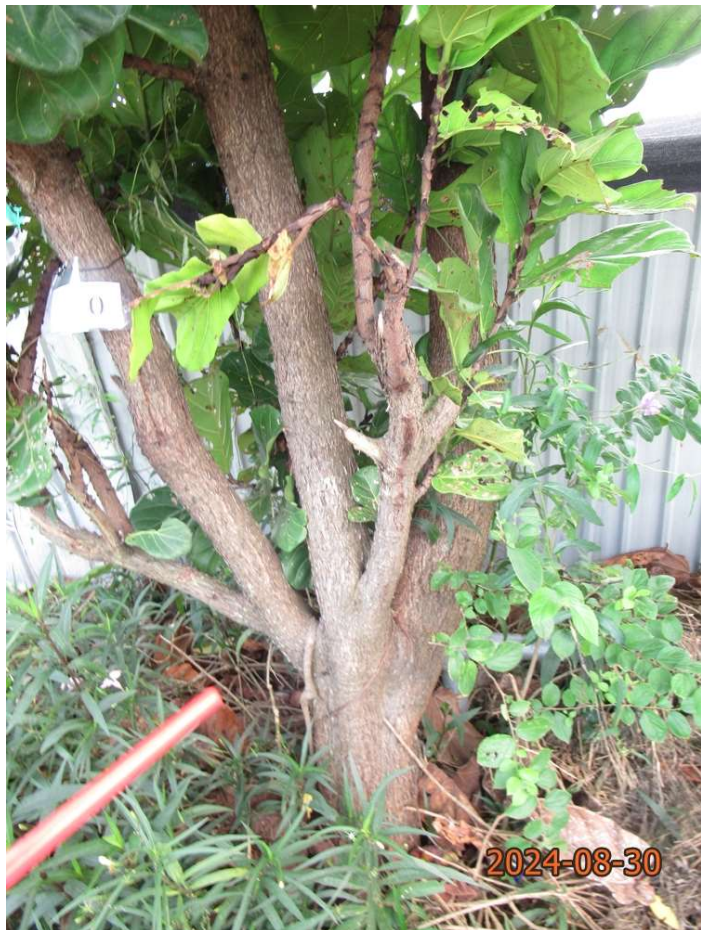
T9 Forked trunk

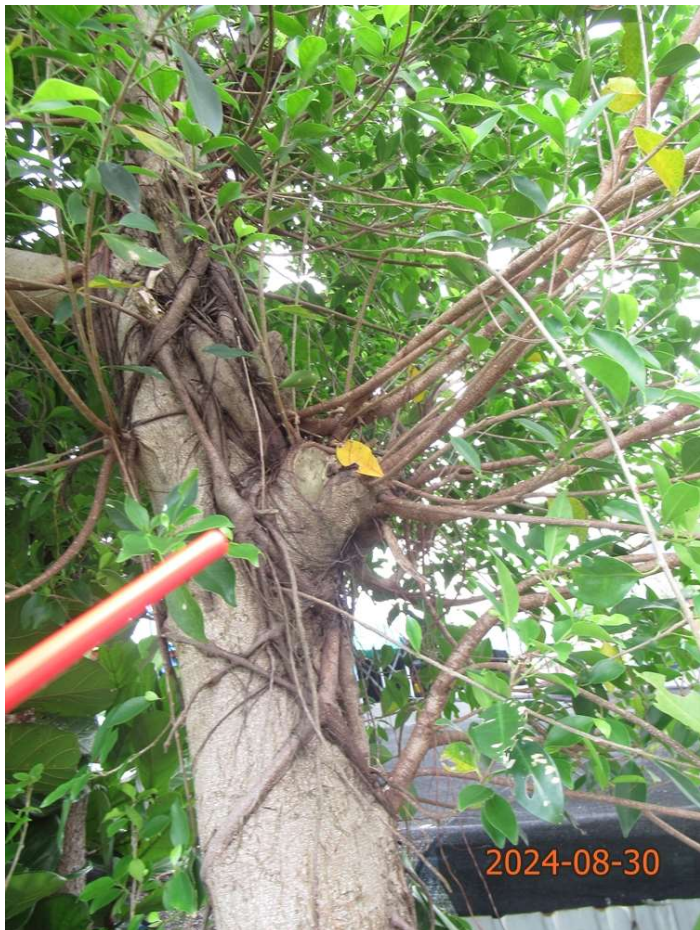
T10 Pruned wound with epicormics

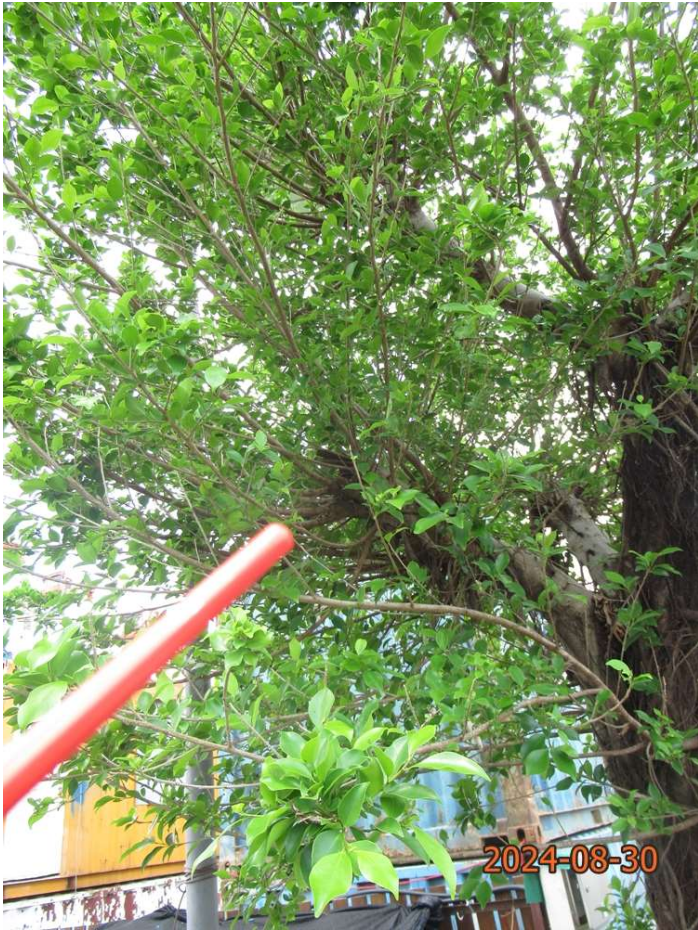
| Tree No. | Tree Species | | Tree Size Measurements | | | Amenity Value | Form | Health Condition | Structural Condition | Suitability for Transplanting | Remarks |
|---|---|---|---|---|---|---|---|---|---|---|---|
| T11 | <i>Ficus microcarpa</i> | 榕樹（細葉榕） | 4.0 | 220 | 3.0 | Low | Fair | Fair | Fair | Low | Broken branches with epicormics |

T11 Broken branches with epicormics

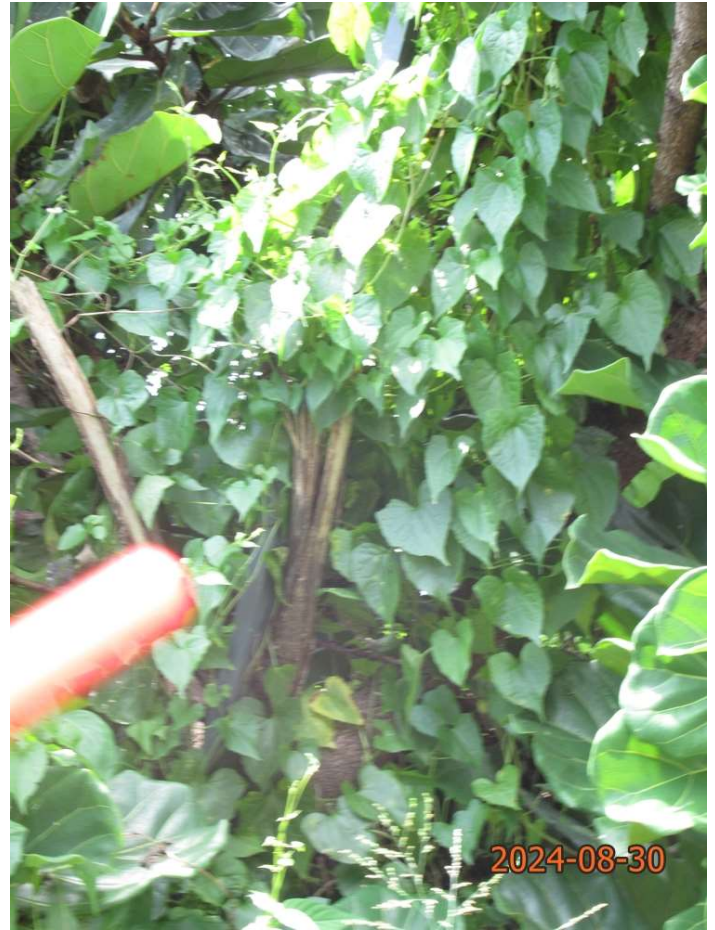
| Tree No. | Tree Species | | Tree Size Measurements | | | Amenity Value | Form | Health Condition | Structural Condition | Suitability for Transplanting | Remarks |
|---|---|---|---|---|---|---|---|---|---|---|---|
| T12 | <i>Ficus lyrata</i> | 大琴葉榕 | 5.0 | 300 | 6.0 | Low | Poor | Fair | Poor | Low | Broken branch with expose dead and decayed wood, forked branch with tree wound |

T12 Broken branch with expose dead and decayed
