**SECTION 16 PLANNING APPLICATION FOR PROPOSED RESIDENTIAL  
CARE HOMES FOR THE ELDERLY IN "VILLAGE TYPE DEVELOPMENT"  
AT LOT NO. 76 S.G. & 76 S.H. IN D.D. 101, MAI PO, YUEN LONG**

**LANDSCAPE PROPOSAL  
&  
TREE TREATMENT PROPOSAL**

**PREPARED BY  
STEPHEN LAI STUDIO LIMITED (S L S L)  
ON BEHALF OF  
GOTLAND ENTERPRISES LIMITED**

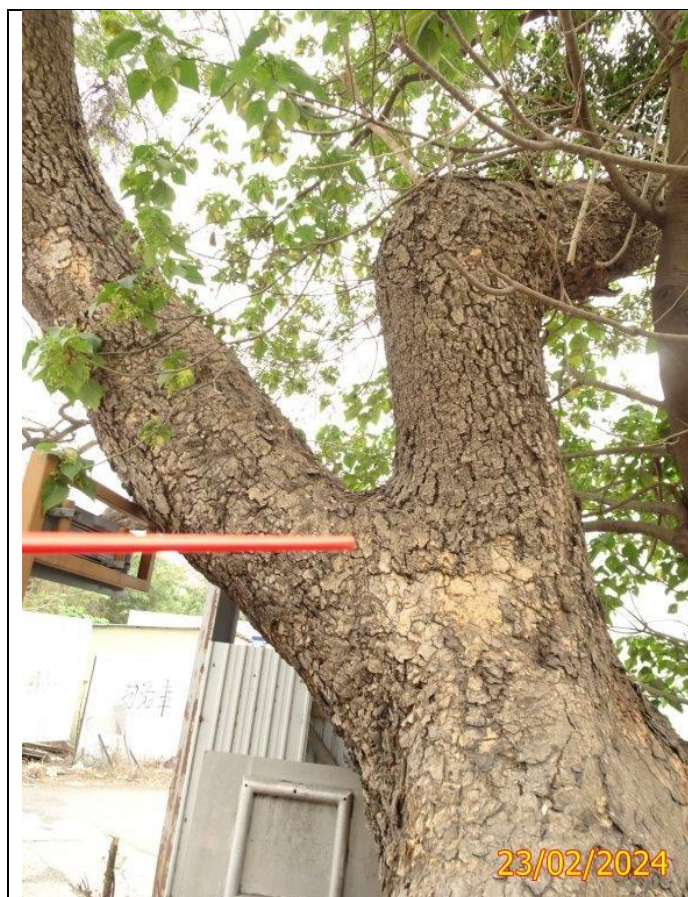
T01 | Albizia lebbeck 大葉合歡 | co-dominant branch

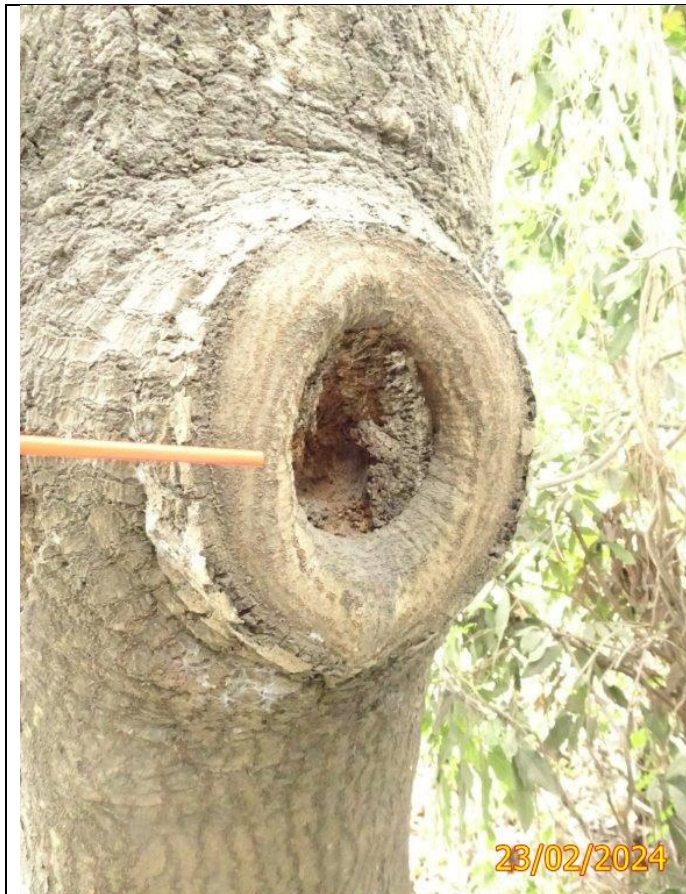
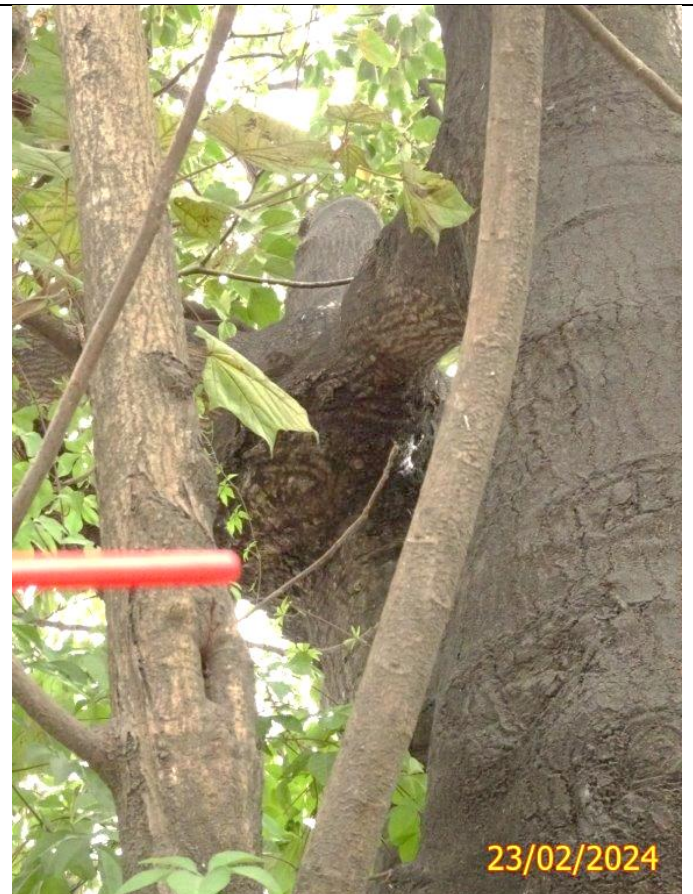
T04 | *Aleurites moluccana* 石栗 | unhealed wound on mid trunk

T04 | *Aleurites moluccana* 石栗 | cross branch with T03

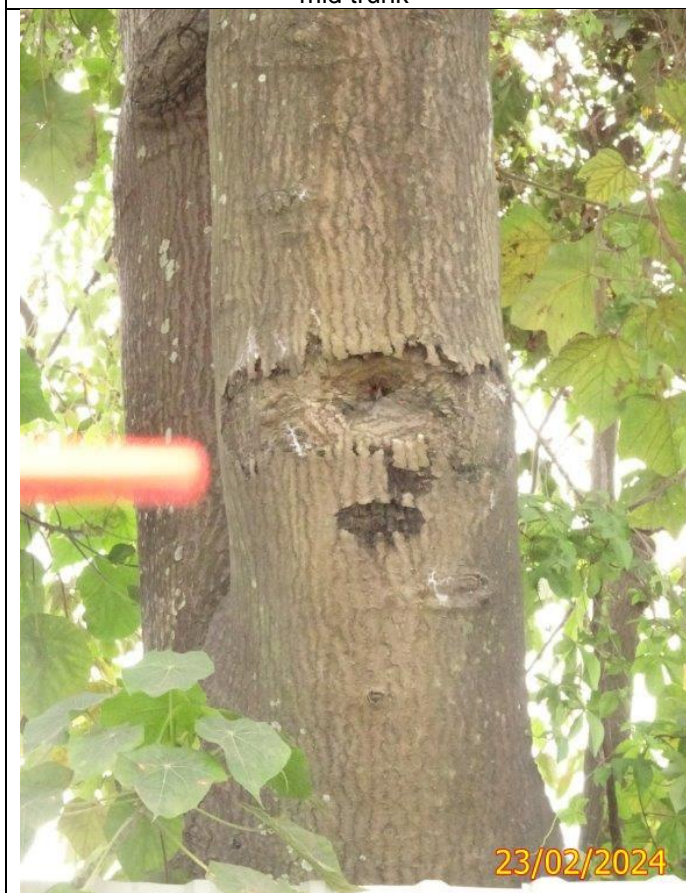
T04 | *Aleurites moluccana* 石栗 | bark crack at lower trunk near hoarding

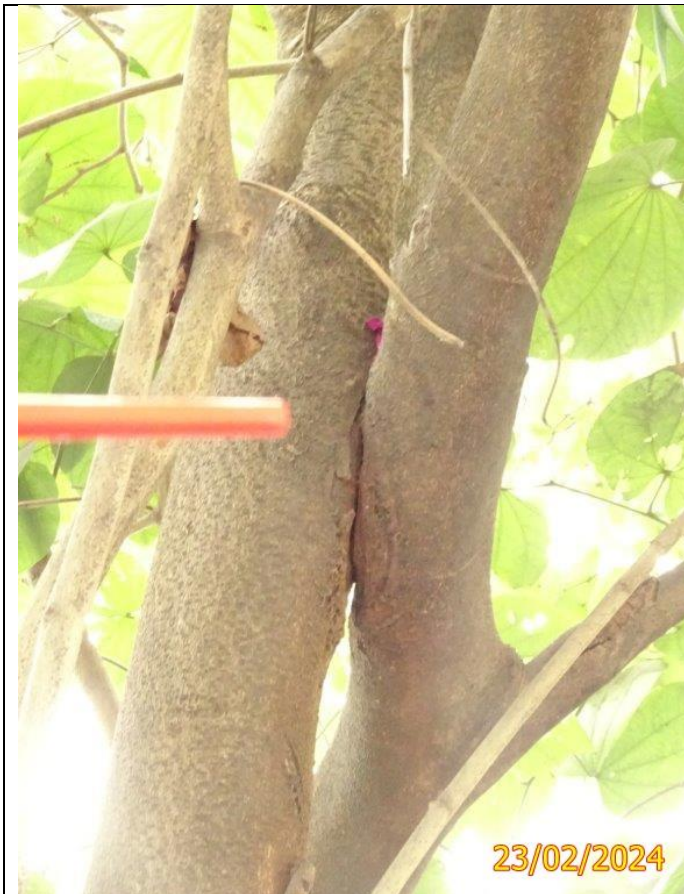
T19 | Bauhinia x blakeana 洋紫荊 | cross branches

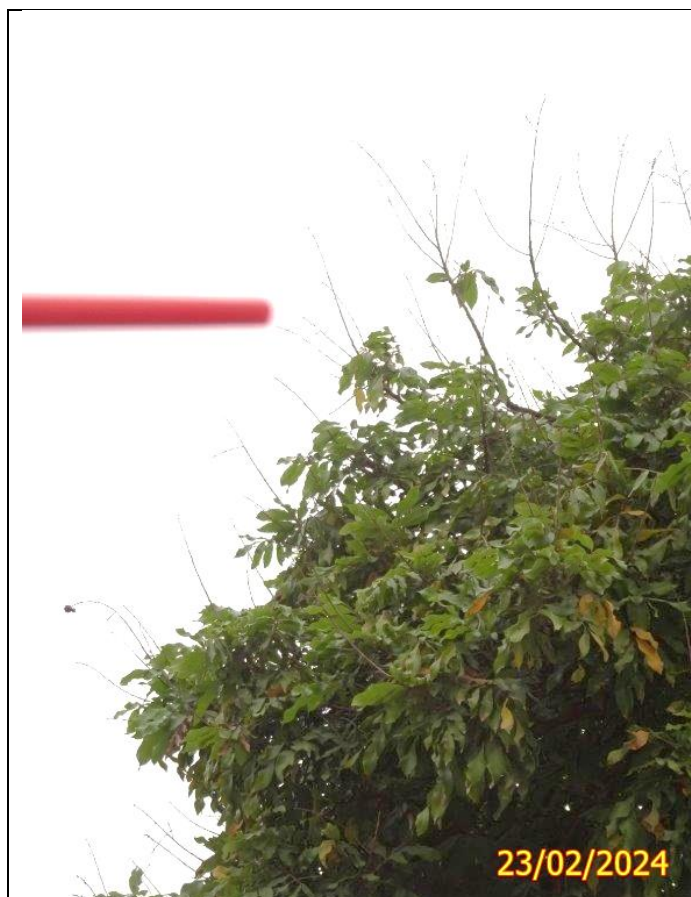
T20 | *Dimocarpus longan* 龍眼 | dieback twigs on upper crown

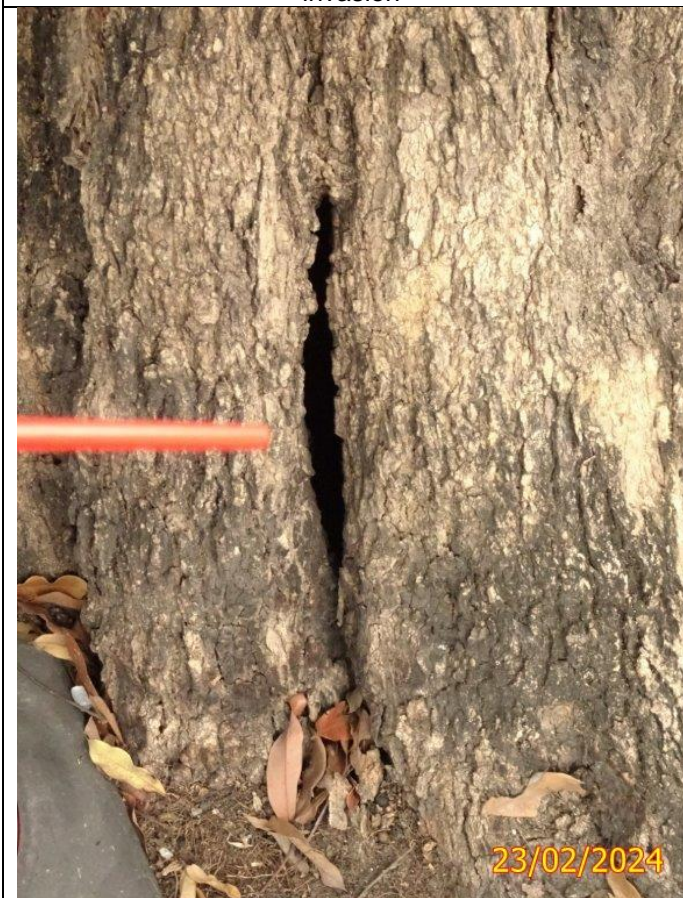
T20 | *Dimocarpus longan* 龍眼 | basal longitudinal crack

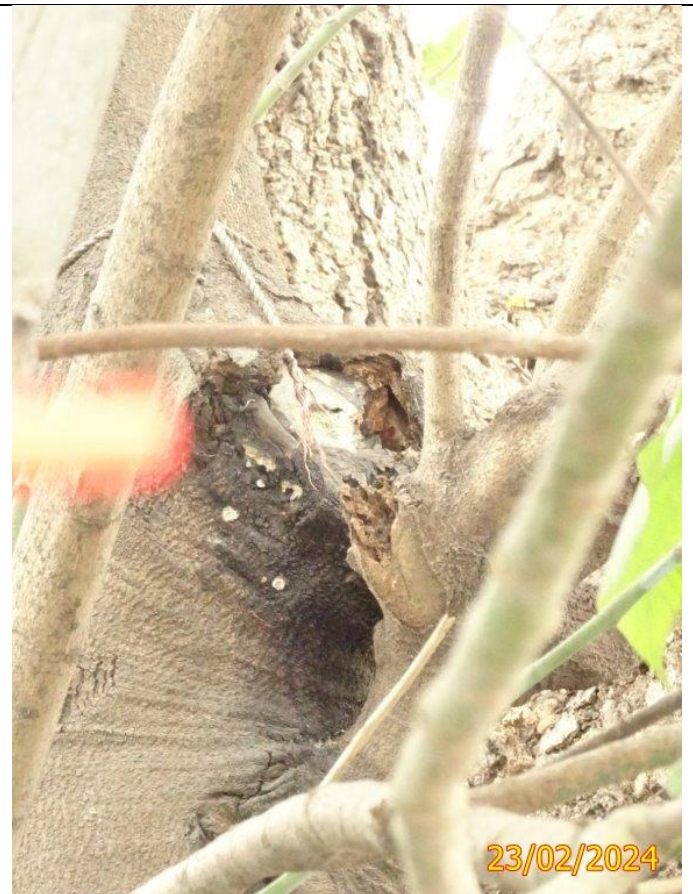
T21 | *Macaranga tanarius* var. *tomentosa* 血桐 | unhealed wound at root collar

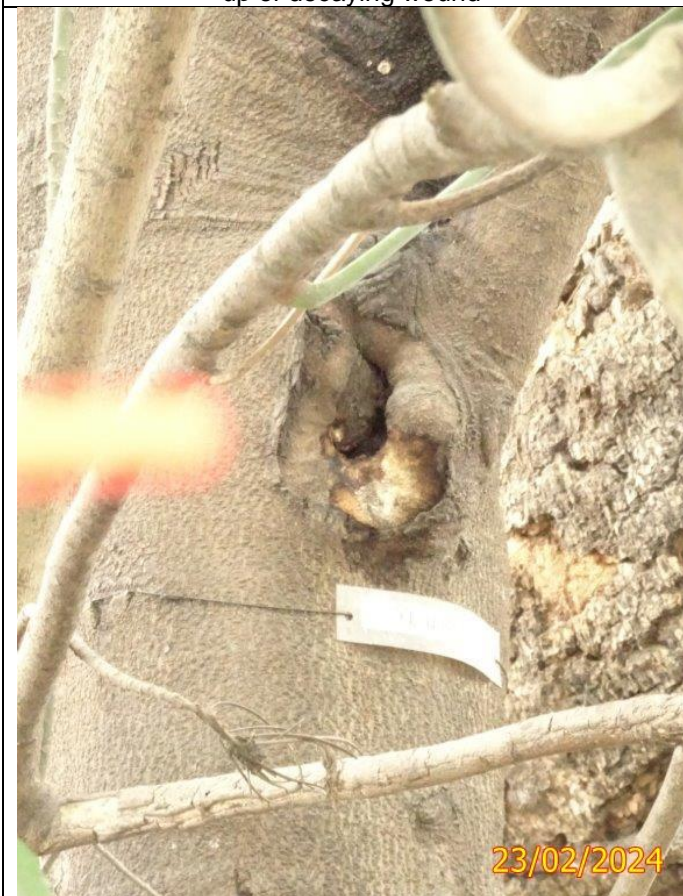
T21 | *Macaranga tanarius* var. *tomentosa* 血桐 | decaying pruning wound at lower trunk

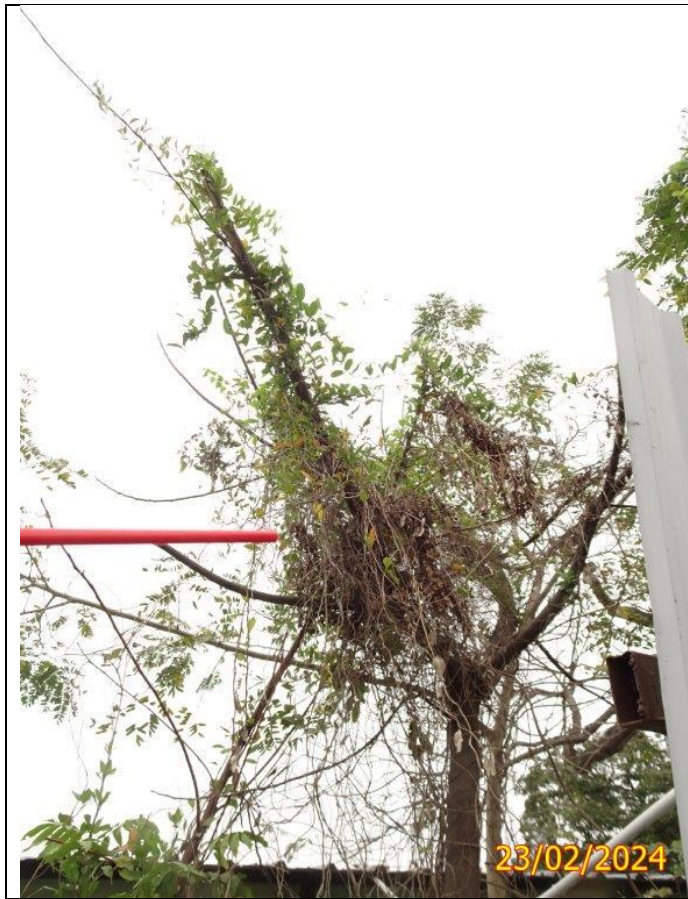
T23 | Melia azedarach 苦楝 | vine on upper crown

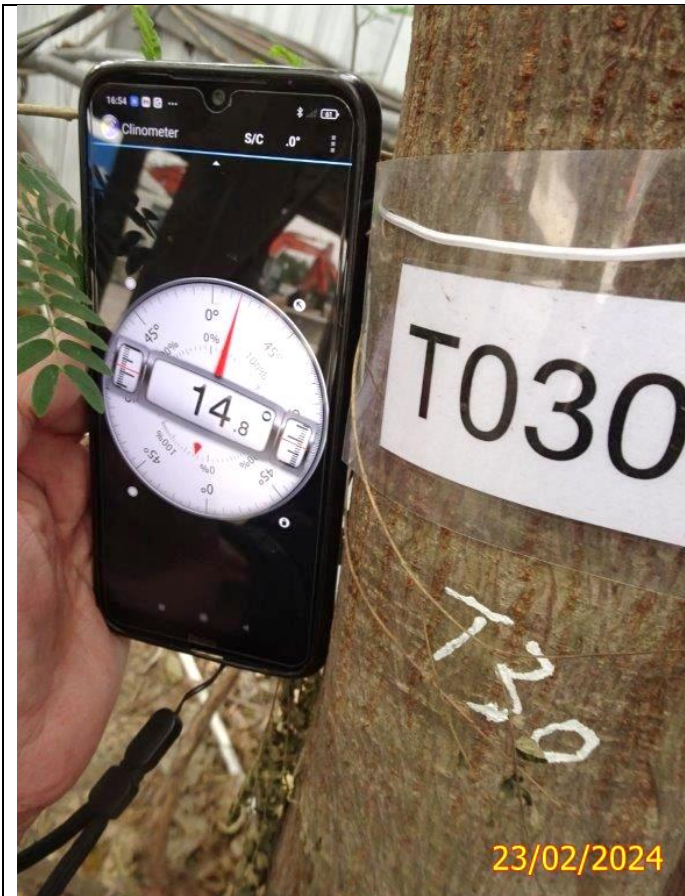
T30 | *Leucaena leucocephala* 銀合歡 | tilted 14.8°

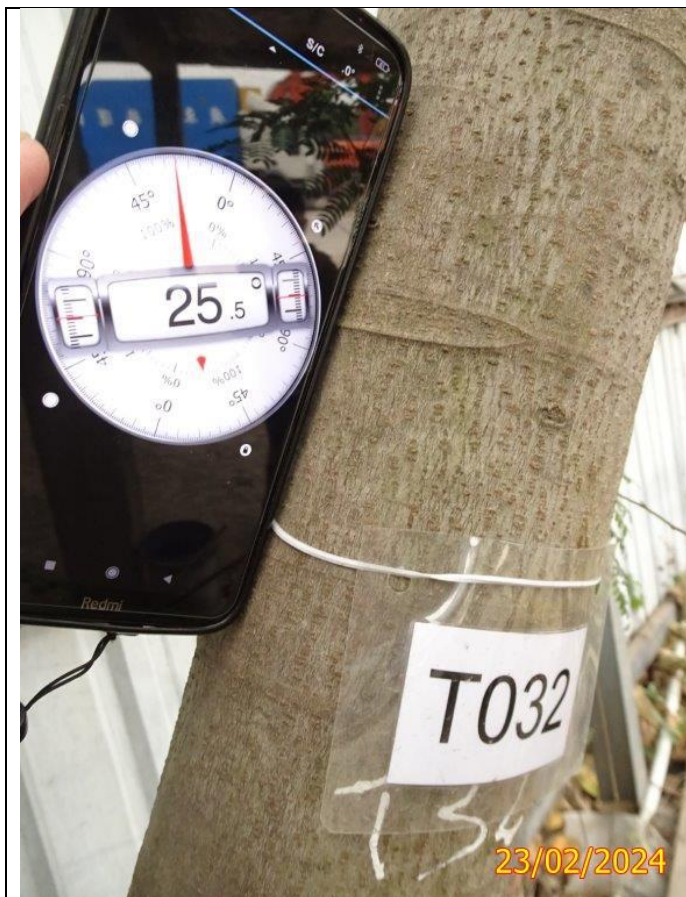
T32 | *Macaranga tanarius* var. *tomentosa* 血桐 | titled  
25.5°

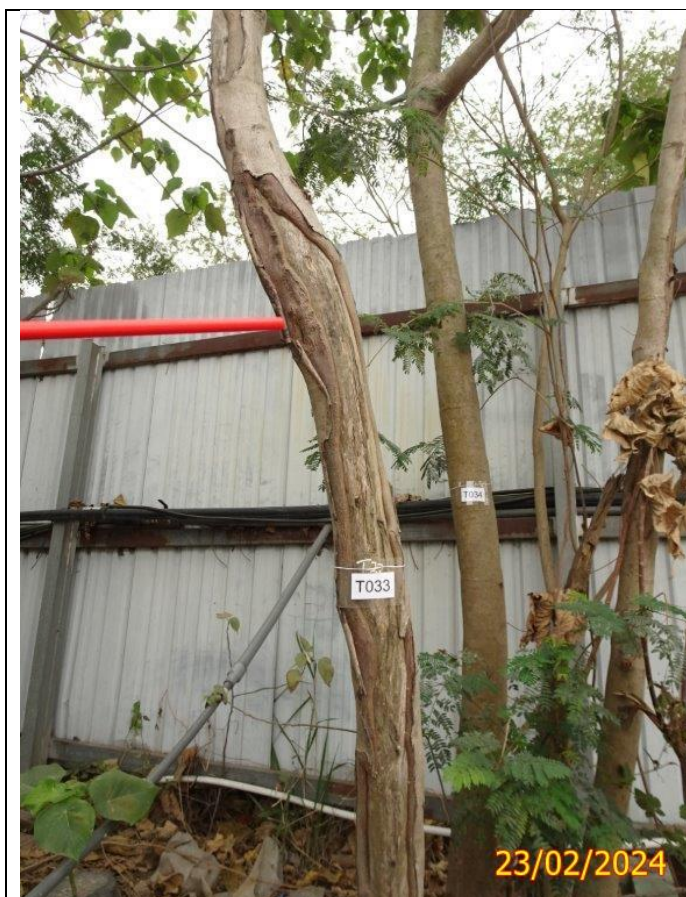
T33 | *Macaranga tanarius* var. *tomentosa* 血桐 | longitudinal bark crack on mid trunk

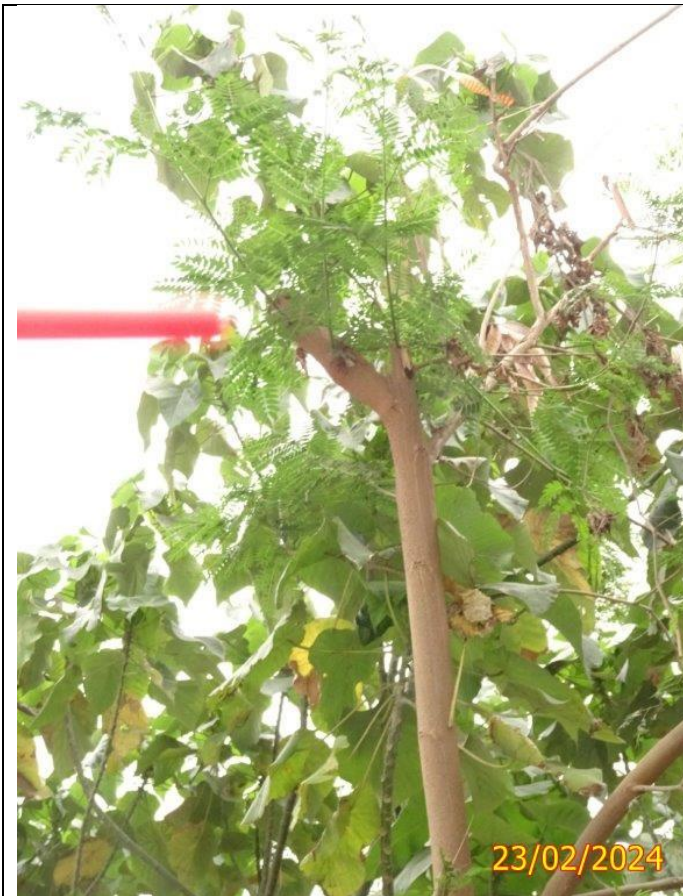
T35 | *Leucaena leucocephala* 銀合歡 | leader broken with sparse foliage

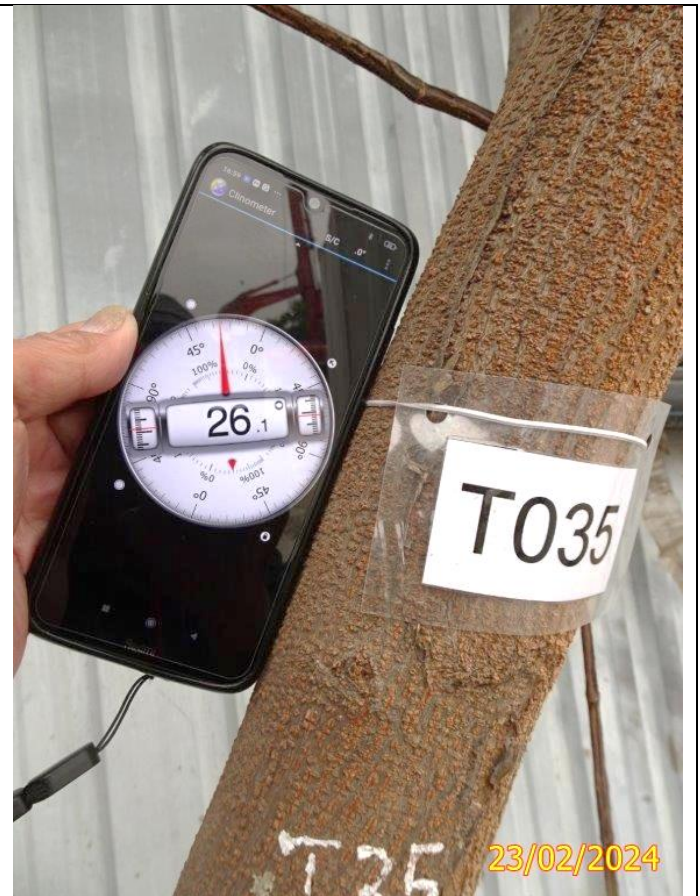
T35 | *Leucaena leucocephala* 銀合歡 | titled 26.1°

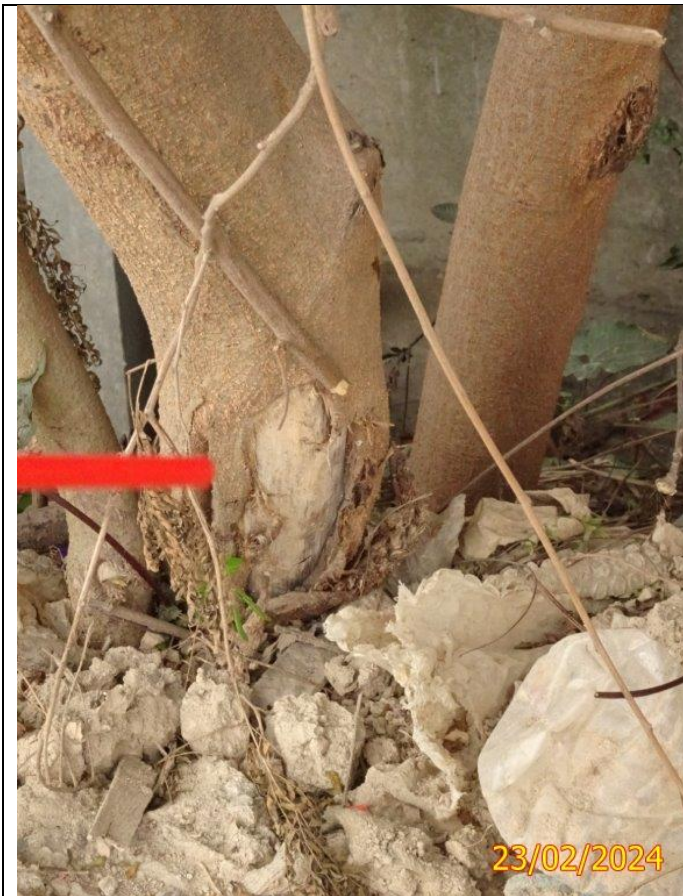
T36 | *Leucaena leucocephala* 銀合歡 | mechanical injury  
at root collar
