**SECTION 16 PLANNING APPLICATION FOR PROPOSED RESIDENTIAL
CARE HOMES FOR THE ELDERLY IN "VILLAGE TYPE DEVELOPMENT"
AT LOT NO. 76 S.G. & 76 S.H. IN D.D. 101, MAI PO, YUEN LONG**

**LANDSCAPE PROPOSAL
&
TREE TREATMENT PROPOSAL**

**PREPARED BY
STEPHEN LAI STUDIO LIMITED (S L S L)
ON BEHALF OF
GOTLAND ENTERPRISES LIMITED**

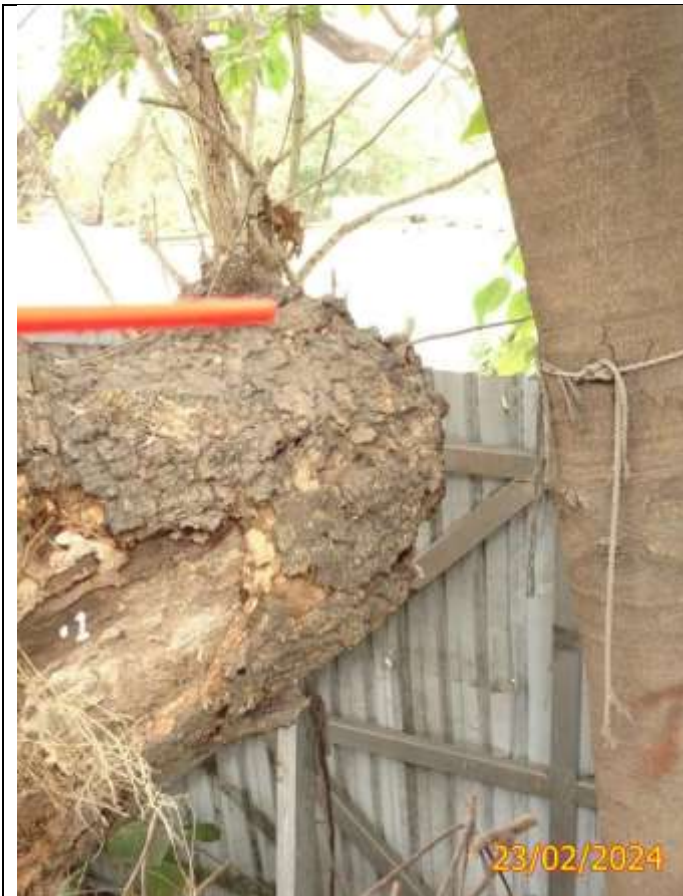
T01 | Albizia lebbeck 大葉合歡 | mechanical injury on broken branch at lower trunk

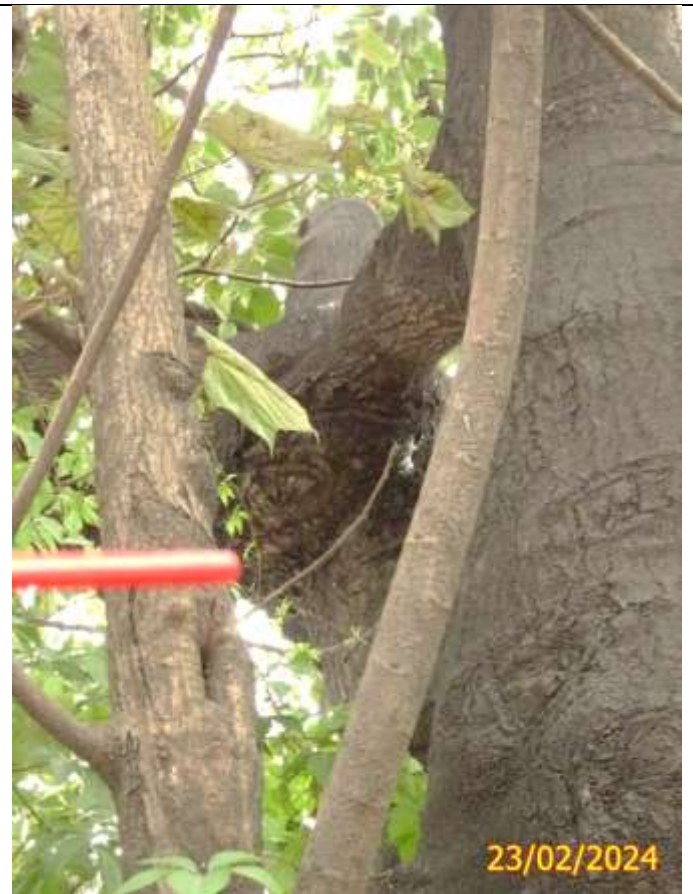
T04 | *Aleurites moluccana* 石栗 | unhealed wound on mid trunk

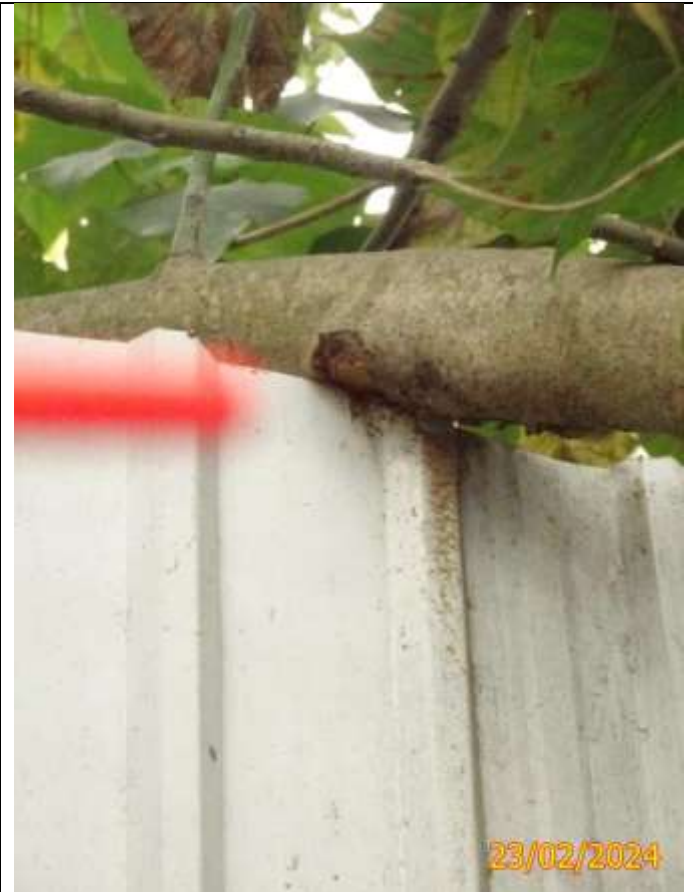
<p>T05 <i>Macaranga tanarius</i> var. <i>tomentosa</i> 血桐 mechanical injury on mid trunk</p>	<p>T05 <i>Macaranga tanarius</i> var. <i>tomentosa</i> 血桐 branch conflict with hoarding</p>

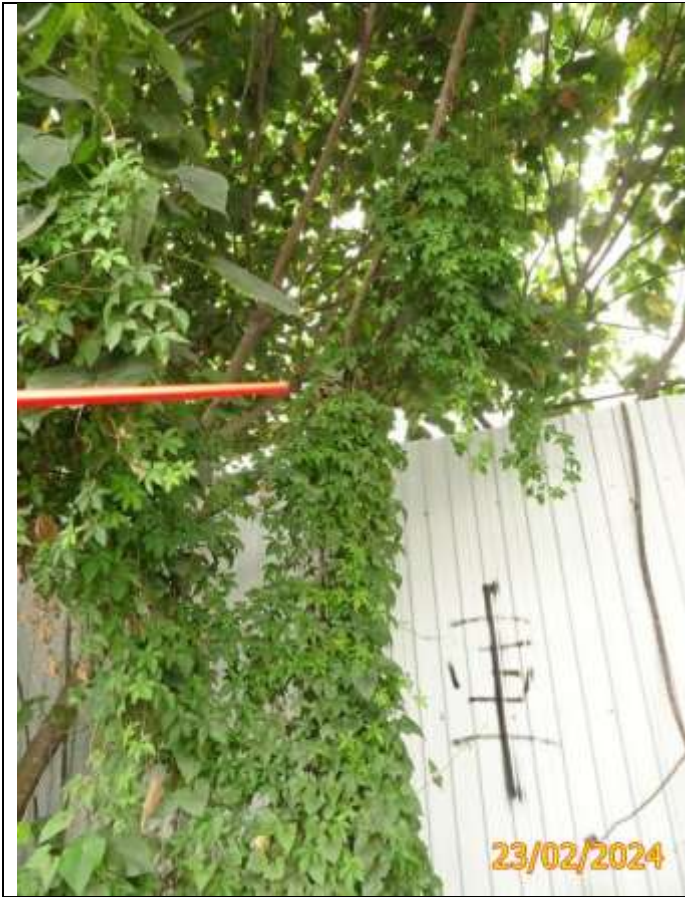
T07 | *Macaranga tanarius* var. *tomentosa* 血桐 | massive climber

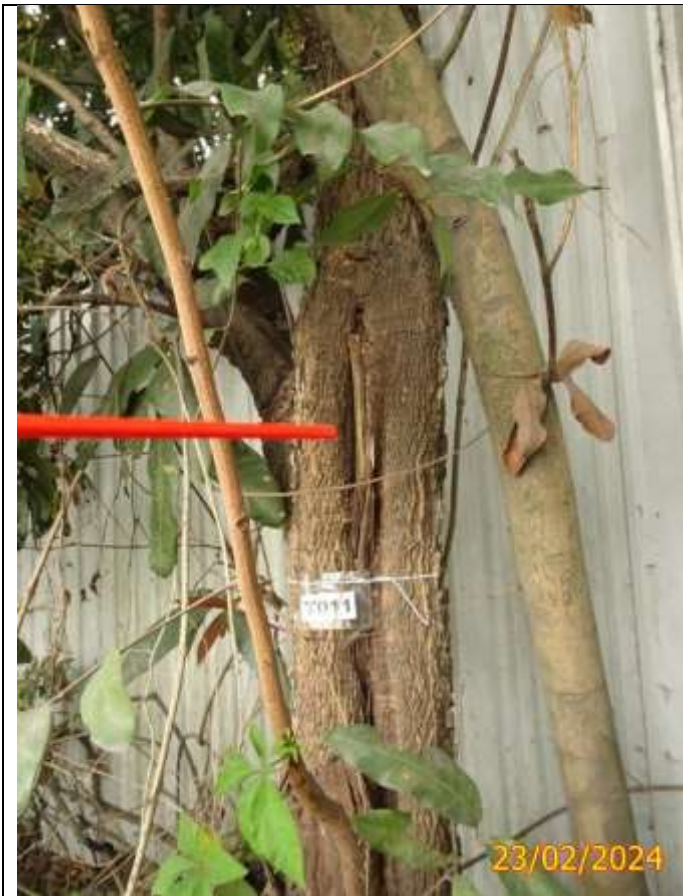
T11 | Dimocarpus longan 龍眼 | longitudinal wound on mid trunk

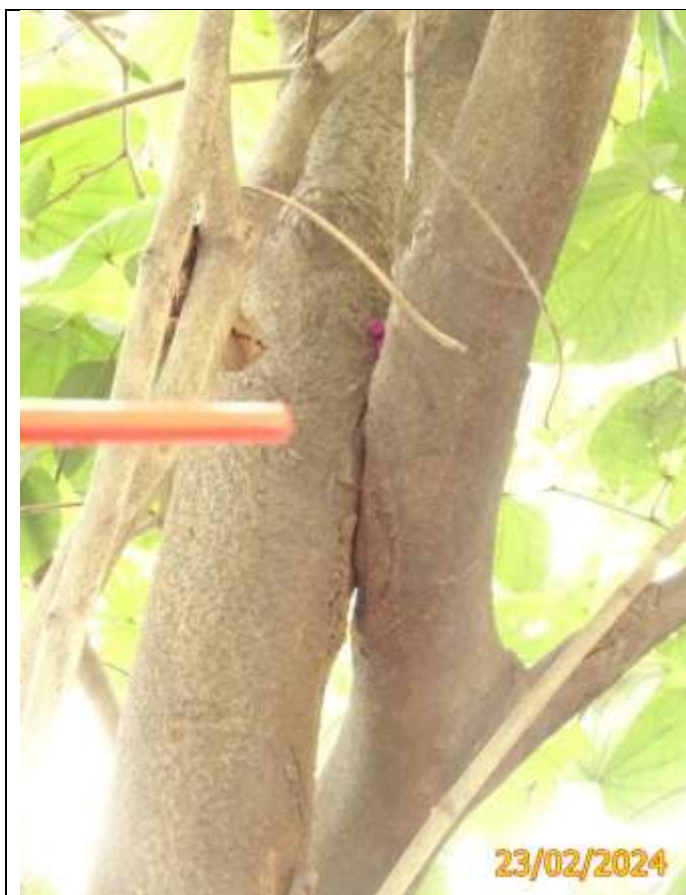
T19 | Bauhinia x blakeana 洋紫荊 | cross branches

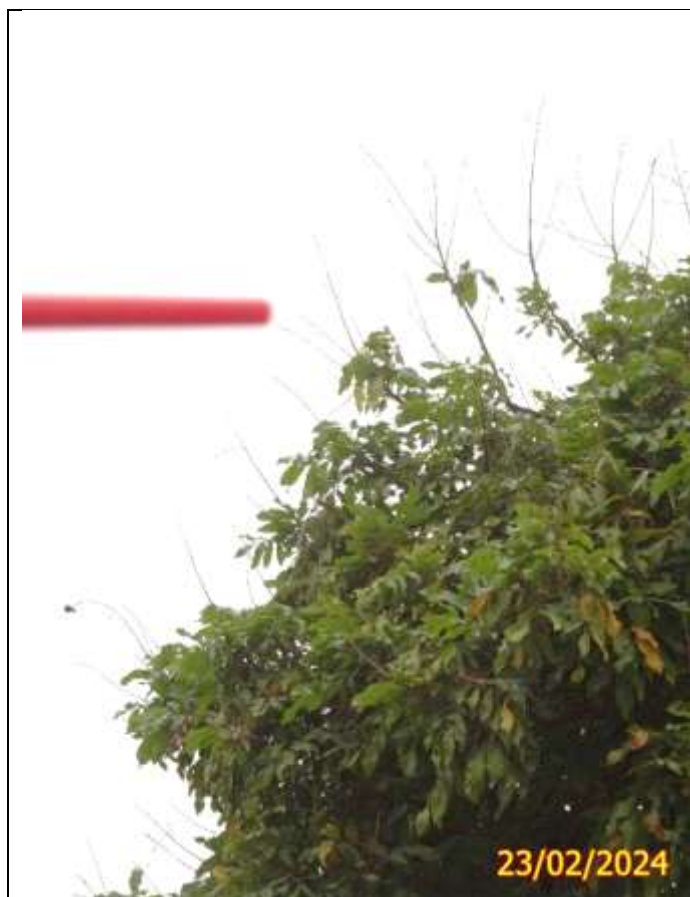
T20 | Dimocarpus longan 龍眼 | dieback twigs on upper crown

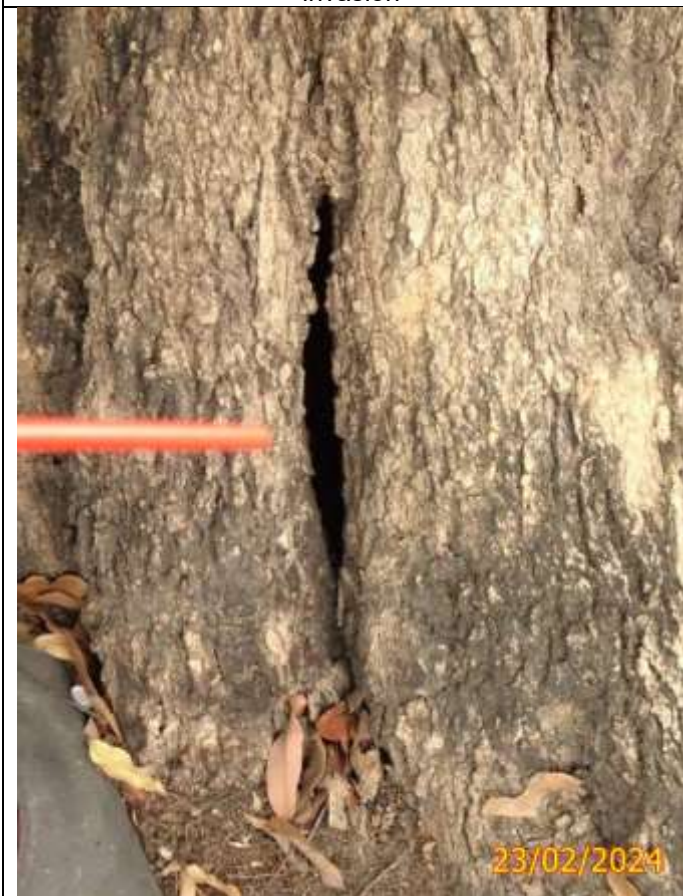
T20 | *Dimocarpus longan* 龍眼 | basal longitudinal crack

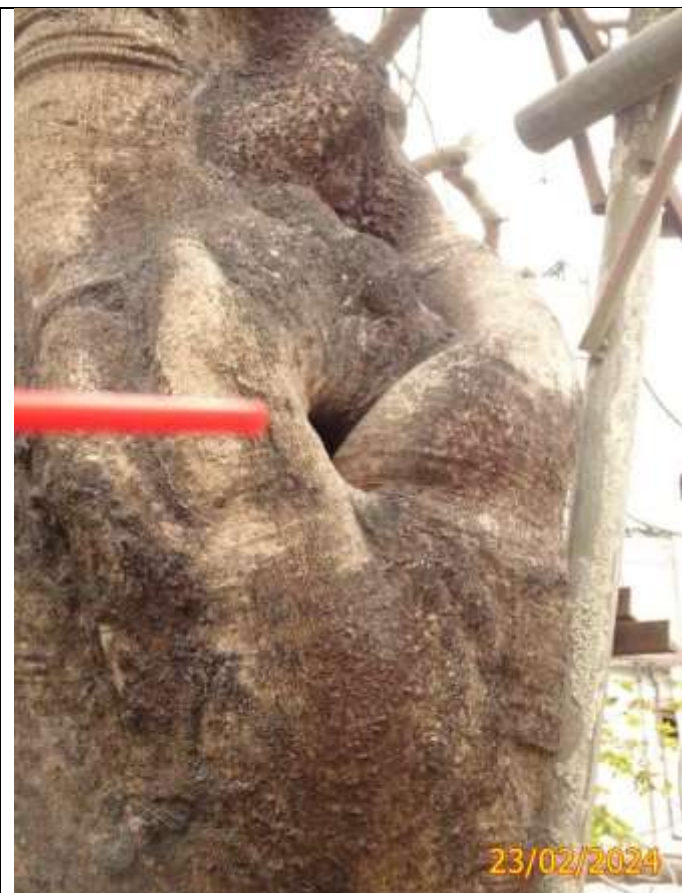
T22 | Delonix regia 鳳凰木 | small open cavity at mid trunk

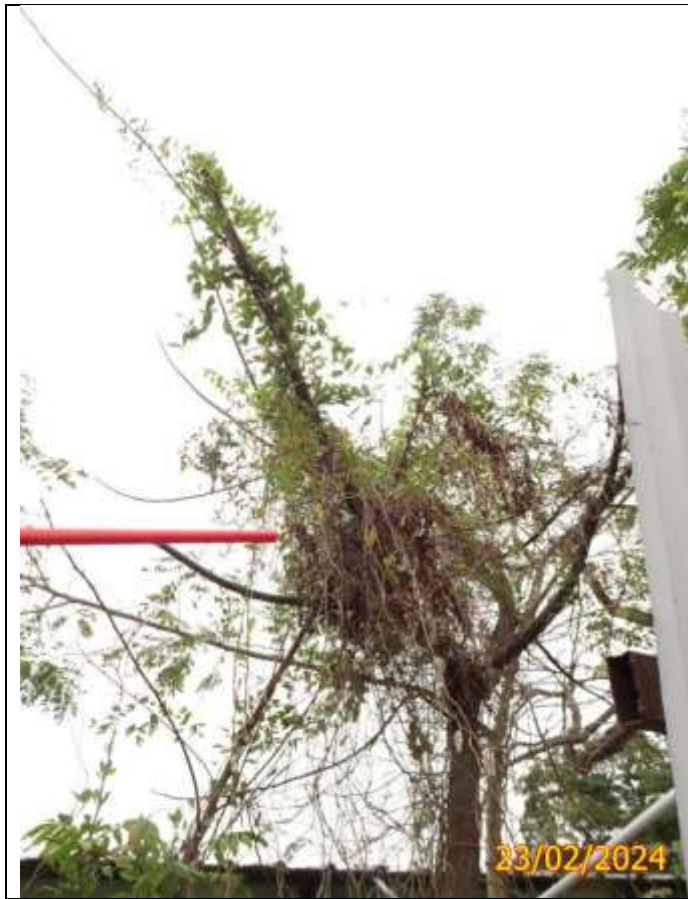
T23 | Melia azedarach 苦楝 | vine on upper crown

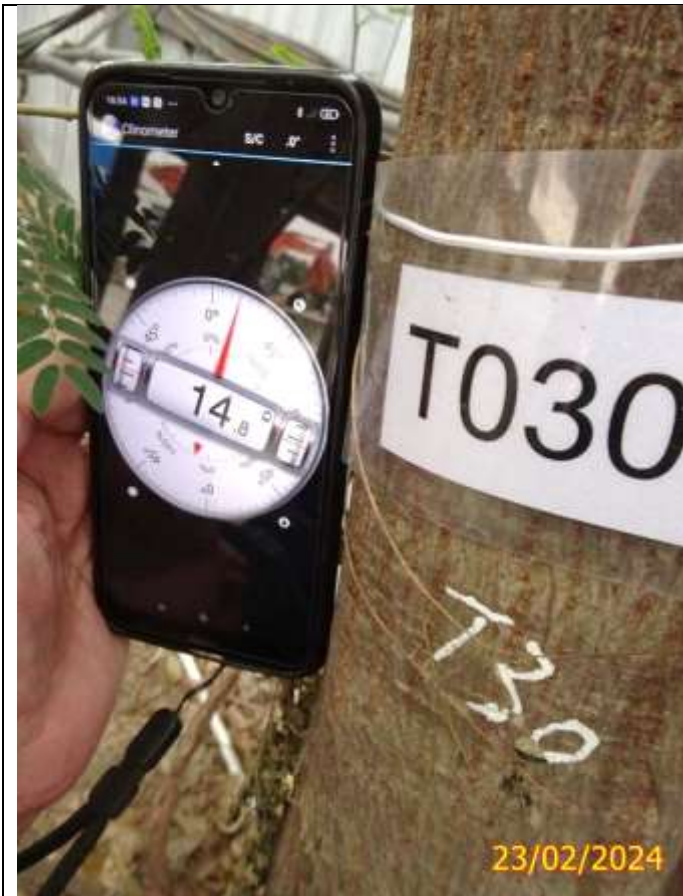
T30 | *Leucaena leucocephala* 銀合歡 | titled 14.8°

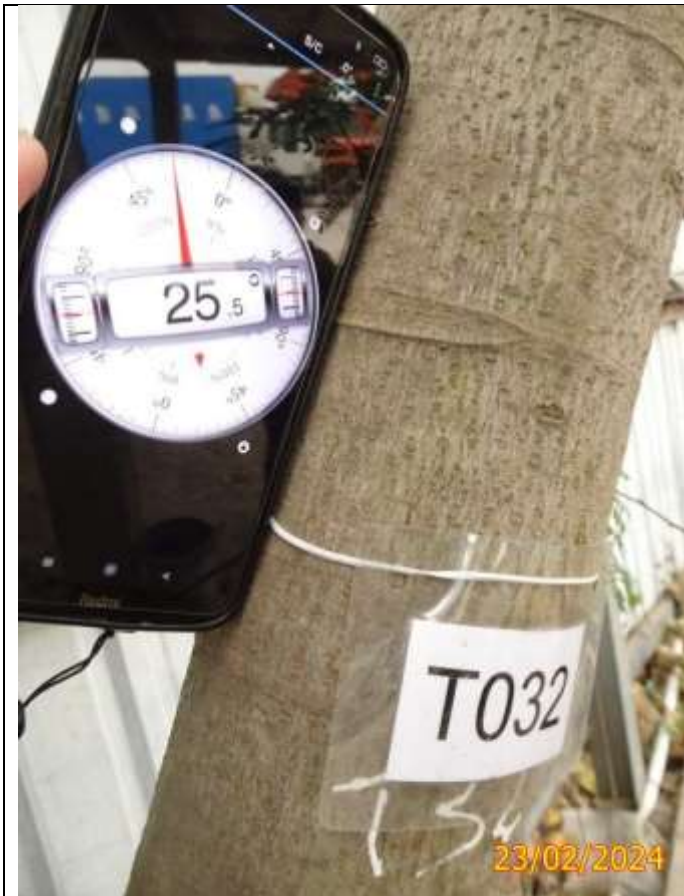
T32 | *Macaranga tanarius* var. *tomentosa* 血桐 | titled
25.5°

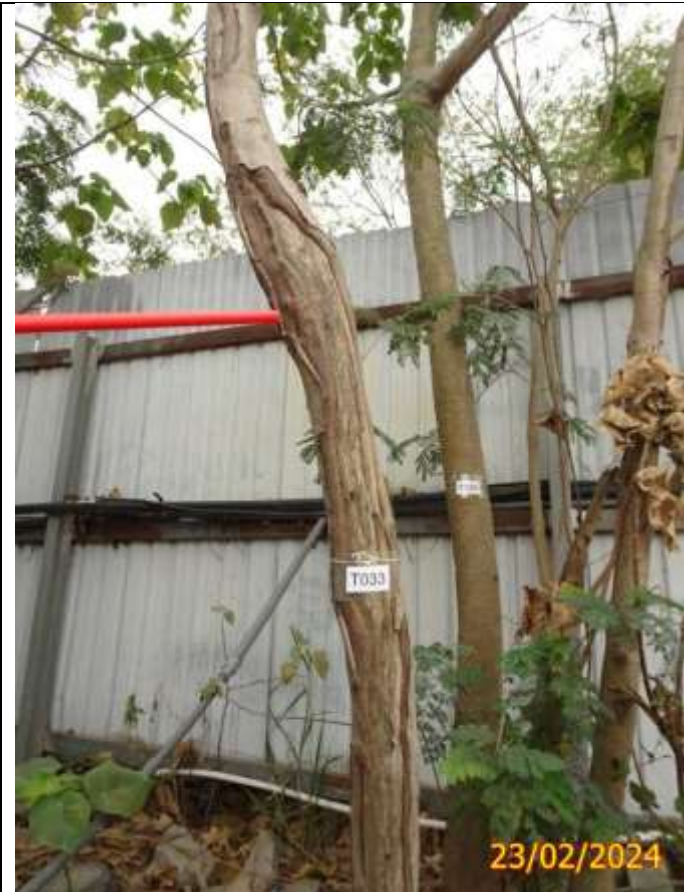
<p>T33 <i>Macaranga tanarius</i> var. <i>tomentosa</i> 血桐 longitudinal bark crack on mid trunk</p>	<p>T33 <i>Macaranga tanarius</i> var. <i>tomentosa</i> 血桐 longitudinal bark crack at lower trunk</p>

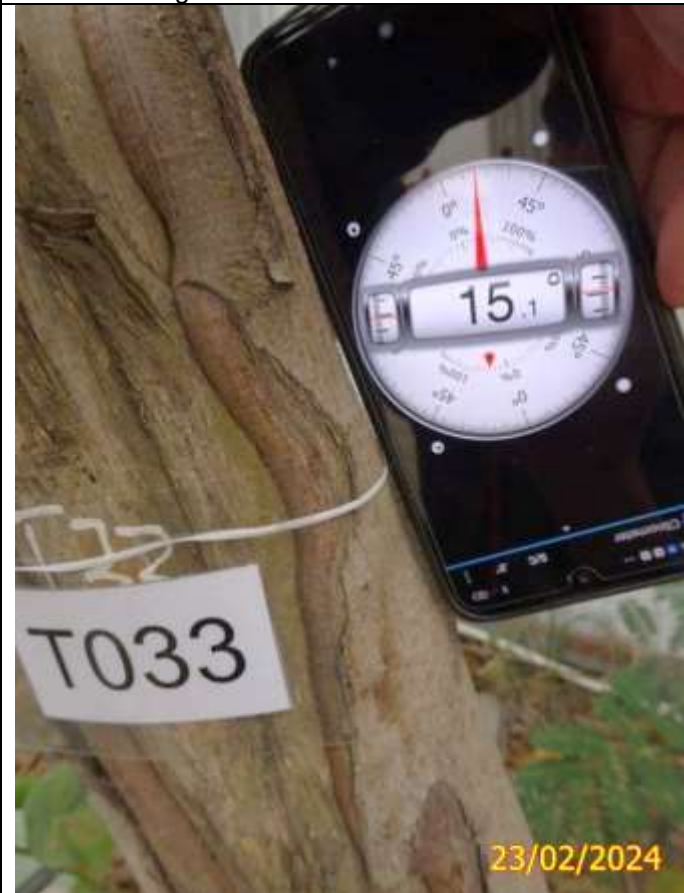
<p>No Photo</p>
<p>T33 <i>Macaranga tanarius</i> var. <i>tomentosa</i> 血桐 titled 15.1°</p>

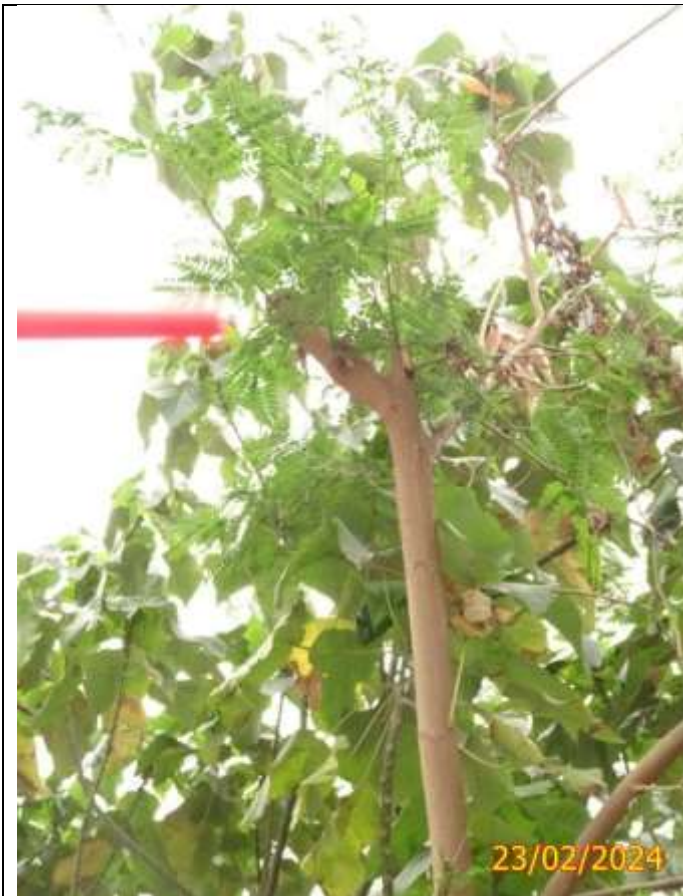
T35 | *Leucaena leucocephala* 銀合歡 | leader broken with sparse foliage

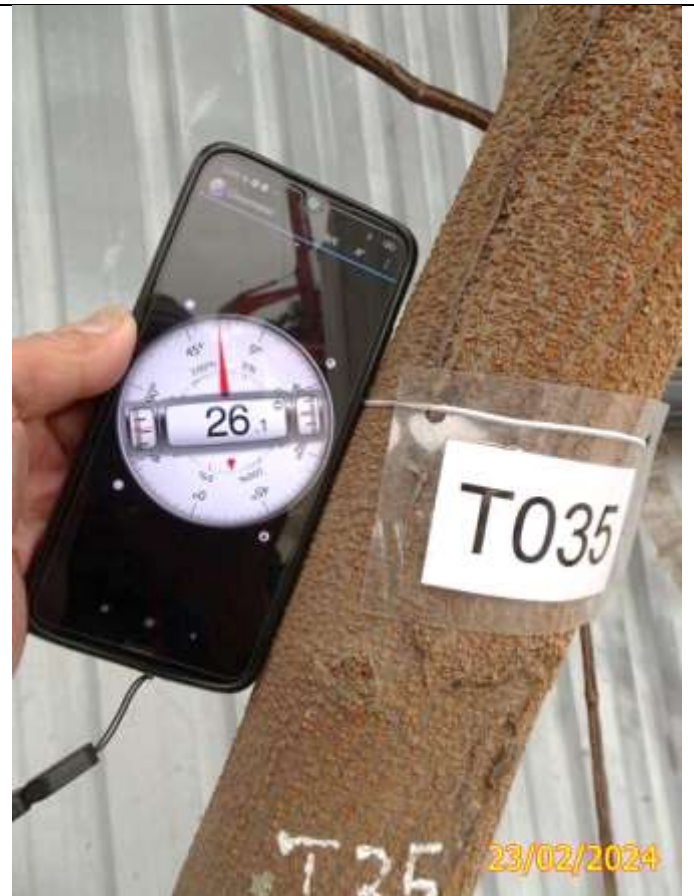
T35 | *Leucaena leucocephala* 銀合歡 | tilted 26.1°

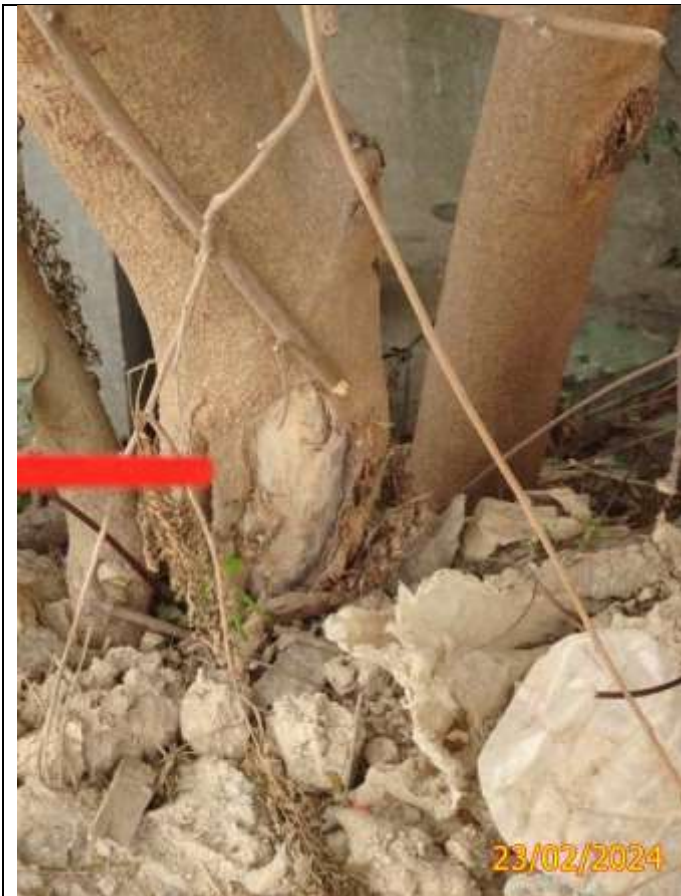
T36 | *Leucaena leucocephala* 銀合歡 | mechanical injury
at root collar

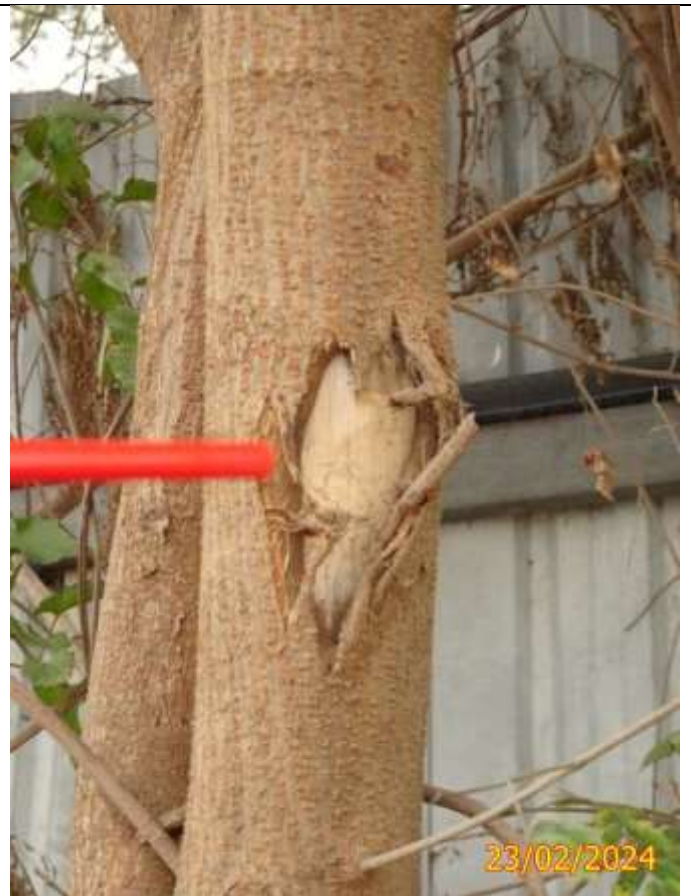
T36 | *Leucaena leucocephala* 銀合歡 | mechanical injury
at mid trunk
