# Planning Application No. A/YL-TYST/1327

Project: Proposed Ancestral Hall at Lot No. 1829 S.A. SS.2 R.P. in D.D. 121, Hung Shui Kiu

Geotechnical Planning Review Report
for the Proposed Ancestral Hall
at Lot No. 1829 SA ss.2 R.P.
in D.D. 121, Hung Shui Kiu,
Yuen Long,
New Territories

October 2025

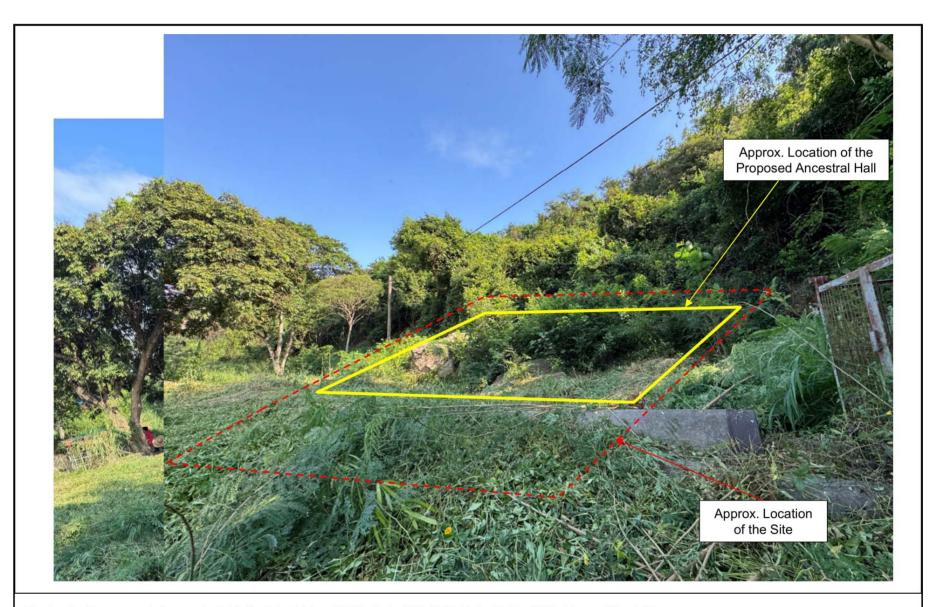
Plate 1

Title: Overview of the Site

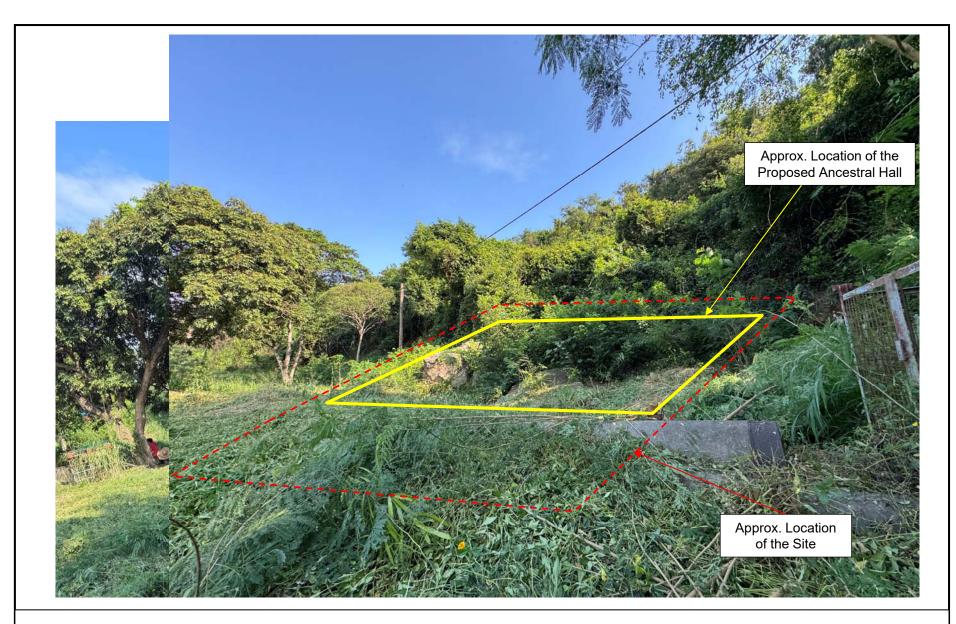
The Site, where the proposed Ancestor Hall is to be constructed, is located on a generally flat area located at the toe of a natural hillside (Figure 1 and Plate 1). According to Table 2.2 of the GEO Report No. 138 2<sup>nd</sup> Edition (GEO, 2016), the proposed ancestral building is classified as Group 2(a).

Title : Overview of the Site

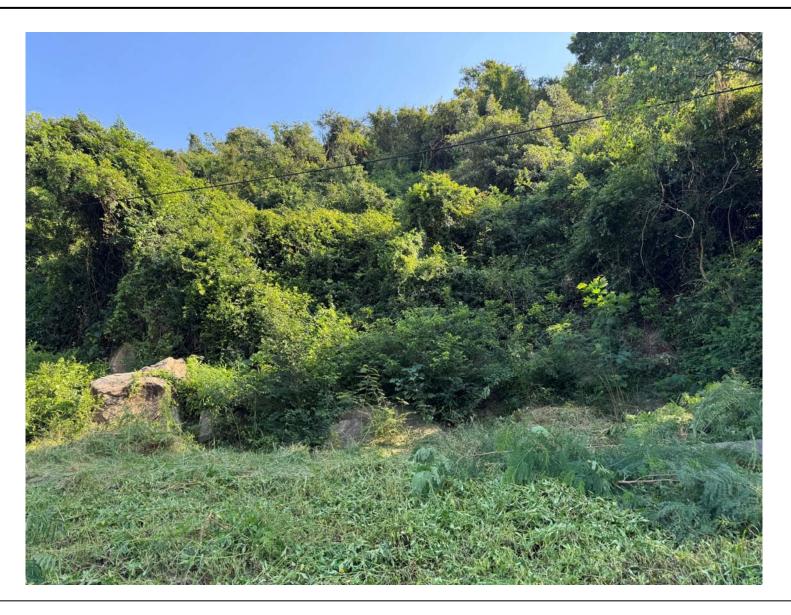
The site is currently covered by dense vegetation. There is no registered slope or retaining wall present within the Site. Site photographs taken on the site are presented in Plate 2 to 3. A natural hillside located to the south is overlooking the proposed development area (Plate 4 and 5). A grave is located about 13m to the west of the site (Plate 6). The location of the lot boundary is shown in Figure 2. The potential natural terrain affected to the proposed site and the registered man-made Feature are shown in Figure 3 and 4 respectively.

Title: Closer View on the Southeastern Portion of the Site

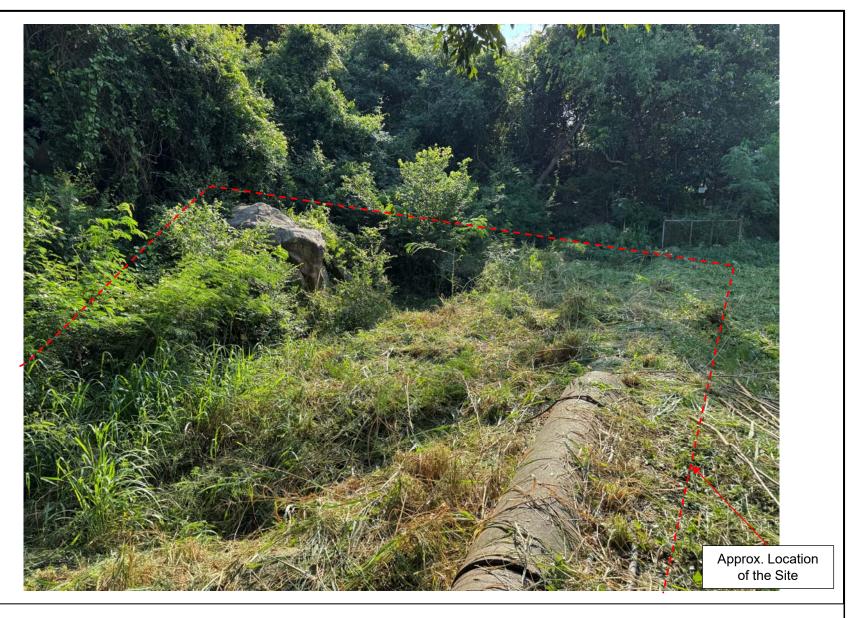
Plate 3

Title: Overview of the Western Side of the Site

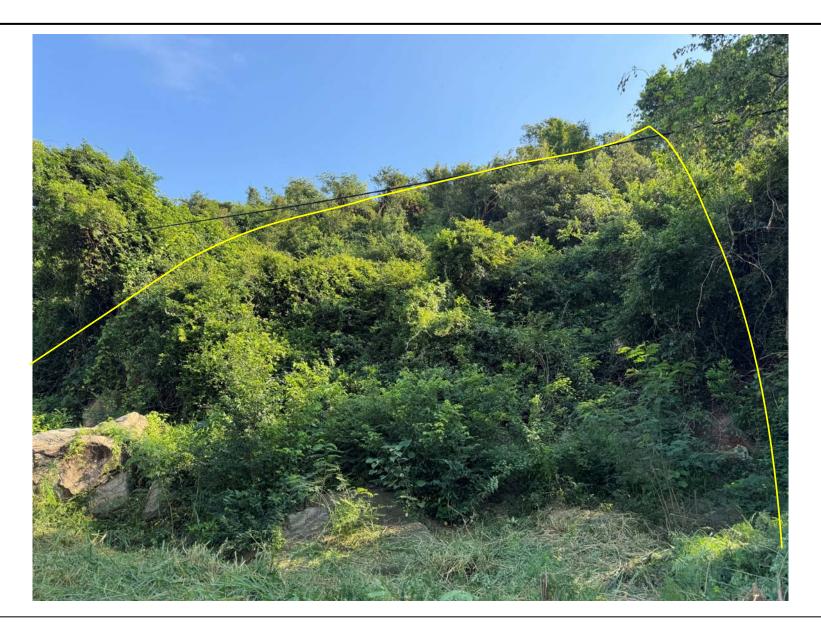
The angular elevation from the top of the natural terrain to the nearest boundary of proposed ancestral house is about 34° and within 50m of ground sloping at >15°. Therefore the proposed development Site does not satisfy the "In-principle Object ion Criteria" but it satisfied the "Alert Criteria" which means further study of the natural terrain hazards posing to the development is required.

Title: Overview of the Natural Hillside Overlooking the Site

geotechnical feasible. In addition, the Natural Terrain Hazard Assessment on the hillside overlooking the proposed ancestral hall discussed in this report will be prepared and provided in separate submission.

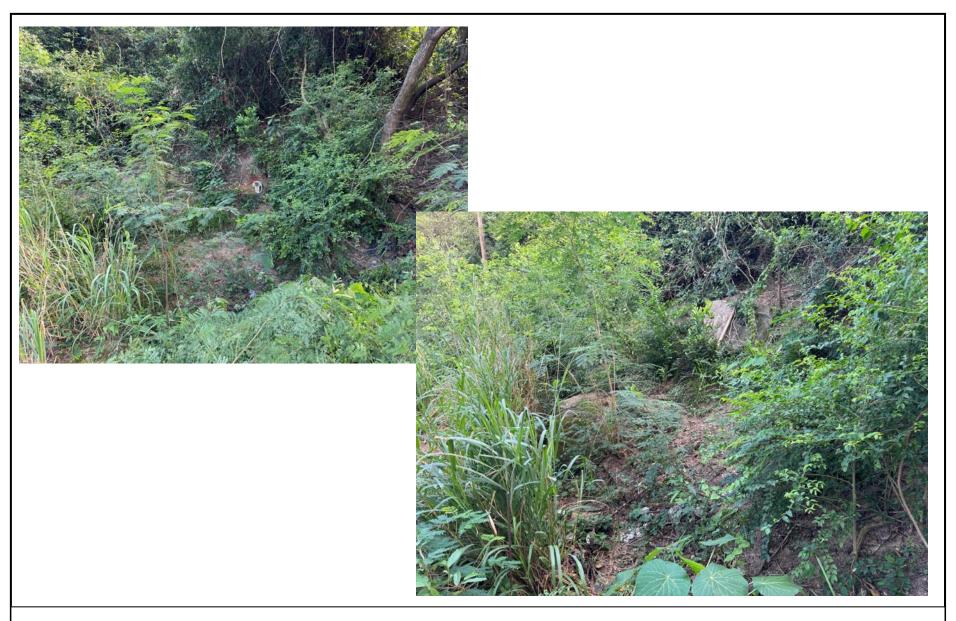
Plate 5

Title: Toe of the Natural Hillside Behind the Site

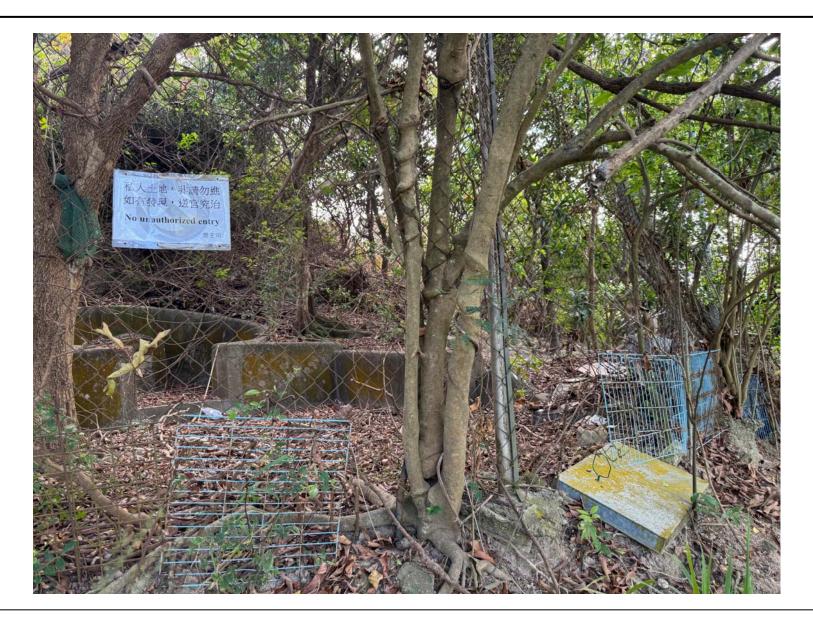
Title: Existing Grave Located to the West of the Site
