Proposed Development at various Lots in D.D.41 Sha Tau Kok, New Territories

GEOTECHNICAL PLANNING REVIEW REPORT

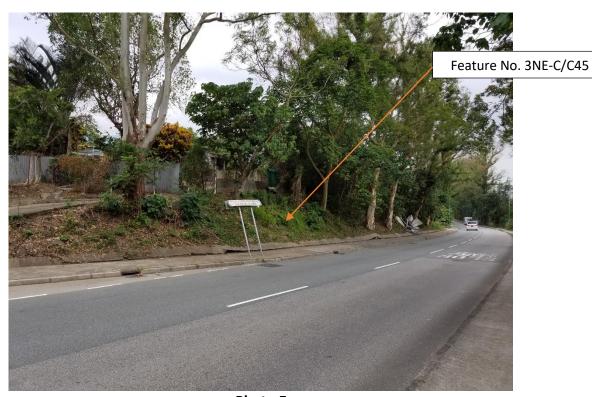
Photo EGeneral View of the Southern Portion of Feature No. 3NE-C/C45, Looking North

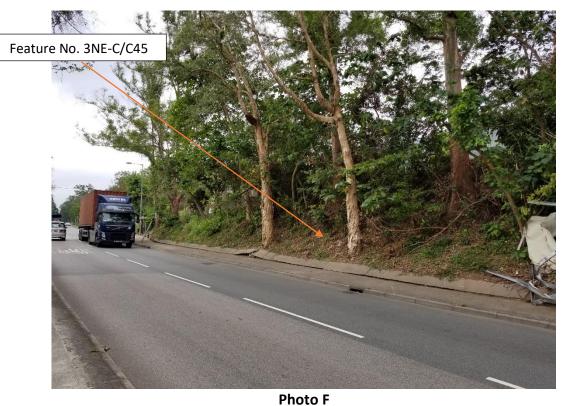
General View of the Northern Portion of Feature No. 3NE-C/C45, Looking West
