Appendix 5 – Geotechnical Planning Review

S12A Rezoning Application for Ching To Yuen, at Lot Nos. 374, 375 S.A and 375 S.B in D.D. 186, To Fung Shan, Sha Tin

Prepared for: Ching To Yeun Limited
25 September 2025

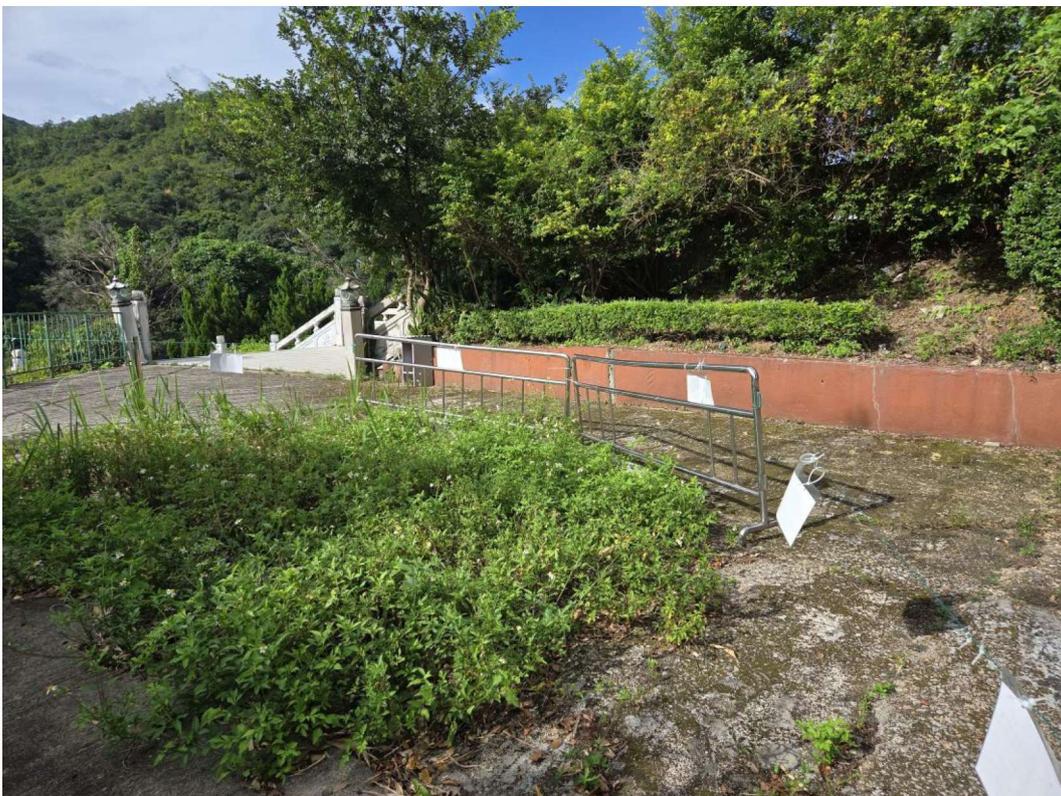
Plate 6 Evidence of ground subsidence at the mid-level platform (facing north-east)

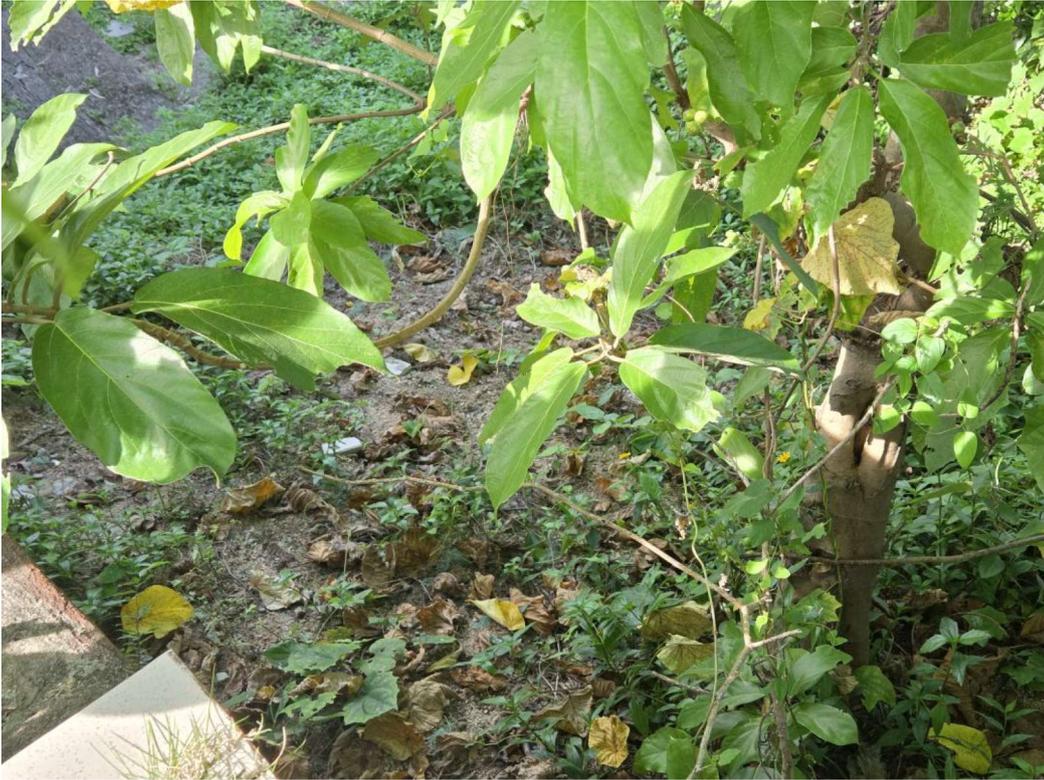
Plate 11

Minor slope failure at lower middle portion of Unregistered Slope 1
(facing south-east)

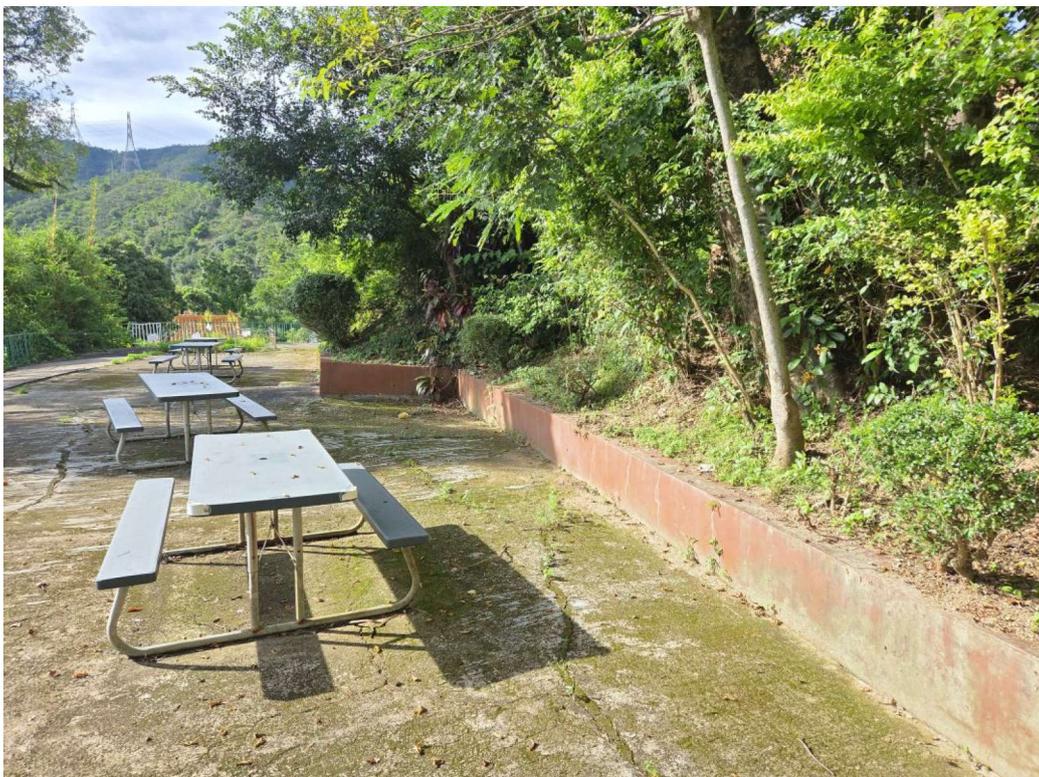
Plate 14

<p>Unregistered Slope 2 (Plate 14 to 15)</p>	<p>This non-registered feature is a south-west facing slope, situated between the upper and mid-level platforms. It is a fill slope approximately 2m high, 35m long, inclining at 30° to 40°. The surface is generally densely covered with vegetation in the forms of bushes and trees. An approx. 0.3m thick planter wall of 0.6m max. height was evident along its toe. No significant signs of distress or instability were evident along the slope during the site inspection, however severe cracks were observed at several locations on the planter wall along the toe.</p>

General view of south-eastern portion of Unregistered Slope 2

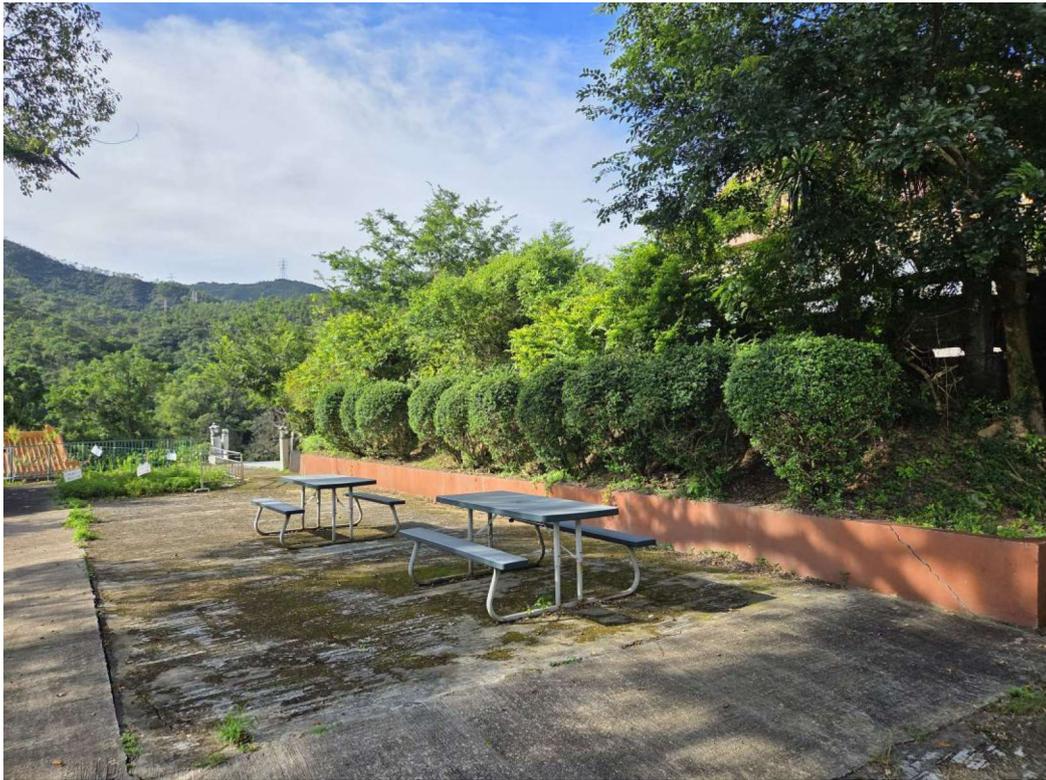
Plate 15

General view of north-western portion of Unregistered Slope 2

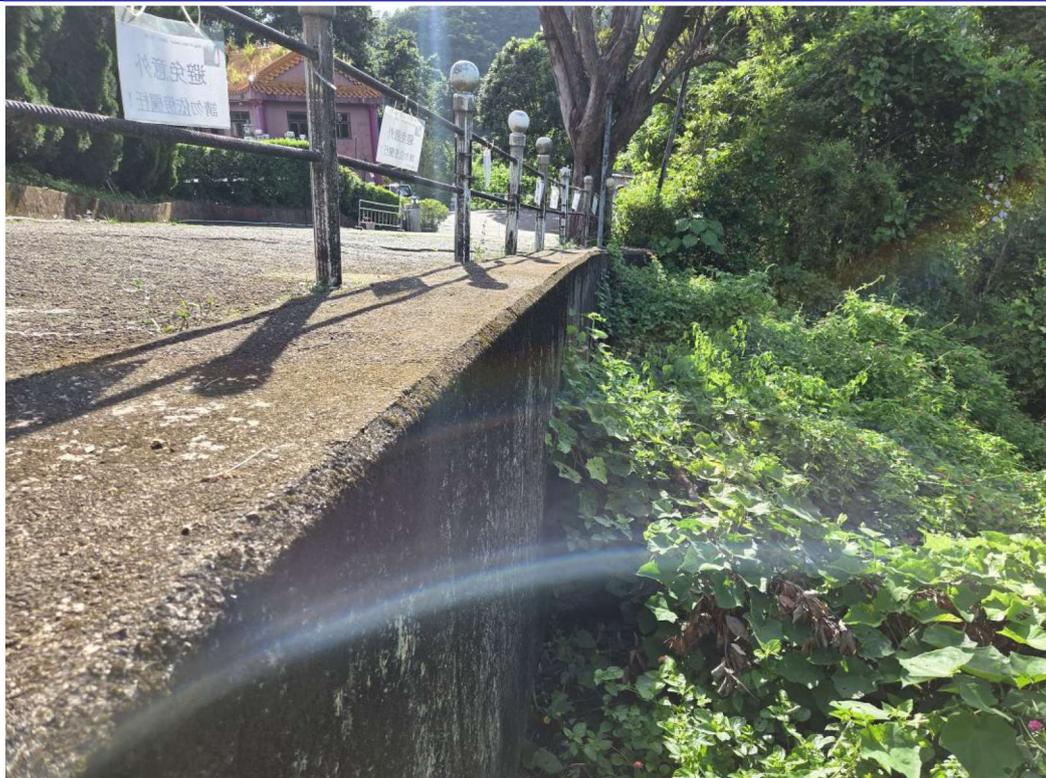
Plate 16

General view of Unregistered Retaining Wall

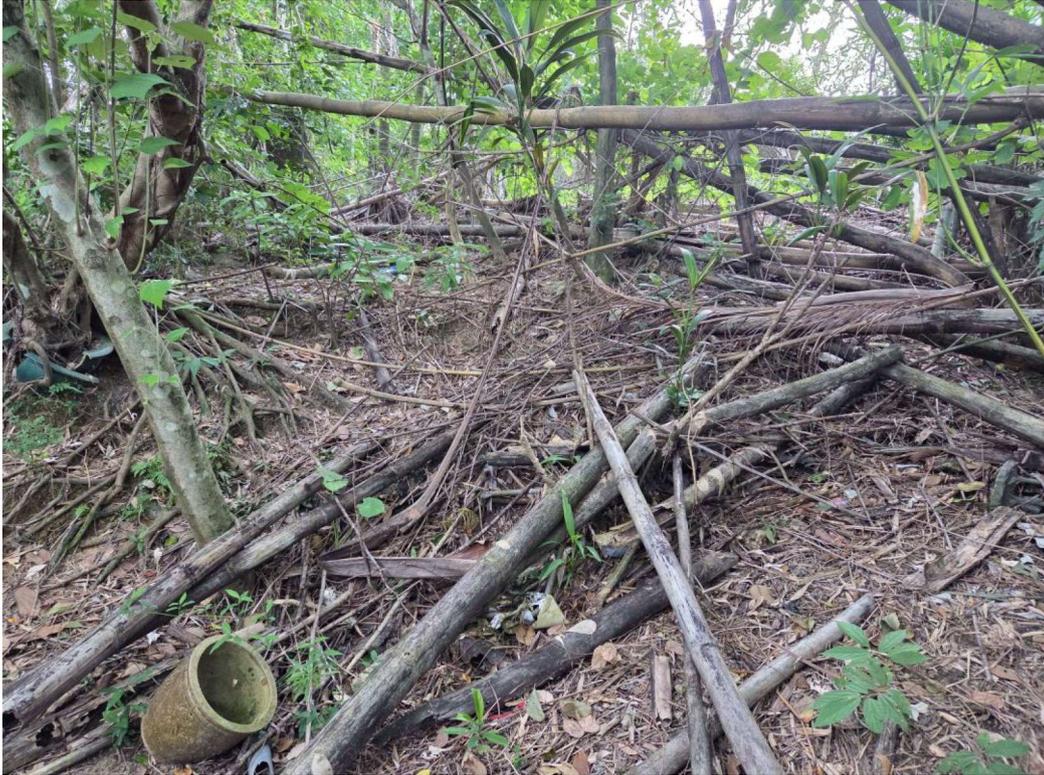
Plate 23

Existing Features	General Descriptions
Unregistered Slope 3 (Plate 23 to 25)	This unregistered feature consists of some abandoned agricultural terraces, which are currently covered with dense vegetation. This man-made feature, which was probably formed prior to 1963 and abandoned in the 1970s, is approximately 120 m long and 4 m high, sloping at a gentle angle of 30°. It is situated directly downhill of the platform, encircling the Site from the southwestern to the eastern sides and it can be accessed via the platform from the crest. The general condition of the terrain was considered satisfactory without signs of distress or instability during site inspection.
Unregistered Retaining Wall (Plate 16)	It is a north facing retaining wall. The wall which is located on the downhill side of the driveway is approximately 2m high and 40m long. Since there is no adequate access to the retaining wall, the inspection was carried out at a vantage point at the crest. There is no weephole or surface channel on retaining wall. During inspection, there is no significant sign of distress or seepage evident at the wall.

General view of north-eastern portion of Unregistered Slope 3
(facing south-east)

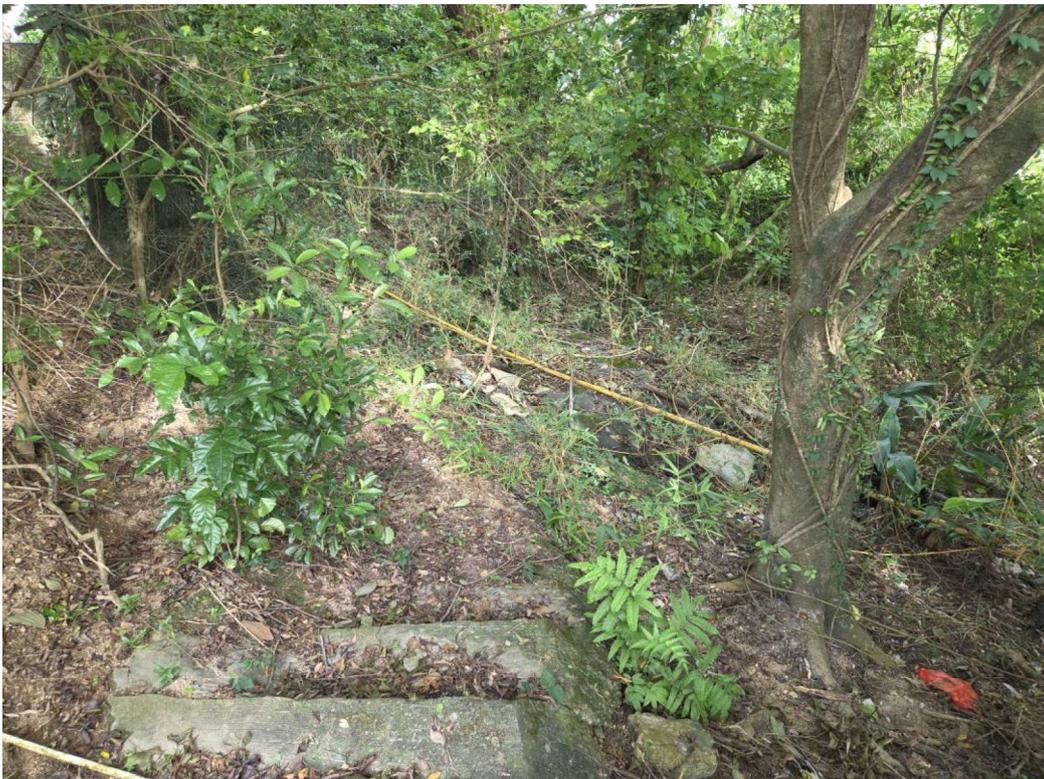
Plate 24

General view of south-eastern portion of Unregistered Slope 3
(facing south-east)

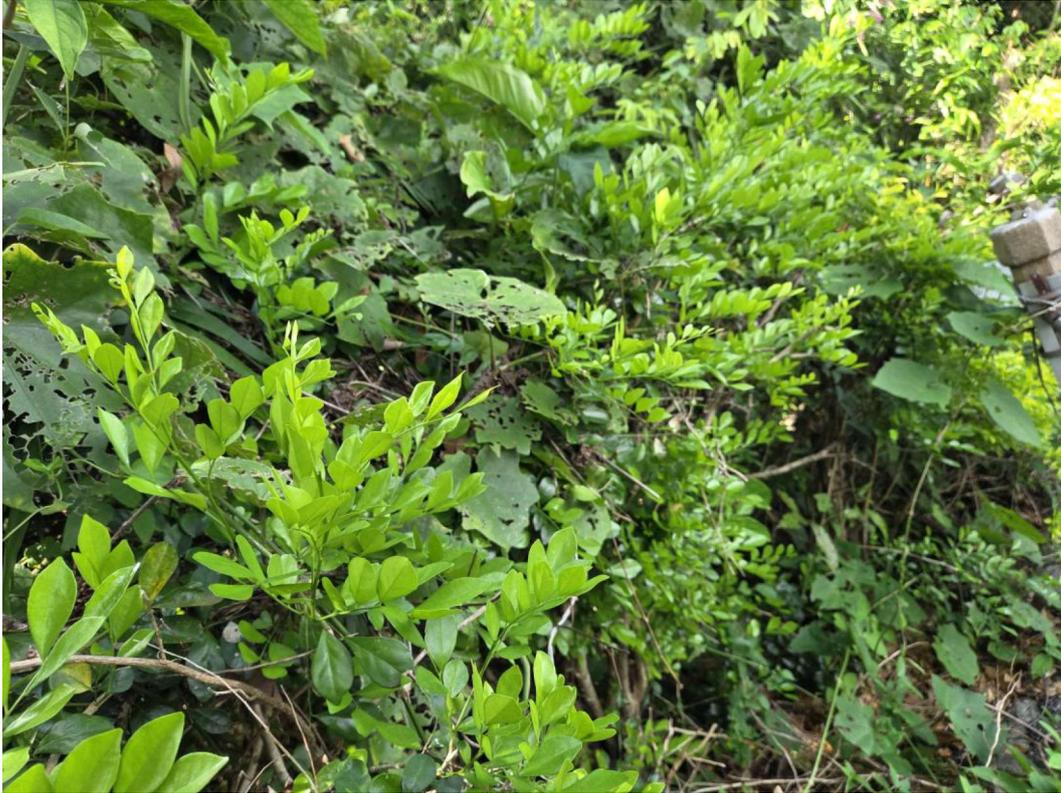
Plate 25

General view of Unregistered Slope 3 below the mid-level platform
(facing north-west)
