Planning Application No. A/YL-TYST/1327

Geotechnical Planning Review Report
for the Proposed Ancestral Hall
at Lot No. 1829 SA ss.2 R.P.
in D.D. 121, Hung Shui Kiu,
Yuen Long,
New Territories

臻亞工程有限公司
Jenya Asia Engineering Limited

October 2025

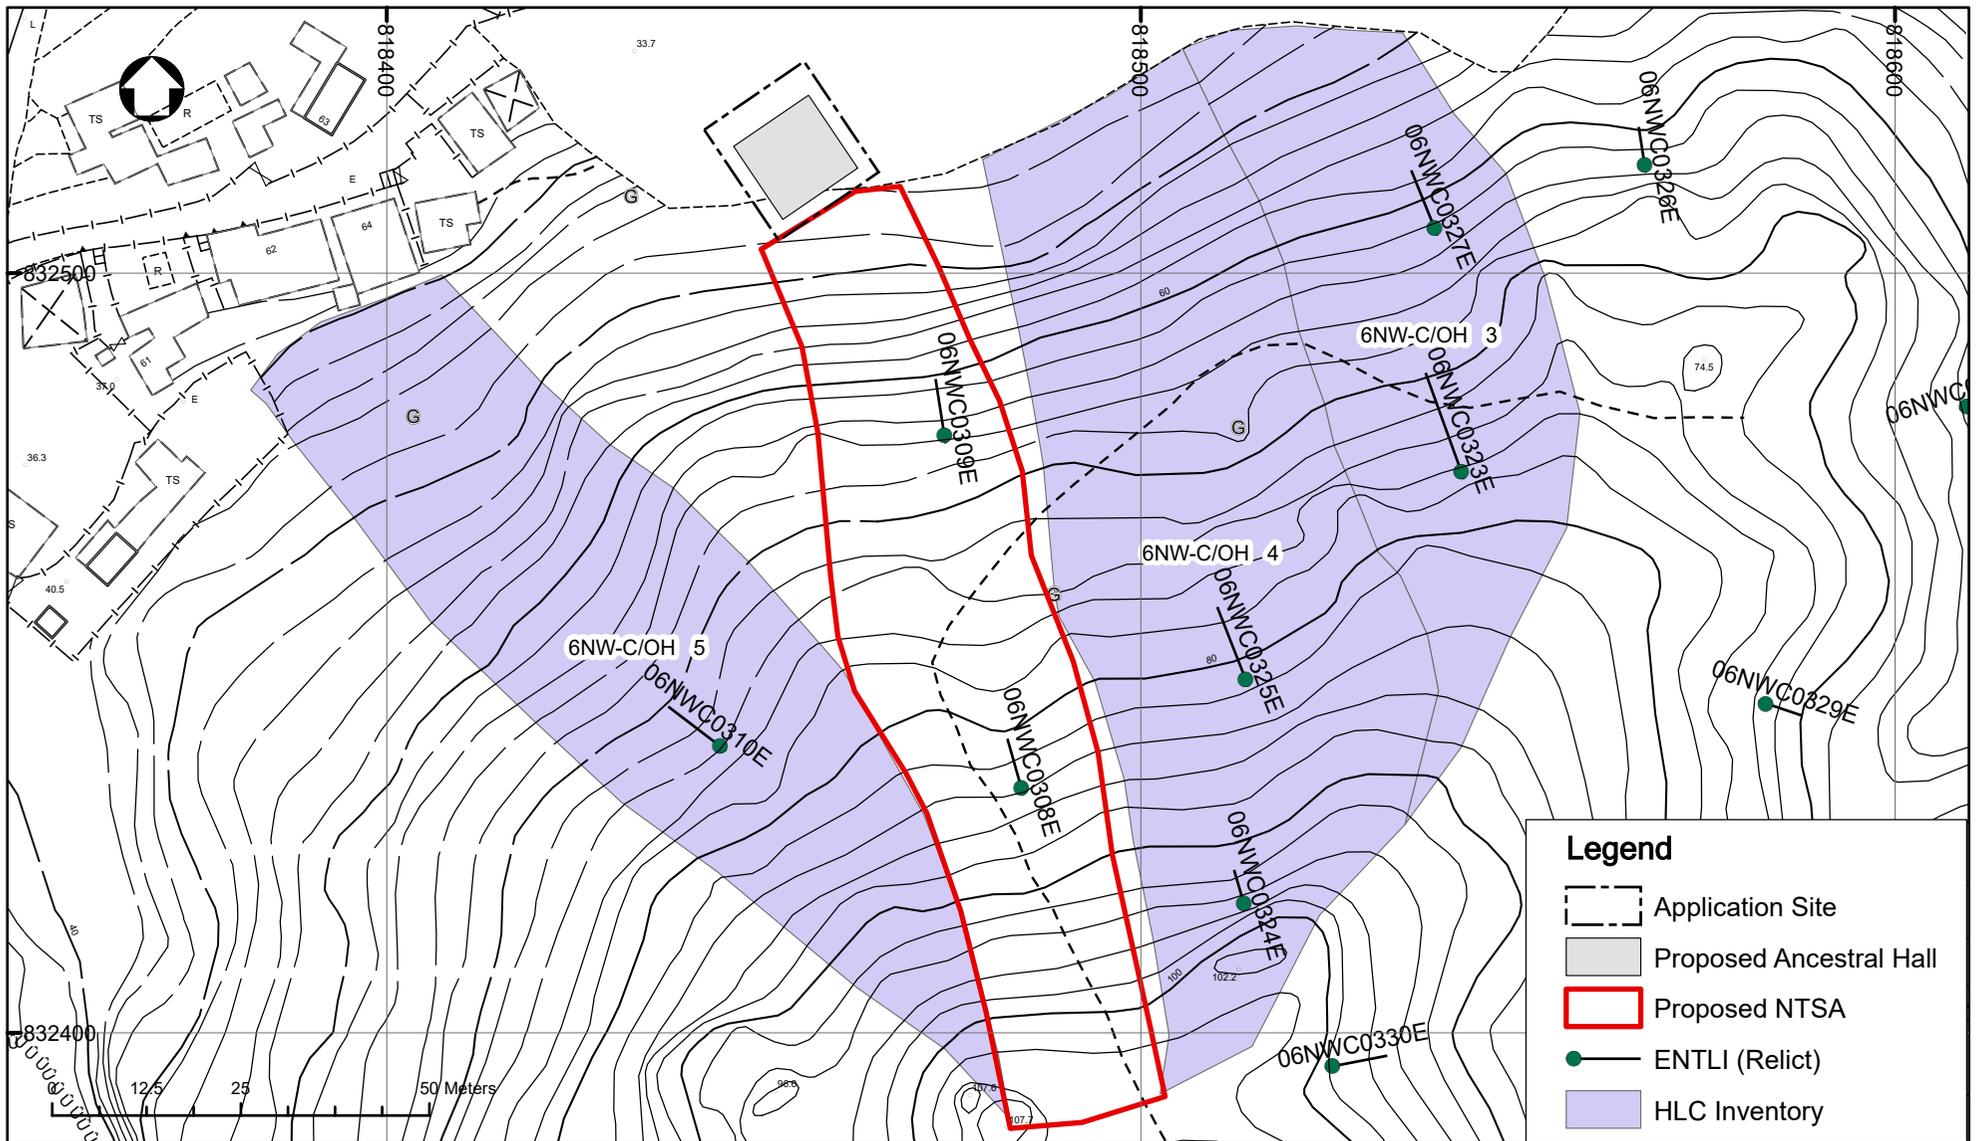
FIGURE 3

A ENTLI features (06NWC0308E and 06NWC0309E) have been recorded within the proposed Natural Terrain Study Area (NTSA). These two ENTLI features are recorded as Class B1 and Class B2 features respectively. Another five relict open hillside landslides (06NWC0310E, 06NWC323E m 06NWC324E, 06NWC325E and 06NWC0327E) were recorded further to the wet and east of the NTSA. These 5 relict landslides are classified as Class C2 features. Details of these ENTLIs are summarised in Table 3.1 and their approximate locations are shown in Figure 3.

Historical Landslide Catchments (HLCs) have been defined by GEO based on the results of the ENTLI. No HLC has been defined within the NTSA. 3 HLCs (6NW-C/OH3, 6NW-C/OH4 and 6NW-C/OH5) have been defined on the hillsides to the west and east of the proposed NTSA. Location of the HLC is shown on Figure 3.

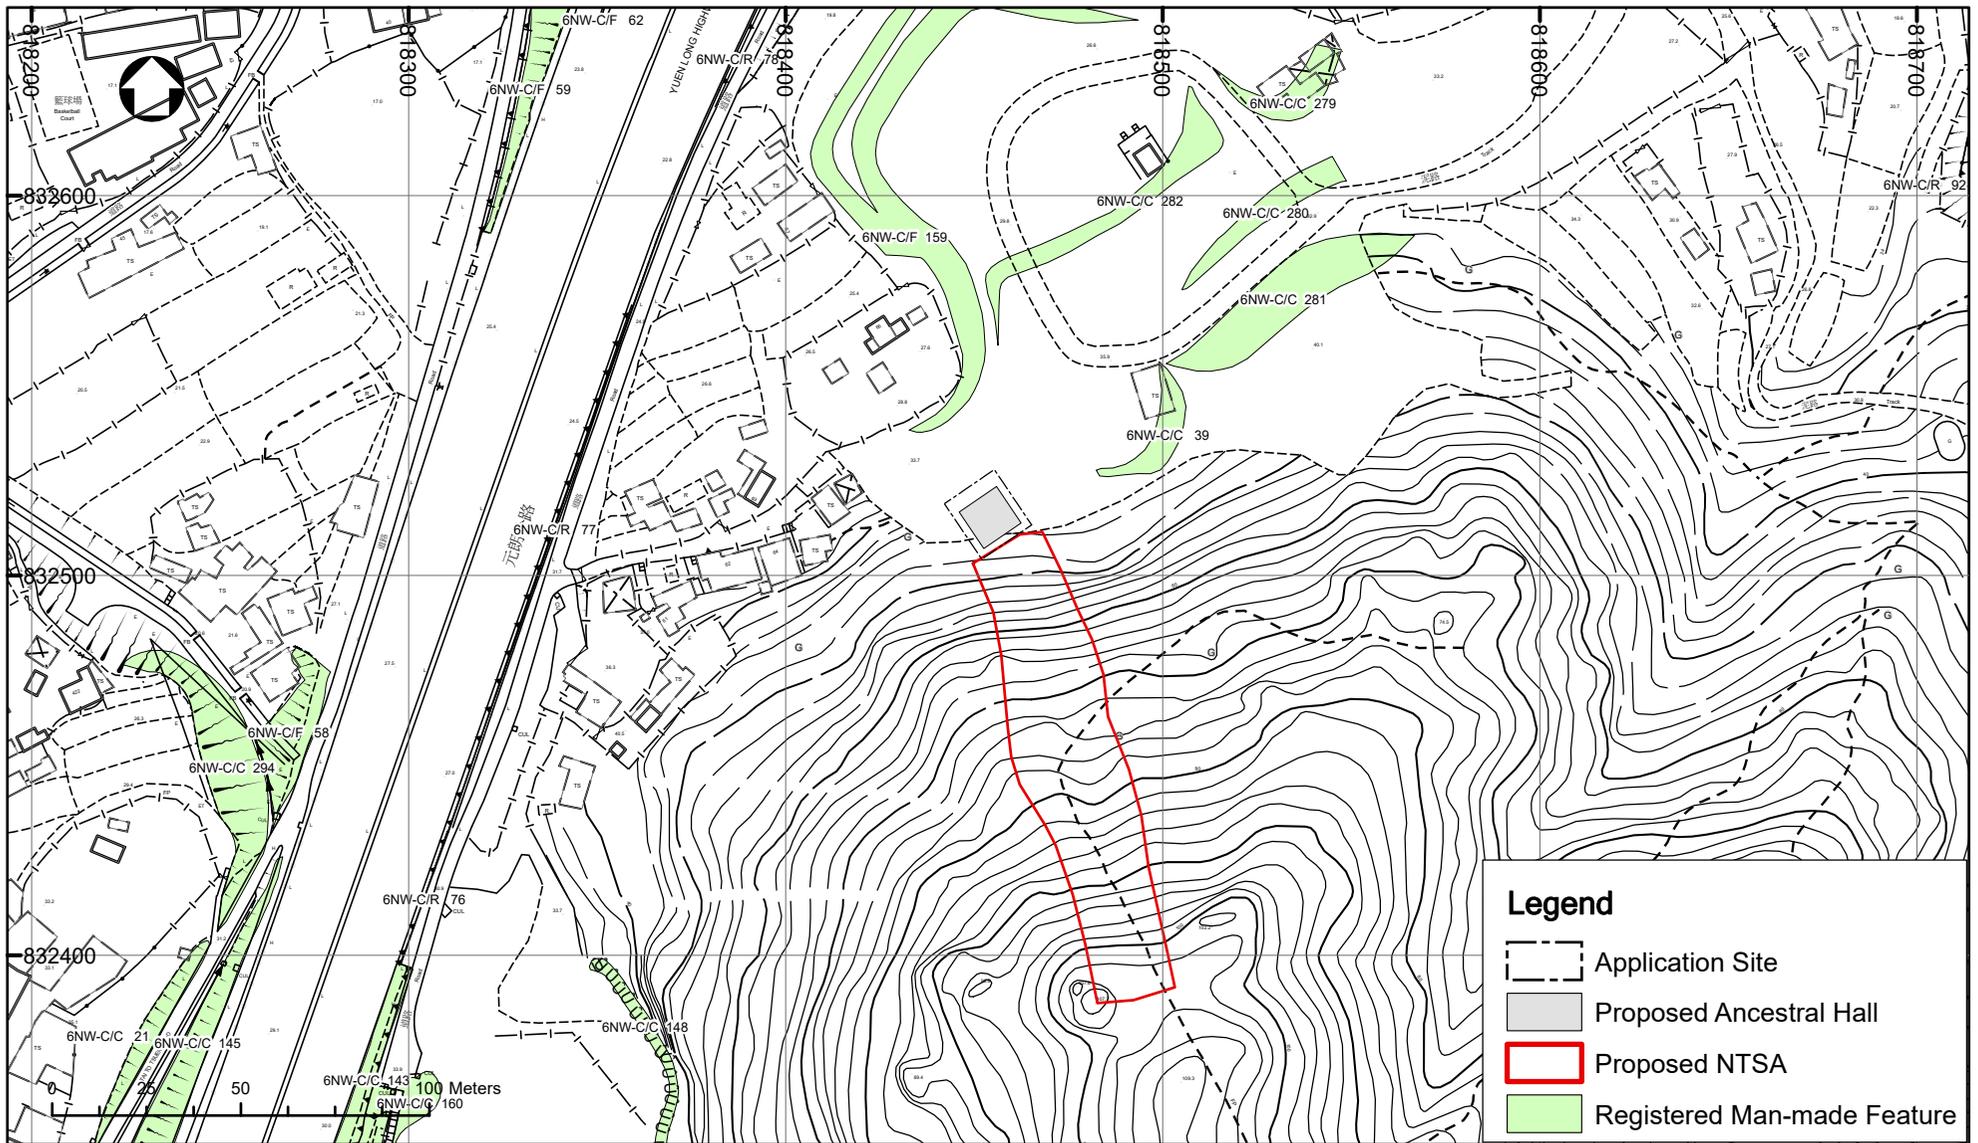
FIGURE 4

There are no registered man-made features or registrable man-made features within the proposed Site. The closest registered slope features are Feature 6NW-C/F159 and 6NW-C/C39 located approximately 20m to the north and east of the site respectively (Figure 4). According to the SIS record, feature 6NW-C/39 is a cut slope with a maximum height and length of 4m and 40m respectively. The average angle of the feature is only about 45°. Feature 6NW-C/F159 is a fill slope with a maximum height and length of 6m and 216m respectively and an average slope angle of 30°. Detailed information of the feature extracted from SIS is presented in Appendix A. A discussion on the potential impact of these registered man-made features on the proposed development is given in Section 5 below.

The registered man-made feature No. 6NW-C/C39 and 6NW-C/F159 are located at mover than 20 m (plan distance) to the east and north of the proposed ancestral hall. Given the far proximity of these man-made features to the proposed site, they are not considered to pose geotechnical impact on the proposed development.

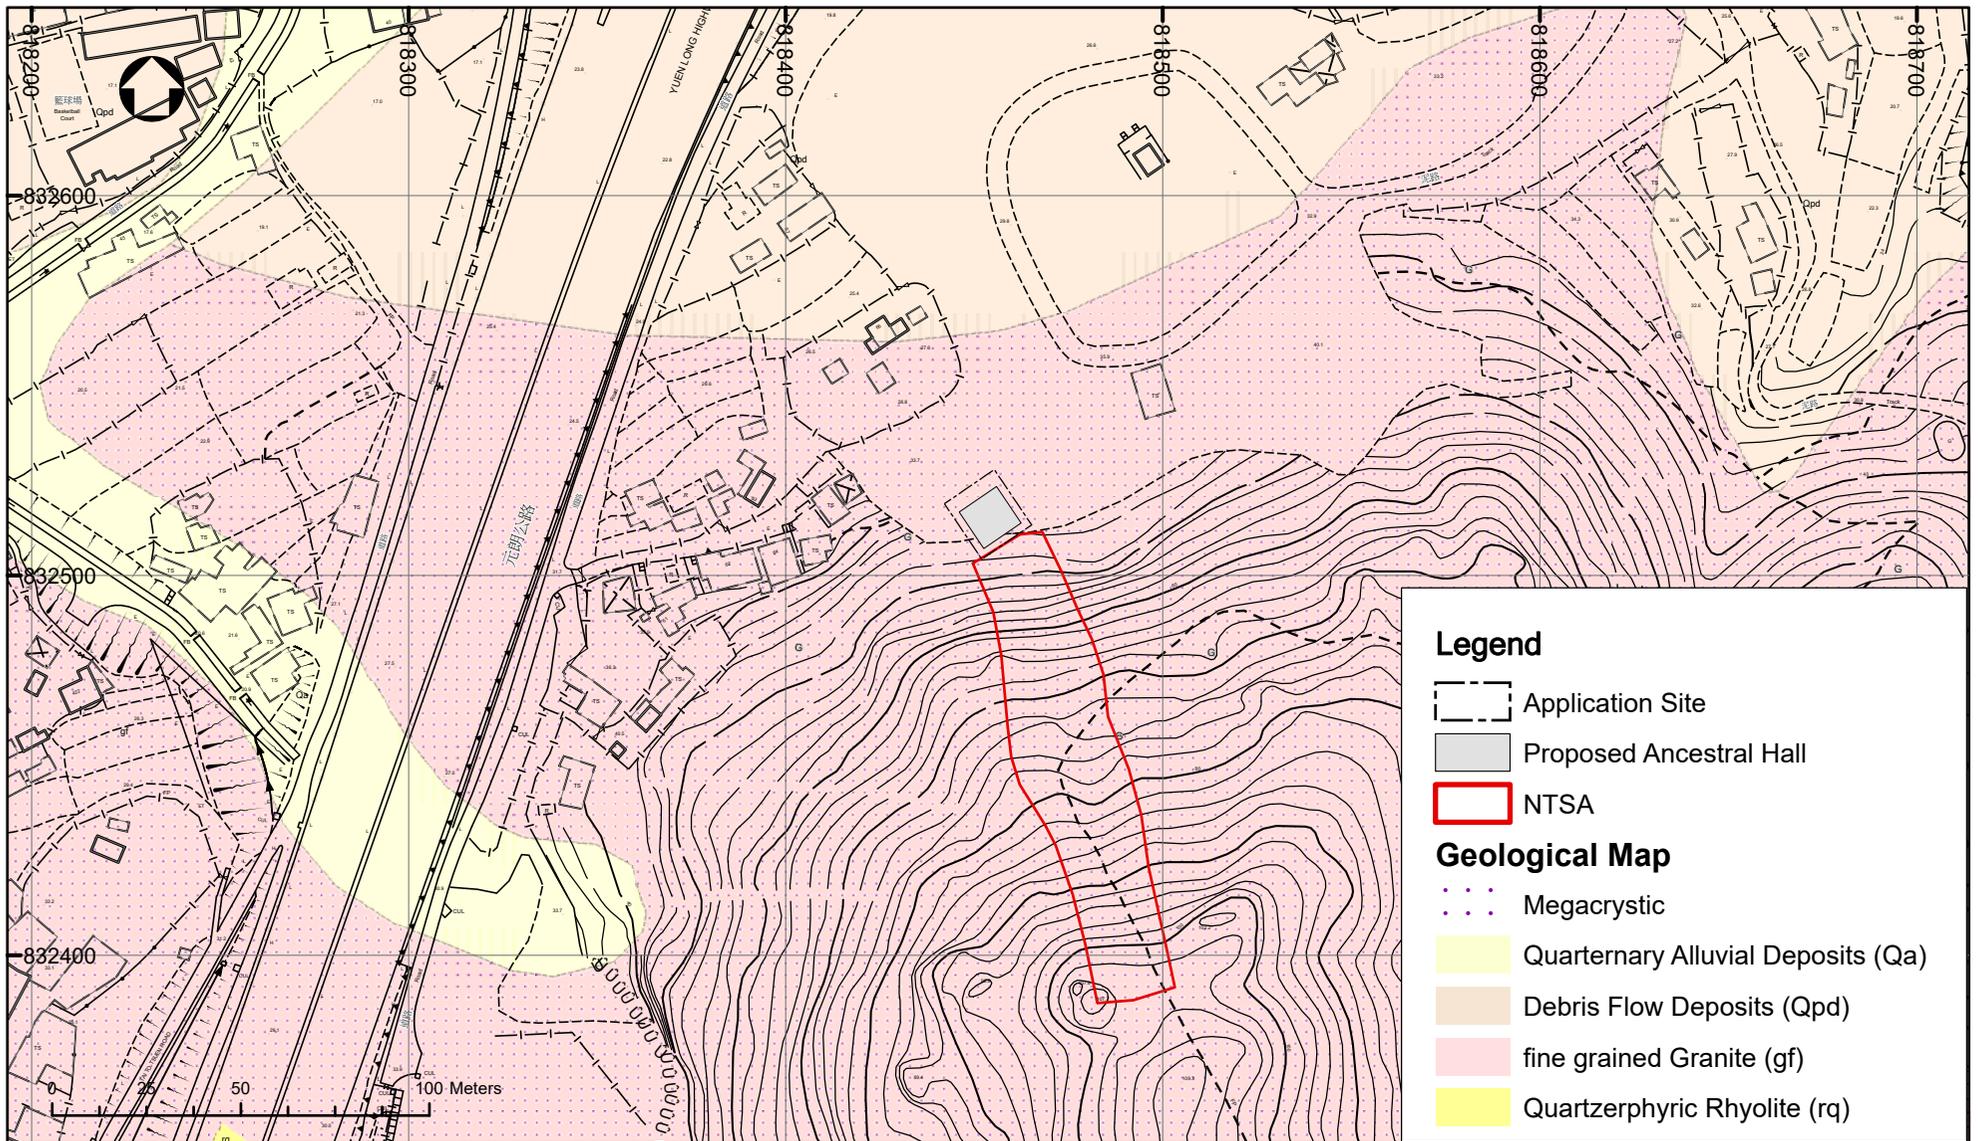
FIGURE 5

The 1:20,000 scale geological map sheet 6 (HKGS, 1989) indicated that the Site is likely to be underlain by megacrystic fine grained Granite (gf).

The footslope further to the south of the Site is covered by covered by Pleistocene debris flow deposits (Qpd).

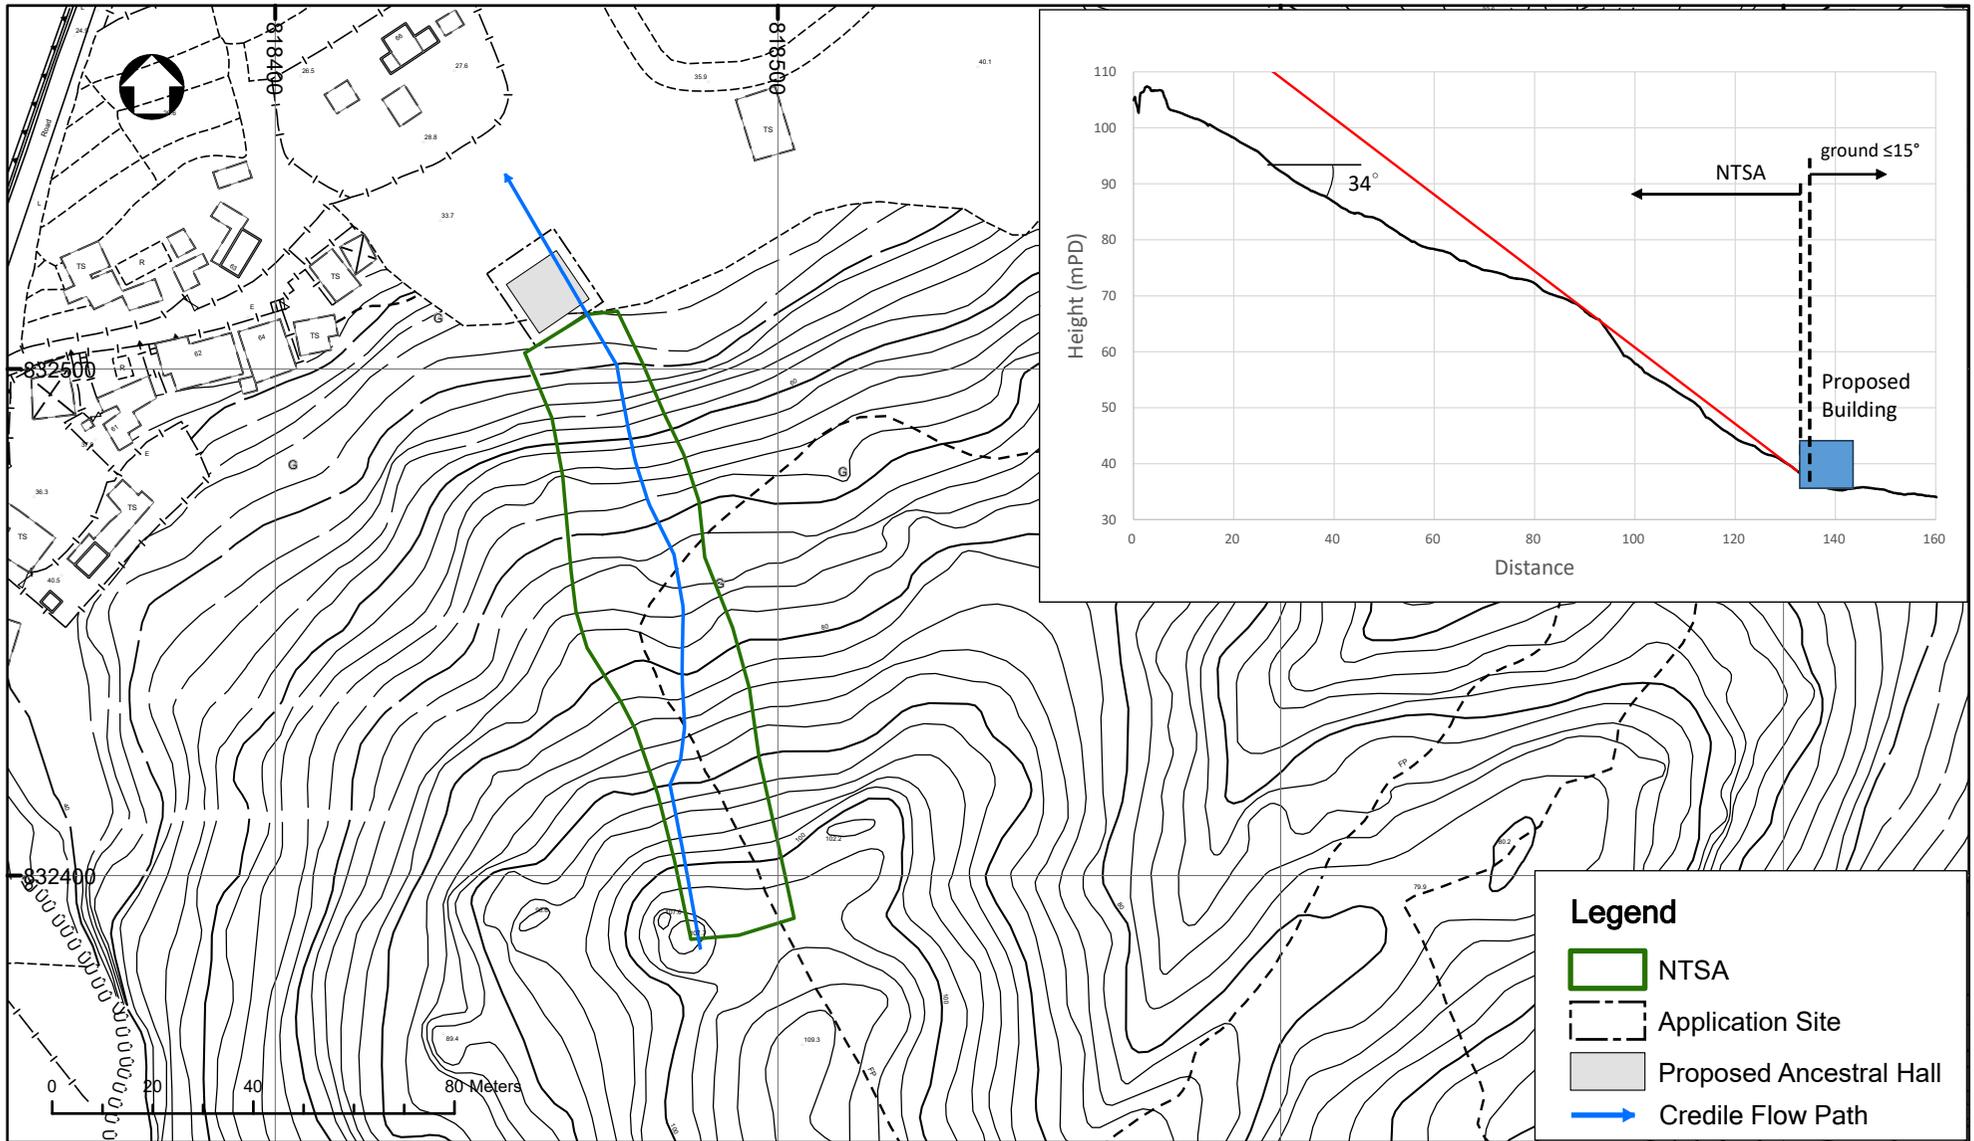
FIGURE 6

(GEO, 2016). The potential hillside catchment that may affect the proposed development has been delineated based on the 1:1000 topographic map and is presented in Figure 6.

The angular elevation from the top of the natural terrain to the nearest boundary of proposed ancestral house is about 34° and within 50m of ground sloping at >15°. Therefore the proposed development Site does not satisfy the “In-principle Object ion Criteria” but it satisfied the “Alert Criteria” which means further study of the natural terrain hazards posing to the development is required.

geotechnical feasible. In addition, the Natural Terrain Hazard Assessment on the hillside overlooking the proposed ancestral hall discussed in this report will be prepared and provided in separate submission.

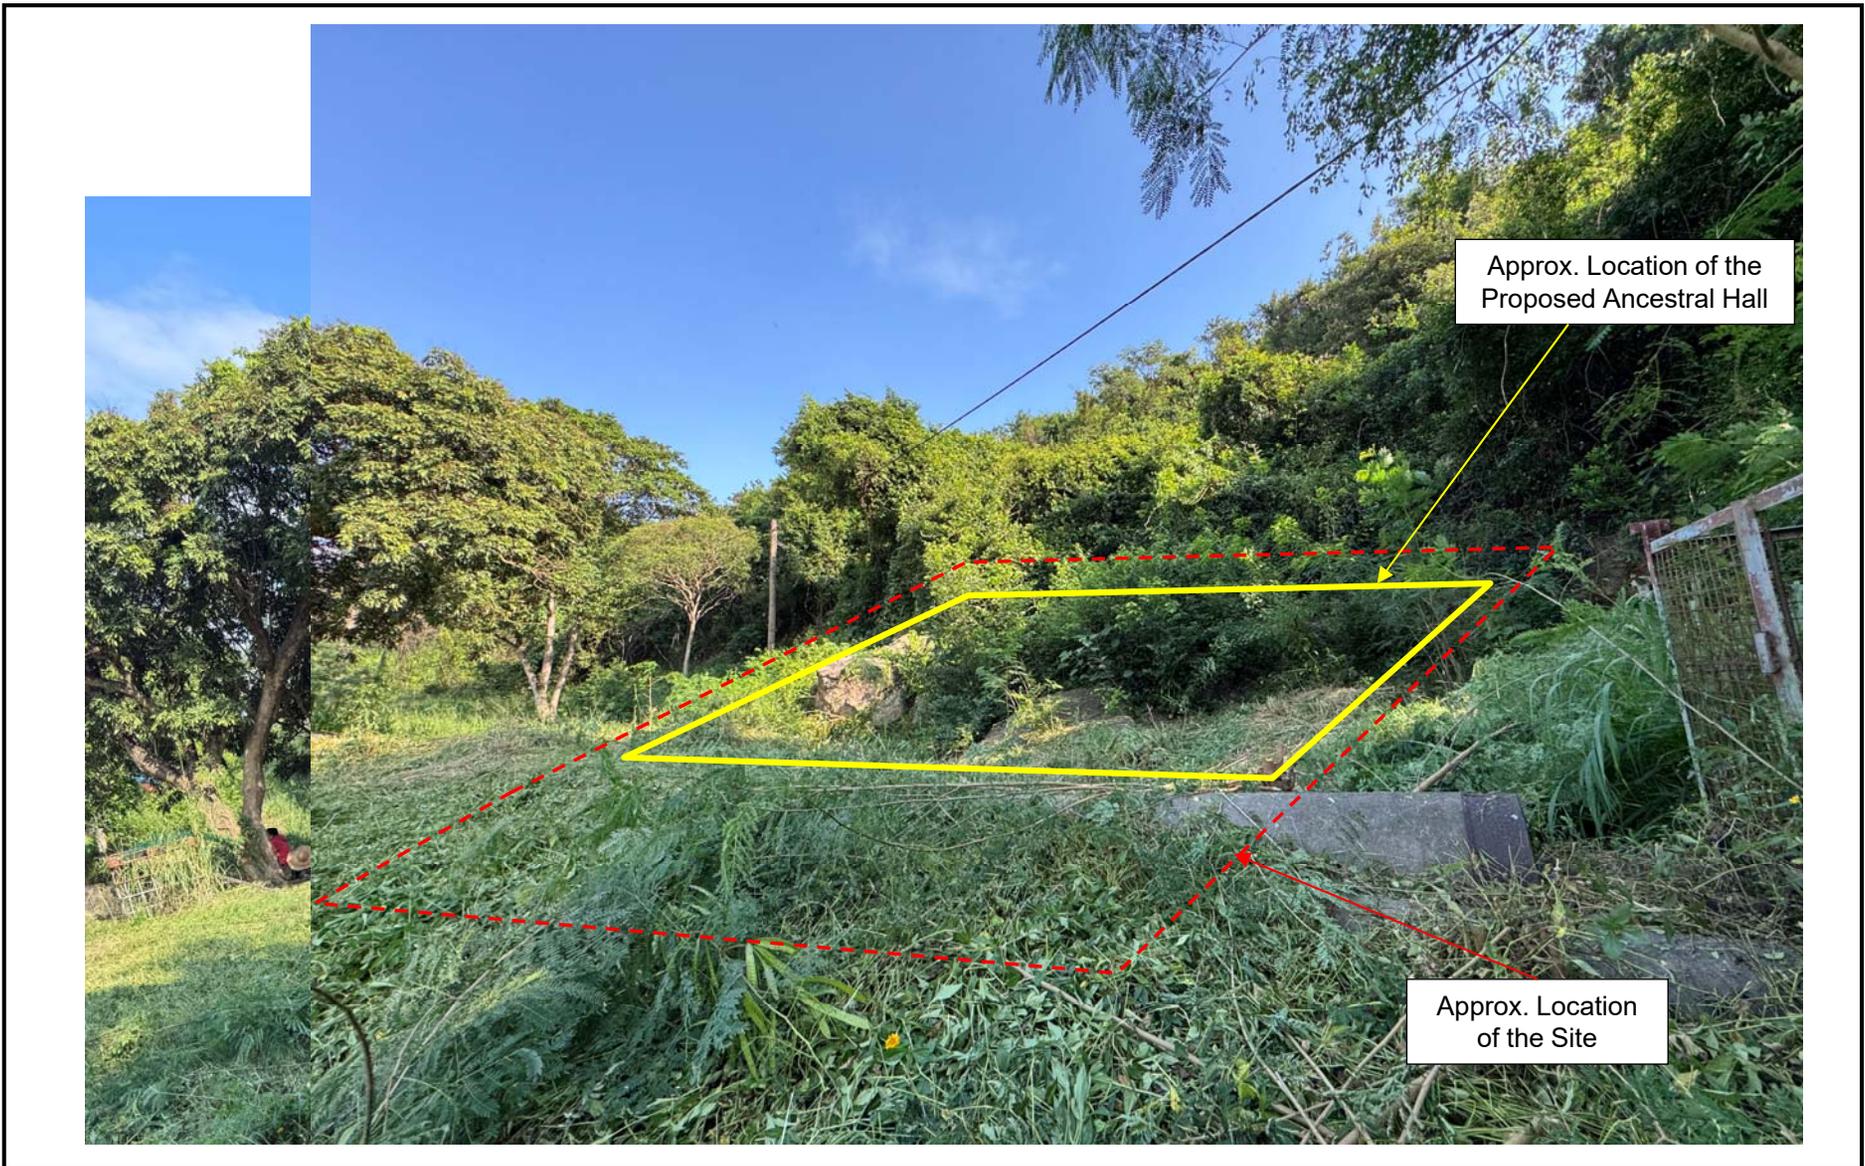
Plate 1

The Site, where the proposed Ancestor Hall is to be constructed, is located on a generally flat area located at the toe of a natural hillside (Figure 1 and Plate 1). According to Table 2.2 of the GEO Report No. 138 2nd Edition (GEO, 2016), the proposed ancestral building is classified as Group 2(a).

The site is currently covered by dense vegetation. There is no registered slope or retaining wall present within the Site. Site photographs taken on the site are presented in Plate 2 to 3. A natural hillside located to the south is overlooking the proposed development area (Plate 4 and 5). A grave is located about 13m to the west of the site (Plate 6). The location of the lot boundary is shown in Figure 2. The potential natural terrain affected to the proposed site and the registered man-made Feature are shown in Figure 3 and 4 respectively.
