GEOTECHNICAL PLANNING REVIEW REPORT (GPRR)

**PROPOSED TEMPORARY WAREHOUSE FOR STORAGE OF
CONSTRUCTION MATERIAL, PLASTIC, MACHINERY,
SPARE PART AND ANCILLARY PACKAGING WORKSHOP
FOR A PERIOD OF 3 YEARS**

**LOT NO. 23 RP (PART), 28 RP (PART), 30 RP (PART), 43
(PART), 193, 194 (PART), 195 (PART) AND 196 (PART)
IN D.D. 128 AND ADJOINING GOVERNMENT LAND,
HA TSUEN, YUEN LONG**

ISSUE 1

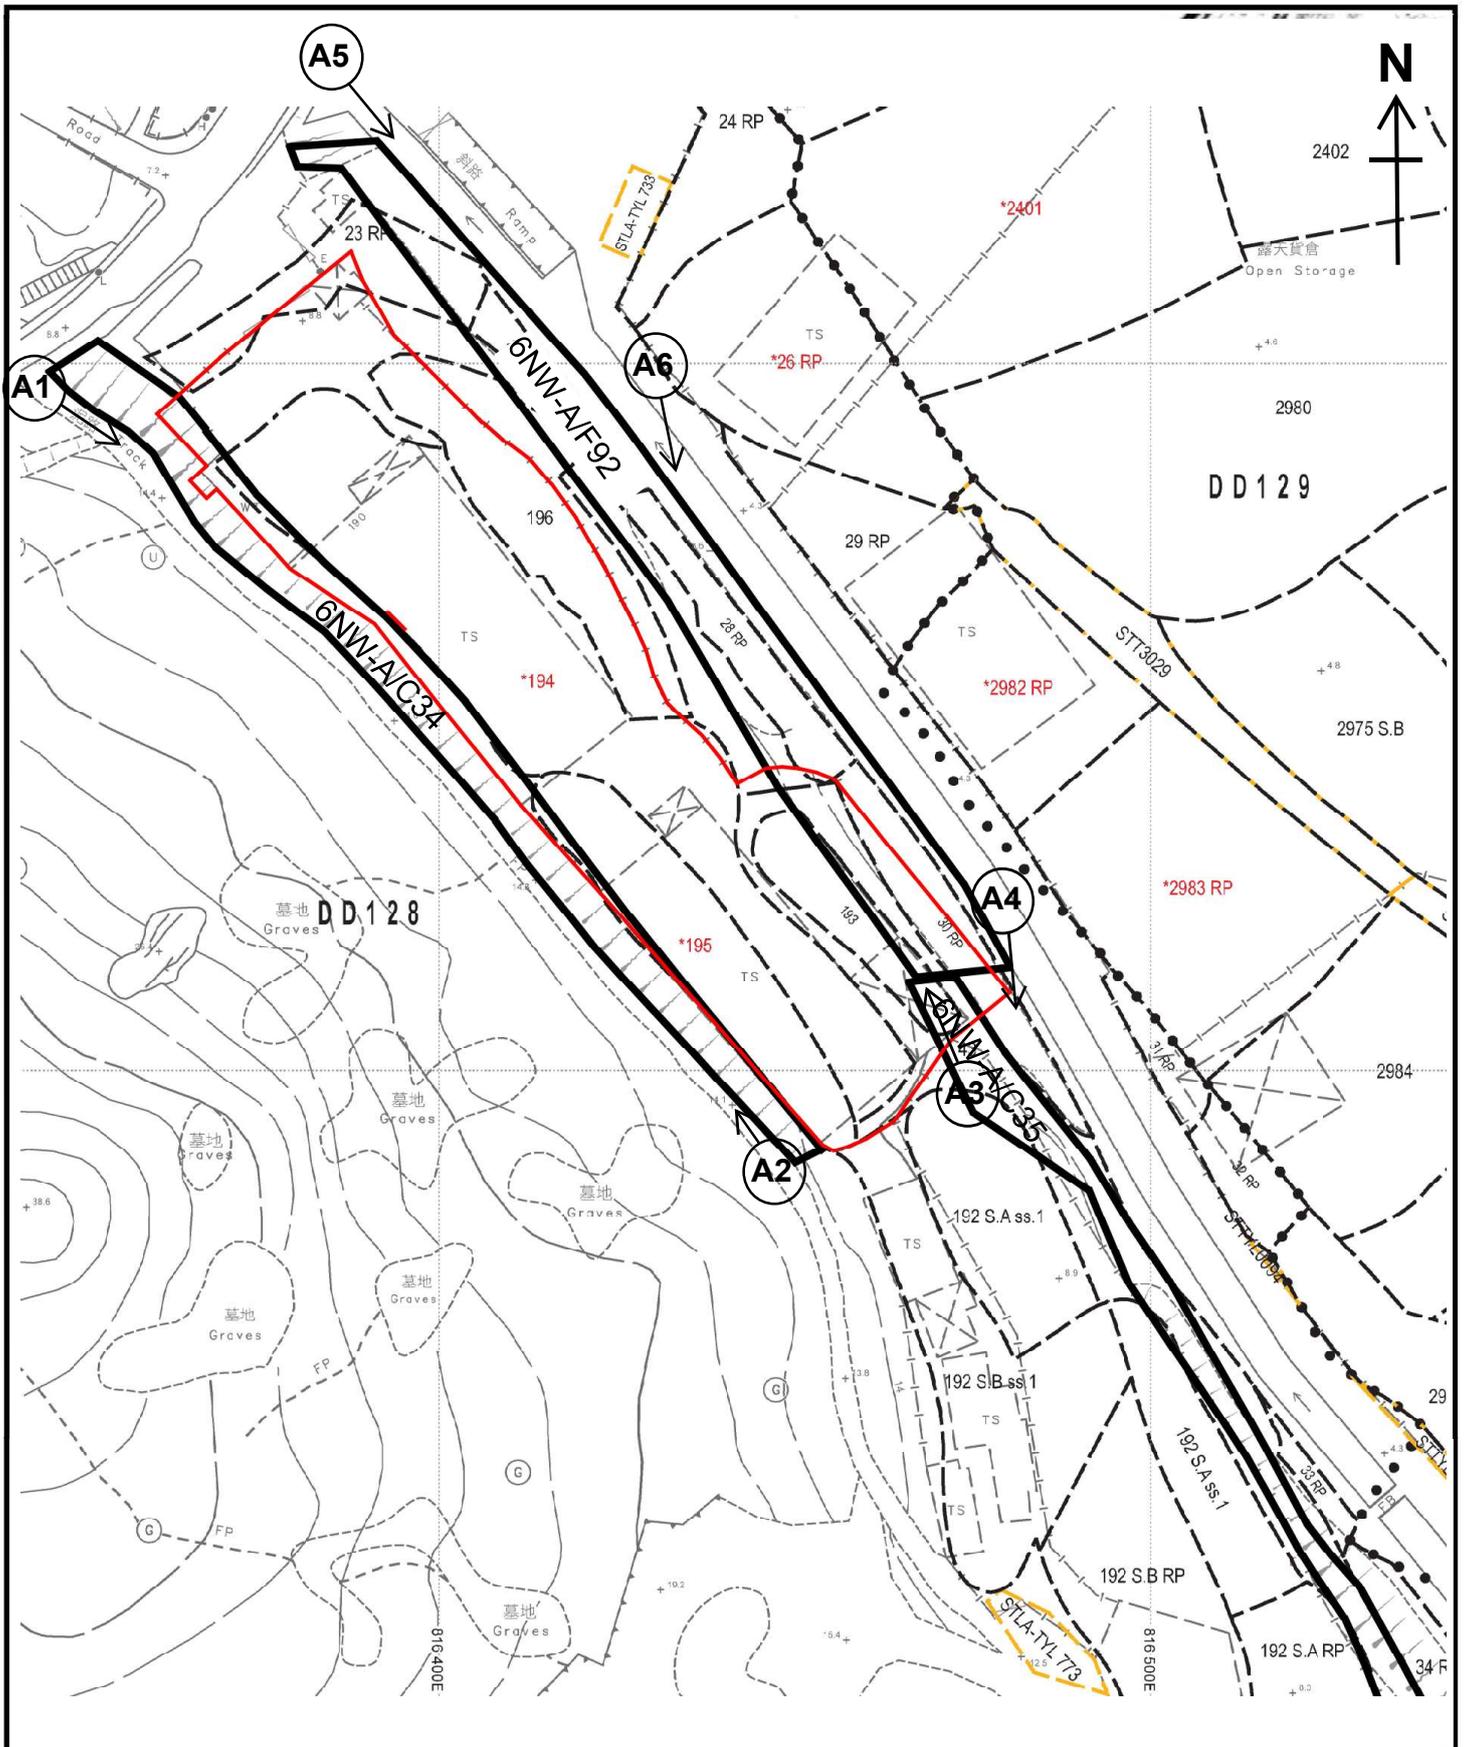
There are 3 registered features in the vicinity of the proposed development. The locations of the features are shown in Figure 3. Slope Information System (SIS) reports and Slope Maintenance Responsibility Information System (SIMAR) reports indicating the location of the features and their maintenance responsibility are attached in Appendix A and B.

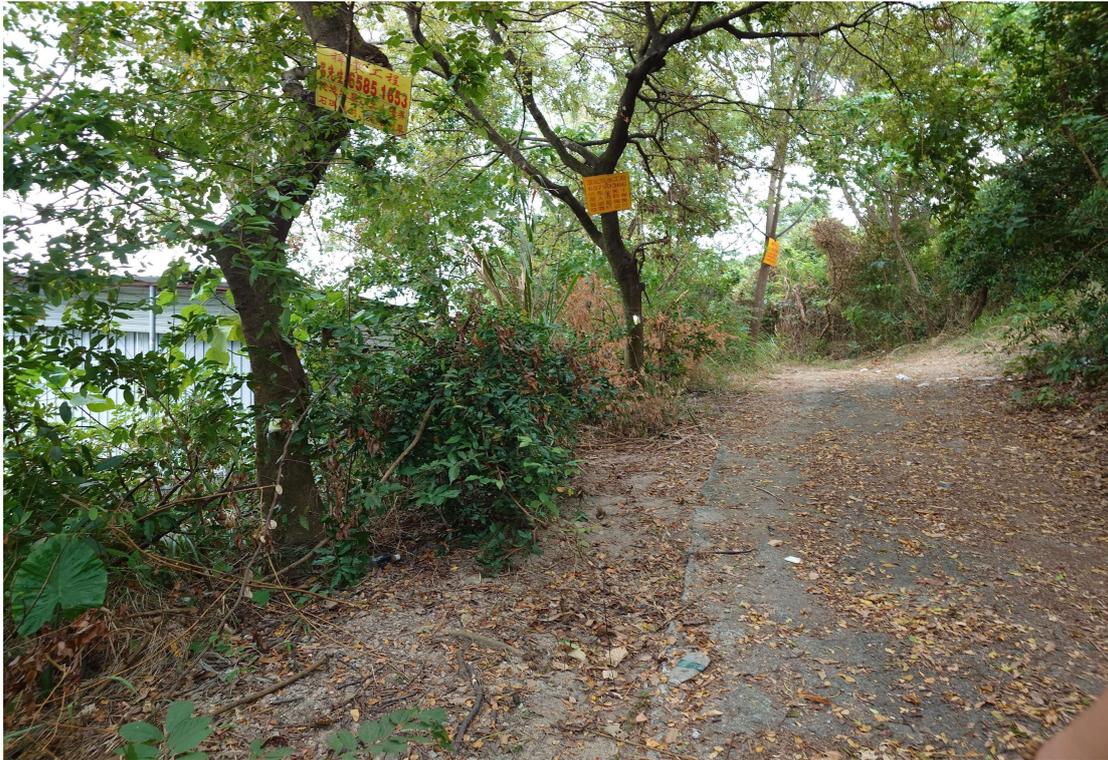
The feature is located at the western boundary of the site. It consists of a vegetated slope with about 3.0m high and has a face angle of about 45°. This feature is about 160m long, an access road is located at the slope crest and temporary structures are located at the toe of the feature. The photo is shown in Plate A1 and A2.

A1 - General view of the site (looking southern) Taken at: 7 November 2025

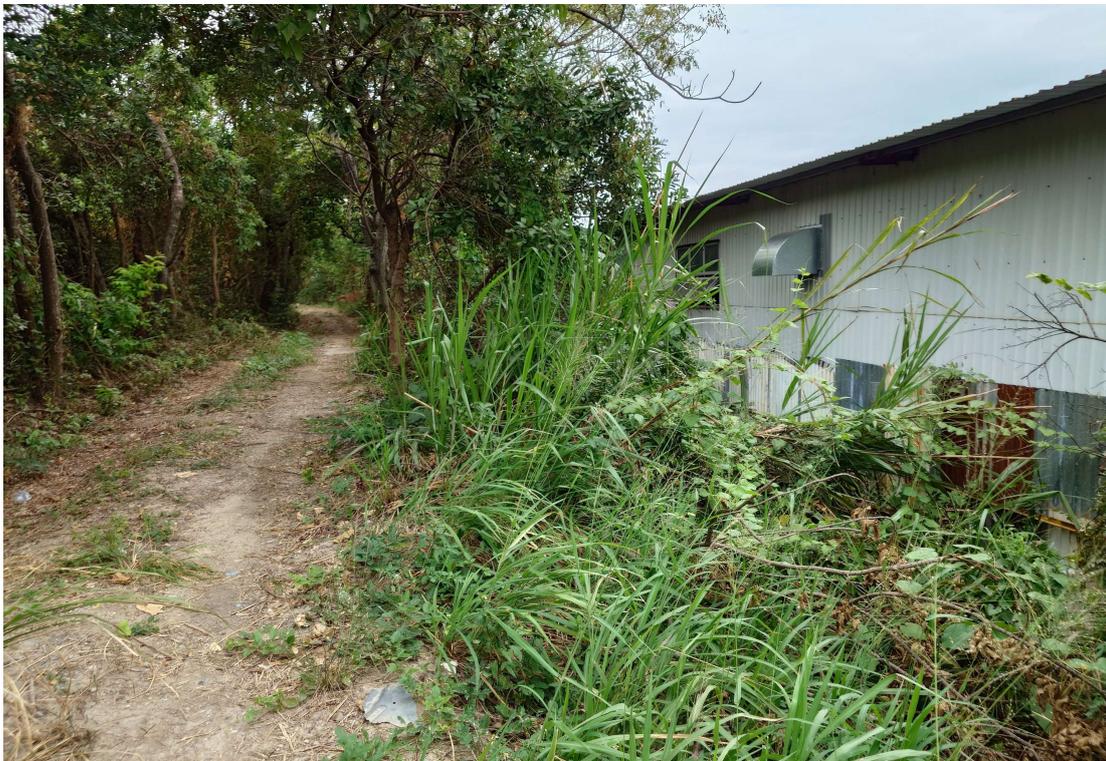
A2 - General view of the site (looking northern) Taken at: 7 November 2025

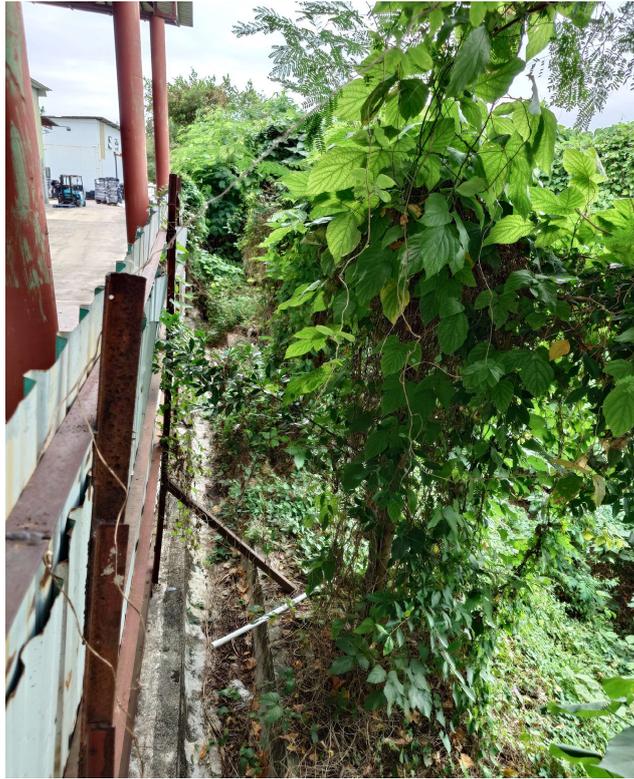
6NW-A/C35 (Sub-division Part 5) is located at the crest of the feature, it is a relatively small part of the feature and it is a vegetation area. The photo is shown in Plate A3.

A3 - General view of the site (looking northern)

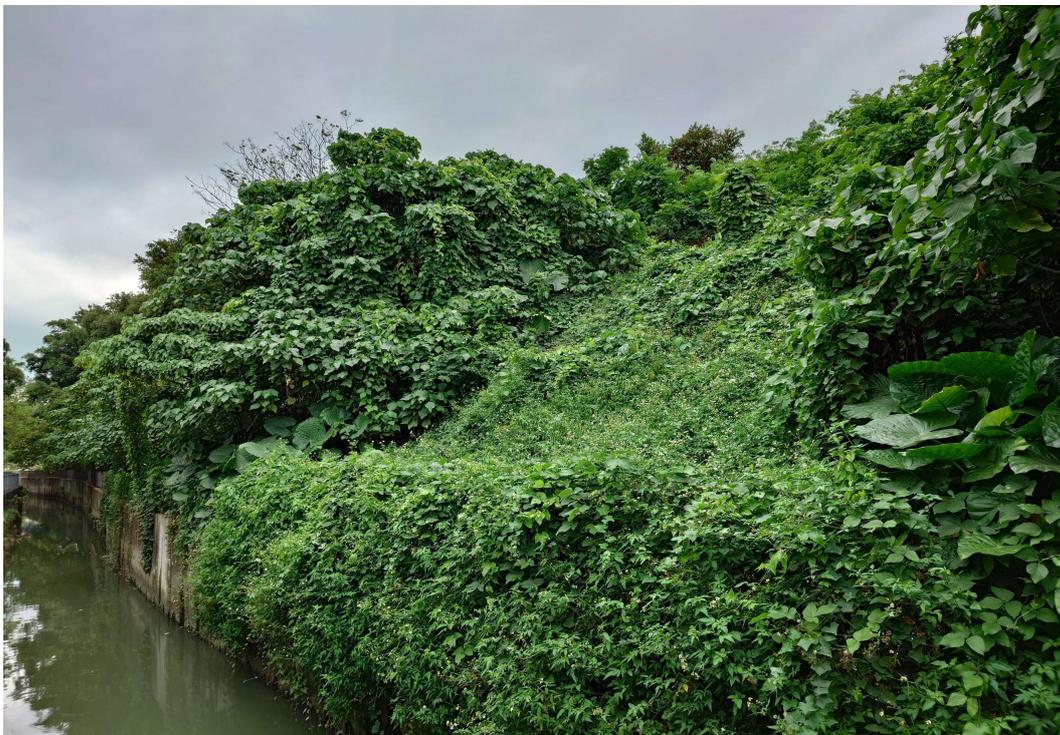
The feature is located at the southern-east side of the site. The feature is a vegetated slope about 4.0m high and the slope angle is about 45°. The slope is dipping from west to east and the length of slope is about 140m. The photo is shown in Plate A4.

A4 - General view of the site (looking southern)

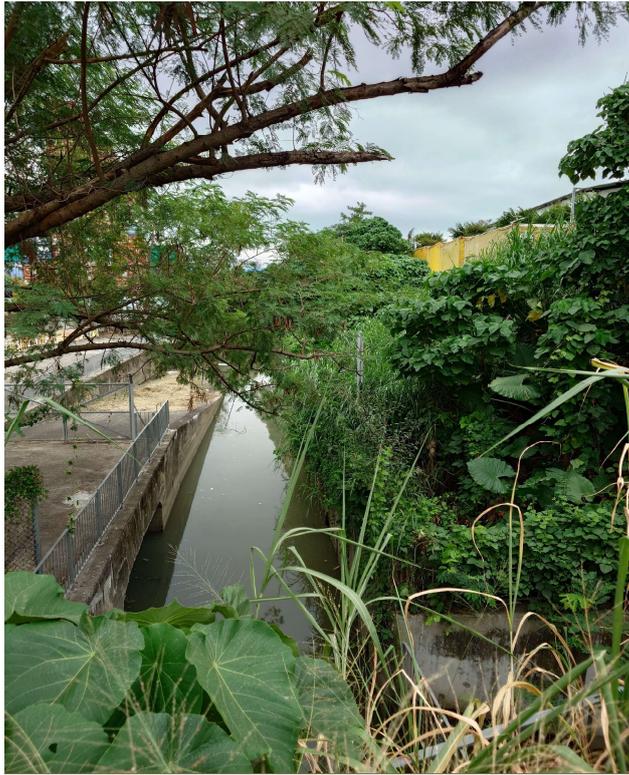
The feature is located at the eastern side and partly within the application site. It is a vegetated slope with about 6.0m high and the slope angle is about 35°. The feature is about 150m long and the slope is facing east. The photo is shown in Plate A5 and A6.

A5 - General view of the site (looking eastern)

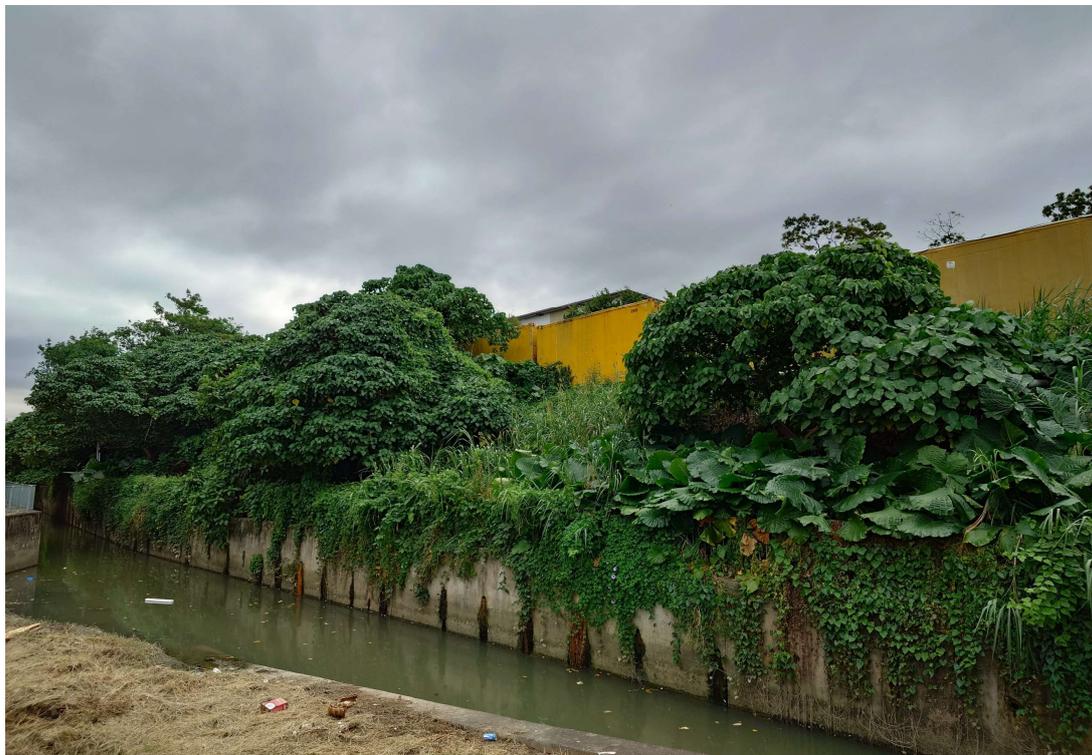
A6 - General view of the site (looking southern)
