Geotechnical Planning Review Report  
for  
Section 16 Planning Application for Proposed Religious Institution  
and Columbarium (Partial Redevelopment of Prajna Dhyana Temple)  
at  
Lot 112, 113RP (Part), 114,116,117 & 118 in DD2  
Tung Chung, Shek Mun Kap, Tung Chung, Lantau Island

Section 16 Planning Application

December 2025

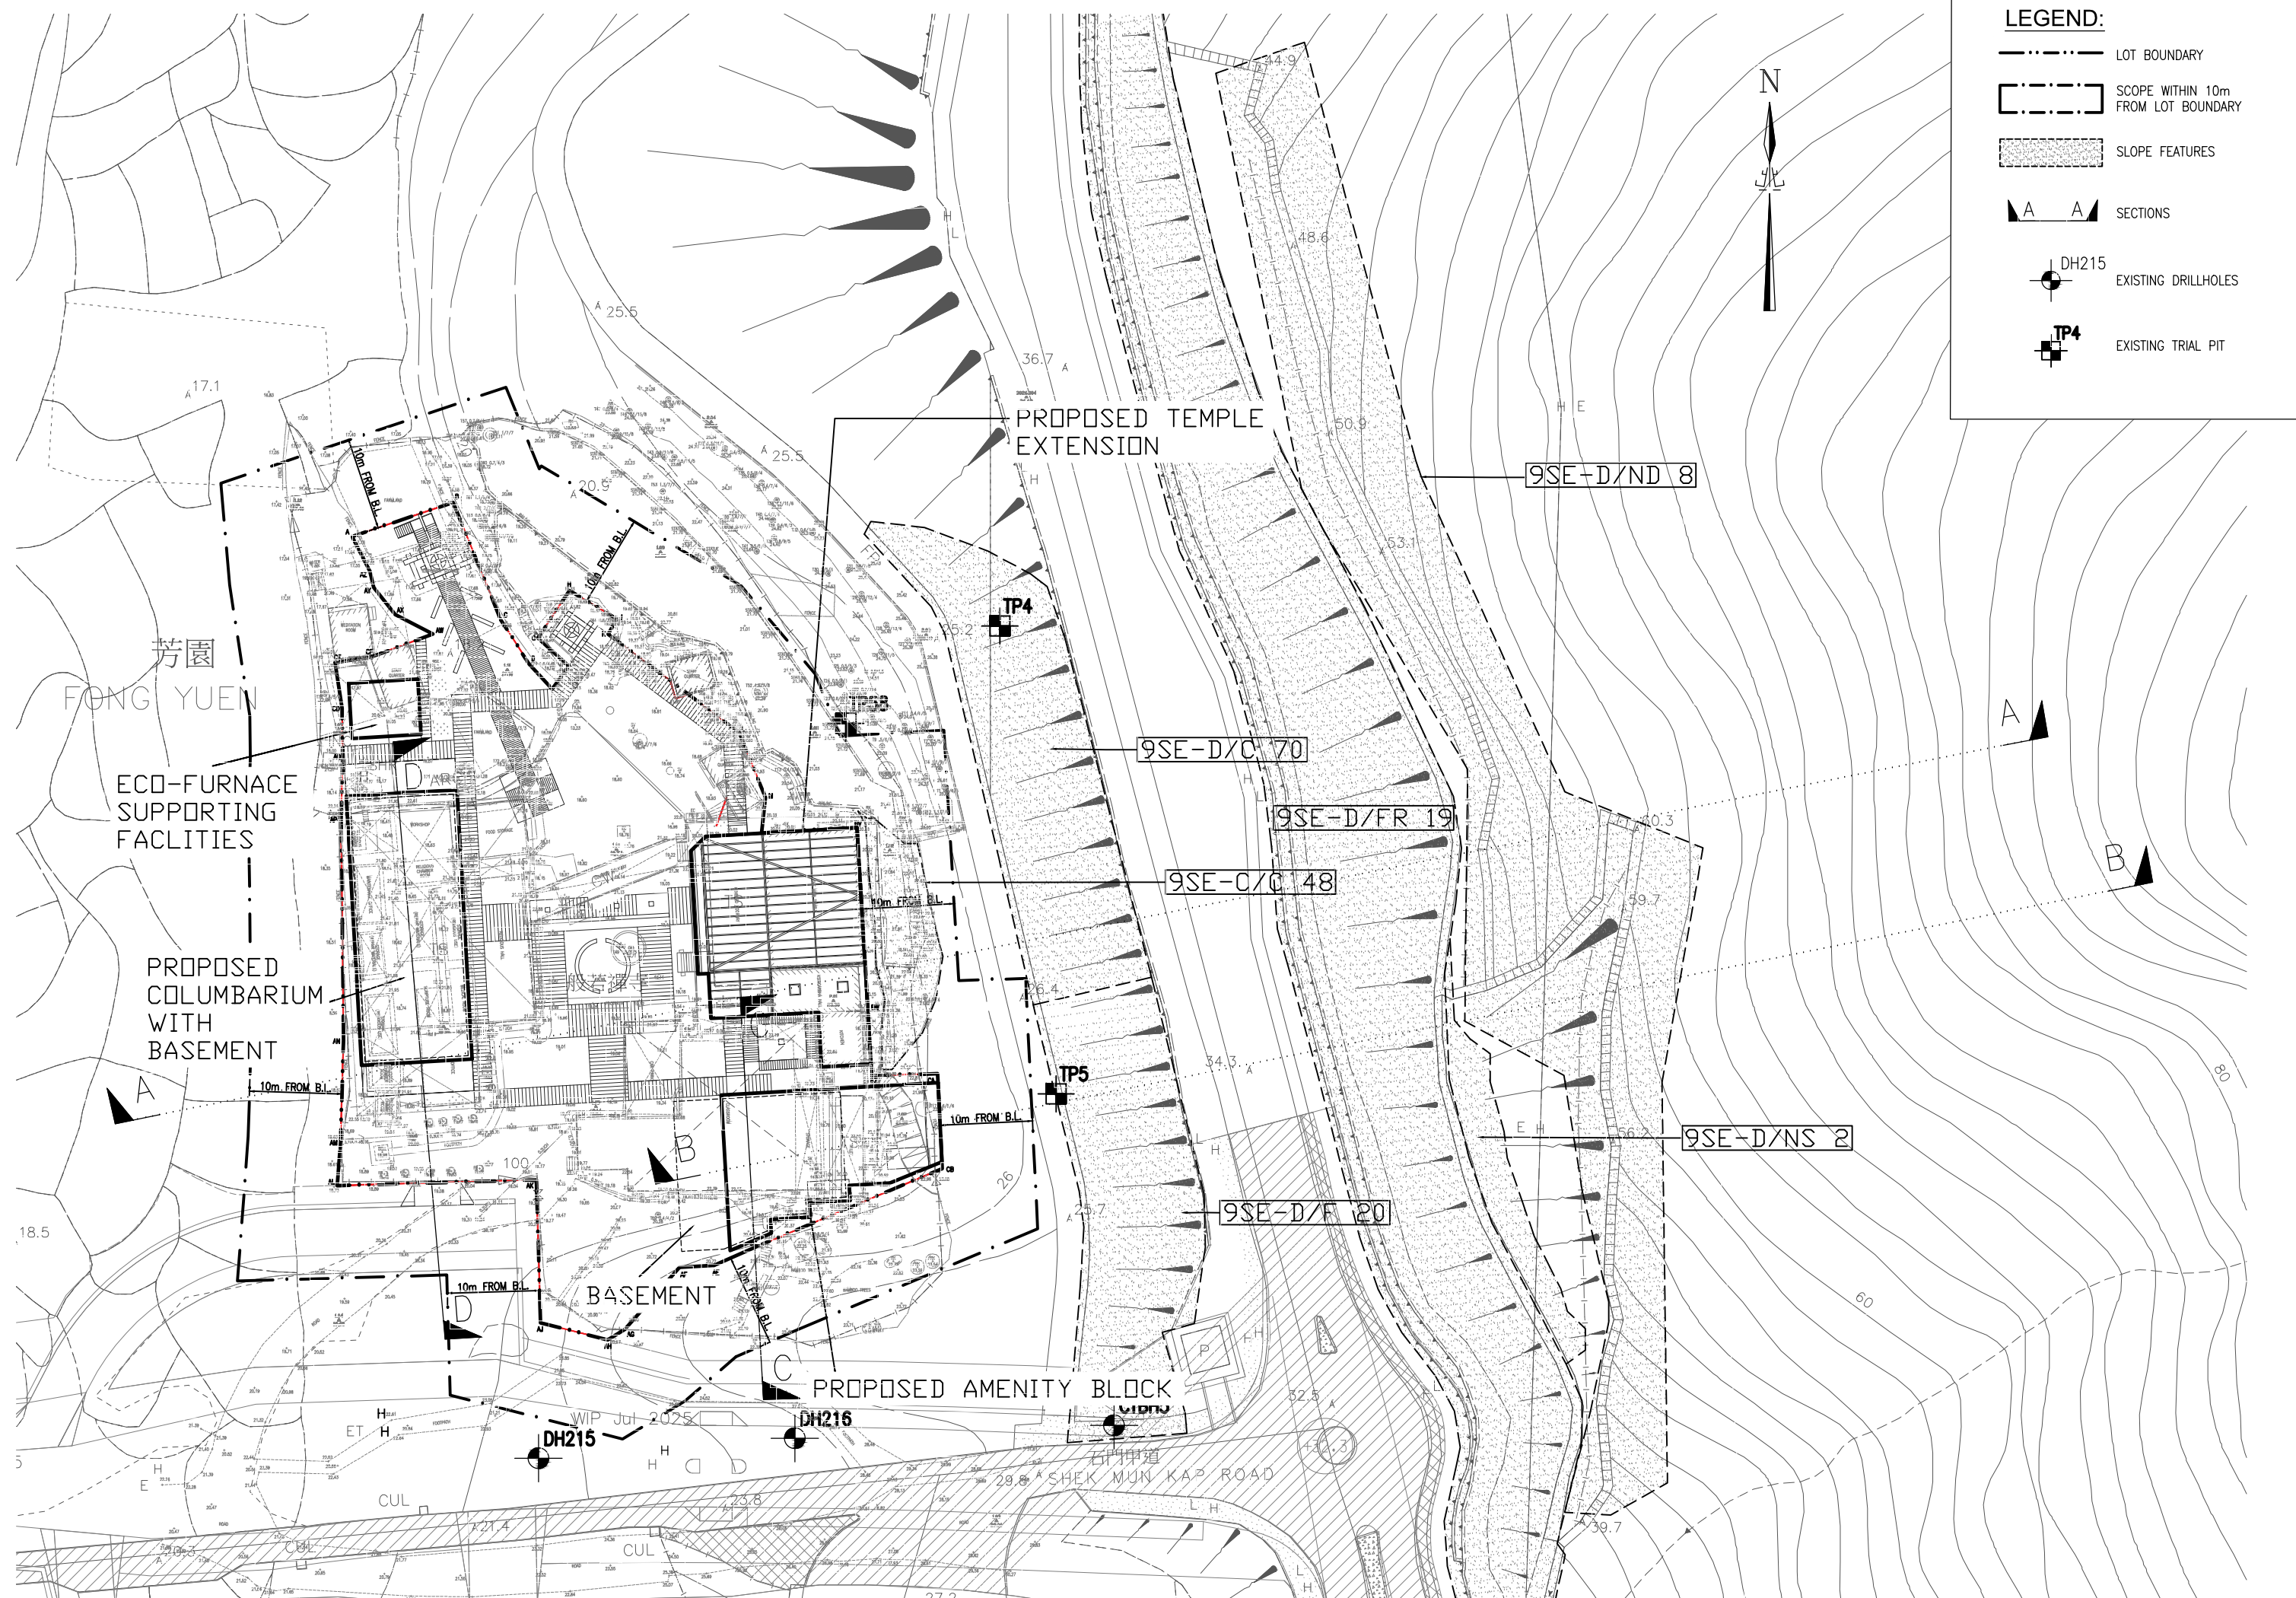
An overall redevelopment layout plan and geological sections are presented as Figure 2 to 4 attached in **Appendix C**.

There is only one registered slope feature 9SE-C/C48 lies within site boundary is shown in Figure 2. Stability check will be carried out to this Feature, and it will be upgraded to meet current FOS if found necessary. Detailed design submission will be made to relevant Government Departments for approval.

Proposed Basements are upto 4m deep, as both basements are located close to site boundary, lateral support excavation system is required. Again, all proposed ELS works will be submitted to relevant Government Departments for approval (Fig 2 to 4 refers).
