Updated Tree Felling and Preservation Proposal

**Proposed Minor Relaxation of Building Height Restriction
for Permitted Flat Use at Tung Chung Town Lot 49, Tung
Chung Road North, Lantau Island**

**TREE FELLING AND PRESERVATION PROPOSAL
(Amendment)**

March 2026

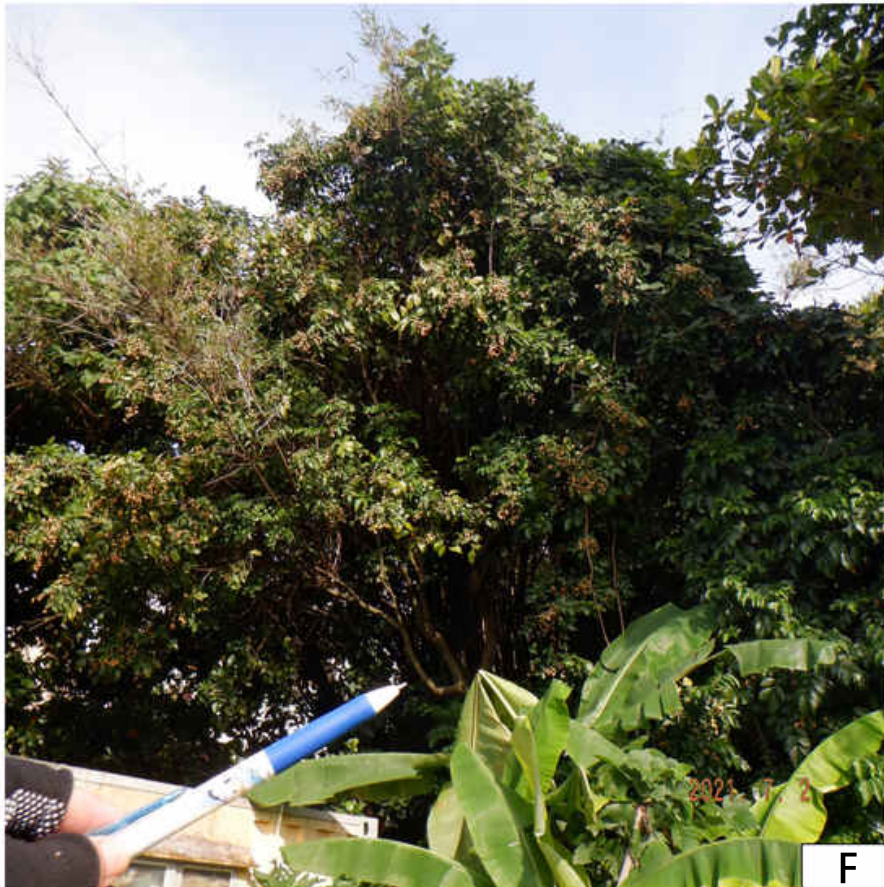
T14	<i>Clausena lansium</i>	黃皮	Lot	7	234.9	5	P	F	P	L	6.10	N/A	Fell	b,c,d	On slope; Multiple trunk; trunk base decay; collapsed by bamboo
T19	<i>Celtis sinensis</i>	朴樹	Lot	10	335	4	P	F	P	L	4.32	N/A	Fell	a,b,c,d,e	Epiphytic plants; On slope
T20	<i>Acacia confusa</i>	台灣相思	Lot	11	720	7	F	F	F	L	3.93	N/A	Fell	a,c,d,e	On slope; Multiple Trunk
T21	<i>Acacia confusa</i>	台灣相思	Lot	3	243	8	P	F	P	L	3.93	N/A	Fell	a,b,c,d	On slope; hanger dead branch; Leaning 10°
T22	<i>Celtis sinensis</i>	朴樹	Lot	5.5	190	3	P	F	P	L	3.05	N/A	Fell	a,b,c	Epiphytic plants; Leaning 20
T23	<i>Celtis sinensis</i>	朴樹	Lot	7	355	6	F	F	F	L	4.07	N/A	Fell	a,c,d	On slope; covered by epiphytic plants
T34	<i>Mallotus paniculatus</i>	白楸	Outside Lot	6	181	8	P	F	P	L	10.14	N/A	Fell	a,b,c,e	Broken branch; Leaning 45°
T35	<i>Mallotus paniculatus</i>	白楸	Outside Lot	8	201	9	F	F	P	L	9.89	N/A	Fell	a,b,c,e	Broken Trunk; epiphytic plants
T36	<i>Microcos nervosa</i>	破布葉	Outside Lot	5	167	3	P	P	P	L	8.73	N/A	Fell	a,b,c,d	On slope; Broken Trunk; epiphytic plants

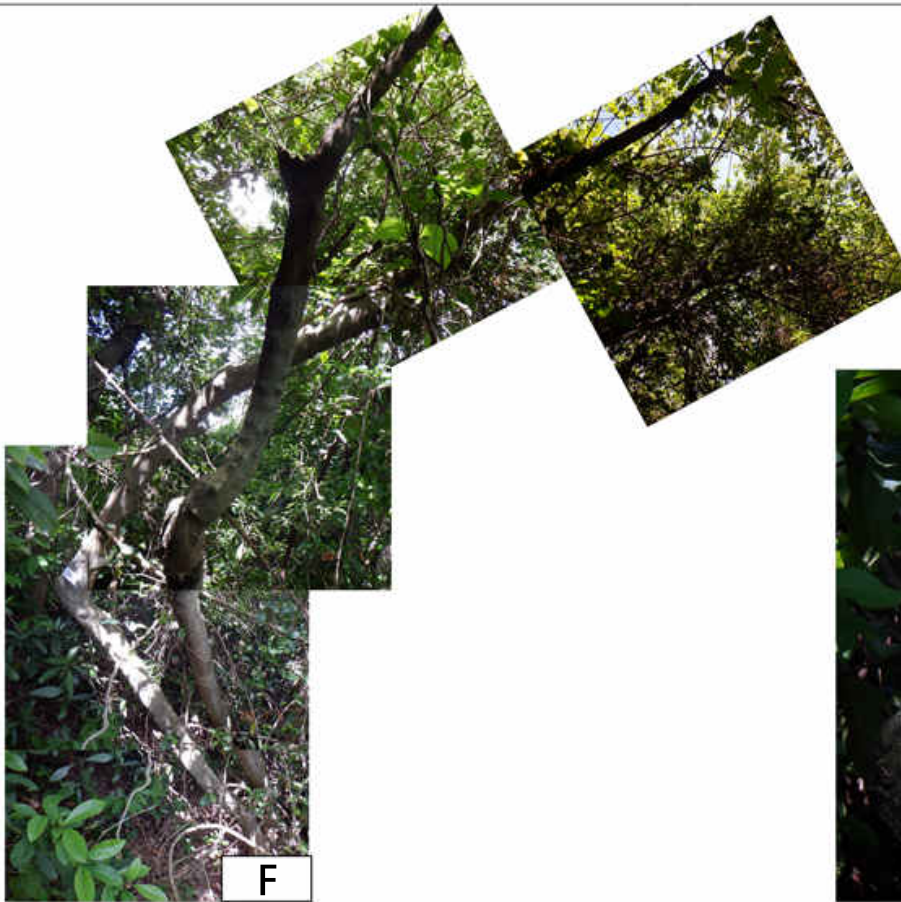
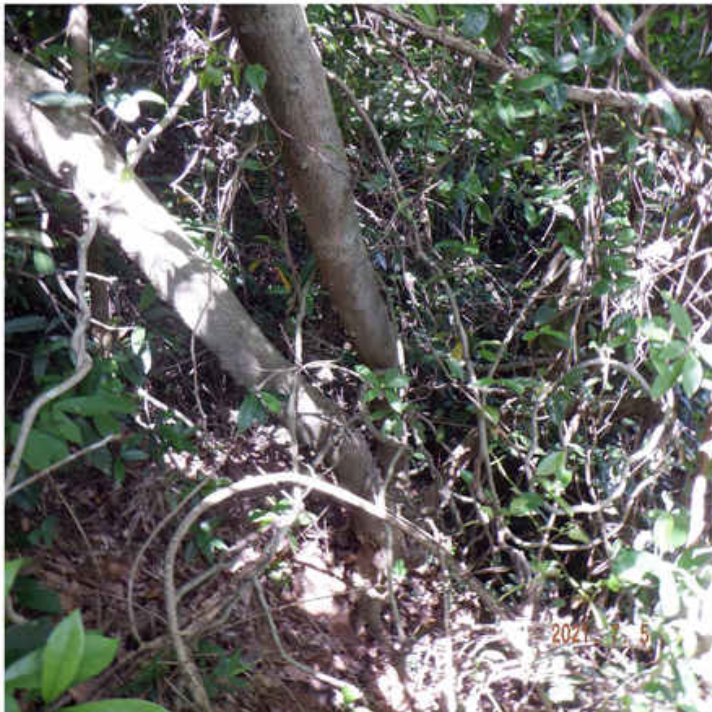
T37	<i>Mallotus paniculatus</i>	白楸	Outside Lot	5	209.2	6	P	P	P	L	7.16	N/A	Fell	a,b,c,d	On slope; Multiple Trunk×2; bending trunk
T38	Dead tree	死樹	Lot	7.3	138	6	-	-	-	-	6.32	N/A	Fell	a,f	fungi fruit bodies; leaning; Living crown ratio in zero;
T40	<i>Cleistocalyx nervosum</i>	水翁	Lot	8.5	326	7	F	F	P	L	5.71	N/A	Fell	a,b,c,e	Broken twigs; dieback branch; epiphytic plants
T41	<i>Cleistocalyx nervosum</i>	水翁	Lot	8.5	349	8	F	P	F	L	5.71	N/A	Fell	a,b,c,e	Leaning; unbalance crown ; epiphytic plants; Asymmetric tree canopy
T42	<i>Mallotus paniculatus</i>	白楸	Outside Lot	8.5	337.4	8	F	F	P	L	6.61	N/A	Fell	a,b,c,d	Long Wound; Multiple Trunk; On slope; Leaning; epiphytic plants
T43	<i>Microcos nervosa</i>	破布葉	Outside Lot	8.5	189.8	7	P	P	P	L	6.65	N/A	Fell	a,b,c,d	On slope; Hanger dead branch;
T44	<i>Microcos nervosa</i>	破布葉	Outside Lot	7	209	5	F	P	P	L	6.73	N/A	Fell	a,b,c	Leaning 45° ; tree crown covered by epiphytic plants; broken trunk

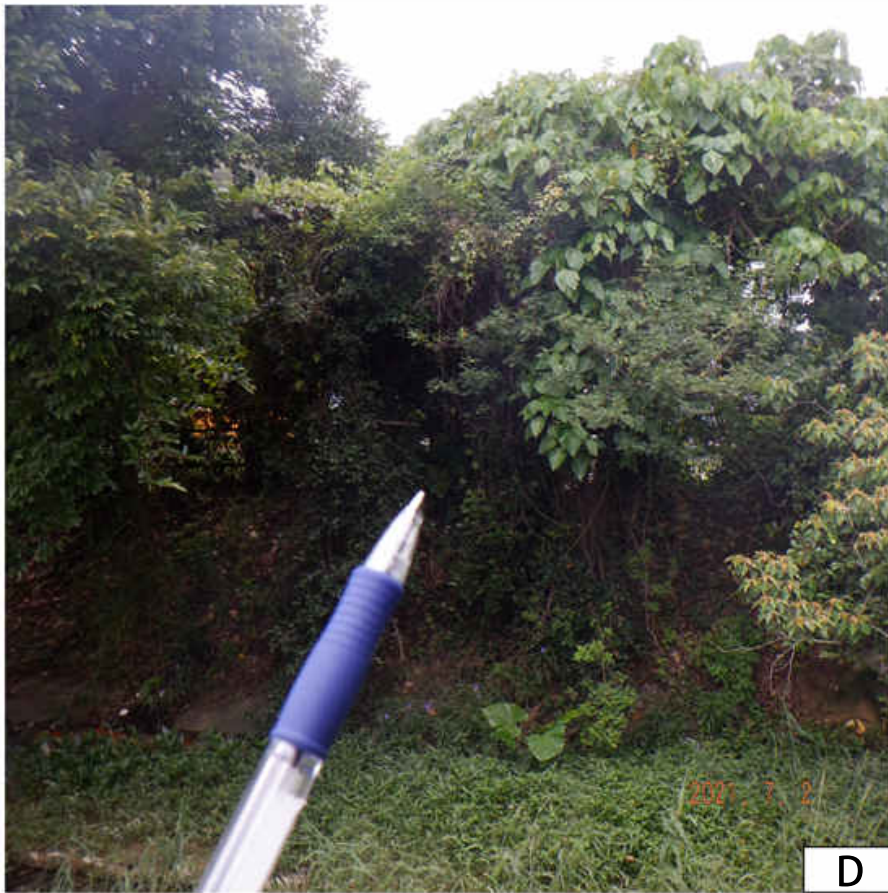
T52	Dead tree	死樹	Lot	3.5	414.9	4	-	-	-	-	4.60	N/A	Fell	a,f	Multiple Trunk, Tree tag had not found on site
T53	<i>Celtis sinensis</i>	朴樹	Lot	6	600	12	F	F	F	L	4.93	N/A	Fell	a,c,d,e	Leaning 45° / On slope/ Multiple Trunk
T54	<i>Macaranga tanariu</i>	血桐	Lot	5	316	4	F	P	F	L	4.77	N/A	Fell	a,b,c,d	On slope/ Multiple Trunk×2
T55	<i>Celtis sinensis</i>	朴樹	Lot	4.5	194	5	F	P	F	L	4.63	N/A	Fell	a,b,c,d	On slope; whole tree covered by epiphytic plants
T56	<i>Microcos nervosa</i>	破布葉	Lot	4.3	96	4.5	F	P	F	L	4.54	N/A	Fell	a,b,c,d	On slope; Multiple Trunk
T57	<i>Celtis sinensis</i>	朴樹	Lot	6.5	127	6	P	F	F	L	4.44	N/A	Fell	a,b,c,d	On slope; Horizontal growth;
T58	<i>Celtis sinensis</i>	朴樹	Lot	5	111	3	P	P	F	L	4.15	N/A	Fell	a,b,c,d	On slope;
T59	<i>Ficus hispida L. f.</i>	對葉榕	Lot	4.5	191	7	F	F	P	L	2.30	N/A	Fell	a,b,c,e	Epiphytic plants

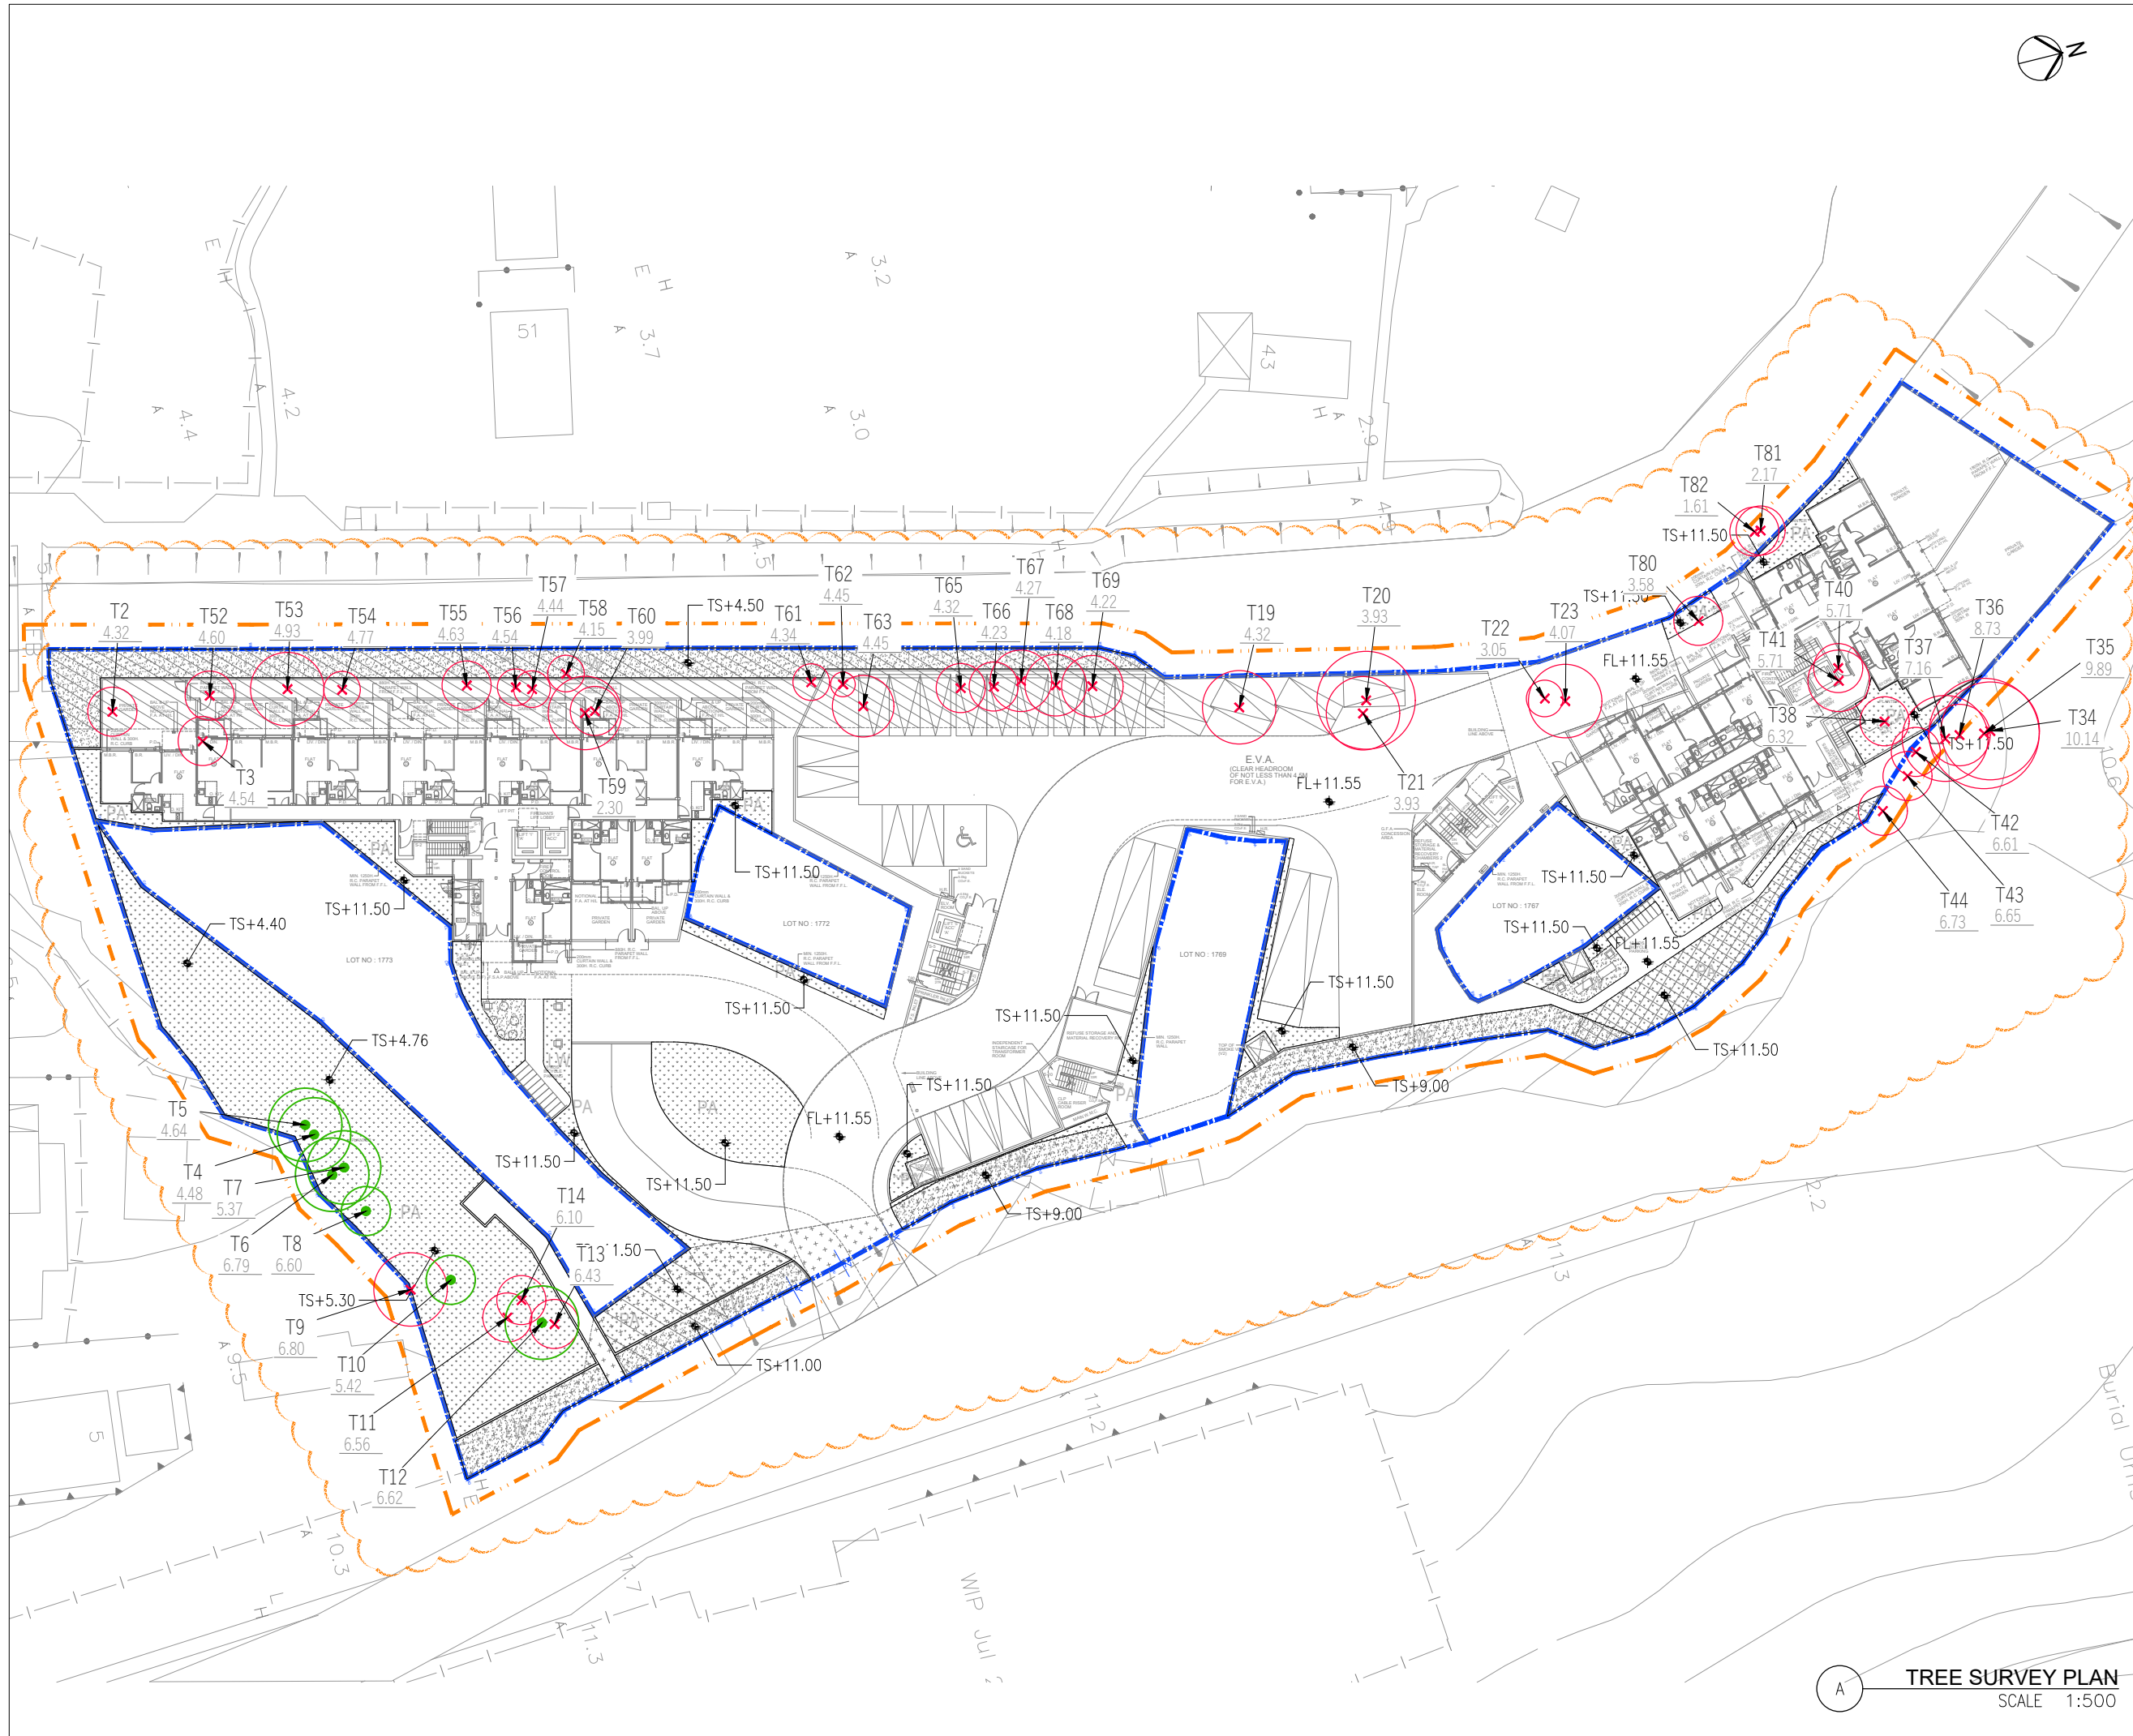
For details, please refer to Tree Assessment Schedule in **Appendix B**, Photographic Record of Existing Trees in **Appendix C** and Tree Survey and Felling Plan in **Appendix D**.

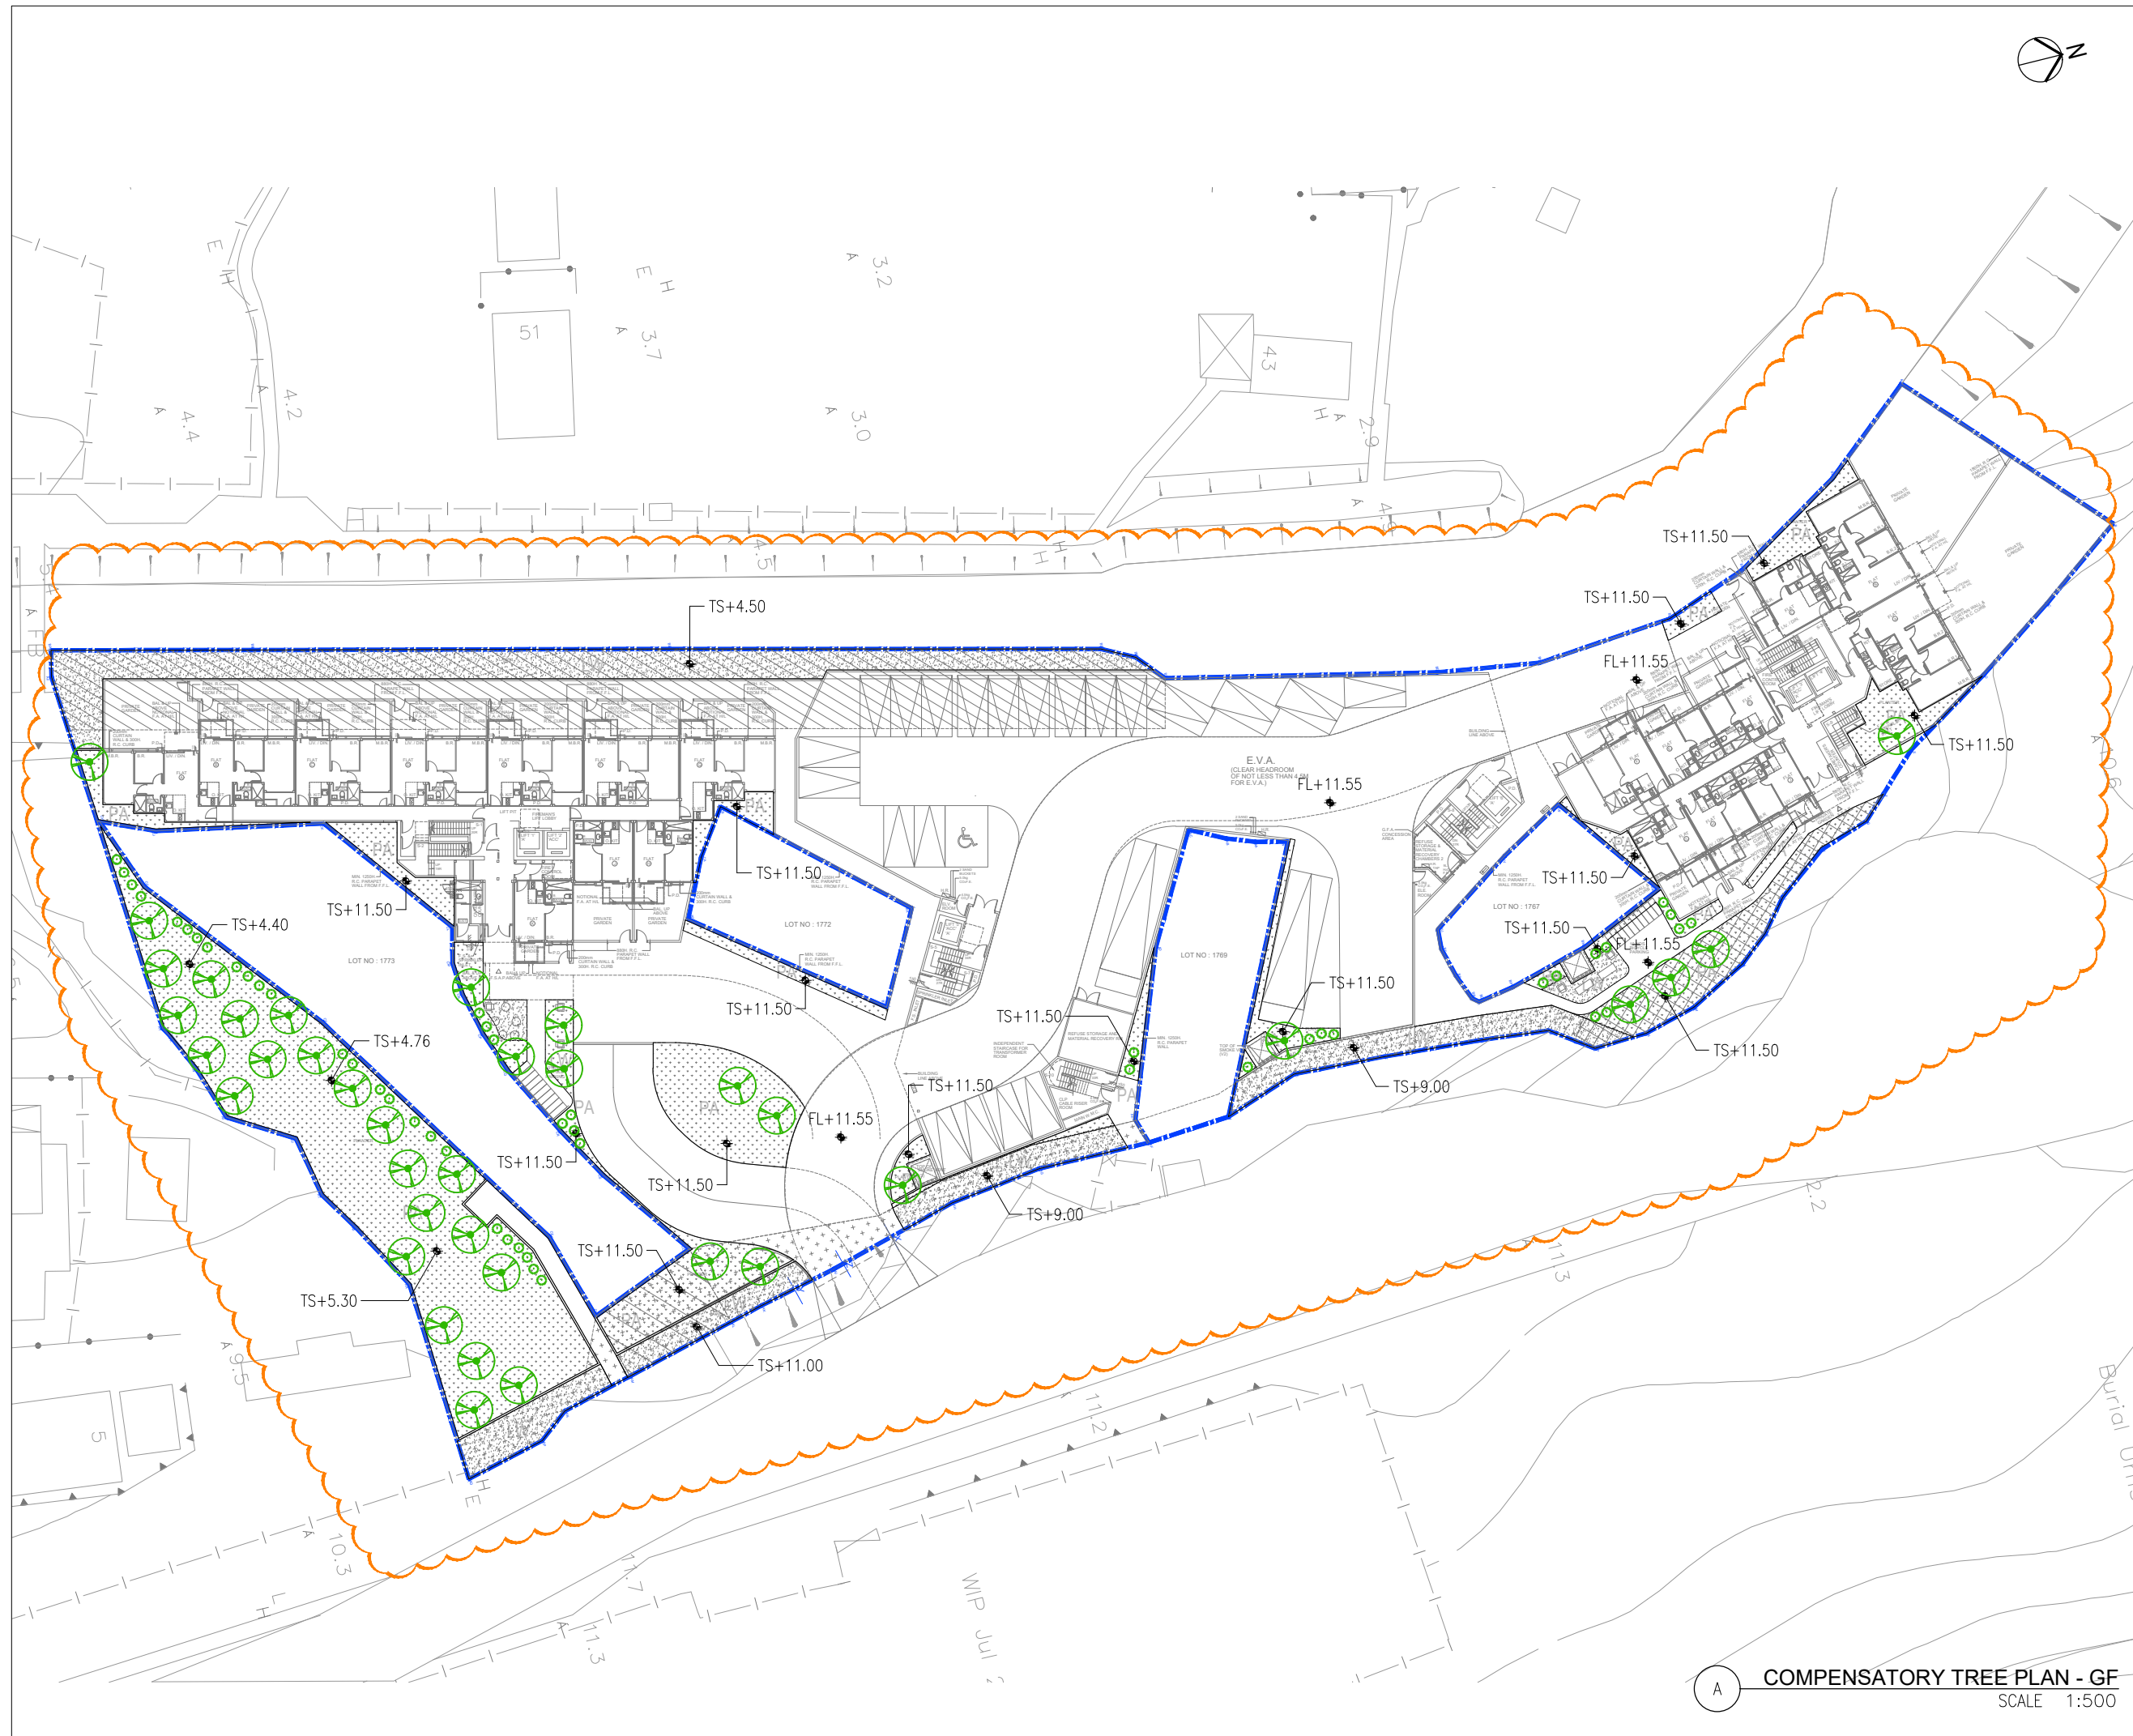
COMPENSATORY TREE PLAN - GF
 SCALE 1:500

Taking into account all the basic requirements as well as the potential constraints on the usable open space, it is confirmed that 211 nos. of new compensatory trees can be provided without jeopardizing the growing environs of the retained trees.

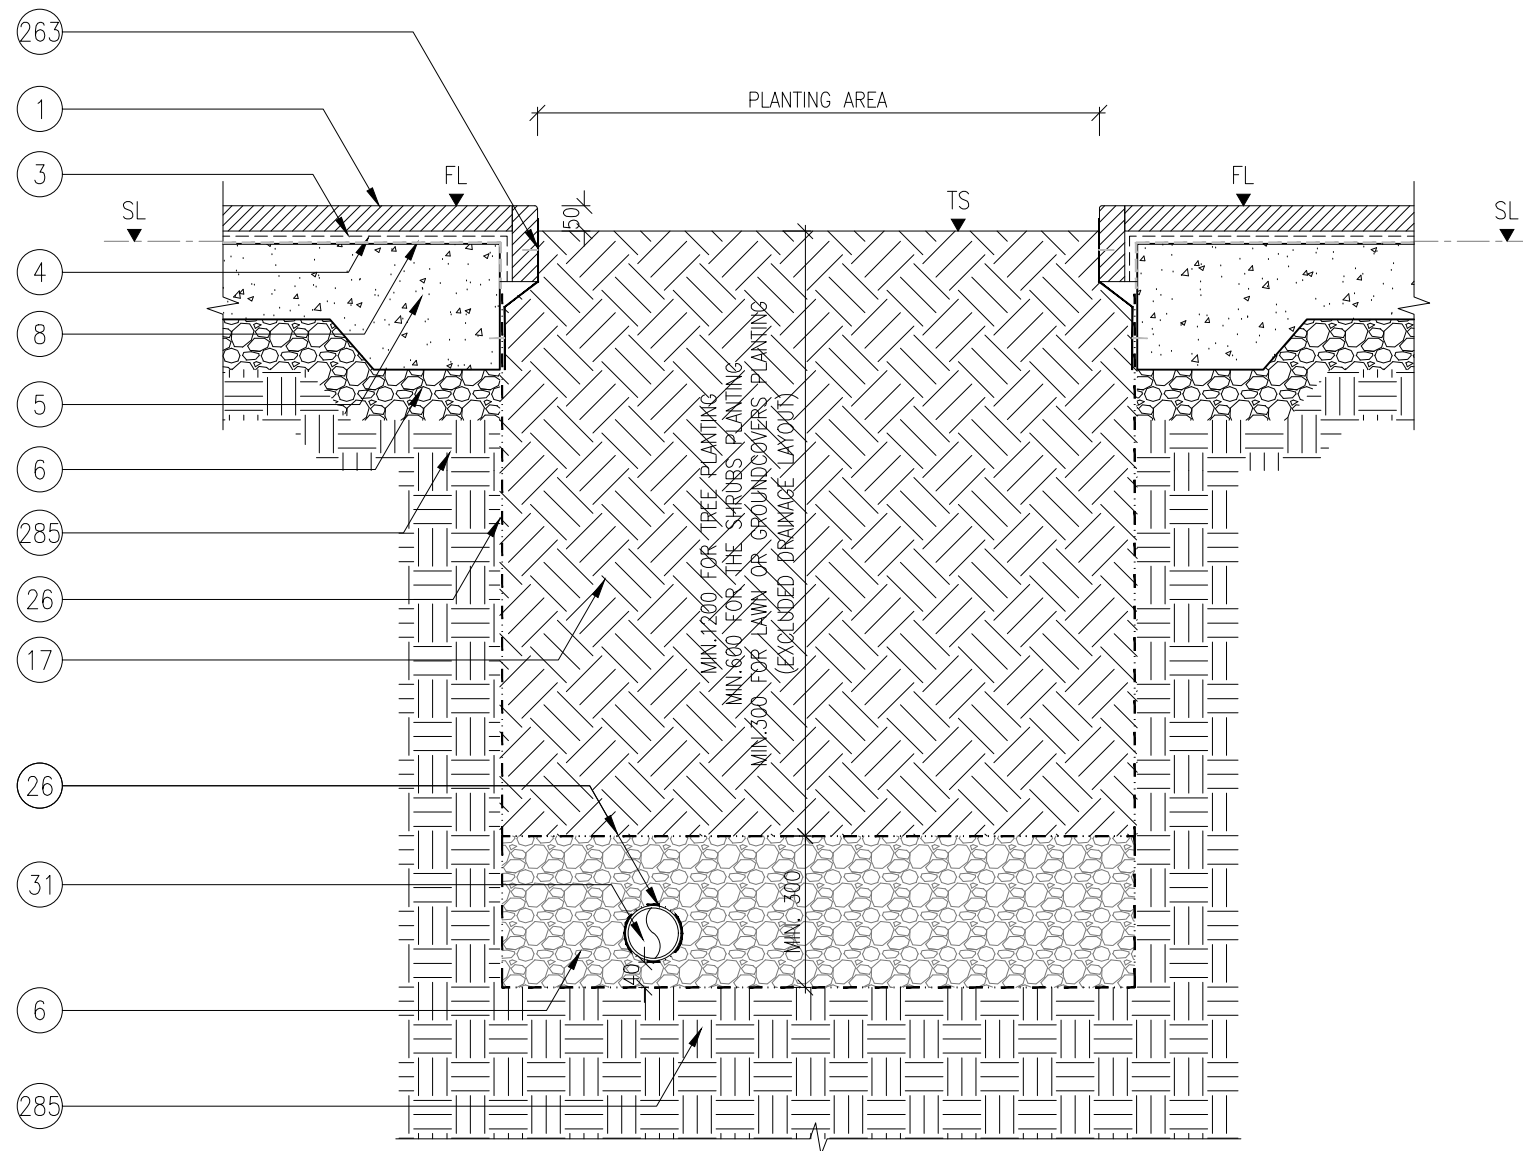
A **DETAIL (ON GRADE)**
SCALE 1:15

- All compensatory trees will be planted at-grade or on structure with not less than 1.2m soil depth excluding drainage layer (refer to **Appendix F**).
- Access path and maintenance area must be maintained for practical use of future residents.
- Trees to be planted/ arranged in such a way to permit clear and unobstructed views from each dwelling unit.
- Provision for outdoor recreation areas to be provided for practical use of future residents.
- Adequate space is allowed between trees to ensure penetration of sunlight for their viable growth.
- Not all unoccupied available open space is usable or suitable for tree planting because of the existing underground utilities.

- ① APPROVED PAVING MATERIAL (REFER TO MATERIAL PLAN)
- ③ 'KERACRETE' CEMENT MORTAR ADHESIVE OR APPROVED EQUAL
- ④ 1:3 CEMENT & SAND SCREEDING
- ⑤ REINFORCED CONCRETE STRUCTURE TO ENGINEER'S DETAIL
- ⑥ COMPACTED GRAVEL BASE COURSE TO ENGINEER'S DETAIL
- ⑧ WATERPROOFING TO ARCHITECT'S SPECIFICATION
- ⑰ SOIL MIXED AS SPECIFIED
- ⑳ GEO-TEXTILE SOIL FILTER w/ LAP 150mm MAX
- ㉑ SUB-SOIL DRAINAGE; ϕ 100mm PERFORATED PVC PIPE IN 20~40mm THK. DRAINAGE GRAVEL LAYER W/ GEO-TEXTILE FABRIC CONNECTED TO WASTE REFER TO E&M ENGINEER'S DETAILS
- ㉒ 1mm THK. STAINLESS STEEL AISI 316 FLASHING W/ LAP 100mm MAX. FIXED BY APPROVED SEALANT
- ㉓ COMPACTED SUB-GRADE TO ENGINEER'S DETAILS

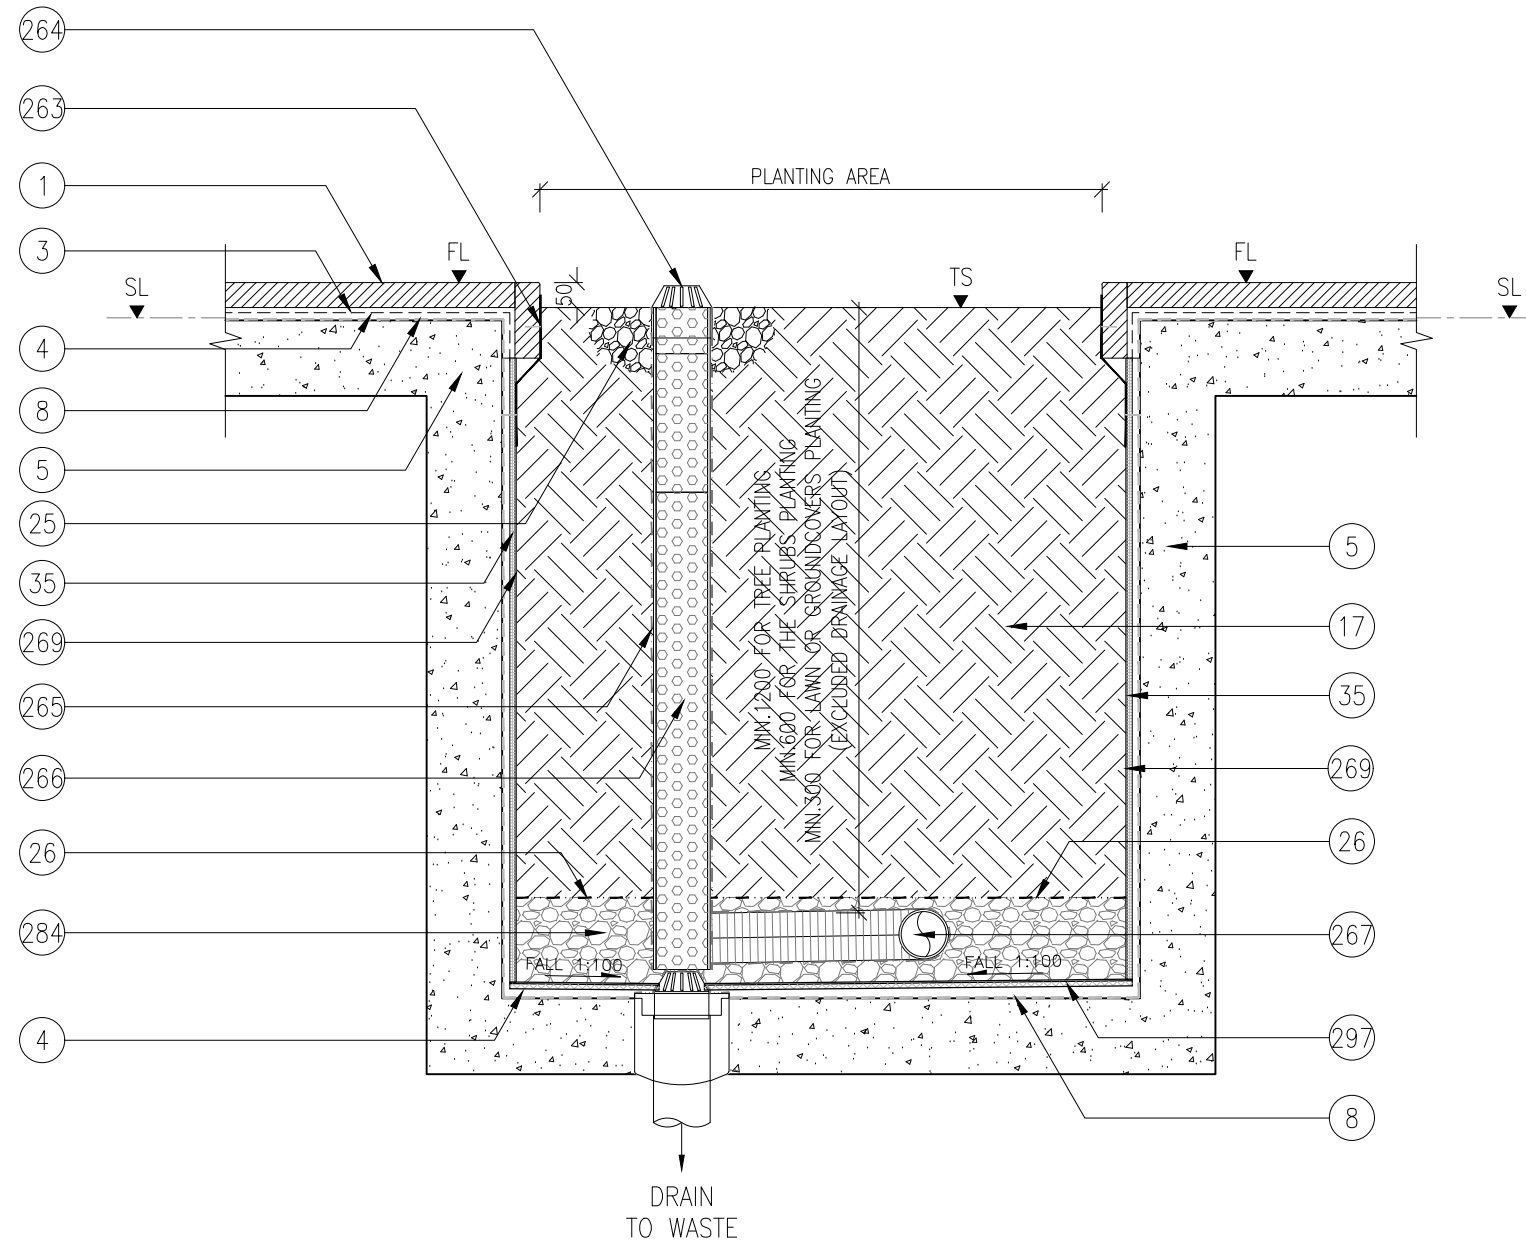
A **DETAIL (ON STRUCTURE)**
SCALE 1:15

- 1mm THK. STAINLESS STEEL AISI 316 FLASHING W/ LAP 100mm MAX. FIXED BY APPROVED SEALANT
- ②④ 'ADS' PVC DOME GRATING
- ㉔⑤ DRAIN-SLEEVE® FILTER FABRIC SOCK OR EQUIVALENT

- ㉔⑥ ϕ150mm 'ADS' SINGLE WALL CORRUGATED HDPE DRAINAGE PIPE TO BE CONNECTED TO BUILDING DRAINAGE SYSTEM INSTALLED AS PER MANUFACTURER'S RECOMMENDATIONS

- ㉔⑦ ϕ100mm 'ADS' SINGLE HDPE DRAIN PIPE WRAPPED IN PROPRIETARY GEO-FABRIC 'ADS' DRAIN FILTER SOCK TO BE INSTALLED AS PER MANUFACTURER'S RECOMMENDATIONS
