### **Tree Felling and Preservation Proposal**

**Proposed Flat with Minor Relaxation of Building Height  
Restriction at Various Lots in D.D. 3 TC and Adjoining  
Government Land, Tung Chung Road North, Tung Chung,  
Lantau Island**

**TREE FELLING AND PRESERVATION PROPOSAL  
(Amendment)**

**February 2026**

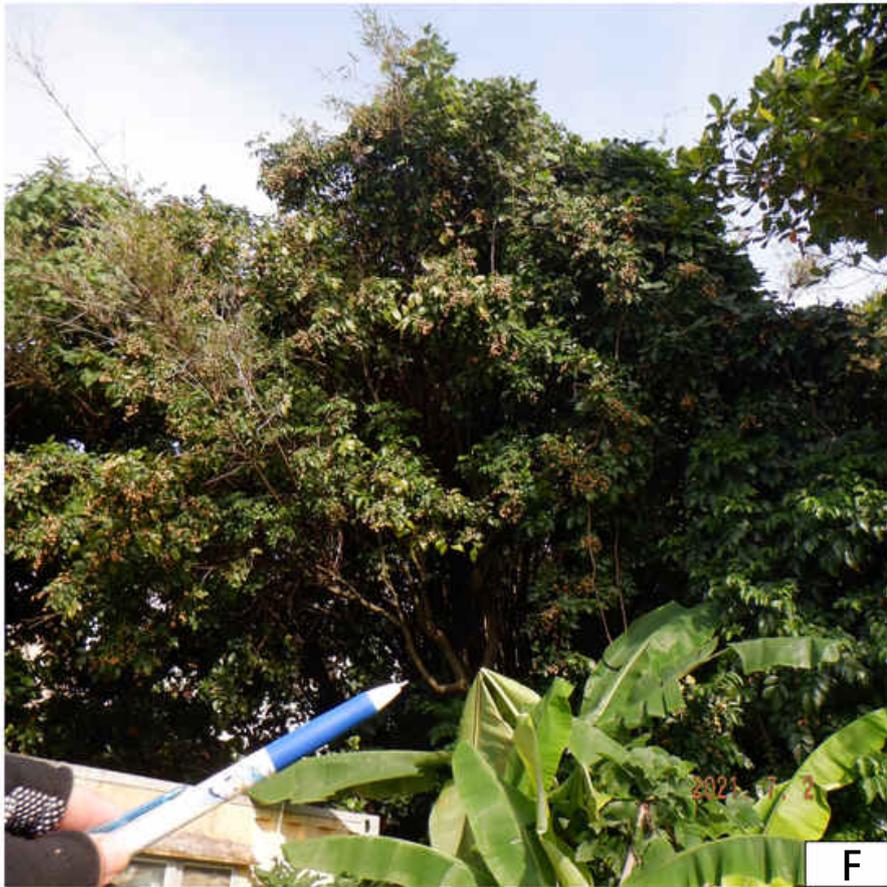
T14	<i>Clausena lansium</i>	黃皮	Lot	7	234.9	5	P	F	P	L	6.10	N/A	Fell	b,c,d	On slope; Multiple trunk; trunk base decay; collapsed by bamboo
T19	<i>Celtis sinensis</i>	朴樹	Lot	10	335	4	P	F	P	L	4.32	N/A	Fell	a,b,c,d,e	Epiphytic plants; On slope
T20	<i>Acacia confusa</i>	台灣相思	Lot	11	720	7	F	F	F	L	3.93	N/A	Fell	a,c,d,e	On slope;Multiple Trunk
T21	<i>Acacia confusa</i>	台灣相思	Lot	3	243	8	P	F	P	L	3.93	N/A	Fell	a,b,c,d	On slope; hanger dead branch; Leaning 10°
T22	<i>Celtis sinensis</i>	朴樹	Lot	5.5	190	3	P	F	P	L	3.05	N/A	Fell	a,b,c	Epiphytic plants; Leaning 20
T23	<i>Celtis sinensis</i>	朴樹	Lot	7	355	6	F	F	F	L	4.07	N/A	Fell	a,c,d	On slope; covered by epiphytic plants
T34	<i>Mallotus paniculatus</i>	白楸	Outside Lot	6	181	8	P	F	P	L	10.14	N/A	Fell	a,b,c,e	Broken branch; Leaning 45°
T35	<i>Mallotus paniculatus</i>	白楸	Outside Lot	8	201	9	F	F	P	L	9.89	N/A	Fell	a,b,c,e	Broken Trunk; epiphytic plants
T36	<i>Microcos nervosa</i>	破布葉	Outside Lot	5	167	3	P	P	P	L	8.73	N/A	Fell	a,b,c,d	On slope; Broken Trunk; epiphytic plants

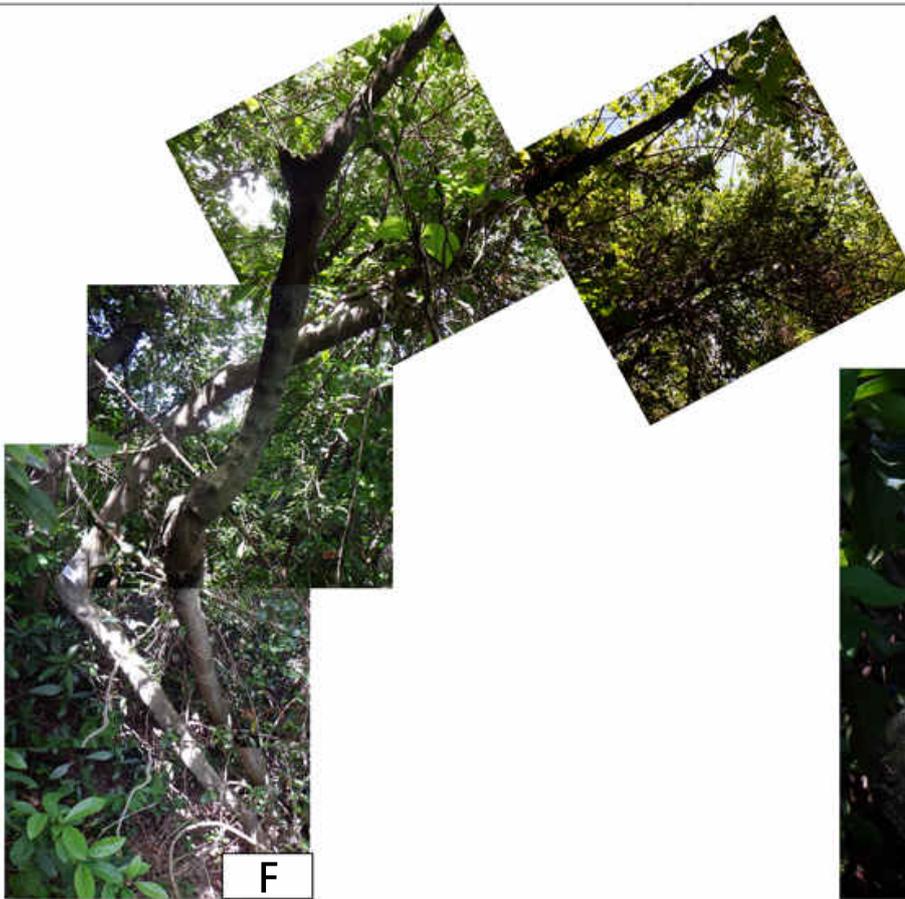
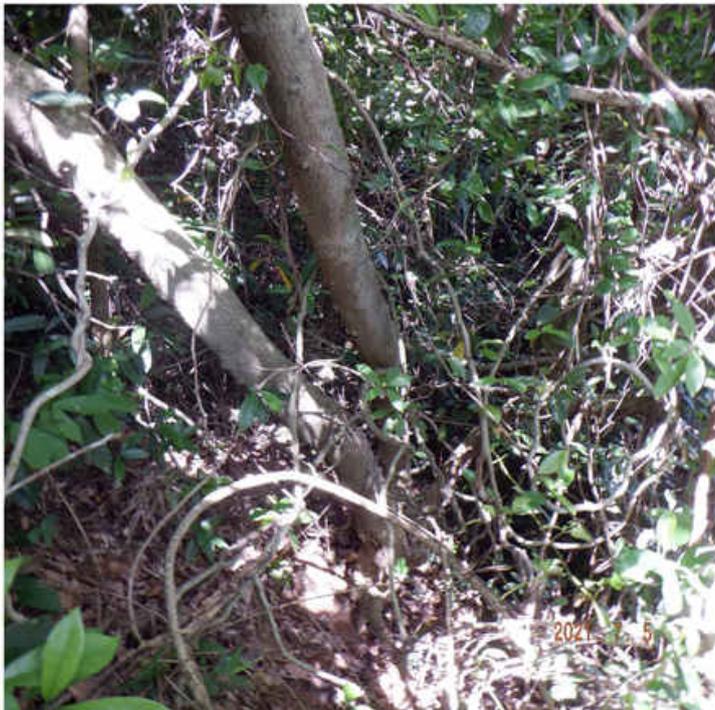
T37	<i>Mallotus paniculatus</i>	白楸	Outside Lot	5	209.2	6	P	P	P	L	7.16	N/A	Fell	a,b,c,d	On slope; Multiple Trunk×2; bending trunk
T38	Dead tree	死樹	Lot	7.3	138	6	-	-	-	-	6.32	N/A	Fell	a,f	fungi fruit bodies; leaning; Living crown ratio in zero;
T40	<i>Cleistocalyx nervosum</i>	水翁	Lot	8.5	326	7	F	F	P	L	5.71	N/A	Fell	a,b,c,e	Broken twigs; dieback branch; epiphytic plants
T41	<i>Cleistocalyx nervosum</i>	水翁	Lot	8.5	349	8	F	P	F	L	5.71	N/A	Fell	a,b,c,e	Leaning; unbalance crown ; epiphytic plants; Asymmetric tree canopy
T42	<i>Mallotus paniculatus</i>	白楸	Outside Lot	8.5	337.4	8	F	F	P	L	6.61	N/A	Fell	a,b,c,d	Long Wound; Multiple Trunk; On slope; Leaning; epiphytic plants
T43	<i>Microcos nervosa</i>	破布葉	Outside Lot	8.5	189.8	7	P	P	P	L	6.65	N/A	Fell	a,b,c,d	On slope; Hanger dead branch;
T44	<i>Microcos nervosa</i>	破布葉	Outside Lot	7	209	5	F	P	P	L	6.73	N/A	Fell	a,b,c	Leaning 45° ; tree crown covered by epiphytic plants; broken trunk

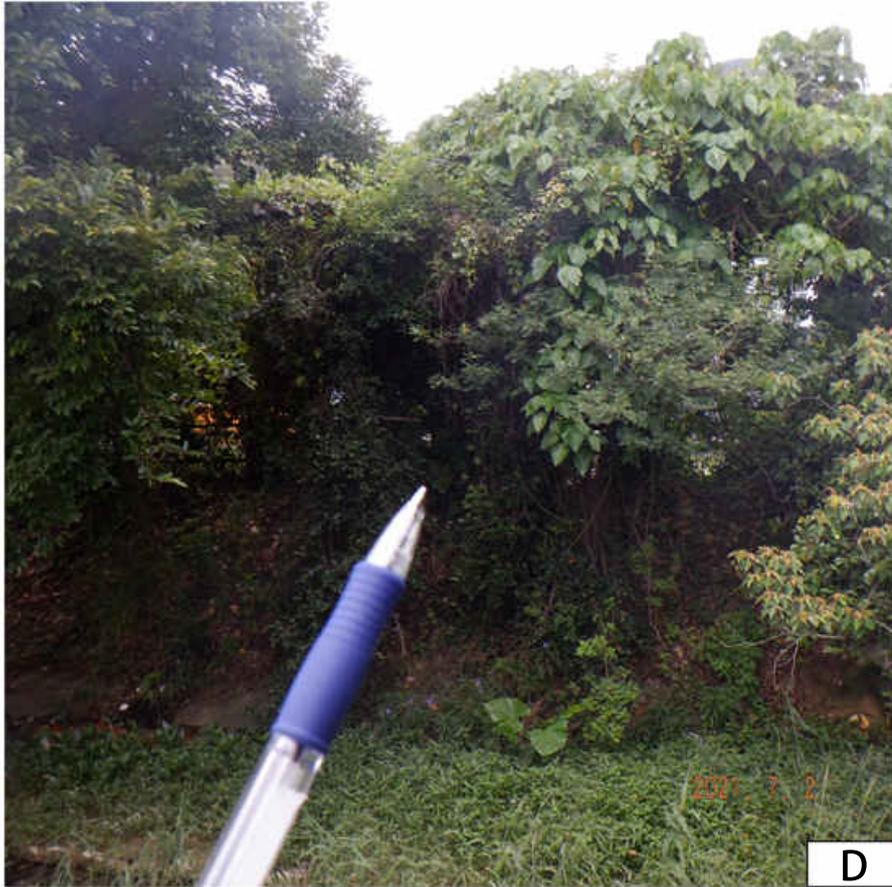
T52	Dead tree	死樹	Lot	3.5	414.9	4	-	-	-	-	4.60	N/A	Fell	a,f	Multiple Trunk, Tree tag had not found on site
T53	<i>Celtis sinensis</i>	朴樹	Lot	6	600	12	F	F	F	L	4.93	N/A	Fell	a,c,d,e	Leaning 45° / On slope/ Multiple Trunk
T54	<i>Macaranga tanariu</i>	血桐	Lot	5	316	4	F	P	F	L	4.77	N/A	Fell	a,b,c,d	On slope/ Multiple Trunk×2
T55	<i>Celtis sinensis</i>	朴樹	Lot	4.5	194	5	F	P	F	L	4.63	N/A	Fell	a,b,c,d	On slope; whole tree covered by epiphytic plants
T56	<i>Microcos nervosa</i>	破布葉	Lot	4.3	96	4.5	F	P	F	L	4.54	N/A	Fell	a,b,c,d	On slope; Multiple Trunk
T57	<i>Celtis sinensis</i>	朴樹	Lot	6.5	127	6	P	F	F	L	4.44	N/A	Fell	a,b,c,d	On slope; Horizontal growth;
T58	<i>Celtis sinensis</i>	朴樹	Lot	5	111	3	P	P	F	L	4.15	N/A	Fell	a,b,c,d	On slope;
T59	<i>Ficus hispida L. f.</i>	對葉榕	Lot	4.5	191	7	F	F	P	L	2.30	N/A	Fell	a,b,c,e	Epiphytic plants

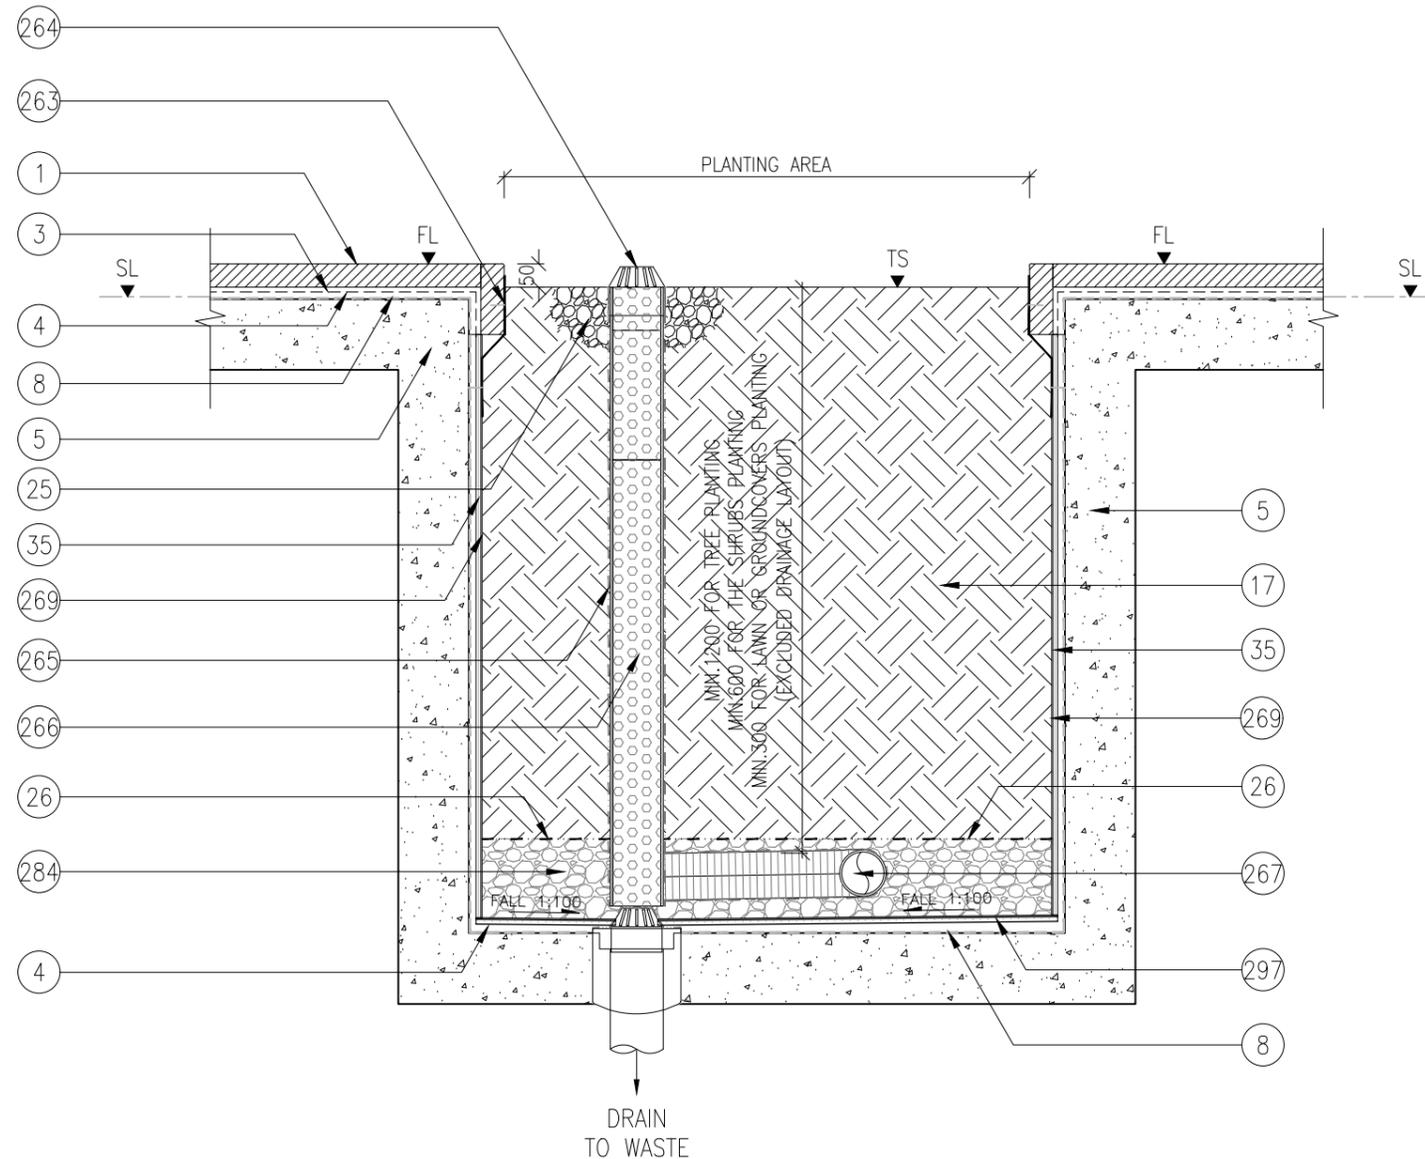
A **DETAIL (ON STRUCTURE)**  
SCALE 1:15

- ㉓ MiraDRAIN 9000 COMPOSITE DRAINAGE SYSTEM OR APPROVED EQUAL
- ㉔ 1mm THK. STAINLESS STEEL AISI 316 FLASHING W/ LAP 100mm MAX. FIXED BY APPROVED SEALANT

- ㉔ 'ADS' PVC DOME GRATING
- ㉔ DRAIN-SLEEVE® FILTER FABRIC SOCK OR EQUIVALENT
- ㉔  $\phi 150$ mm 'ADS' SINGLE WALL CORRUGATED HDPE DRAINAGE PIPE TO BE CONNECTED TO BUILDING DRAINAGE SYSTEM INSTALLED AS PER MANUFACTURER'S RECOMMENDATIONS

- ㉔  $\phi 100$ mm 'ADS' SINGLE HDPE DRAIN PIPE WRAPPED IN PROPRIETARY GEO-FABRIC 'ADS' DRAIN FILTER SOCK TO BE INSTALLED AS PER MANUFACTURER'S RECOMMENDATIONS

- All compensatory trees will be planted at-grade or on structure with not less than 1.2m soil depth excluding drainage layer (refer to **Appendix F**).
- Access path and maintenance area must be maintained for practical use of future residents.
- Trees to be planted/ arranged in such a way to permit clear and unobstructed views from each dwelling unit.
- Provision for outdoor recreation areas to be provided for practical use of future residents.
- Adequate space is allowed between trees to ensure penetration of sunlight for their viable growth.
- Not all unoccupied available open space is usable or suitable for tree planting because of the existing underground utilities.
