**REDEVELOPMENT OF NOS. 20-24 TAI YAU
STREET, SAN PO KONG, KOWLOON, N.K.I.L.S
4735, 4736, 4737, 4738, 4739 RP, 4739 S.A &
4739 S.B**

CONTAMINATION ASSESSMENT PLAN

22 July 2025

Ref No: RT24152_02-LCA-01r1

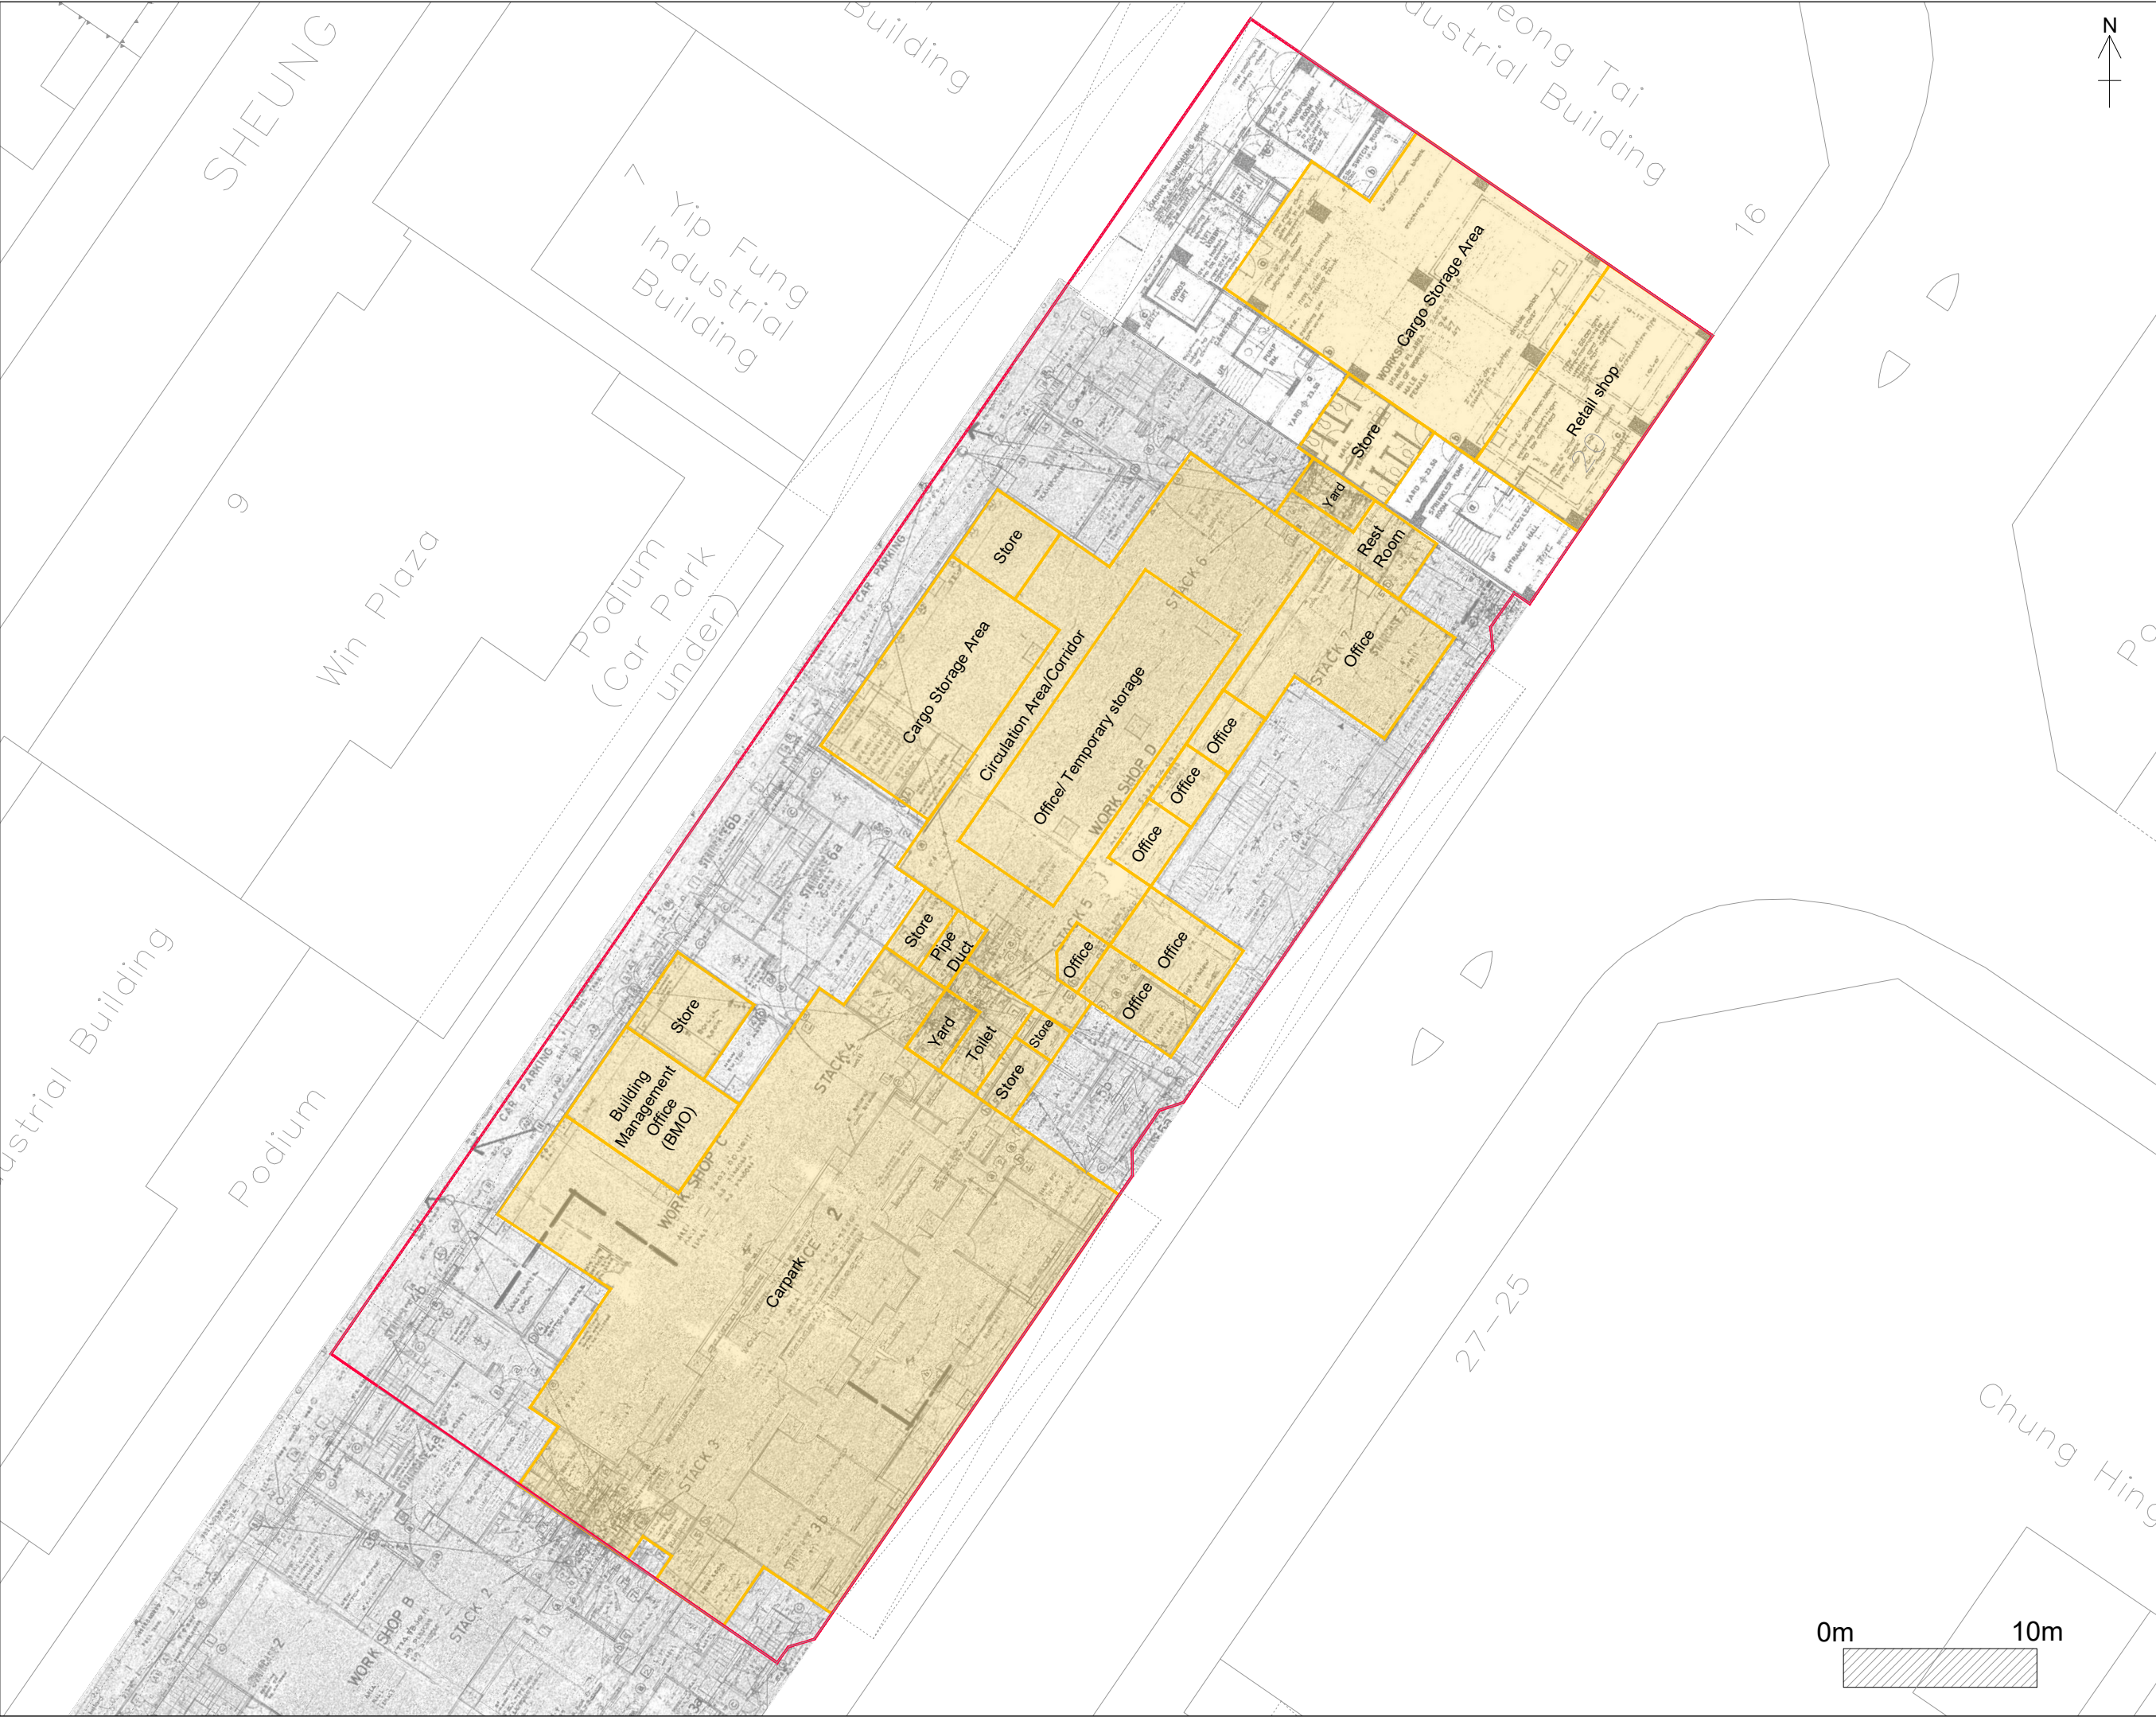
FIGURE 2 EXISTING LAYOUT PLAN

- Project Site
- Existing Layout after the renovation in '80s

- Remarks:
- Non-shaded areas are those that were not renovated in the '80s and have remained unchanged since the building was occupied.
 - The original GBP for 20 Tai Yau Street and 22-24 Tai Yau Street can be found in Appendix C.

In order to verify the existing site condition, a site inspection of the G/F of 20 Tai Yau Street and G/F of 22-24 Tai Yau Street by the Consultant was carried out on 10 July 2024. Site walkover checklist and photo records are provided in **Appendix E** and **Appendix F**. The existing layout of the Project Site showing the change of space after the renovation in the '80s is provided in **Figure 2**.

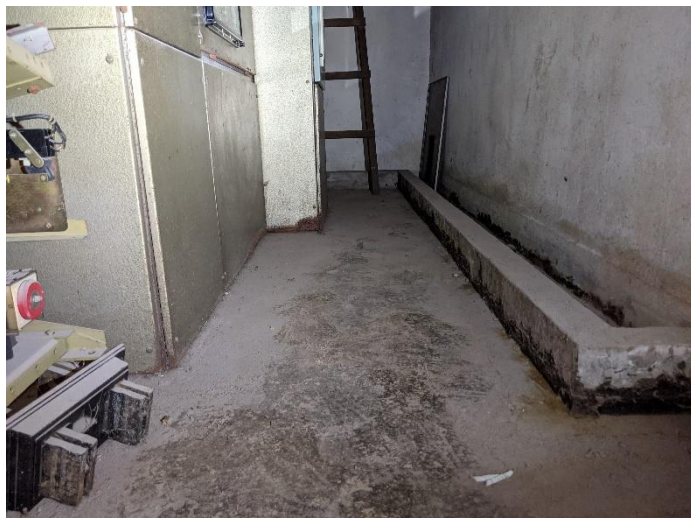
Photo 8: Switch Room at G/F

As advised by Project Proponent, the building has been used for security printing since the '80s. All printing machines, materials and chemicals are stored at 3/F to 8/F with a security gate. Therefore, the G/F workshop has never been used for printing or any industrial activities with the use of chemicals. The female and male toilets at G/F have been demolished and changed into store room (Photo 6). Only pallets are stored in the store room with mold and damp stains observed on the wall and floor of the store room (Photo 6). Meanwhile, no change is observed for the corridor and plant room at the G/F (Photo 7 – 8). Dust and damp stains were observed in the switch room (Photo 8).

Switch Room (Existing space use remained unchanged)	G/F of 20TYS	Photo 8	Dust and damp stains are observed in the area. The switch room consists of switchboards and meters, which do not involve any use of chemicals. It is unlikely to have land contamination issue.	N/A	N/A
Switch Room (Existing space use remained unchanged)	G/F of 22 - 24TYS	Photo 20	Spalling concrete and dust stains are observed in the area. The switch room consists of switchboards and meters, which do not involve any use of chemicals. It is unlikely to have land contamination issue.	N/A	N/A
Toilet (Existing rest room)	G/F of 22 - 24TYS	Photo 33	Dust and damp stains are observed in the area. Considering the previous and existing land use do not involve any use of chemicals, it is unlikely to have land contamination issue.	N/A	N/A

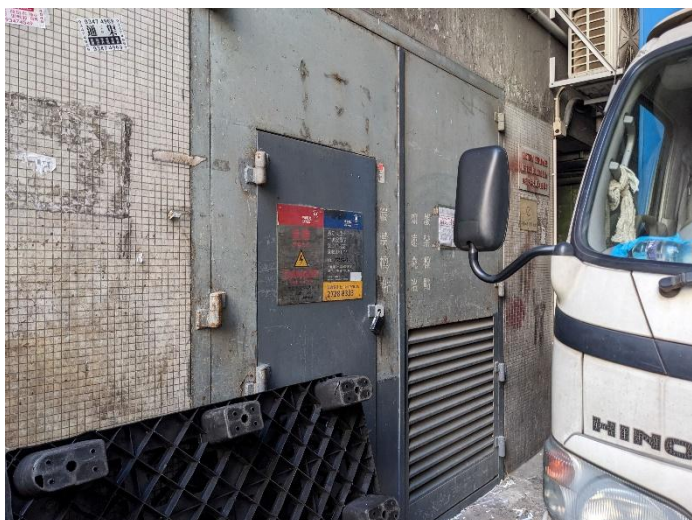
Photo 9: Transformer room at G/F

Transformer Room (Existing space use remained unchanged)	G/F of 20TYS	Photo 9	The space is inaccessible with no available information during the site visit. Further contamination investigation shall be conducted once access is granted from CLP.	Metals, PCRs, VOCs, SVOCs and PCBs	Grid sampling covering hotspot

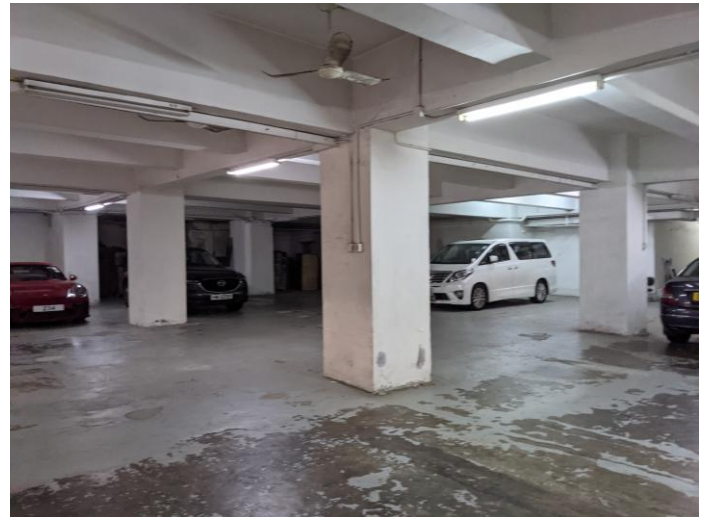
Photo 16: Existing carpark (previous workshop C & toilet & store room at G/F)

Management Office (BMO)(Photo 17). Waterproof protective paint has been used as the floor finish of the carpark with some peeling observed, while no observable oil stain on the carpark floor (Photo 16 – 18). The boiler room near workshop C at G/F has changed to a store room (Photo 19) with unknown stains observed on the floor. Hand tools are stored inside the store room (Photo 19). Spalling concrete and some dust stains were observed on the floor of the switch room (Photo 20).

Store room near staircase 3 (Existing carpark)	G/F of 22 - 24TYS	Photo 16	The store room was demolished and used as carpark currently. The previous stored material and the previous ground condition were uncertain. Fuels and chemicals may potentially stored in the store room. It is likely to have land contamination issue. Instructive site investigation shall be carried out.	Metals, PCRs, VOCs, and SVOCs	Grid sampling covering hotspot
Two store rooms near staircase 5 (Existing space use remained unchanged)	G/F of 22 - 24TYS	Photo 26	Although no chemical stain is observed at these areas, previous stored material and the previous ground condition were uncertain. Fuels and chemicals may potentially stored in the store room. Mold and damp stains were observed on the floor. It is likely to have land contamination issue. Instructive site investigation shall be carried out.	Metals, PCRs, VOCs, and SVOCs	Grid sampling covering hotspot, hotspot

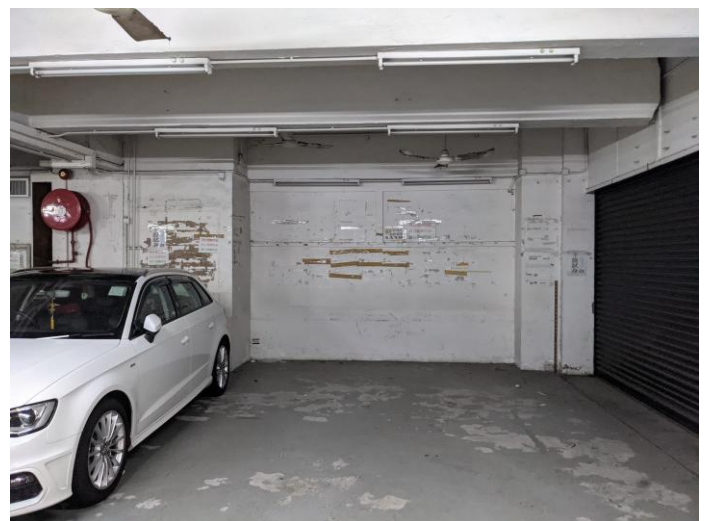
Photo 18: Existing carpark (previous board room and first aid room at G/F)

Board room, first aid room (Existing carpark)	G/F of 22 - 24TYS	Photo 18	Peeling waterproof protective paint was observed at the existing carpark. It is likely to have land contamination issue. Considering the size ratio of existing carpark at G/F, sampling for existing carpark can be covered in the regular grid samples.	Metals, PCRs, VOCs, and SVOCs	Grid sampling covering hotspot
Workshop D (Existing office and temporary storage)	G/F of 22 - 24TYS	Photo 27-32	The area was used for garment manufacturing before the '80s. No available information to determine whether there is any heavy machines or heavy industrial activities in the space. Currently temporary storage contains office appliances. Peeling vinyl flooring was observed. It is likely to have land contamination issue. Considering the size ratio of workshop D at G/F, sampling for workshop D can be covered in the regular grid samples.	Metals, PCRs, VOCs, and SVOCs	Grid sampling covering hotspot

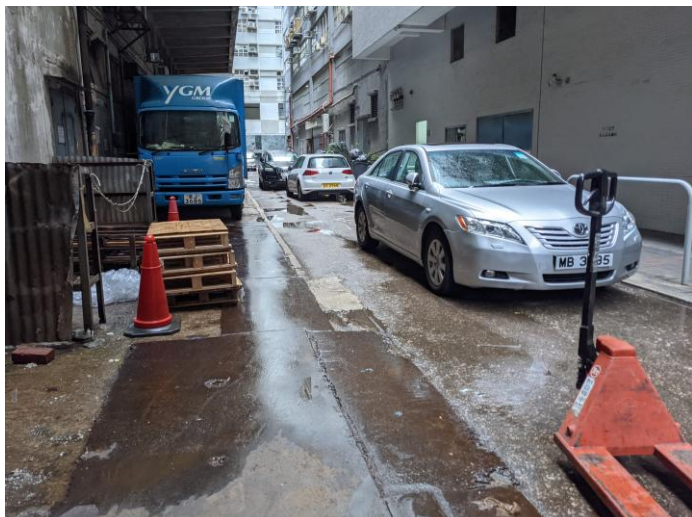
Photo 21: Car parking space at the back lane is covered by the metal plate at G/F

According to the indicated GBP provided in **Appendix C**, two underground fuel tanks are situated in the loading/unloading space at the back lane. During the site visit, it was observed that the entire loading/unloading space at the back lane is covered with metal plates, making it impossible to inspect the condition of the underground fuel tanks (Photo 21). While the section drawing of the underground fuel tank in **Appendix C** illustrates a pipe structure within the underground fuel tank, the exact location of this pipeline is not shown in any of the retrieved layout drawings from relevant government departments. The Project Proponent stated that the underground fuel tanks were decommissioned during renovations in the '80s. The pipeline shown in the section drawing was likely connected to the demolished boiler rooms. However, the precise routing and location of the pipeline remains uncertain. Further contamination investigation shall be conducted once the metal plates are removed.

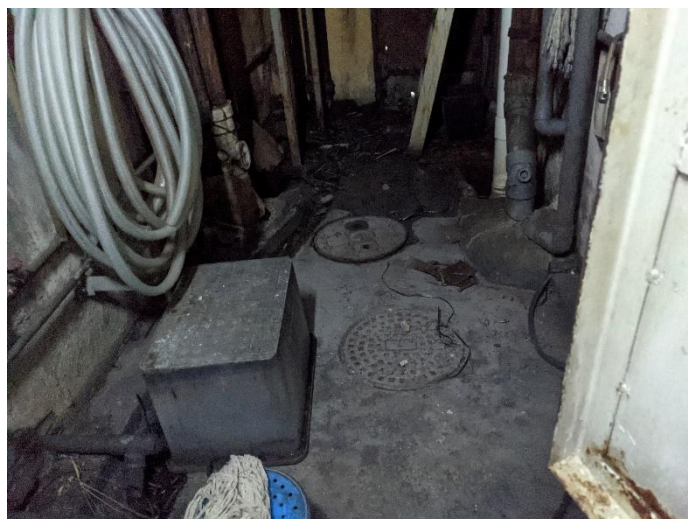
Photo 34: Yard at G/F

The toilet near cargo lift and staircase 6a has been demolished and used as store room (Photo 25) with closets and staff clothes observed inside the store room, which served as changing room for staff and drivers. The store rooms near staircase 5 at G/F have been downsized and part of the area was used as corridor (Photo 26). Office appliances and paper were stored in the store room with some water and damp stains observed on the floor (Photo 26). The toilet near staircase 7 at G/F has been changed to the workers/drivers' restroom (Photo 33) with dust and damp stains observed on the floor. The yard at G/F is an outdoor space for pipe duct, MVAC outdoor units and toilet exhaust ventilation (Photo 34). Water hose and mop are observed in the yard (Photo 34).

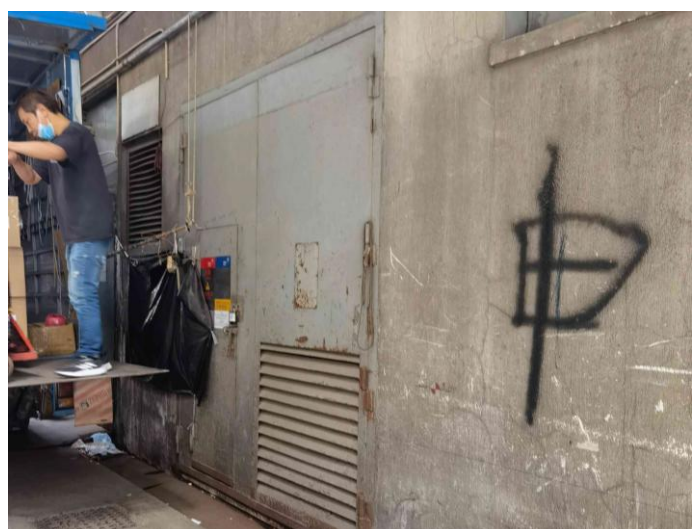
Photo 35: Transformer room for 22 Tai Yau Street at G/F

Two transformer rooms operated by China Light Power (CLP) are situated at the north of the building at G/F, which is currently in use and inaccessible during the site visit (Photo 35 – 36). Further contamination investigation shall be carried out after the termination of the transformer or once access is granted from CLP.

Area ⁽¹⁾	Location	Photo ID	Necessity and Justification for Hotspot	Chemicals of Concern (COCs) ⁽²⁾	Sampling Type
Two Transformer Rooms (Existing space use remained unchanged)	G/F of 22 - 24TYS	Photo 35-36	The space is inaccessible with no available information during the site visit. Further contamination investigation shall be conducted once access is granted from CLP.	Metals, PCRs, VOCs, SVOCs and PCBs	Grid sampling covering hotspot
Underground fuel tanks and their associated pipelines (Existing space use remained unchanged)	G/F of 22 - 24TYS	Photo 21	<p>The underground fuel tanks are covered with metal plates and the condition of the underground fuel tanks is uncertain. The exact location of the associated pipeline is uncertain. Fuels may potentially exist in underground fuel tanks and their associated pipelines. Further contamination investigation shall be conducted once the metal plates are removed.</p> <p>It is likely to have land contamination issues for the underground fuel tanks and their associated pipelines. Instructive site investigation shall be carried out.</p>	Metals, PCRs, VOCs, and SVOCs	Hotspot
