Landscape Master Plan and Tree Preservation Proposal

**S16 Planning Application for Amendment to Approved Hotel &  
Related Tourism Development Former Marine Police  
Headquarters Site Junction of Canton Road and Salisbury  
Road, Tsim Sha Tsui**

**Landscape Master Plan**

**27<sup>th</sup> November 2023**

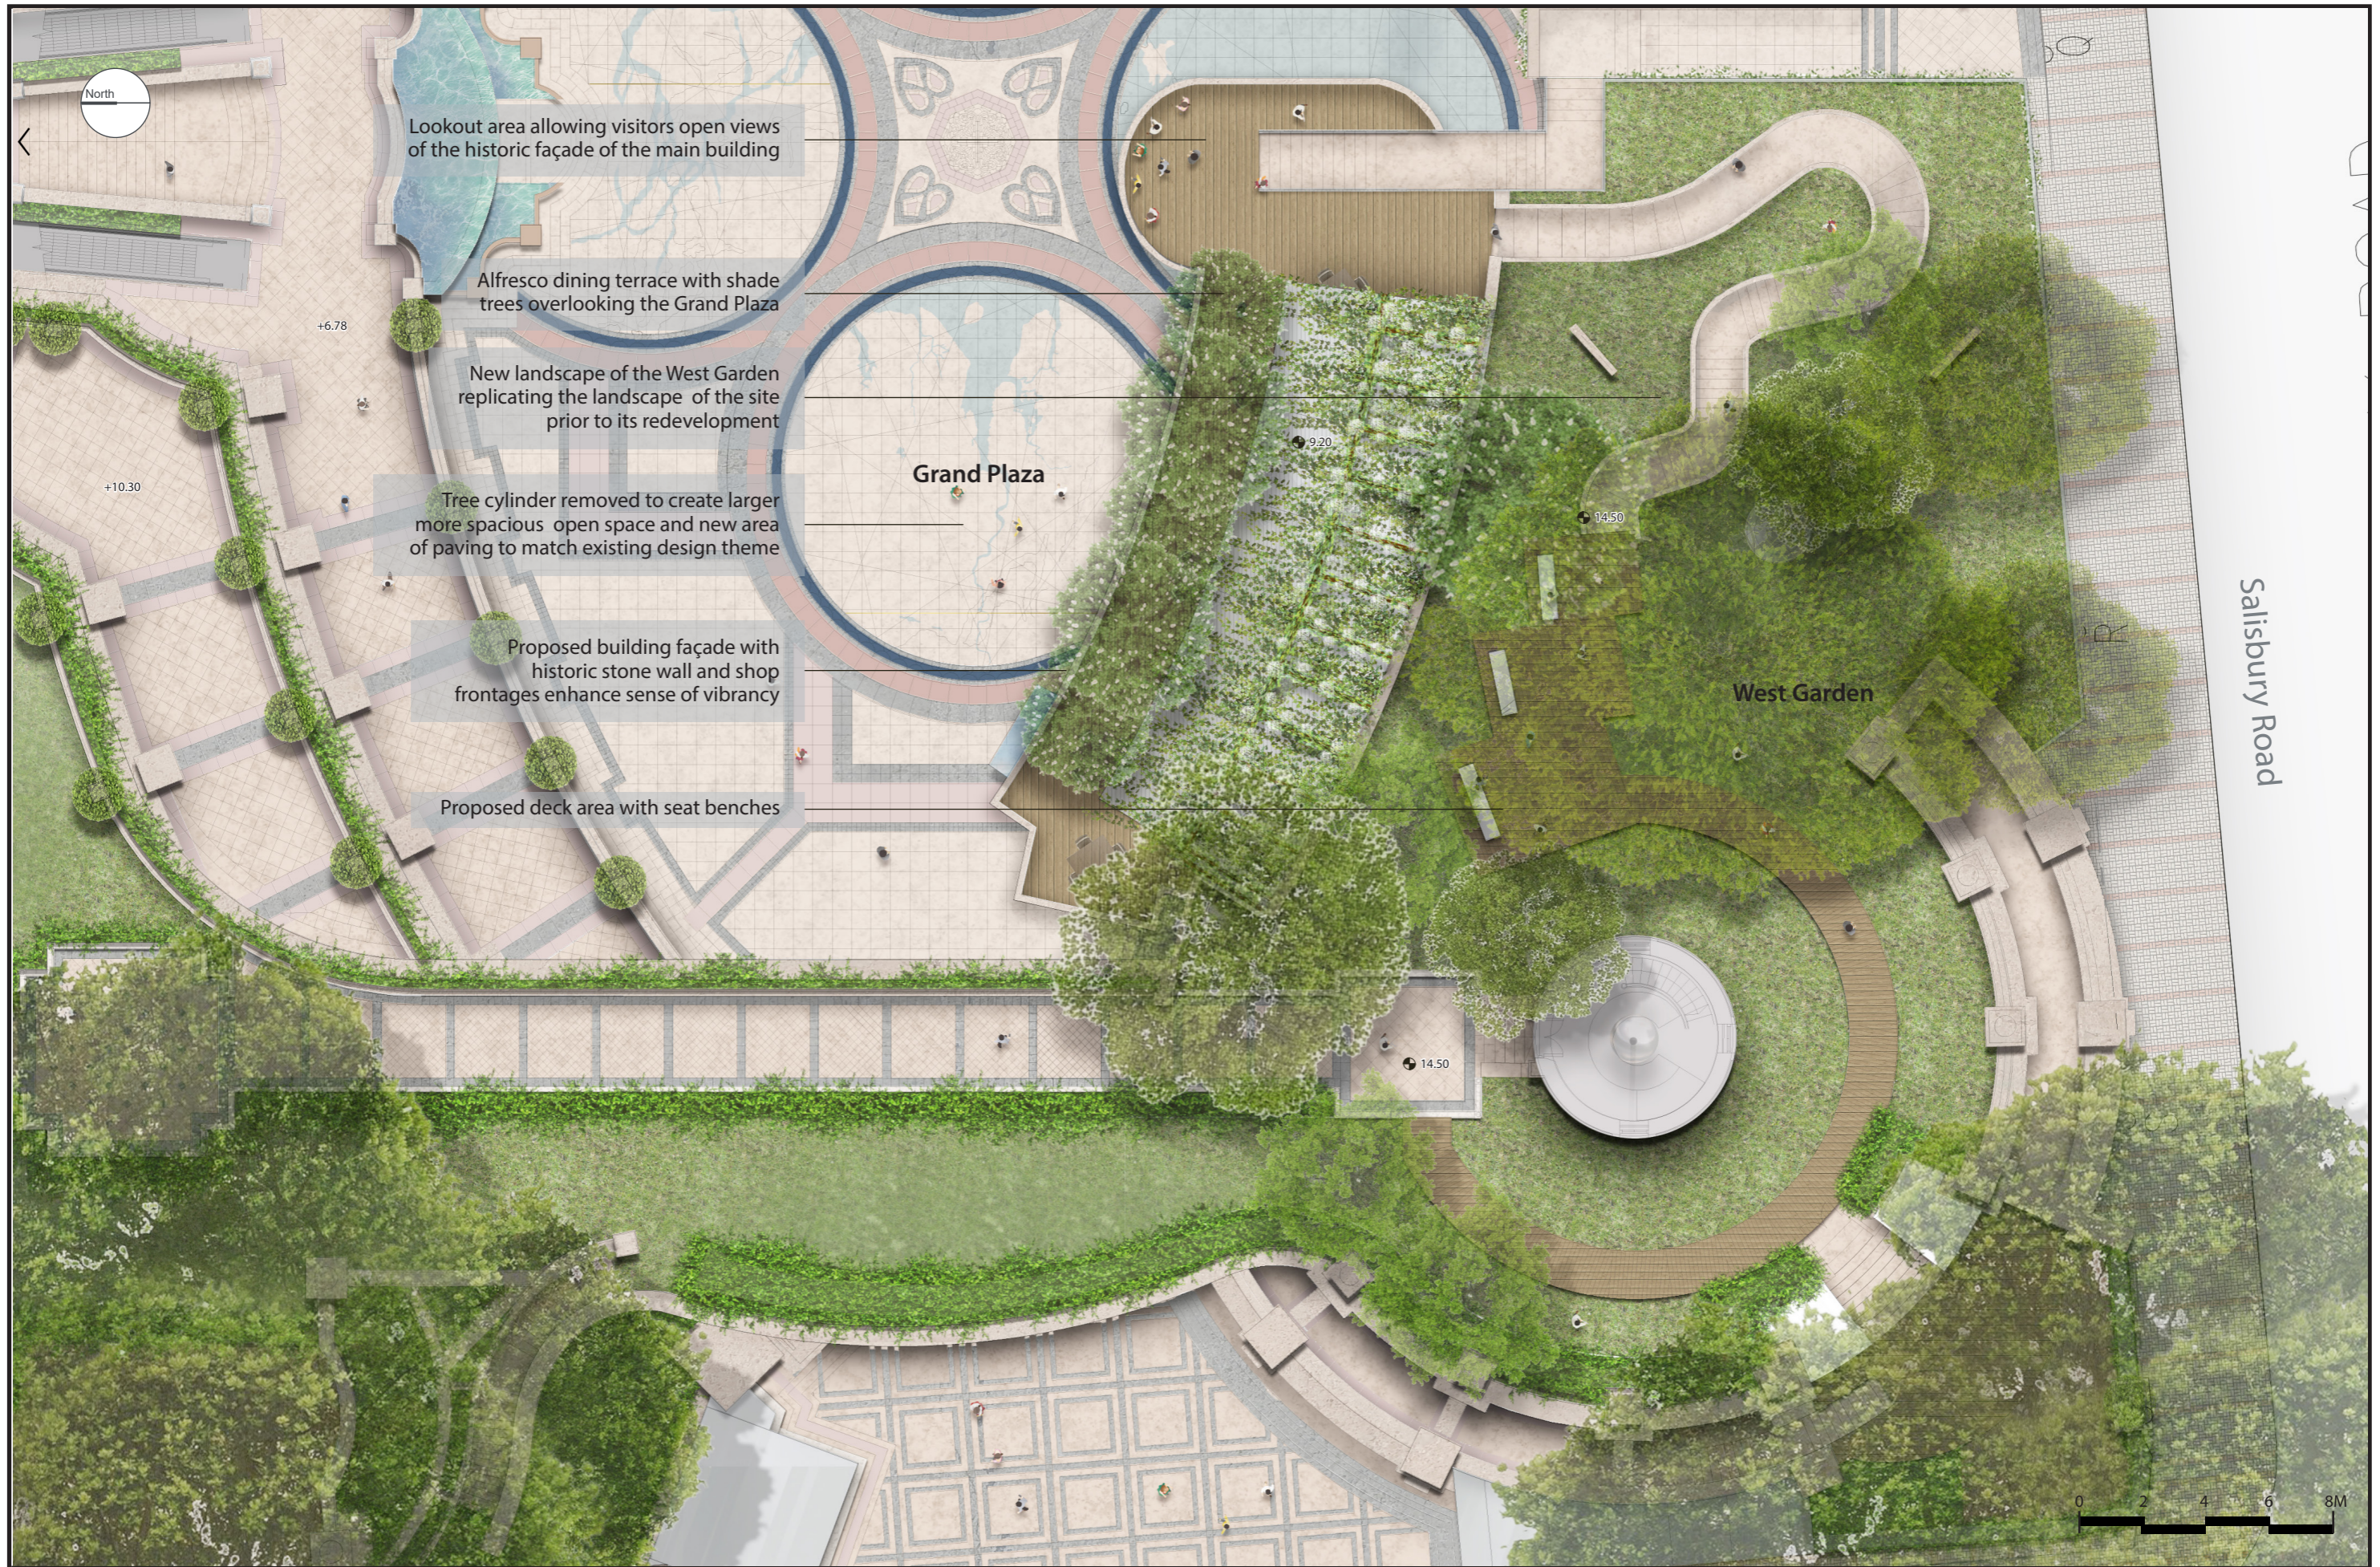
FIGURE TITLE  
 S16 Planning Application for Amendment to Approved Hotel & Related Tourism Development  
 at the FMPHQ Site j/o of Canton Road and Salisbury Road, TST  
**Landscape Master Plan - Blow-up Plan - West Garden**

6.7 It is envisaged that the West Garden will provide the location for the replacement for tree T54, the large *Ficus microcarpa* which collapsed during Typhoon Mangkhut. The tree will be planted in the centre of the summit of the slope and will be brought to site as an oversized specimen to provide a more immediate mature effect. The rooting structures of the new tree will be able to take advantage of the large soil body covering the whole of the top of the West Garden and to a depth of approximately 2,000mm.

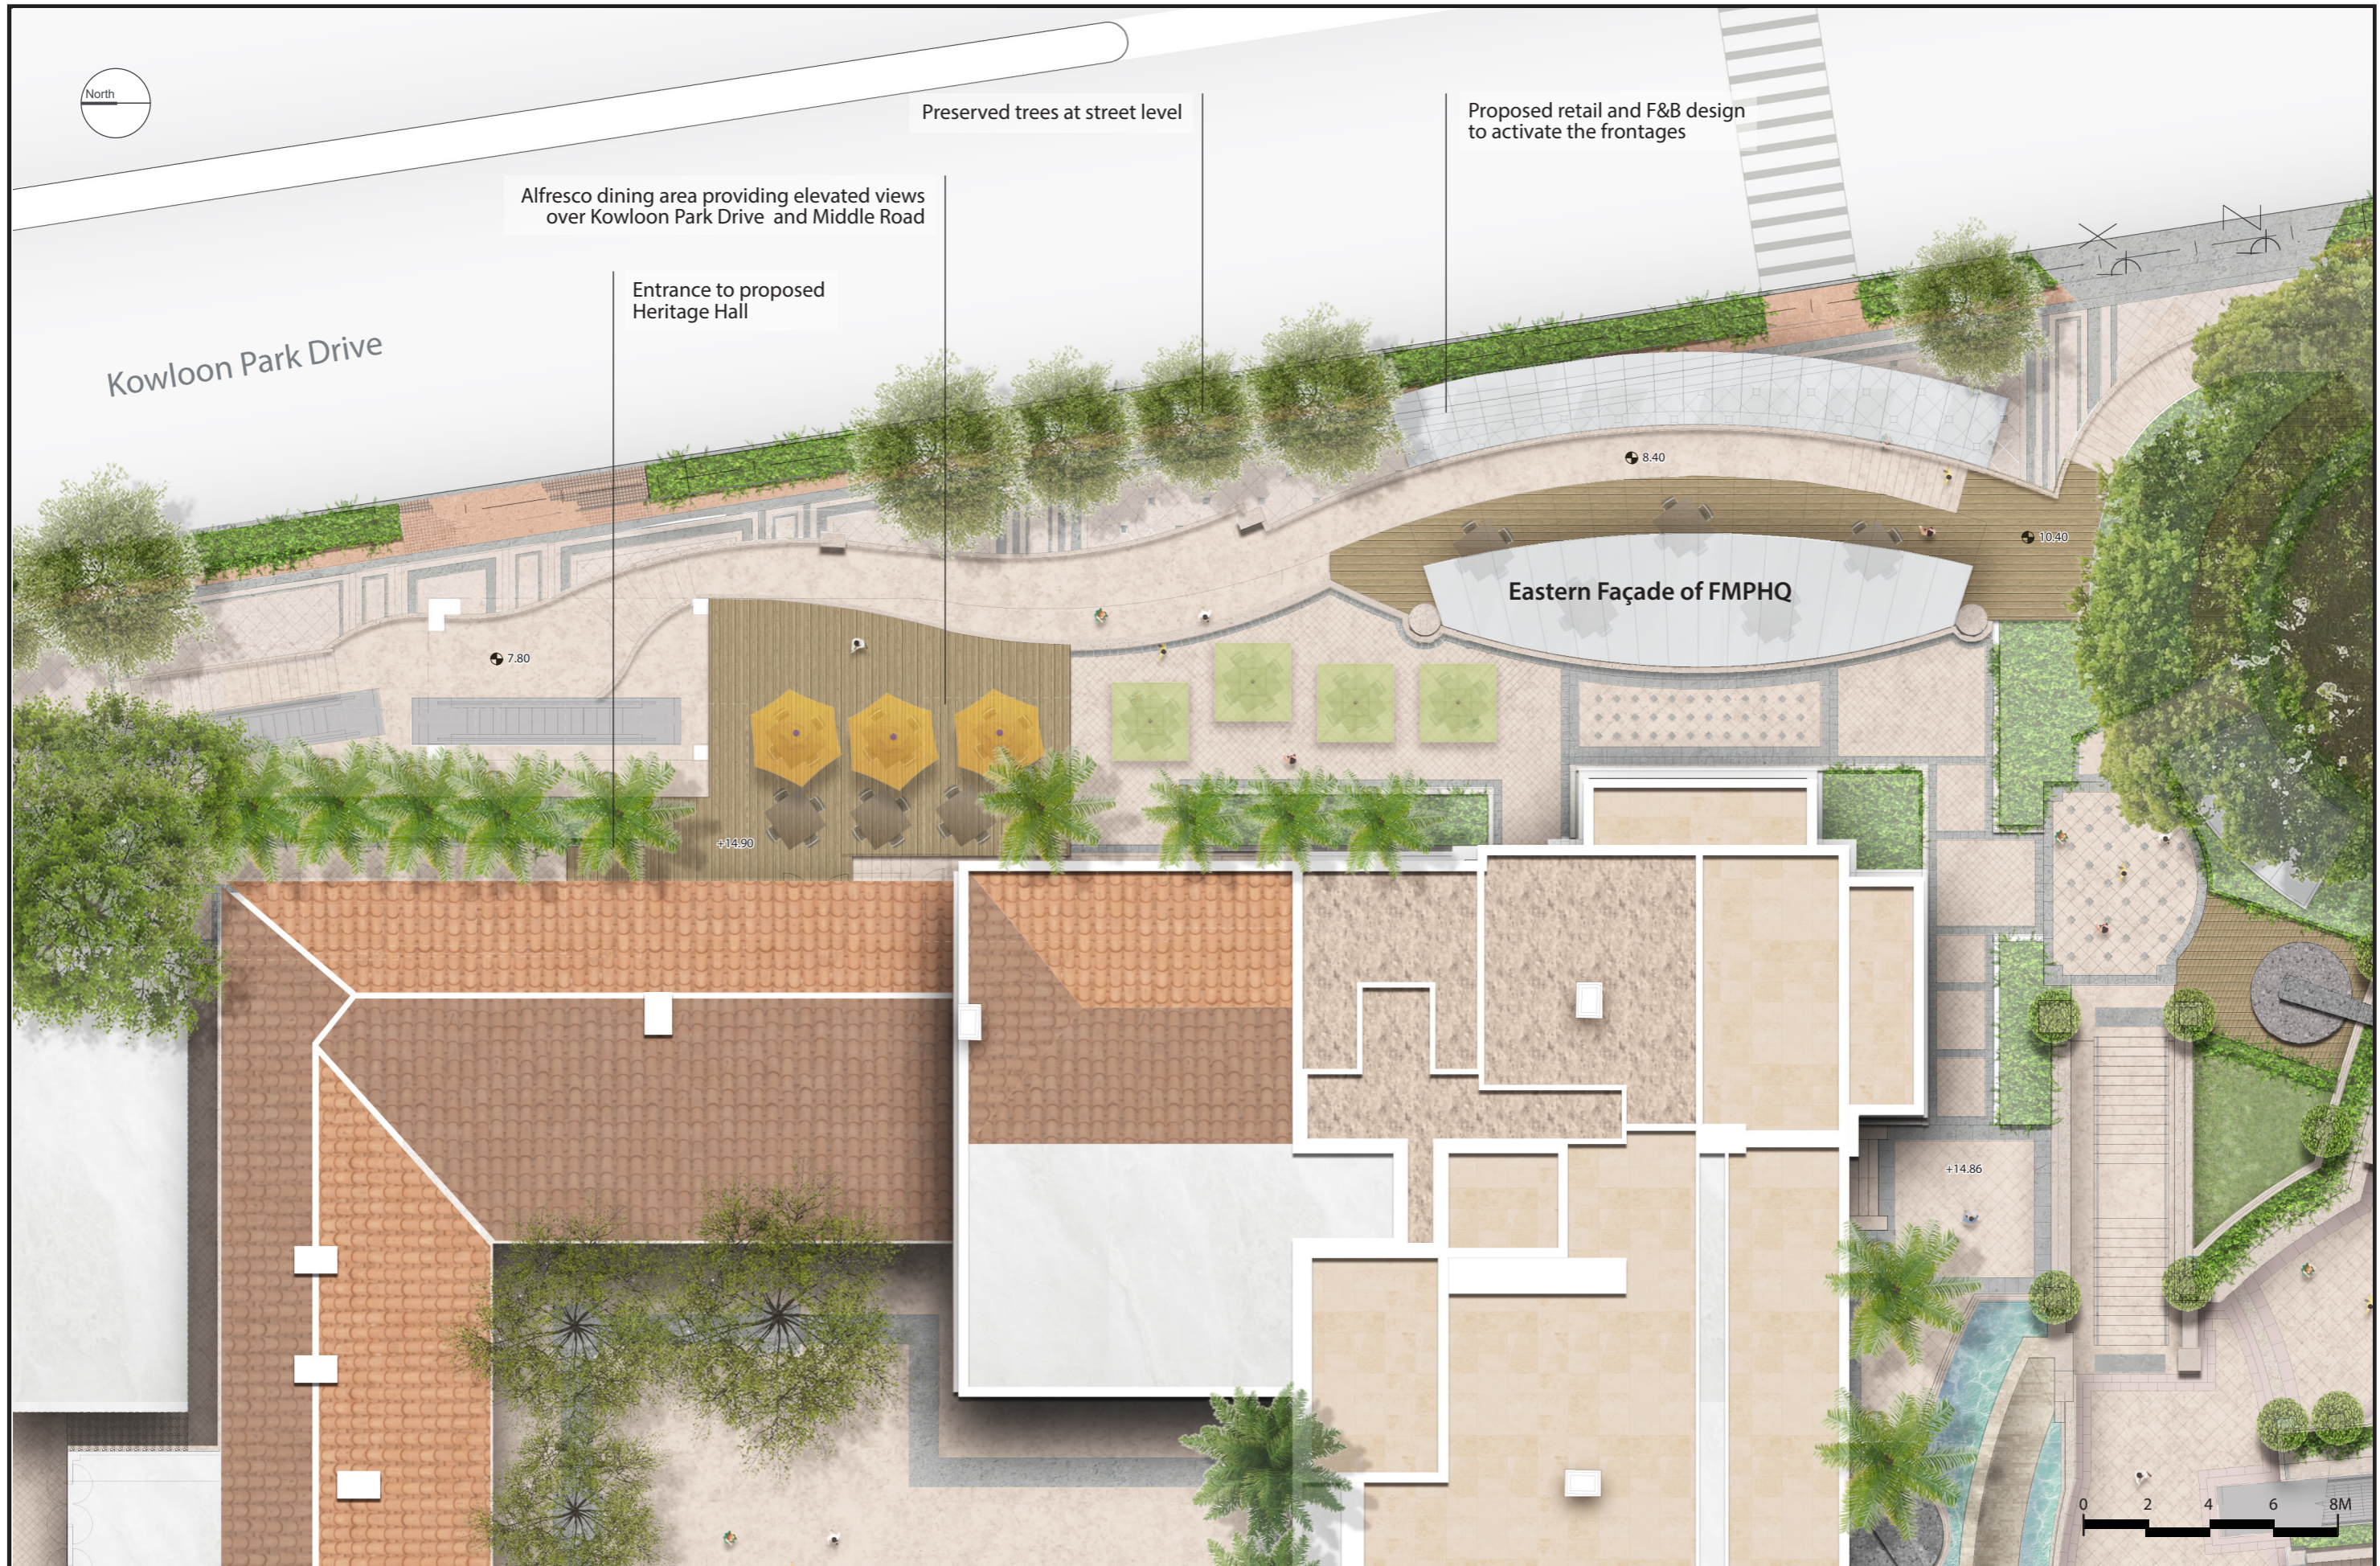
FIGURE TITLE  
 S16 Planning Application for Amendment to Approved Hotel & Related Tourism Development  
 at the FMPHQ Site j/o of Canton Road and Salisbury Road, TST  
**Landscape Master Plan - Blow-up Plan - Eastern Façade of FMPHQ**

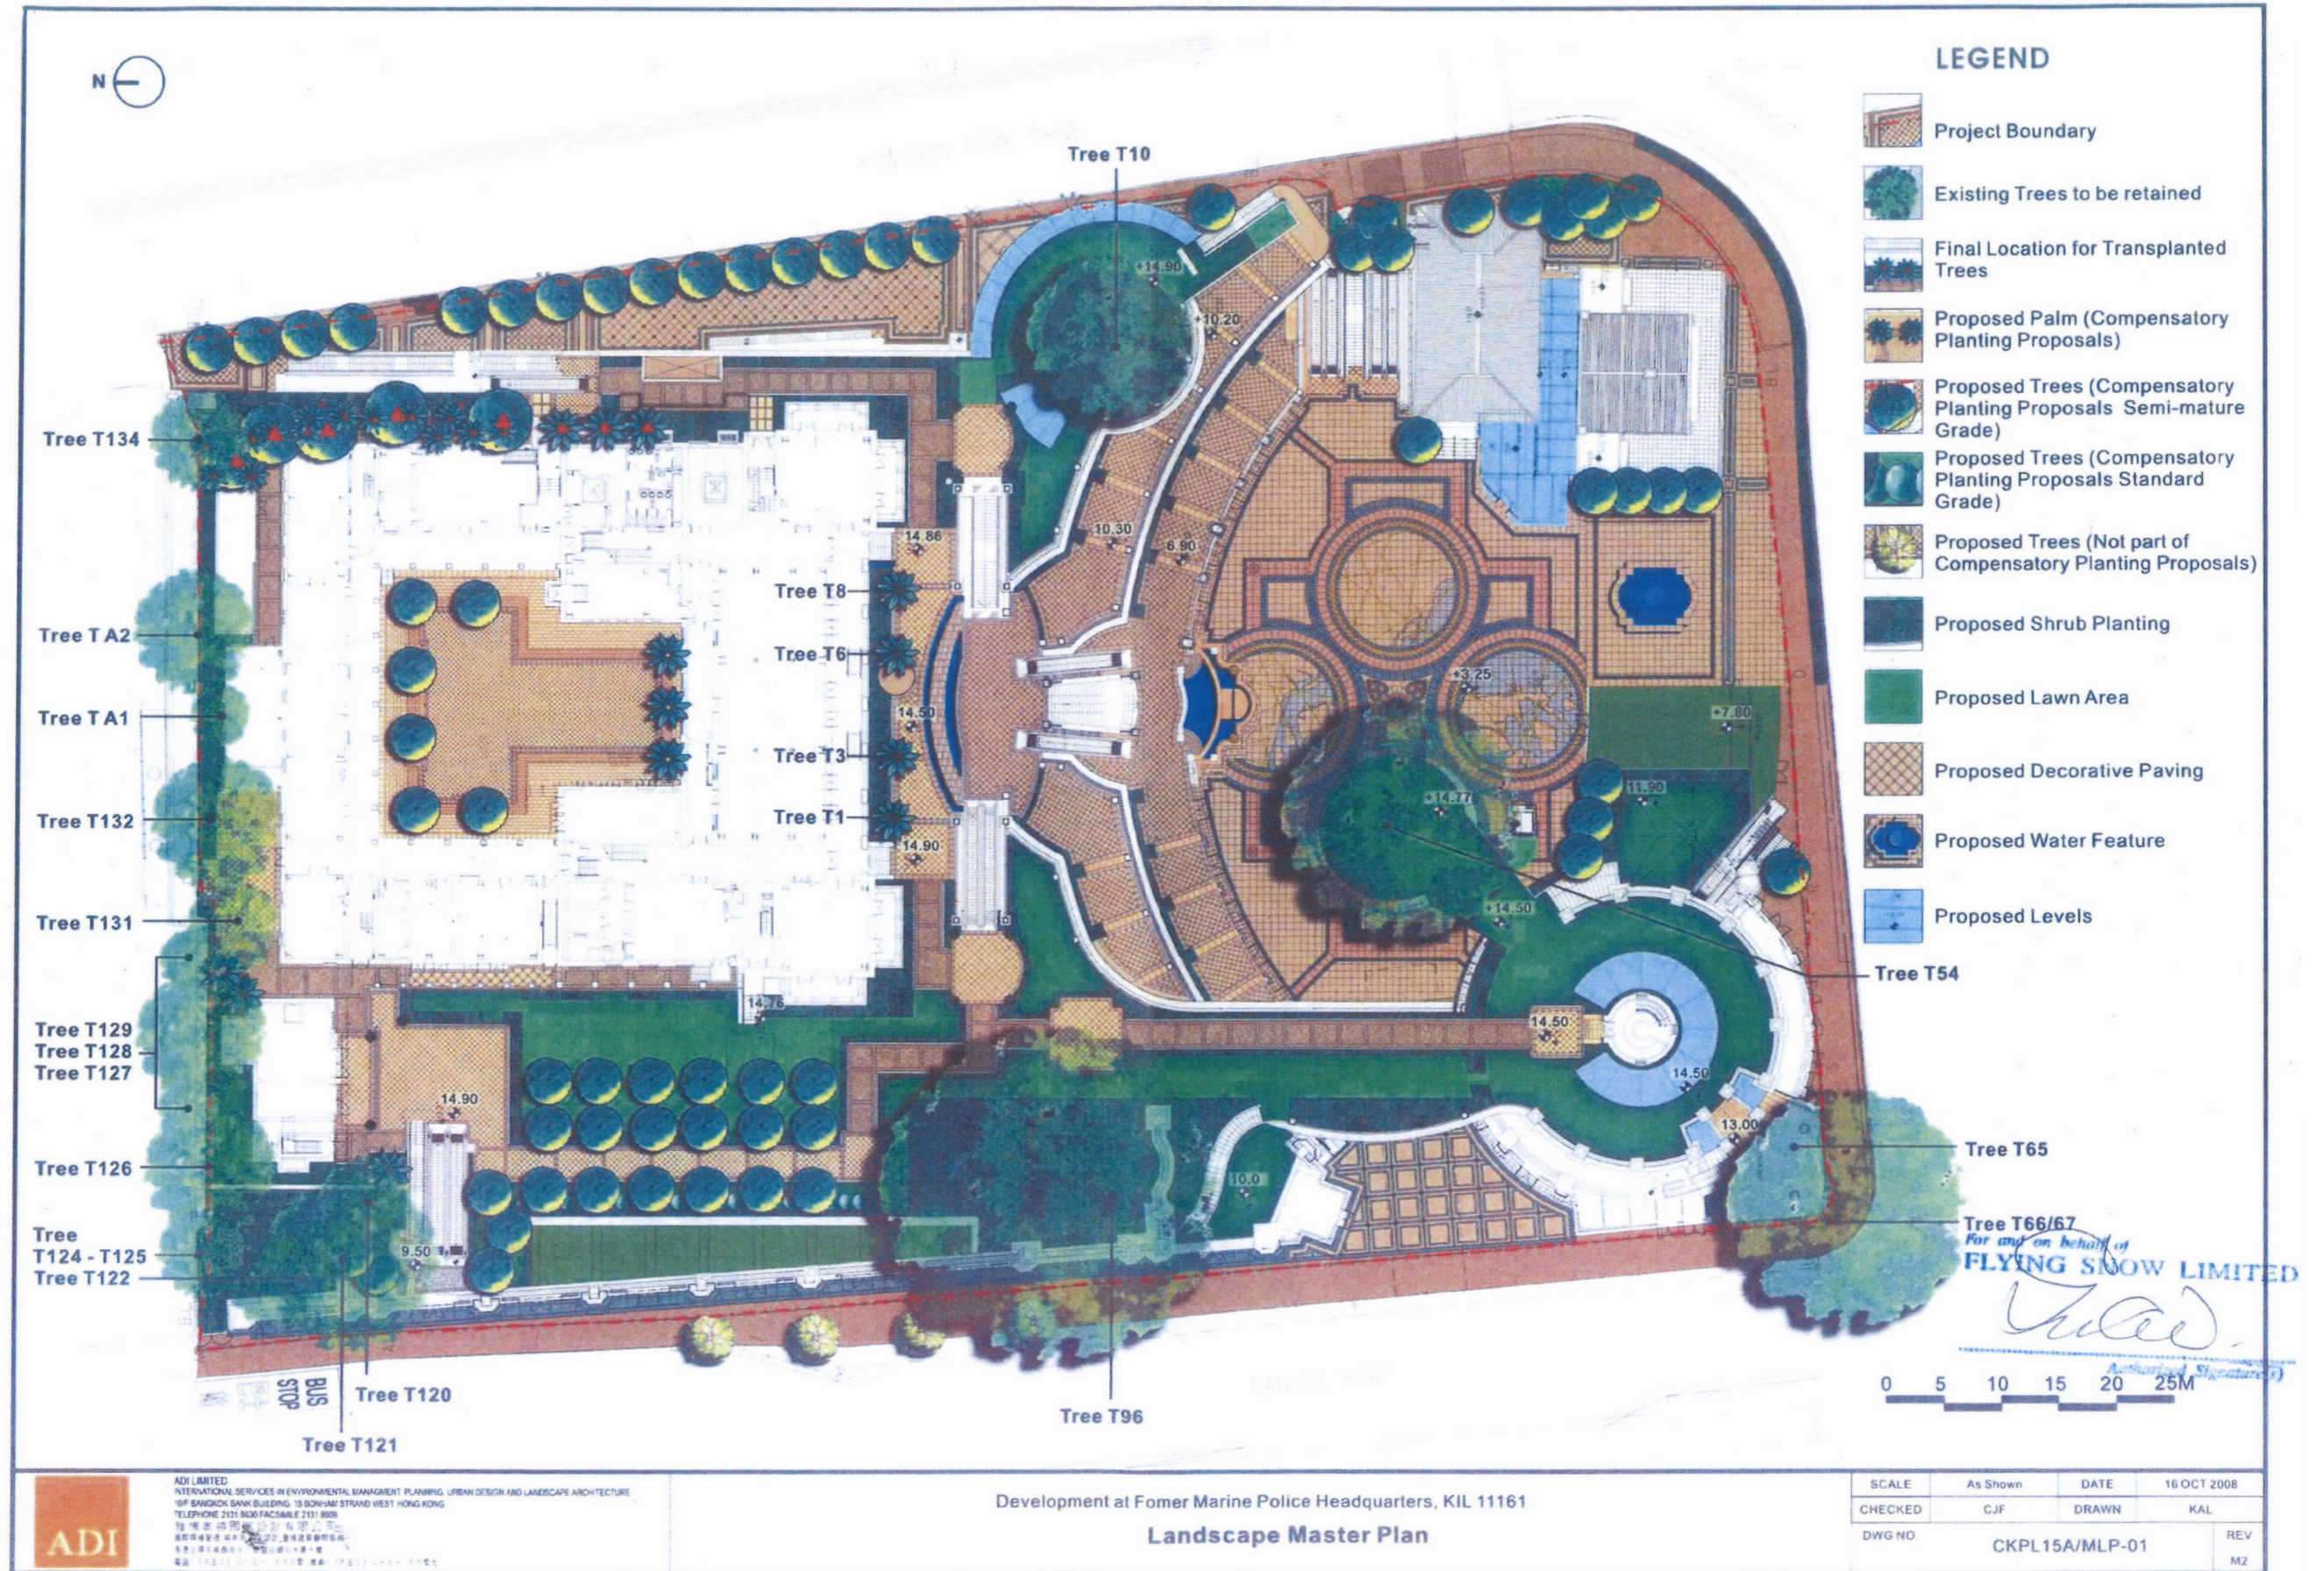
Landscape Master Plan approved in compliance with the planning application approval conditions in 2009

- 2.6 **Figures 2.1 to 2.2** illustrate the existing landscape conditions and context of the site. **Figure 4.5** shows the approved Landscape Master Plan from the original planning application dated 2009, **Figure 4.6** the Landscape Master Plan from the approved SCC submission dated 2012 and **Figure 4.7** a Landscape Master Plan showing the existing condition of the landscape.

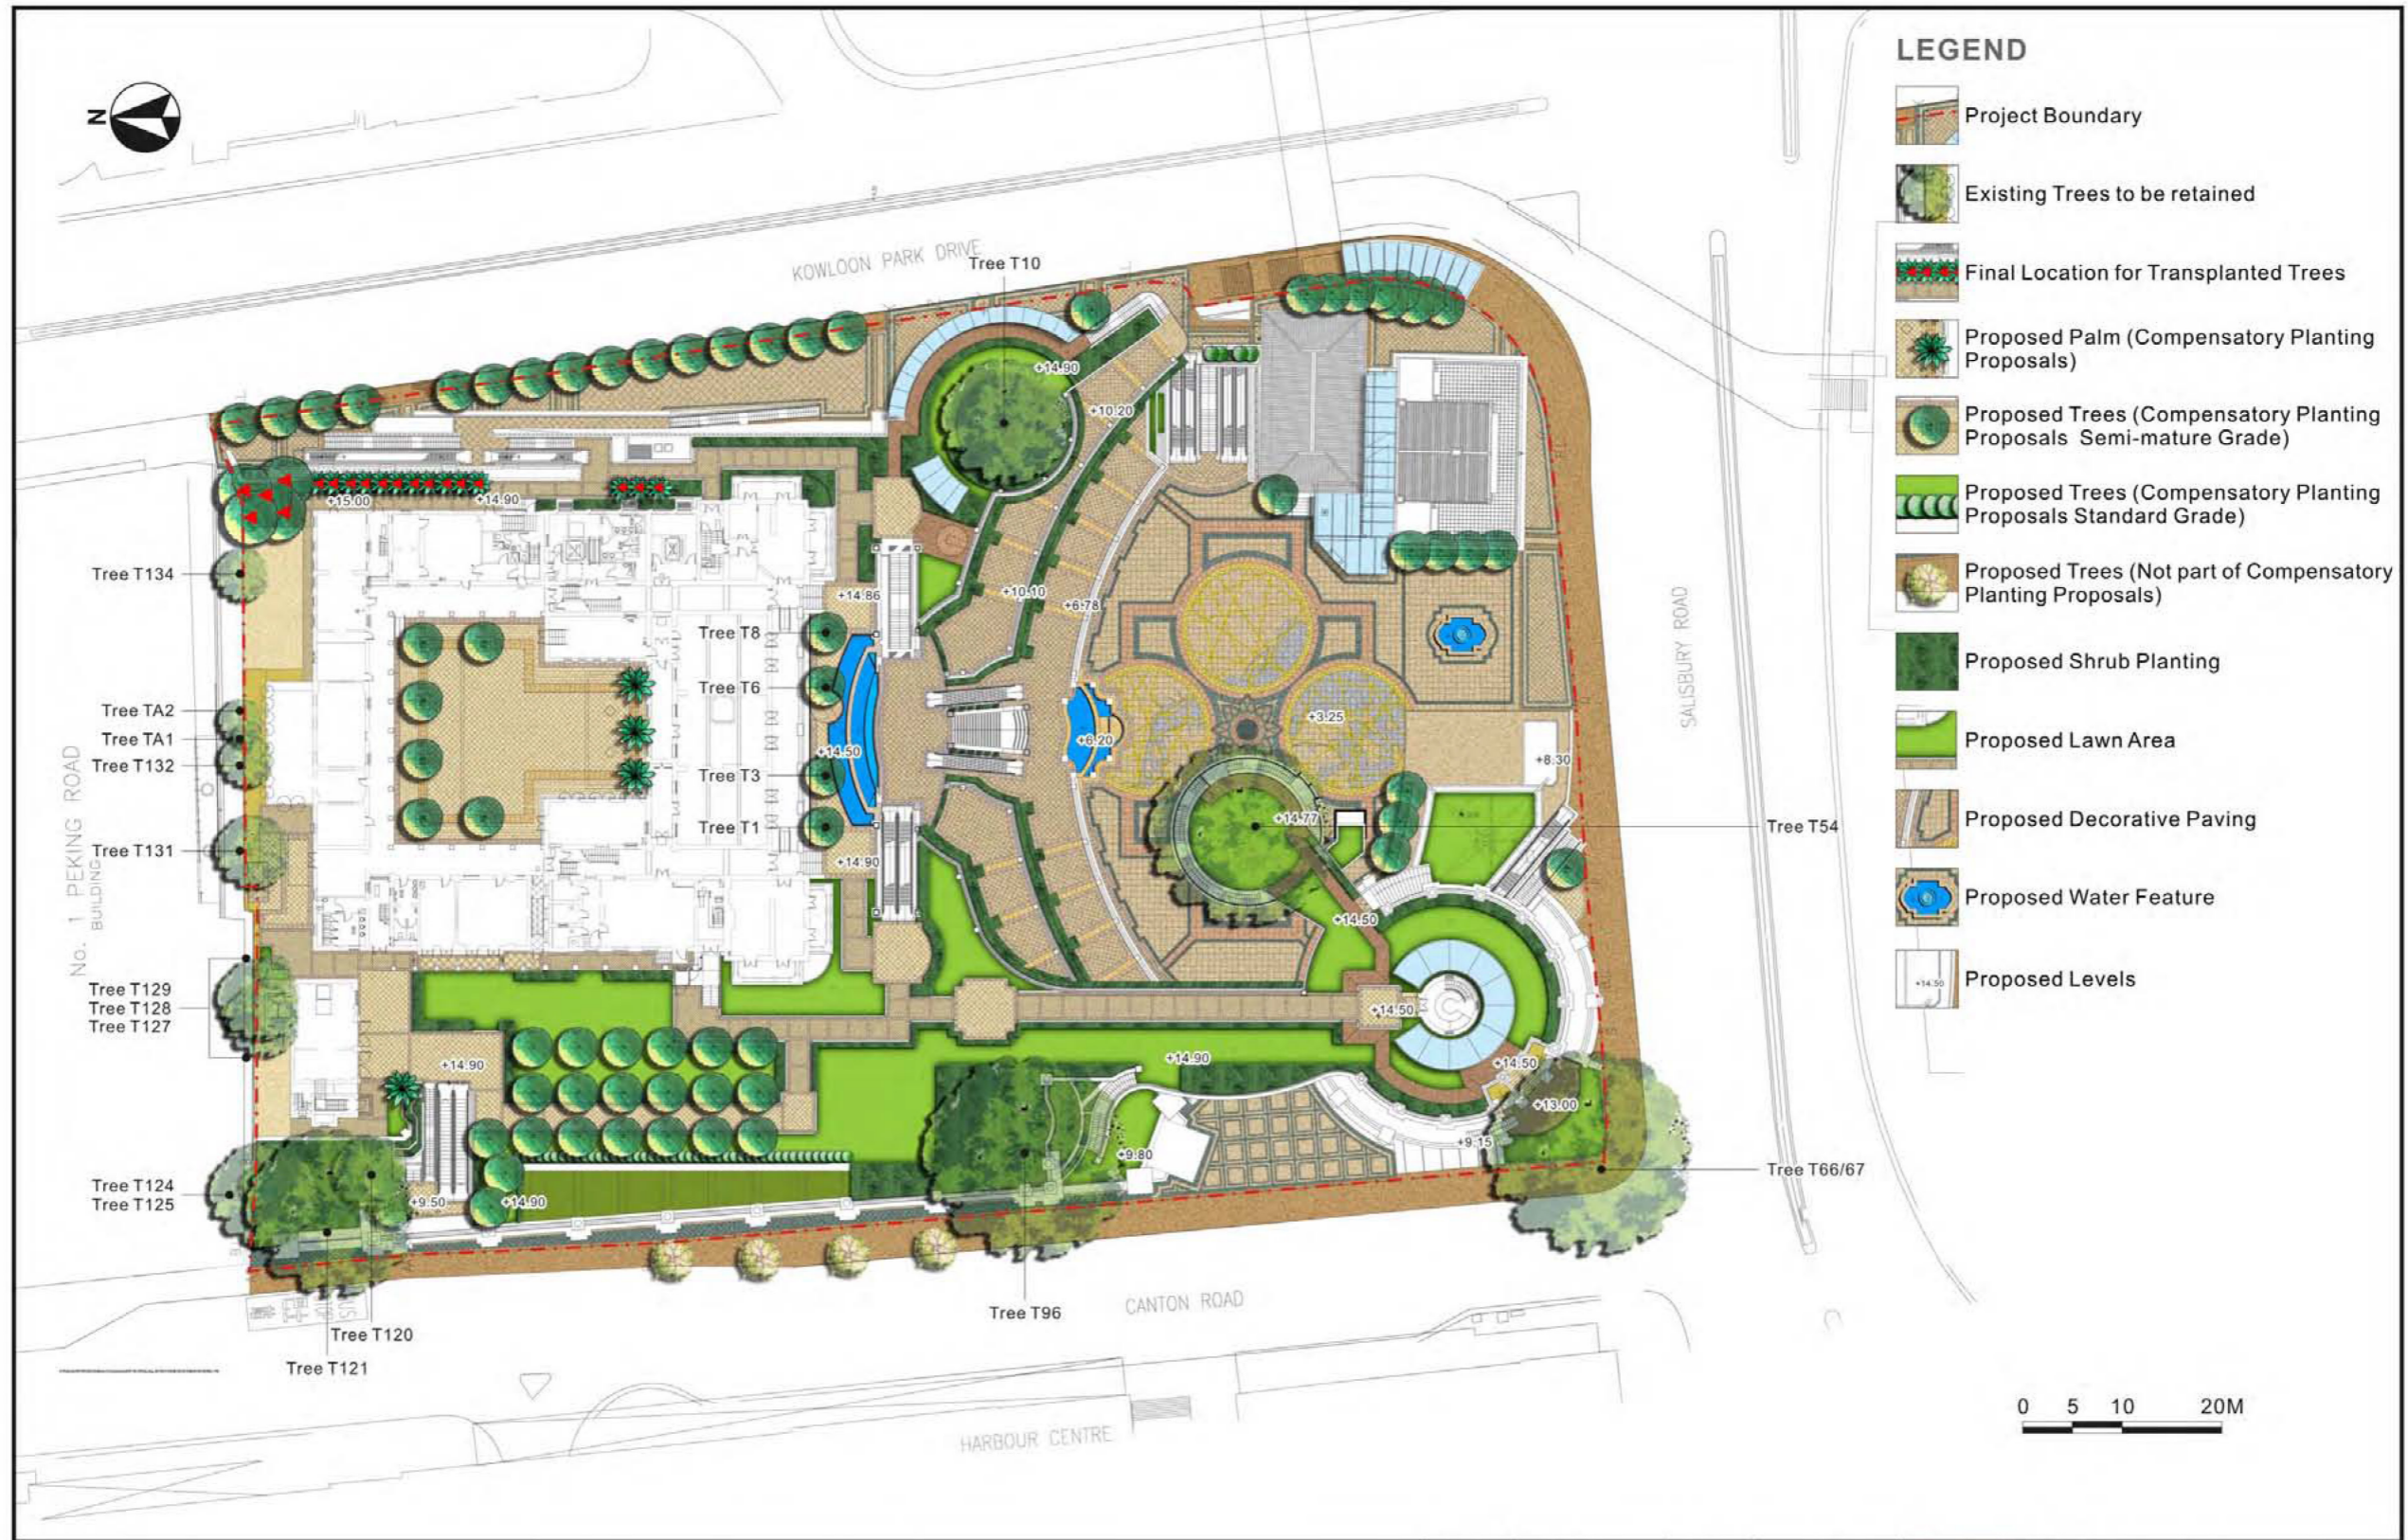
Landscape Master Plan submitted 13th January 2012 by the RLA as part of the Self-Certification of Compliance for the landscape in accordance with LandsD LAO PN no. 6/2003. It should be noted that this plan indicates the changes to the scheme arising from the detailed design process and comments from various government departments.

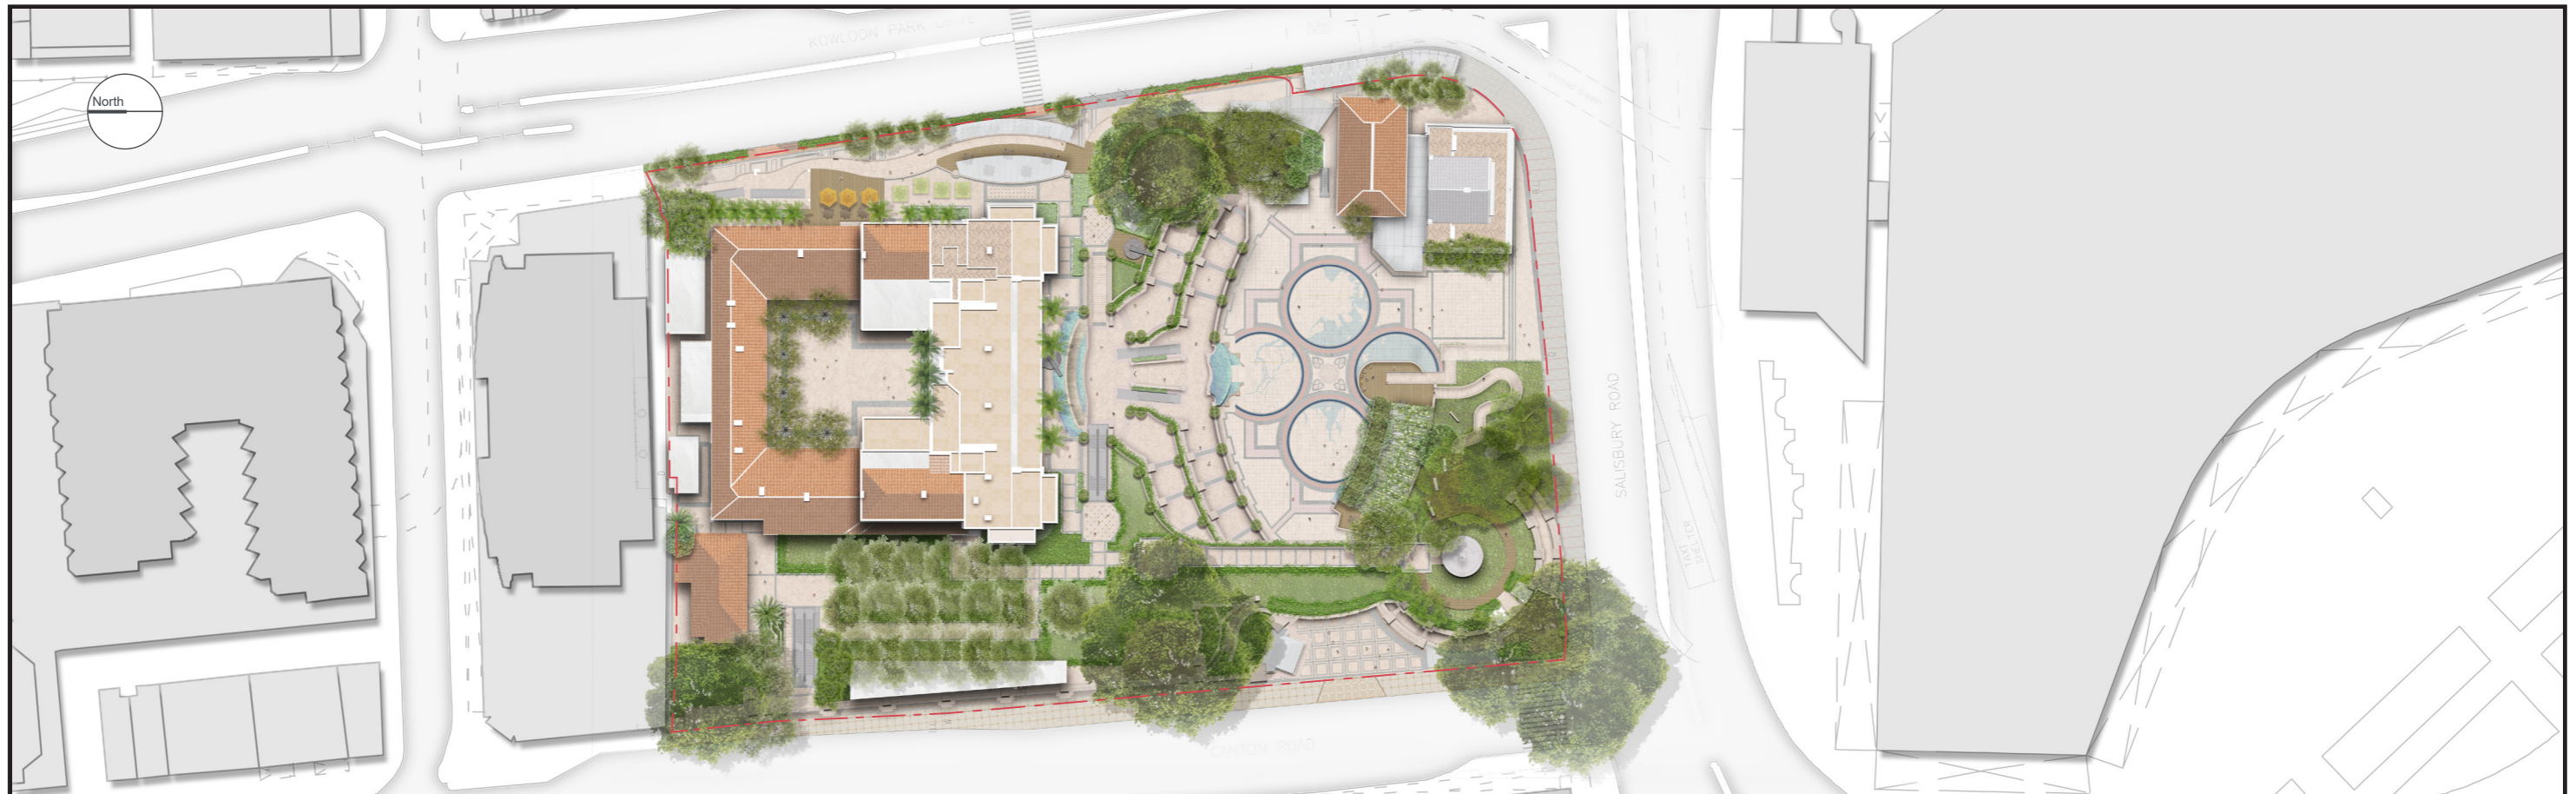
Landscape Master Plan: Proposed Enhancement Scheme

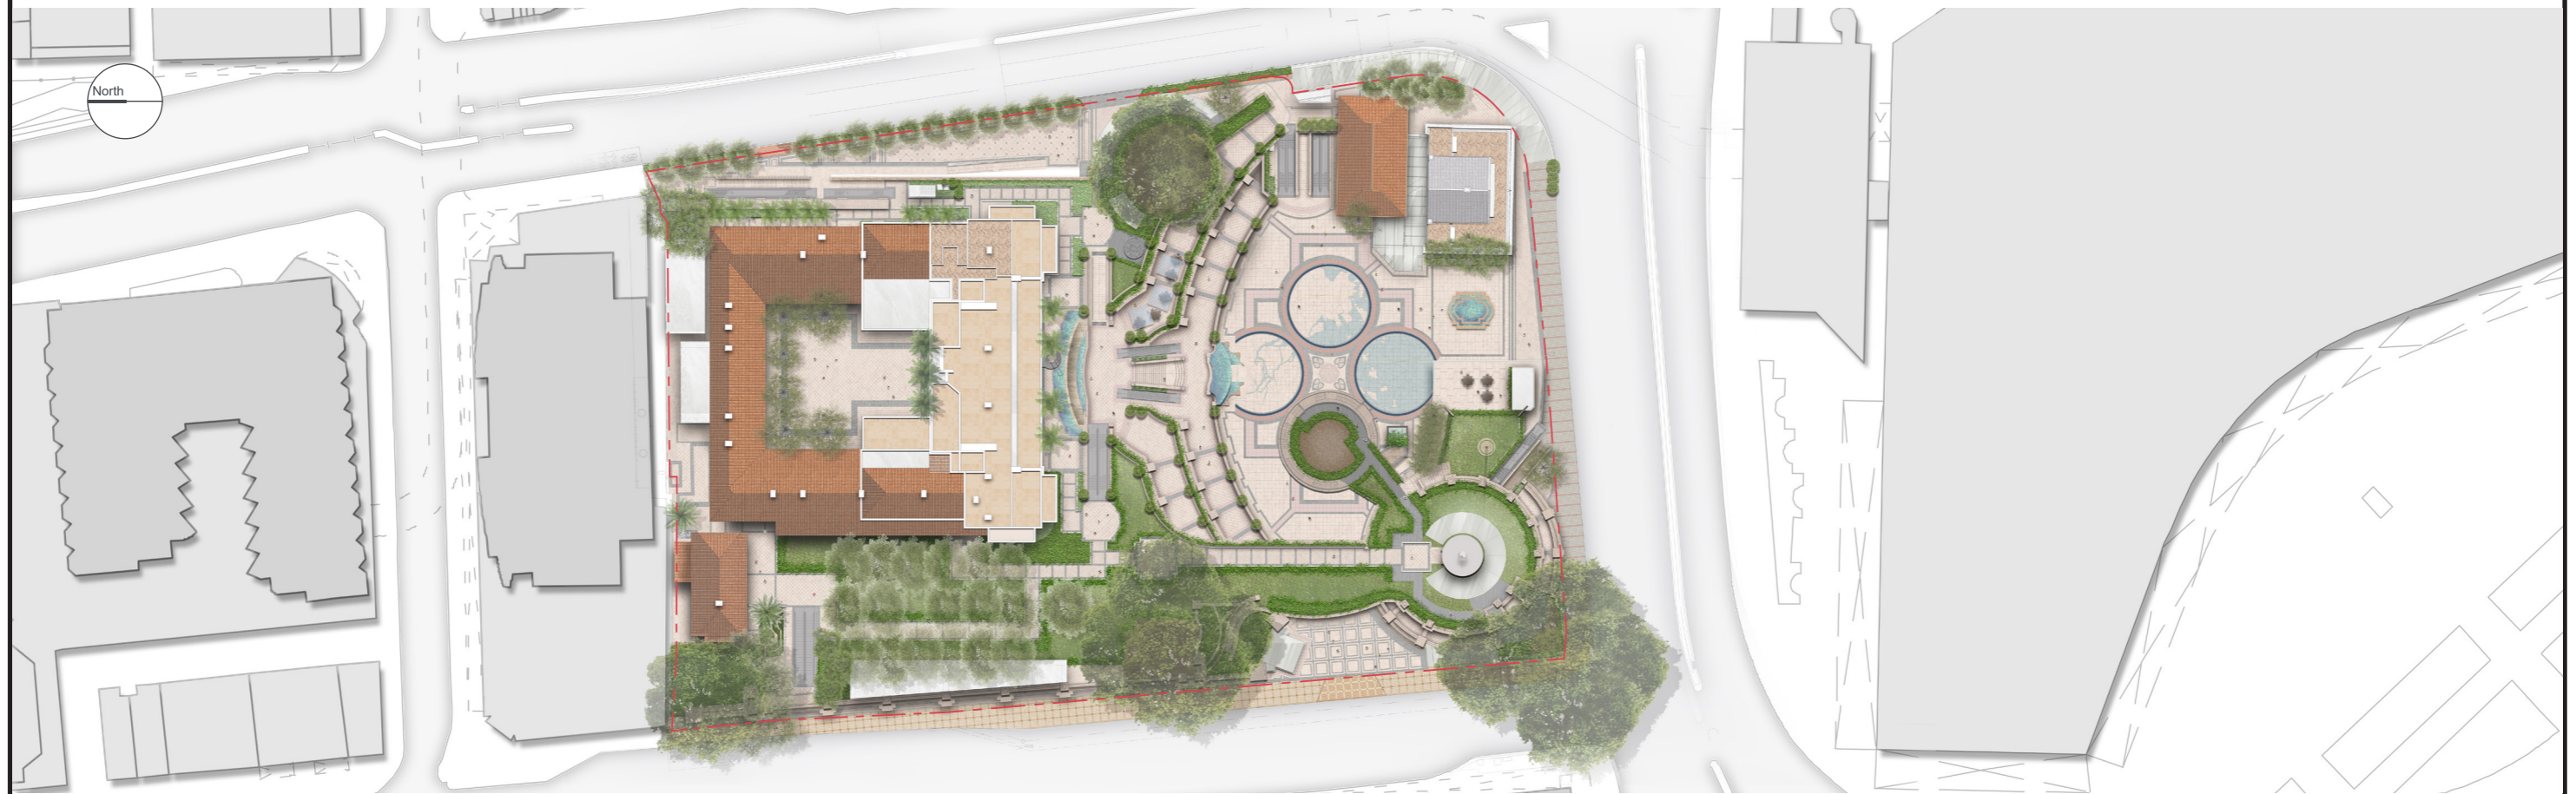
Landscape Master Plan: Approved Scheme

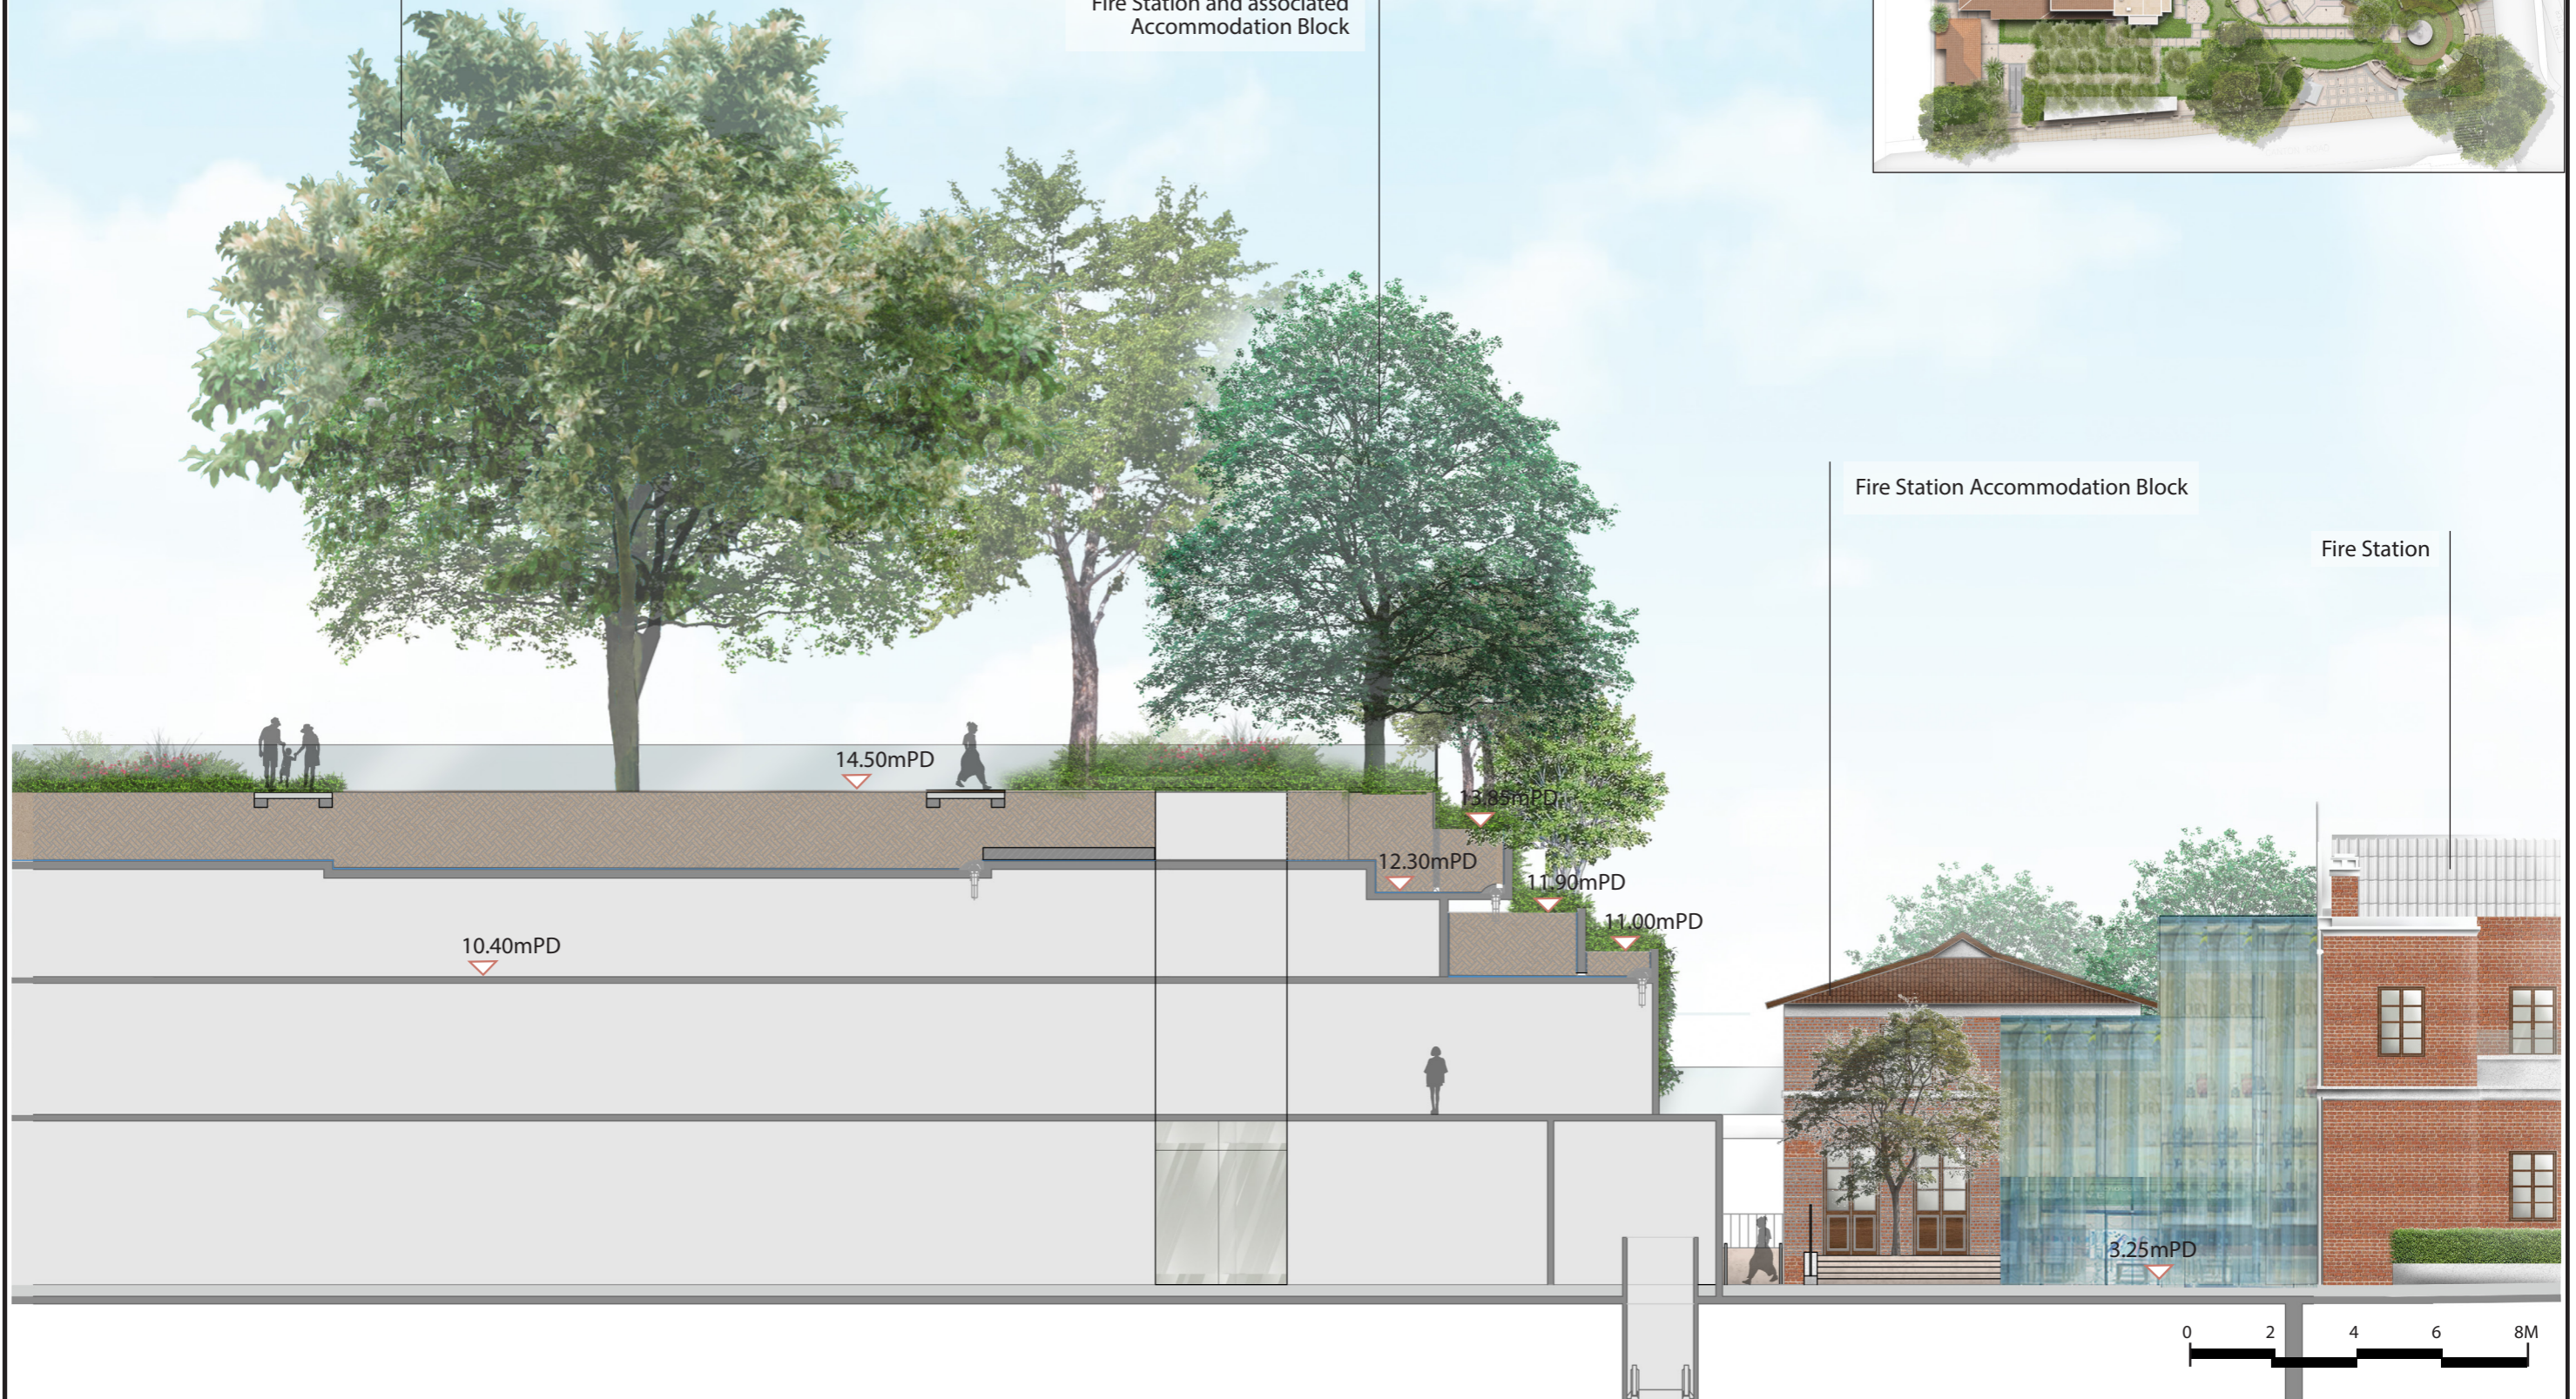
New terraced planter with tree planting designed to create wooded backdrop to Fire Station and associated Accommodation Block

- 1 West Garden
- 2 East Garden
- 3 Activated frontage at pedestrian level
- 4 New footpath / trail
- 5 Alfresco dining
- 6 Preserved trees
- 7 New trees
