Landscape Master Plan and Tree Preservation Proposal

**S16 Planning Application for Amendment to Approved Hotel &  
Related Tourism Development Former Marine Police  
Headquarters Site Junction of Canton Road and Salisbury  
Road, Tsim Sha Tsui**

**Landscape Master Plan**

**27<sup>th</sup> November 2023**

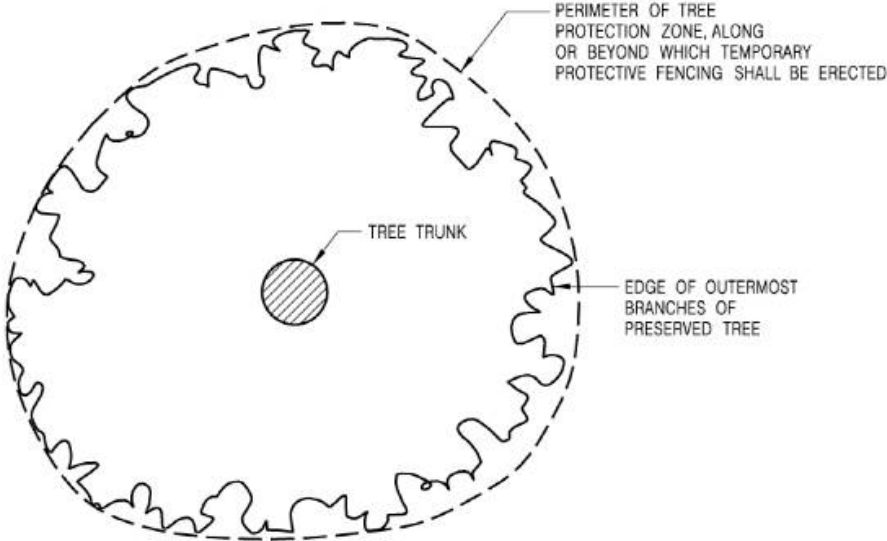
**PLAN - INDIVIDUAL TREE**  
(DIAGRAMMATIC)

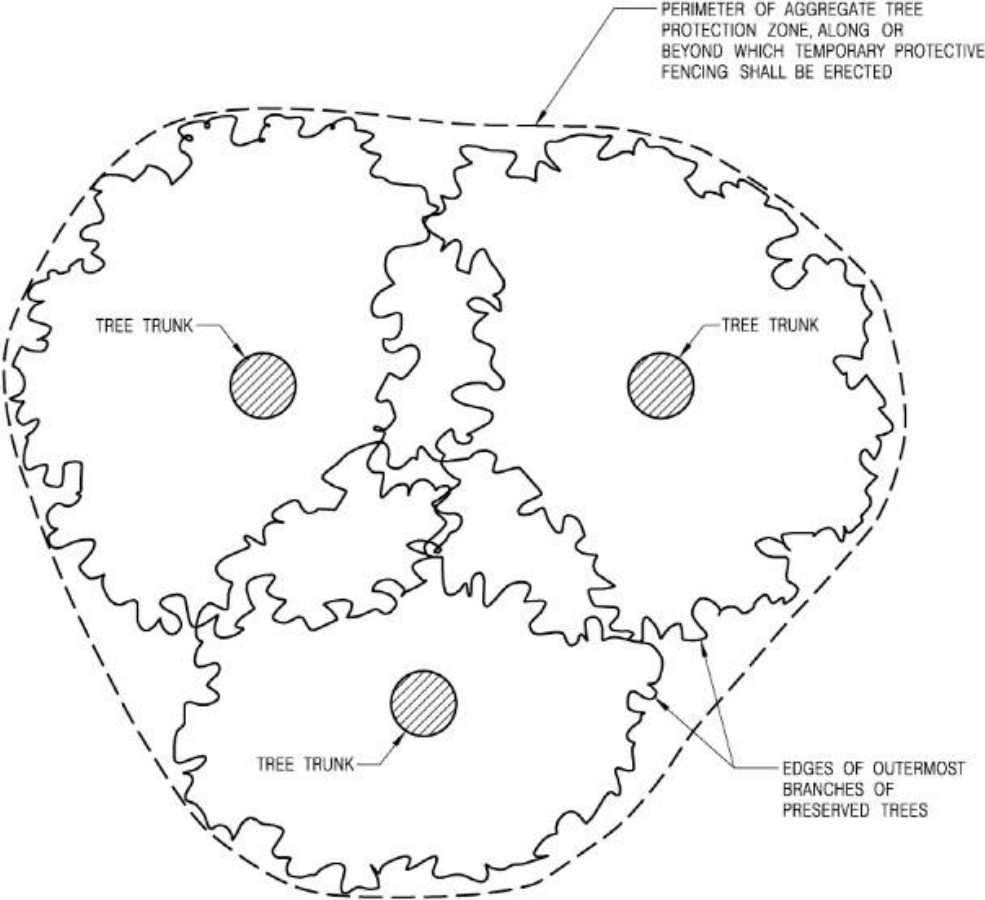
**PLAN - GROUP OF TREES**  
(DIAGRAMMATIC)
