Section 16 Planning Application

Proposed Filling of Land/Pond for Site Formation Works for Permitted Agricultural Use

Planning Statement

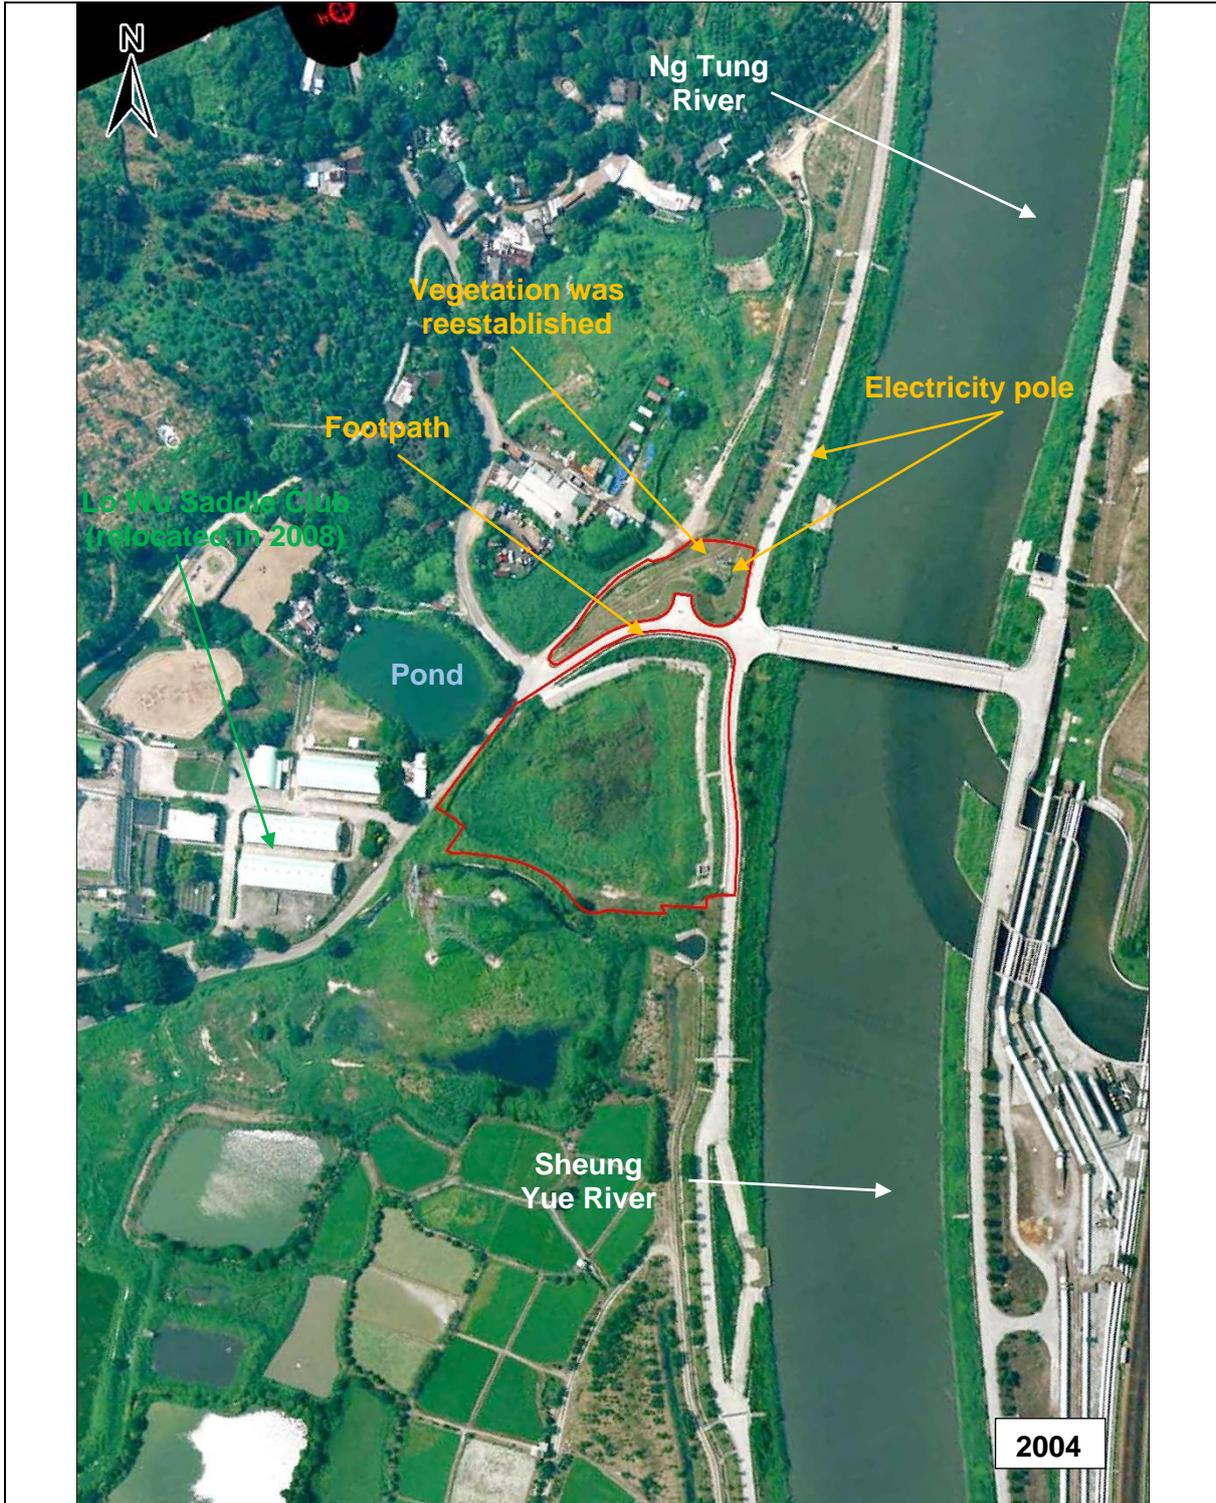
<p>Drn. By JYCT</p>	<p>Drn. By THLM</p>
		<p>Scale -</p>	<p>Date 16/04/2024</p>
		<p>Job No. 60624717</p>	<p>Plate. No. B8</p>

Drawing Title
 Aerial Photograph
 Interpretation of Site
 KTN-2

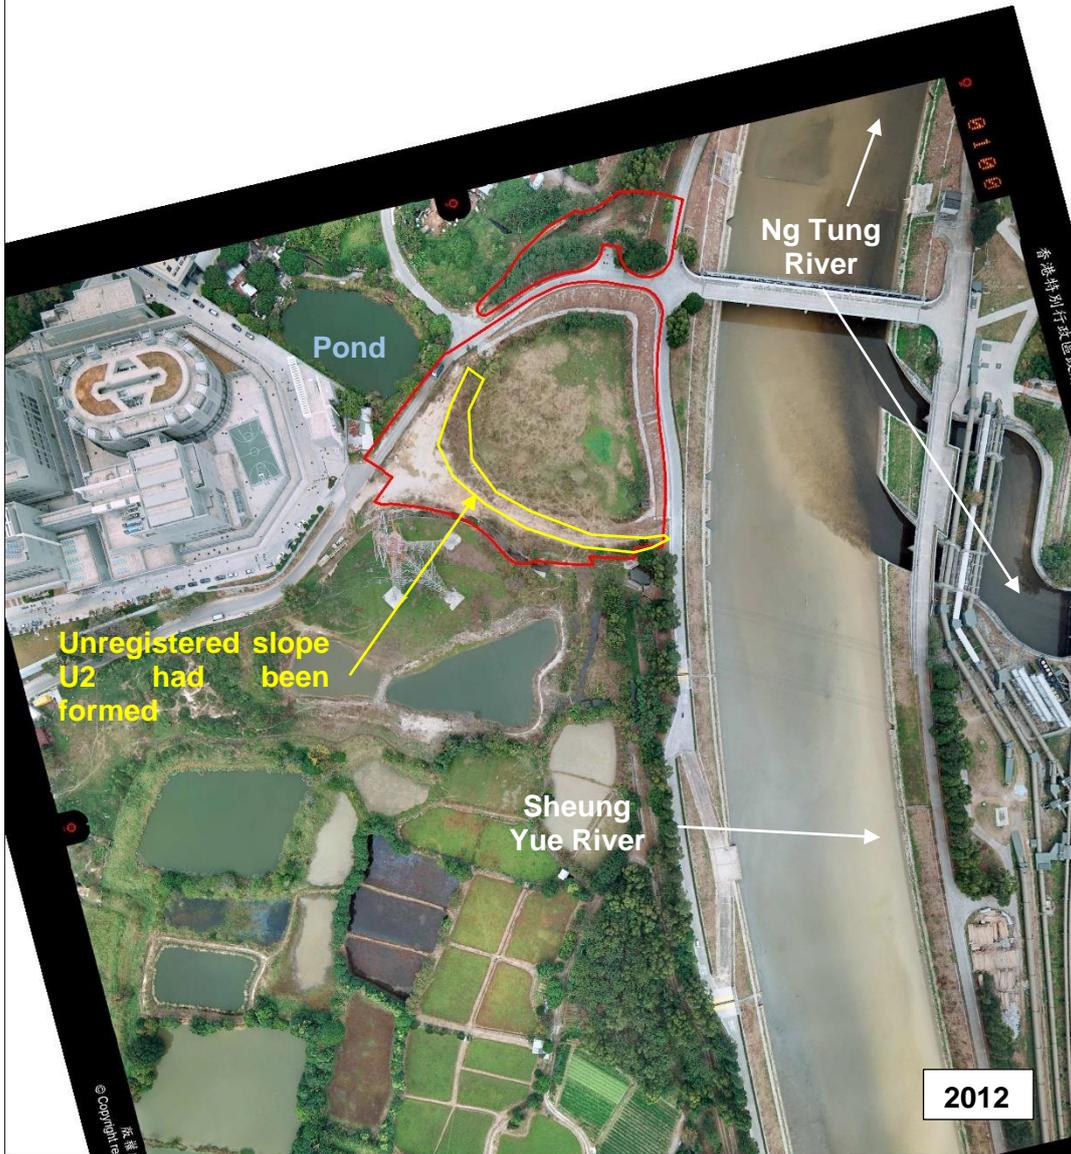
AECOM	
Drn. By JYCT	Drn. By THLM
Scale -	Date 16/04/2024
Job No. 60624717	Plate No. B11

Drawing Title
Aerial Photograph
Interpretation of Site
KTN-2

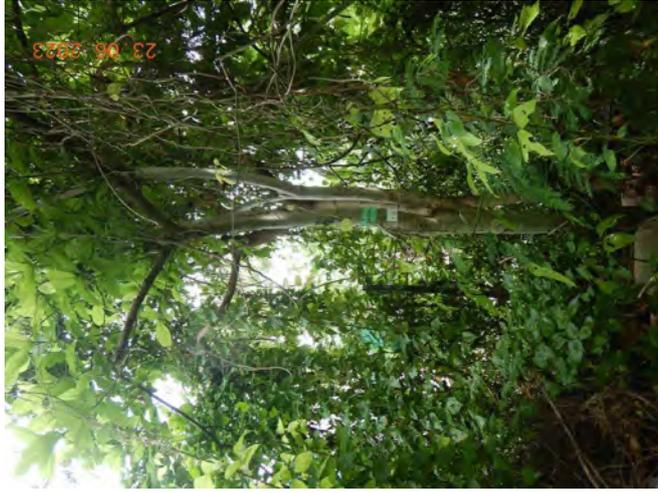
LS-T-014_1_Ficus hispida_Overview_Remove

LS-T-014	<i>Ficus hispida</i>	對葉榕	5.0	150	3.0	829806.16	842026.42	4.43	Medium	Poor	Average	Average	Low	f	Nil	Remove	Conflict with proposed site formation works	LandsD	-	multi-trunks; broken branches; unbalanced crown; climbers on crown	C1
LS-T-015	<i>Ficus hispida</i>	對葉榕	4.0	145	3.0	829807.32	842033.62	4.43	Medium	Poor	Average	Average	Low	f	Nil	Remove	Conflict with proposed site formation works	LandsD	-	multi-trunks; climbers on crown	C1
LS-T-016	<i>Ficus hispida</i>	對葉榕	4.0	190	3.0	829830.74	842042.33	4.45	Medium	Poor	Average	Average	Low	f	Nil	Remove	Conflict with proposed site formation works	LandsD	-	codominant trunks; broken trunk; poor taper	C1
LS-T-017	<i>Carica papaya</i>	番木瓜	4.0	110	2.0	829838.84	842047.82	4.45	Medium	Average	Average	Average	Medium	-	Nil	Remove	Conflict with proposed site formation works	LandsD	-	-	C1
LS-T-018	<i>Ficus virens</i>	黃葛樹	4.0	180	3.0	829840.24	842050.20	4.46	Medium	Poor	Average	Average	Low	f	Nil	Remove	Conflict with proposed site formation works	LandsD	-	poor taper; climbers on crown	C1

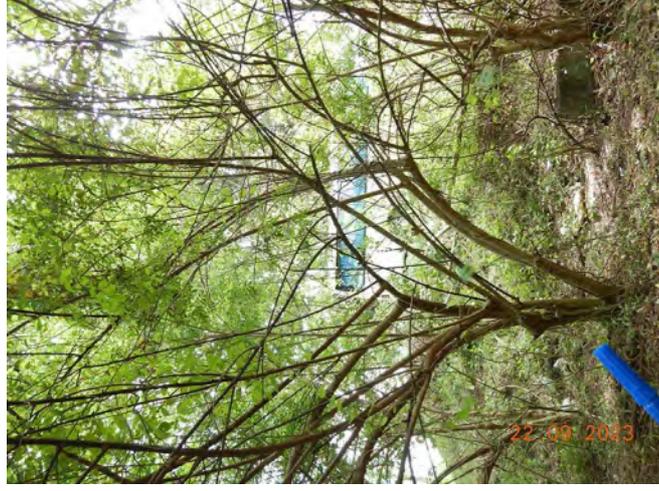
LS-T-052_2_Flueggea virosa_Crown_Remove

LS-T-052	<i>Flueggea virosa</i>	白飯樹	2.5	165	3.5	829814.78	842025.46	4.45	Medium	Poor	Average	Average	Low	f	Nil	Remove	Conflict with proposed site formation works	LandsD	-	multi-stems; broken branches	C1
LS-T-053	<i>Flueggea virosa</i>	白飯樹	2.5	95	3.5	829815.89	842027.01	4.42	Medium	Poor	Average	Average	Low	f	Nil	Remove	Conflict with proposed site formation works	LandsD	-	multi-stems; broken branches	C1
LS-T-054	<i>Leucaena leucocephala</i>	銀合歡	5.0	150	4.0	829822.48	842031.09	4.67	Low	Poor	Average	Poor	Low	a, f, g	Nil	Remove	Undesirable species	LandsD	-	on slope; extensive epicormic shoots	C1
LS-T-055	<i>Flueggea virosa</i>	白飯樹	2.5	260	4.0	829820.55	842036.05	4.46	Medium	Poor	Average	Average	Low	f	Nil	Remove	Conflict with proposed site formation works	LandsD	-	multi-stems; broken branches; climbers on crown	C1
LS-T-056	<i>Leucaena leucocephala</i>	銀合歡	4.5	240	2.0	829823.31	842037.26	4.46	Low	Poor	Poor	Poor	Low	a, f, g	Nil	Remove	Undesirable species	LandsD	-	uprooted; collapsed	C1
