JOINT-USER COMPLEX AND JOINT-USER GENERAL OFFICE BUILDING  
AT AREA 29, KWU TUNG NORTH

# **Landscape Impact Assessment**

## **Section 16 Planning Application for Joint-user Complex and Joint-user General Office Building at Area 29, Kwu Tung North**

Urban Design & Planning Consultants Limited  
(UDP International)

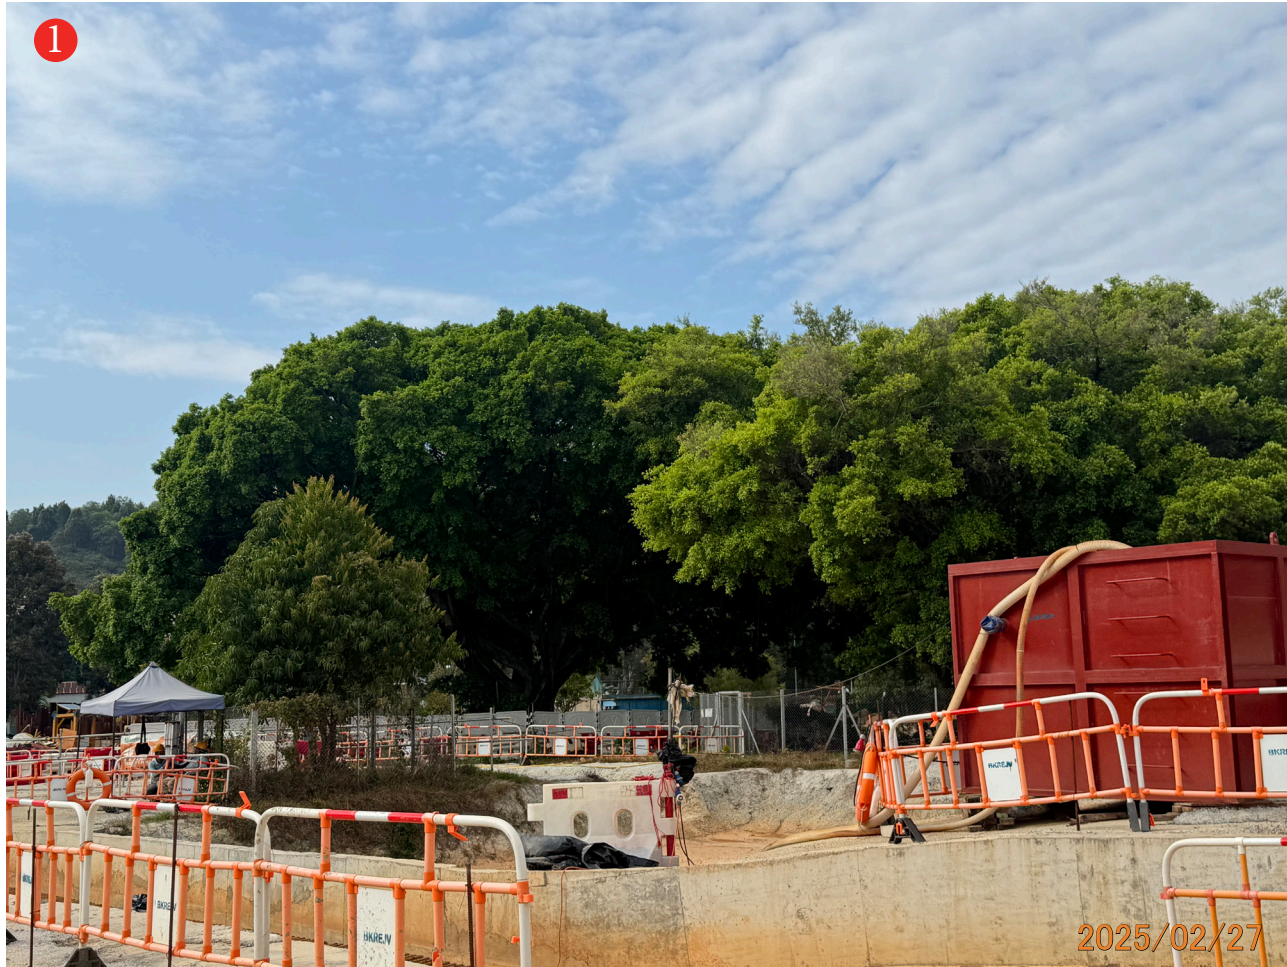
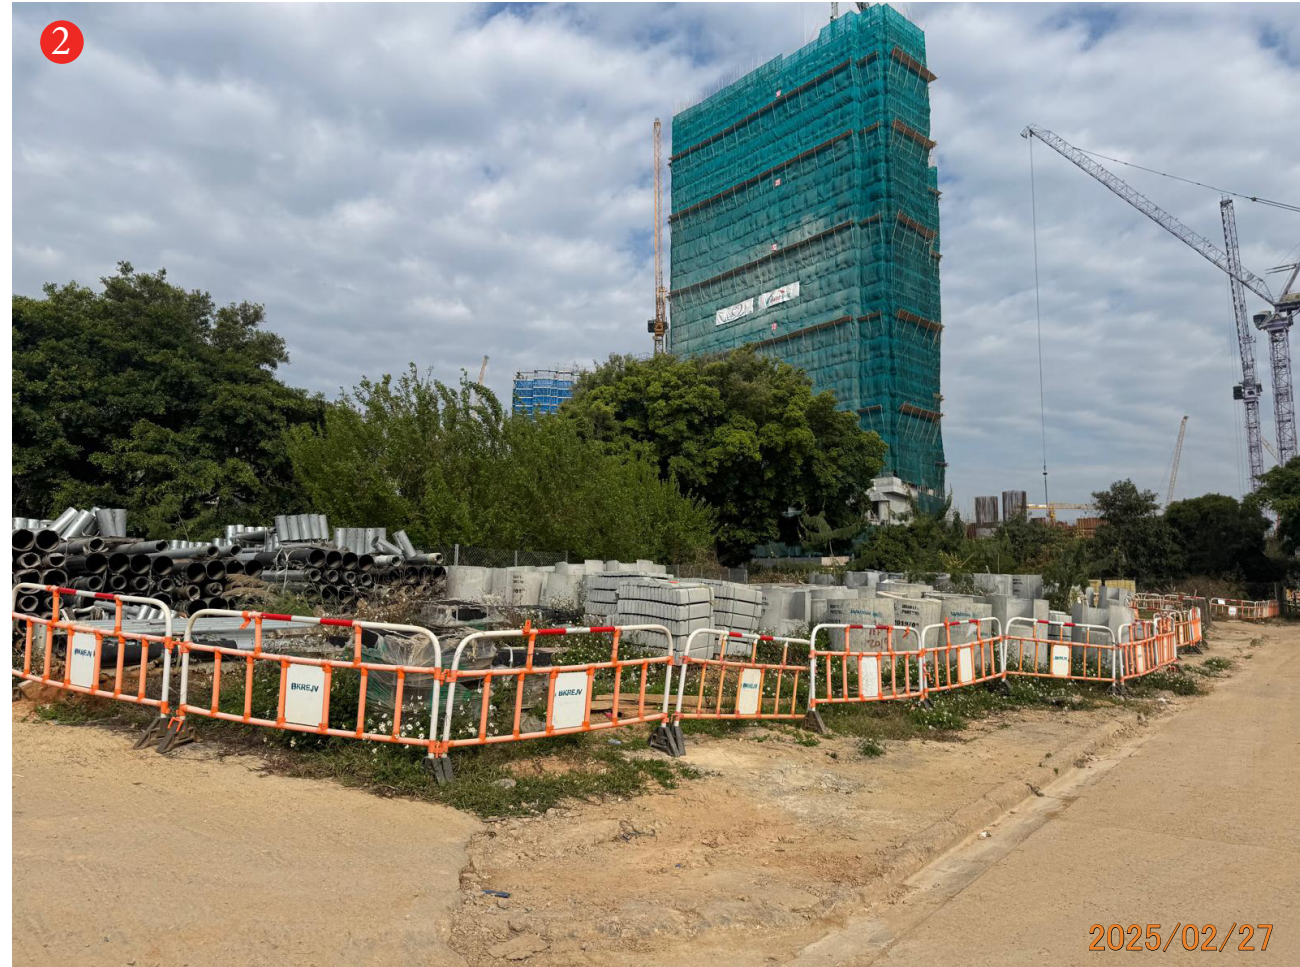
LDR-1.1 Site Retained Trees and Ground within former Dills Corner Garden

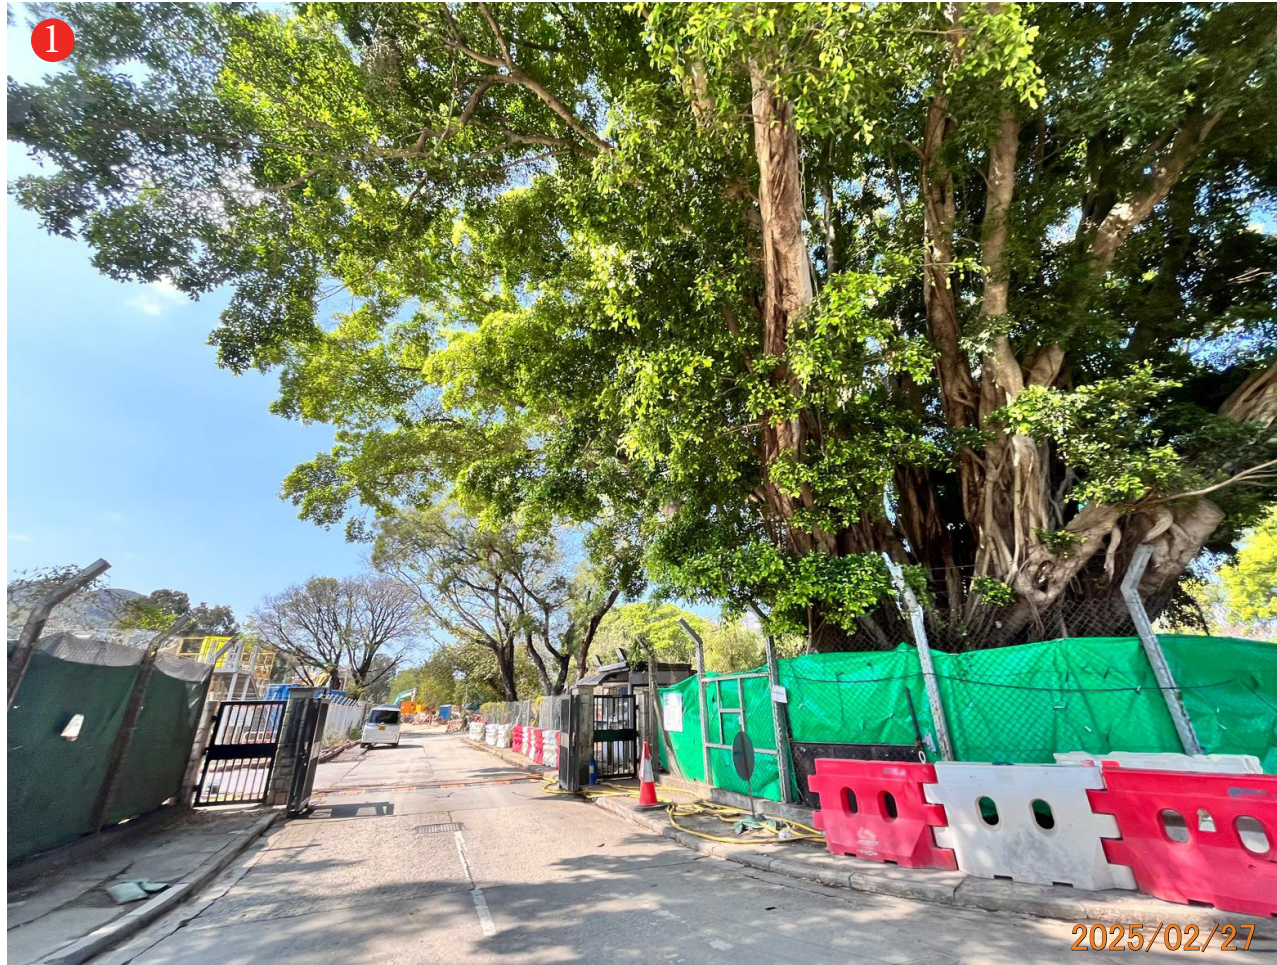
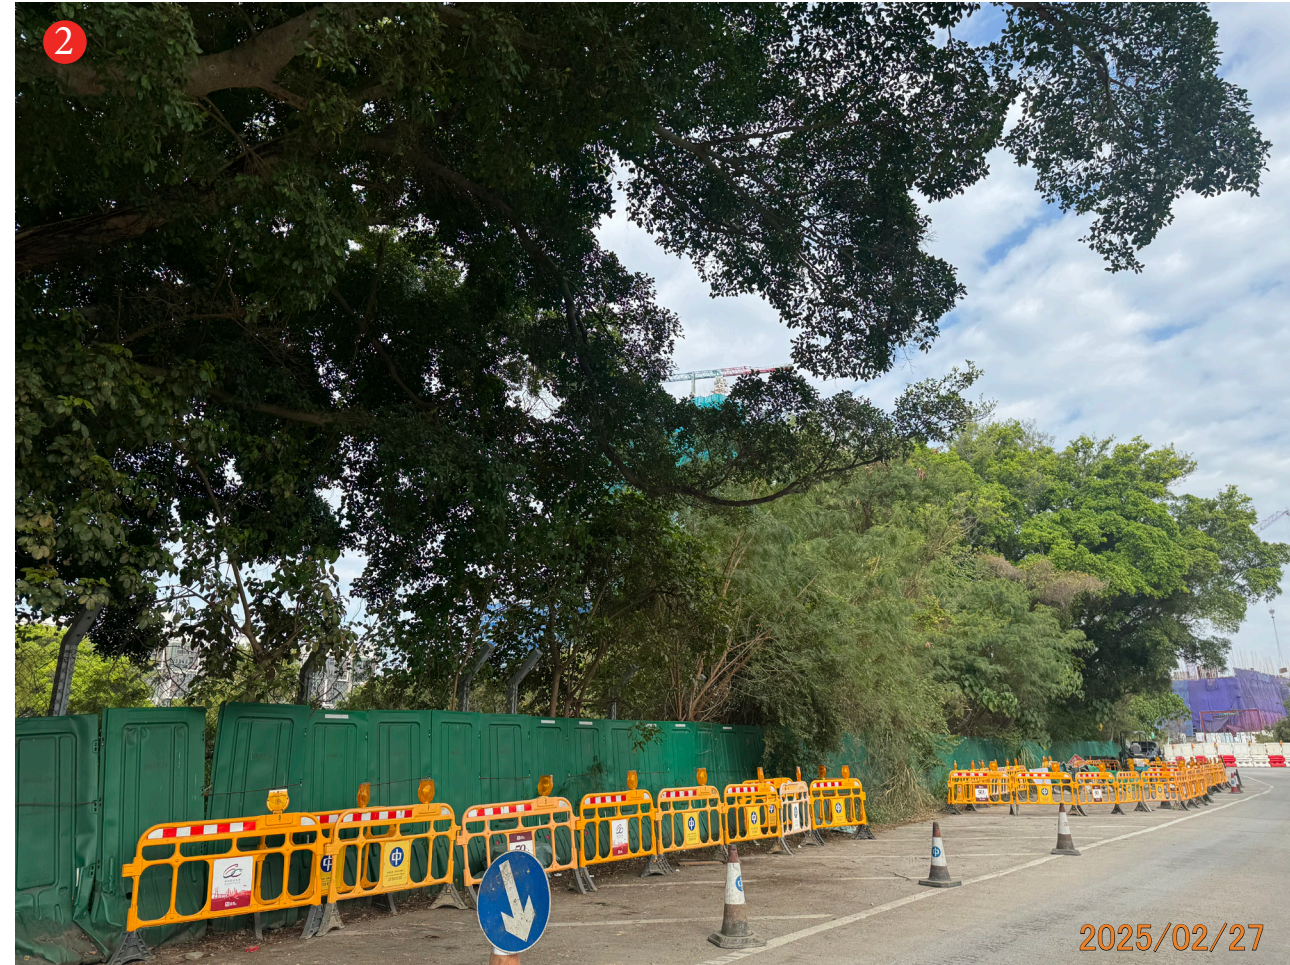
LDR-1.2 Boundary Trees and Vegetation along Po Lau Road

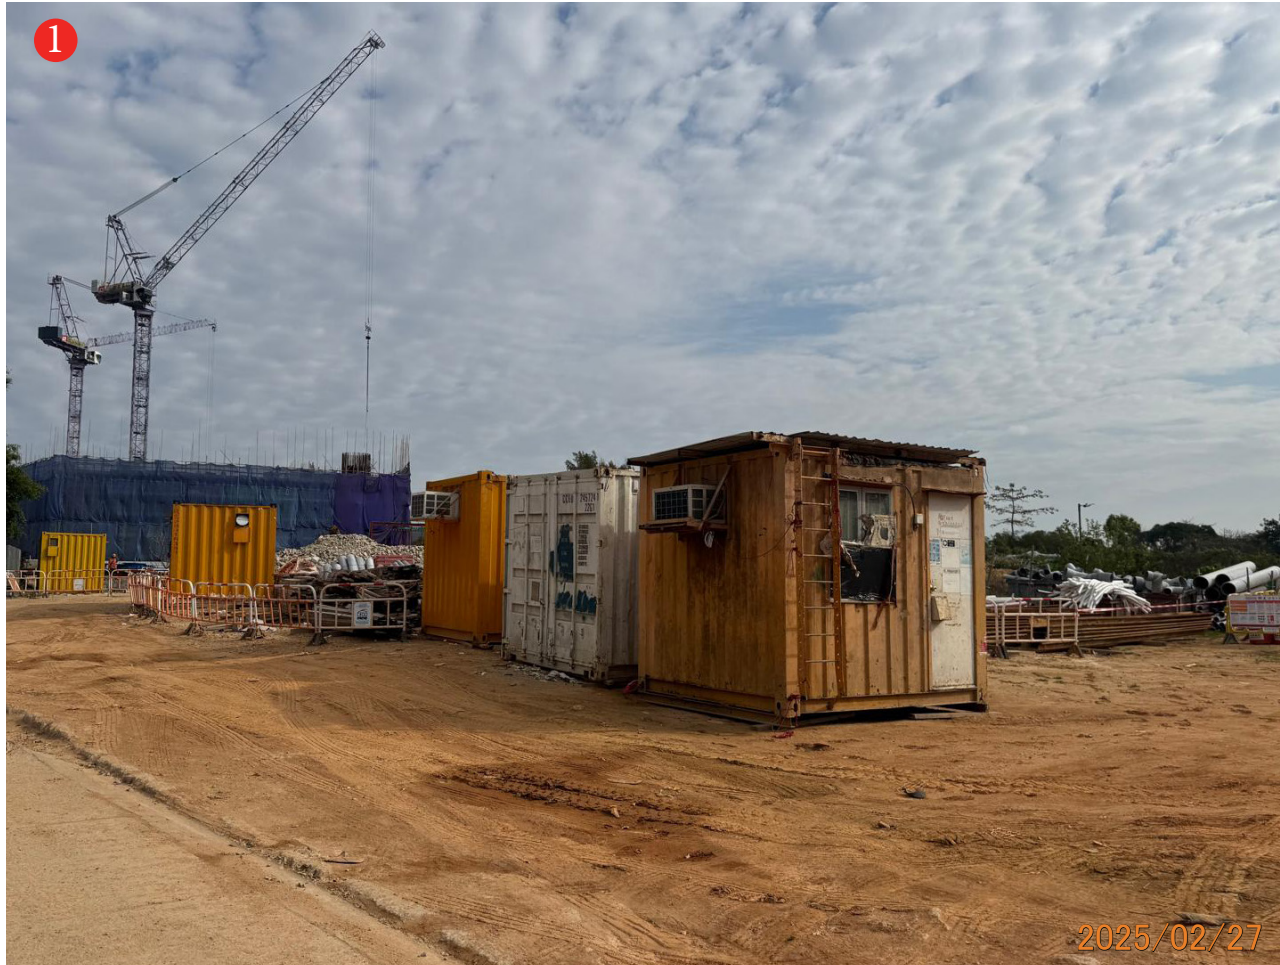
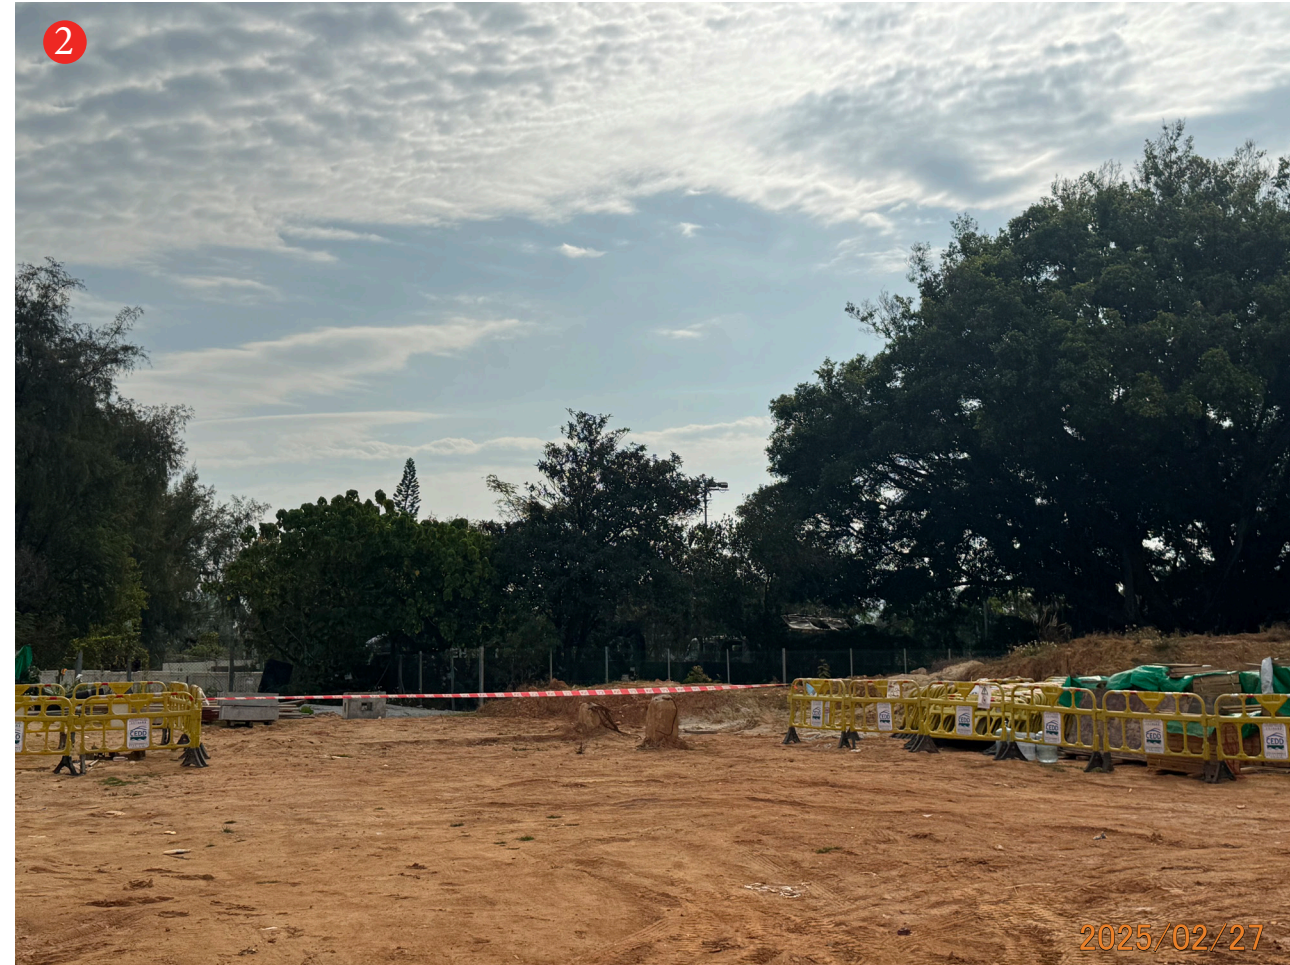
**LDR-2.1** Site Formation Areas Including Remains of Dills Corner Garden Housing

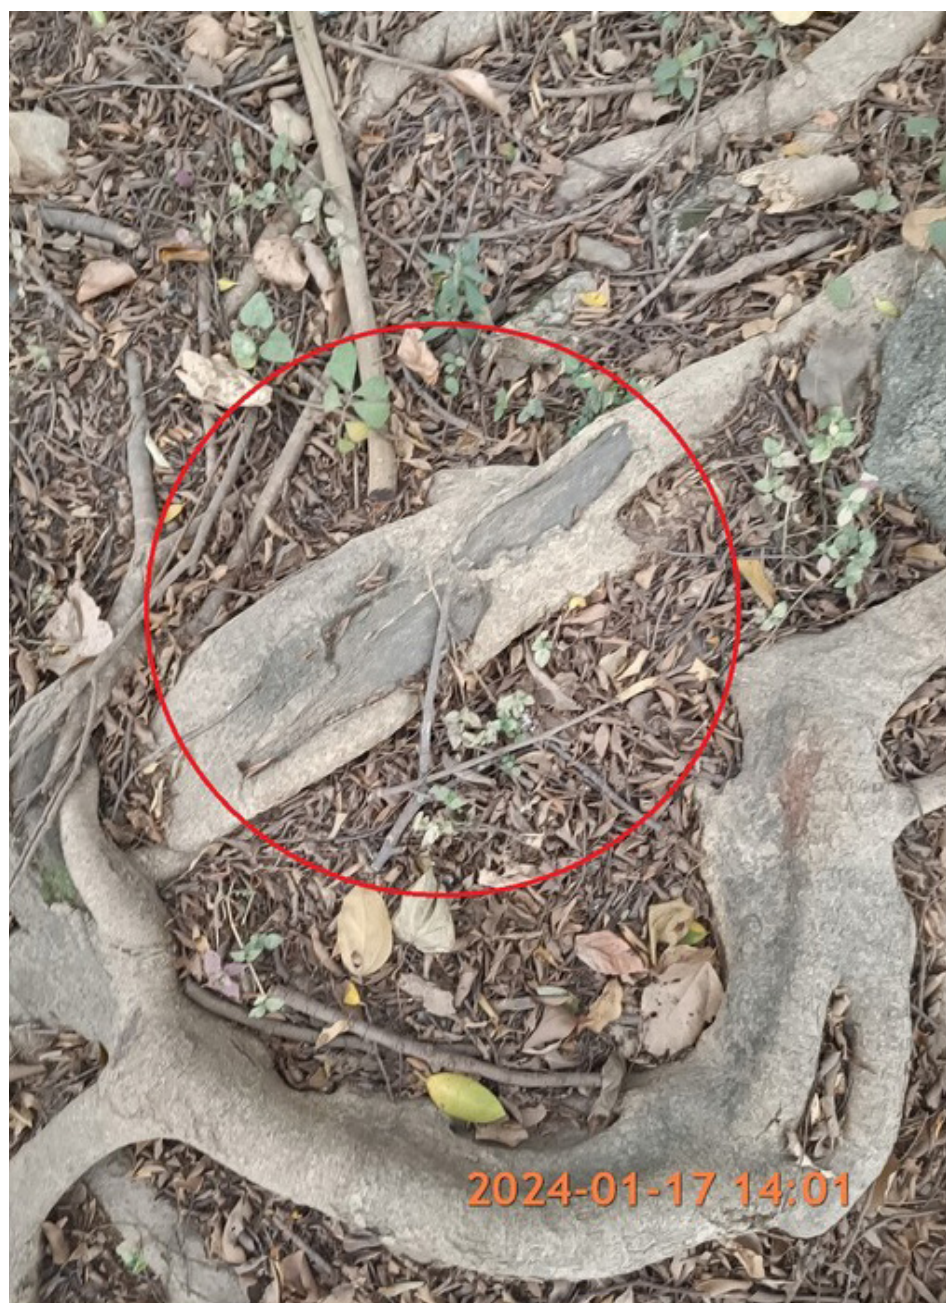
T038\_Ficus\_microcarpa (6)\_Retain\_Mechanical wound on root

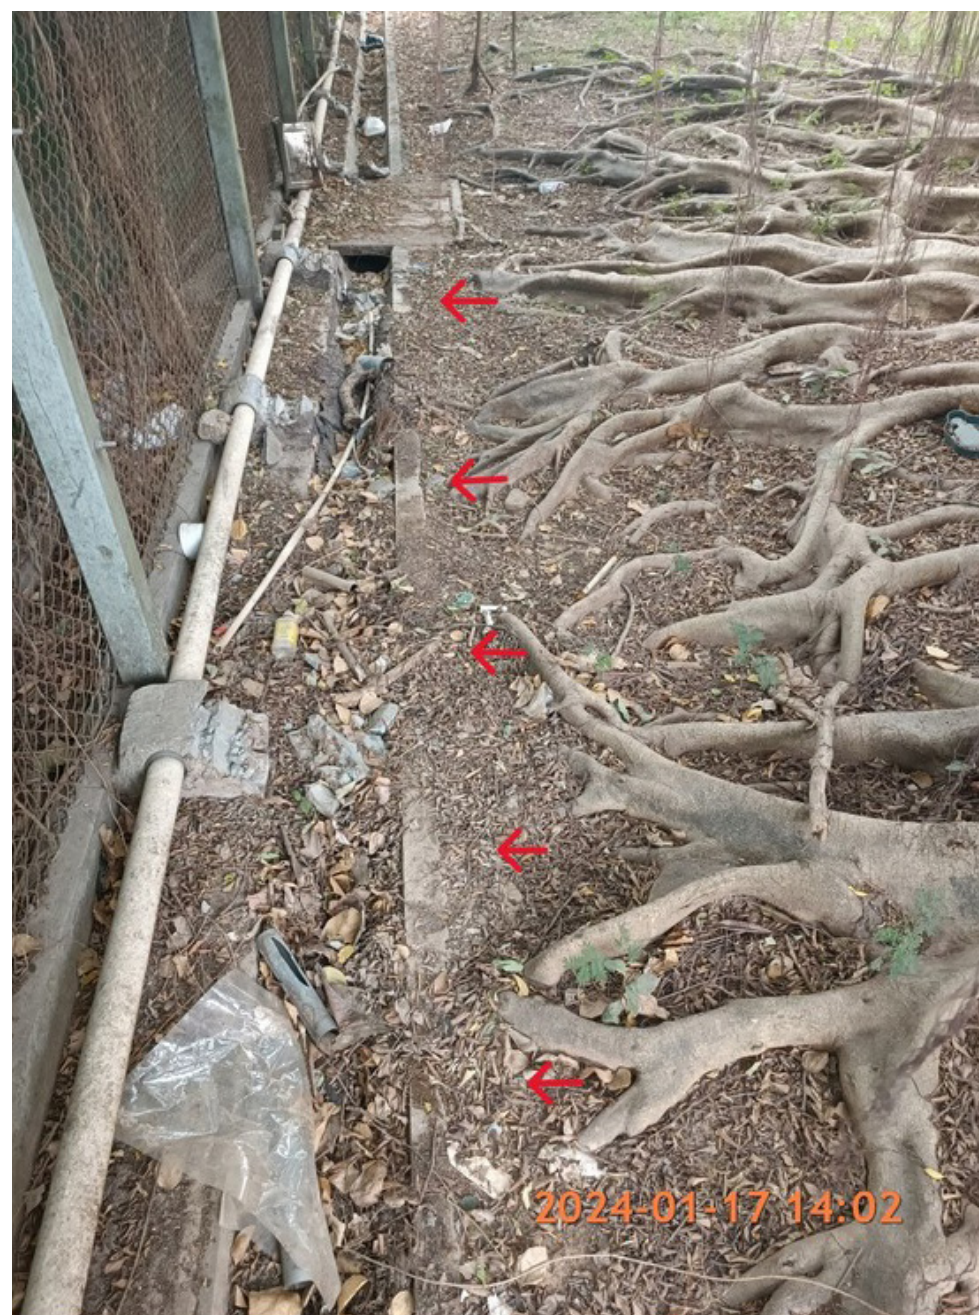
T038\_Ficus\_microcarpa (7)\_Retain\_Restricted root

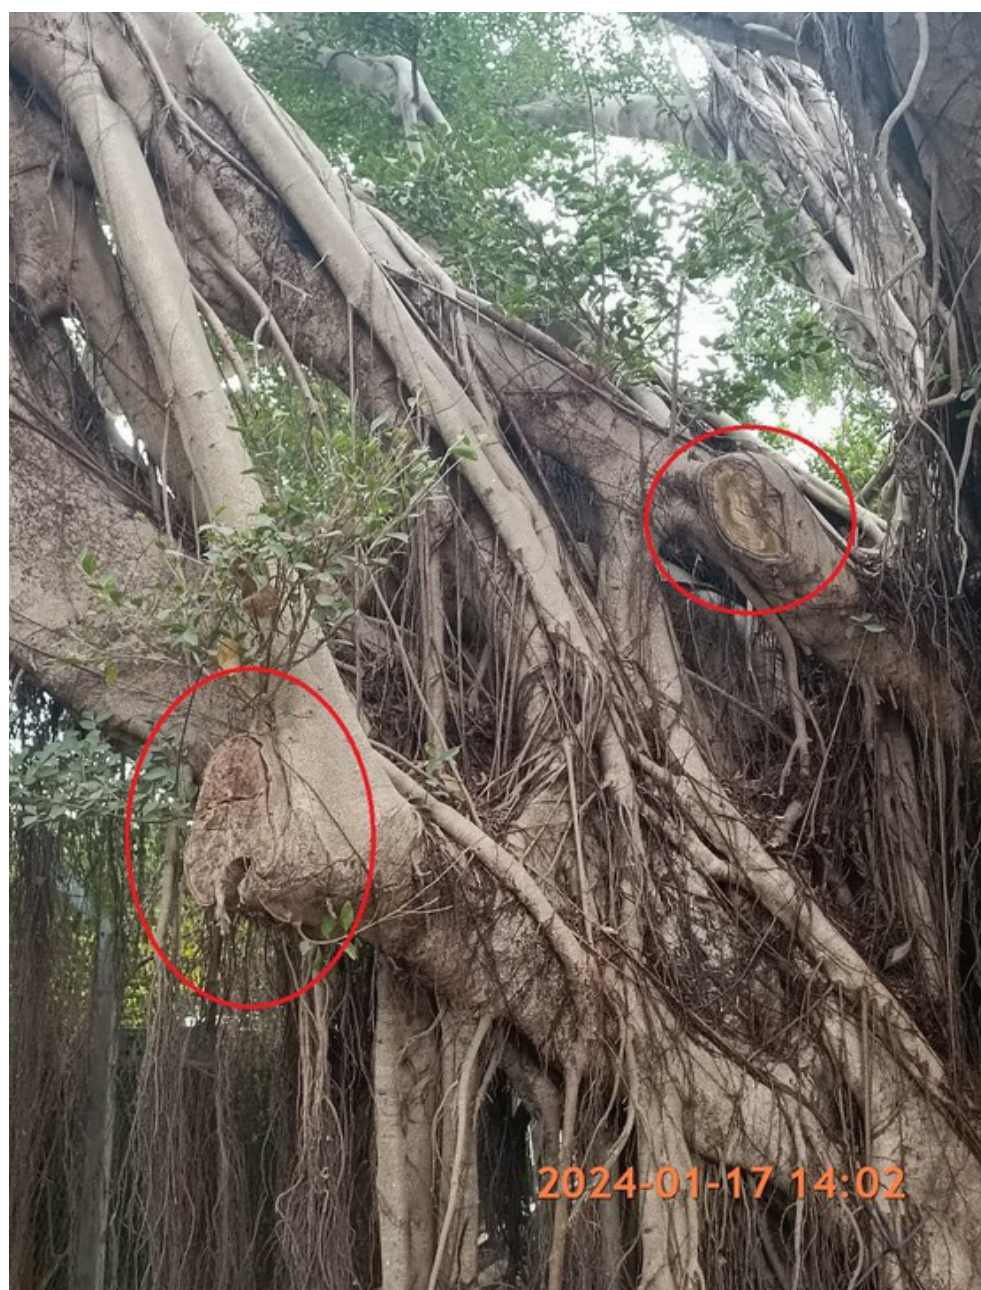
T038\_Ficus\_microcarpa (8)\_Retain\_Pruning wounds

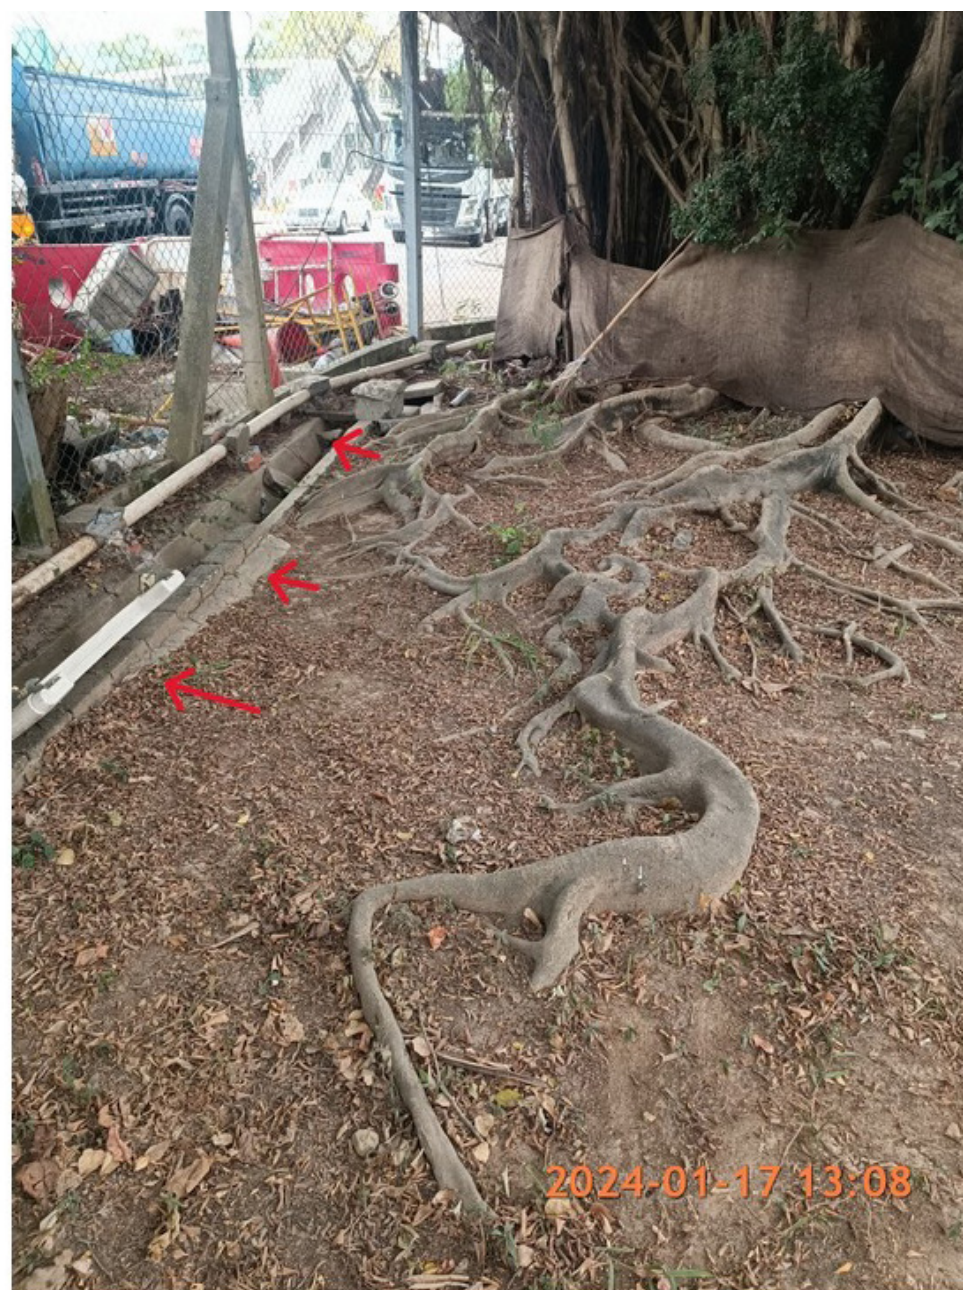
T042\_Ficus\_microcarpa (6)\_Retain\_Root\_Restricted root

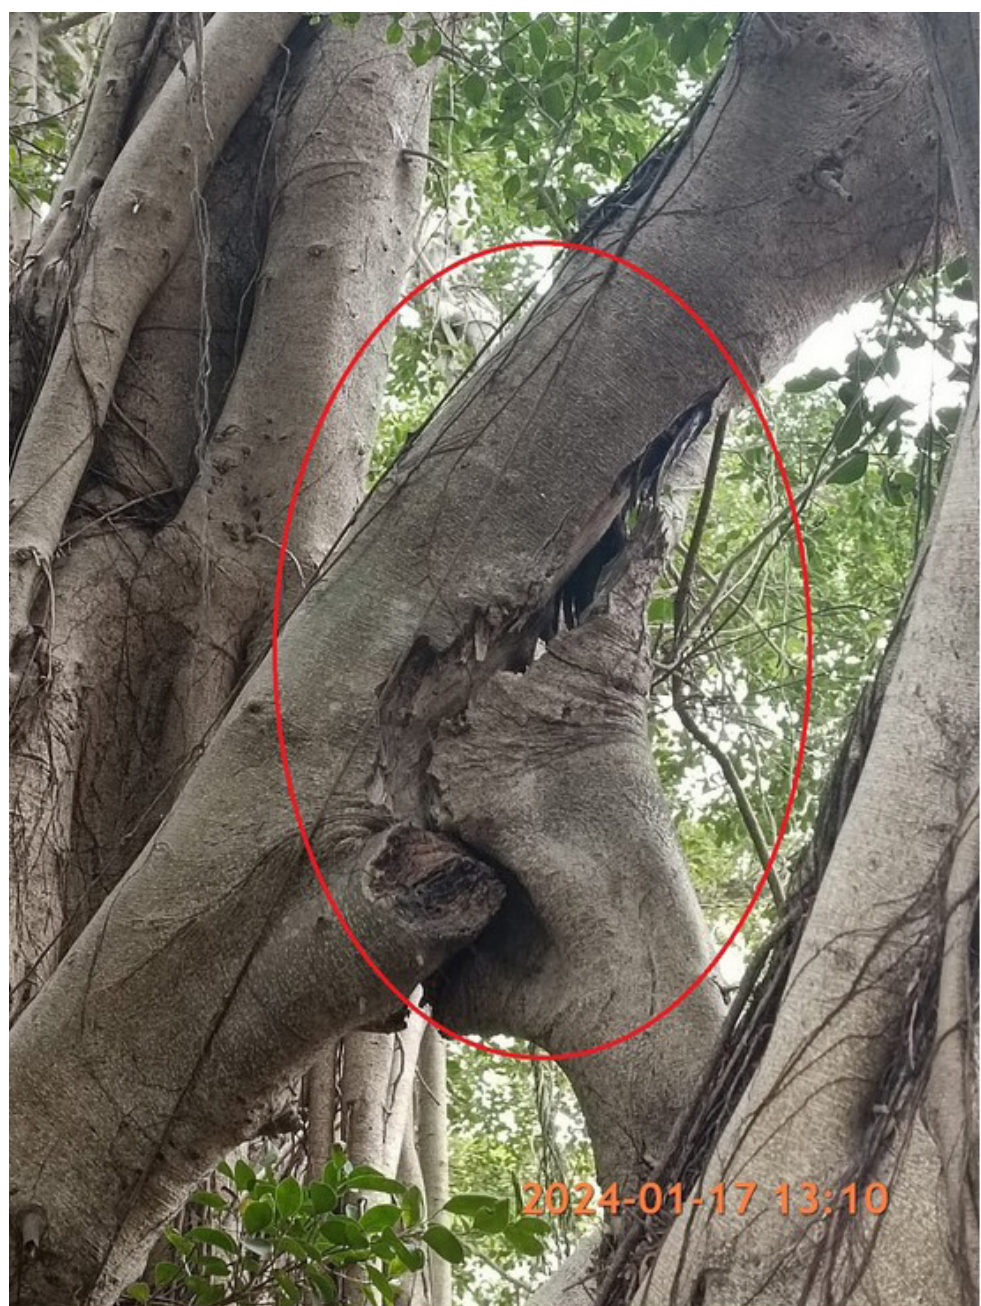
T042\_Ficus\_microcarpa (7)\_Retain\_Split branch

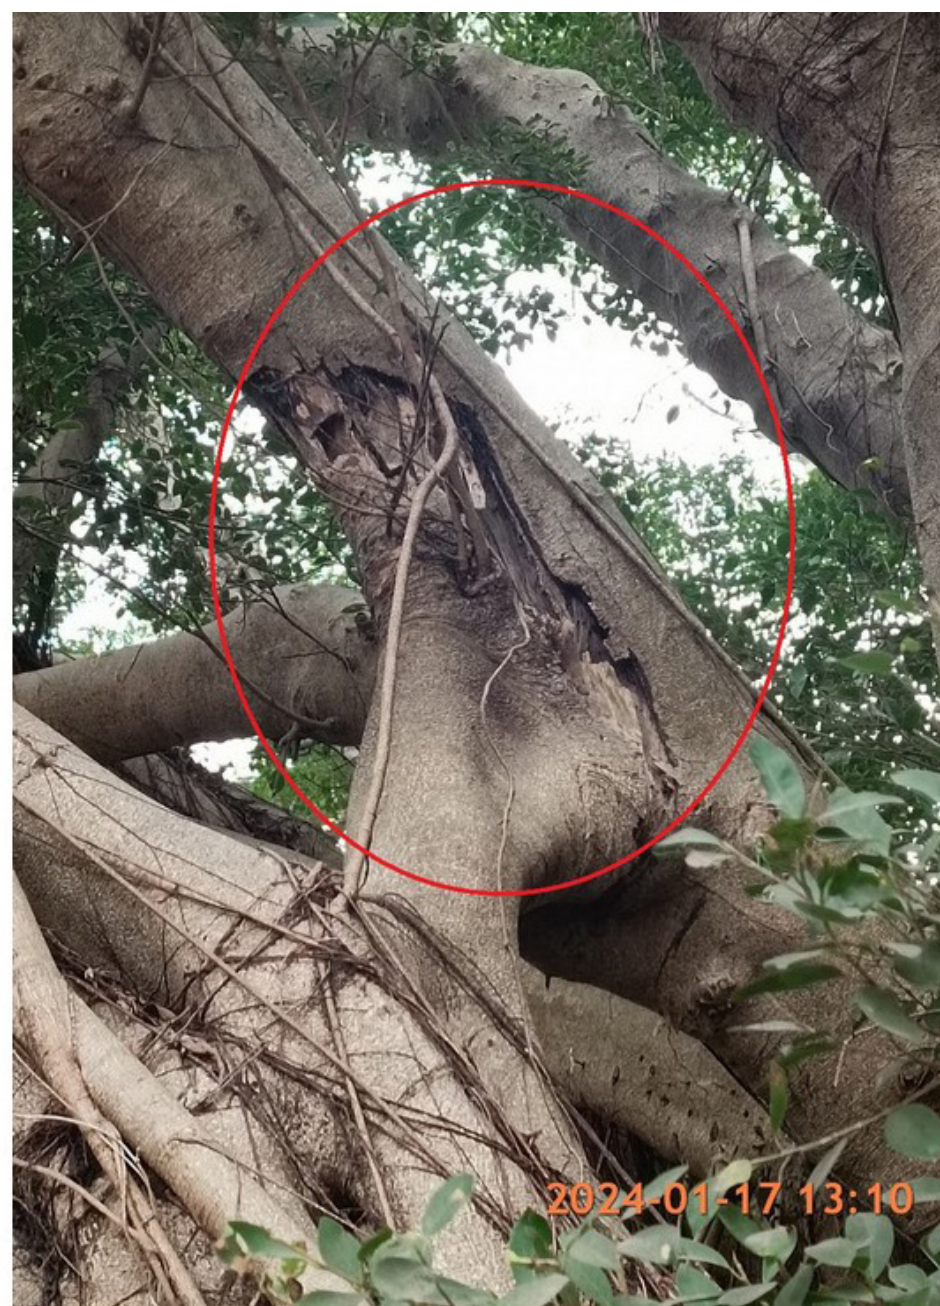
T042\_Ficus\_microcarpa (8)\_Retain\_Split branch

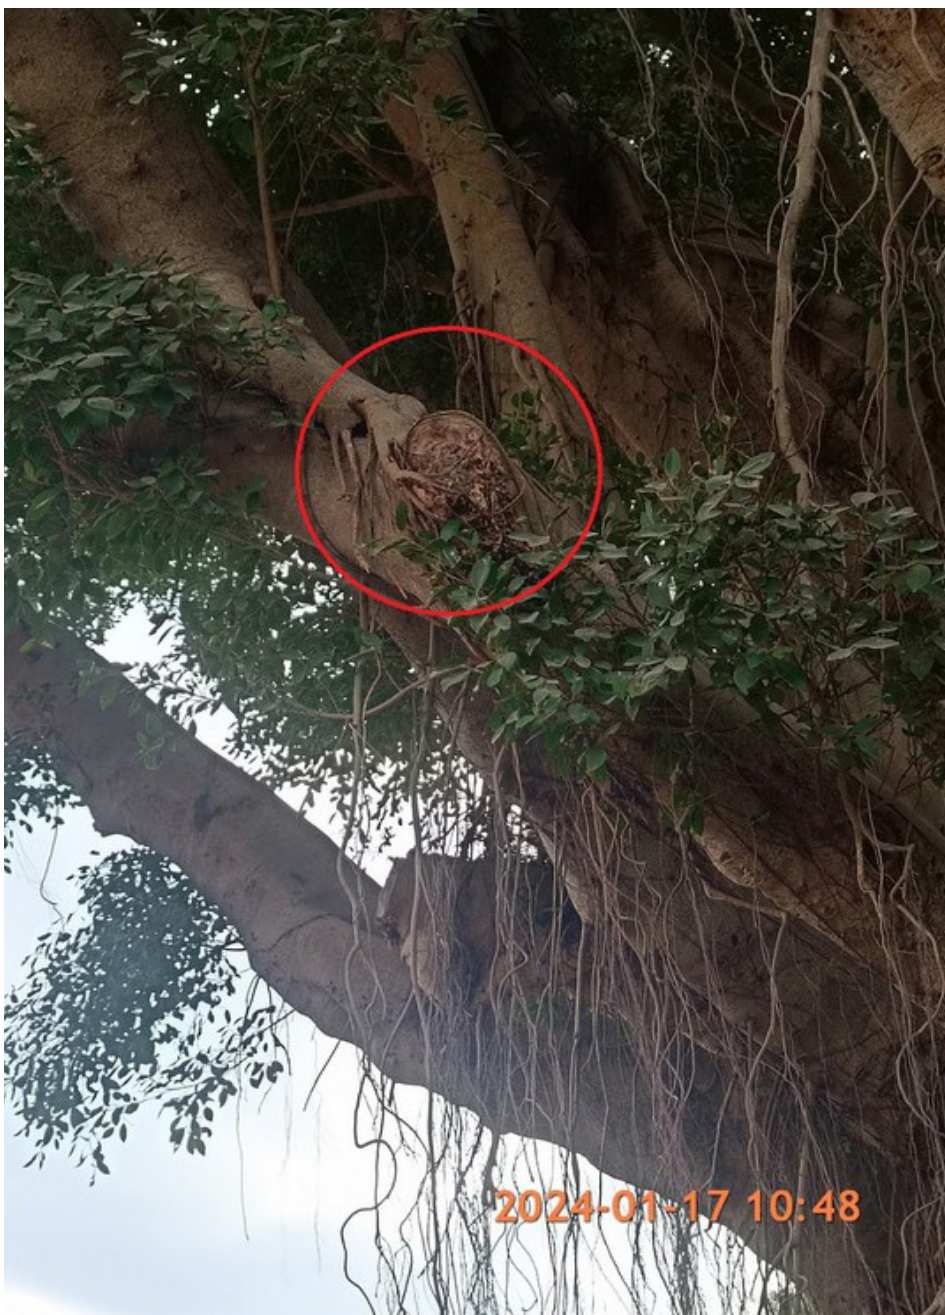
T059\_Ficus\_microcarpa (7)\_Retain\_Decayed pruning wound on branch

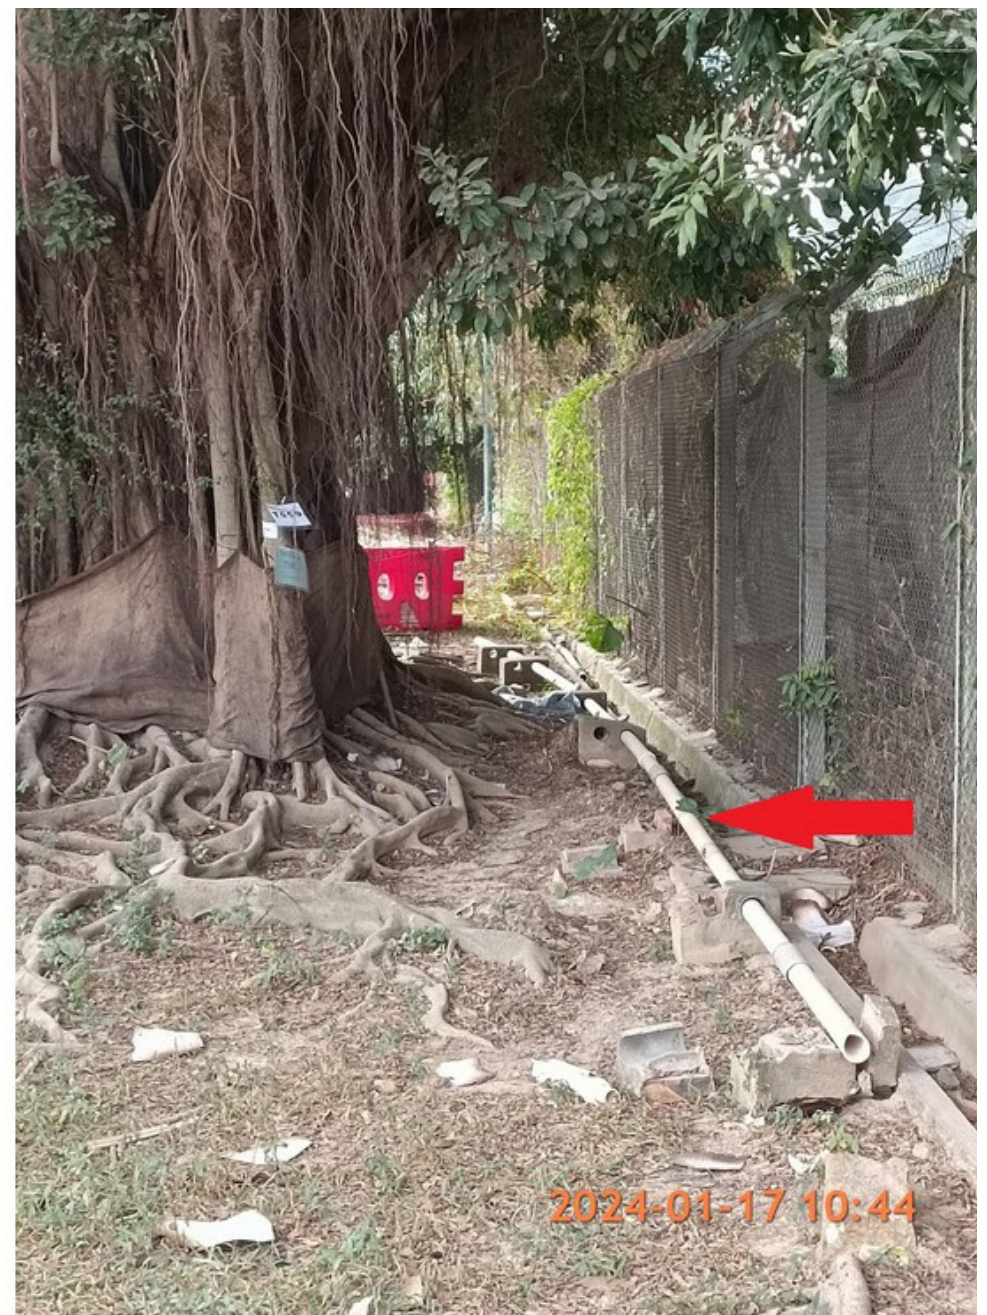
T059\_Ficus\_microcarpa (8)\_Retain\_Restricted root

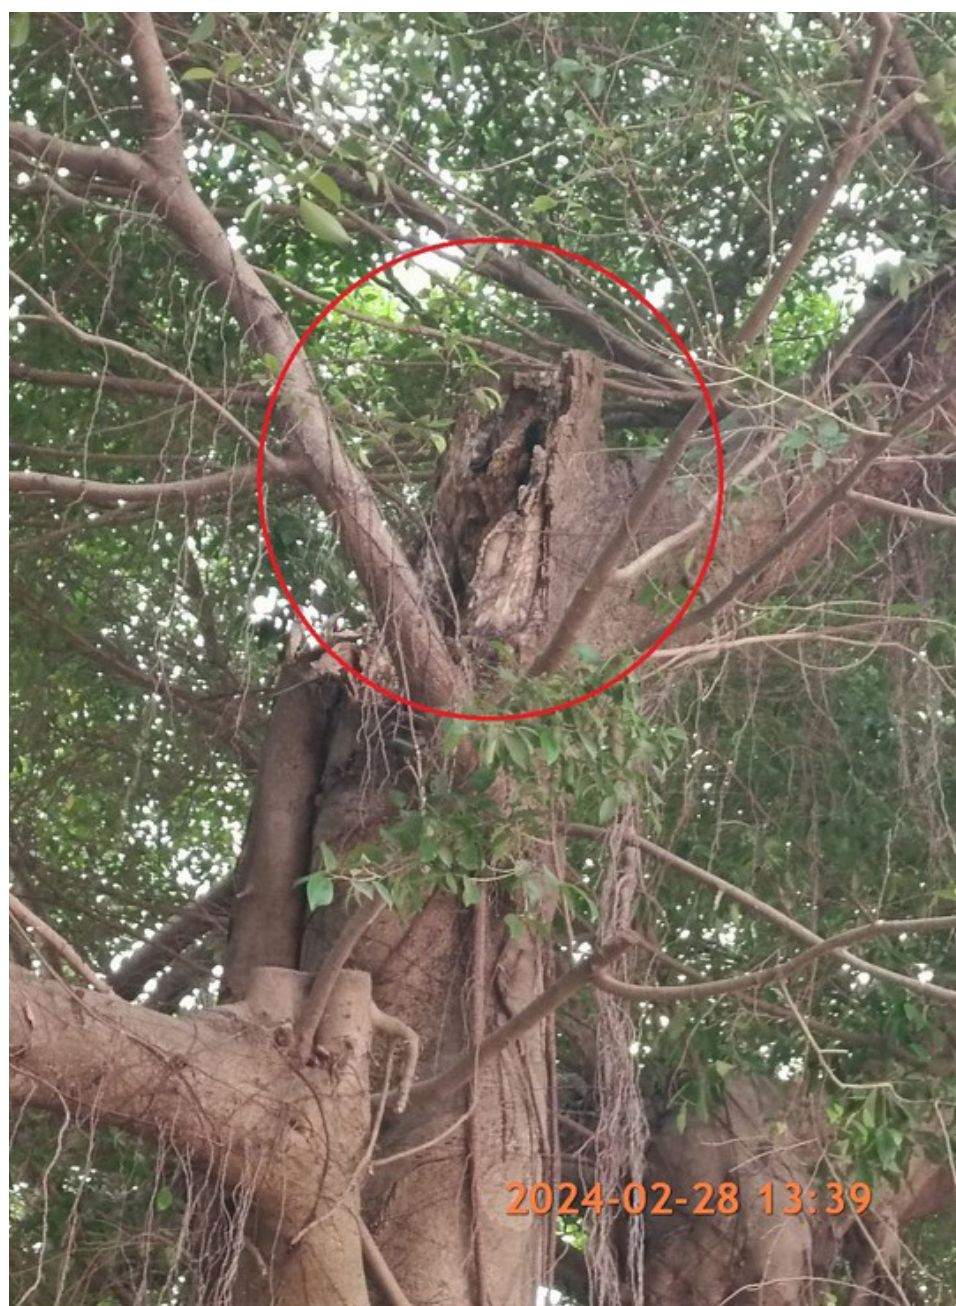
T064\_Ficus\_microcarpa (3)\_Fell\_Cavity on branch

“The tree exhibits significant decay, with two primary limbs previously removed, leaving stumps that are now severely decayed and likely to impact the trunk base in the future. The TPI is in poor condition with multiple structural defects, and the anticipated survival and recovery after transplantation is low. Should transplanting be carried out, the tree would require substantial root pruning to form a reasonable sized root ball. Additionally, the presence of the existing U-channel and fence footings restricts root growth on the west side, impeding the formation of a balanced root ball. Extensive crown pruning would be necessary for transplantation, which would result the loss of the tree's natural form and further compromise the tree's structure and stability. In view of the tree's maturity and very large size, the tree has low resilience to transplanting shock and the anticipated survival rate after transplanting is low. As such, T064 is not recommended to be transplanted.”

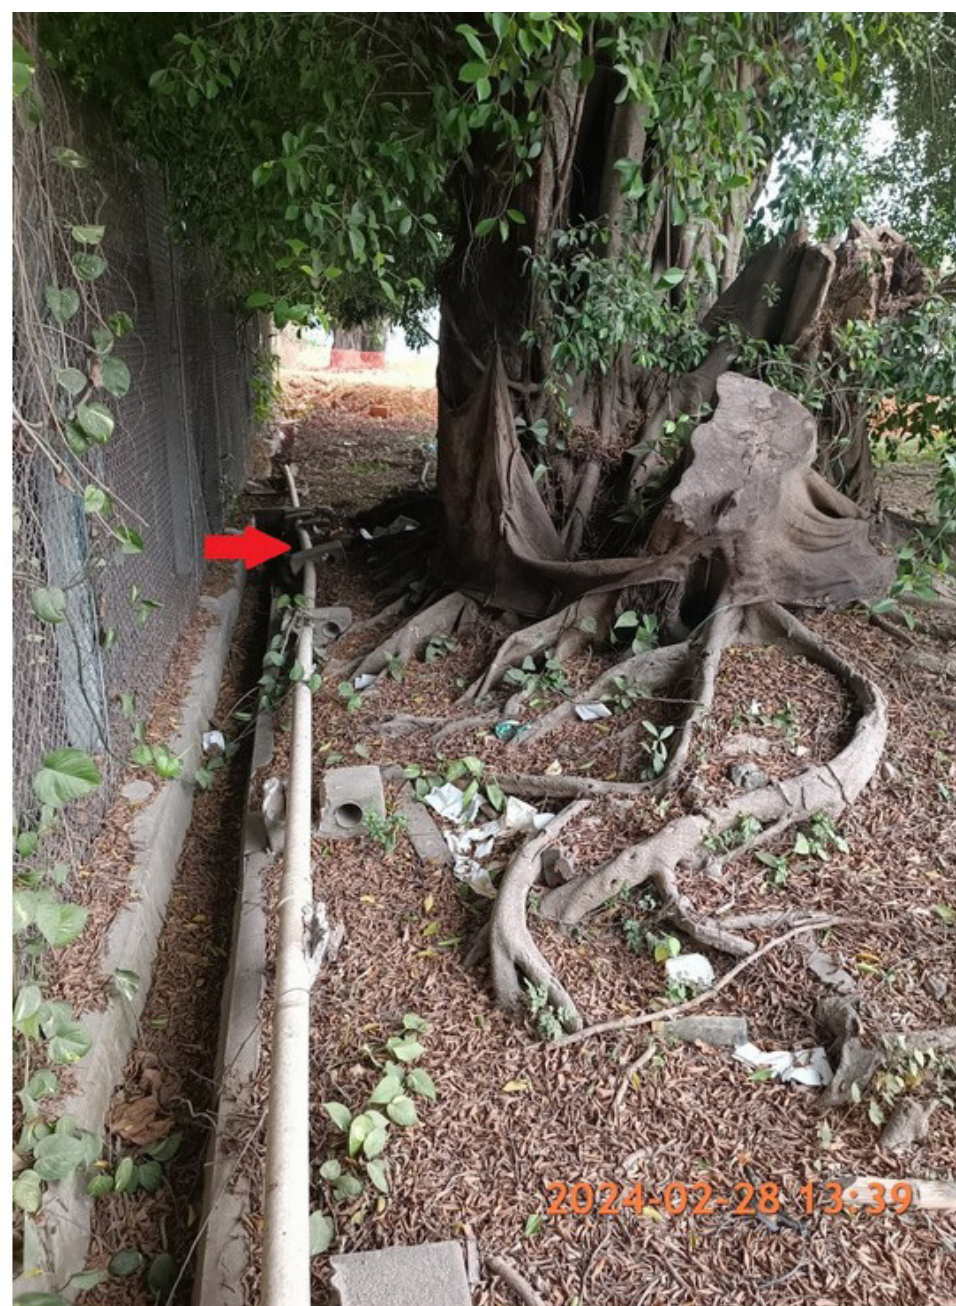
T064\_Ficus\_microcarpa (4)\_Fell\_Restricted root

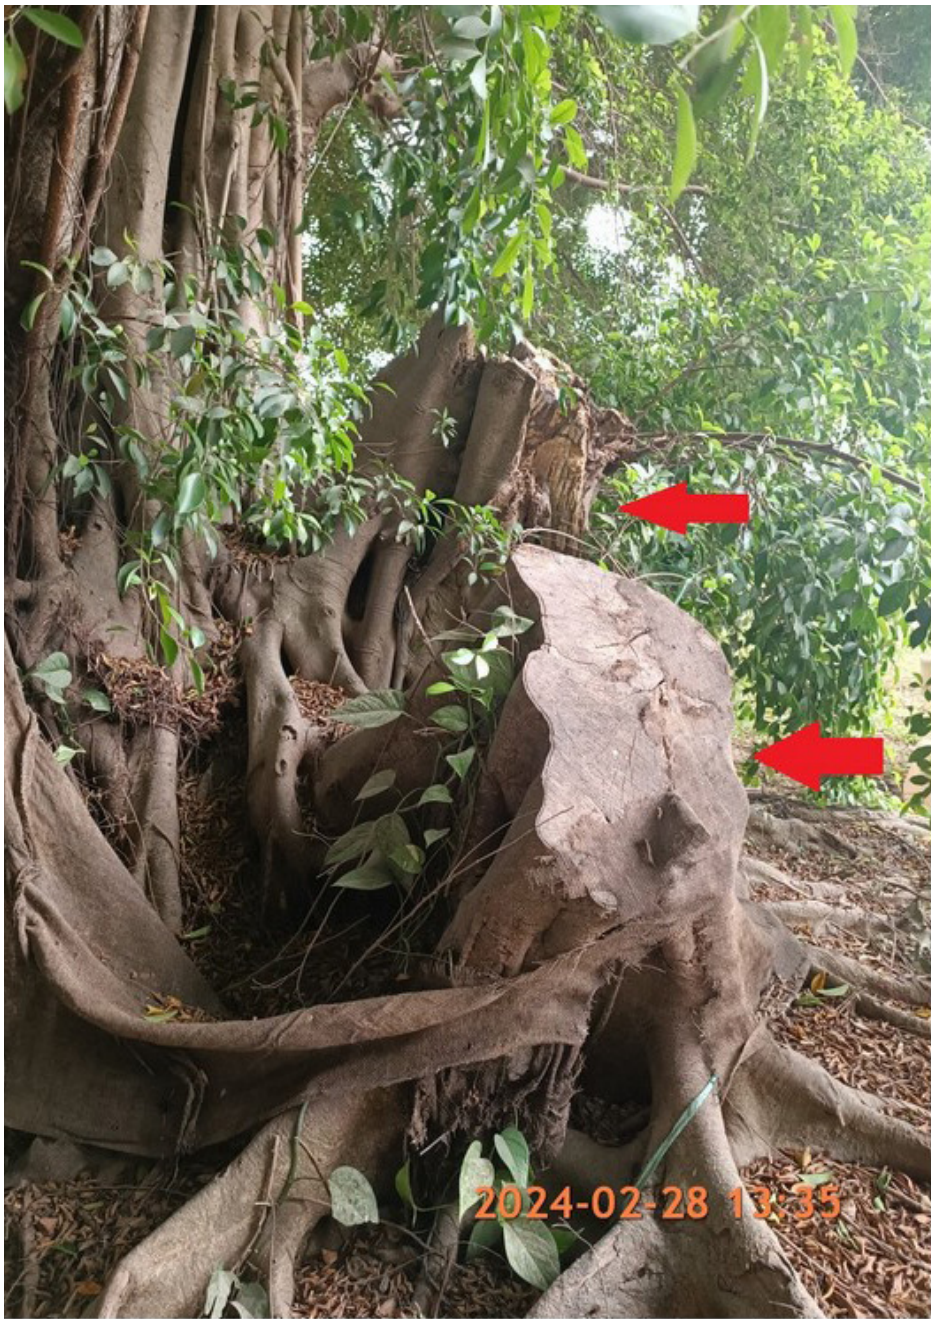
T064\_Ficus\_microcarpa (5)\_Fell\_ Two removed primary limbs
